I. H. MATHERS

Presentation Overview

1520 Queen Street

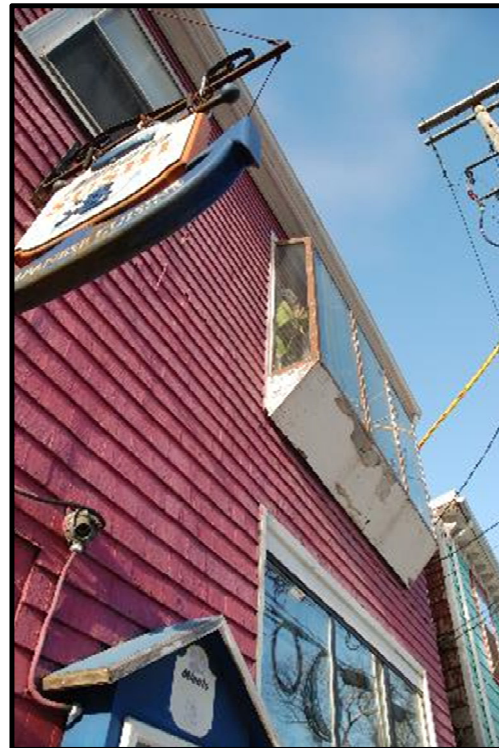
Detail of second floor bay window addition

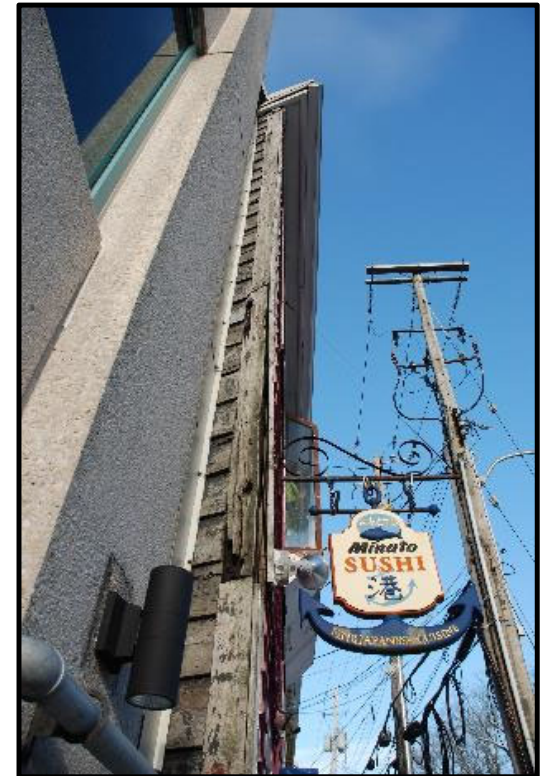
Detail of deteriorated corner board adjacent 5475 Spring Garden Road

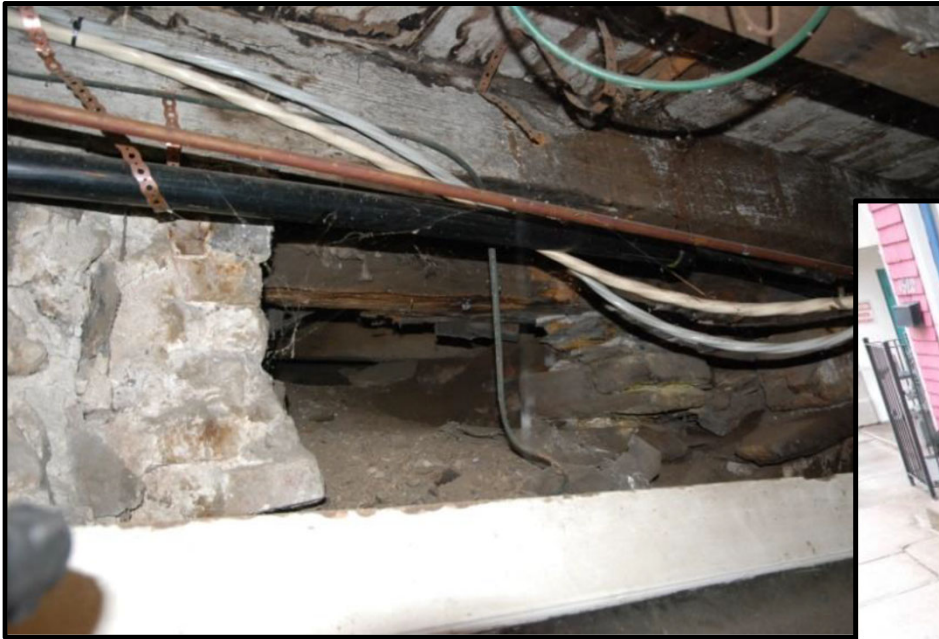
Decayed floor joist at top of foundation wall.

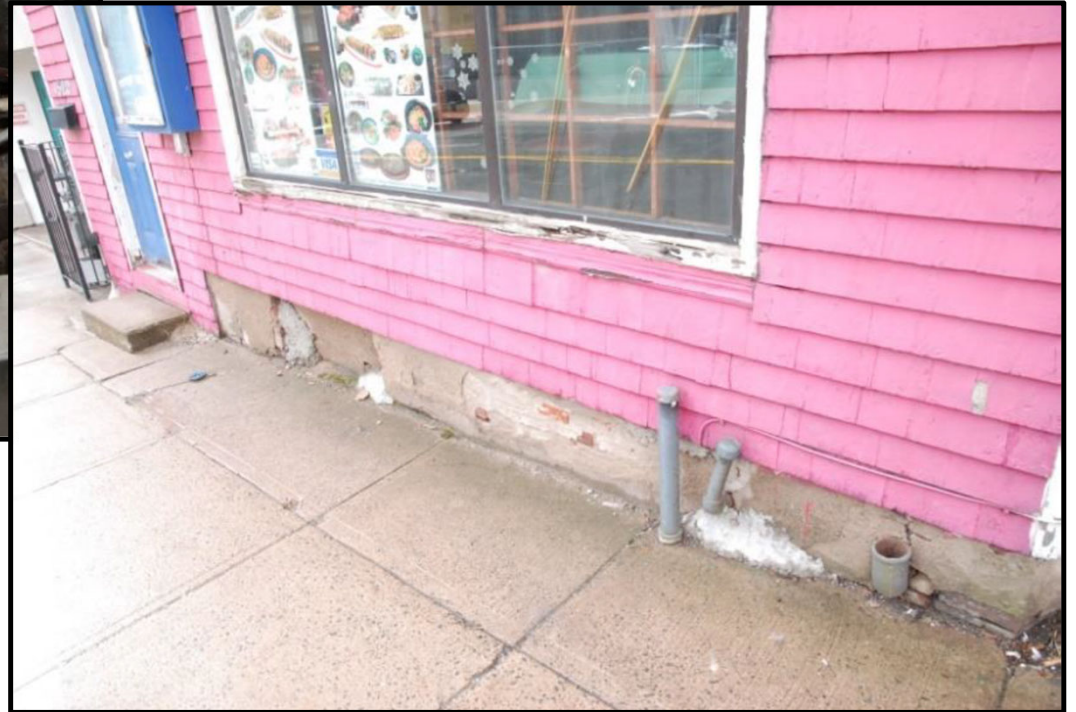
Deteriorated front foundation wall above sidewalk

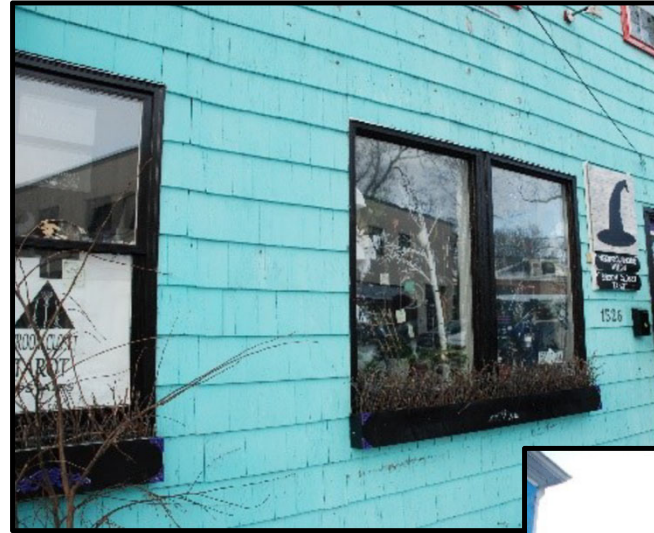
Detail of first floor replacement window

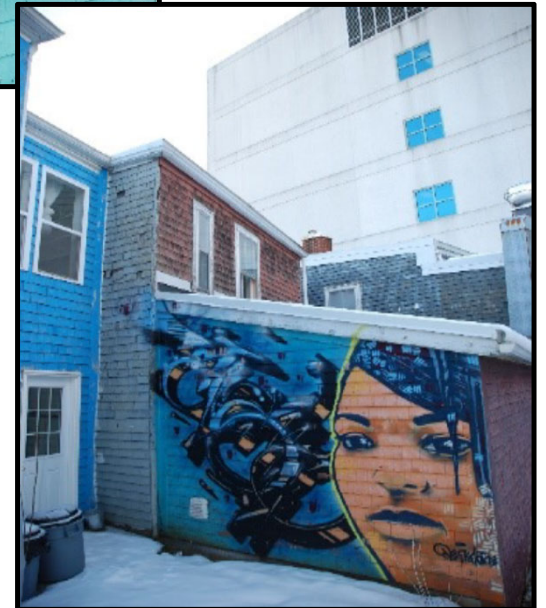
Rear addition

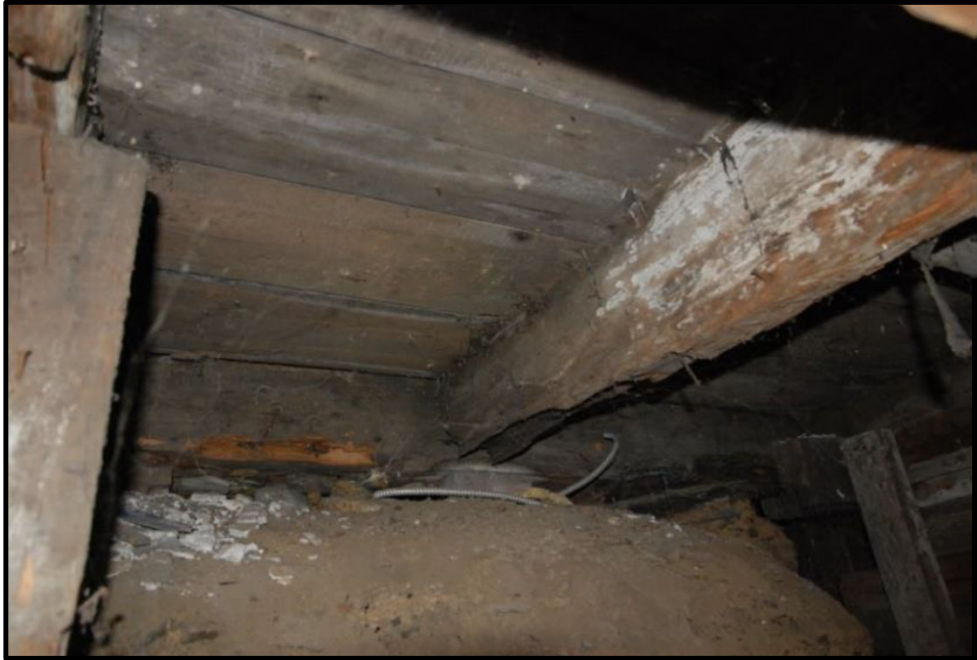
Rotted floor joist and bearing at top of excavated soil face

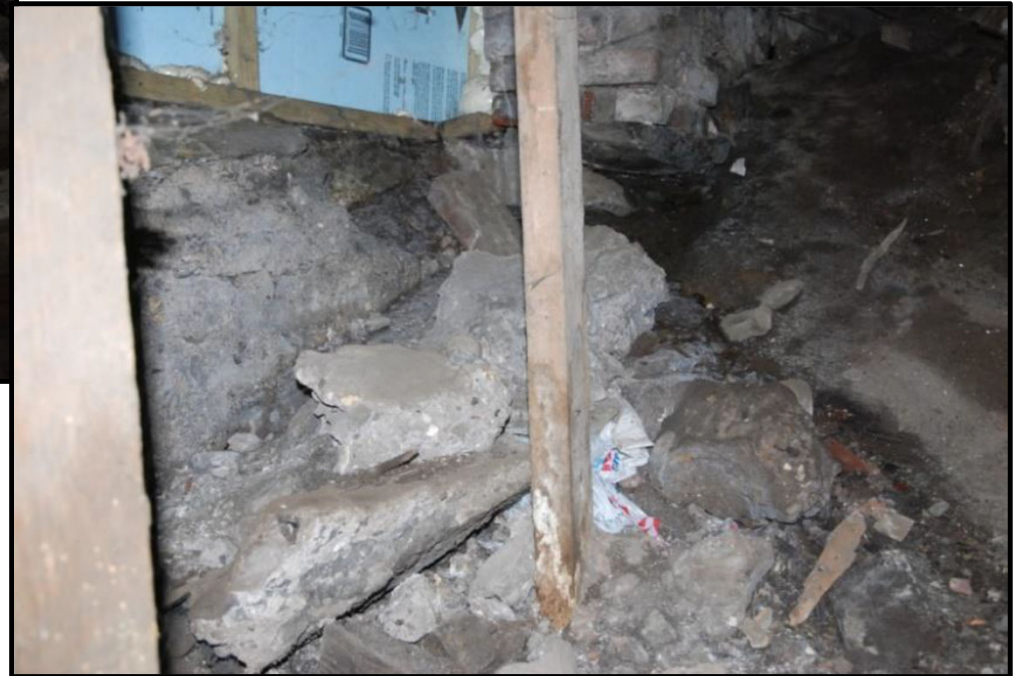
Unsupported foundation wall section

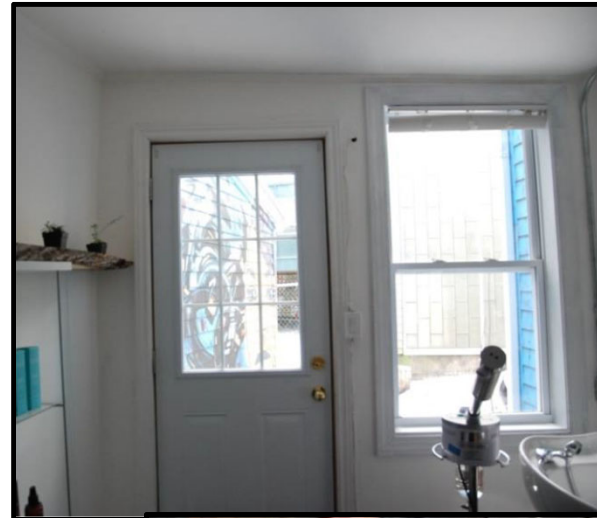
Distorted ceiling line at rear of building

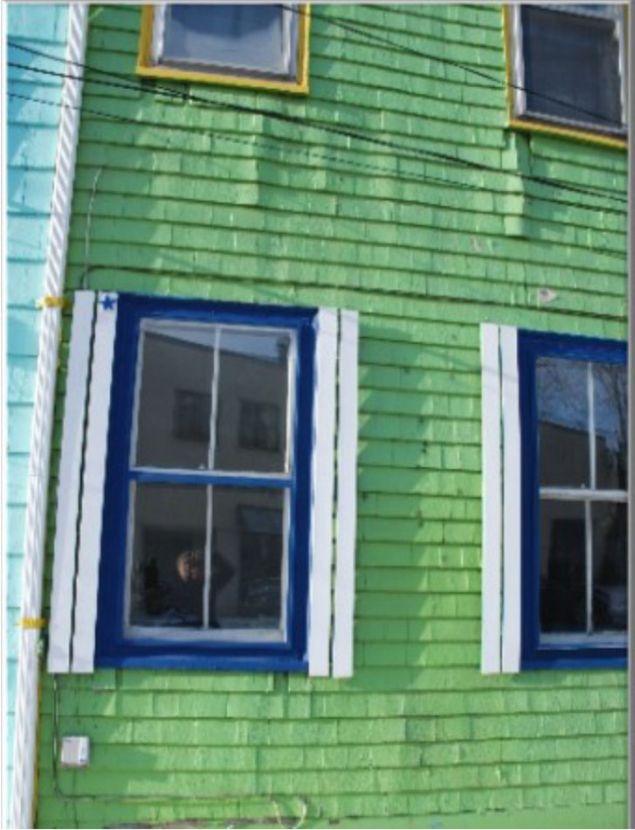
Buckled shingles in front of building

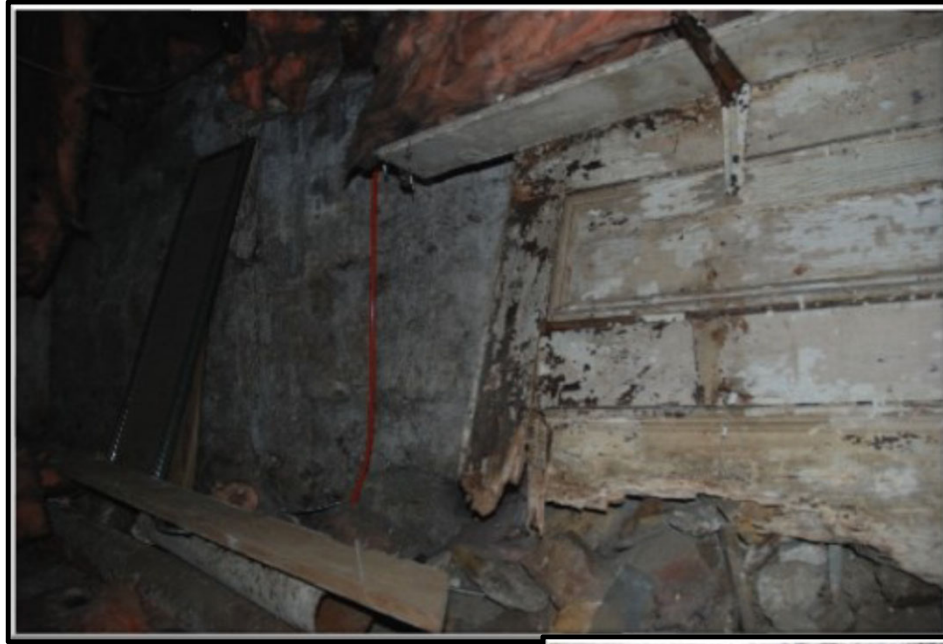
Door used to retain earth at basement wall

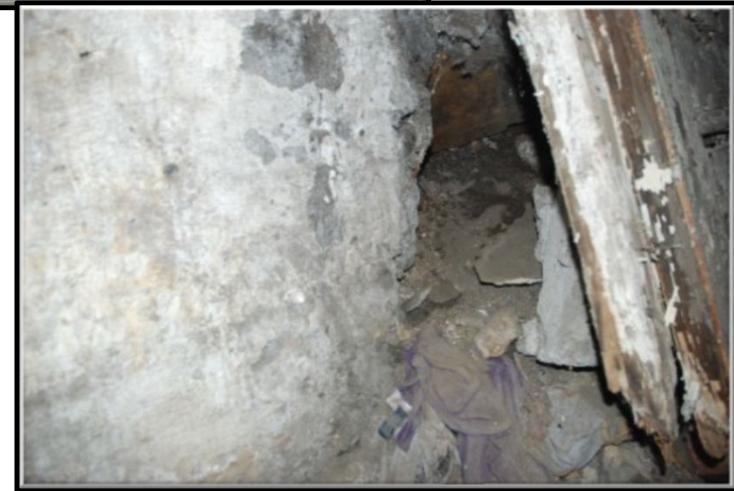
Detail of door used to retain earth at basement wall

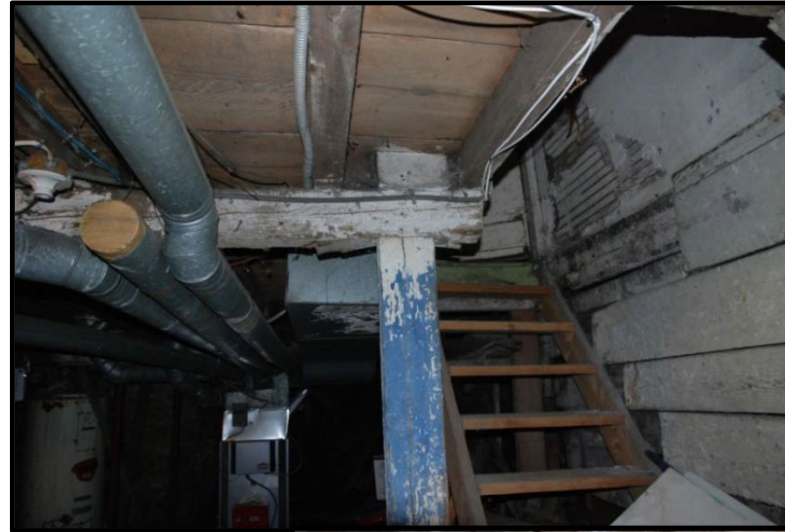
Crushing of bearing at main beam support; note small 4 x 3 floor joists

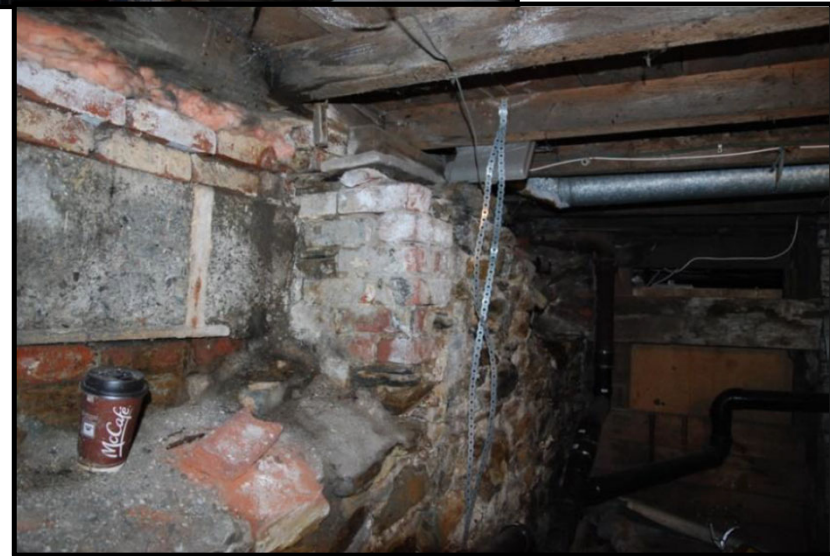
Bulging and deteriorated stone foundation at front. Loose stones and bricks

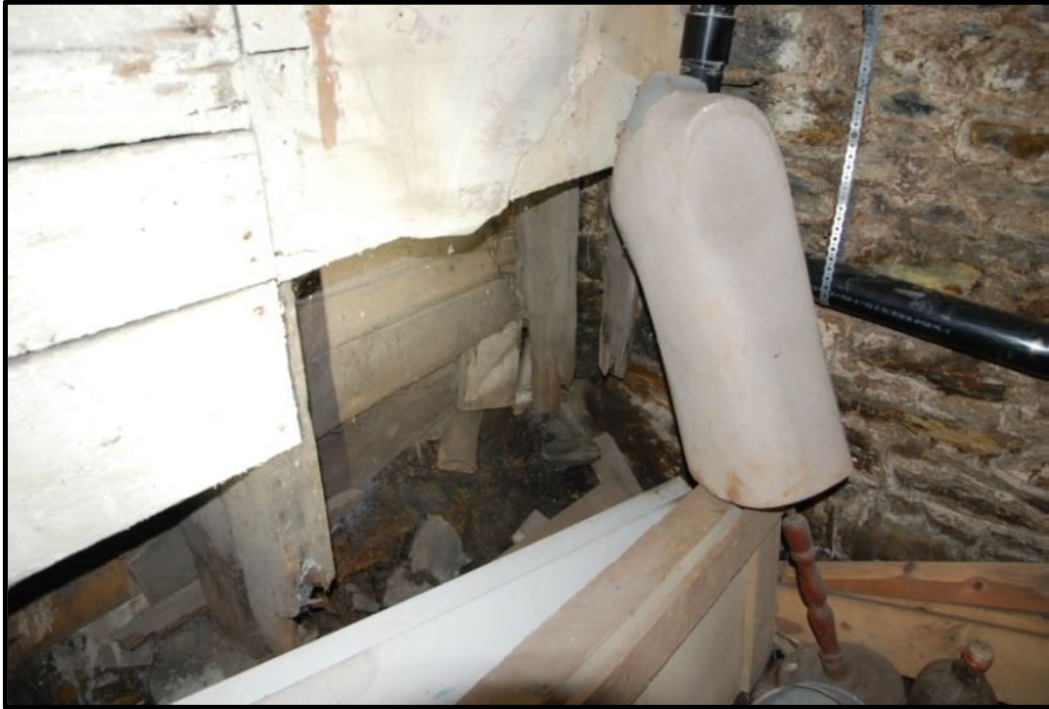
Partition wall at north side of basement rotted and missing framing

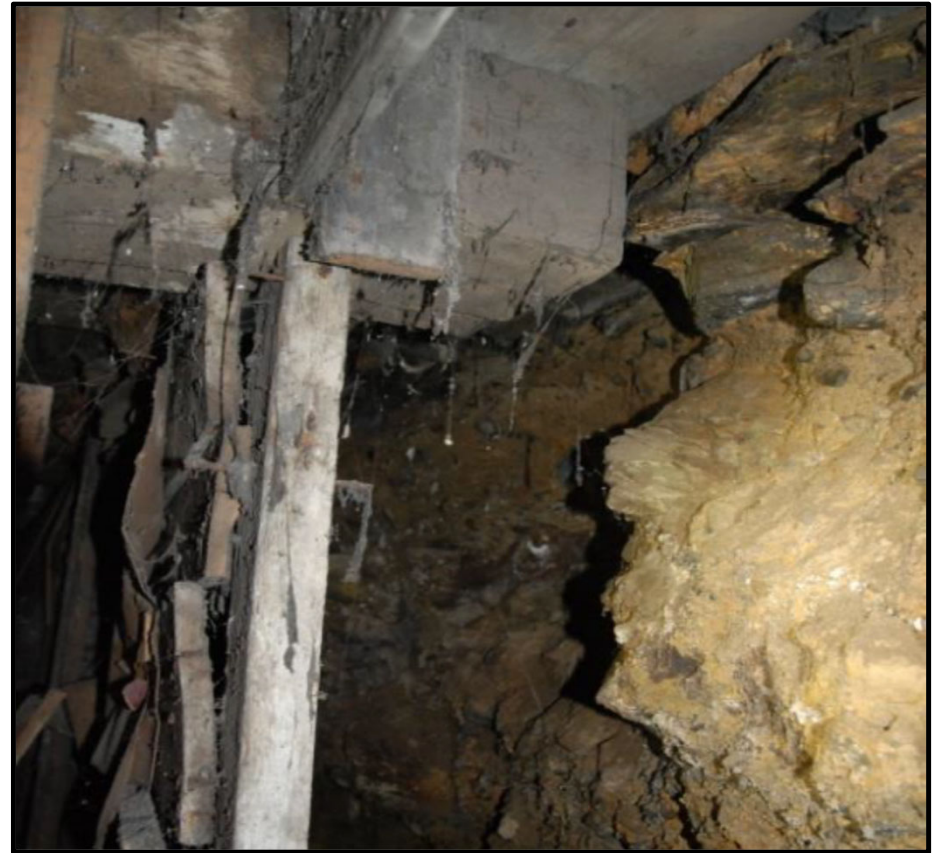
Exposed earth at back of basement
