Portland St and Pleasant St

MicroTraffic Video Diagnostic Findings and Recommendations

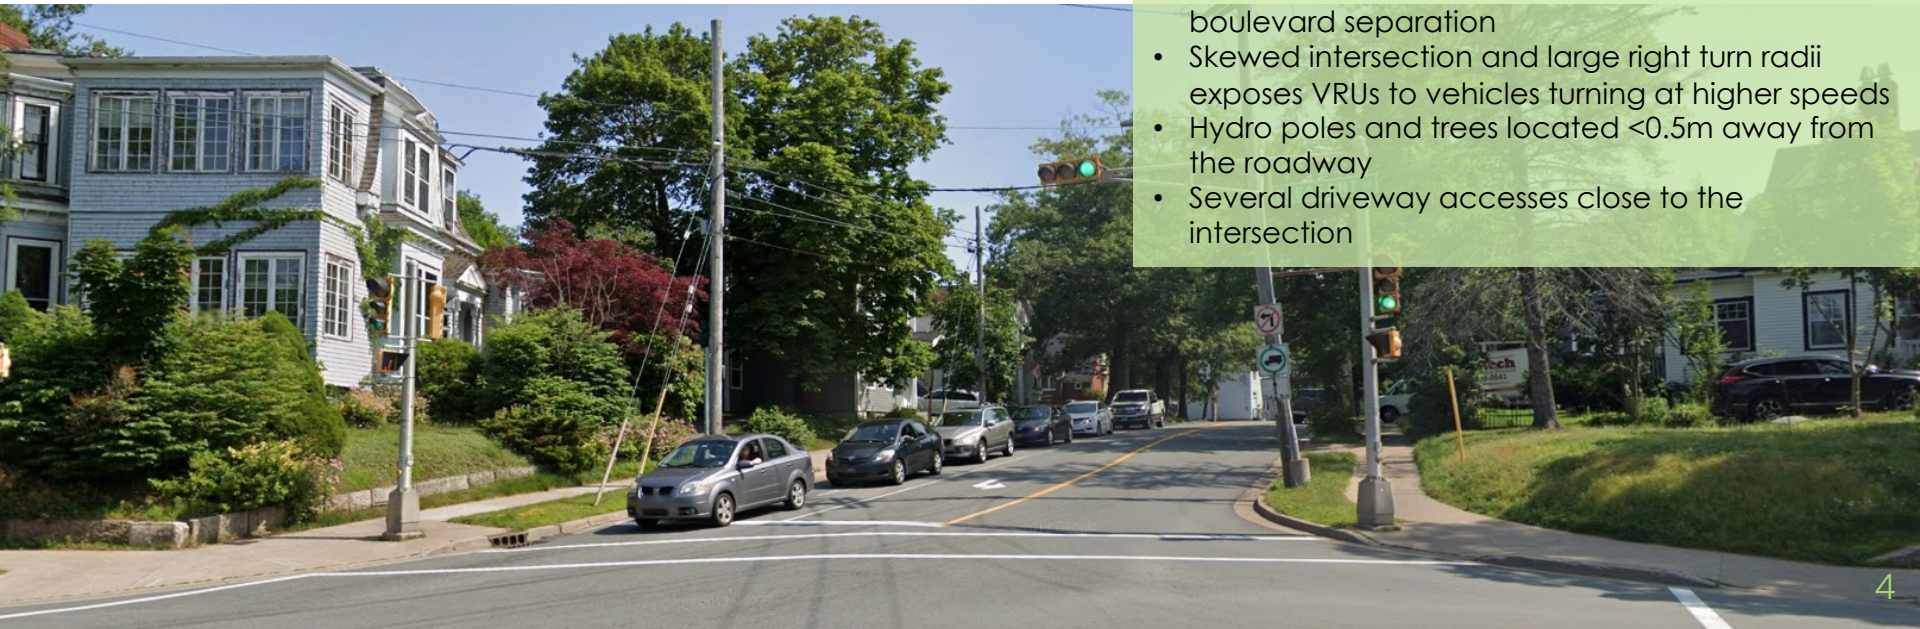
Portland St. Looking North

- Southbound: One through lane and a left turn auxiliary lane
- Northbound: One through lane and a right turn auxiliary lane
- 50 km/h posted speed limit (assumed)
- Northbound left turn not permitted
- Southbound left permissive only
- Four signal heads NB and SB (one nearside each)
- Right turn on red is not restricted
- No reflective back plates on signals
- Sidewalks on both sides of the road with boulevard separation
- Skewed intersection and large right turn radii exposes VRUs to vehicles turning at higher speeds
- Hydro poles and trees located <0.5m away from the roadway
- Several driveway accesses close to the intersection

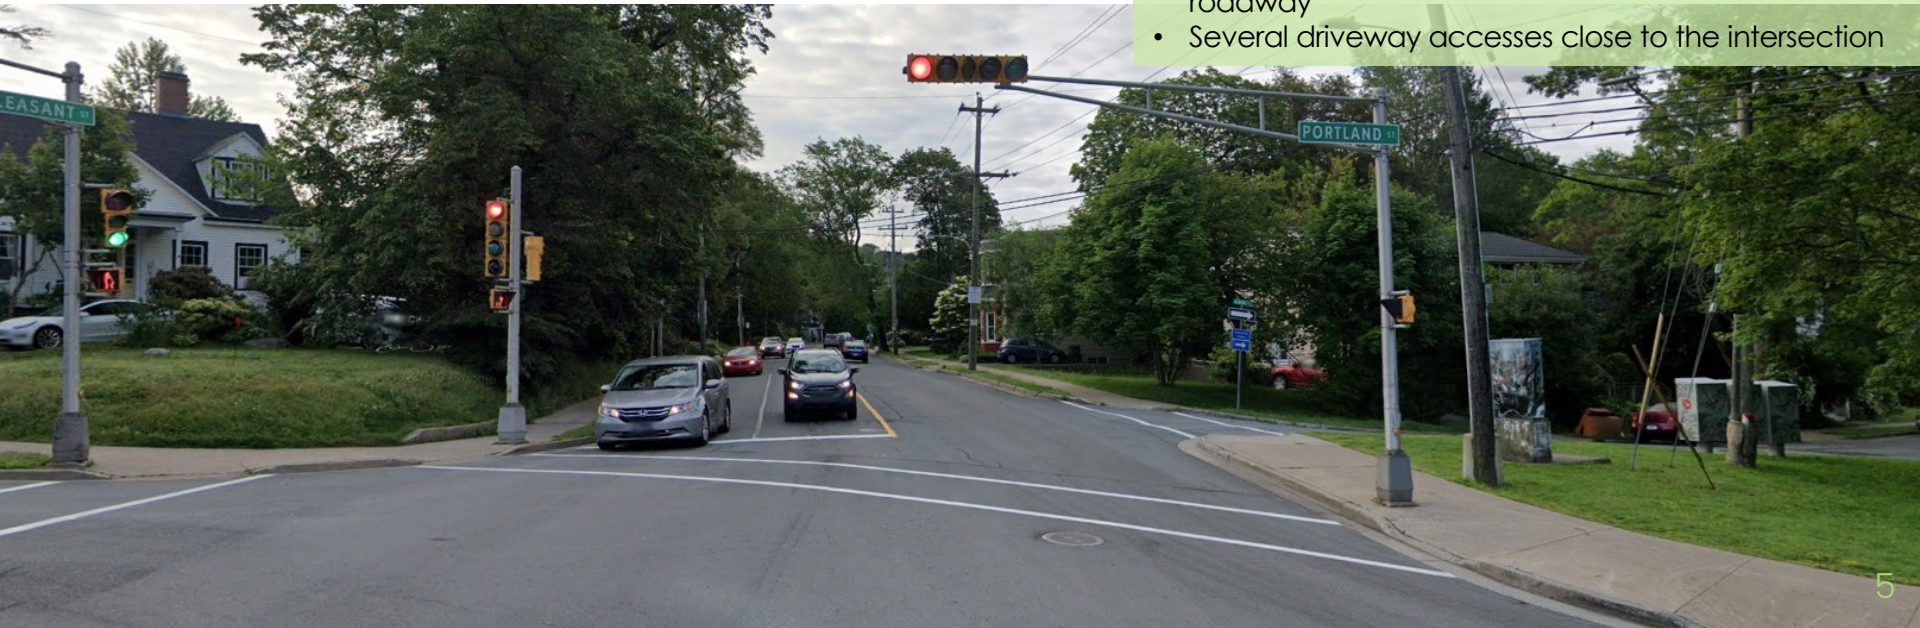
Pleasant St. Looking East

- One through lane and a left turn auxiliary lane
- 50 km/h posted speed limit
- Eastbound and westbound left turn signalization protected/permissive
- Two signal heads EB and three signal heads WB (one nearside)
- Right turn on red is not restricted
- No reflective back plates on signals
- Sidewalks on both sides of the road with boulevard separation
- Hydro poles and trees located <0.5m away from the roadway
- Several driveway accesses close to the intersection

<p>Angle collisions:</p> <ul style="list-style-type: none">• Two angle collisions were recorded in the collision data, both included a westbound vehicle running a red light.• Signal perception improvements would be valuable, especially in the EB/WB directions when sun glare may contribute to signal perception failure.	<p>Add reflective backplates to signals.</p>

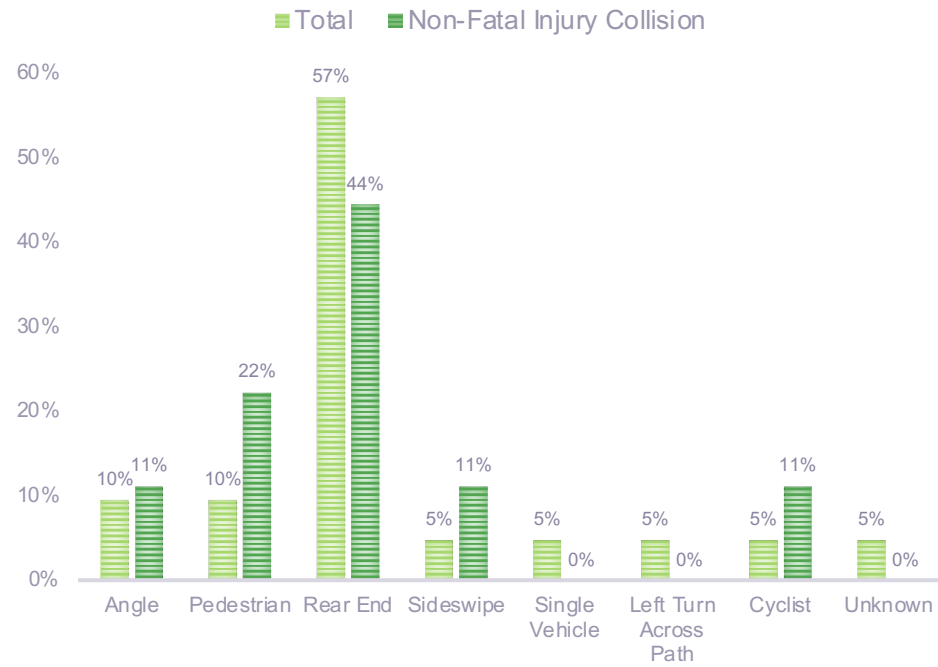
CONFIGURATION DISTRIBUTION OF COLLISIONS

- Pedestrian collisions represent 22% (2 events) of the non-fatal injury collisions. Both pedestrian collisions involved a northbound-right vehicle. The 1 cyclist collision event included a westbound-left vehicle.
- Rear End collisions represent 57% of total collisions and 44% of the non-fatal injury collisions. Of the known directions, the distribution was approximately equal between all four directions.
- Angle collisions represent 10% (2) of total collisions and 11% of the non-fatal injury collisions. Both events included a westbound through vehicle (on Pleasant) running the red light and colliding with a northbound through vehicle.

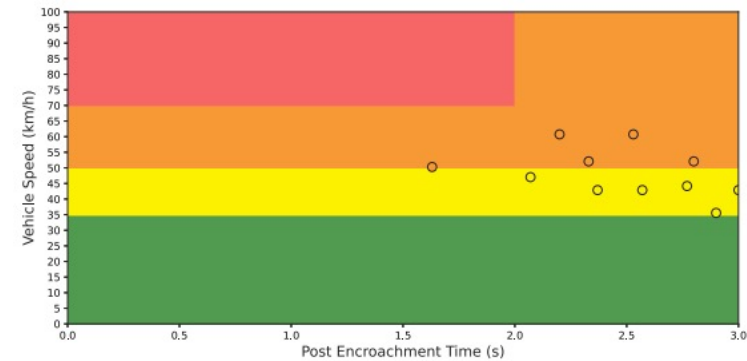
Above: East-left vs West-through data shows that several conflicts occurred with through vehicle speeds exceeding the 50 km/h posted speed limit (up to 60 km/h). At impact speeds of 50 km/h, opposing drivers have a 40% chance of a severe injury (MAIS 3+), which increases to >65% at 60 km/h.

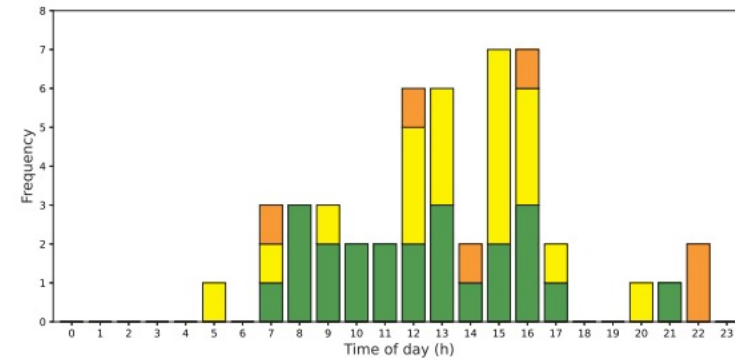
Below: West-left vs East-through conflict data also has high-risk events (speeds > 50 km/h). There is a concentration of conflicts around noon and during peak PM periods.

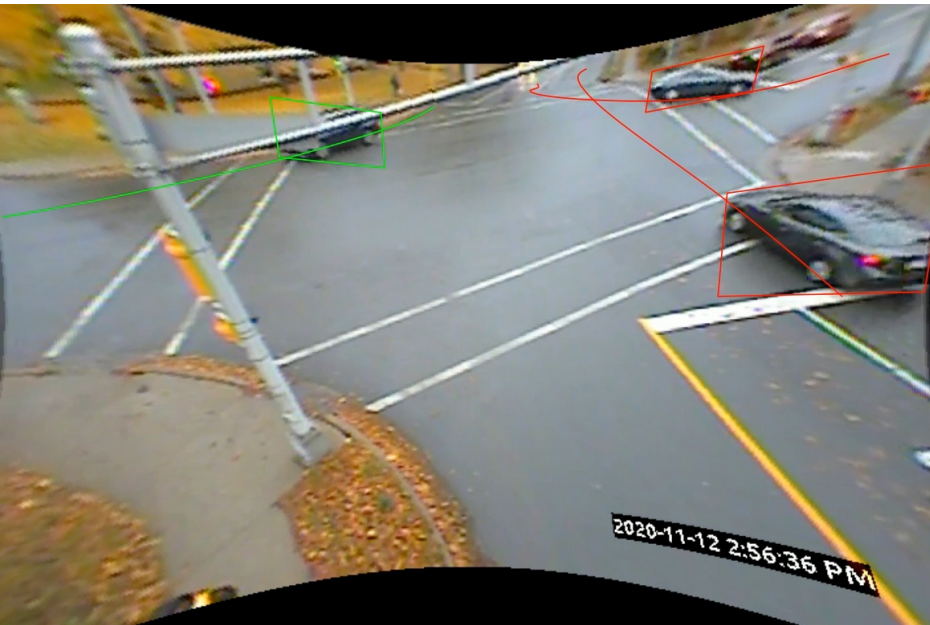
North-Left vs South-Through: PET= 2.5s, vehicle speed 42 km/h

NBL is a restricted movement. Due to the skewed intersection, this movement requires a near U-turn maneuver to complete the turn.

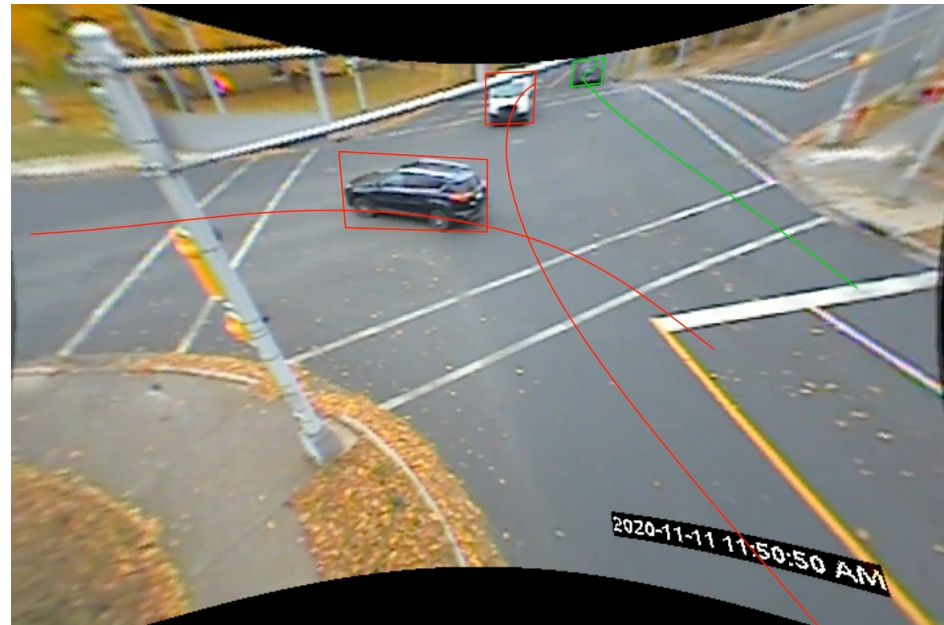
South-Left vs North-Through: PET= 1.9s, vehicle speed 52 km/h

The sightline between permissive SBL vehicles and oncoming NB vehicles is moderately obstructed due to the bend in the roadway.

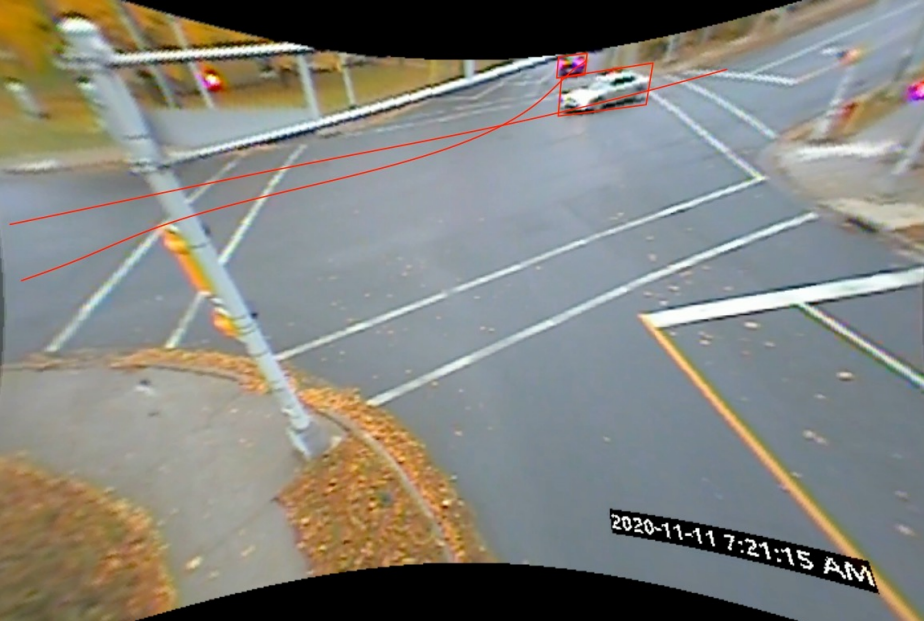
West-Left vs East-Through: PET= 2.5s, vehicle speed 55 km/h
Eastbound travelling vehicles may approach the intersection with higher speeds than expected due to downgrade in topography. The skewed geometry also impacts driver sightlines as they cross the intersection. Crest curve impacts sightlines.

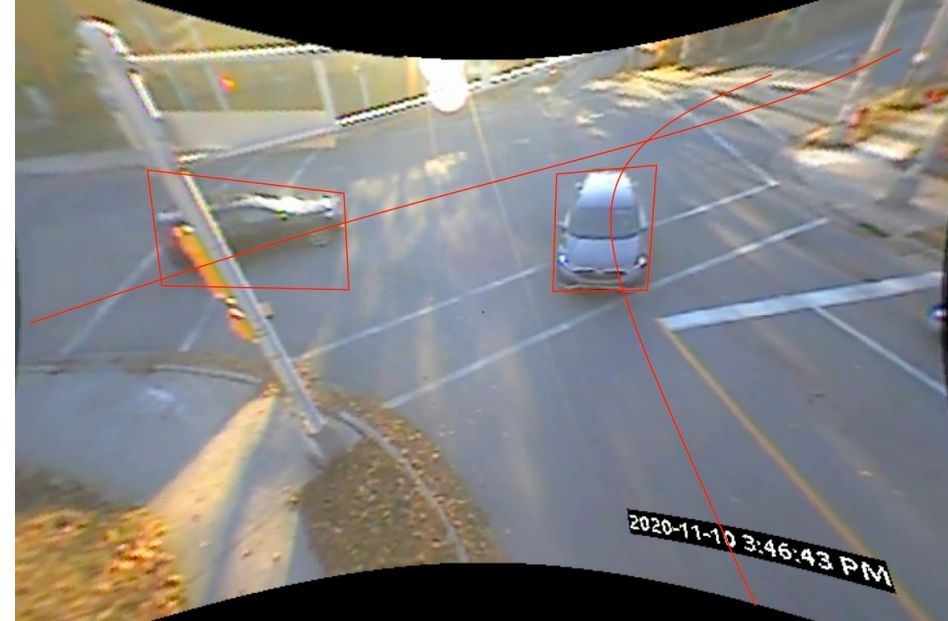
East-Left vs West-Through: PET= 1.6s, vehicle speed 50 km/h
The skewed geometry impacts driver sightlines as they cross the intersection.

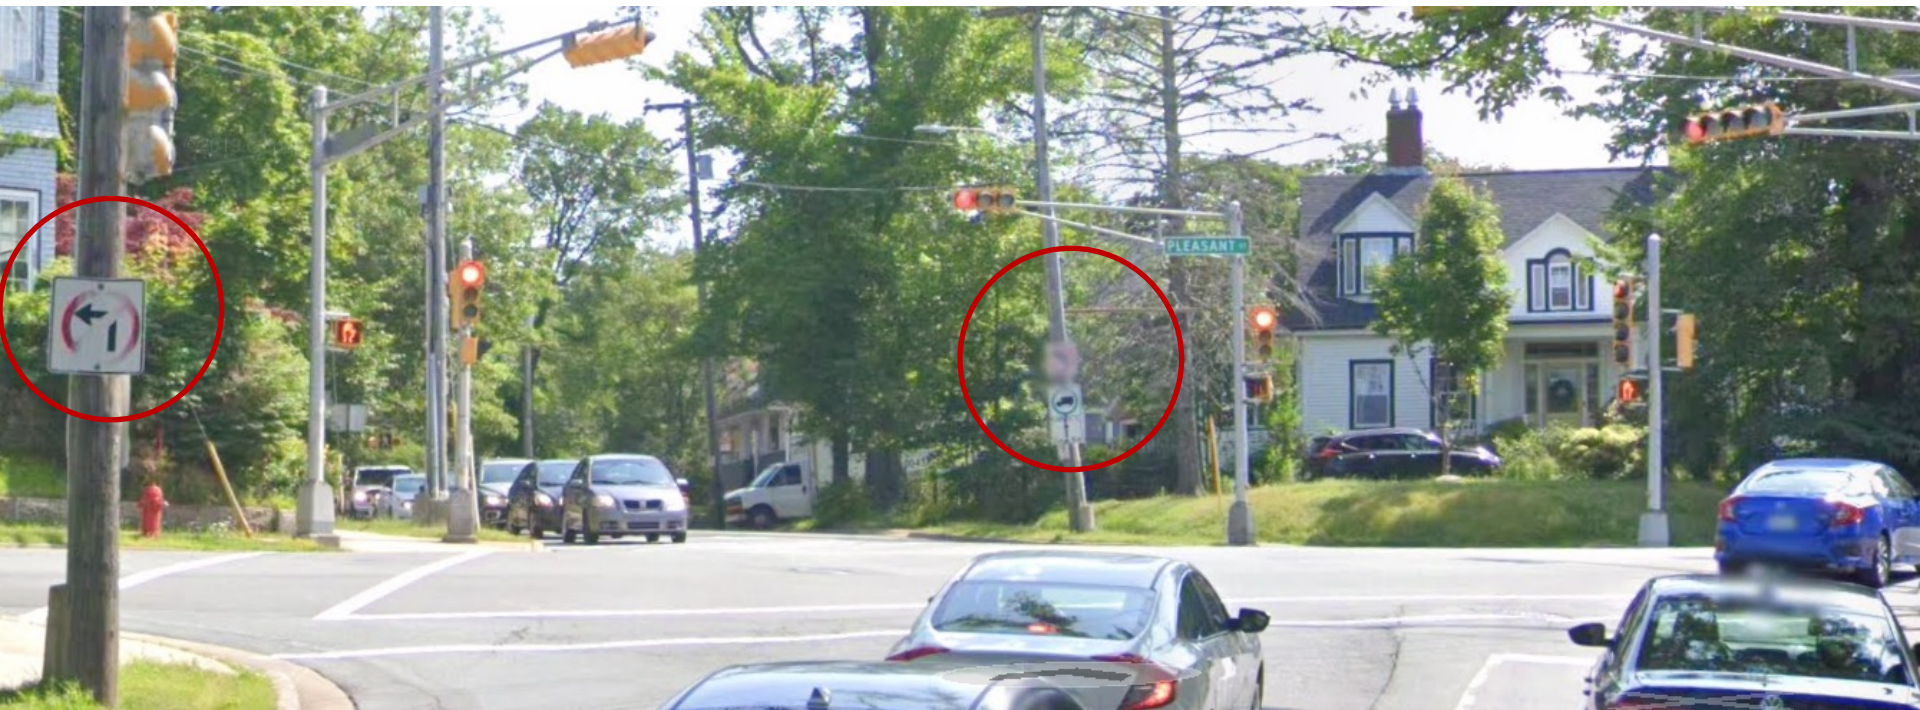
According to 2019 Google Street View, two signs were provided to advise drivers of the restricted NBL turn. The nearside sign appears to be in poor condition and the far-side sign may be outside the driver line of sight (if they are focused on oncoming vehicles to their left). Signs with improved retroreflectivity and more prominent placements may reduce the number of northbound-left turn violations.

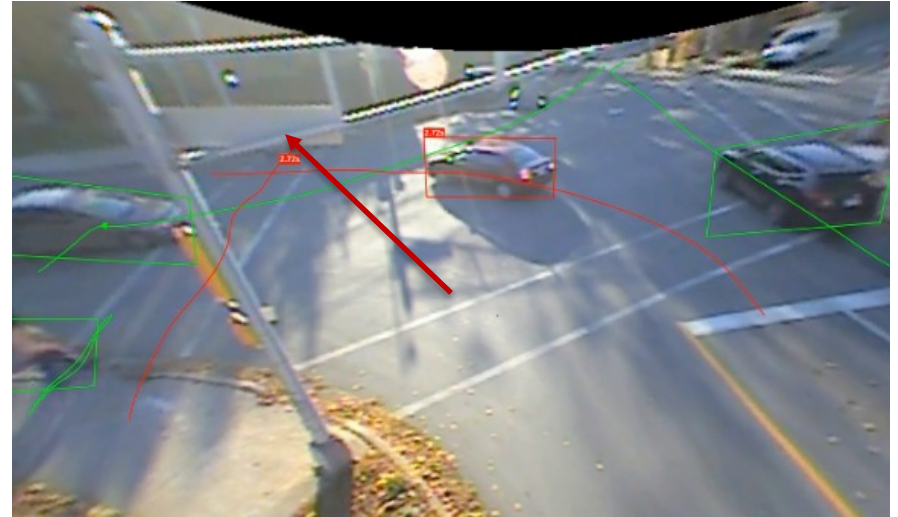
VRU visibility on the east crossing is slightly blocked due to street signage and poles in the foreground

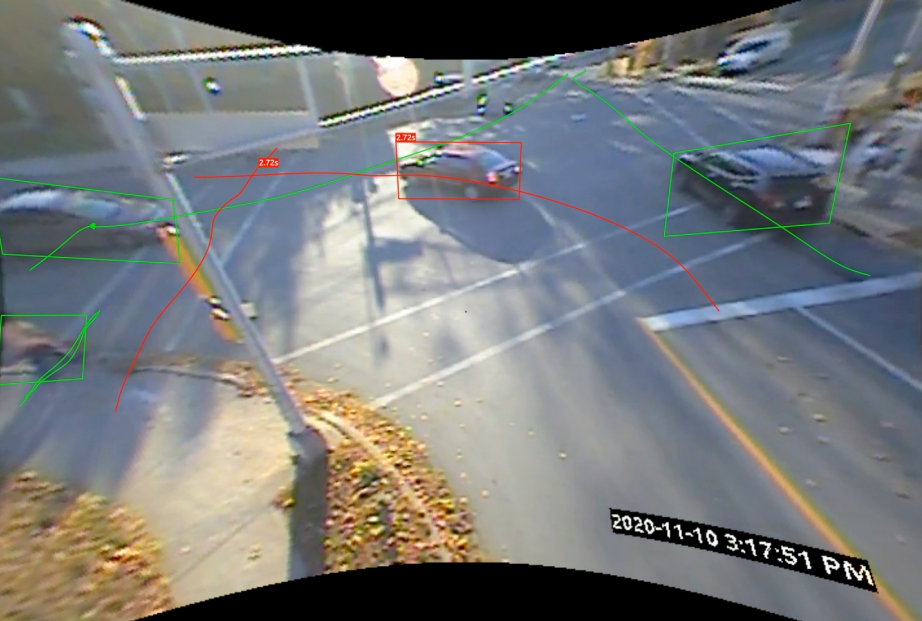
Pedestrian South-Left Hook: $T_2 = 2.3s$, vehicles speed = 15 km/h

The left turning driver did not notice the crossing pedestrian until they initiated their permissive left turn movement. As they yielded to the right-of-way pedestrian, they were placed in conflict with oncoming through vehicles.

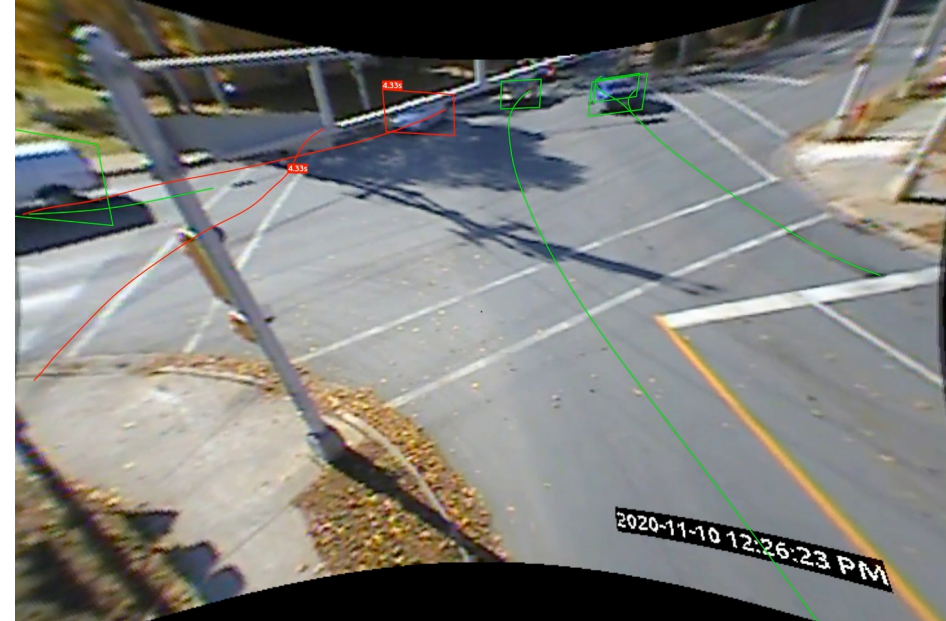
Pedestrian North-Right Hook: $T_2 = 3.0s$, vehicles speed = 12 km/h
