**SUBJECT:** Flood Mitigation Near John Stewart and Arklow Drive, Cole Harbour

### INFORMATION REPORT

# Cole Harbour: National Disaster Mitigation Program Follow-Up Study

Final Report

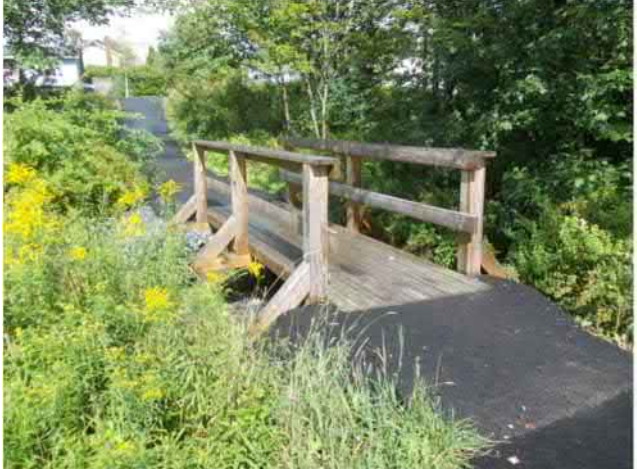
| Structure/Stormwater Infrastructure | Capacity/Description | |
|---|---|---|
| <p>#4: Walking bridge<br/>(Near the southern intersection of John Stewart Drive and Inglewood Crescent)</p> | <p>The walking bridge is adequately sized to convey up to and including the 10-year return period event</p> | |

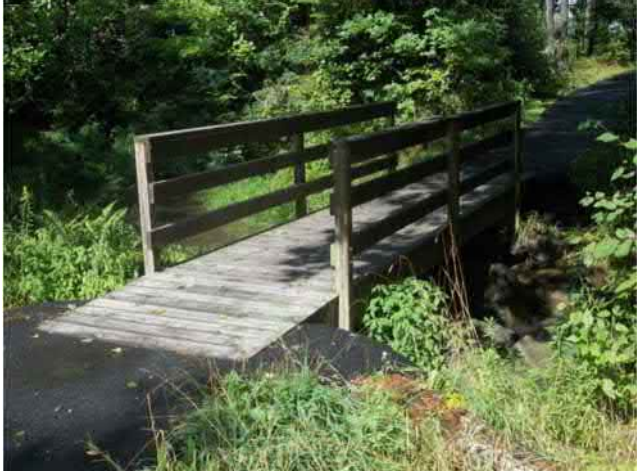
| Structure/Stormwater Infrastructure | Capacity/Description | |
|---|---|---|
| <p>#5: Walking bridge<br/>(Near the intersection of John Stewart Drive and Halo Lane)</p> | <p>The walking bridge is adequately sized to convey up to and including the 100-year return period event</p> | |

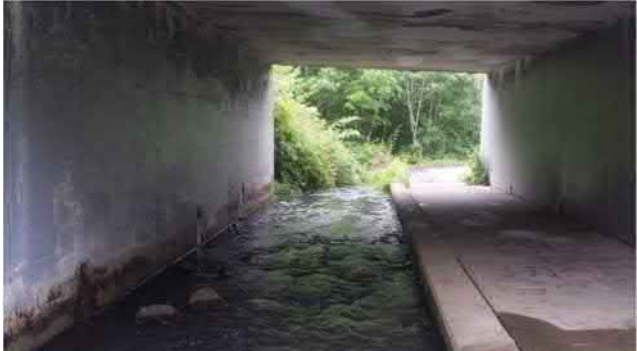
| Structure/Stormwater Infrastructure | Capacity/Description | |
|---|---|---|
| <p>#6: Bridge crossing<br/>(Intersection of Arklow Drive and John Stewart Drive)</p> | <p>The bridge crossing is adequately sized to convey up to and including the 100-year return period event</p> | |

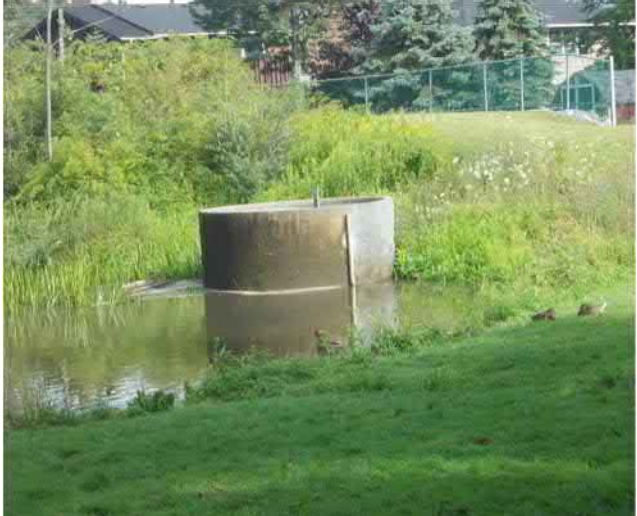
| Structure/Stormwater Infrastructure | Capacity/Description | |
|---|---|---|
| <p>#7: Concrete chamber culvert<br/>(End of the pond adjacent to the walking path that connects Amaranth Crescent and John Stewart Drive)</p> | <p>The weir structure and culvert are not being engaged in rainfall event due to pond elevations spilling over the pedestrian walkway before reaching the weir elevation. The pedestrian walkway is at a lower elevation than the top of the weir. Therefore, peak rainfall events spill over the pedestrian walkway and downstream thus not engaging the culvert. The spillway is engaged in less than the 2-year return period event.</p> | |

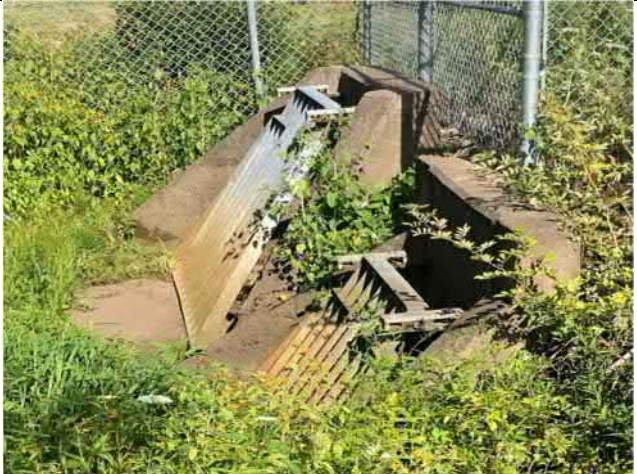
| Structure/Stormwater Infrastructure | Capacity/Description | |
|---|---|---|
| <p>#8: Dual culvert<br/>(Located behind Fong's restaurant)</p> | <p>Less than 2-year return period event</p> | |

- The dual culverts and chamber conveying stormwater under Cole Harbour Road are undersized and are resulting in high HGL elevations north of Cole Harbour Road. It is therefore recommended that

they be replaced with twin 3.6 m by 1.5 m concrete box culverts. This will reduce the upstream HGL by 0.86 m near Fong's restaurant;

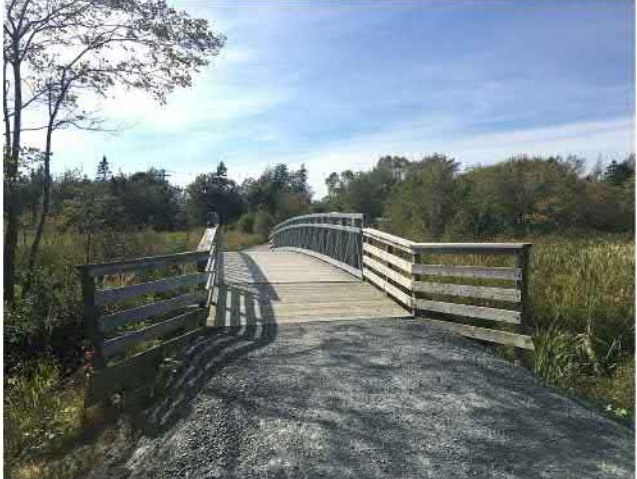
| Structure/Stormwater Infrastructure | Capacity/Description | |
|---|---|---|
| <p>#9: Walking bridge<br/>(Near the inlet from Bissett Run to Bissett Lake)</p> | <p>Up to and including the 100-year return period event</p> | |

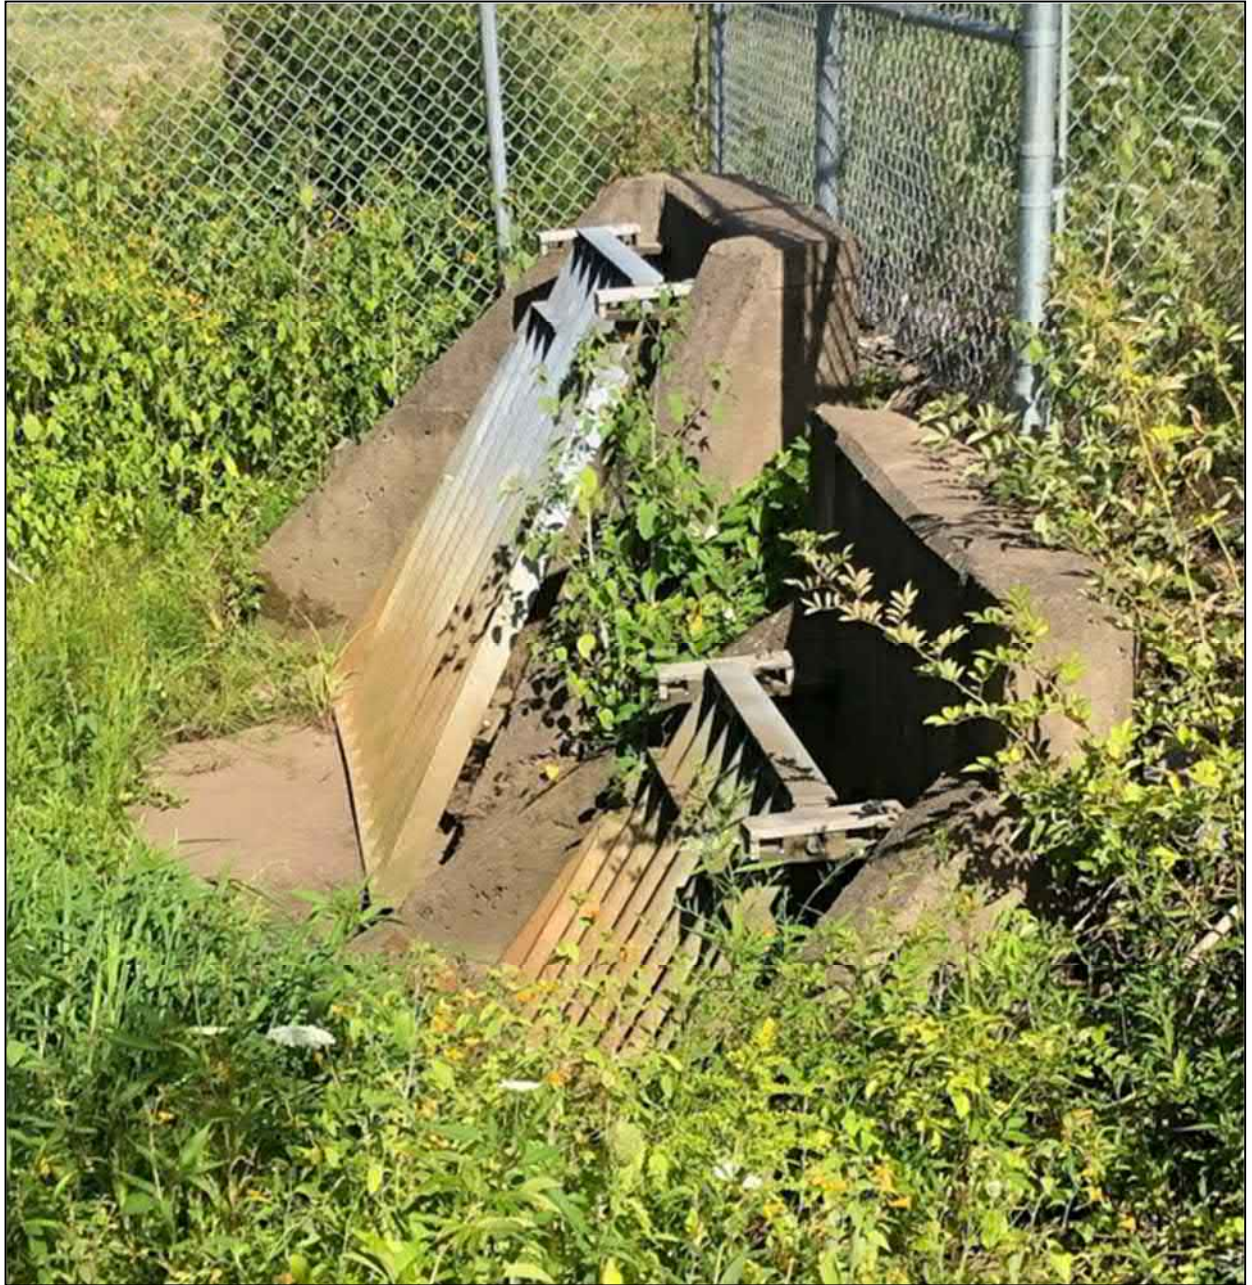
Figure 4-4: Culvert Inlets to Cole Harbour Road

The hydraulic model was used to simulate upgrades at the existing Cole Harbour Road Crossing near Fong's Restaurant. Two circular concrete culverts are the inlet of Upper Bisset Run which discharge under Cole Harbour Road (presented in Figure 4-4). The CCTV inspection report (Appendix A) confirms that one culvert is a 1200 mm. The culverts were inaccessible during the field visit due to fencing, therefore the second culvert was estimated to be 600 mm based on a visual inspection. These circular culverts discharge to a chamber under Cole Harbour Road, which ultimately discharge to a 1350 mm culvert to Lower Bissett Run. The Cole Harbour Road culverts were subsequently updated in the hydraulic model. The maximum culvert diameter given existing cover depth limitations is expected to be 1500 mm. The hydraulic simulation suggested that three 1500 mm diameter culverts was insufficient to reduce the upstream HGL to mitigate flooding in the area.

Given the hydraulic performance limitations of the circular pipe, a box culvert scenario was also considered. The existing crossing was upgraded to include twin 3.6 m x 1.5 m box culverts. With the twin box culverts the HGL elevation upstream of Cole Harbour Road is expected to be 34.6 m. This represents a decrease of 0.86 m below existing conditions. This significant reduction in HGL would benefit the residents immediately downstream from Structure 7 by providing a decrease of 0.52 m during the 100-year return period event. Based on the site survey, however, finished floor elevations of those residences are approximately 33.67 m, which puts those homes at risk of basement flooding during extreme precipitation events.
