SUBJECT: Flood Mitigation Near John Stewart and Arklow Drive, Cole Harbour

INFORMATION REPORT

Cole Harbour: National Disaster Mitigation Program Follow-Up Study

Final Report

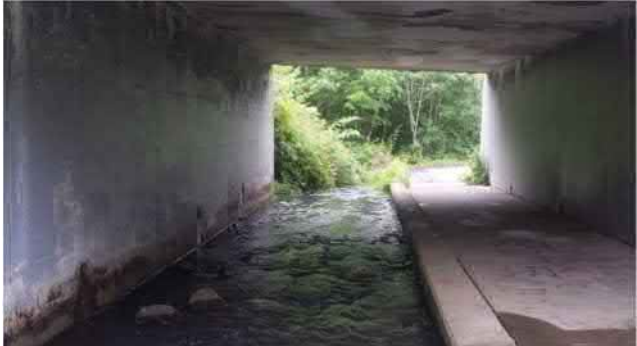
<p>#6: Bridge crossing (Intersection of Arklow Drive and John Stewart Drive)</p>	<p>The bridge crossing is adequately sized to convey up to and including the 100-year return period event</p>

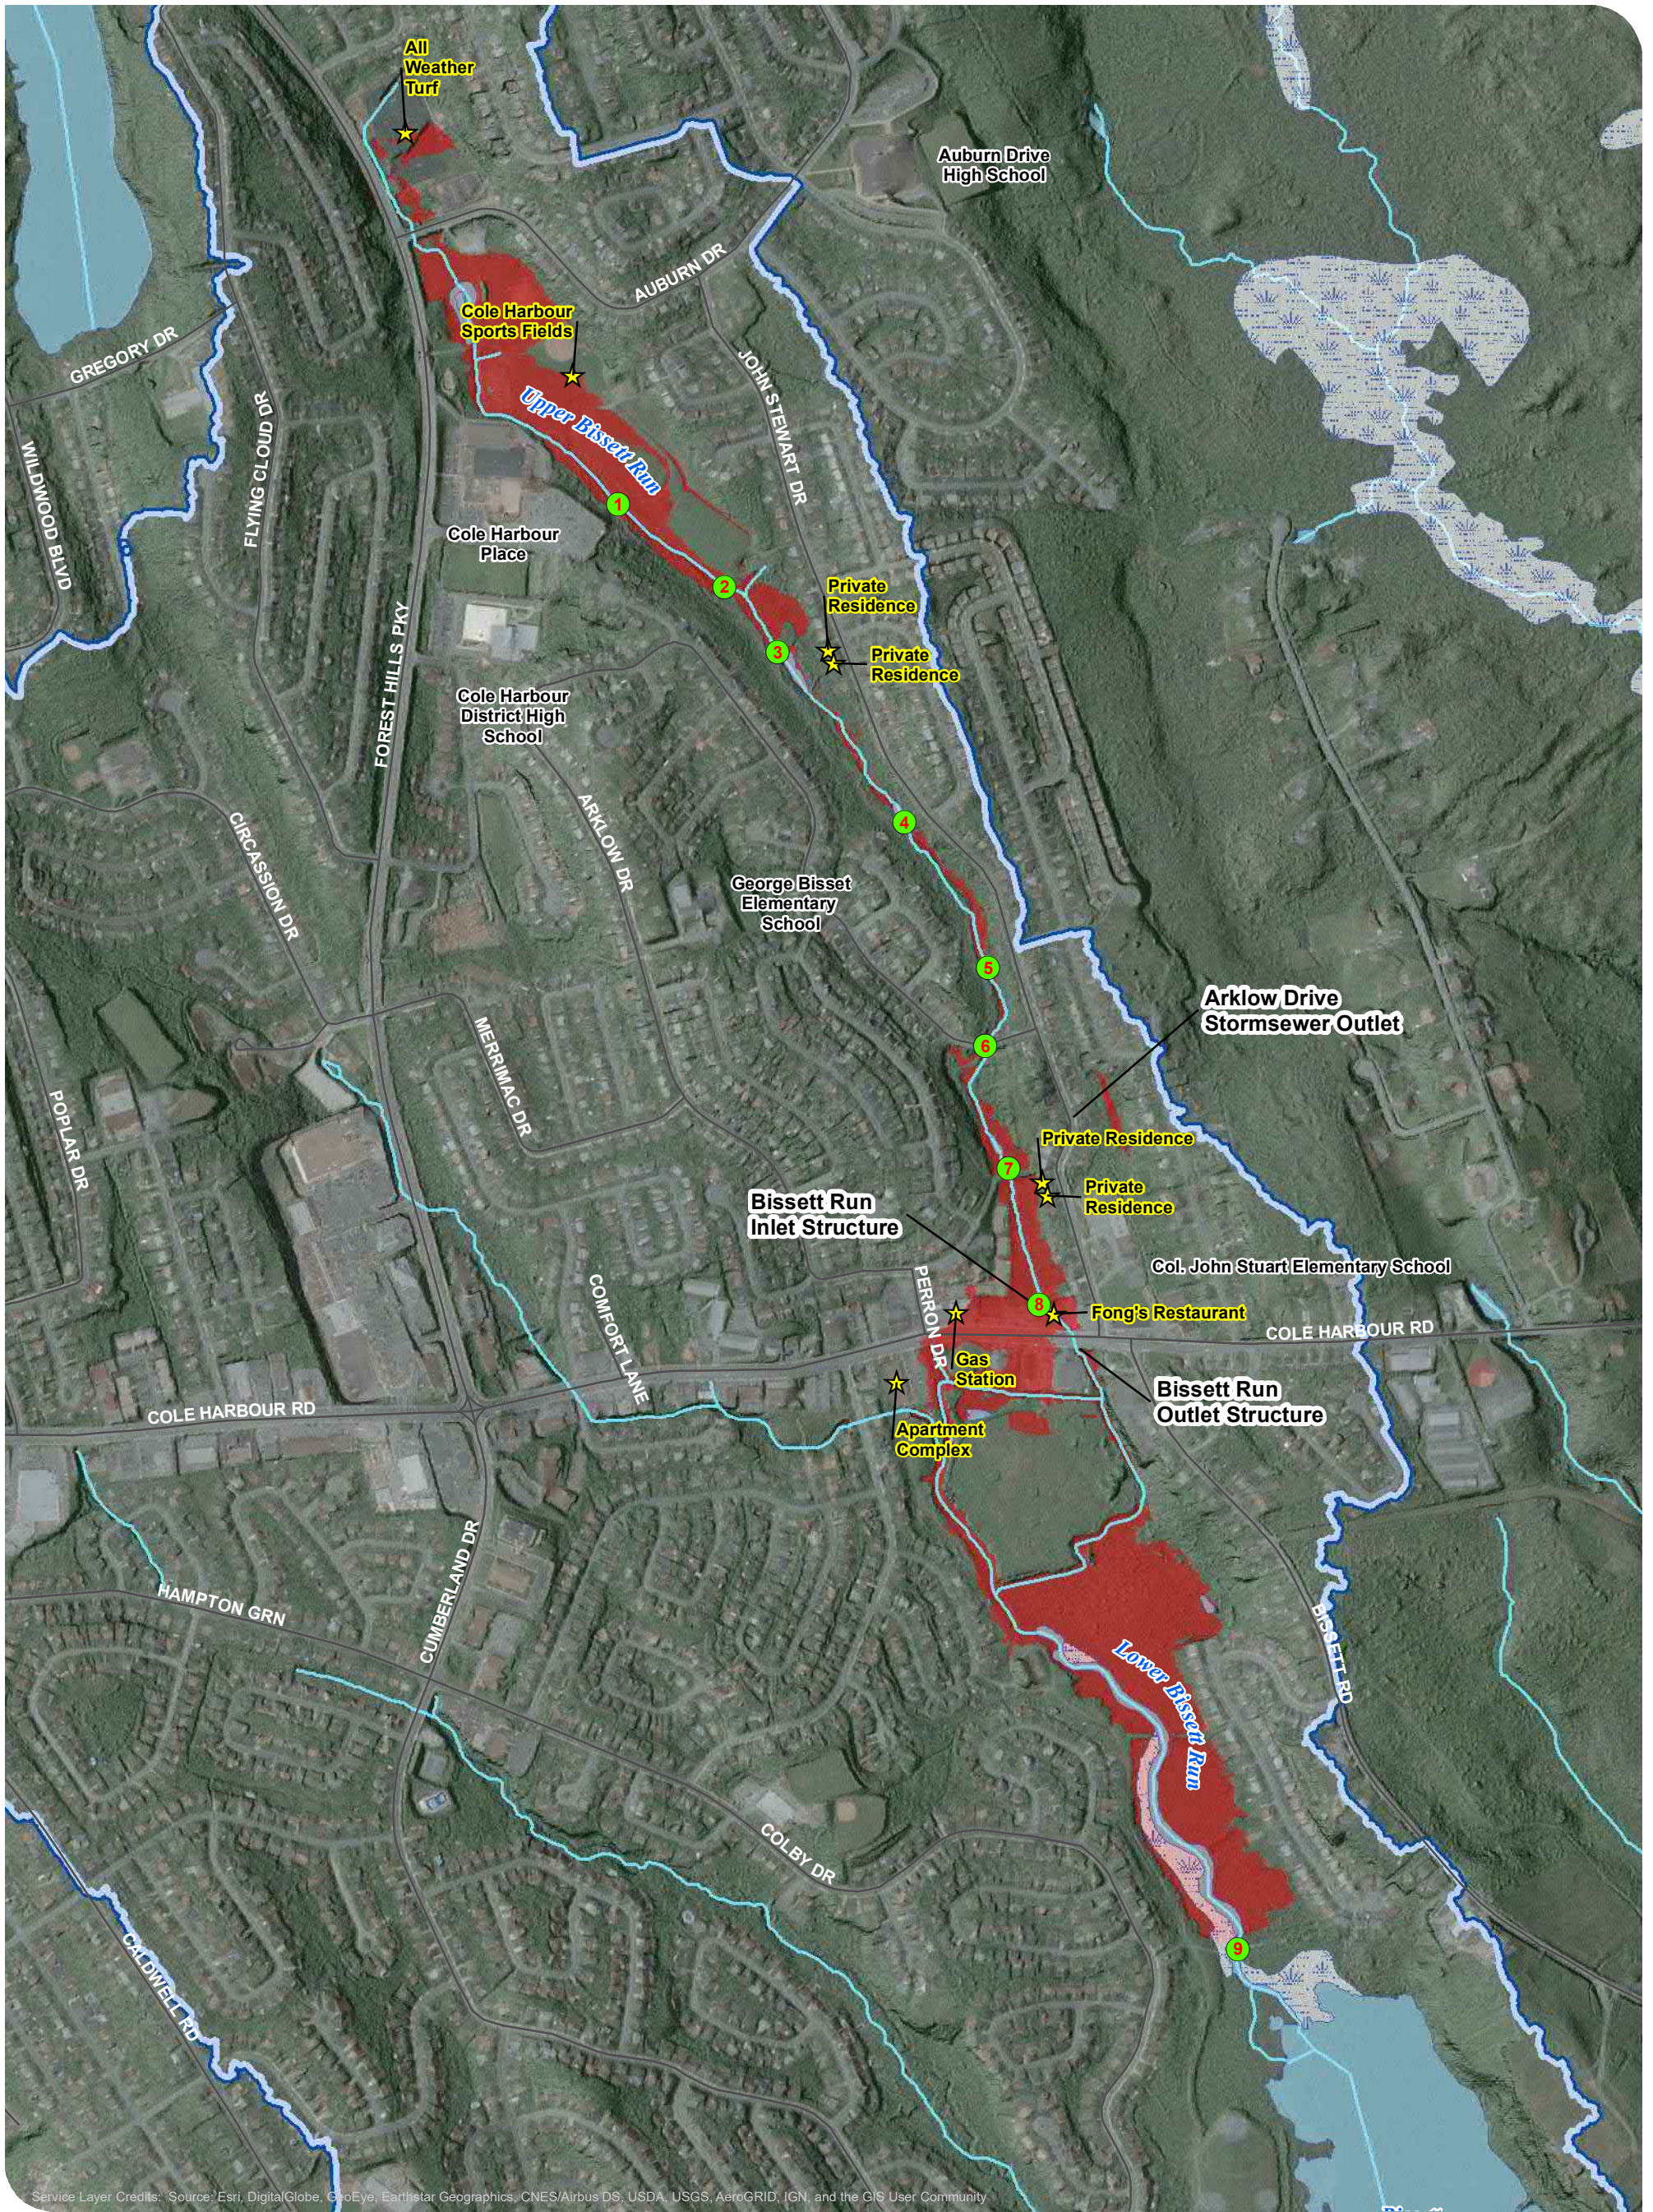
EXISTING CONDITIONS
100-YEAR RETURN PERIOD
HGLS OF BISSETT RUN
FIGURE 4-1

Figure 4-1 below and Table 4-1 presents the simulated maximum HGL elevations along Upper and Lower Bissett Run.

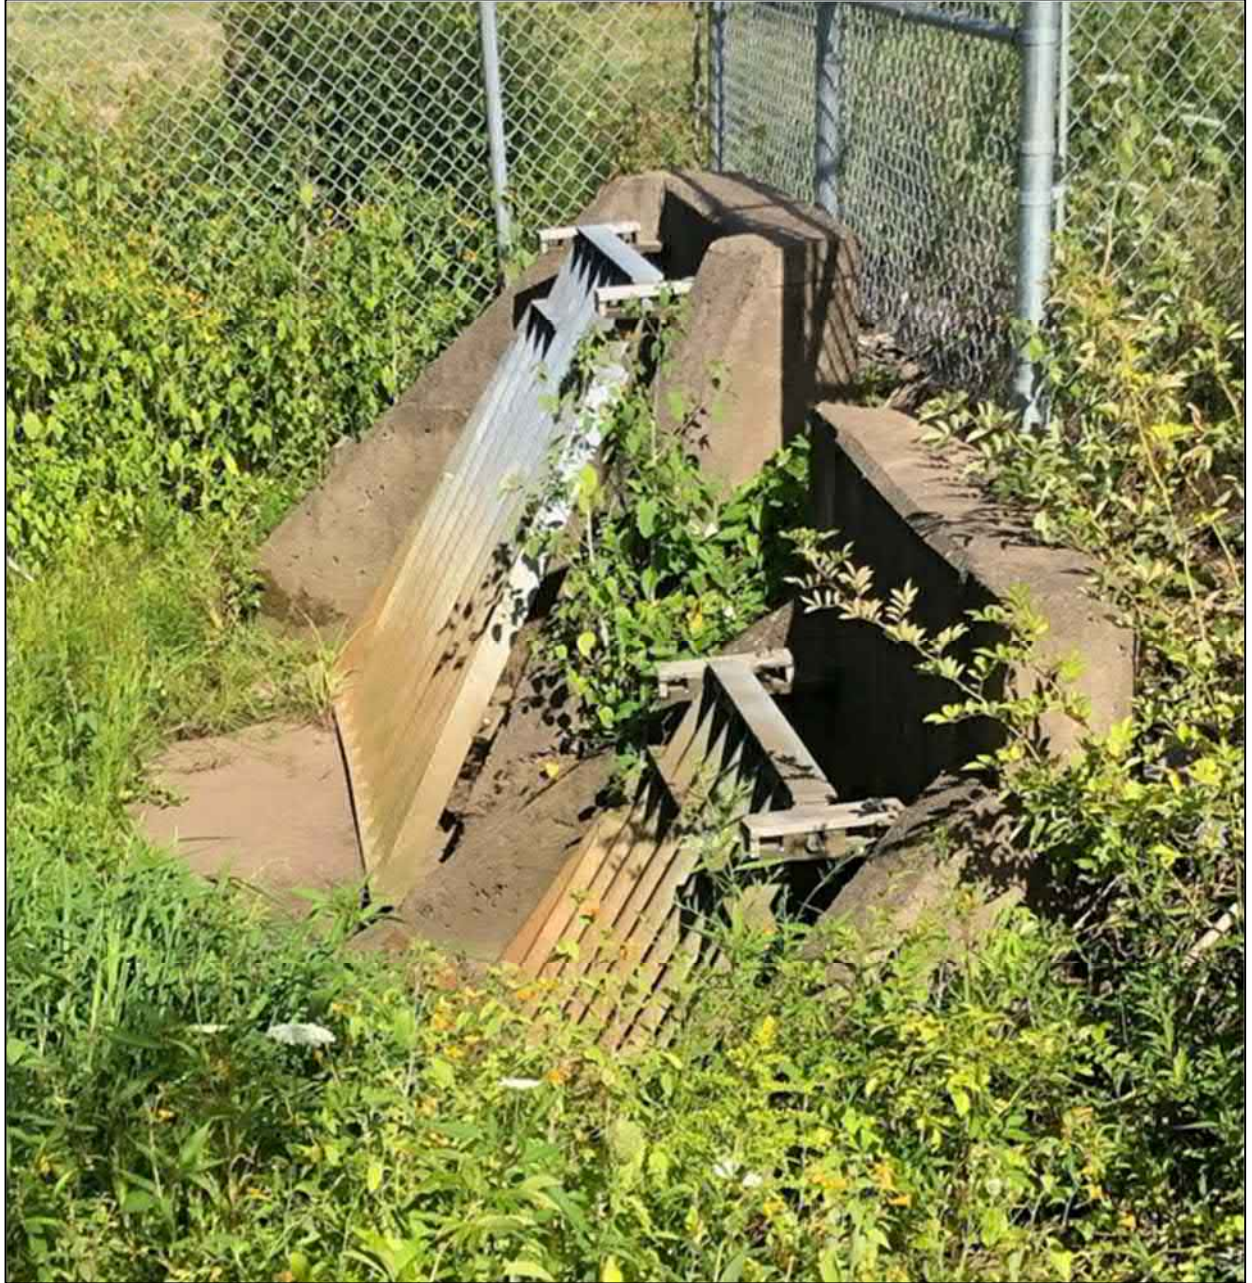
Figure 4-4: Culvert Inlets to Cole Harbour Road

The hydraulic model was used to simulate upgrades at the existing Cole Harbour Road Crossing near Fong's Restaurant. Two circular concrete culverts are the inlet of Upper Bisset Run which discharge under Cole Harbour Road (presented in Figure 4-4). The CCTV inspection report (Appendix A) confirms that one culvert is a 1200 mm. The culverts were inaccessible during the field visit due to fencing, therefore the second culvert was estimated to be 600 mm based on a visual inspection. These circular culverts discharge to a chamber under Cole Harbour Road, which ultimately discharge to a 1350 mm culvert to Lower Bissett Run. The Cole Harbour Road culverts were subsequently updated in the hydraulic model. The maximum culvert diameter given existing cover depth limitations is expected to be 1500 mm. The hydraulic simulation suggested that three 1500 mm diameter culverts was insufficient to reduce the upstream HGL to mitigate flooding in the area.

Given the hydraulic performance limitations of the circular pipe, a box culvert scenario was also considered. The existing crossing was upgraded to include twin 3.6 m x 1.5 m box culverts. With the twin box culverts the HGL elevation upstream of Cole Harbour Road is expected to be 34.6 m. This represents a decrease of 0.86 m below existing conditions. This significant reduction in HGL would benefit the residents immediately downstream from Structure 7 by providing a decrease of 0.52 m during the 100-year return period event. Based on the site survey, however, finished floor elevations of those residences are approximately 33.67 m, which puts those homes at risk of basement flooding during extreme precipitation events.

they be replaced with twin 3.6 m by 1.5 m concrete box culverts. This will reduce the upstream HGL by 0.86 m near Fong's restaurant;
