10 Kirk Road Heritage Impact Statement

Heritage Impact Statement
Re Finntigh Mara/Mathers Estate
10 Kirk Road, Halifax, Nova Scotia, B3P 1A6
Aug 31 2022

Prepared by
MacKay-Lyons Sweetapple Architects
2188 Gottingen Street, Halifax, NS, B3K 3B4
902 429 1867
mlsarchitects.ca

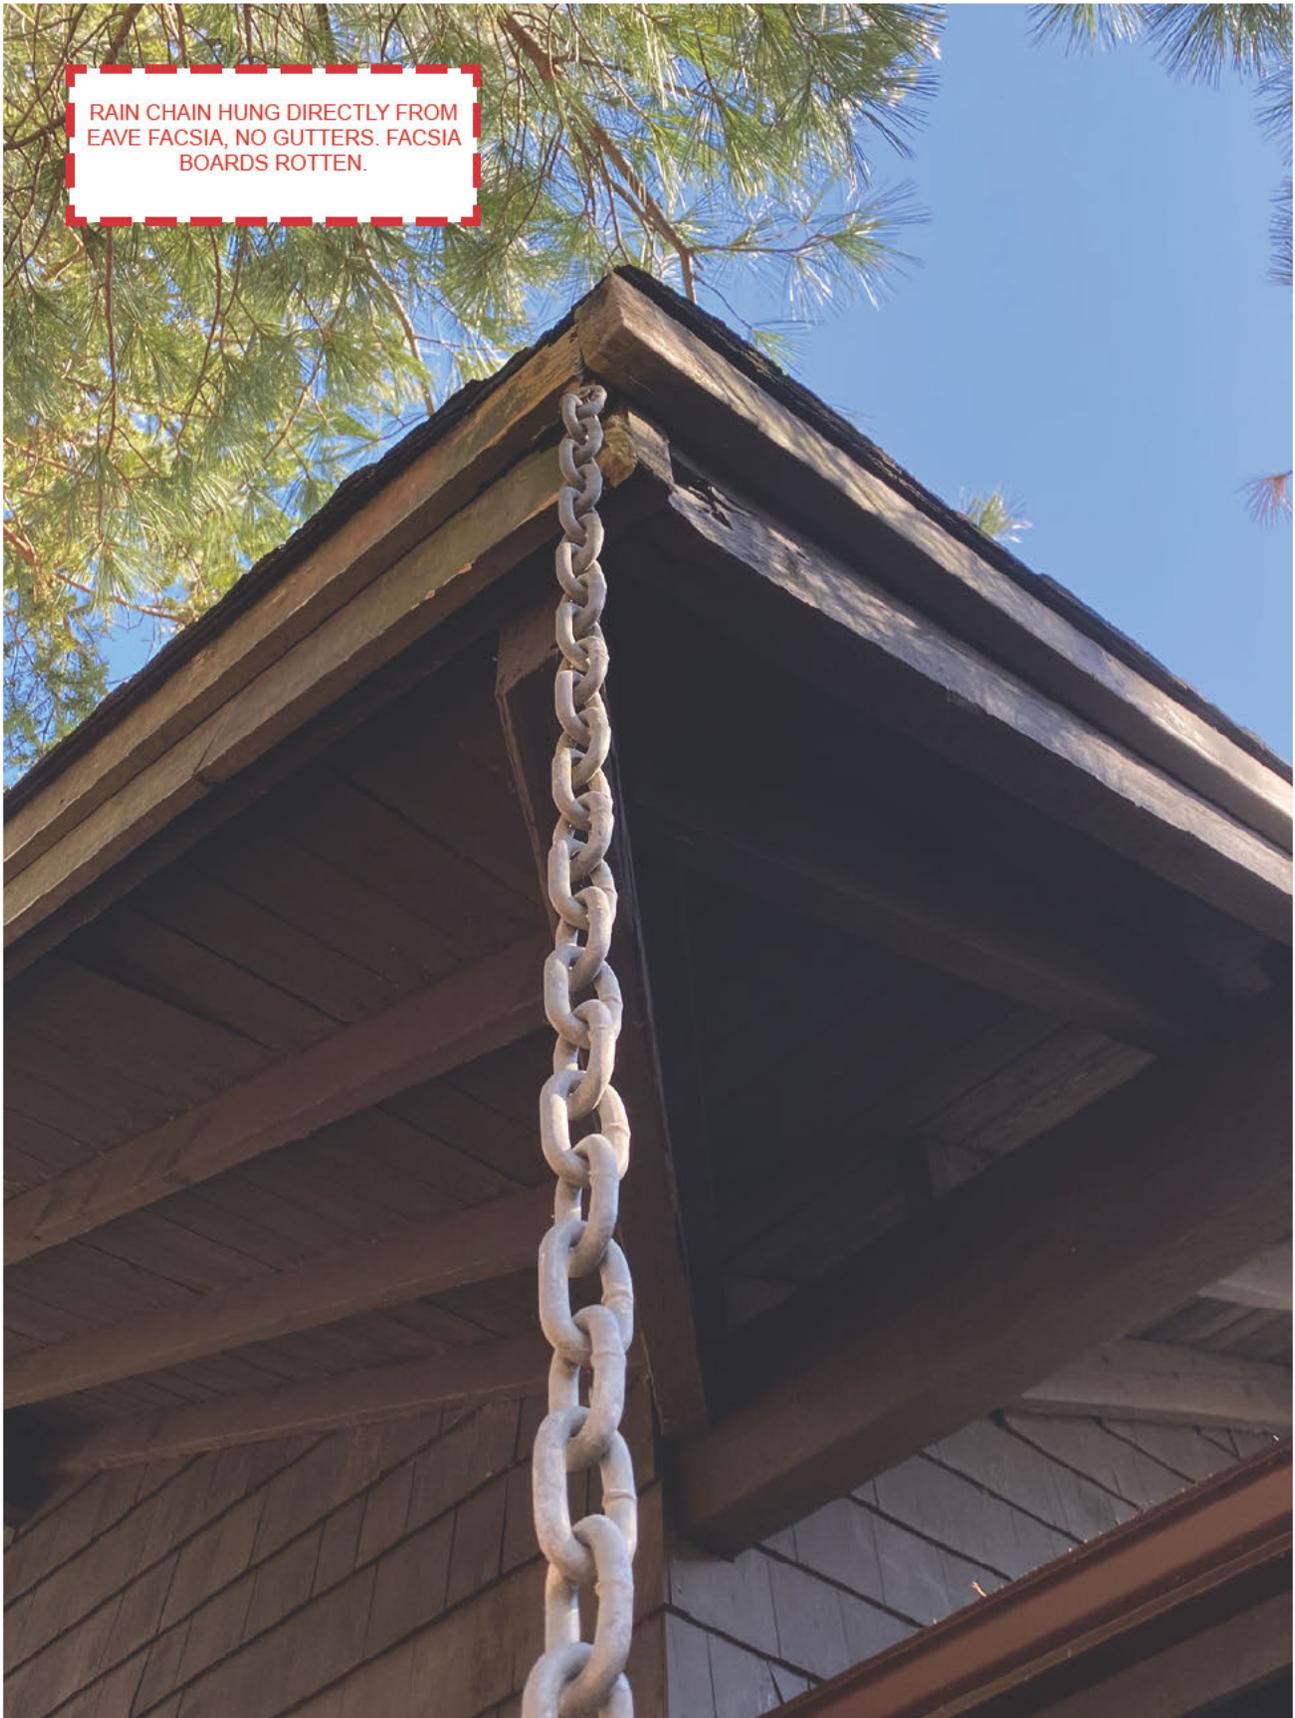
2.2 EAVE CONDITION AT SOUTHWEST CORNER OF MAIN HOUSE.

Some fascia boards at the overhanging eaves require repair (refer to AFRR image 2.2). Water runoff from the roof should be properly managed with a combination of gutters and downspouts to divert water away from the building.

RAIN CHAIN HUNG DIRECTLY FROM
EAVE FACIA, NO GUTTERS. FACIA
BOARDS ROTTEN.

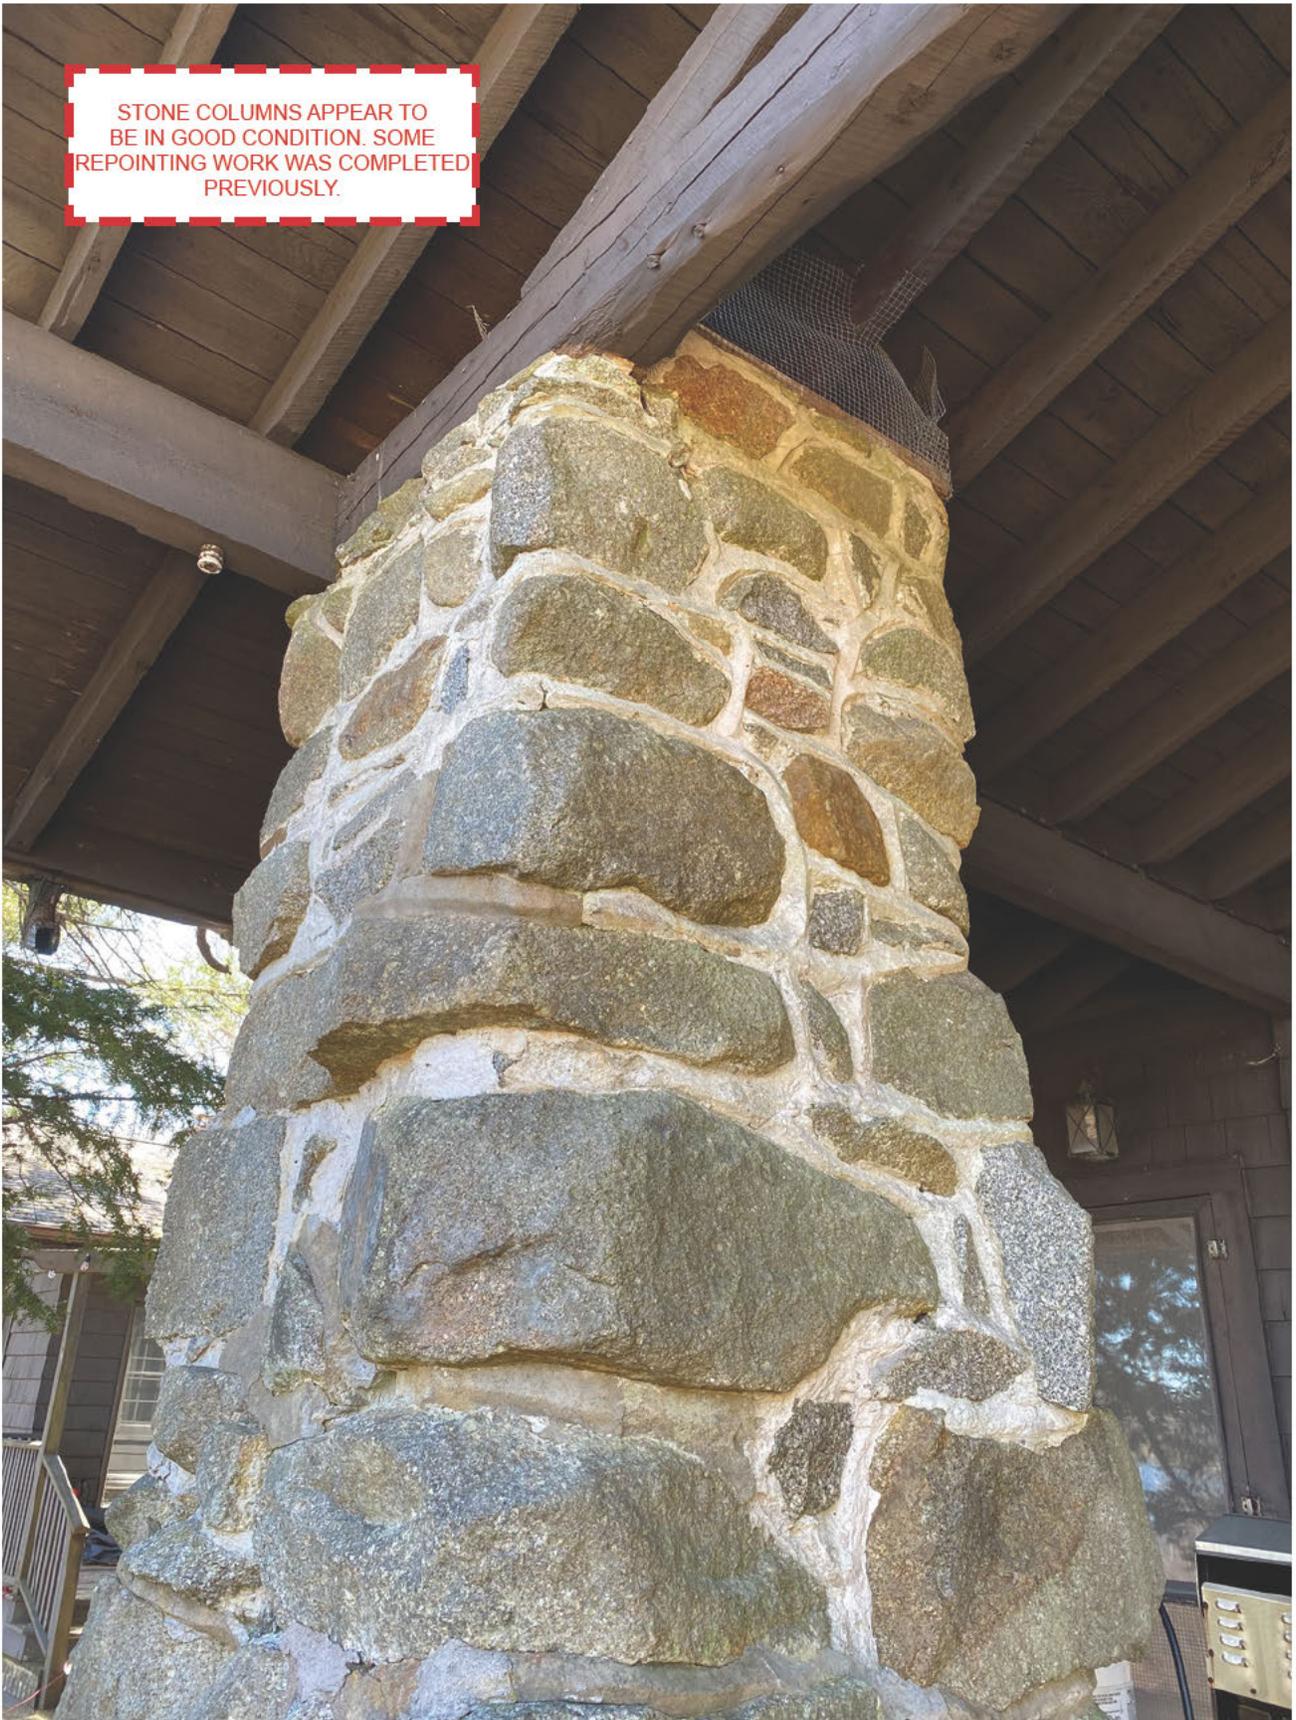
2.4 STONE COLUMN AT COVERED PORCH (EAST SIDE).

The stone columns at the covered porch appear in good condition. Some repointing work was completed previously

STONE COLUMNS APPEAR TO BE IN GOOD CONDITION. SOME REPOINTING WORK WAS COMPLETED PREVIOUSLY.

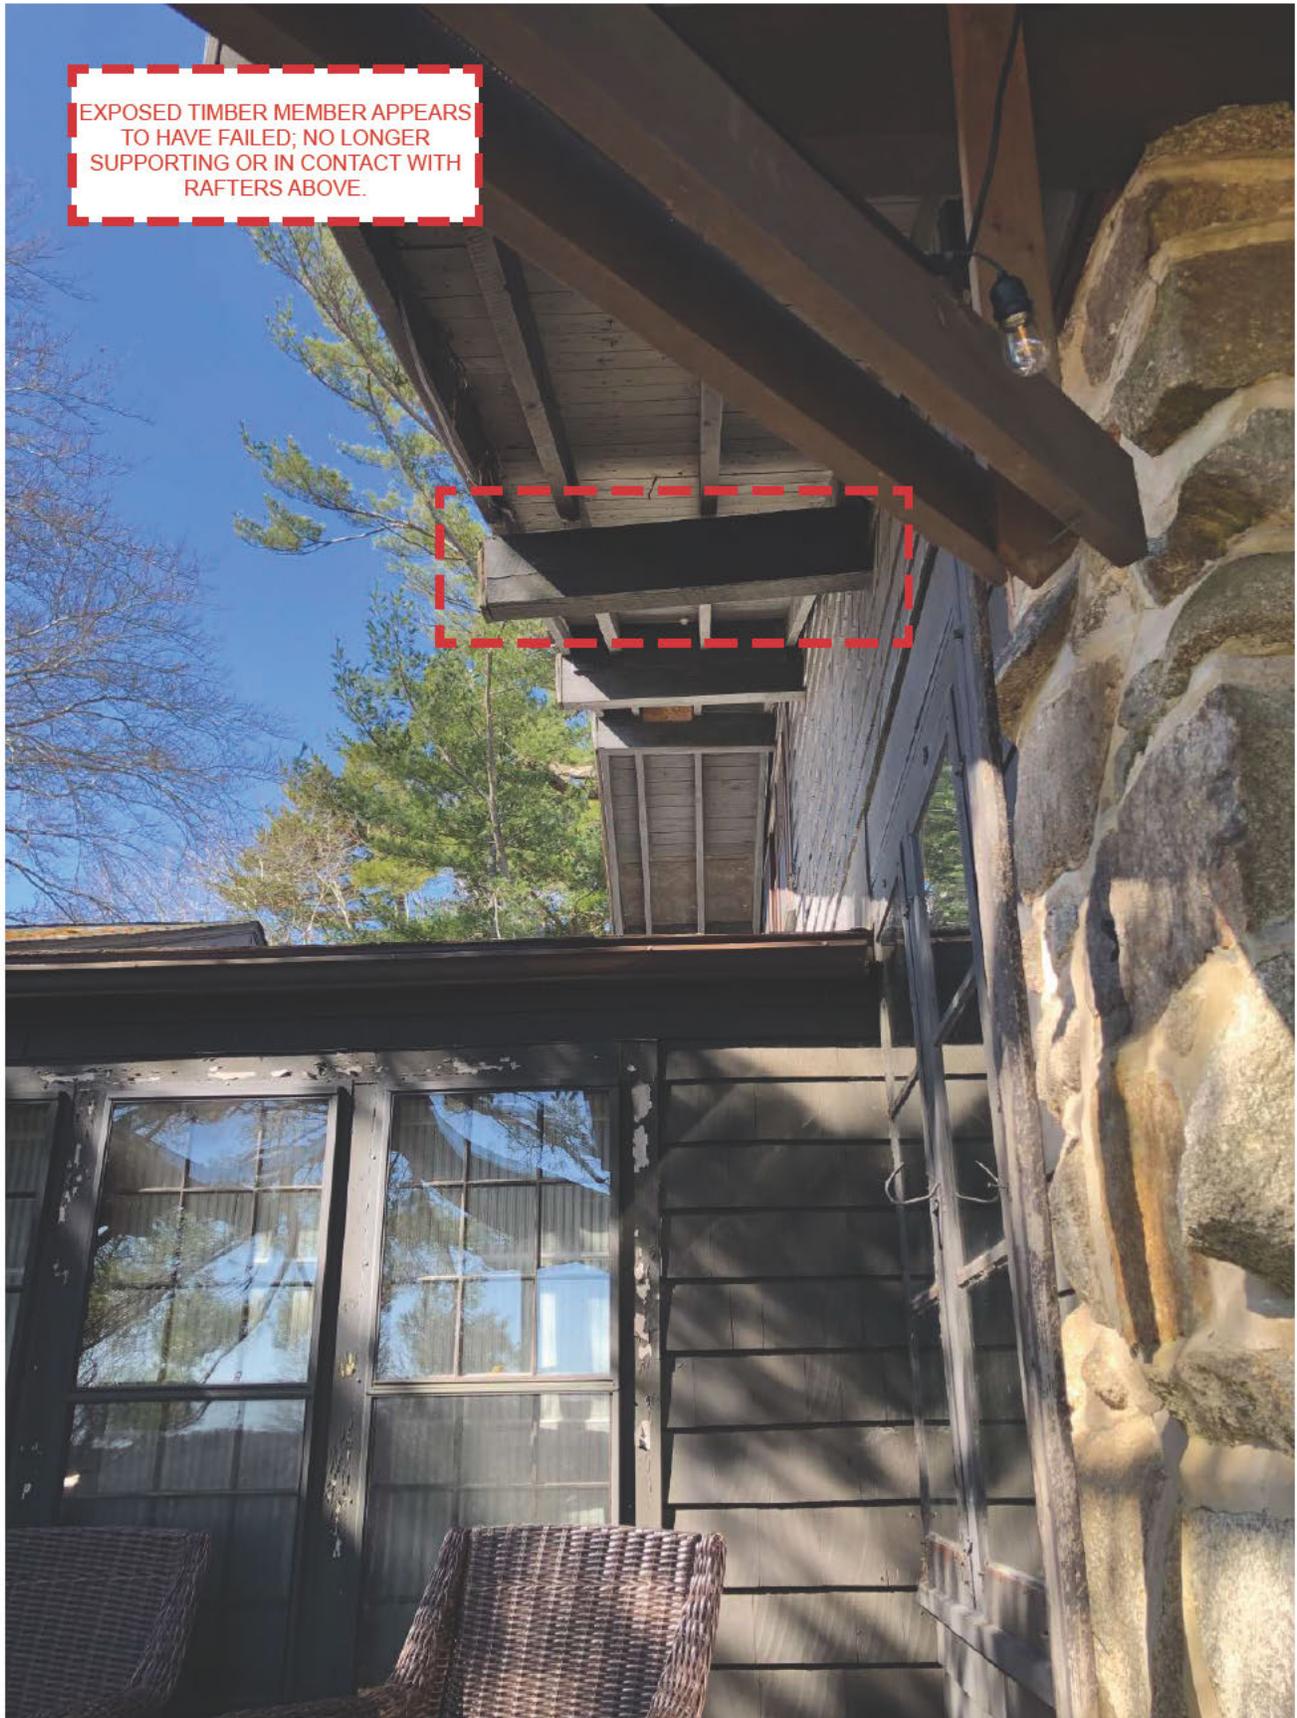
2.7 EXPOSED TIMBER FRAMING ABOVE ANNEX (SOUTH SIDE).

The exposed timber framing, which supports the overhanging eaves and covered porch, requires further examination. One framing member on the south side of the building appears to have failed and is no longer in contact or supporting the rafters above (refer to Architectural Field Review Report [AFRR] image 2.7).

EXPOSED TIMBER MEMBER APPEARS TO HAVE FAILED; NO LONGER SUPPORTING OR IN CONTACT WITH RAFTERS ABOVE.

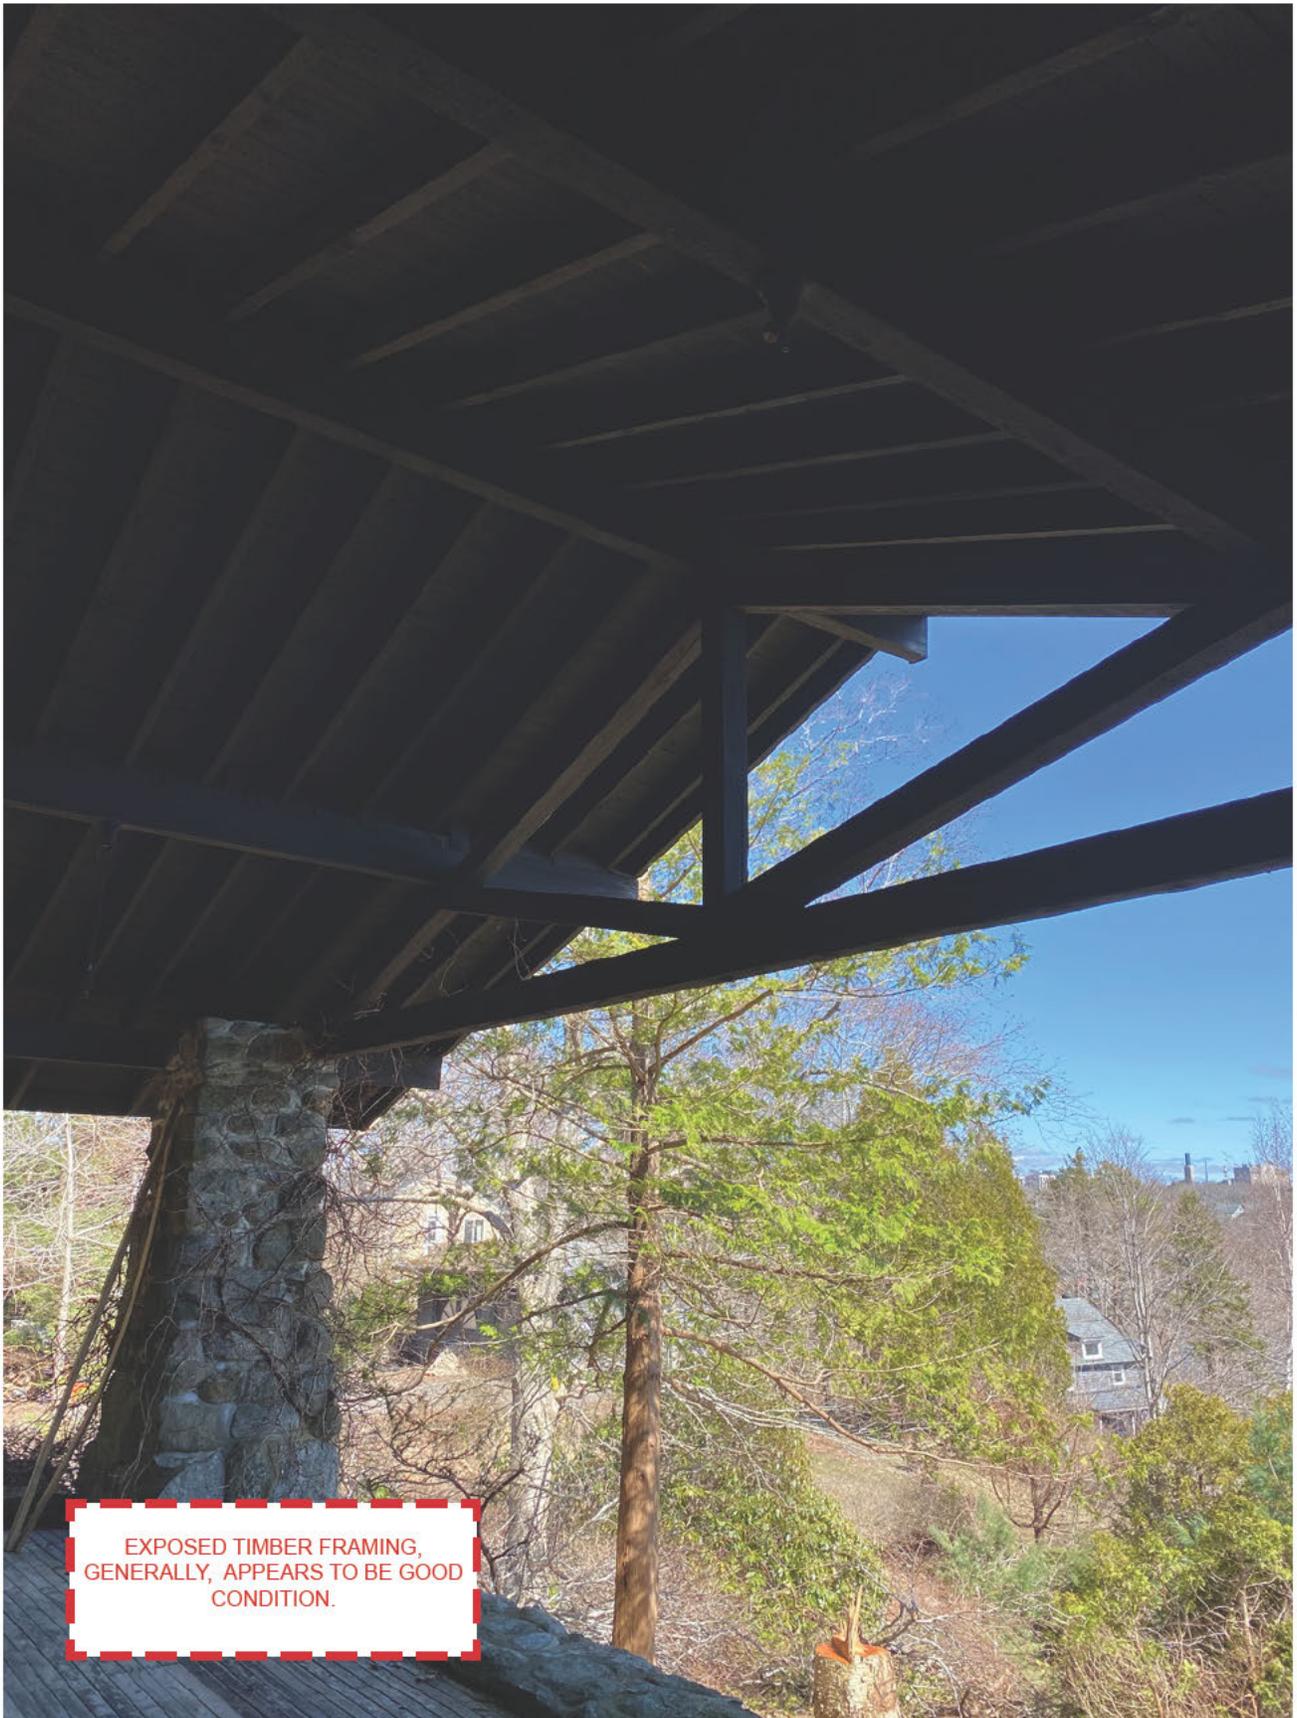
2.8 EXPOSED WOOD FRAMING AT COVERED PORCH (EAST SIDE).

The exposed timber framing, rafters, and sheathing boards generally appear in good condition in the covered porch (refer to AFRR image 2.8). This area should be further examined to confirm.

EXPOSED TIMBER FRAMING,
GENERALLY, APPEARS TO BE GOOD
CONDITION.

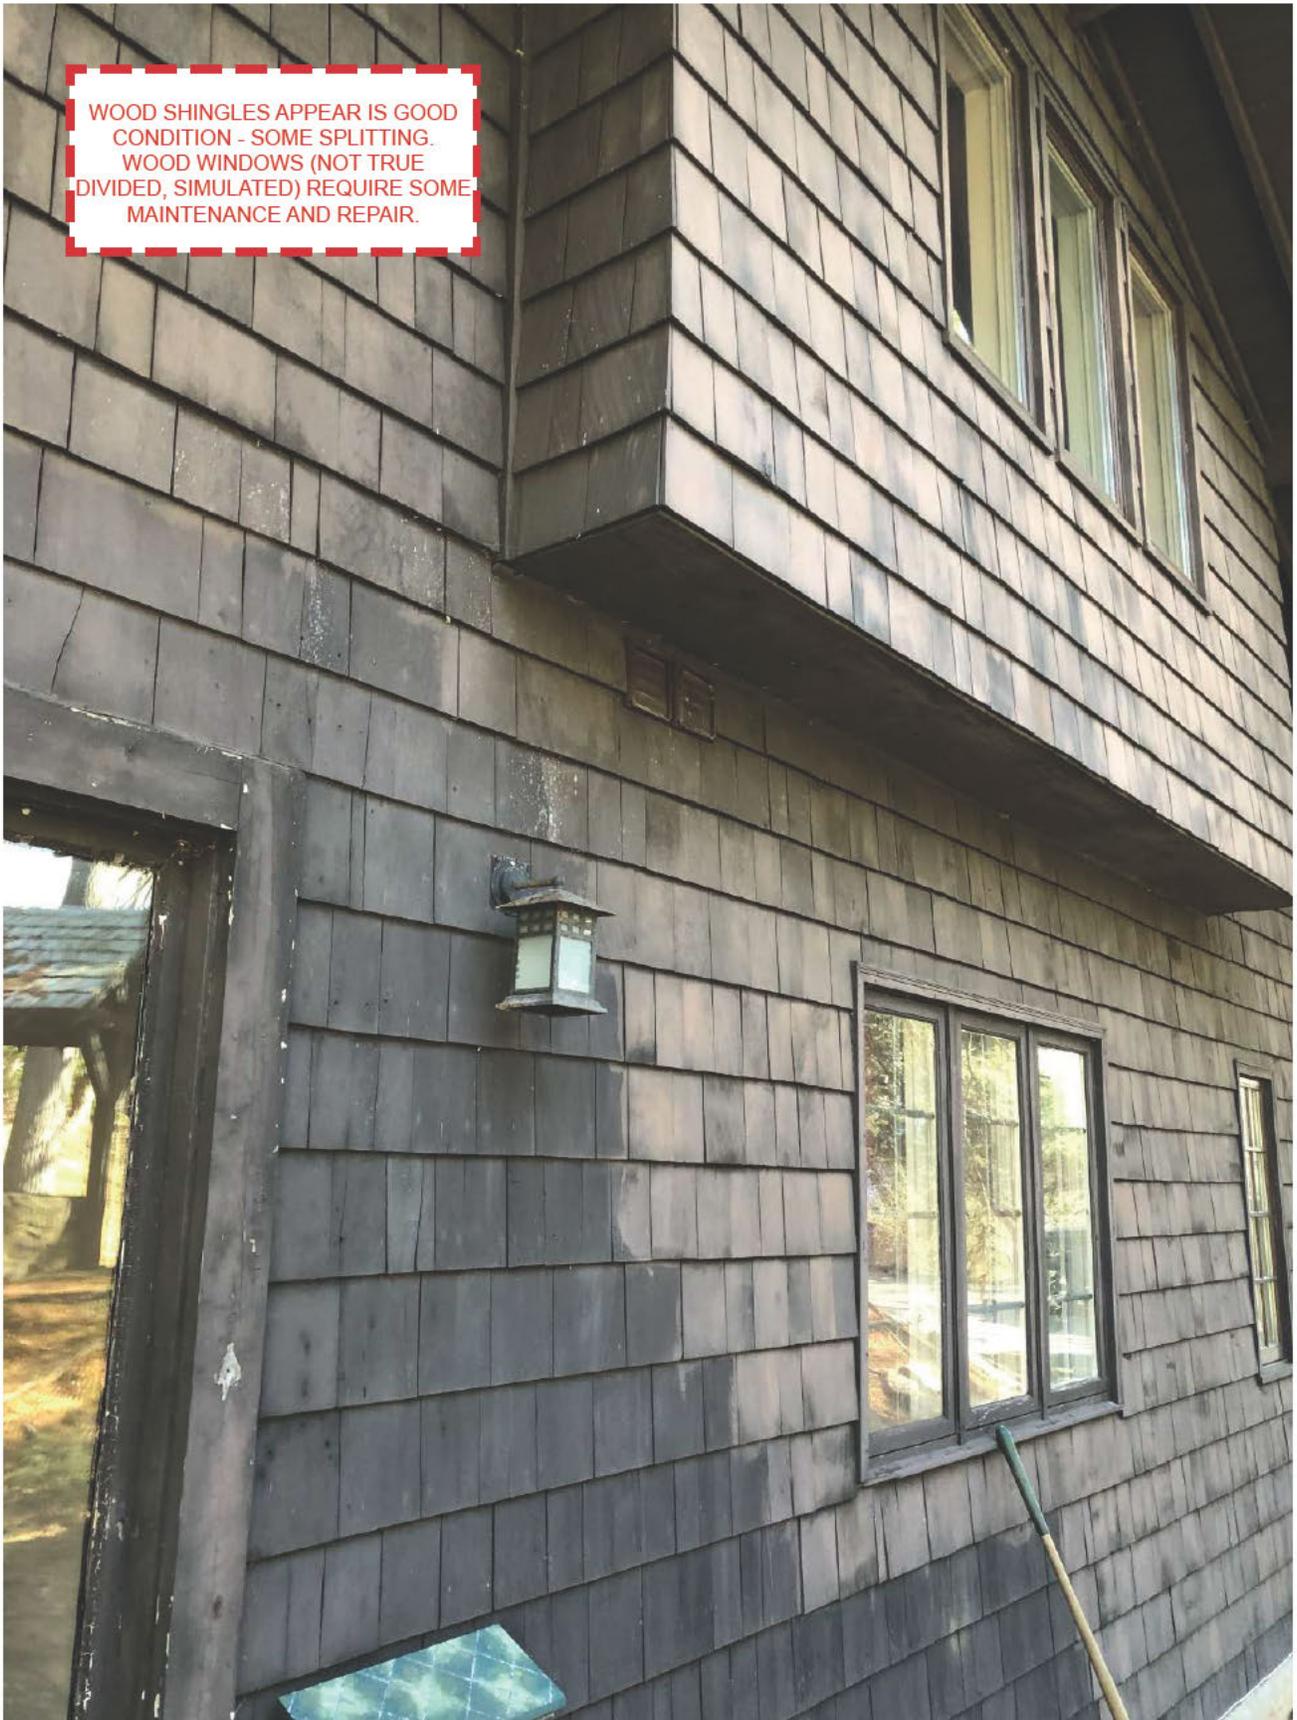
2.12 BUMP OUT AT UPPER LEVEL (WEST SIDE).

Some simulated divided wood windows were observed on the west side of the house, main and upper floors (refer to AFRR image 2.12). The layout and arrangement of these windows differs from the original drawings by Brown (refer to West Elevation sheet No 2). The main entry door and sidelites are not original to the house (refer to AFRR image 2.11).

The wood shingle cladding on the sidewalls generally appears in good condition. Some minor splitting was observed (refer to AFRR image 2.12). Shingles appear mostly flat with no major curling, cupping, bowing, or warping. The paint finish is in good condition - some fading but no major cracking or peeling was observed.

WOOD SHINGLES APPEAR IS GOOD
CONDITION - SOME SPLITTING.
WOOD WINDOWS (NOT TRUE
DIVIDED, SIMULATED) REQUIRE SOME
MAINTENANCE AND REPAIR.

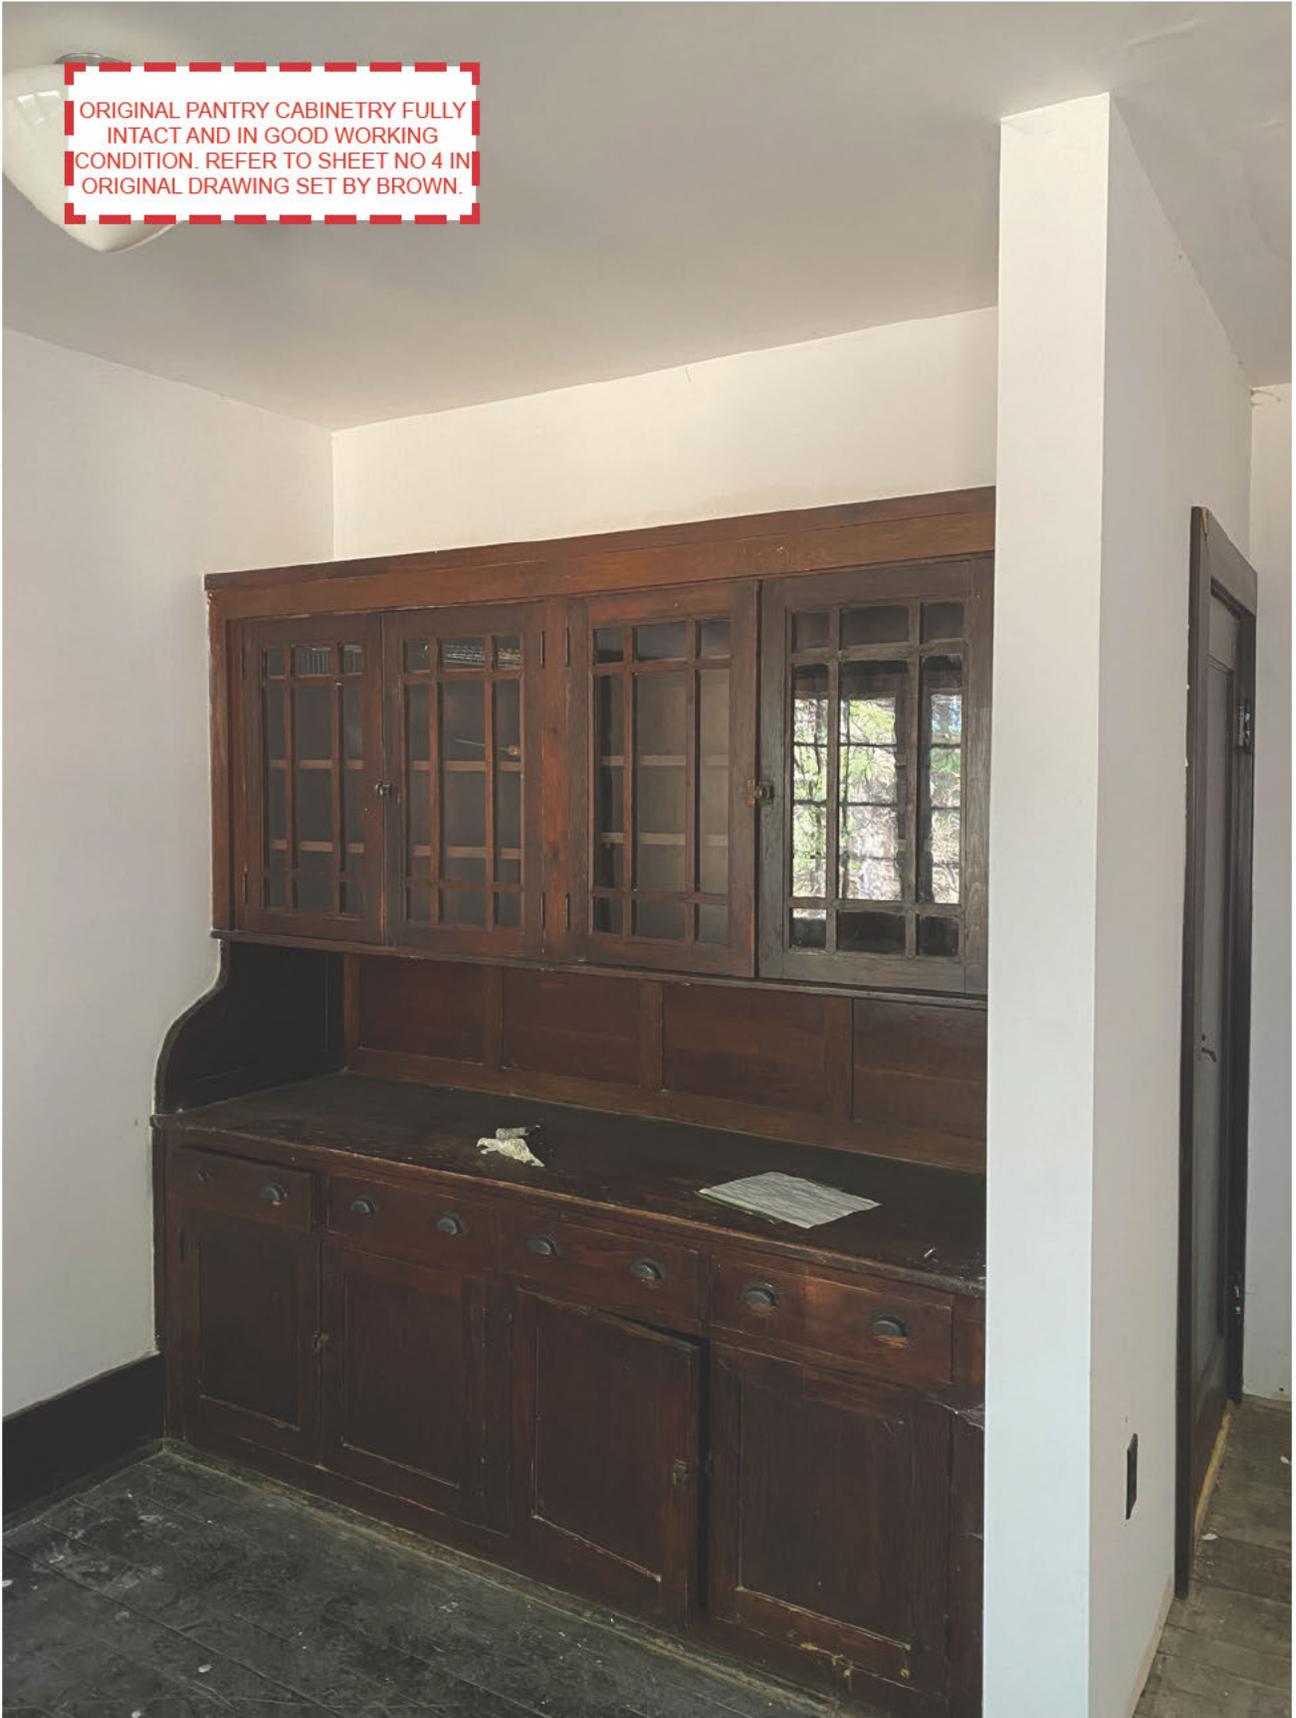
2.13 MAIN FLOOR PANTRY AREA (OPPOSITE DINING AREA).

ORIGINAL PANTRY CABINETRY FULLY
INTACT AND IN GOOD WORKING
CONDITION. REFER TO SHEET NO 4 IN
ORIGINAL DRAWING SET BY BROWN.

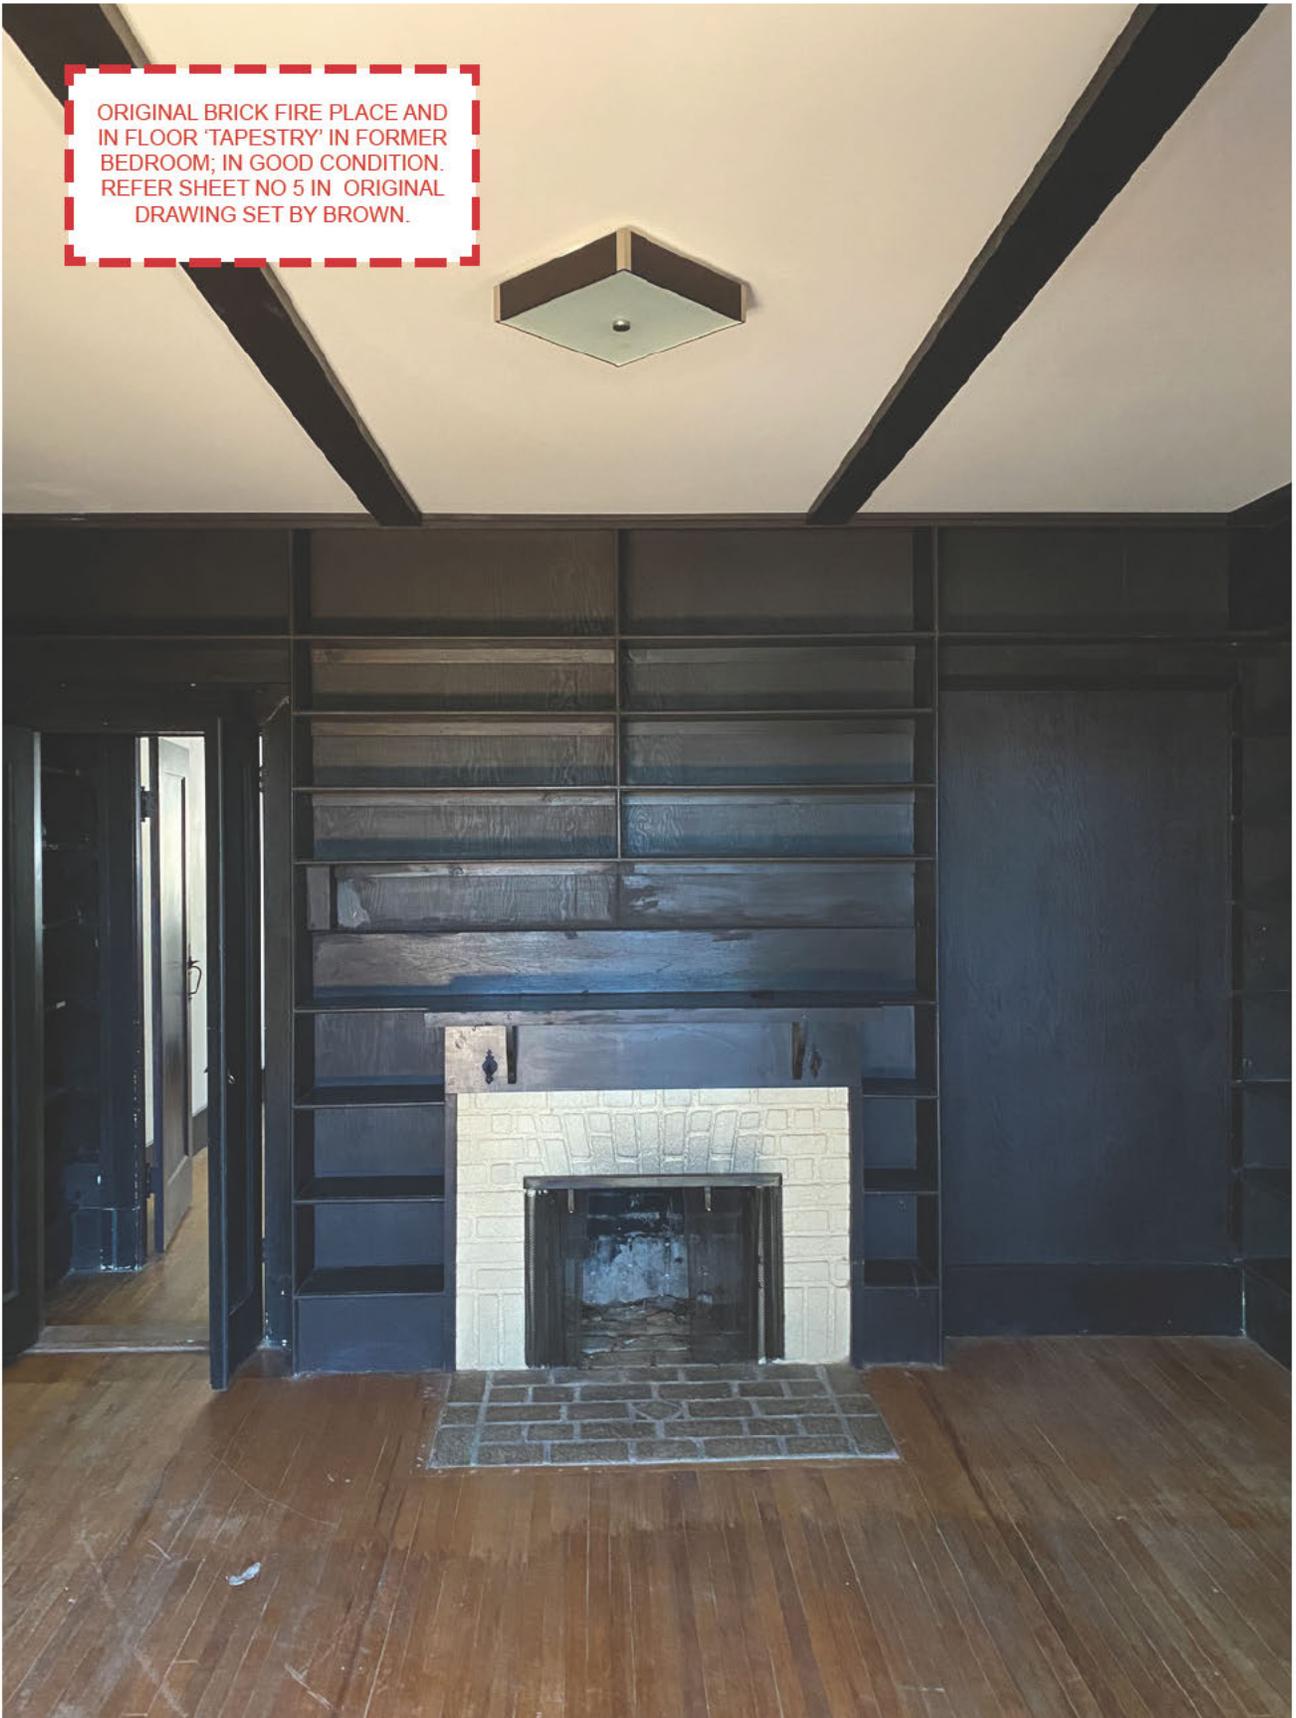
2.15 MAIN FLOOR, FORMER BEDROOM AREA (WEST).

ORIGINAL BRICK FIRE PLACE AND
IN FLOOR 'TAPESTRY' IN FORMER
BEDROOM; IN GOOD CONDITION.
REFER SHEET NO 5 IN ORIGINAL
DRAWING SET BY BROWN.

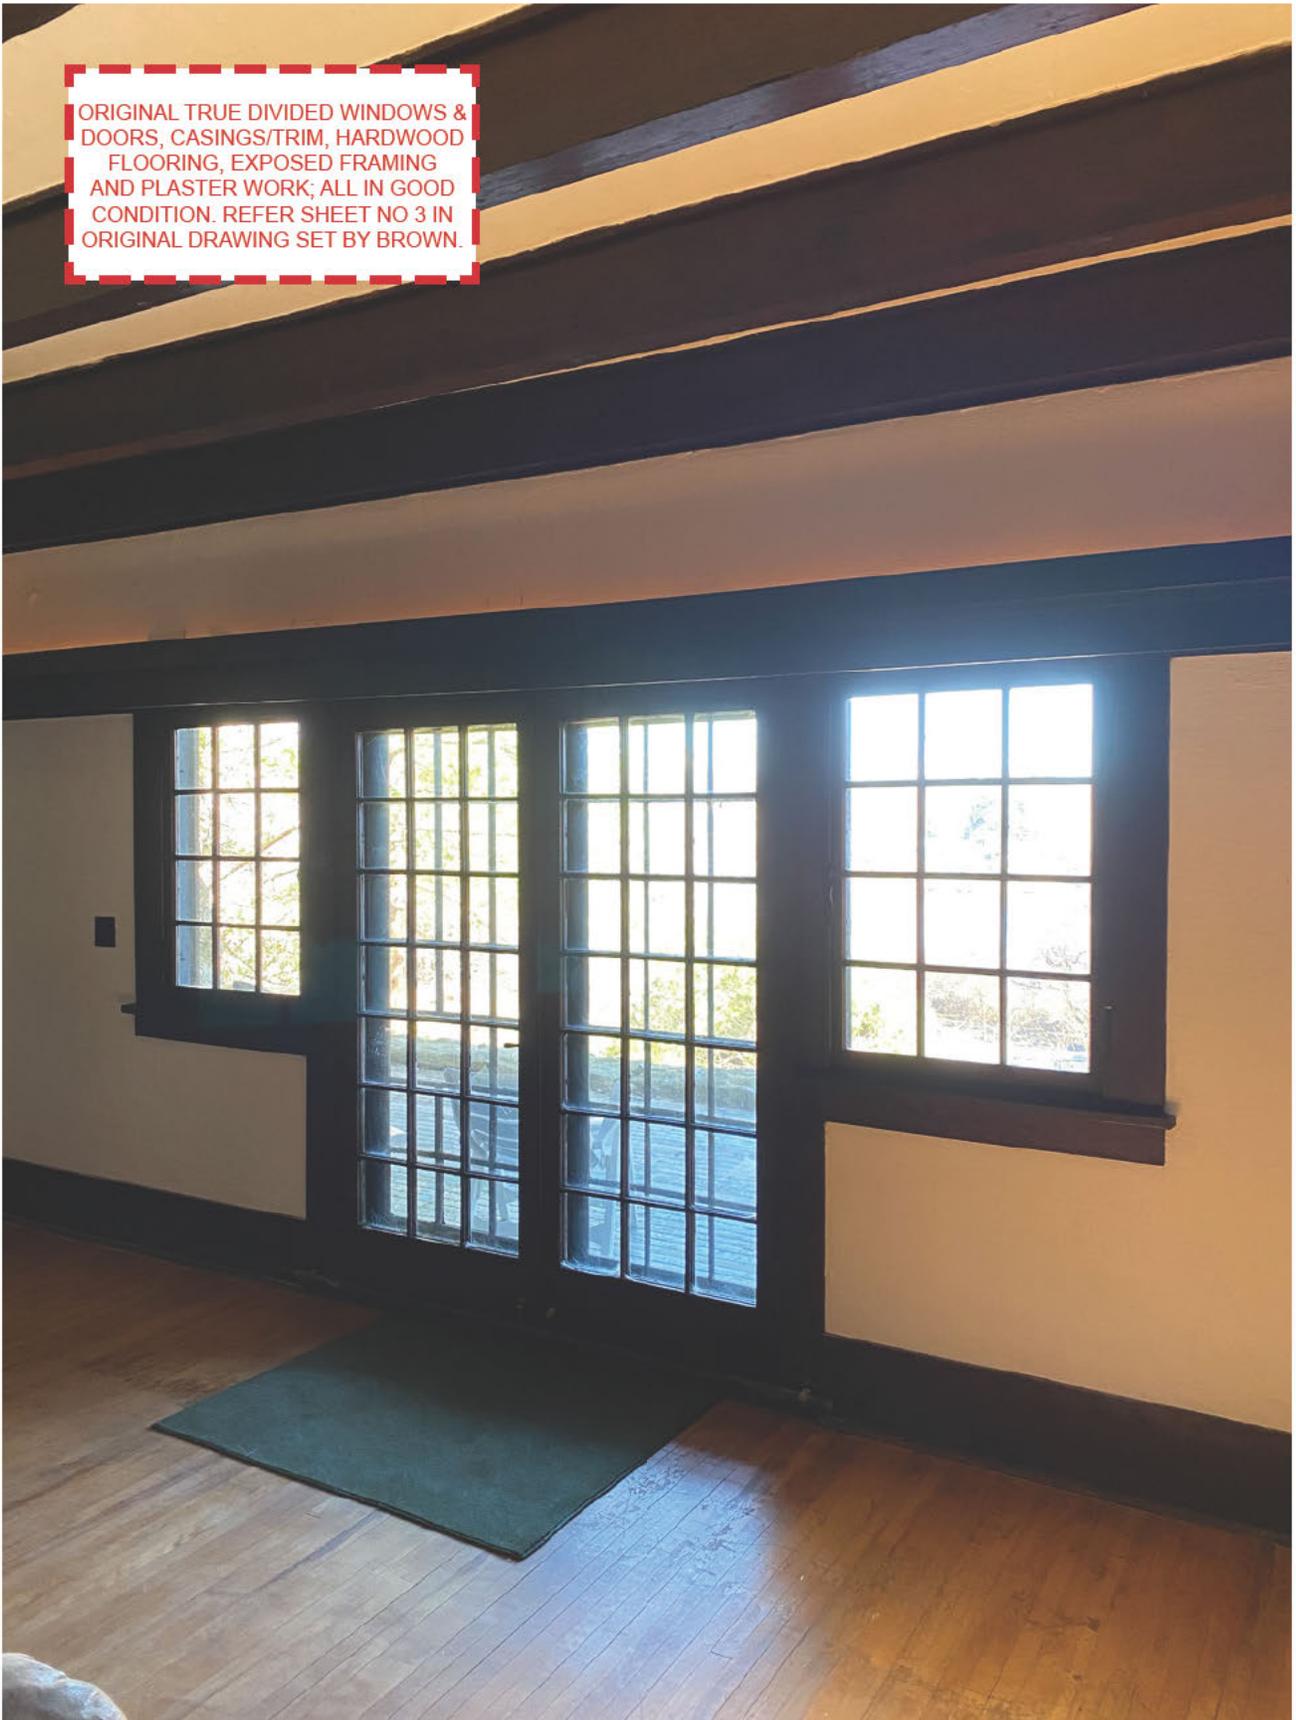
2.16 MAIN FLOOR LIVING ROOM (EAST).

ORIGINAL TRUE DIVIDED WINDOWS & DOORS, CASINGS/TRIM, HARDWOOD FLOORING, EXPOSED FRAMING AND PLASTER WORK; ALL IN GOOD CONDITION. REFER SHEET NO 3 IN ORIGINAL DRAWING SET BY BROWN.

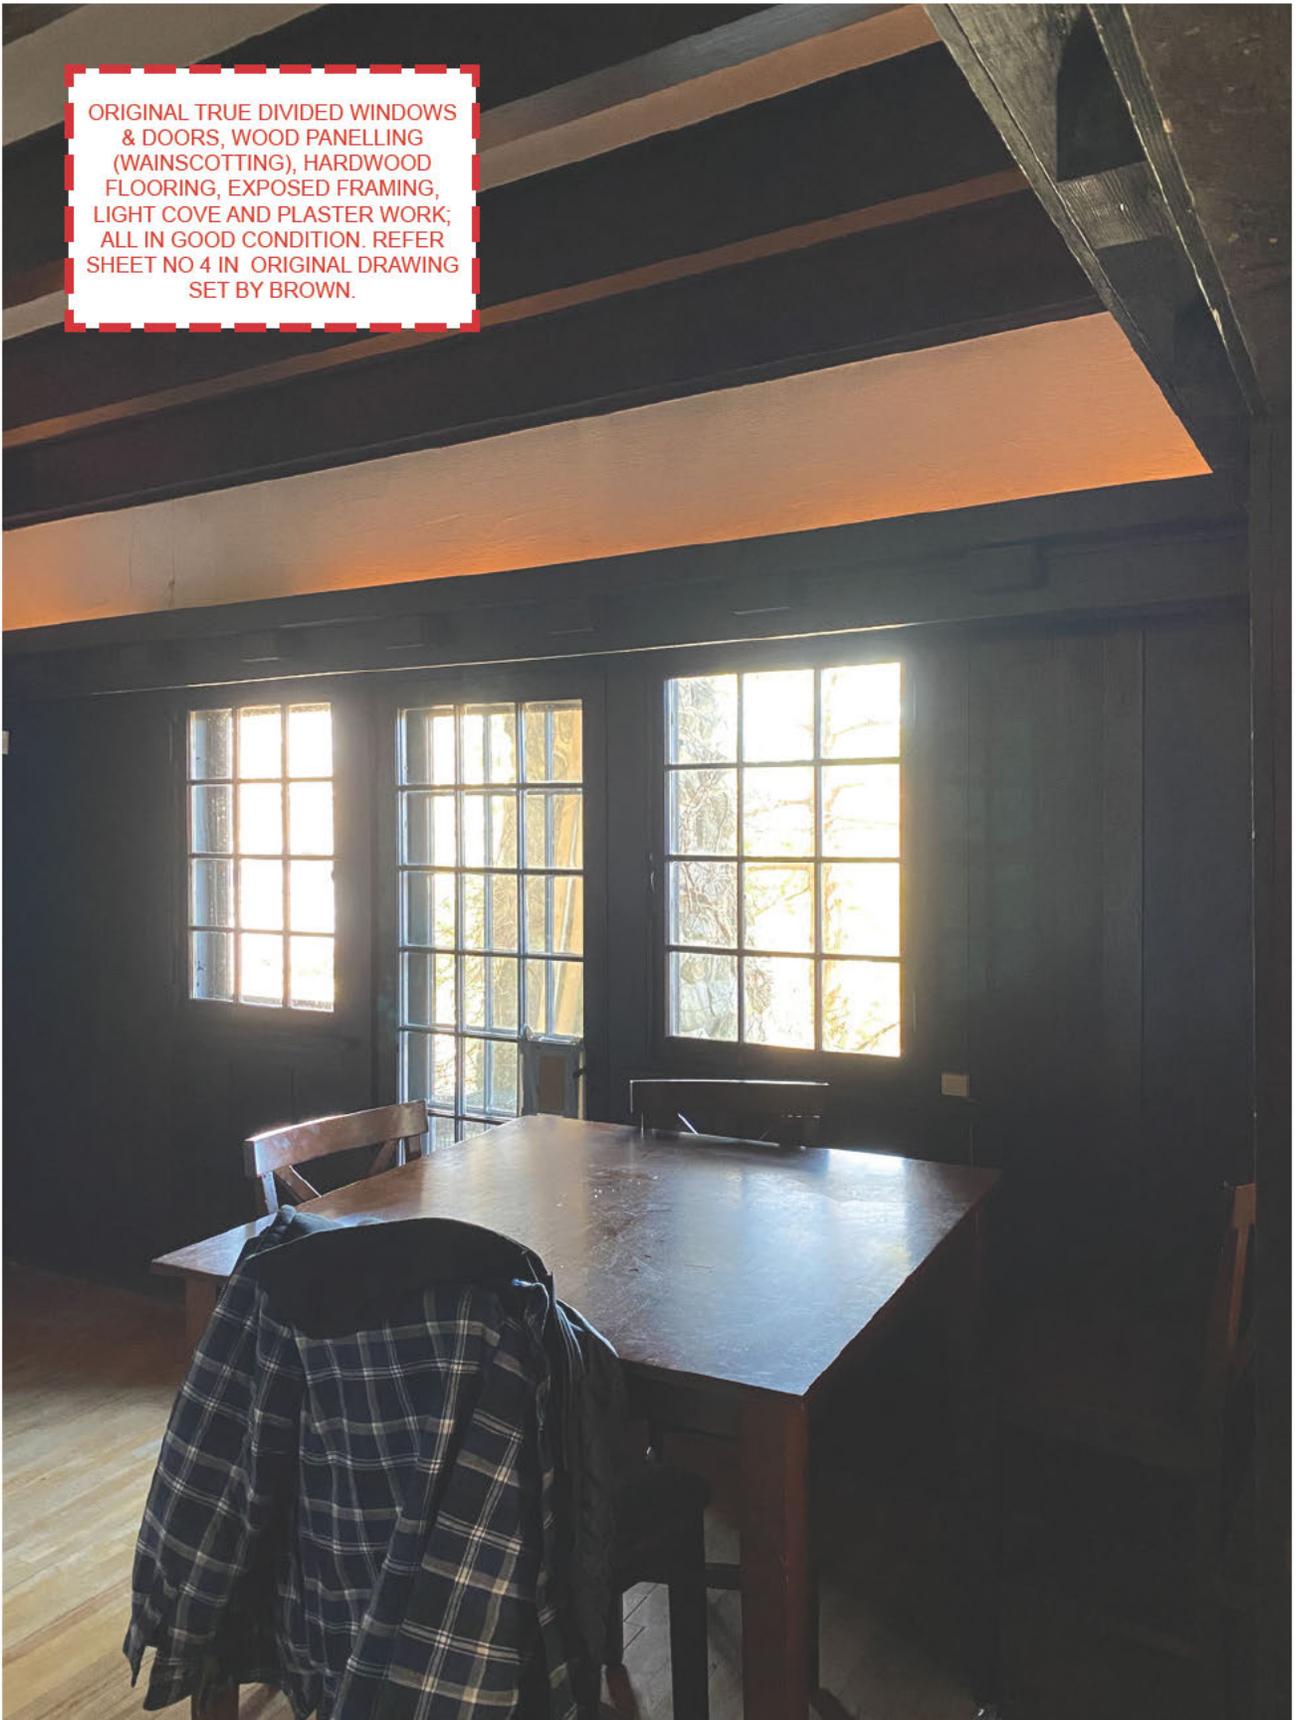
2.16 MAIN FLOOR DINING ROOM (EAST).

ORIGINAL TRUE DIVIDED WINDOWS
& DOORS, WOOD PANELLING
(WAINSCOTTING), HARDWOOD
FLOORING, EXPOSED FRAMING,
LIGHT COVE AND PLASTER WORK;
ALL IN GOOD CONDITION. REFER
SHEET NO 4 IN ORIGINAL DRAWING
SET BY BROWN.

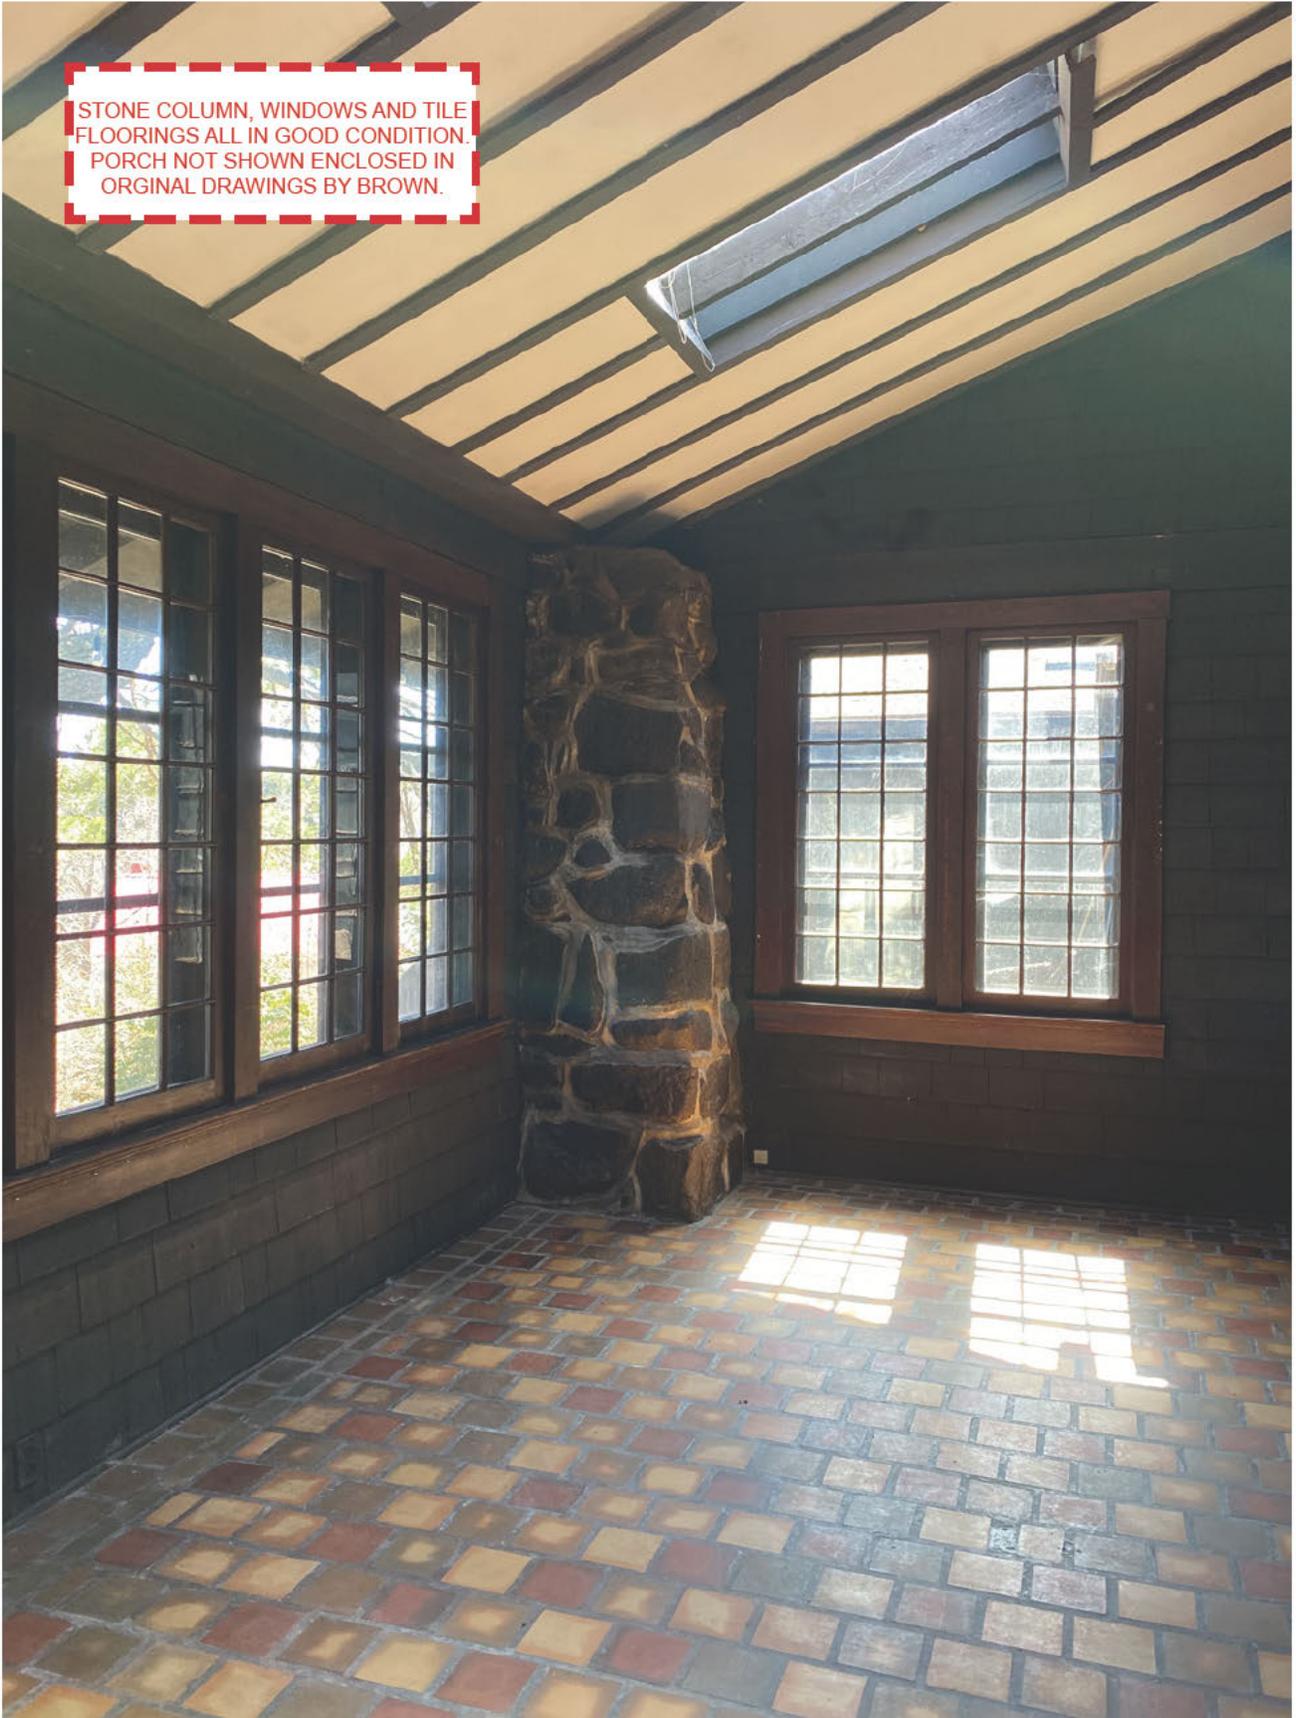
2.18 ENCLOSED PORCH, MAIN FLOOR (SOUTHEAST CORNER).

STONE COLUMN, WINDOWS AND TILE FLOORINGS ALL IN GOOD CONDITION. PORCH NOT SHOWN ENCLOSED IN ORIGINAL DRAWINGS BY BROWN.
