10 Kirk Road Heritage Impact Statement

Heritage Impact Statement
Re Finntigh Mara/Mathers Estate
10 Kirk Road, Halifax, Nova Scotia, B3P 1A6
Aug 31 2022

Prepared by
MacKay-Lyons Sweetapple Architects
2188 Gottingen Street, Halifax, NS, B3K 3B4
902 429 1867
mlsarchitects.ca

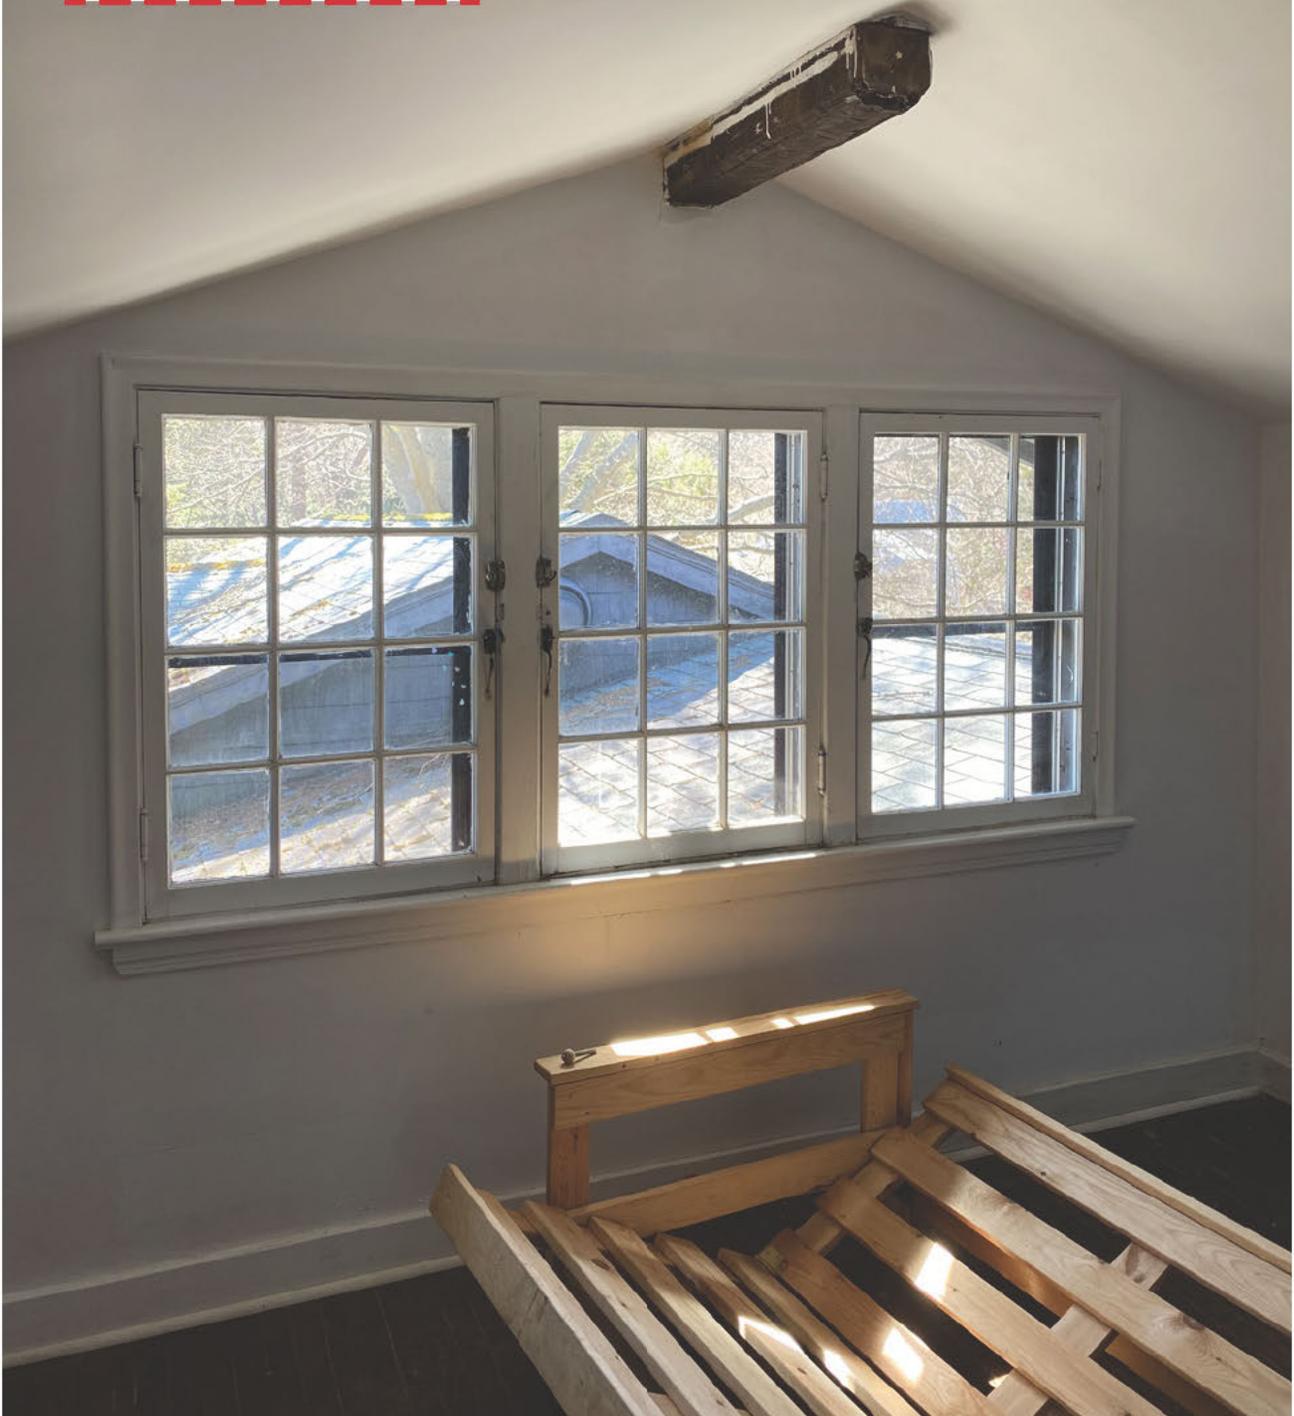
2.19 BEDROOM, UPPER FLOOR (SOUTH SIDE).

TRUE DIVIDED WINDOWS IN GOOD
CONDITION; SOME MAINTENANCE
AND REPAIR WORK REQUIRED.
WINDOW SIZE AND ARRANGEMENT
DIFFERS FROM ORIGINAL DRAWINGS
BY BROWN - REFER SHEET NO 2
SOUTH ELEVATION.

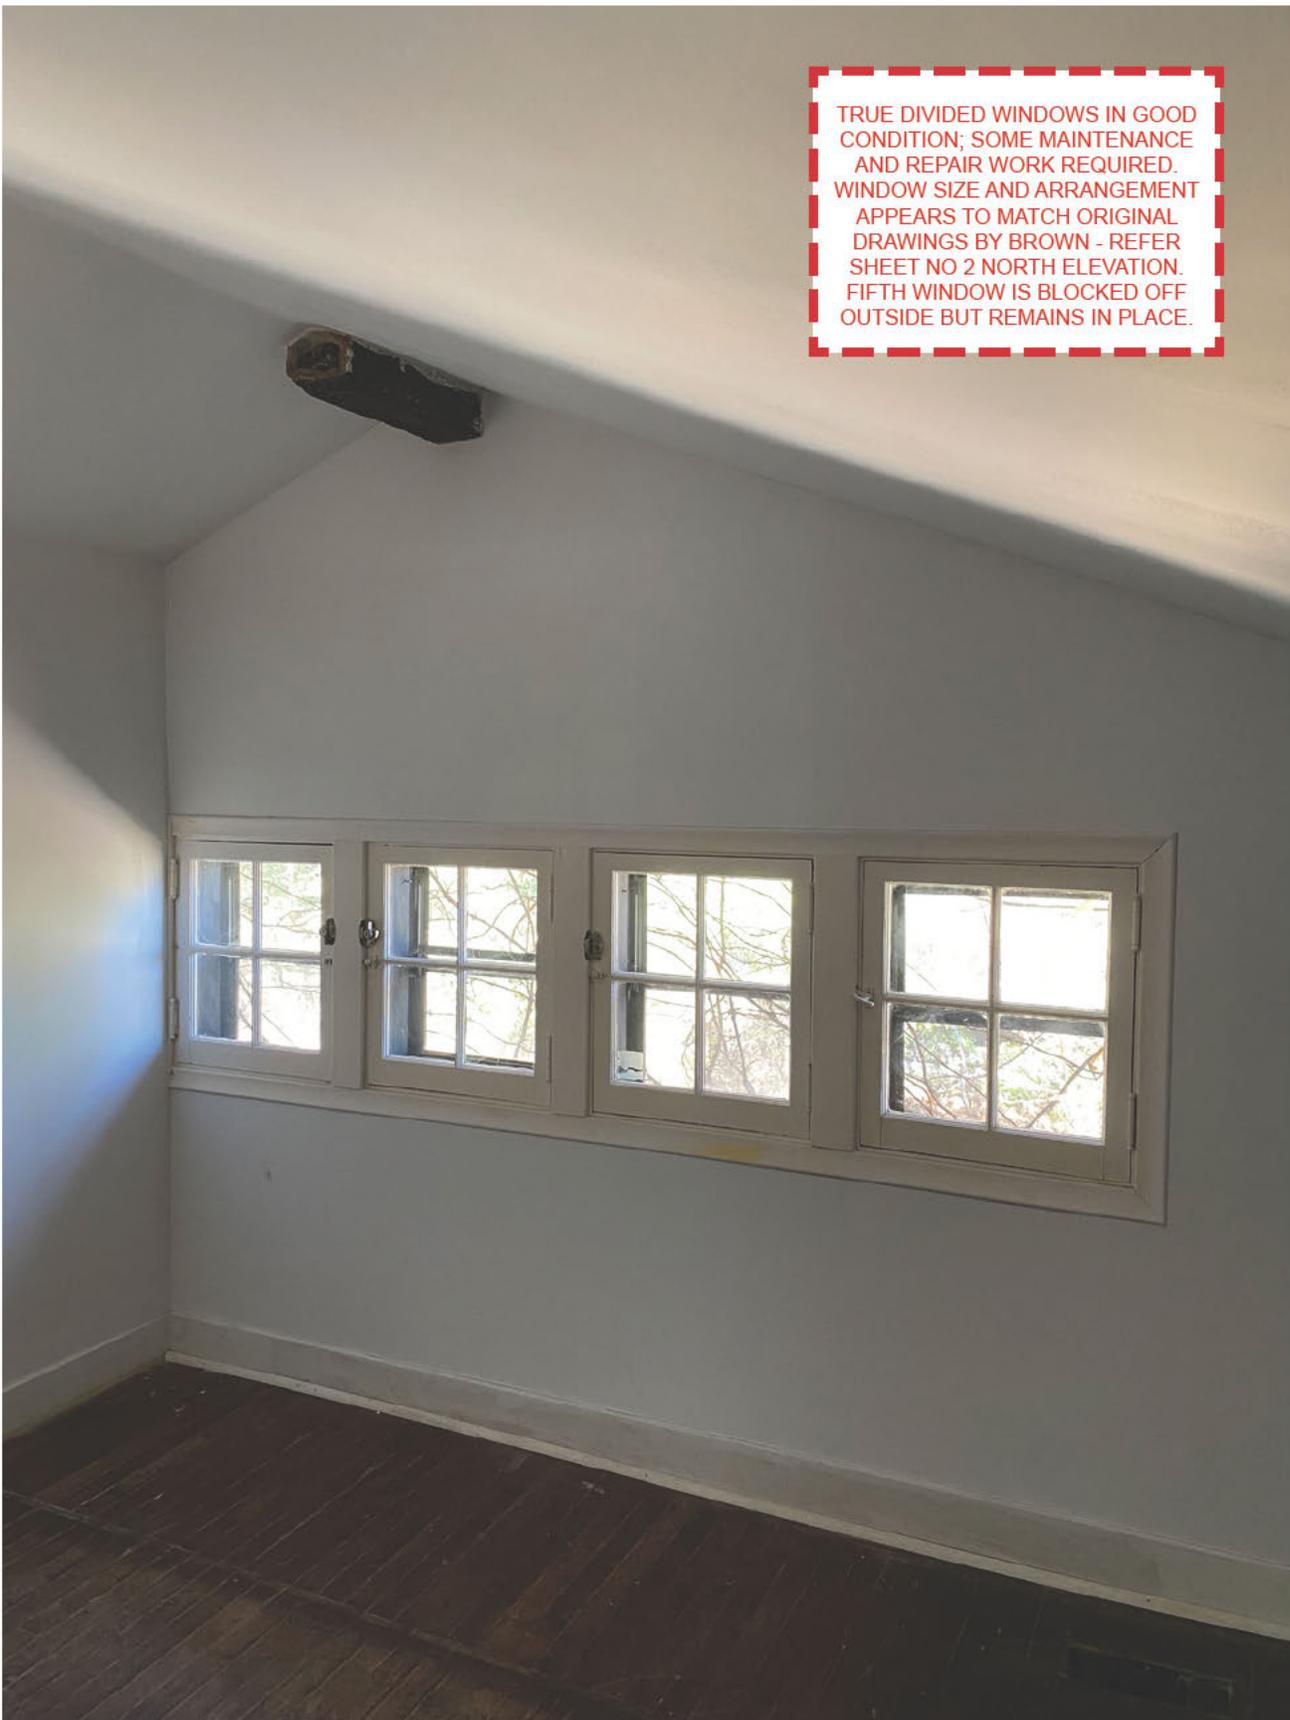
2.20 BEDROOM, UPPER FLOOR (NORTH SIDE).

TRUE DIVIDED WINDOWS IN GOOD
CONDITION; SOME MAINTENANCE
AND REPAIR WORK REQUIRED.
WINDOW SIZE AND ARRANGEMENT
APPEARS TO MATCH ORIGINAL
DRAWINGS BY BROWN - REFER
SHEET NO 2 NORTH ELEVATION.
FIFTH WINDOW IS BLOCKED OFF
OUTSIDE BUT REMAINS IN PLACE.

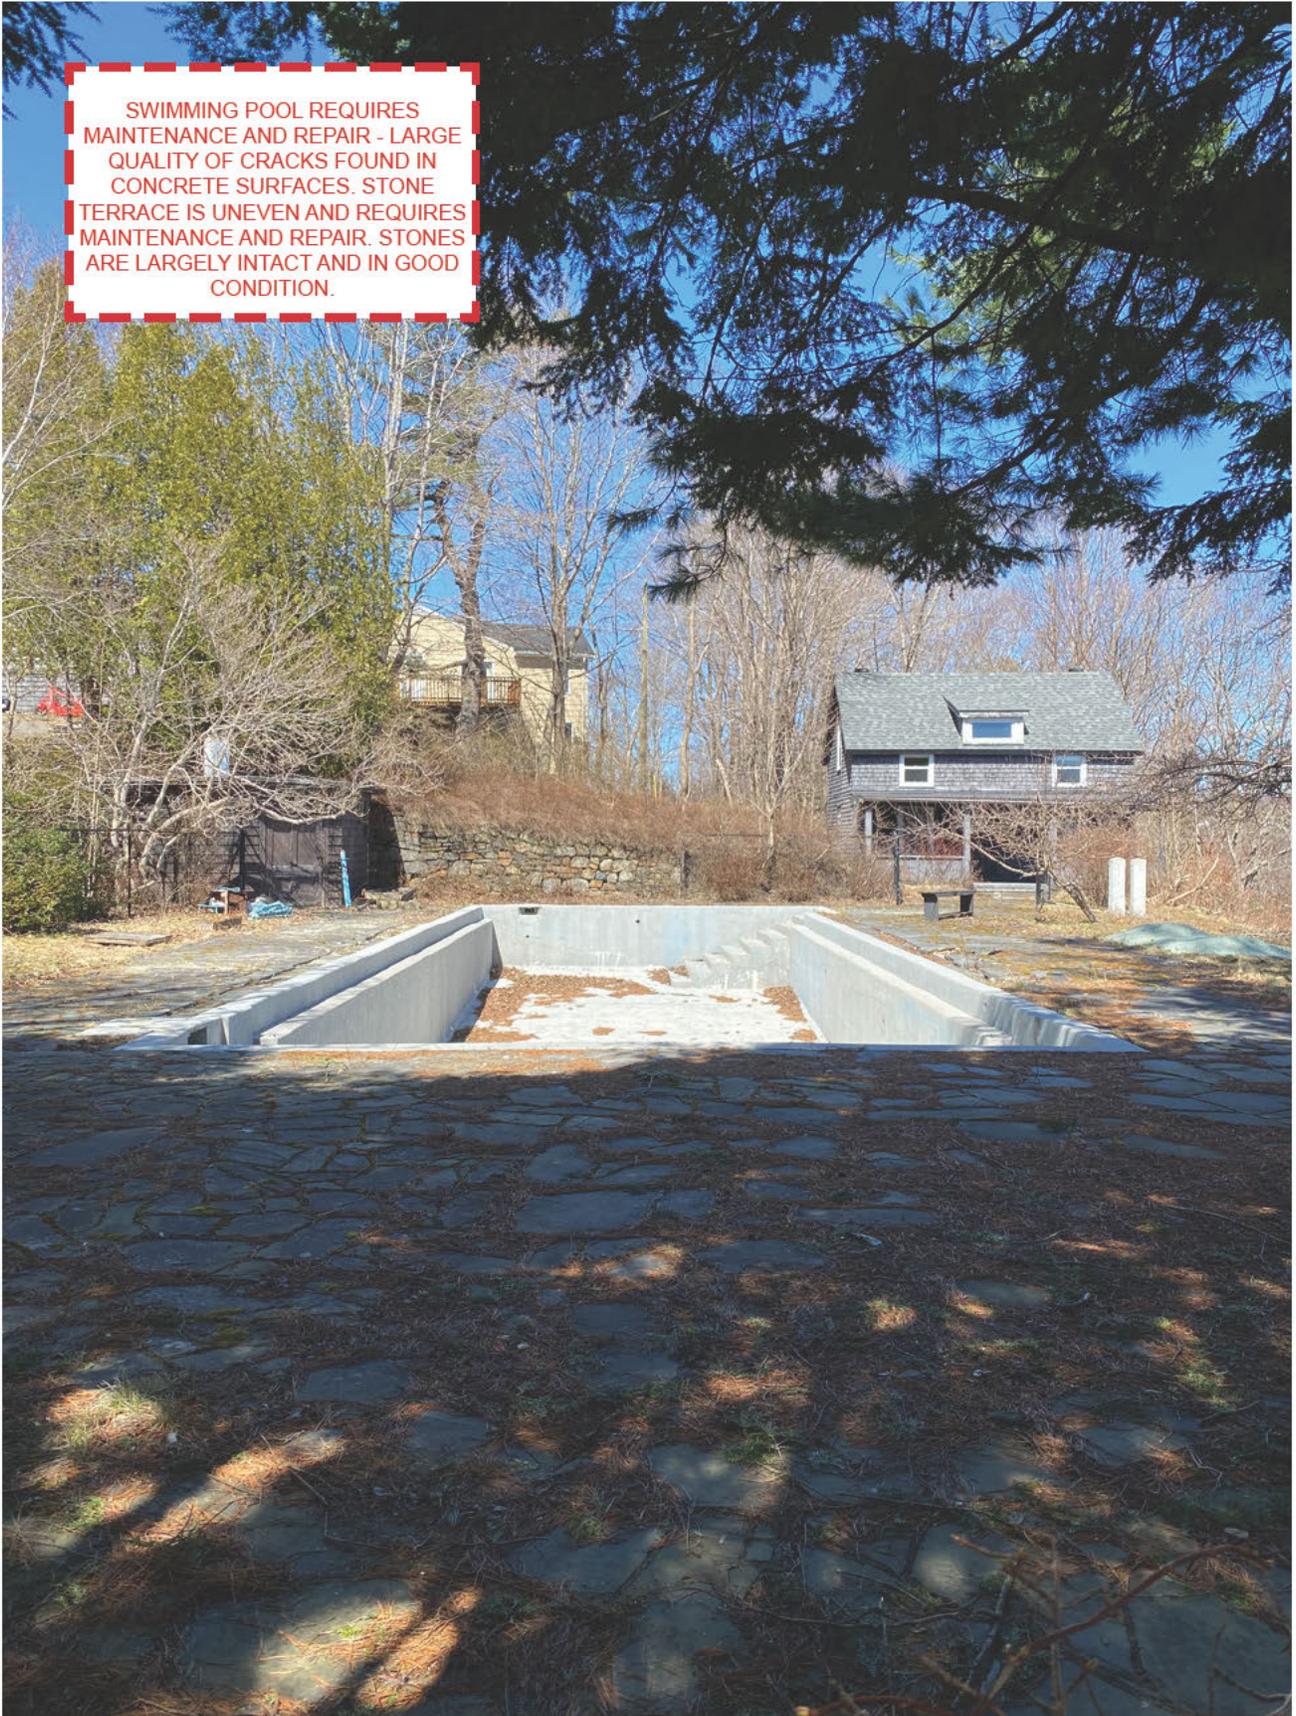
2.23 SWIMMING POOL WITH STONE TERRACE (NORTH VIEW).

The concrete swimming pool requires maintenance and repair. A significant quantity of cracks (of varying sizes) were observed throughout the concrete walls and floor of the pool (refer to AFRR image 2.23A).

The flagstone terrace surrounding the swimming pool also requires maintenance and repair. The surface is uneven, and some stones are cracked - likely caused by frost heave. Most stones appear in good condition and are intact (refer to AFRR images 2.23 and 2.23B).

SWIMMING POOL REQUIRES MAINTENANCE AND REPAIR - LARGE QUALITY OF CRACKS FOUND IN CONCRETE SURFACES. STONE TERRACE IS UNEVEN AND REQUIRES MAINTENANCE AND REPAIR. STONES ARE LARGELY INTACT AND IN GOOD CONDITION.

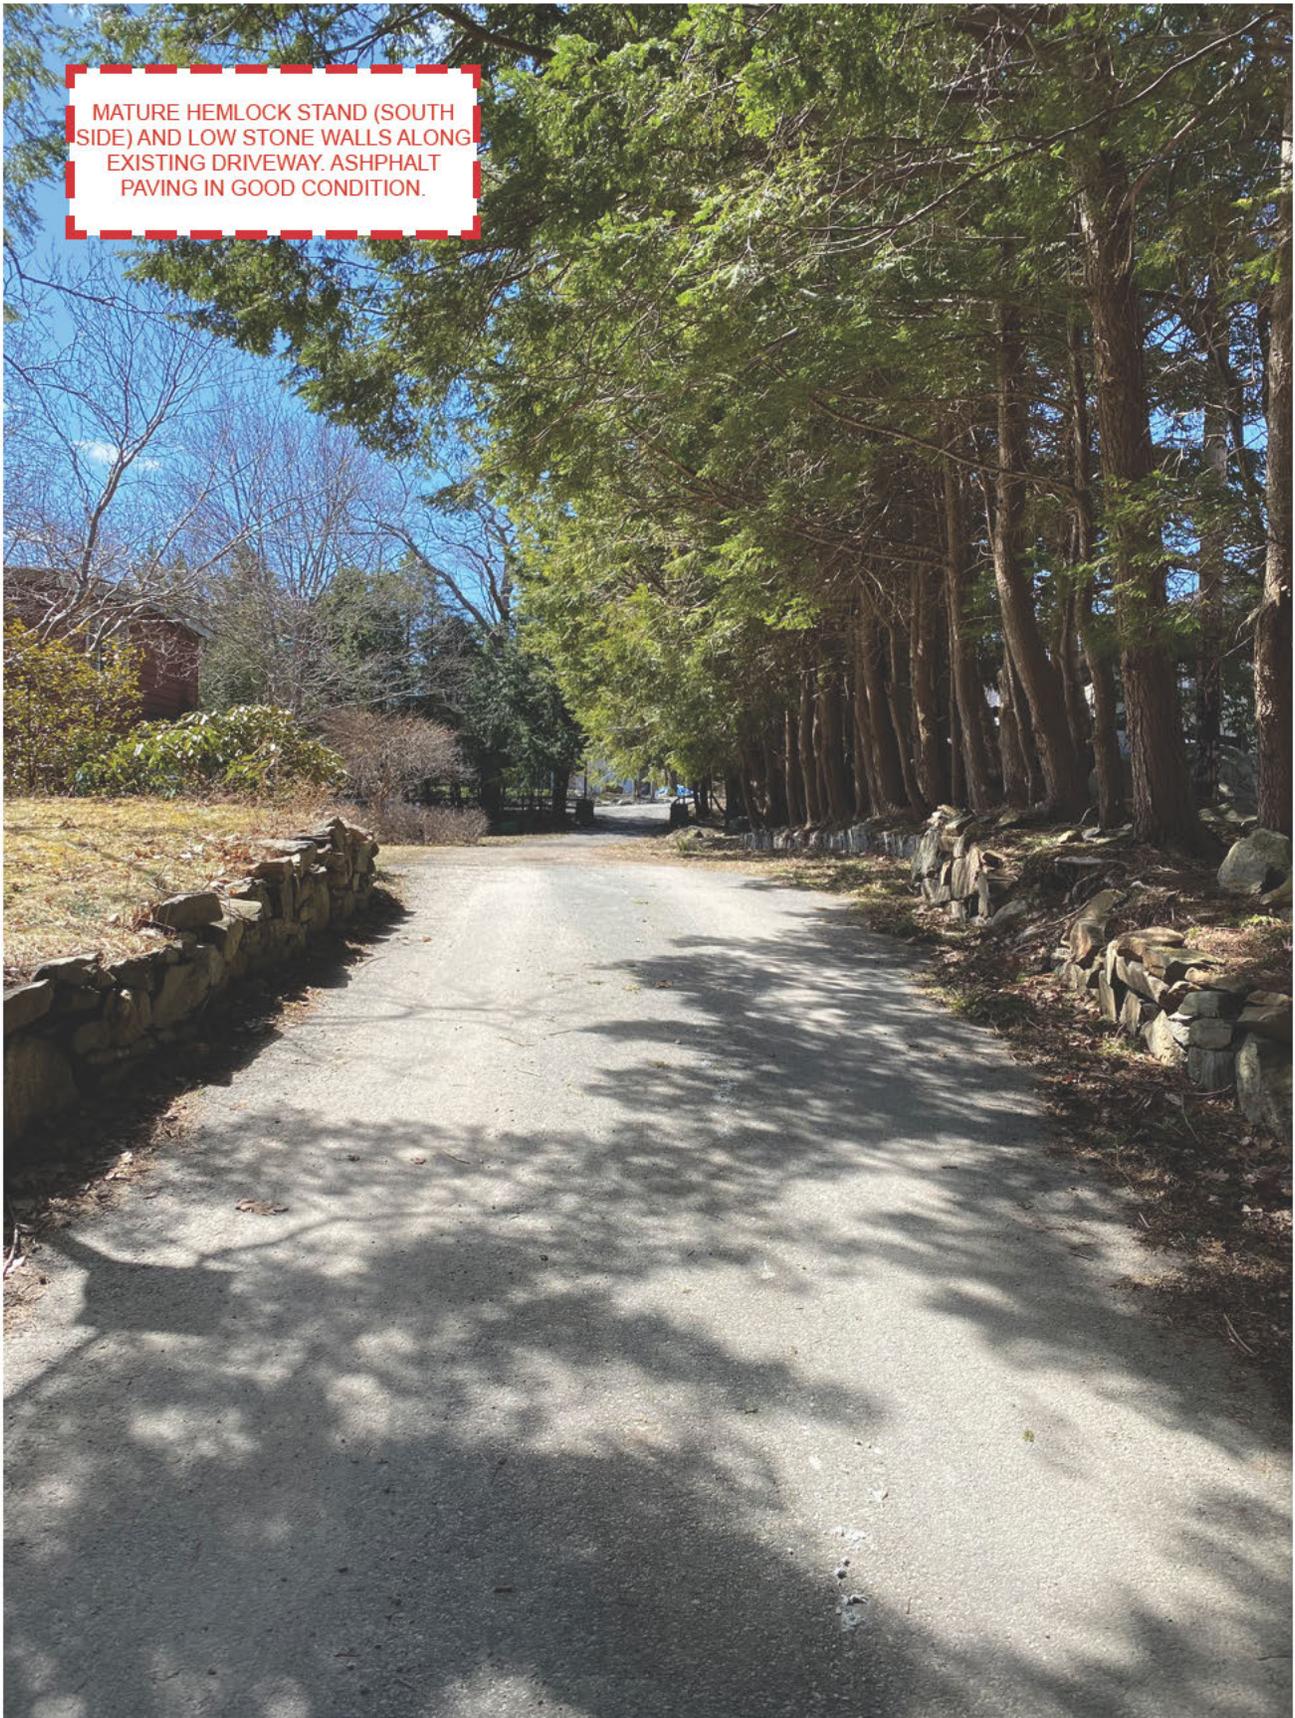
2.25 HEMLOCK STAND ALONG DRIVEWAY (WEST VIEW).

MATURE HEMLOCK STAND (SOUTH SIDE) AND LOW STONE WALLS ALONG EXISTING DRIVEWAY. ASPHALT PAVING IN GOOD CONDITION.

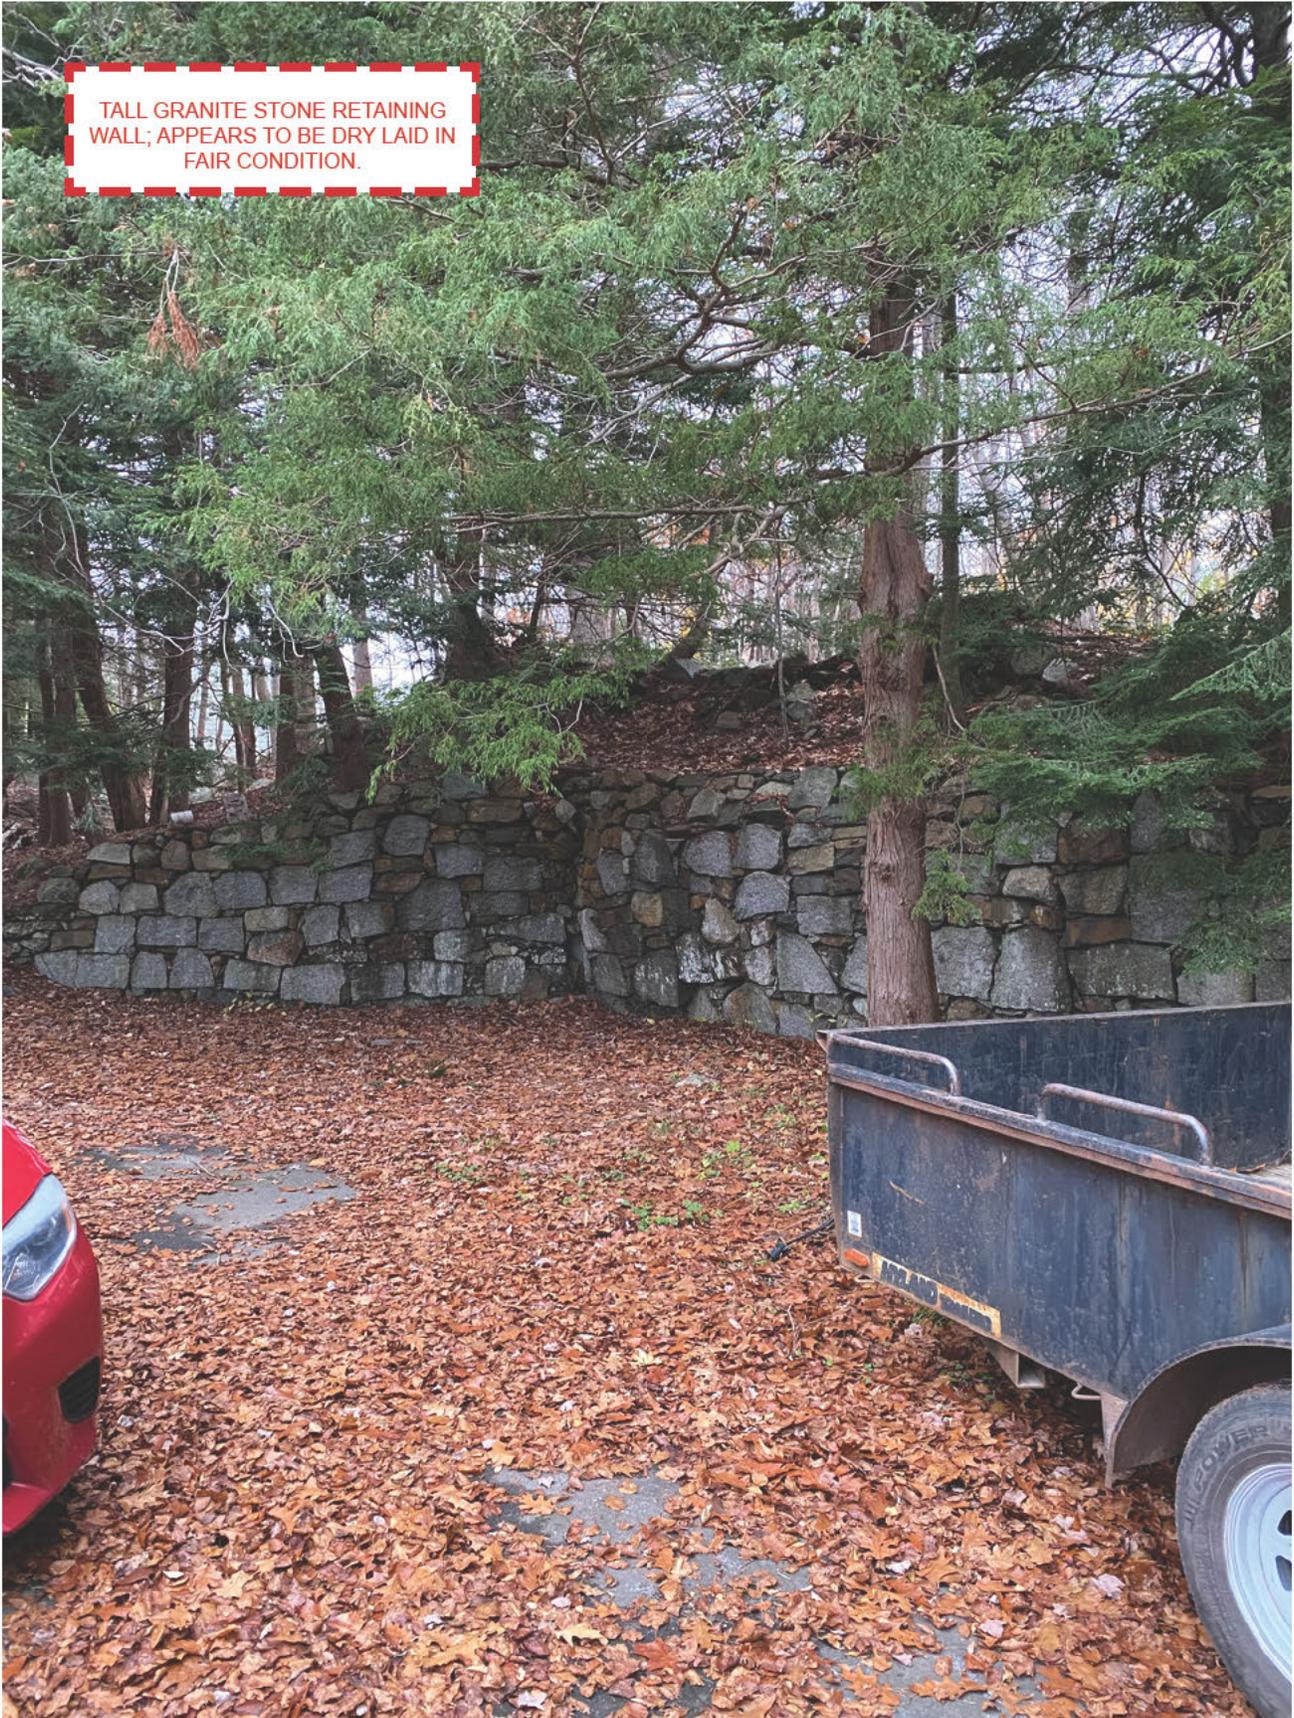
2.27 STONE WALL NEXT TO ROOST (SOUTHWEST VIEW).

GRANITE STONE RETAINING WALL;
APPEARS TO BE DRY LAID IN FAIR
CONDITION - SOME FALLEN STONES.

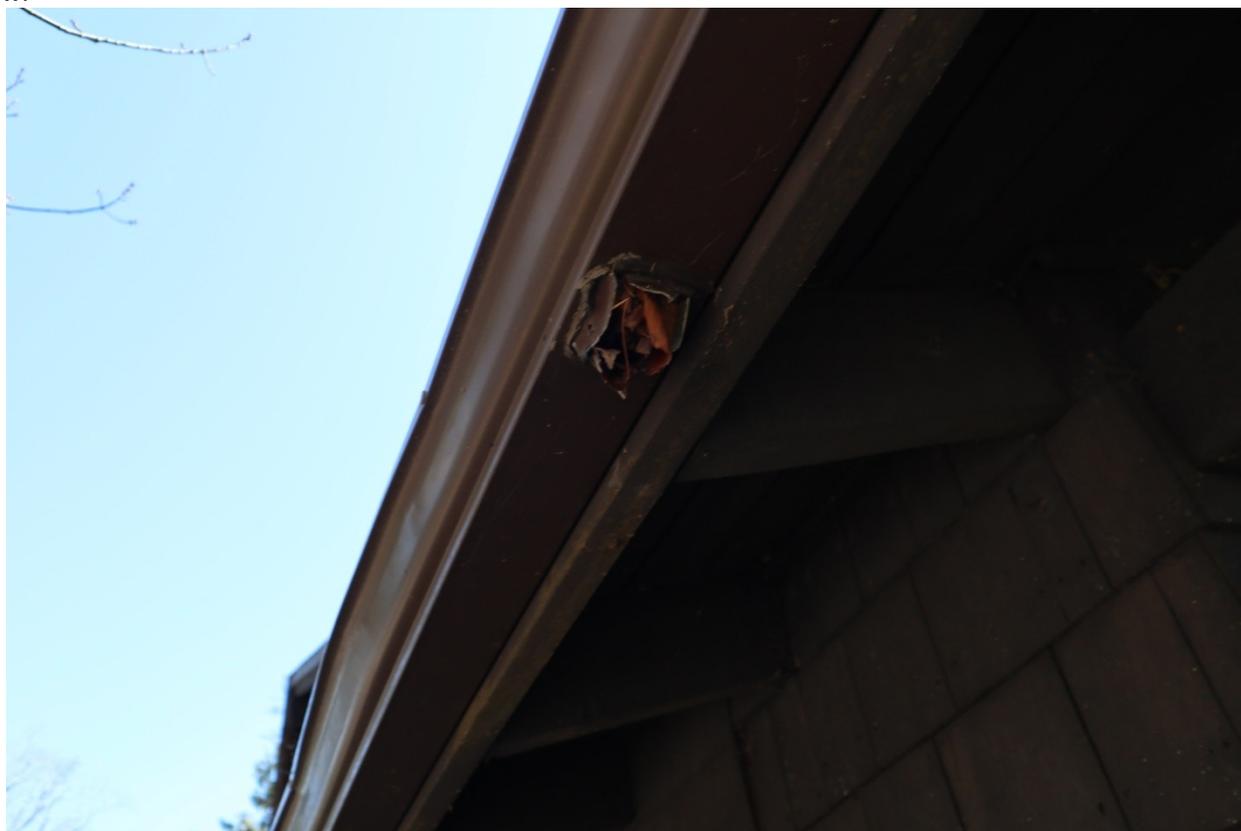
3) The gutters and downspouts were another item in very bad condition. See sample of damages in photograph below.

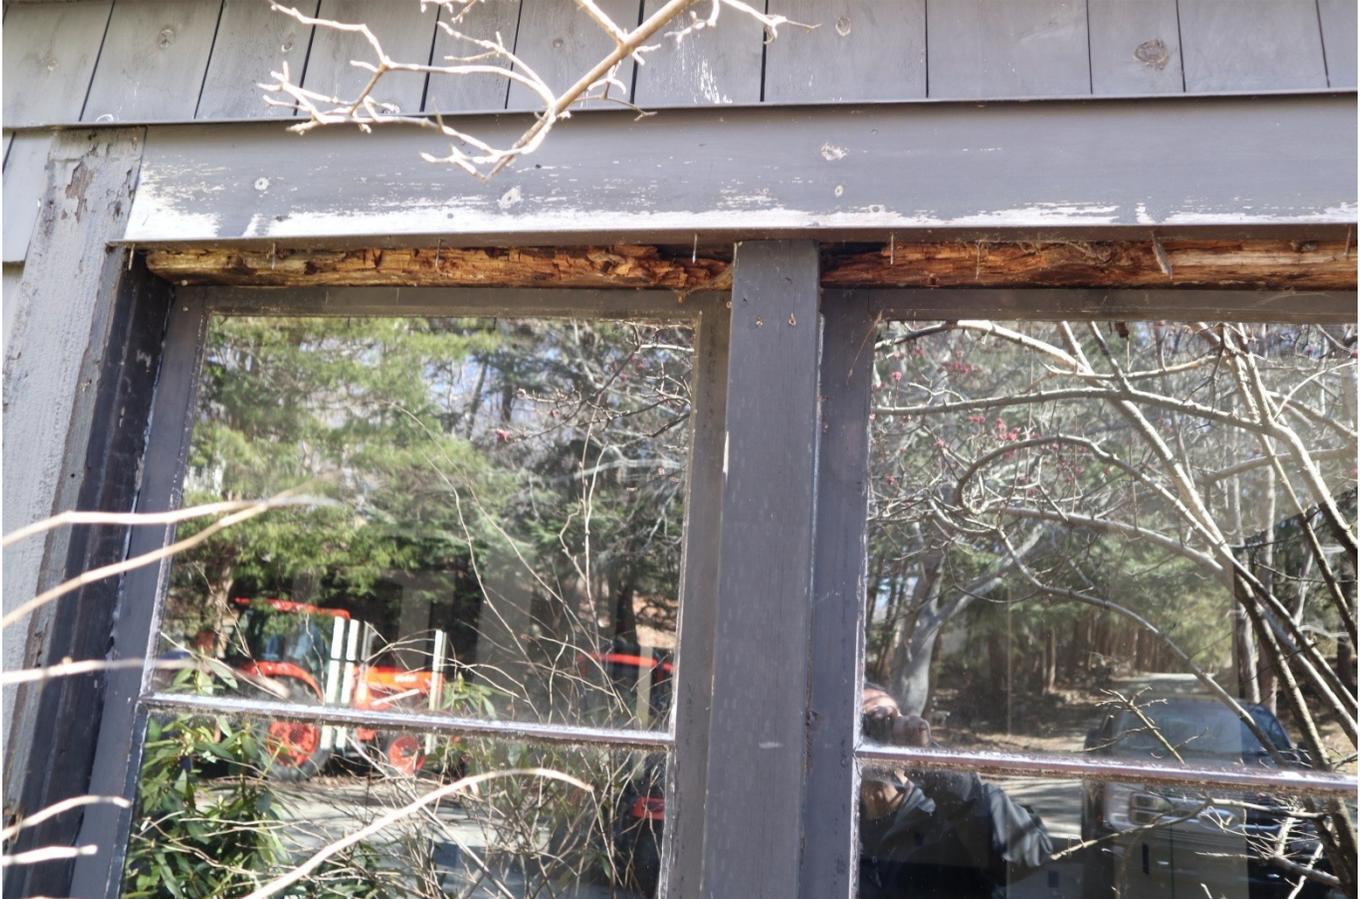
4) Another item of major concern was the rotting of the siding, windows, etc. around the building. The amount of rot varied as you inspected around the building, but most is considered as severe. This probably was effected by the direction of the most severe weather. In a variety of locations the rot is to an extreme, and must be considered as a severe problem which must be fixed. See a sample of this in the photograph below.

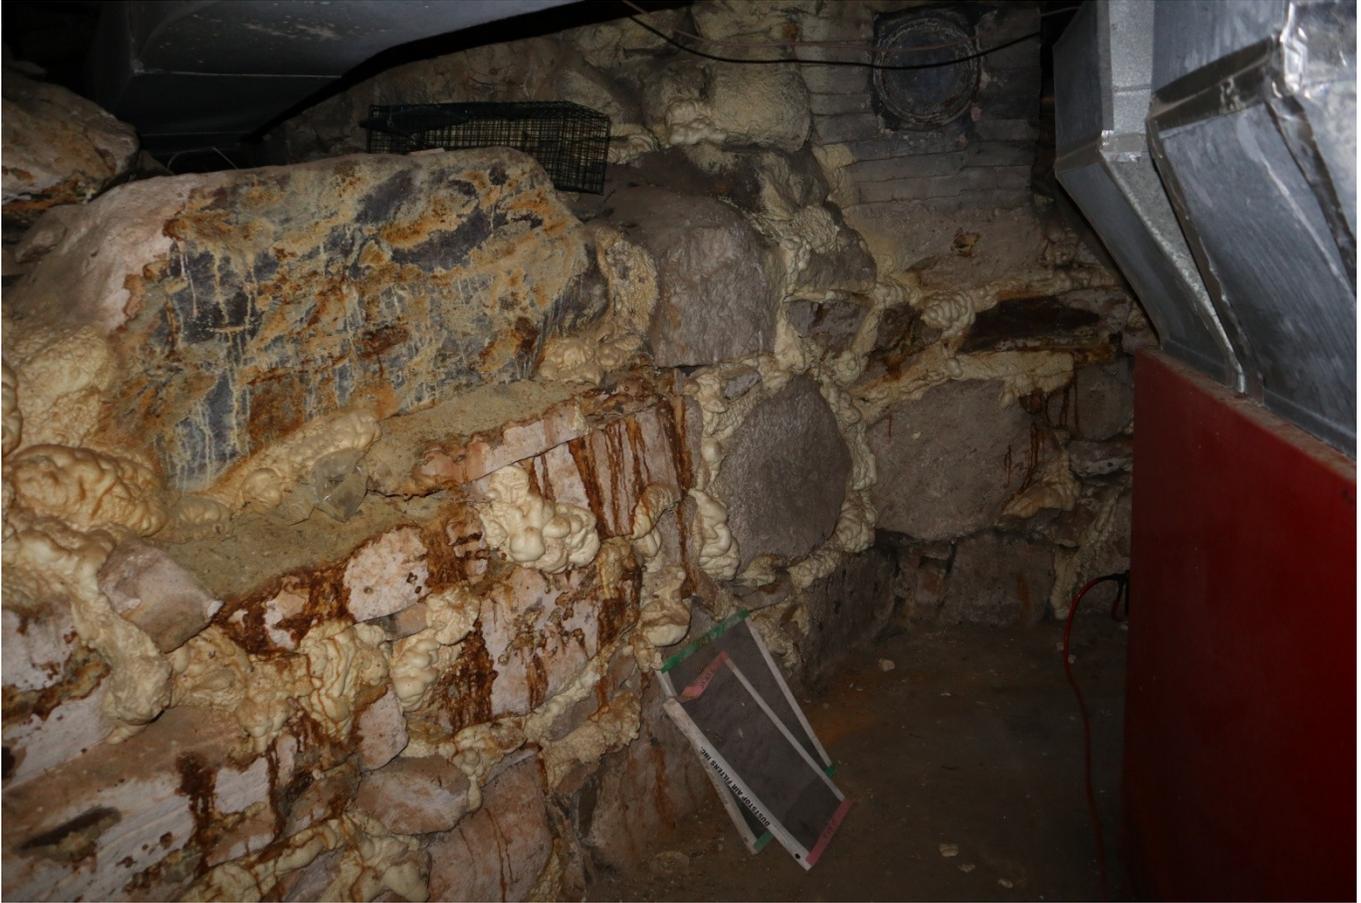
As can be seen in the photograph below, there are water stains all over the rock foundation. One can see as to how deep and clear this staining has become. This is a sign of the fact that this has been an ongoing problem extended over the life of the building.

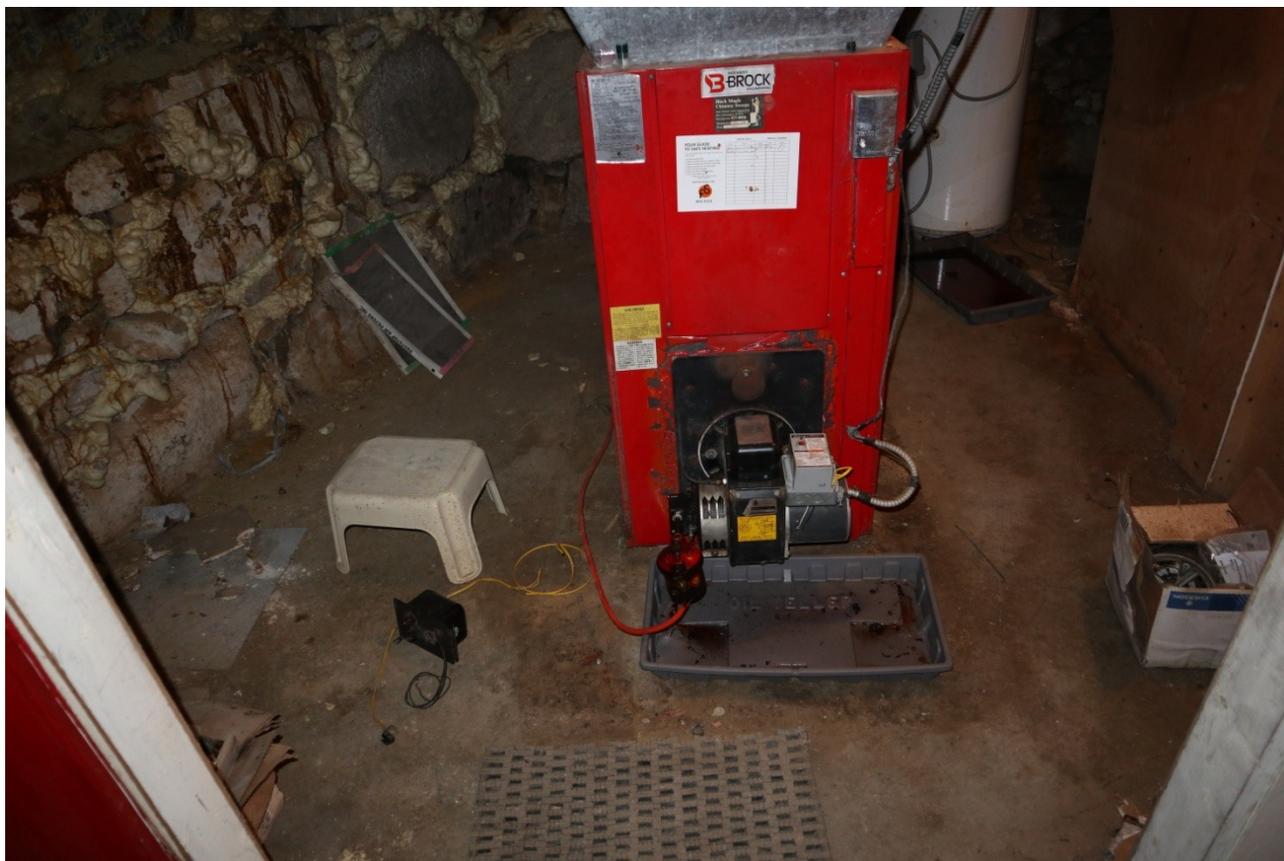
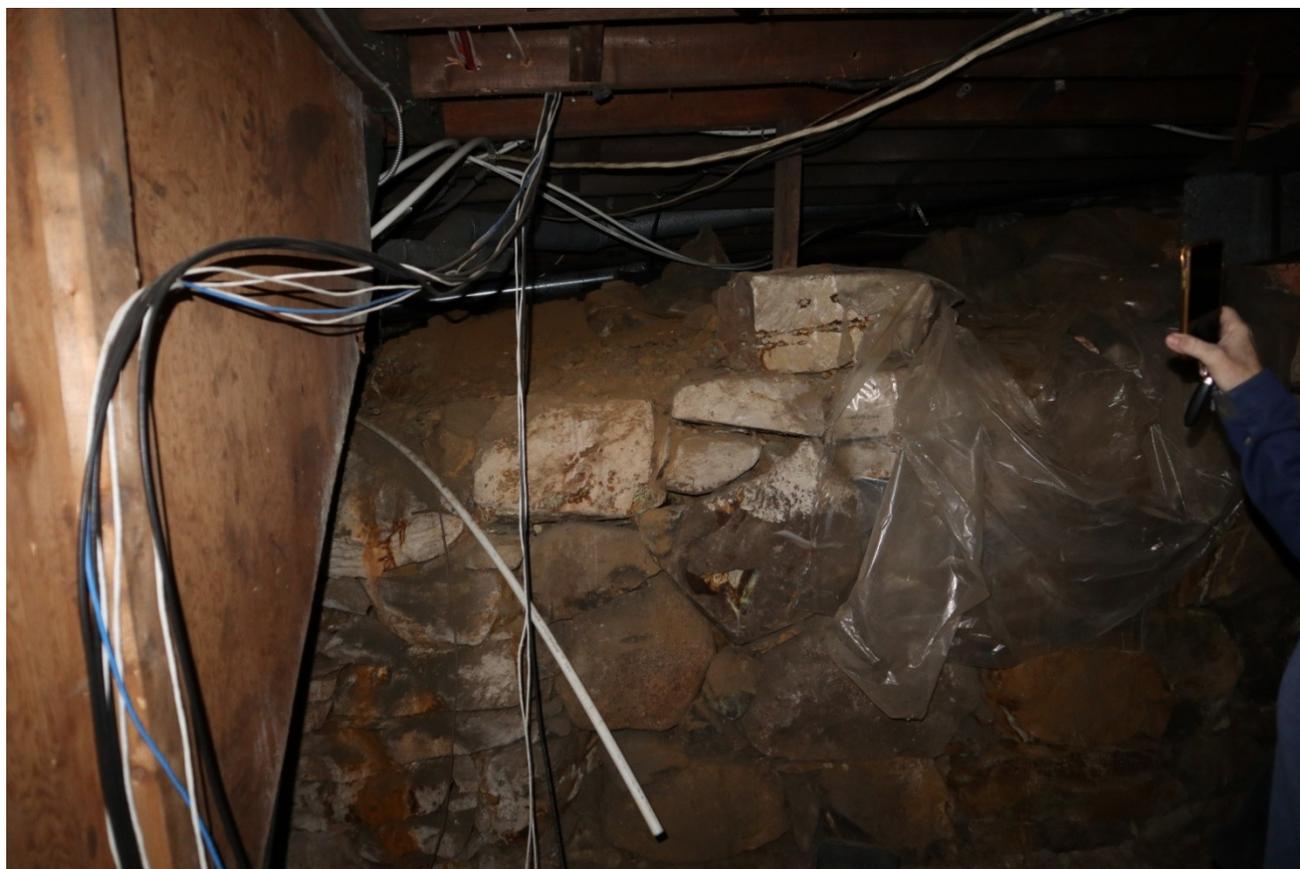
See in the photograph below, a sample of what moisture in the basement has done to the furnace for the building. The rust and corrosion are very evident all over the unit. It is unknown as to what the present operational condition is for this unit.

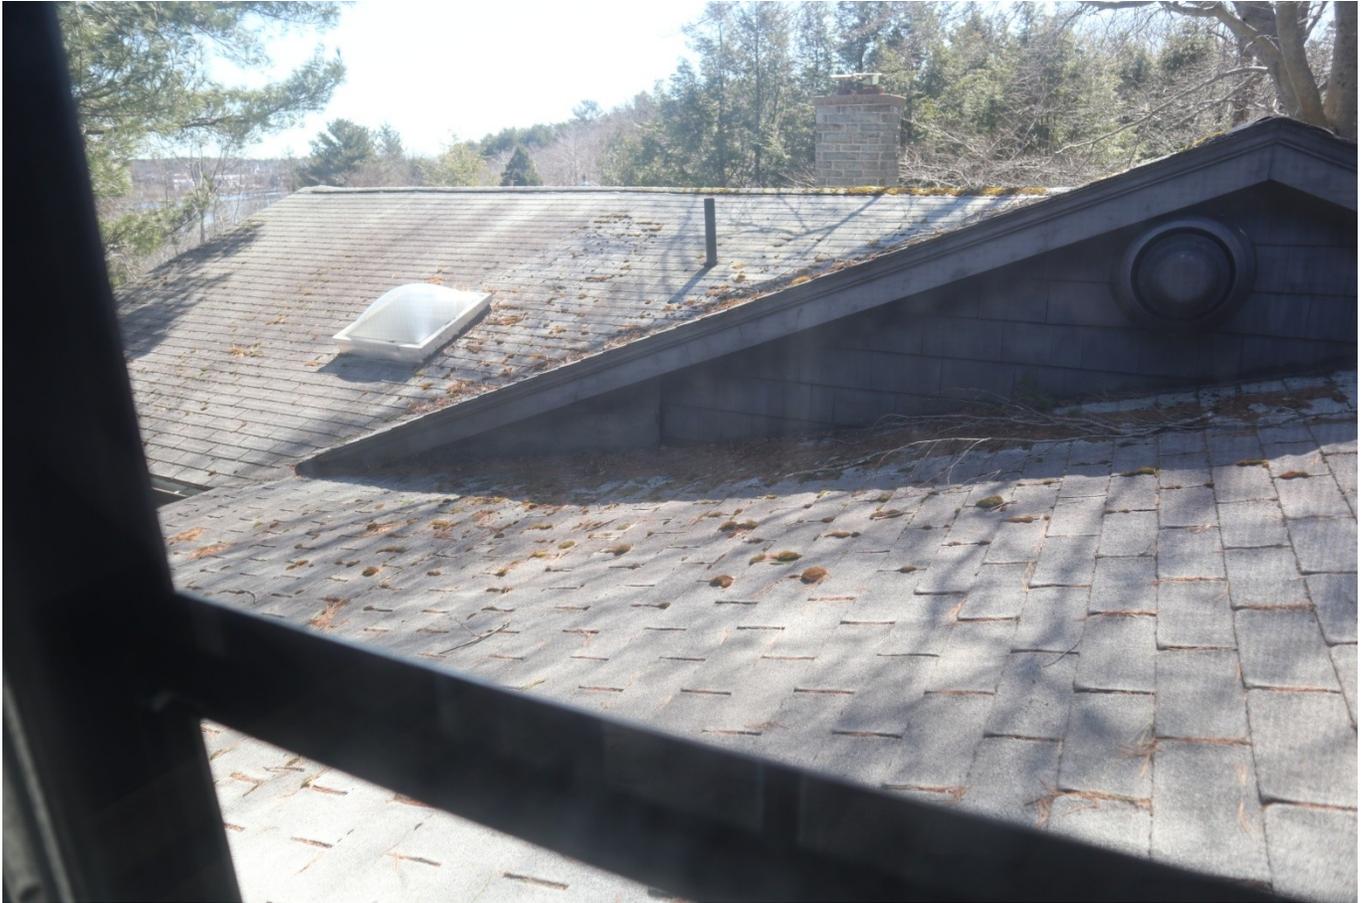
From the upper level window, one can look down over a lower roof area. This roof has what appears to be basic shingle on it. However, as can be seen in the photograph below, the roof appears to have very little slope, thus the water does not run off of it properly. This could be the cause of some of the water leaks, and should be addressed,

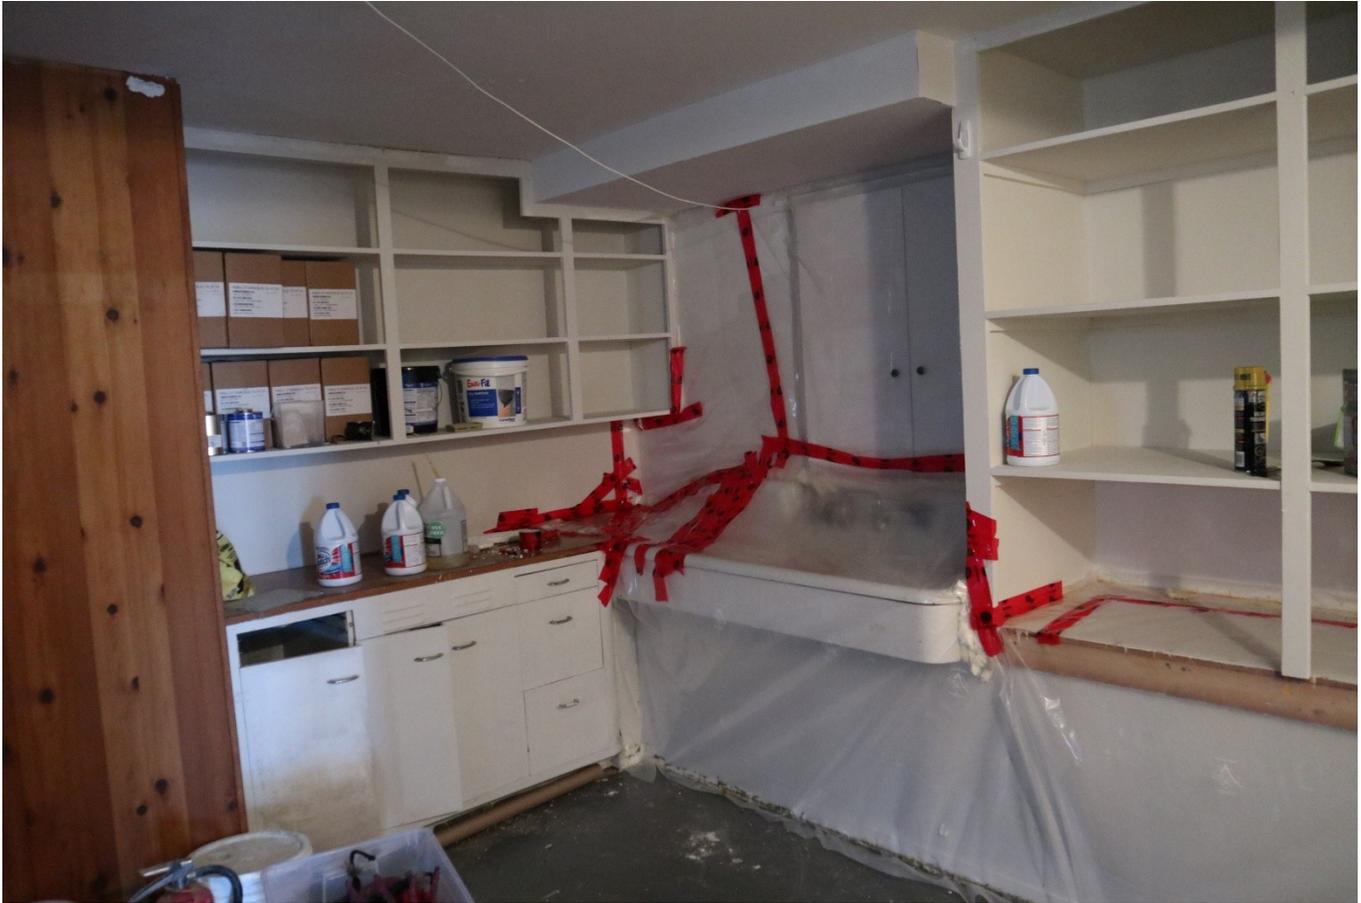
The smell could also have been flowing from the older section of the building, through the wall systems. In one area, there was plastic sheets placed as a barrier between the older and this newer section. In questioning the reasoning for the plastic covering, I was informed that this was to minimize the smell of mold and mildew coming through the dividing walls. Please see sample of this in the photograph below.

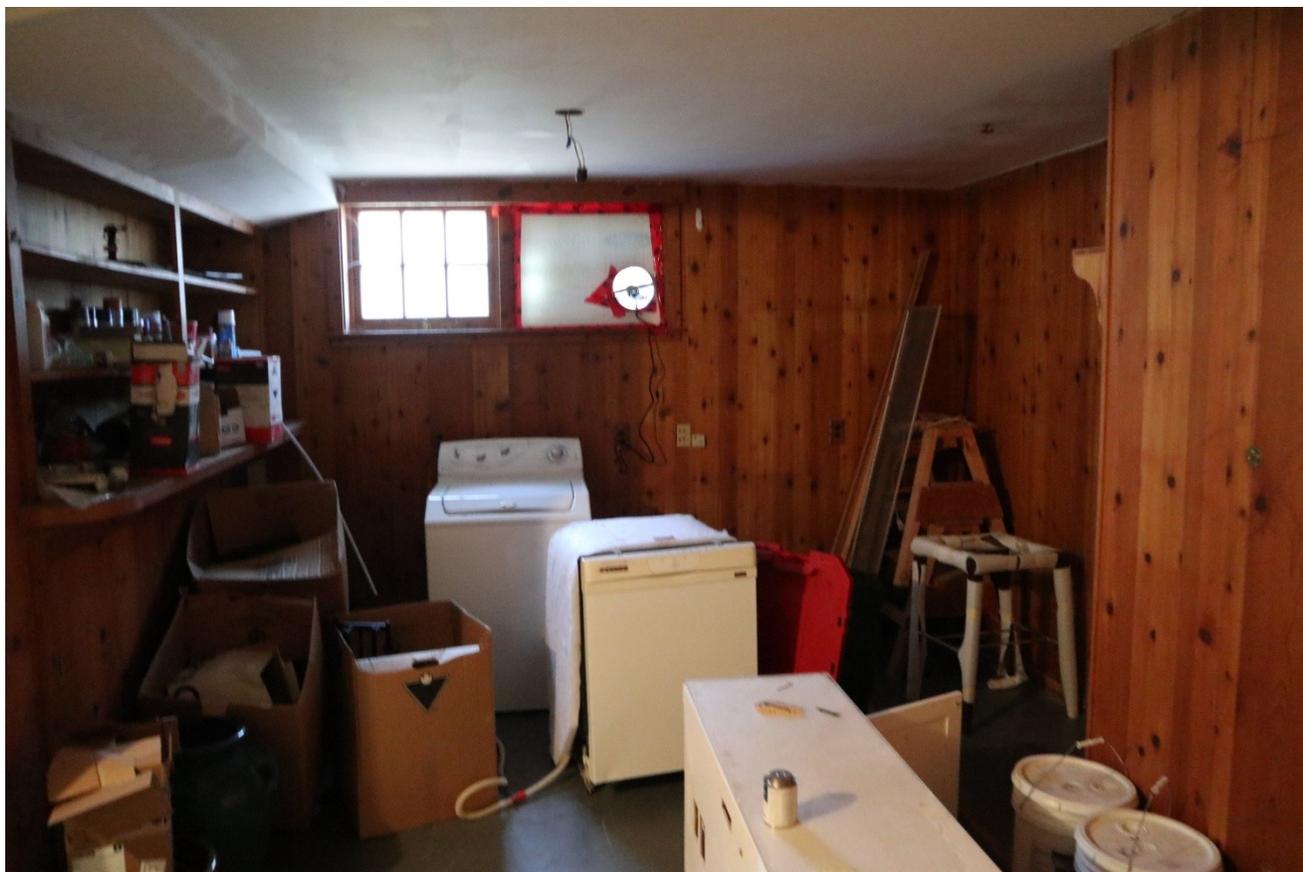
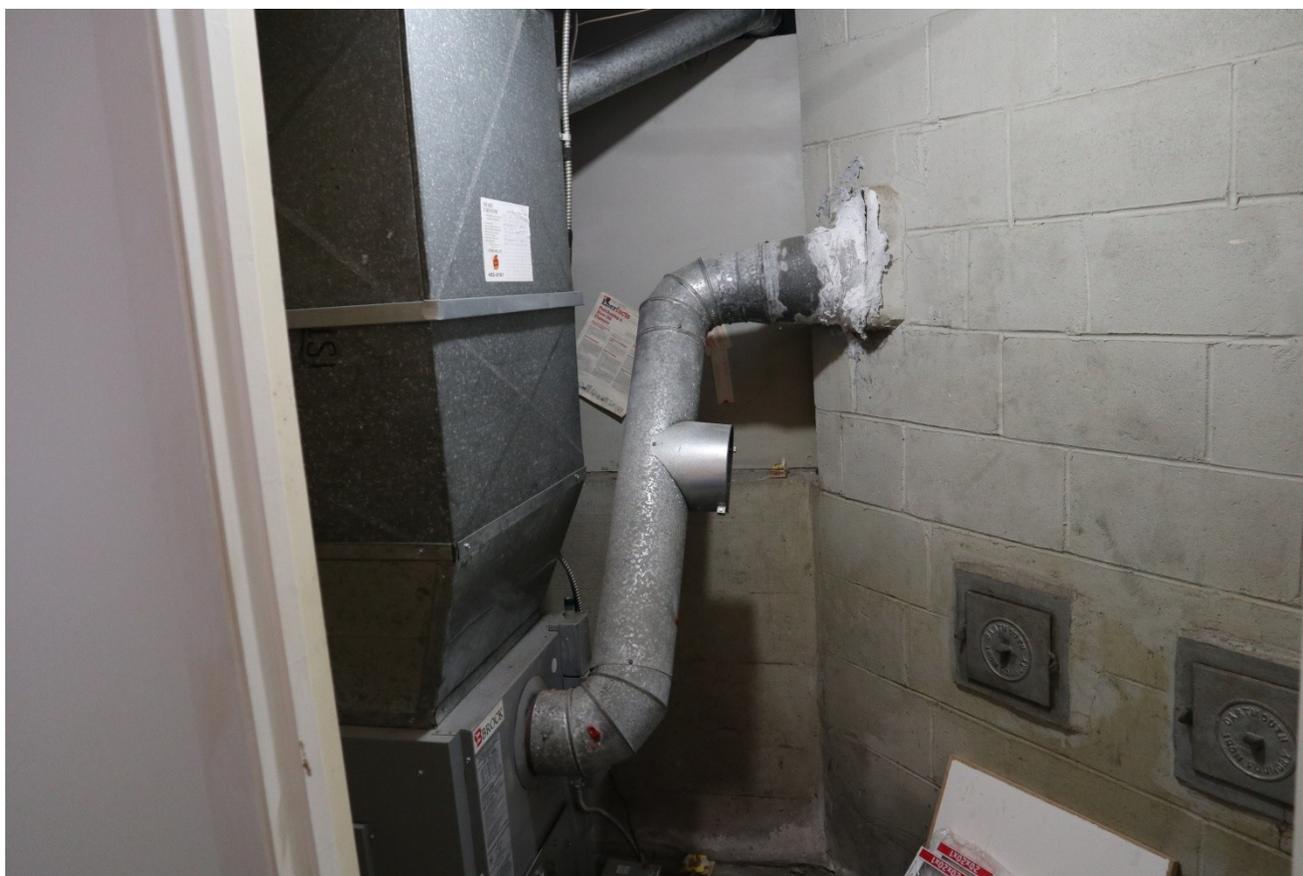
In the photograph below, you can see some of the resulting effect of the lack of heat over the years, and the present dampness in the basement. The ceiling looks to be blackened along the wall area.

In the second photograph below taken of the furnace room wall, the evidence of mold and mildew is very apparent. Please view the lower half of the concrete block wall.
