10 Kirk Road Heritage Impact Statement

Heritage Impact Statement
Re Finntigh Mara/Mathers Estate
10 Kirk Road, Halifax, Nova Scotia, B3P 1A6
Aug 31 2022

Prepared by
MacKay-Lyons Sweetapple Architects
2188 Gottingen Street, Halifax, NS, B3K 3B4
902 429 1867
mlsarchitects.ca

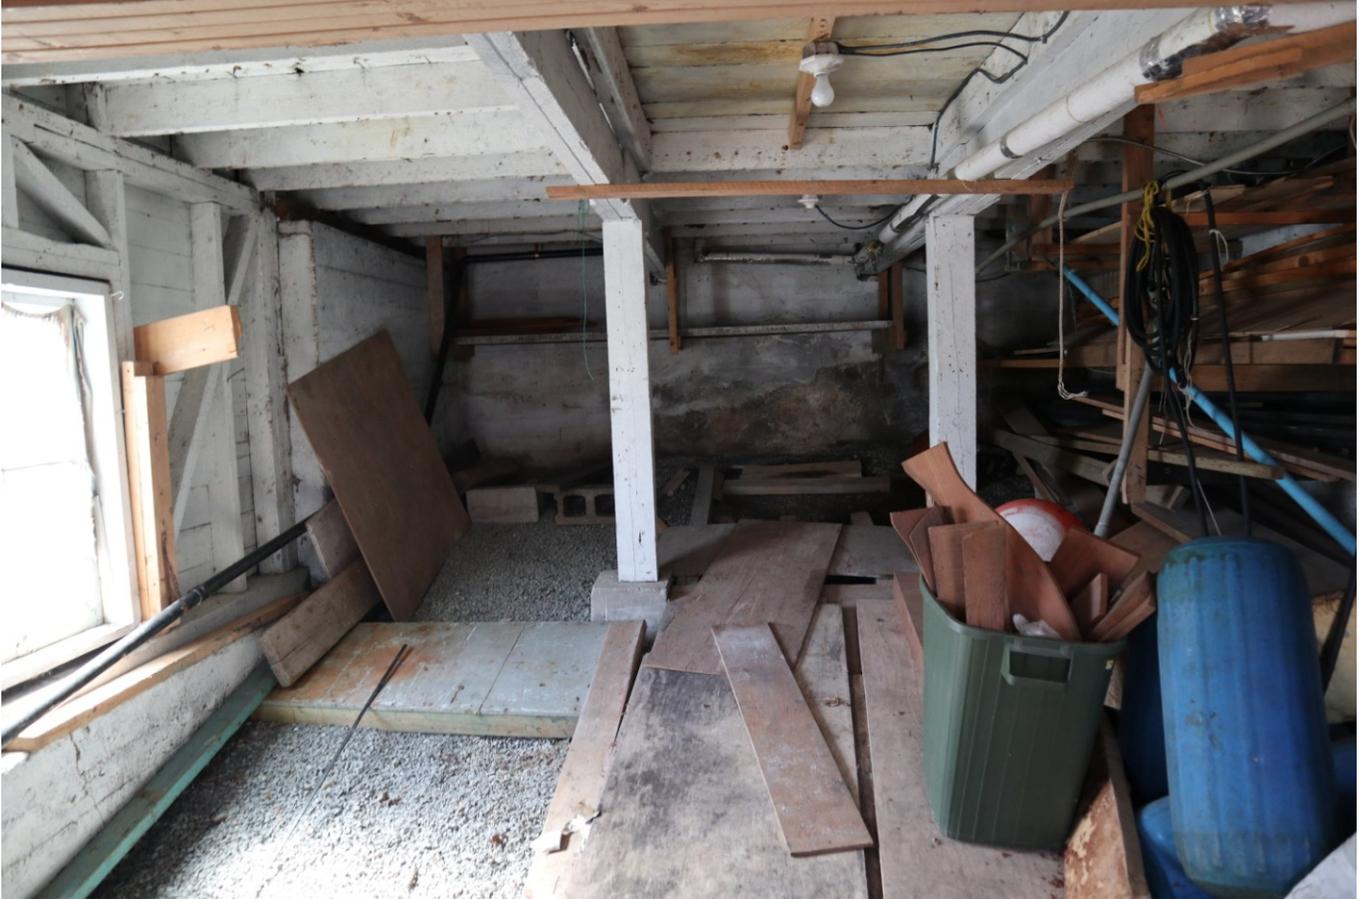
As can be seen in this photograph, the crawl space has a sloped gravel and rock surface. There is a section of floor above, which is supported with a 2" x 4" joist (not strong enough), and one can see the color change on the back foundation wall due to the penetration of water through, over, and under this wall.

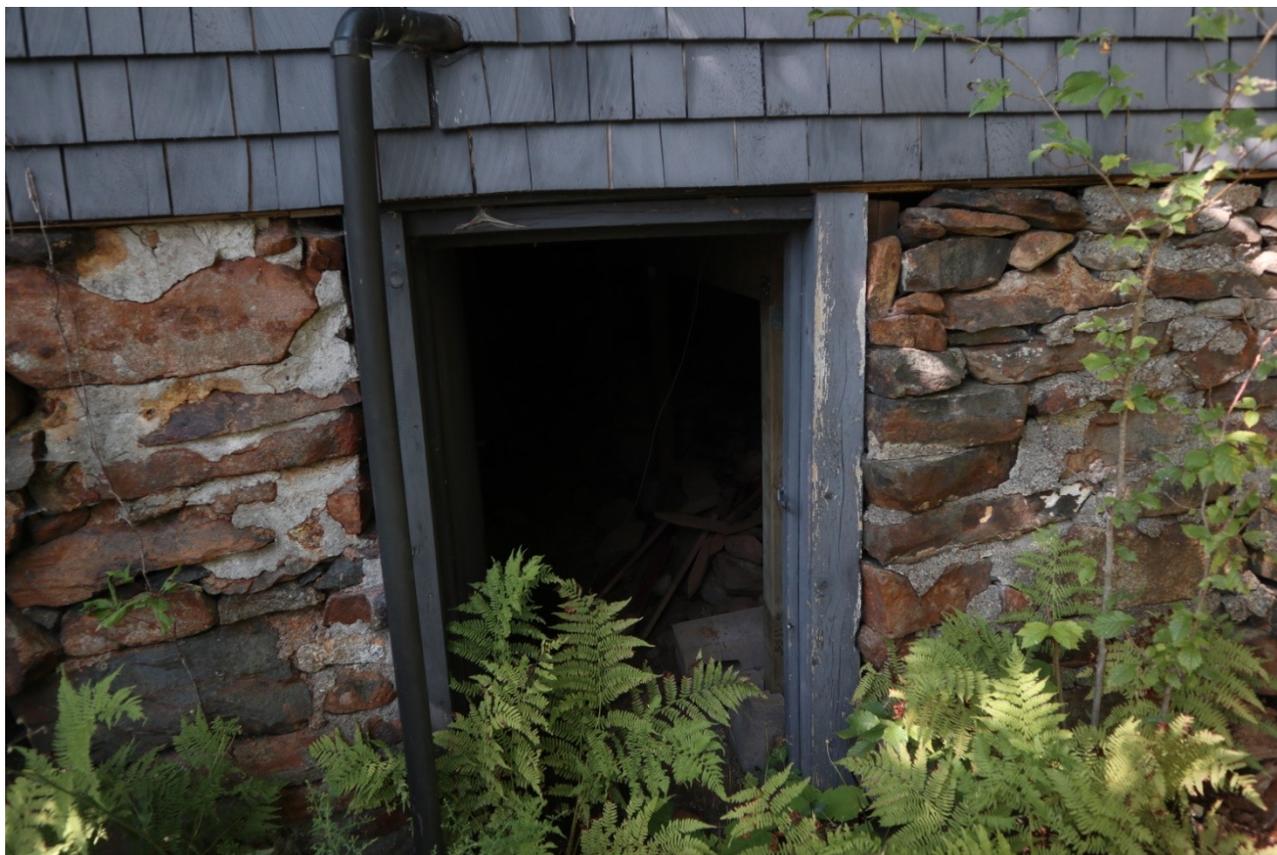
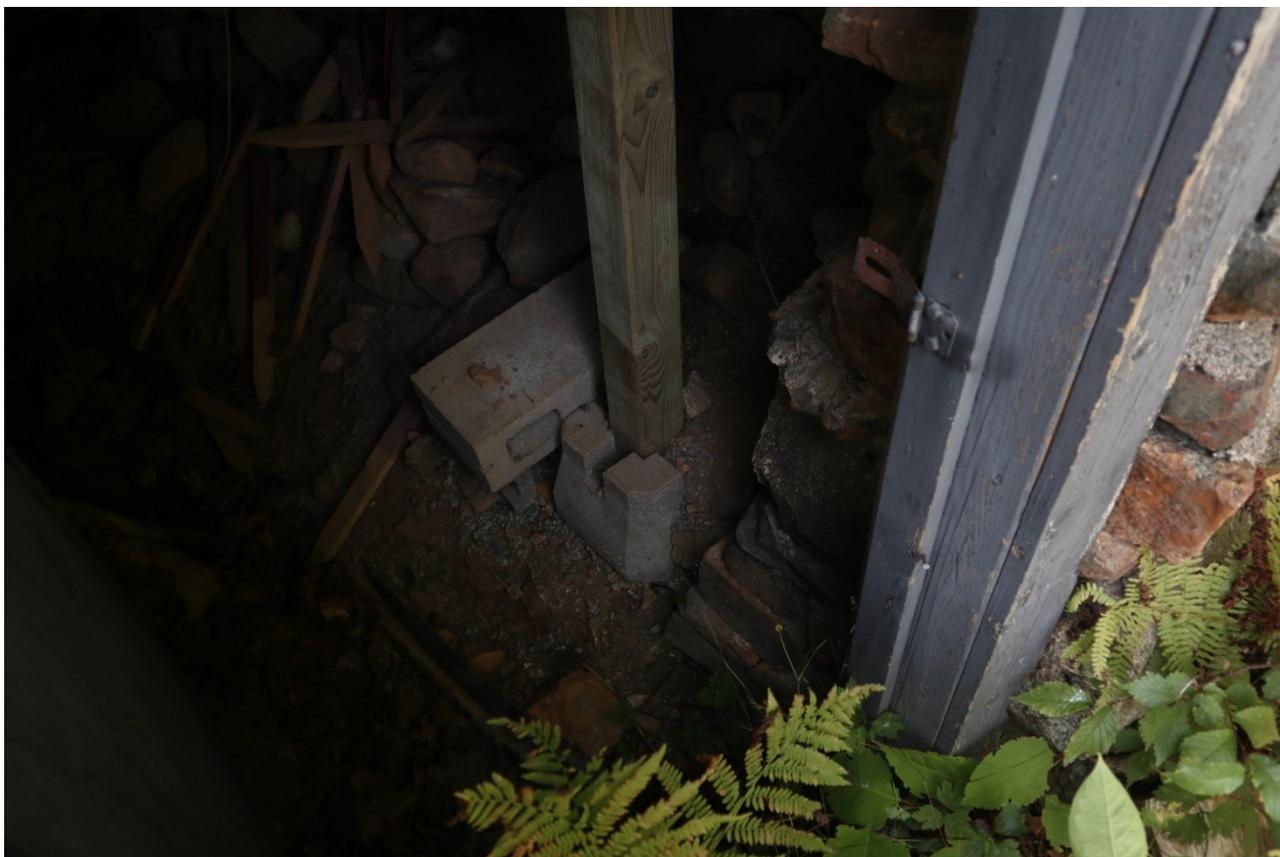
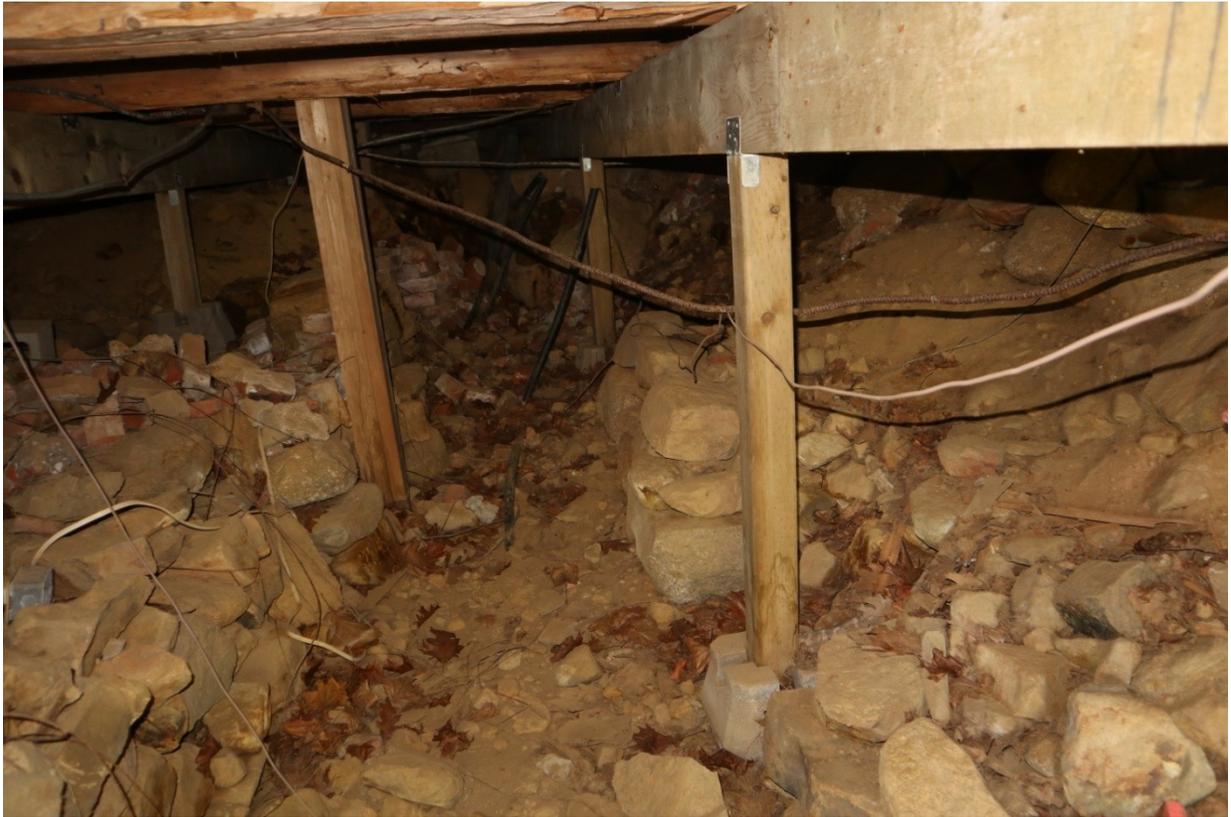
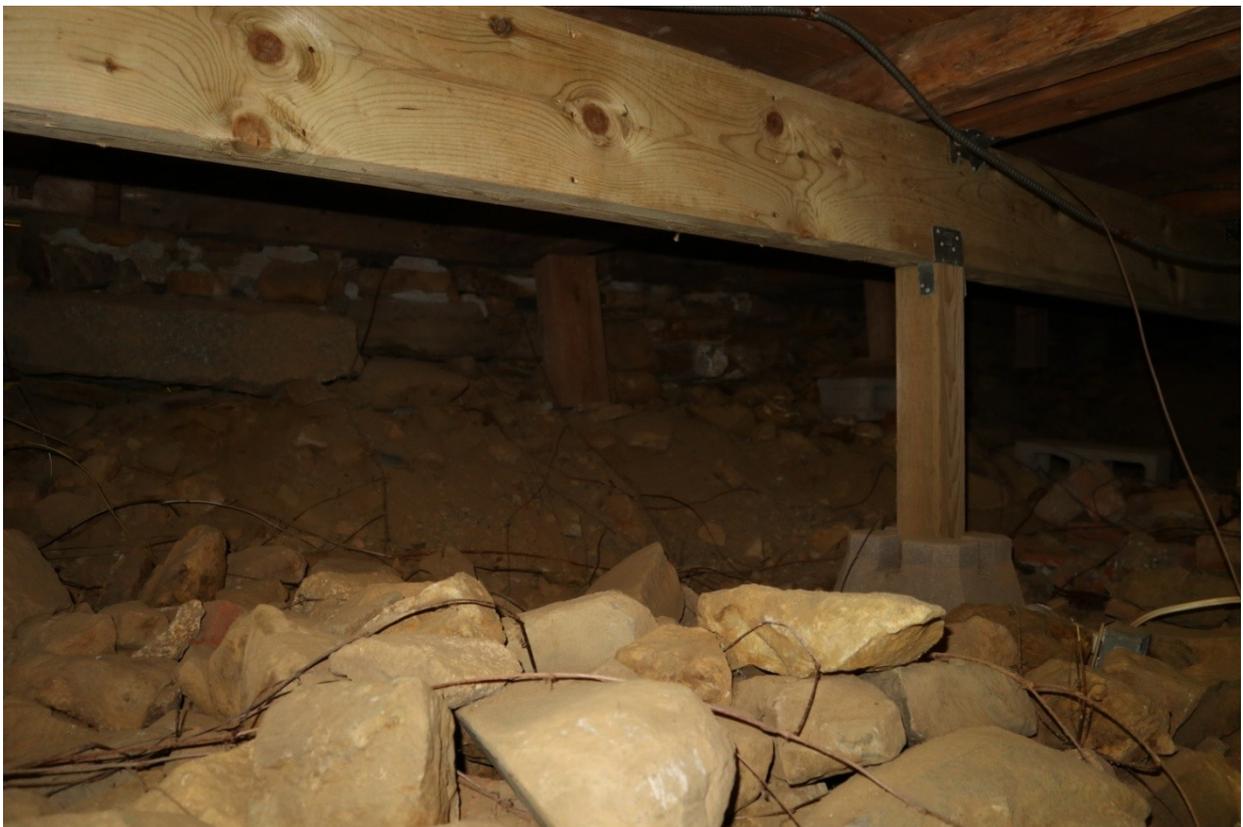
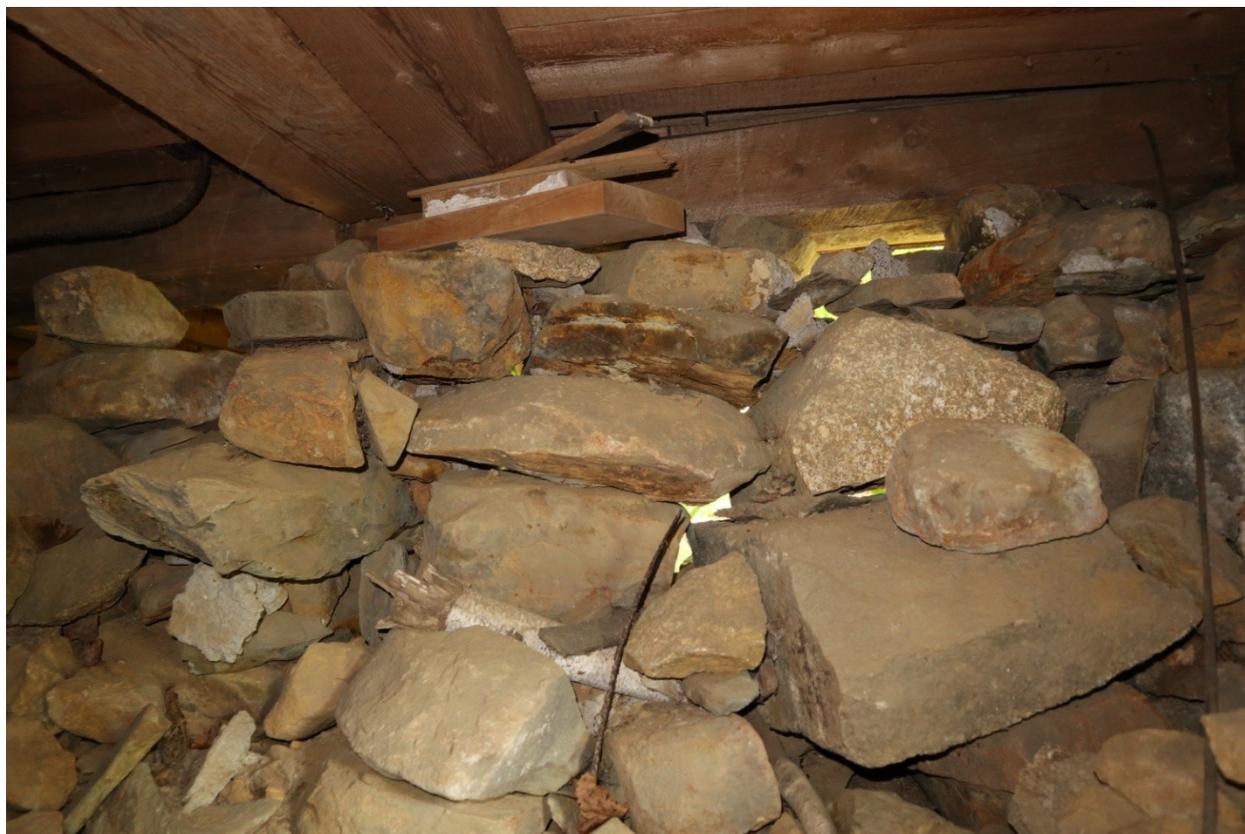
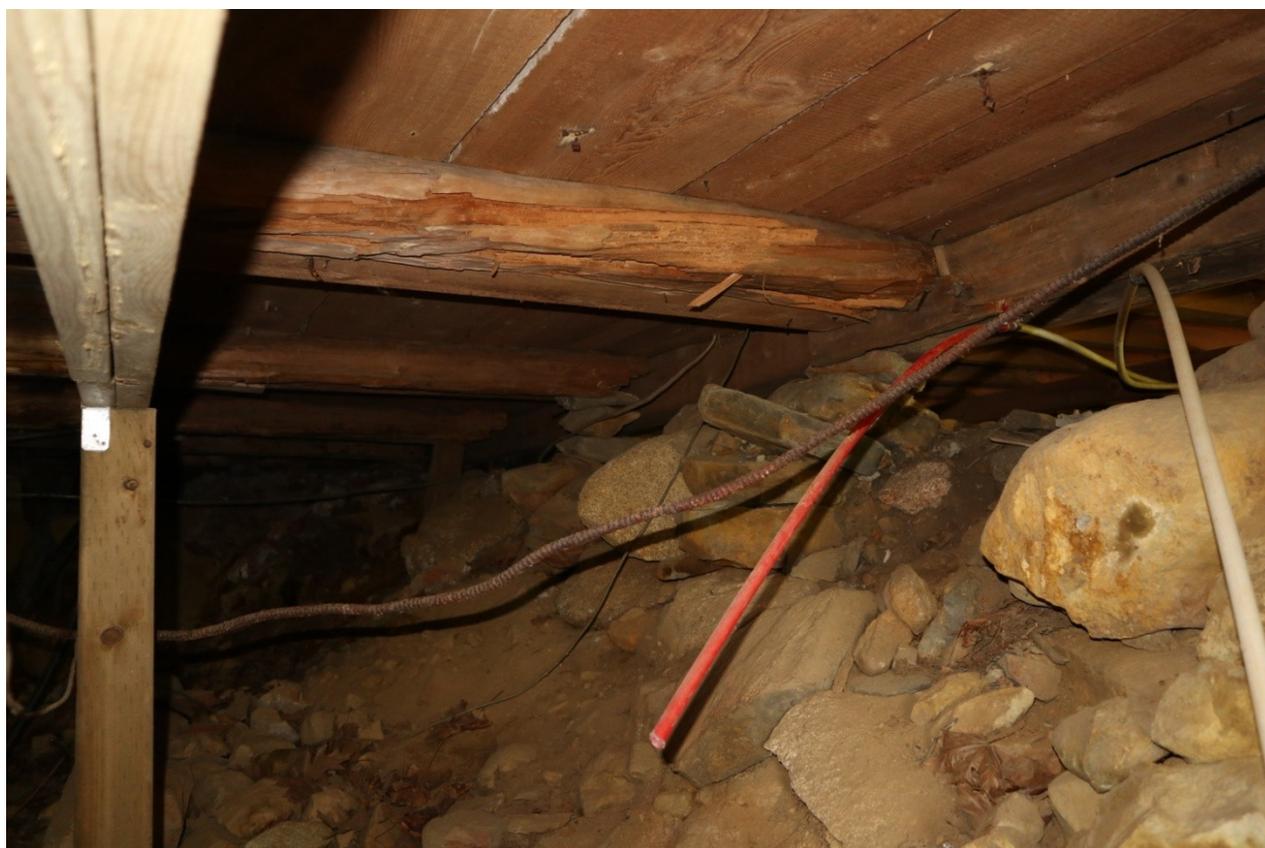
Please see in the photographs below some of the discovered conditions of the foundation in the crawl space.

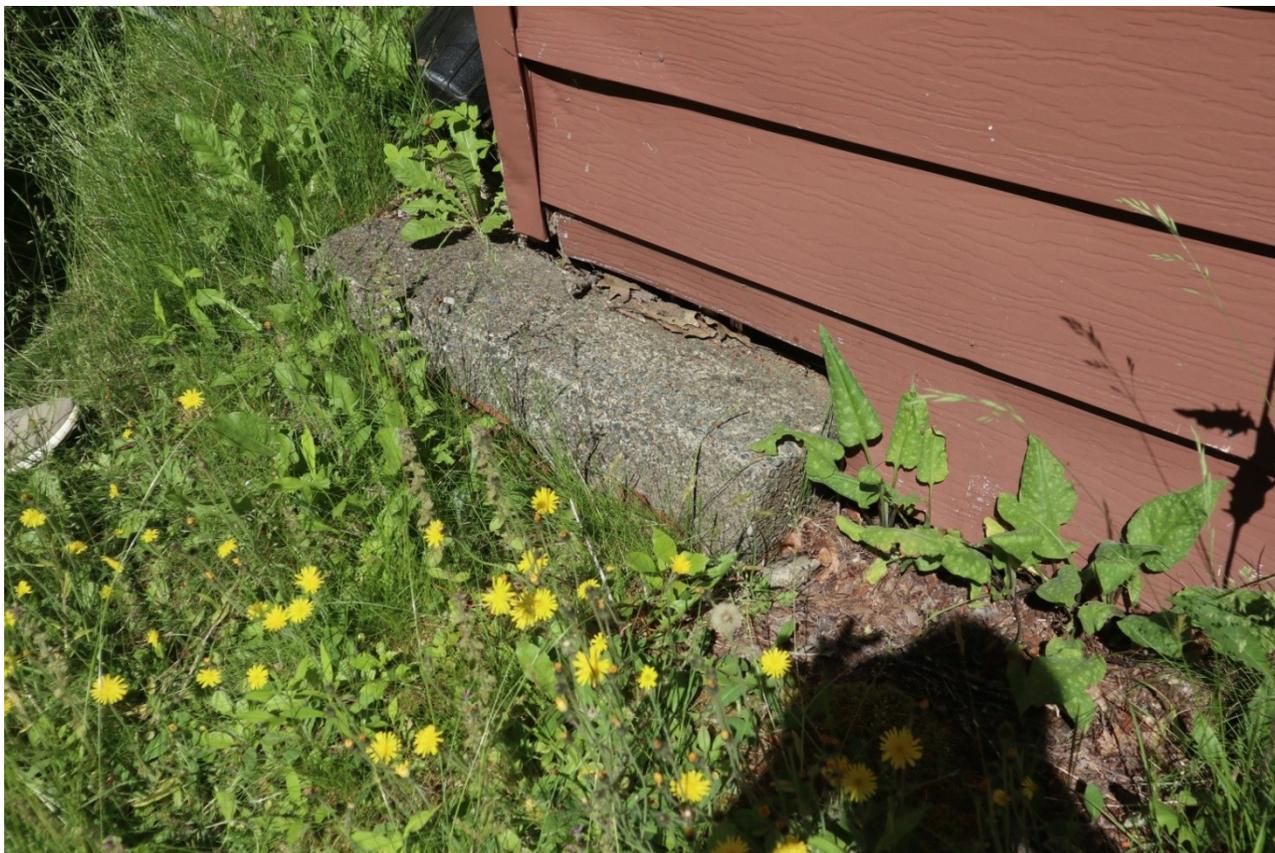
As is evident in the above photograph, the building is resting directly on the footing. Being on the surface of the ground, this footing has visible cracking.
