Item No. 9.1.1
Heritage Advisory Committee
July 26, 2023

SUBJECT: **Case H00528: Substantial Alteration to the municipally registered heritage property at 10 Kirk Road, Halifax**

4.0 - Assessment of Existing Conditions

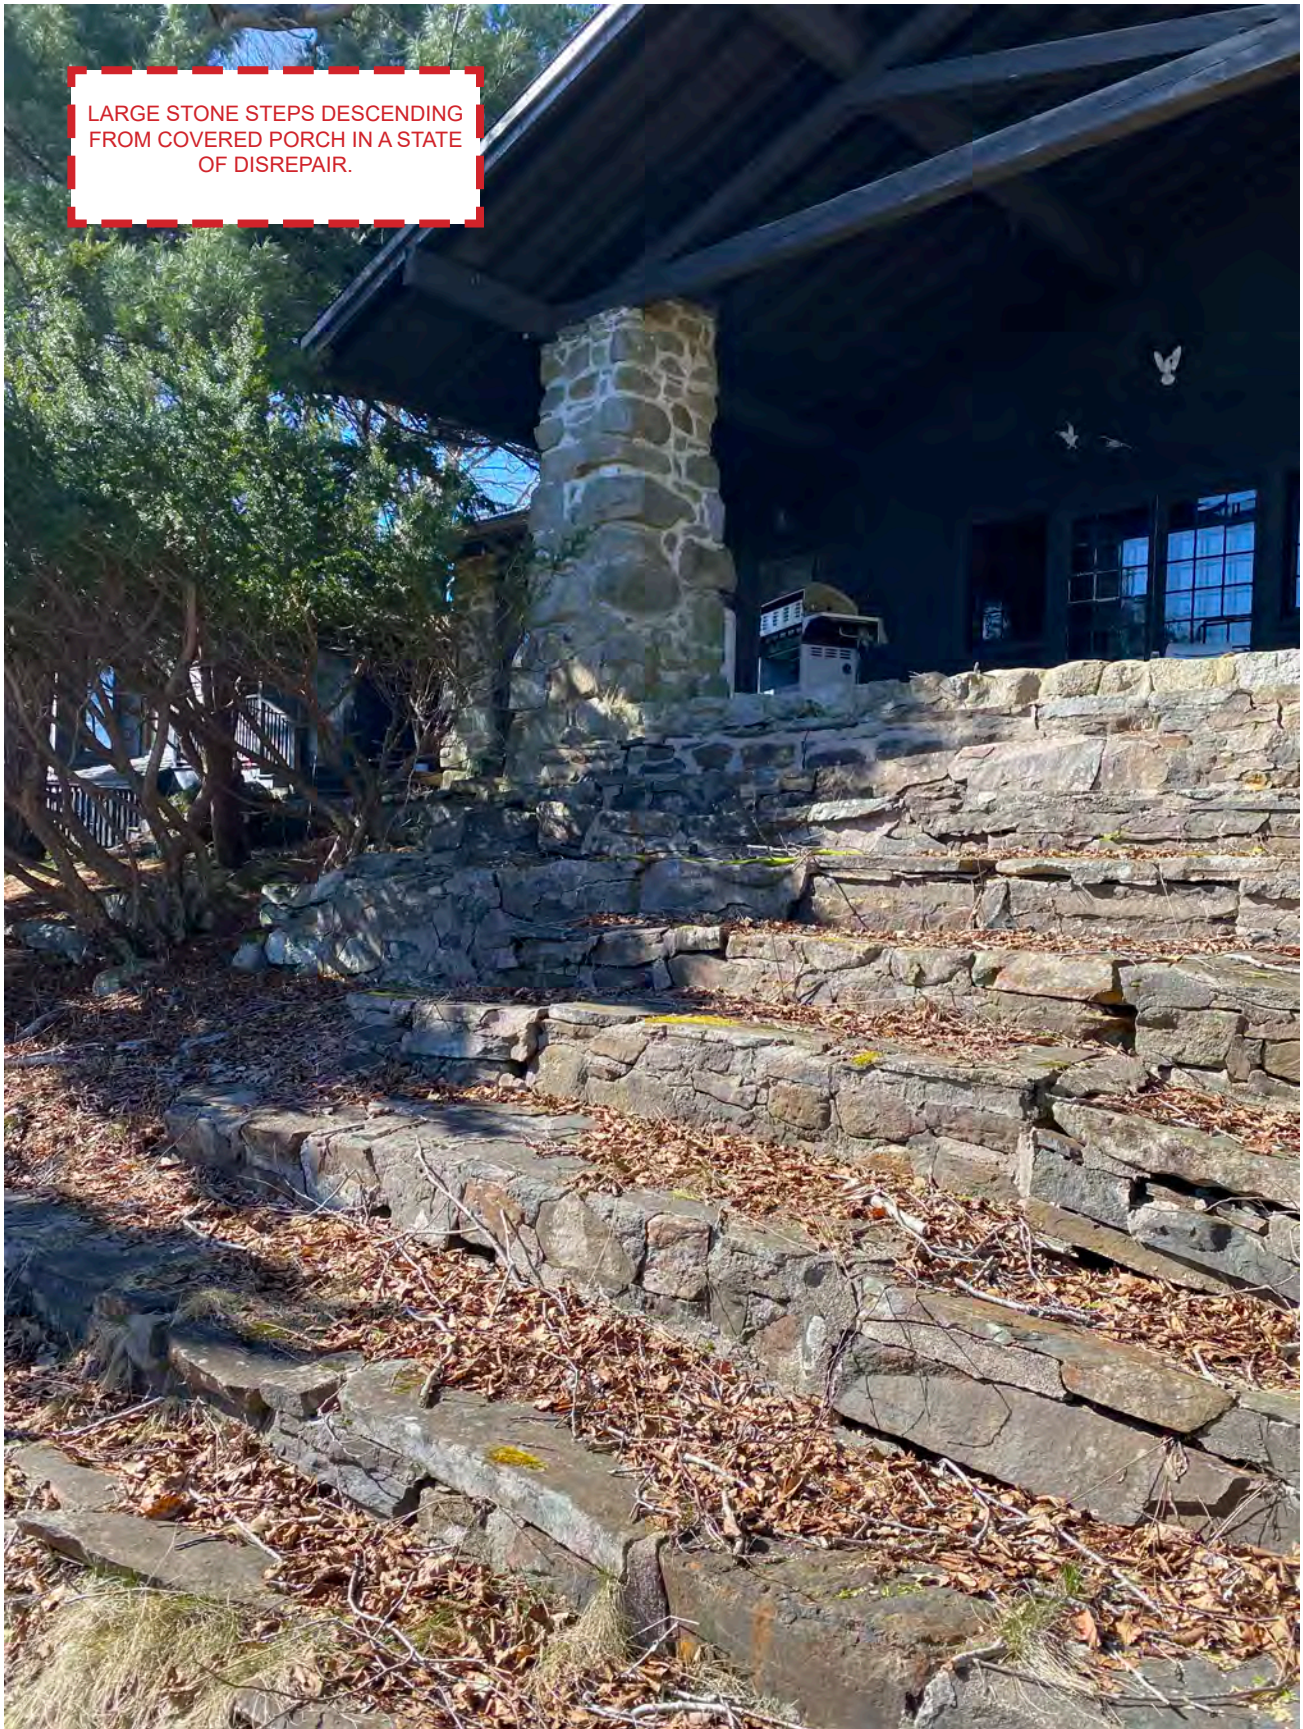
2.2 EAVE CONDITION AT SOUTHWEST CORNER OF MAIN HOUSE.

Some fascia boards at the overhanging eaves require repair (refer to AFRR image 2.2). Water runoff from the roof should be properly managed with a combination of gutters and downspouts to divert water away from the building.

RAIN CHAIN HUNG DIRECTLY FROM
EAVE FASCIA, NO GUTTERS. FASCIA
BOARDS ROTTEN.

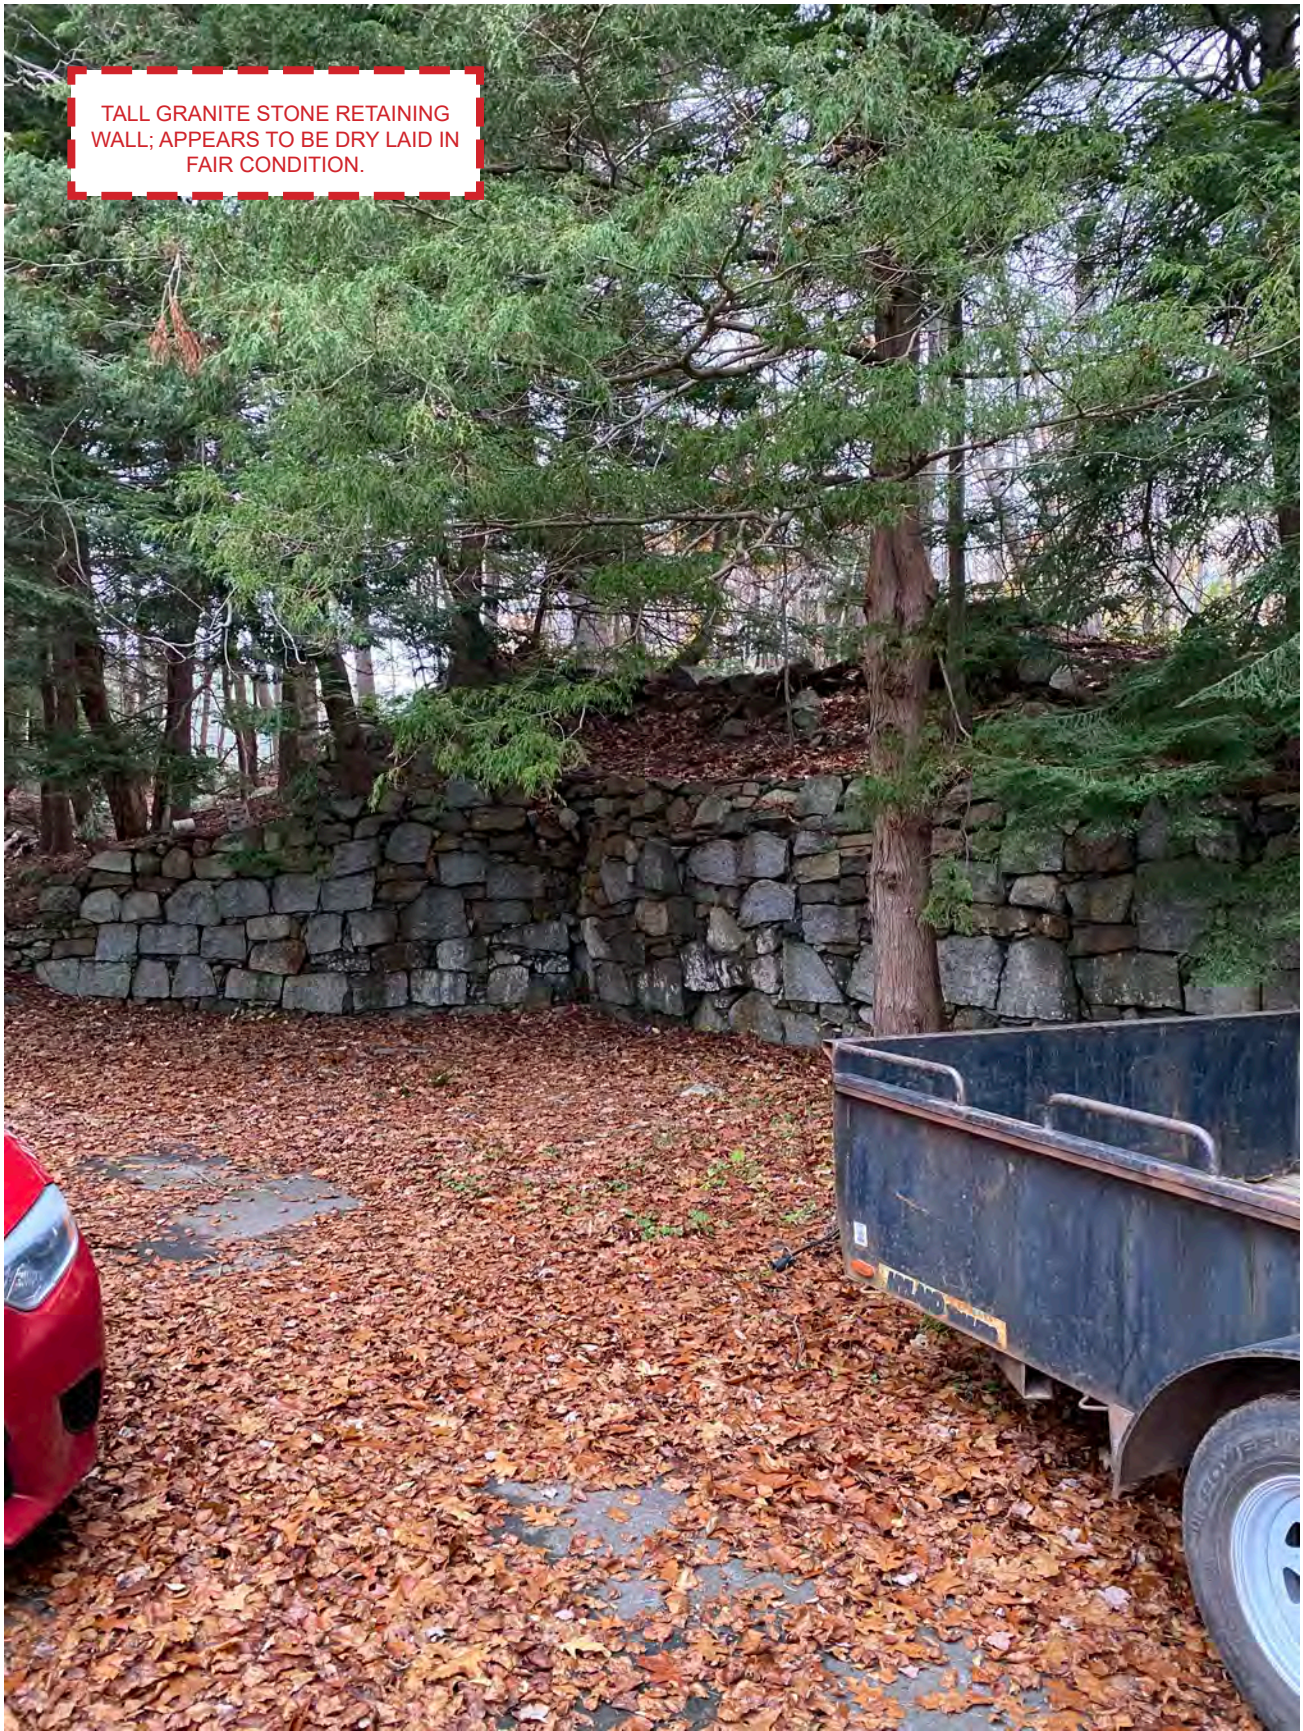
2.27 STONE WALL NEXT TO ROOST (SOUTHWEST VIEW).

GRANITE STONE RETAINING WALL;
APPEARS TO BE DRY LAID IN FAIR
CONDITION - SOME FALLEN STONES.

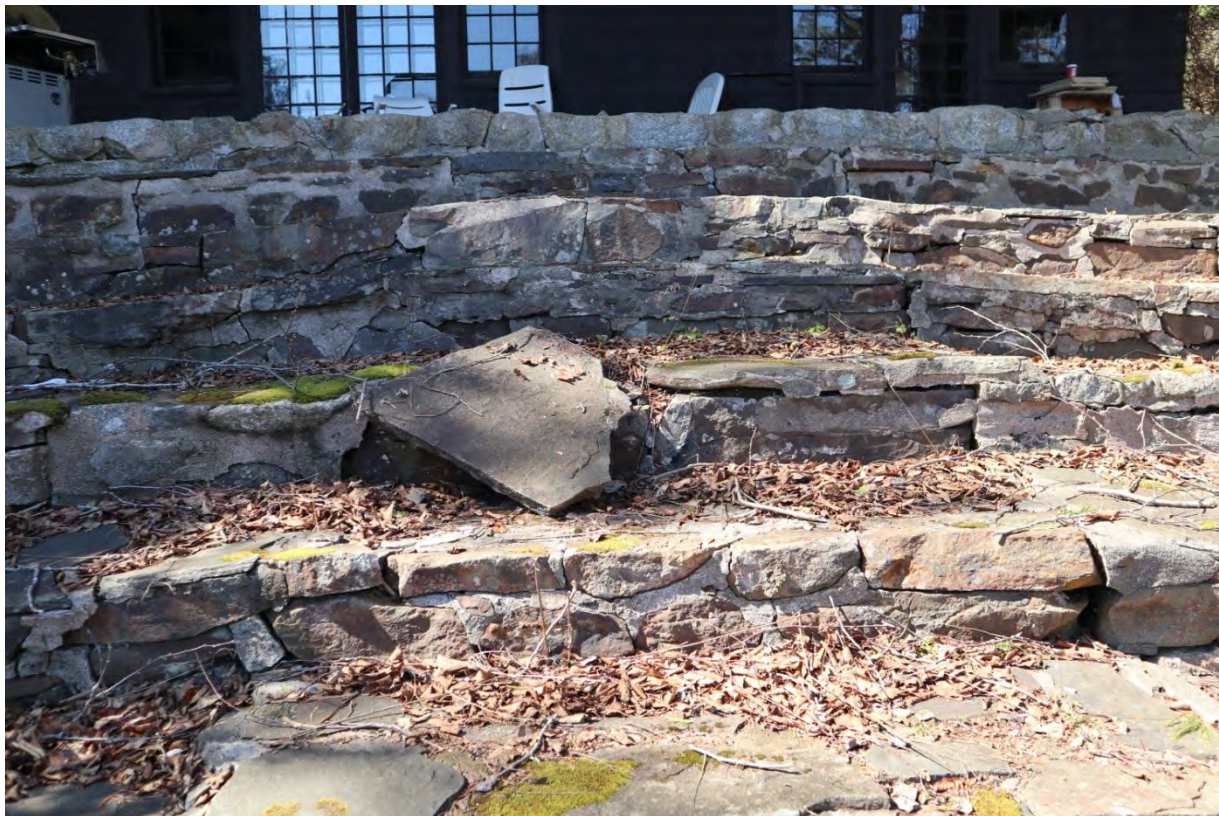
Around the building there are a number of rock walls. Some of these are for the support of rock stairs, others to support deck areas, and others simple as architectural features. In all cases you can clearly pick out the fact that these wall have failed.

These wall have all failed to some degree, with some which can be classified as not structurally sound. These will all require a total rebuild. Others will have to be realigned, and sealed in place with some type of a mortar compound.

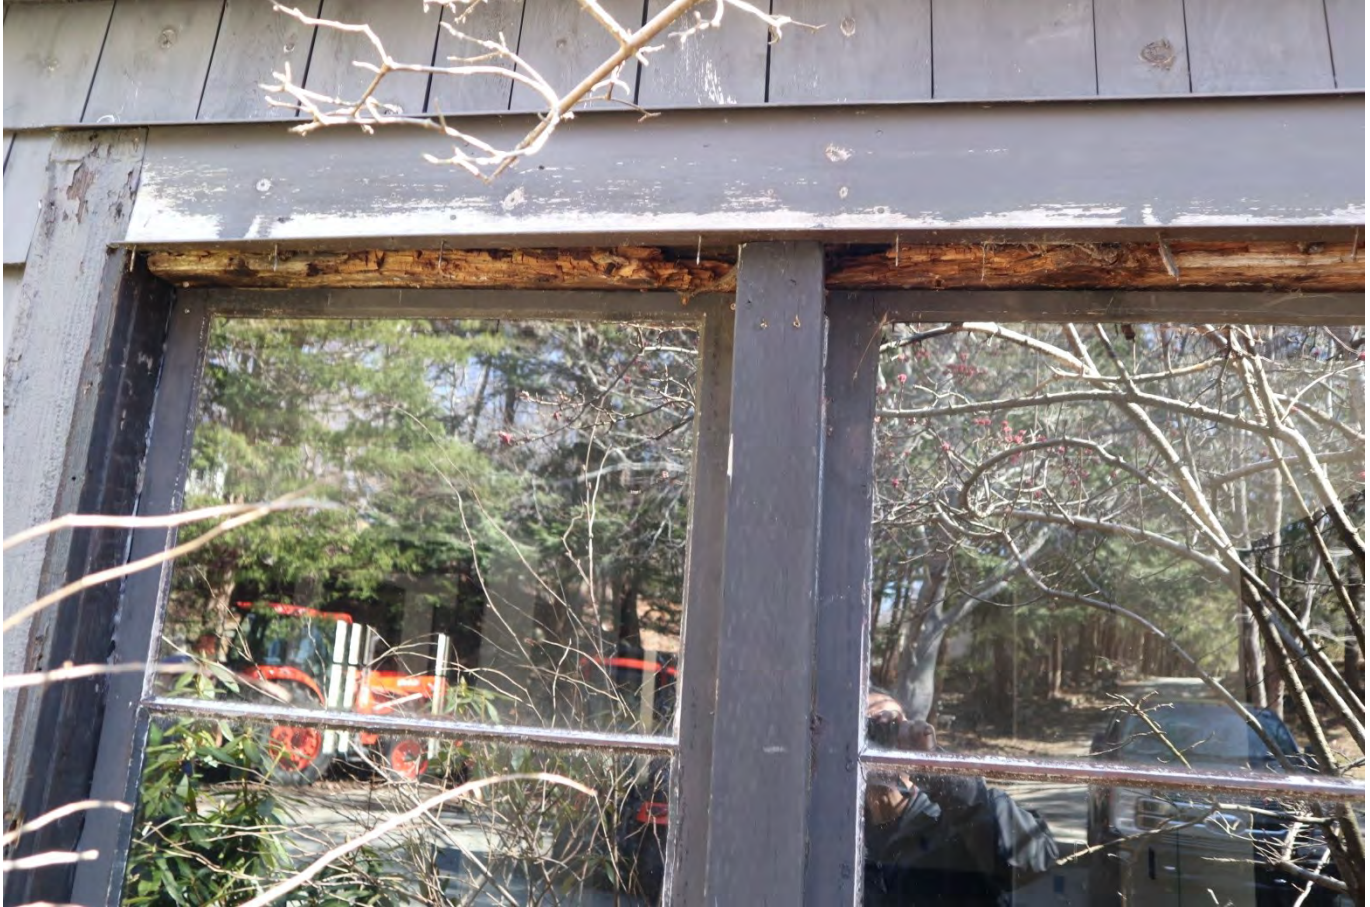
4) Another item of major concern was the rotting of the siding, windows, etc. around the building. The amount of rot varied as you inspected around the building, but most is considered as severe. This probably was effected by the direction of the most severe weather. In a variety of locations the rot is to an extreme, and must be considered as a severe problem which must be fixed. See a sample of this in the photograph below.

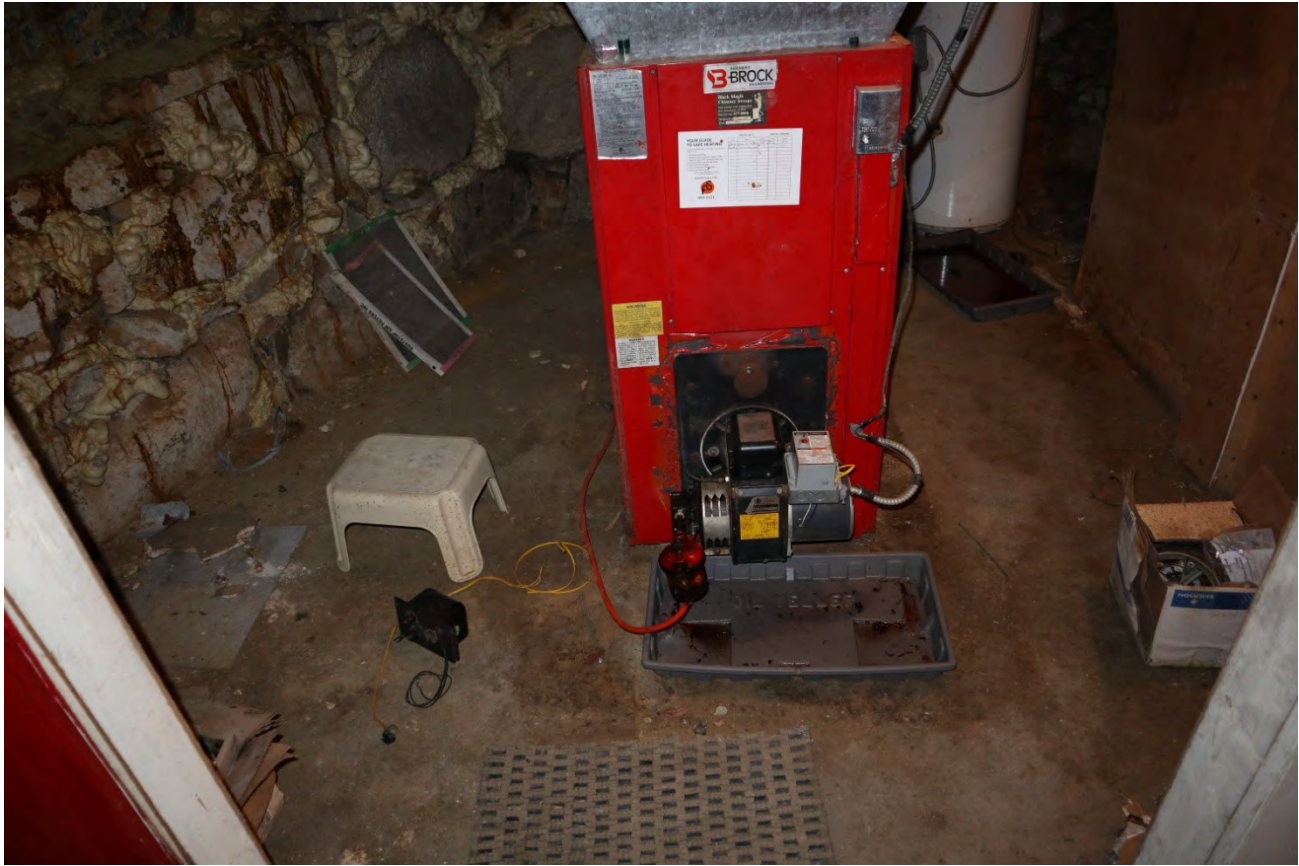
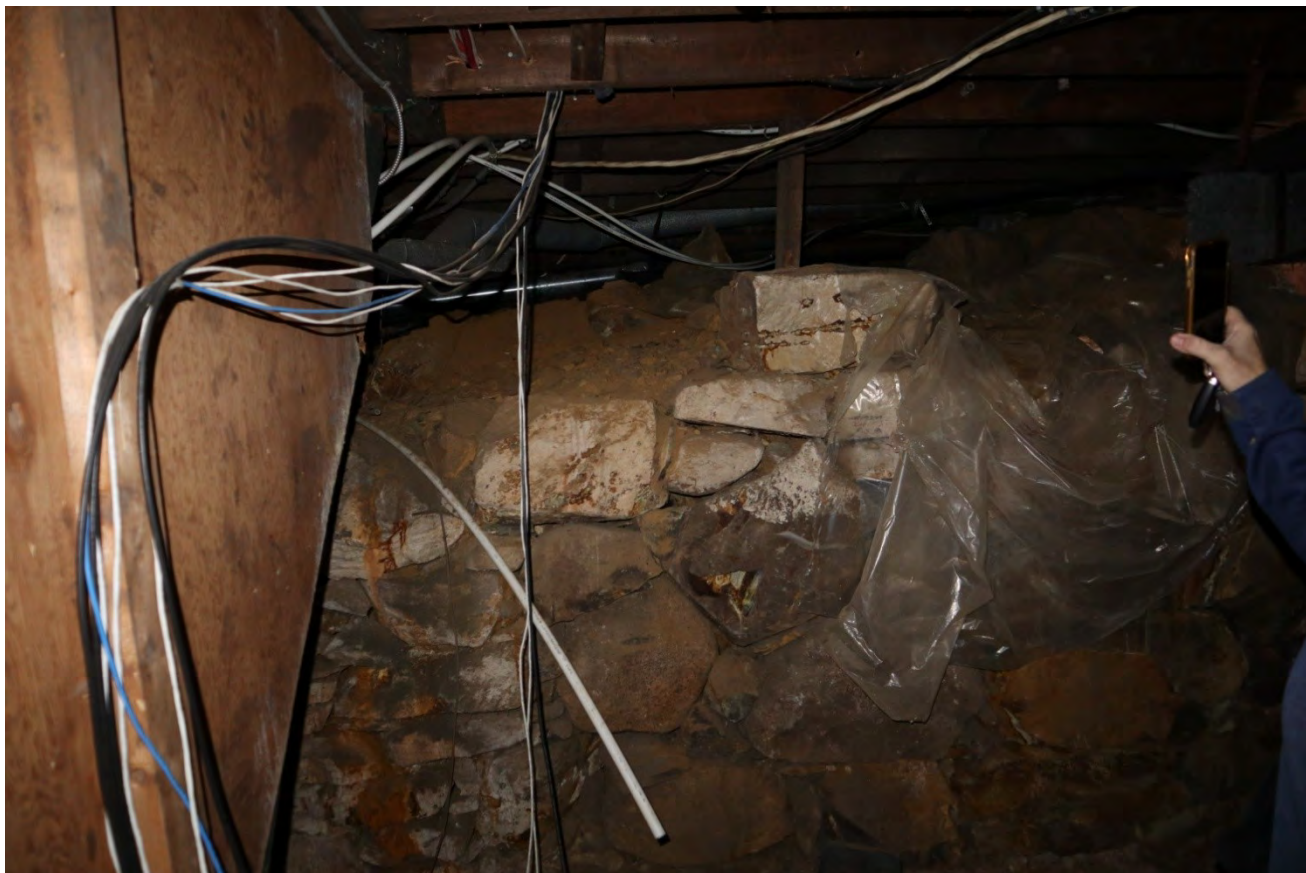
See in the photograph below, a sample of what moisture in the basement has done to the furnace for the building. The rust and corrosion are very evident all over the unit. It is unknown as to what the present operational condition is for this unit.

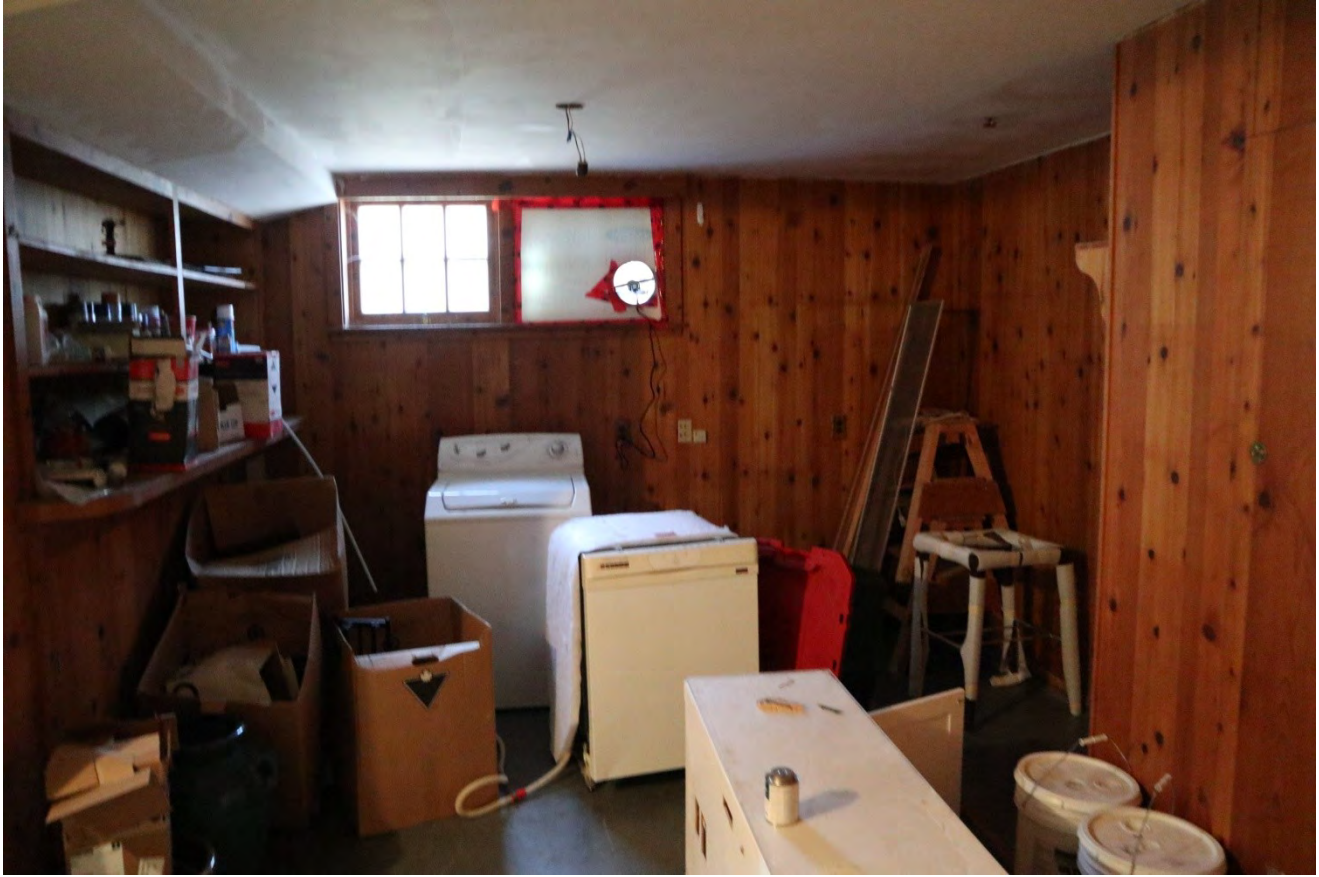
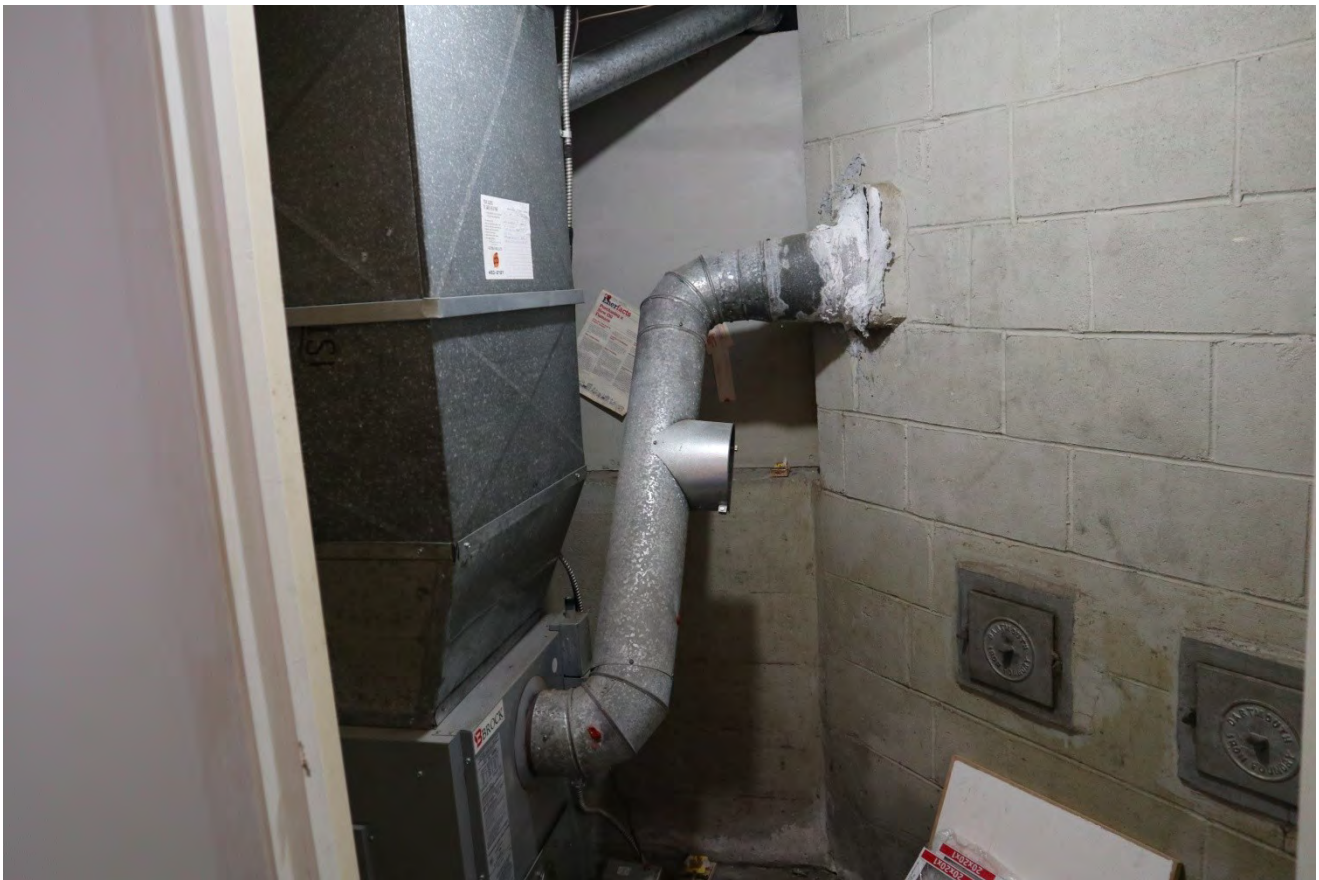
In the photograph below, you can see some of the resulting effect of the lack of heat over the years, and the present dampness in the basement. The ceiling looks to be blackened along the wall area.

In the second photograph below taken of the furnace room wall, the evidence of mold and mildew is very apparent. Please view the lower half of the concrete block wall.

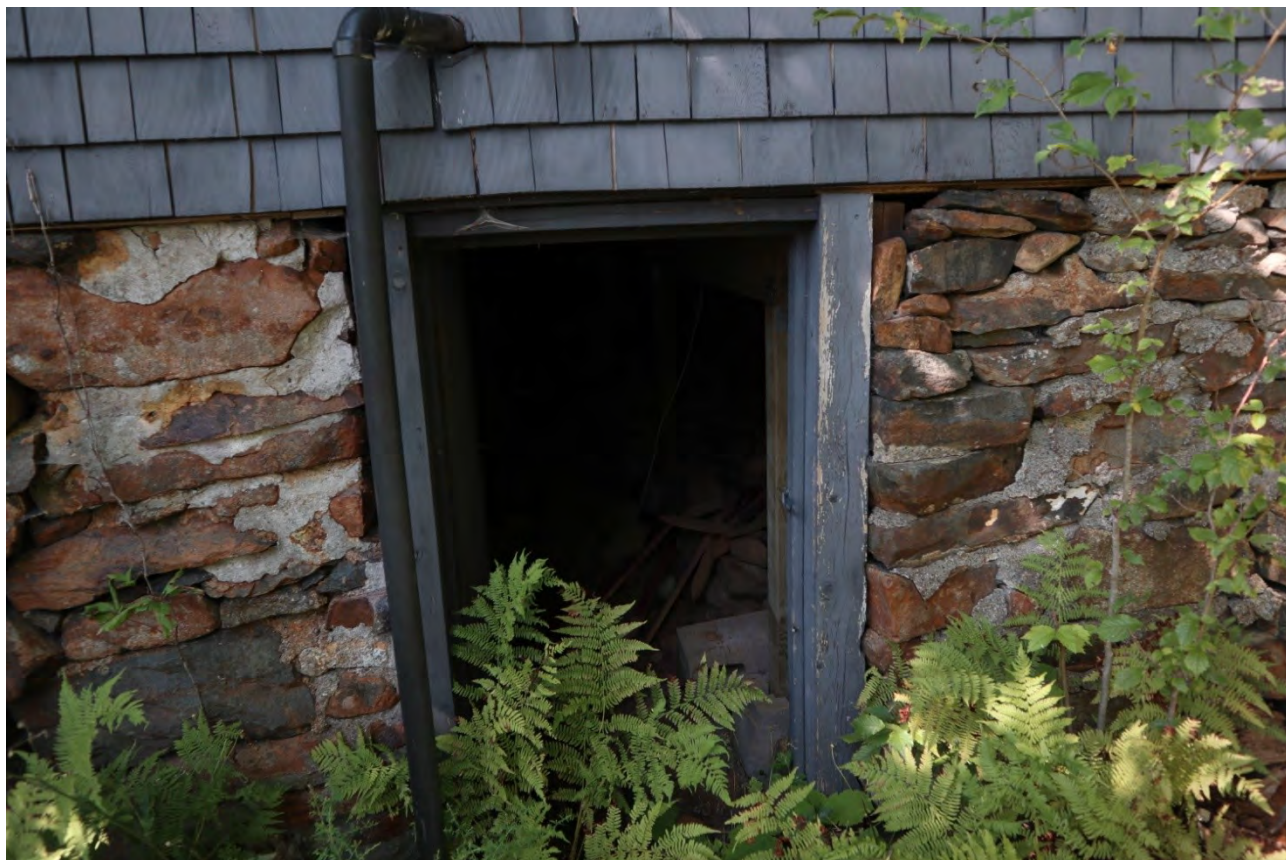
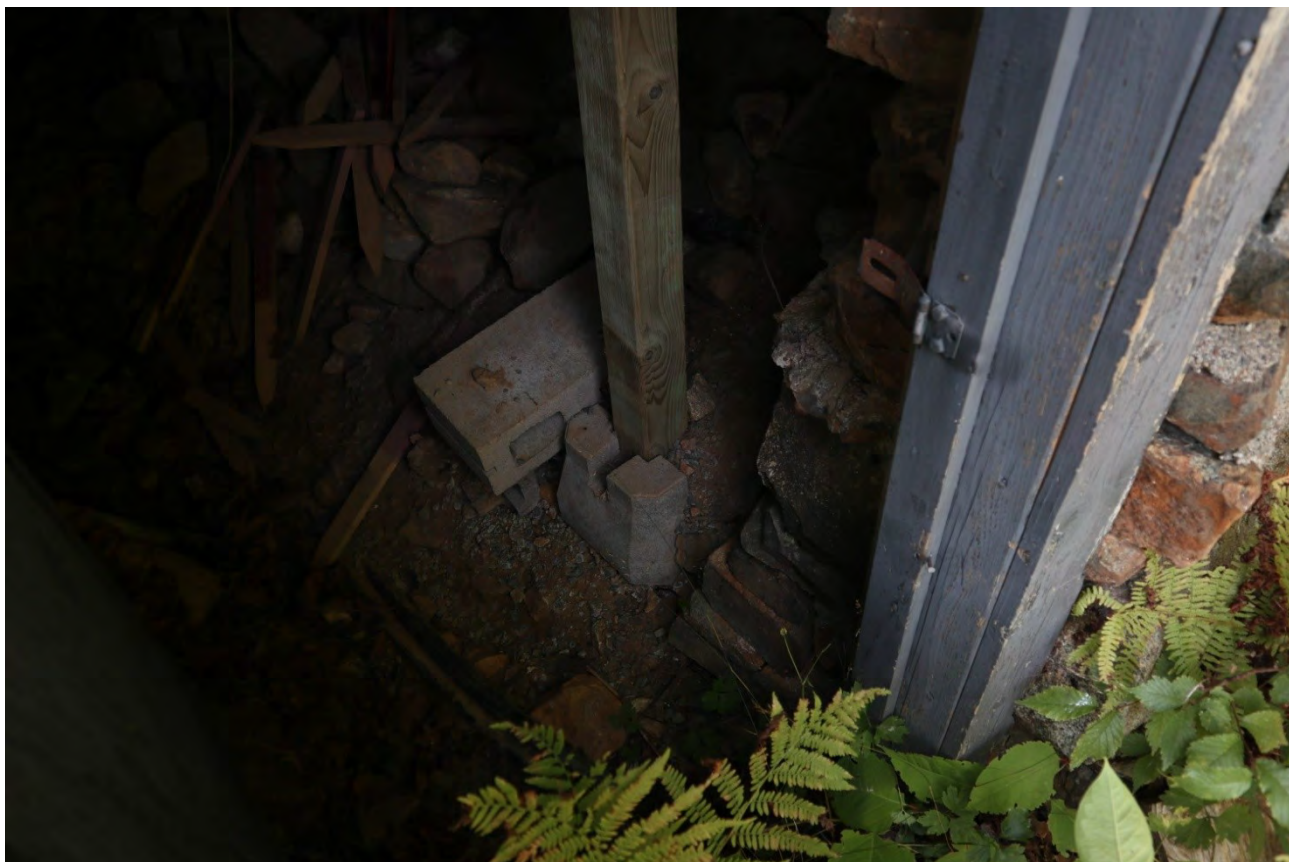
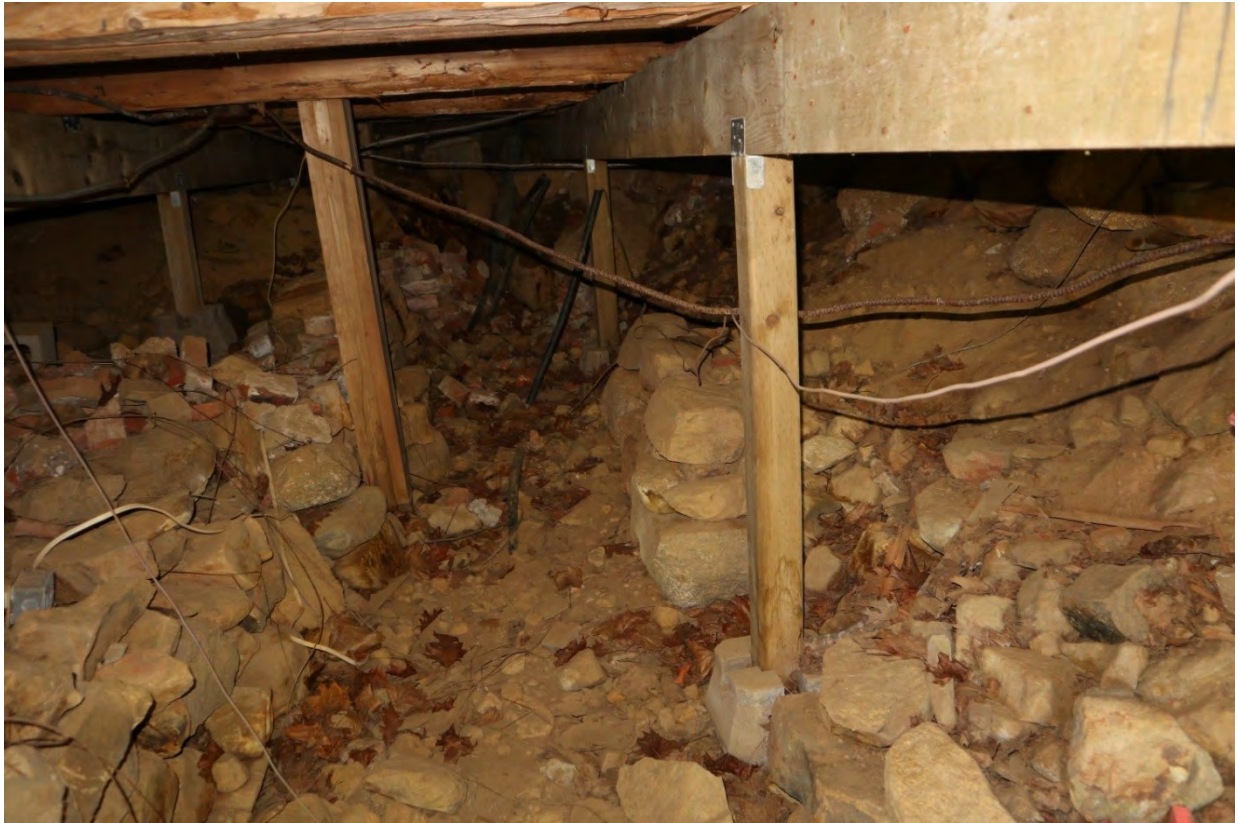
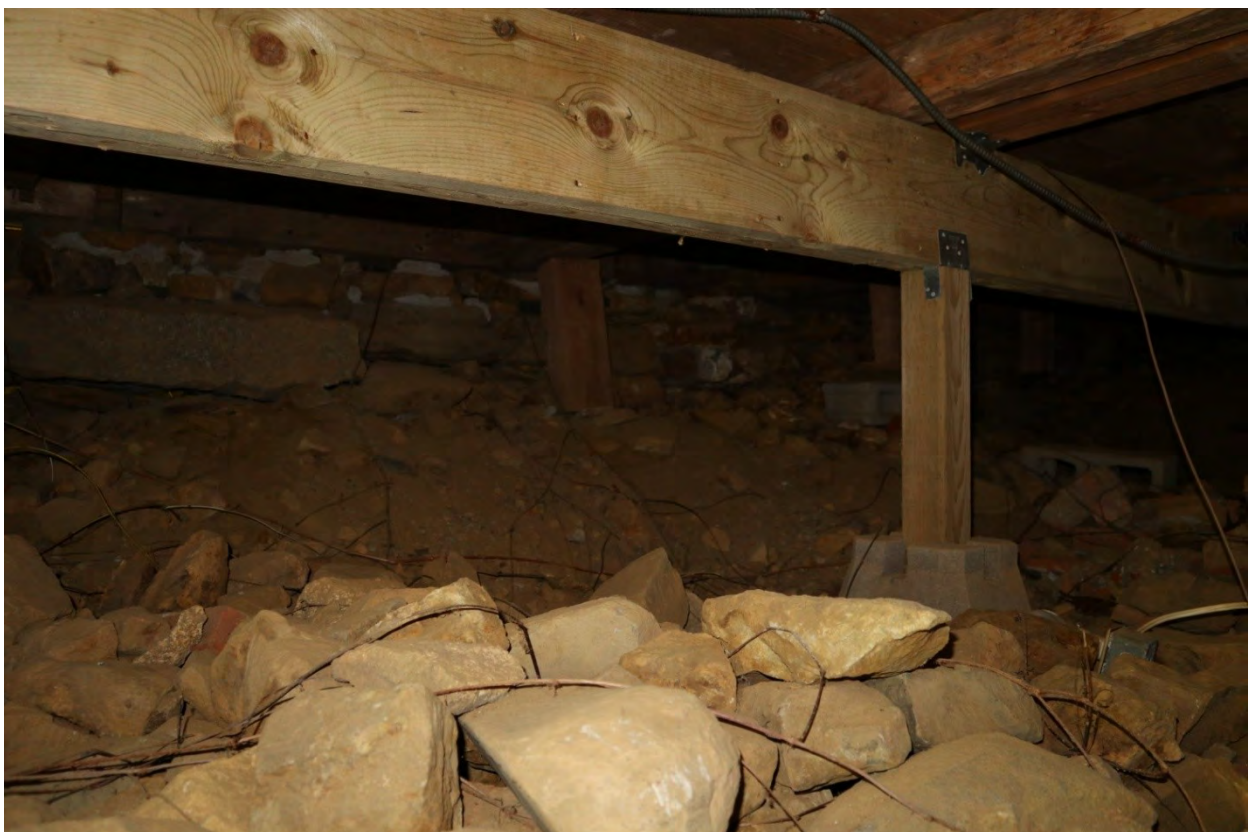
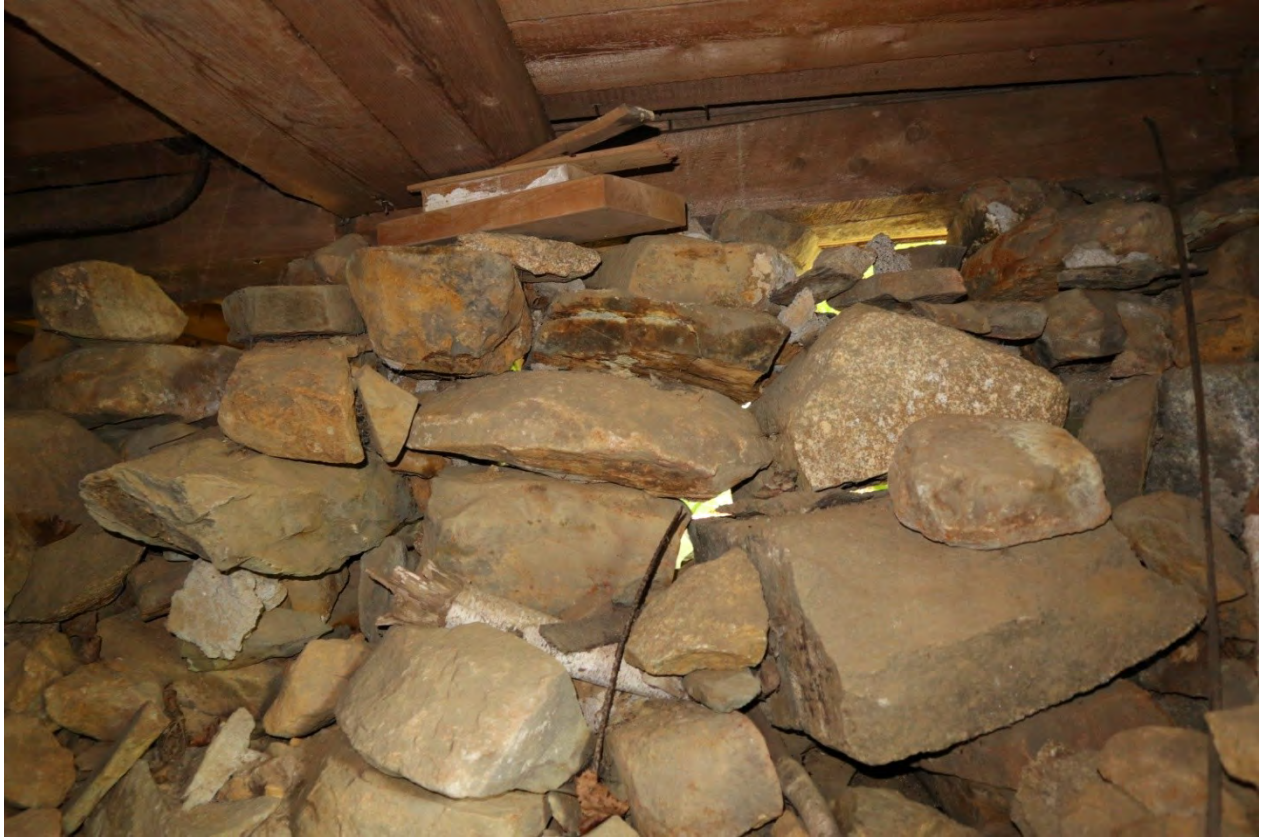
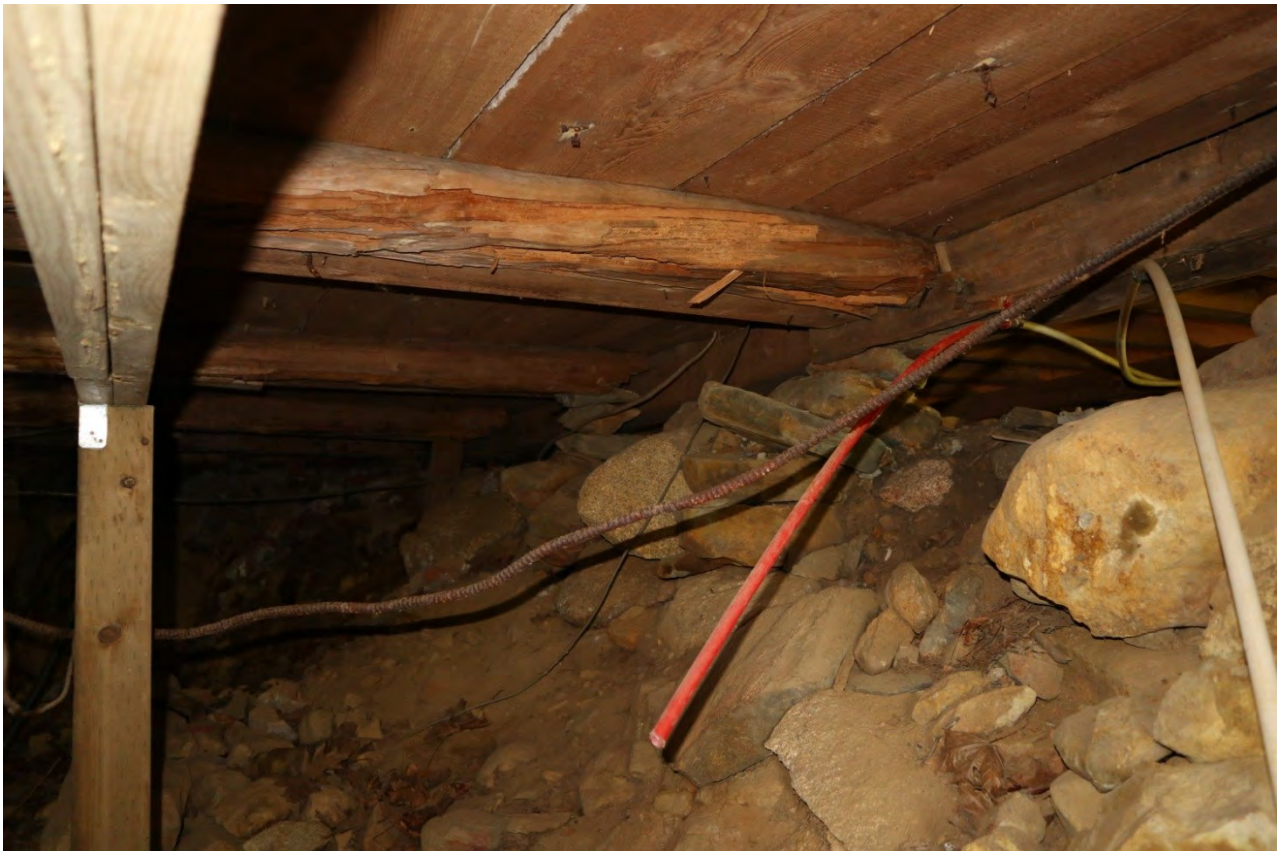
Please see in the photographs below some of the discovered conditions of the foundation in the crawl space.

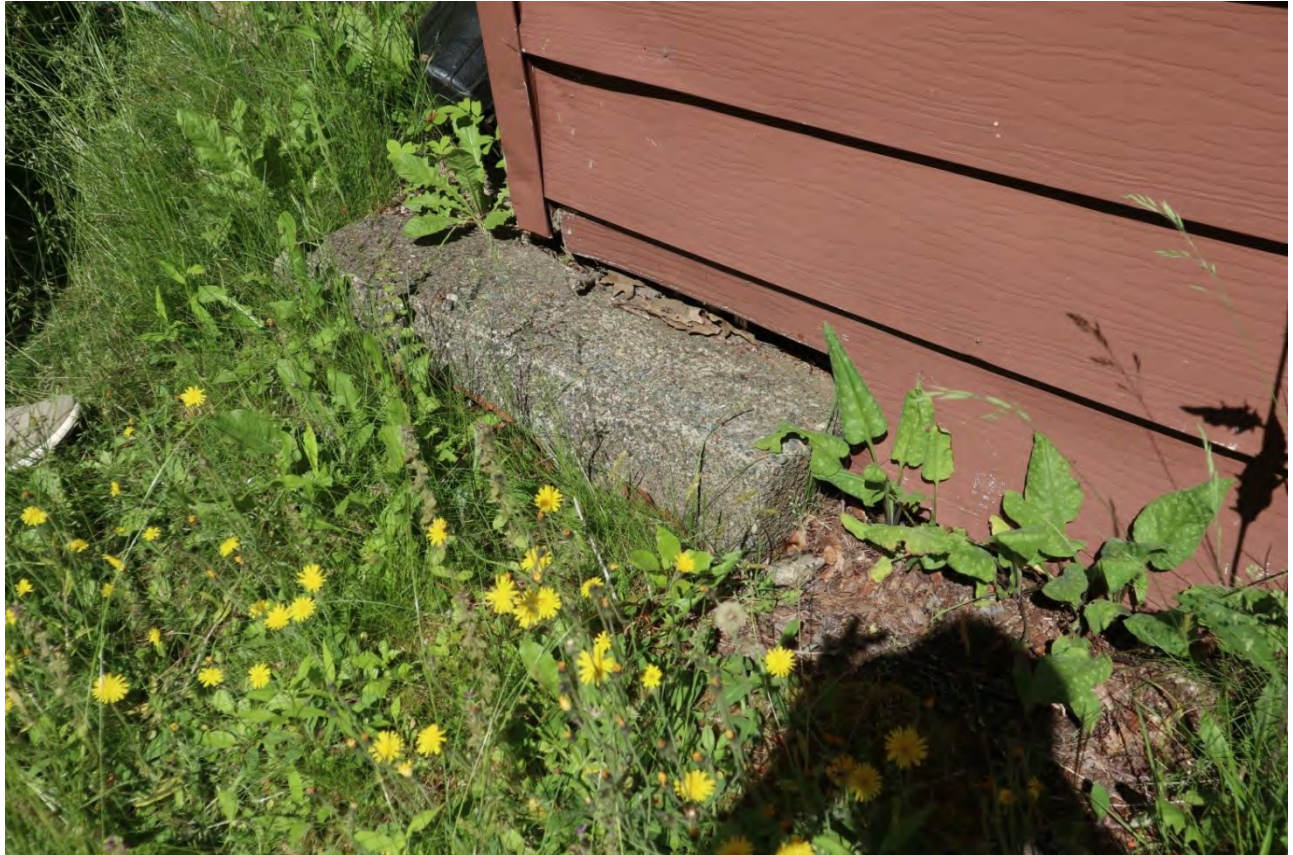
As is evident in the above photograph, the building is resting directly on the footing. Being on the surface of the ground, this footing has visible cracking.
