**Item No. 15.7.1**  
**Halifax Regional Council**  
**August 22, 2023**

**DATE:** July 26, 2023

**SUBJECT:** **Case H00528: Substantial Alteration to the municipally registered heritage property at 10 Kirk Road, Halifax**

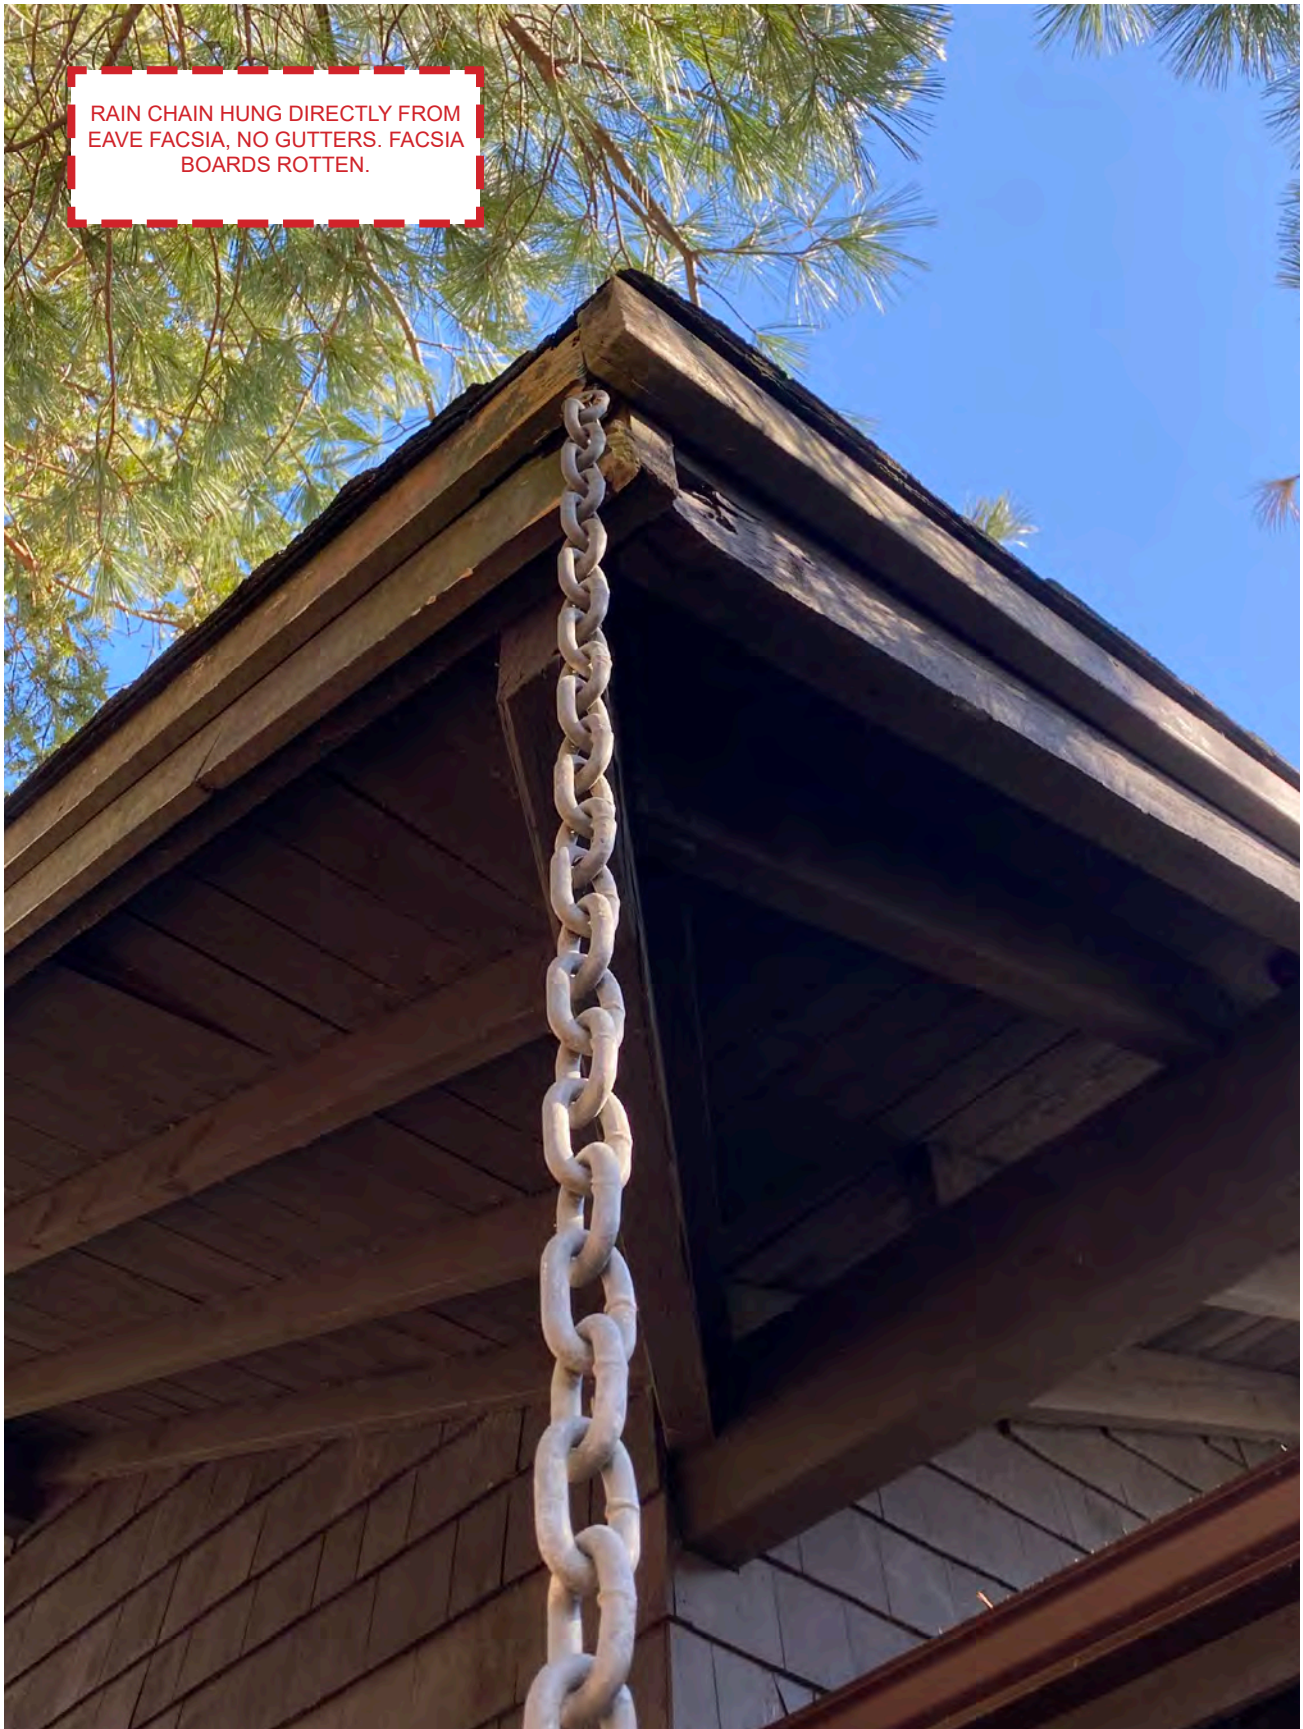
**2.2** EAVE CONDITION AT SOUTHWEST CORNER OF MAIN HOUSE.

Some fascia boards at the overhanging eaves require repair (refer to AFRR image 2.2). Water runoff from the roof should be properly managed with a combination of gutters and downspouts to divert water away from the building.

RAIN CHAIN HUNG DIRECTLY FROM  
EAVE FASCIA, NO GUTTERS. FASCIA  
BOARDS ROTTEN.

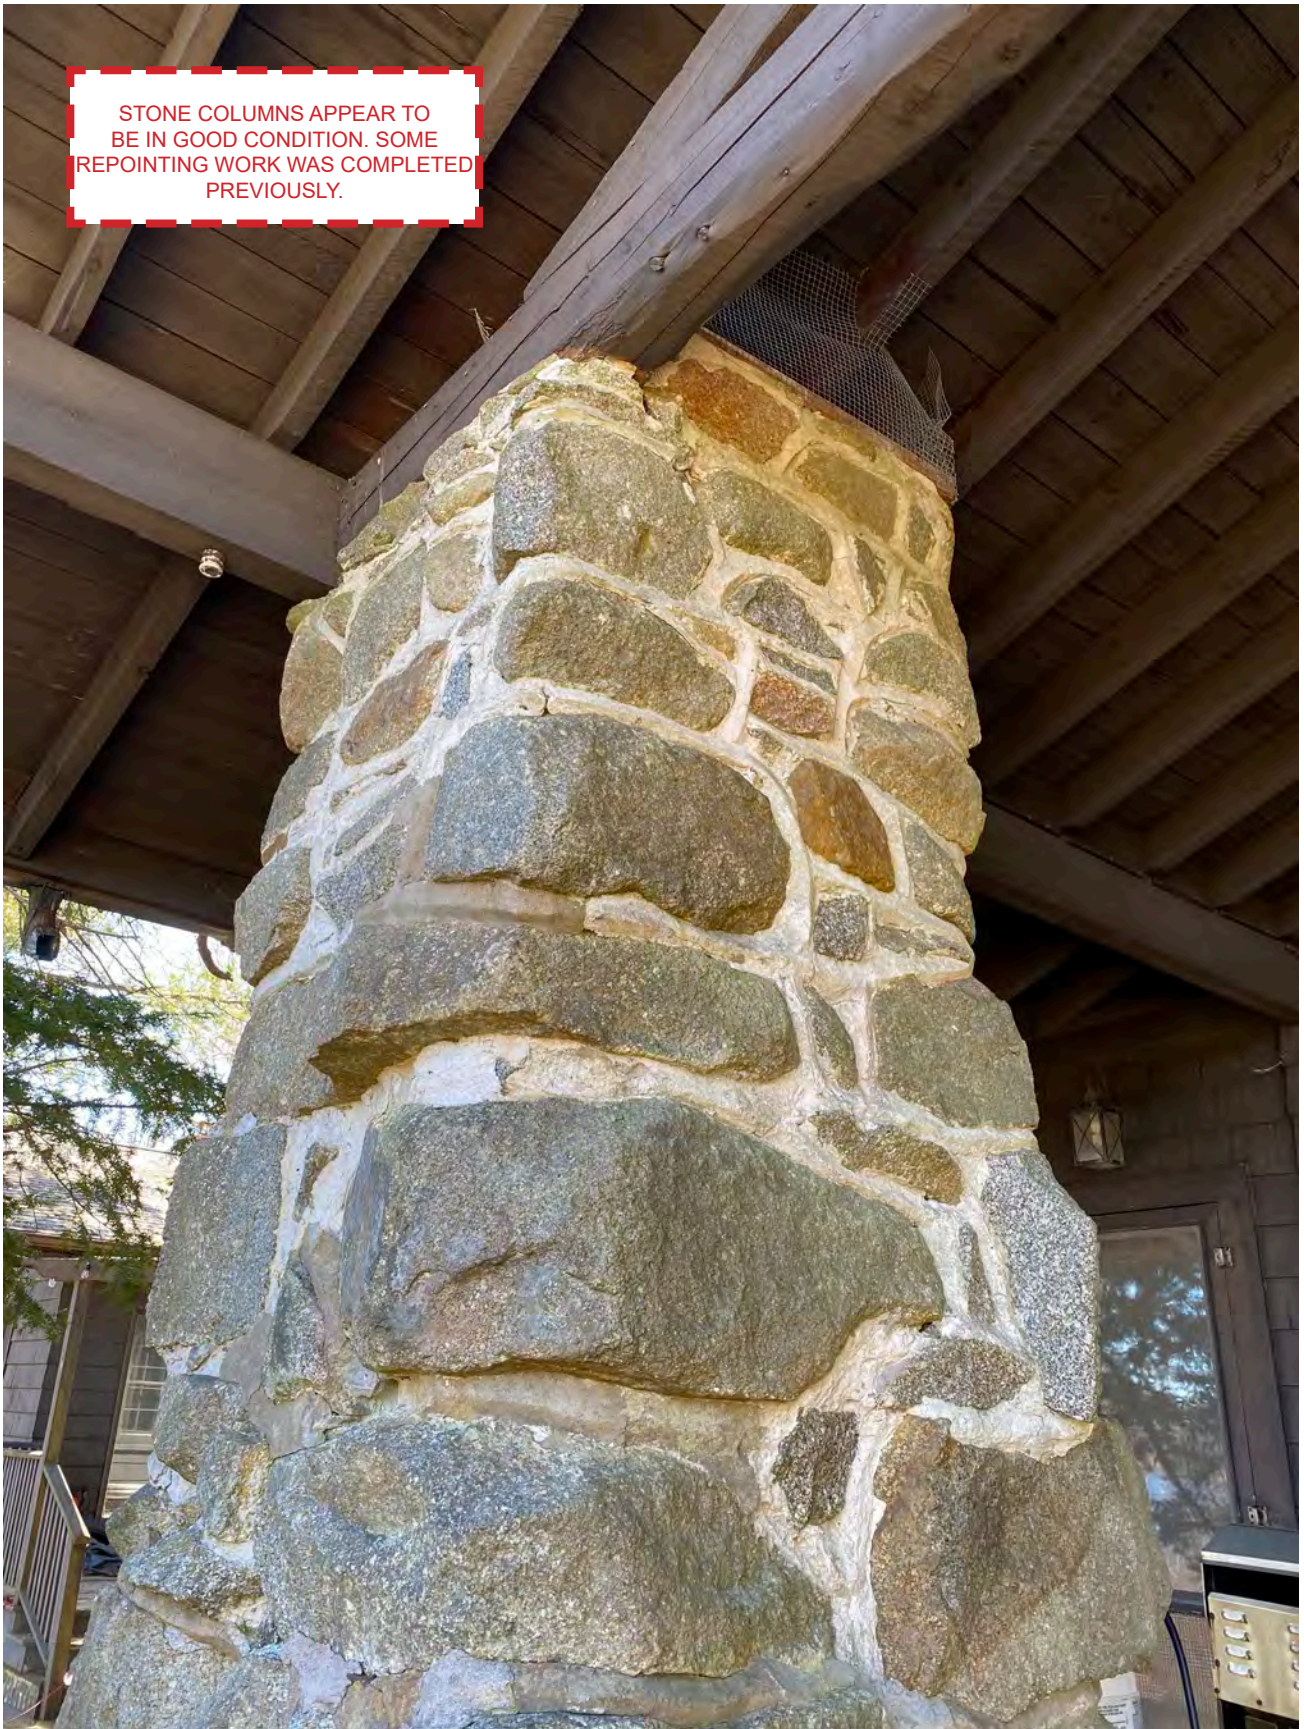
**2.4** STONE COLUMN AT COVERED PORCH (EAST SIDE).

The stone columns at the covered porch appear in good condition. Some repointing work was completed previously

STONE COLUMNS APPEAR TO BE IN GOOD CONDITION. SOME REPOINTING WORK WAS COMPLETED PREVIOUSLY.

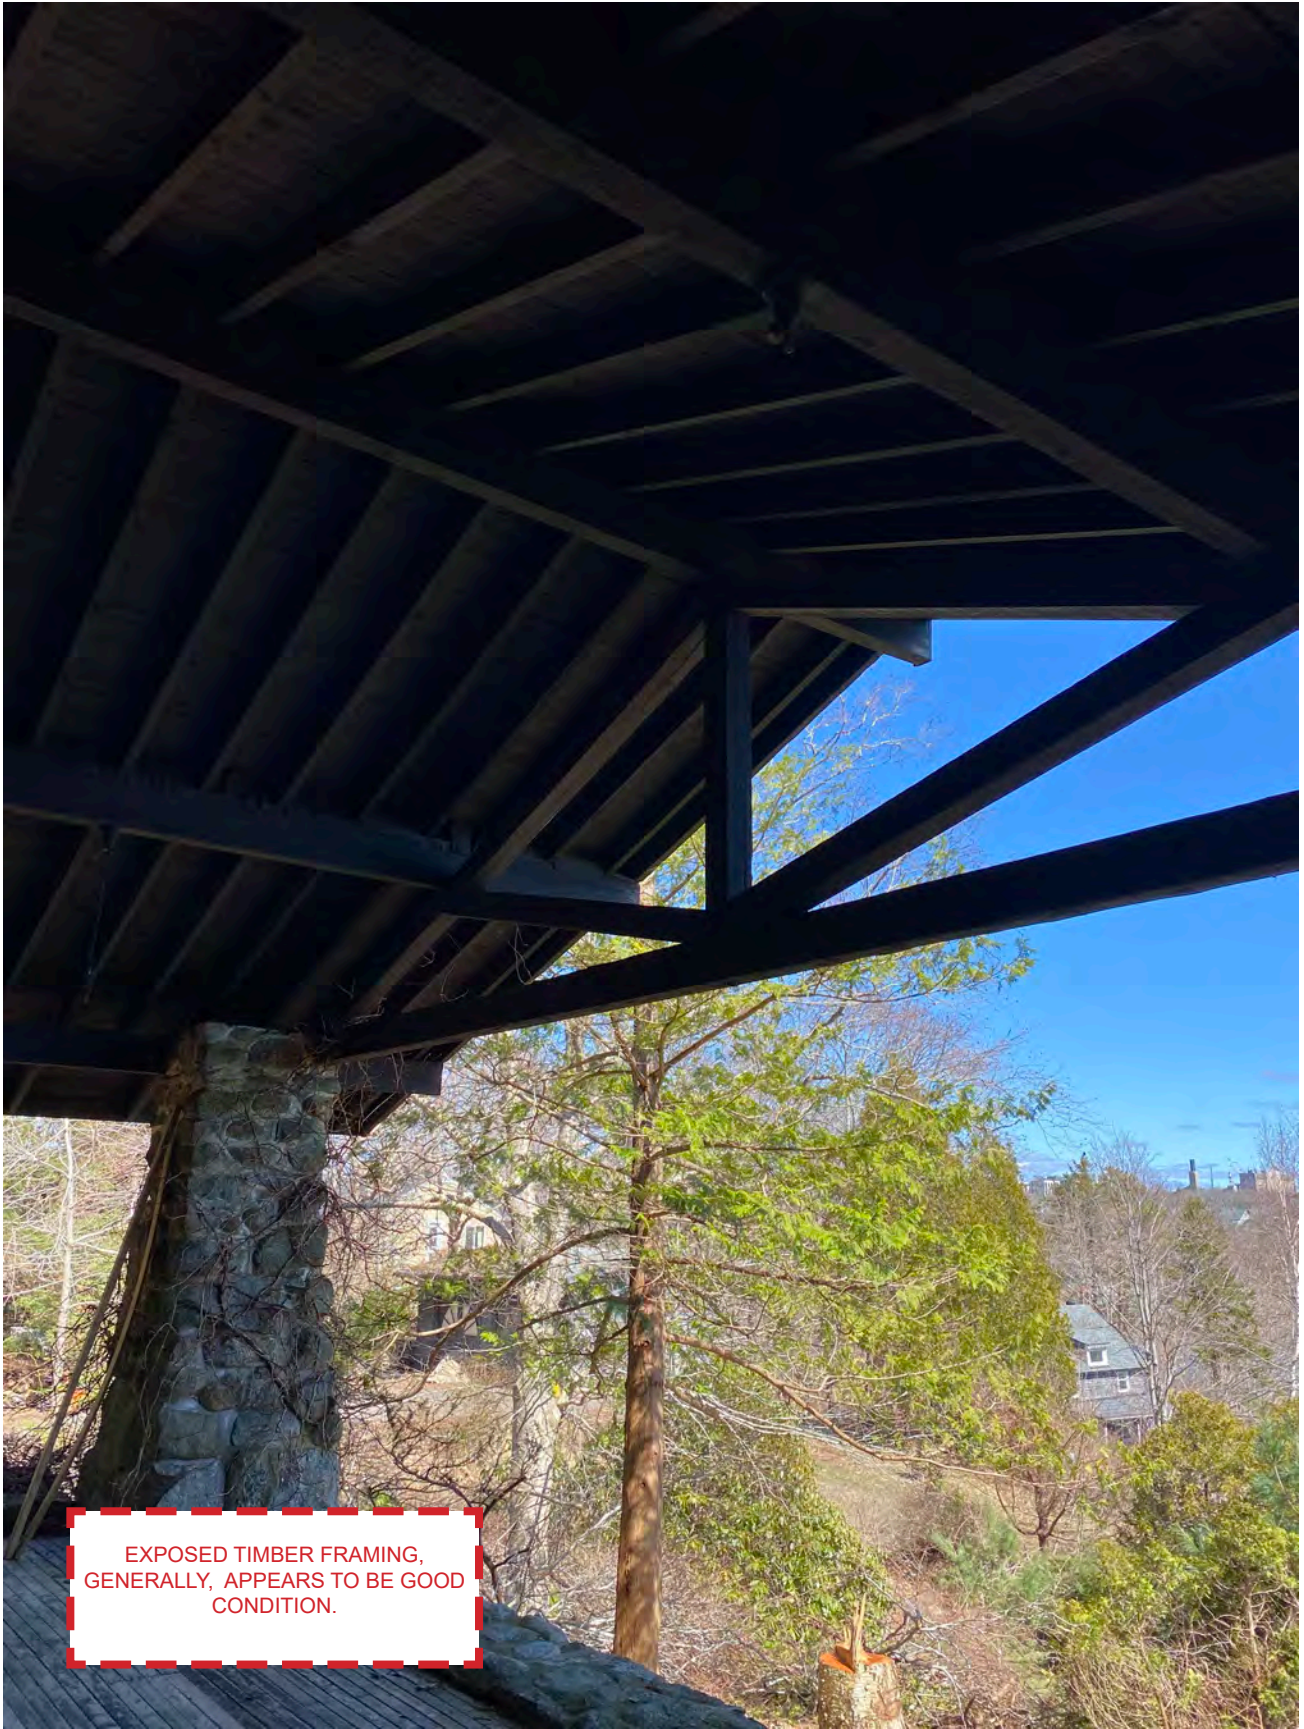
2.8 EXPOSED WOOD FRAMING AT COVERED PORCH (EAST SIDE).

The exposed timber framing, rafters, and sheathing boards generally appear in good condition in the covered porch (refer to AFRR image 2.8). This area should be further examined to confirm.

EXPOSED TIMBER FRAMING,  
GENERALLY, APPEARS TO BE GOOD  
CONDITION.

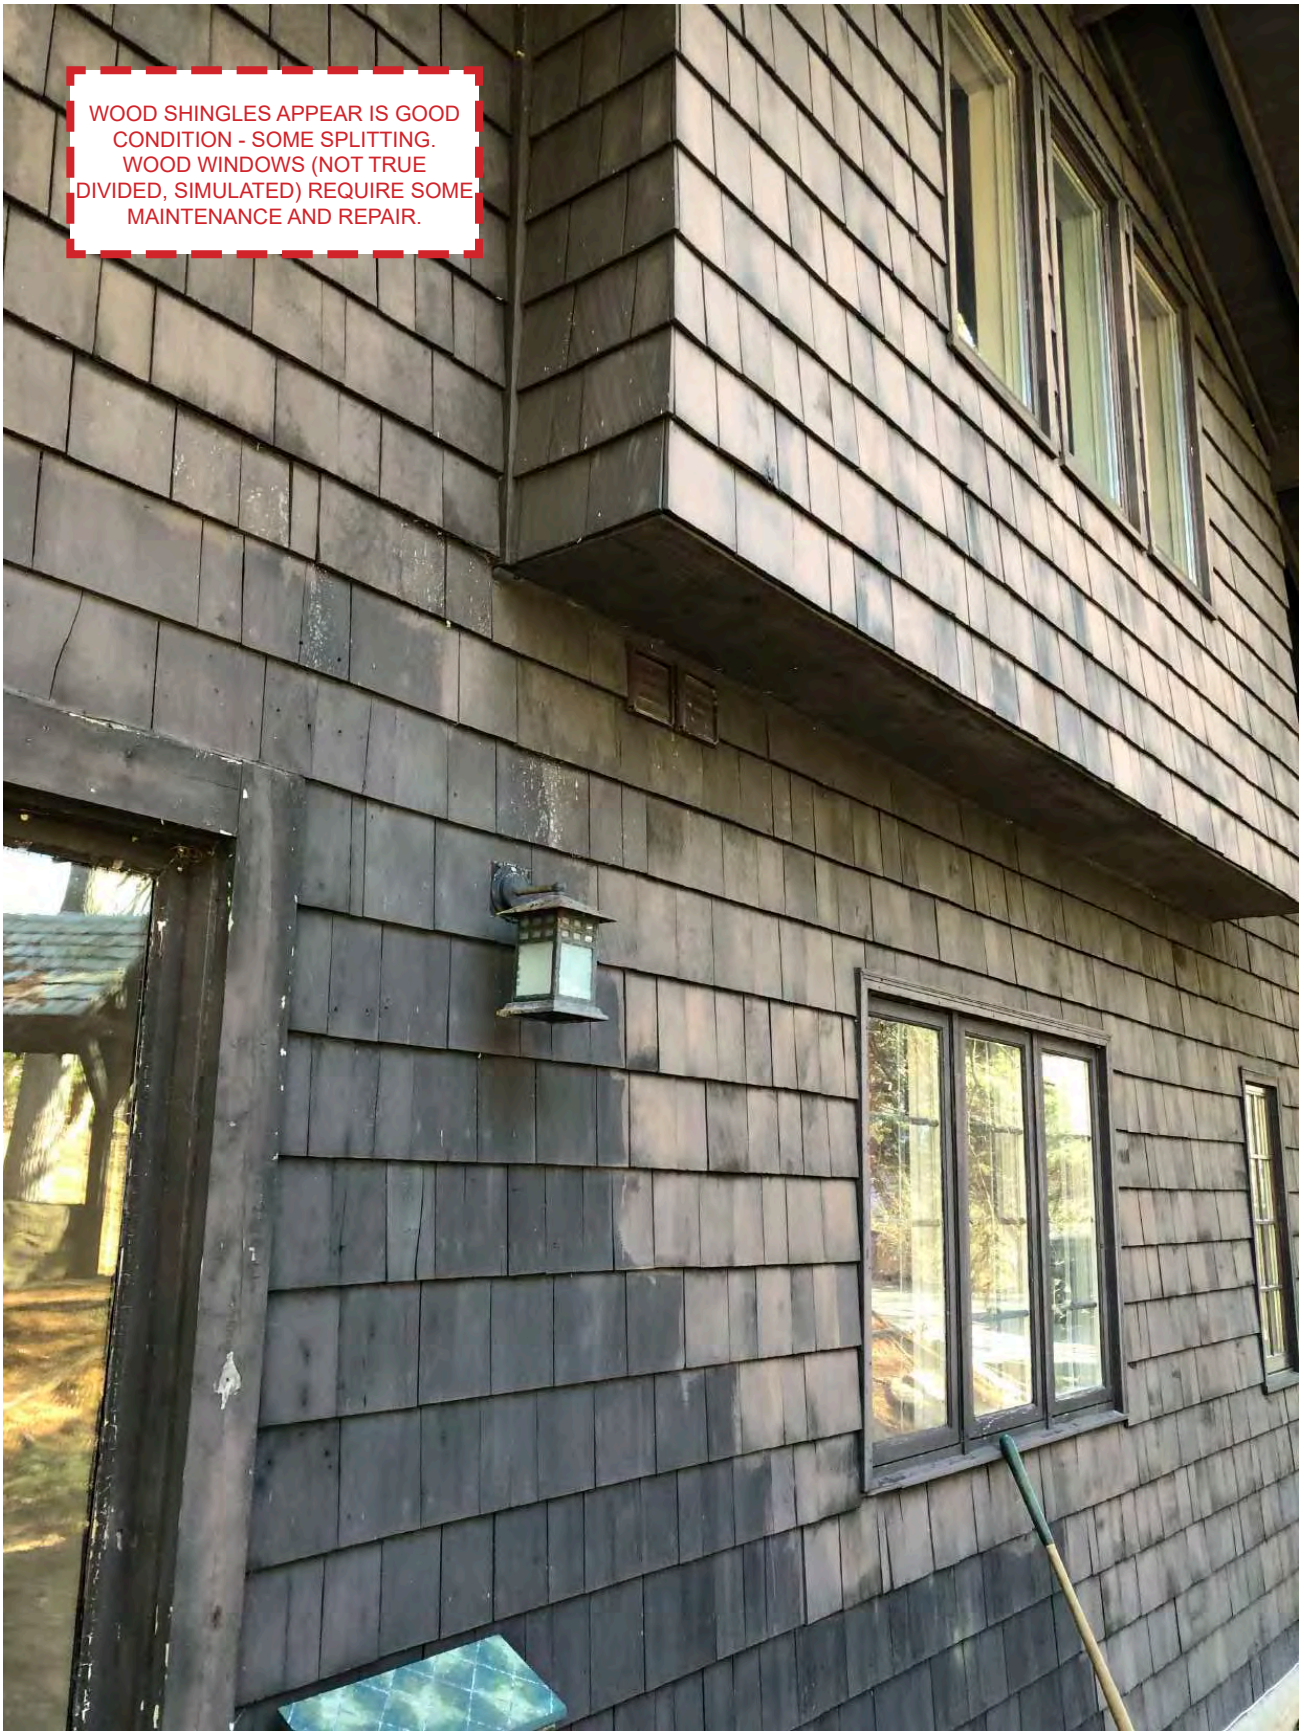
**2.12** BUMP OUT AT UPPER LEVEL (WEST SIDE).

WOOD SHINGLES APPEAR IS GOOD  
CONDITION - SOME SPLITTING.  
WOOD WINDOWS (NOT TRUE  
DIVIDED, SIMULATED) REQUIRE SOME  
MAINTENANCE AND REPAIR.

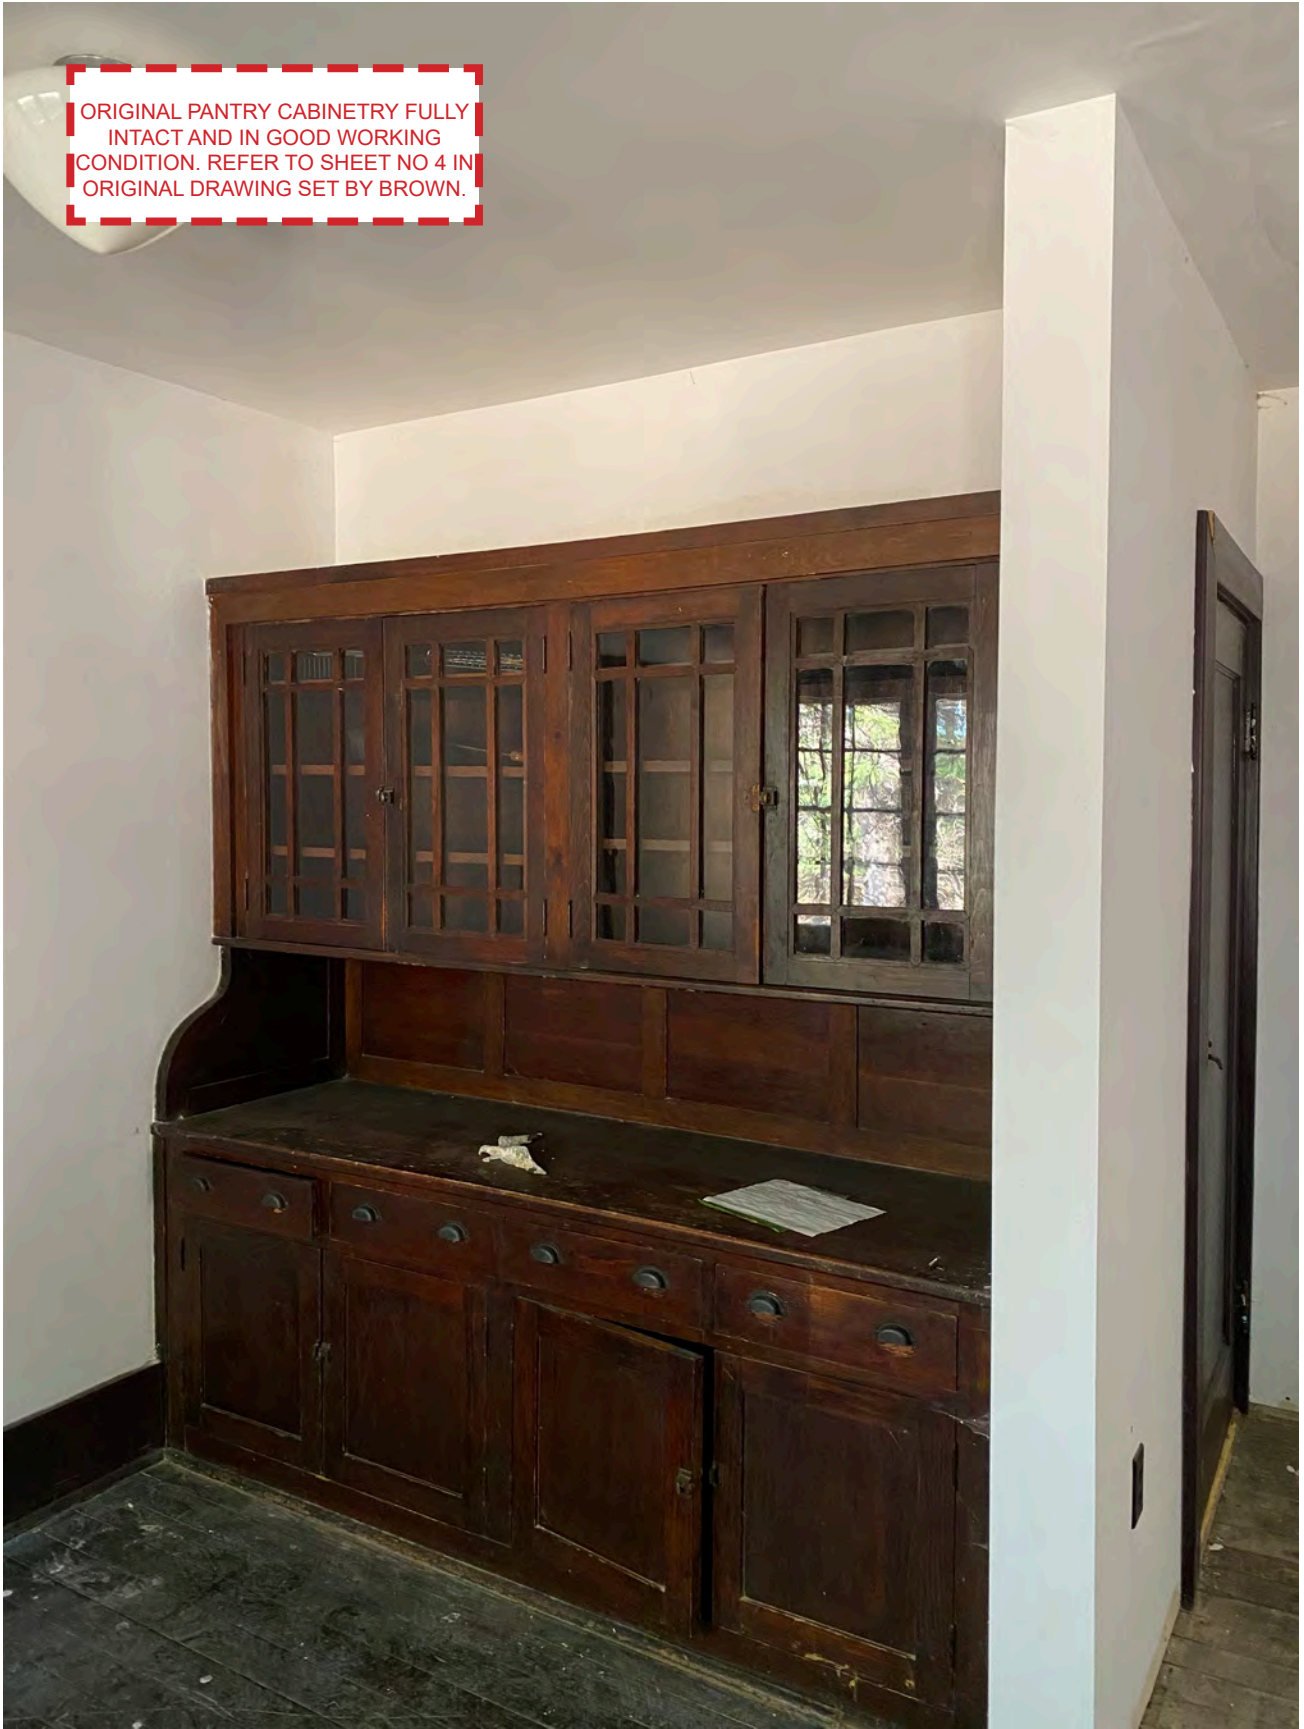
**2.13** MAIN FLOOR PANTRY AREA (OPPOSITE DINING AREA).

ORIGINAL PANTRY CABINETS FULLY  
INTACT AND IN GOOD WORKING  
CONDITION. REFER TO SHEET NO 4 IN  
ORIGINAL DRAWING SET BY BROWN.

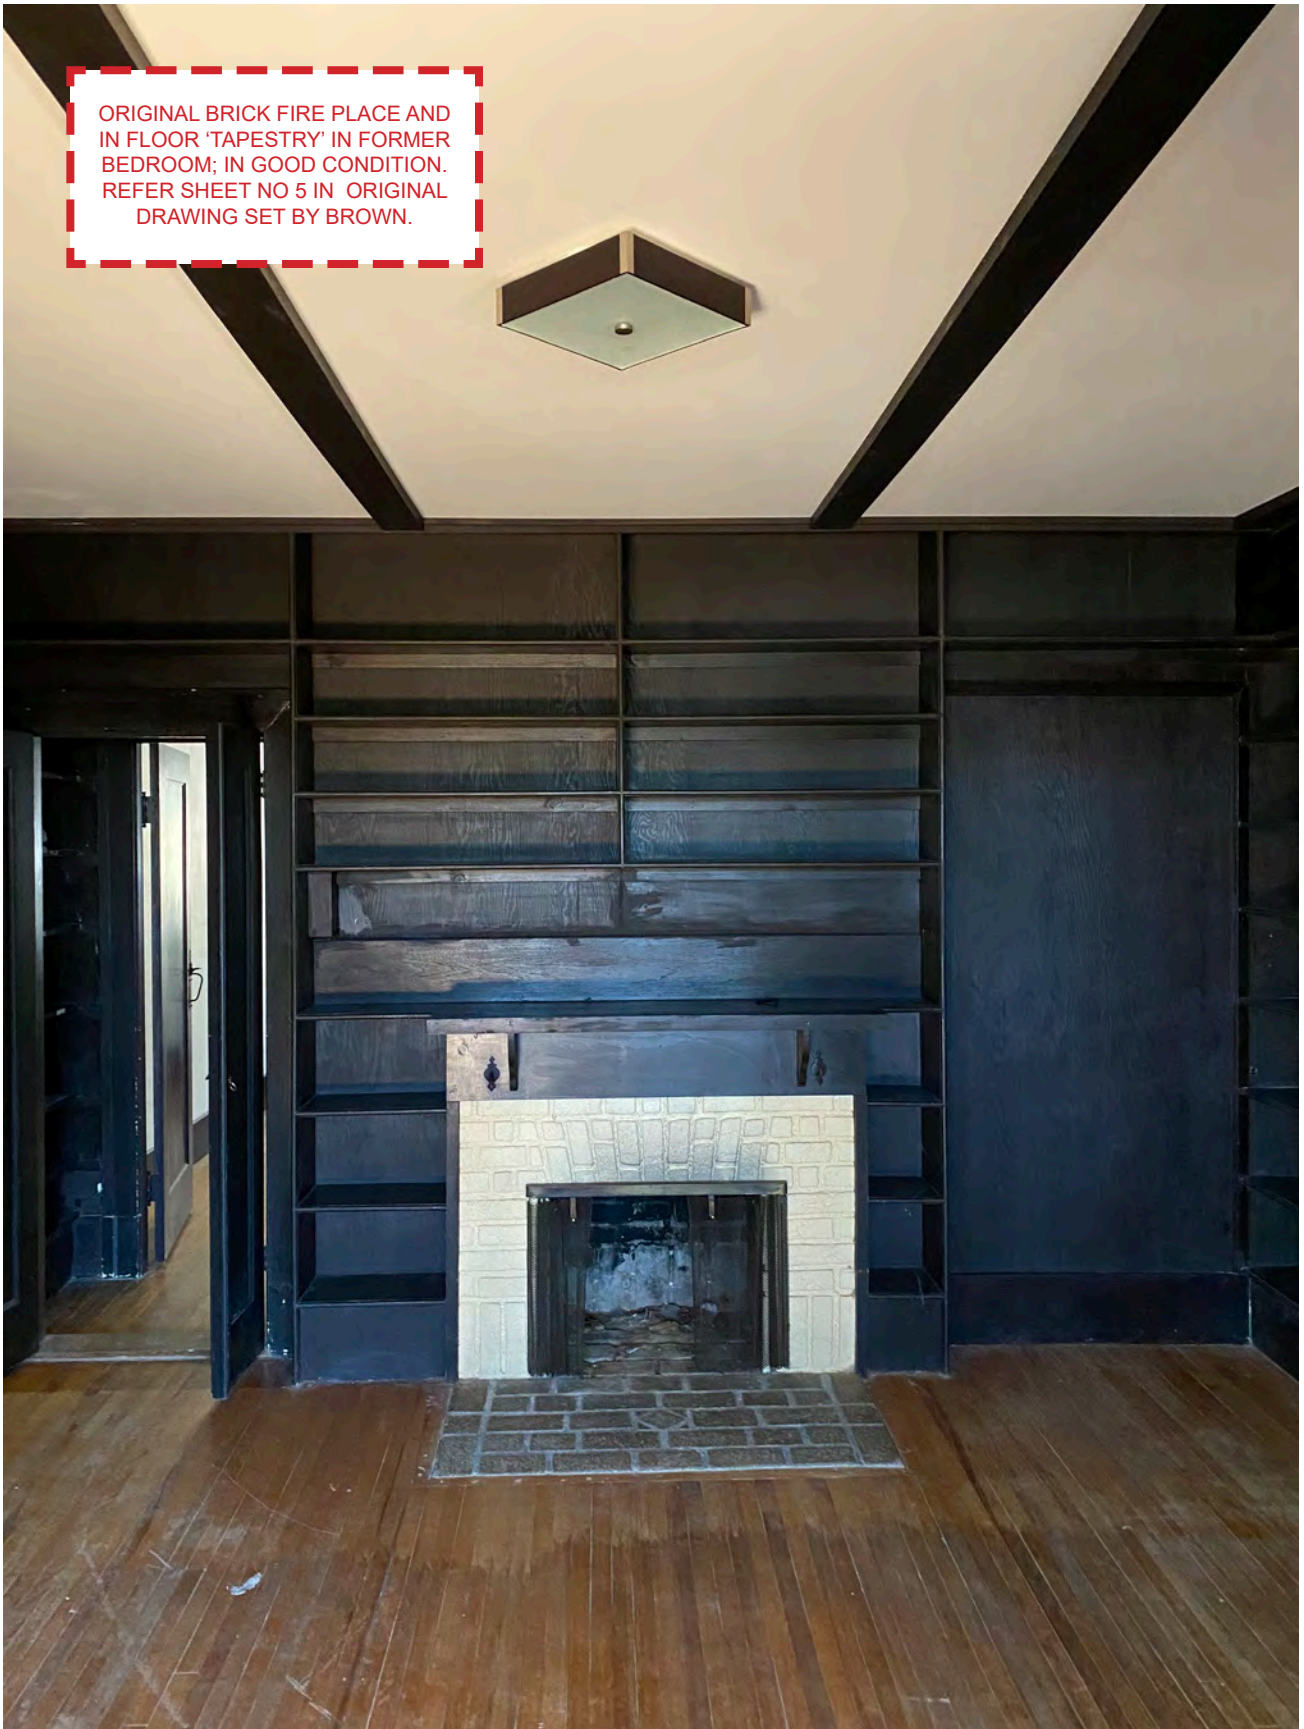
**2.15** MAIN FLOOR, FORMER BEDROOM AREA (WEST).

ORIGINAL BRICK FIRE PLACE AND  
IN FLOOR 'TAPESTRY' IN FORMER  
BEDROOM; IN GOOD CONDITION.  
REFER SHEET NO 5 IN ORIGINAL  
DRAWING SET BY BROWN.

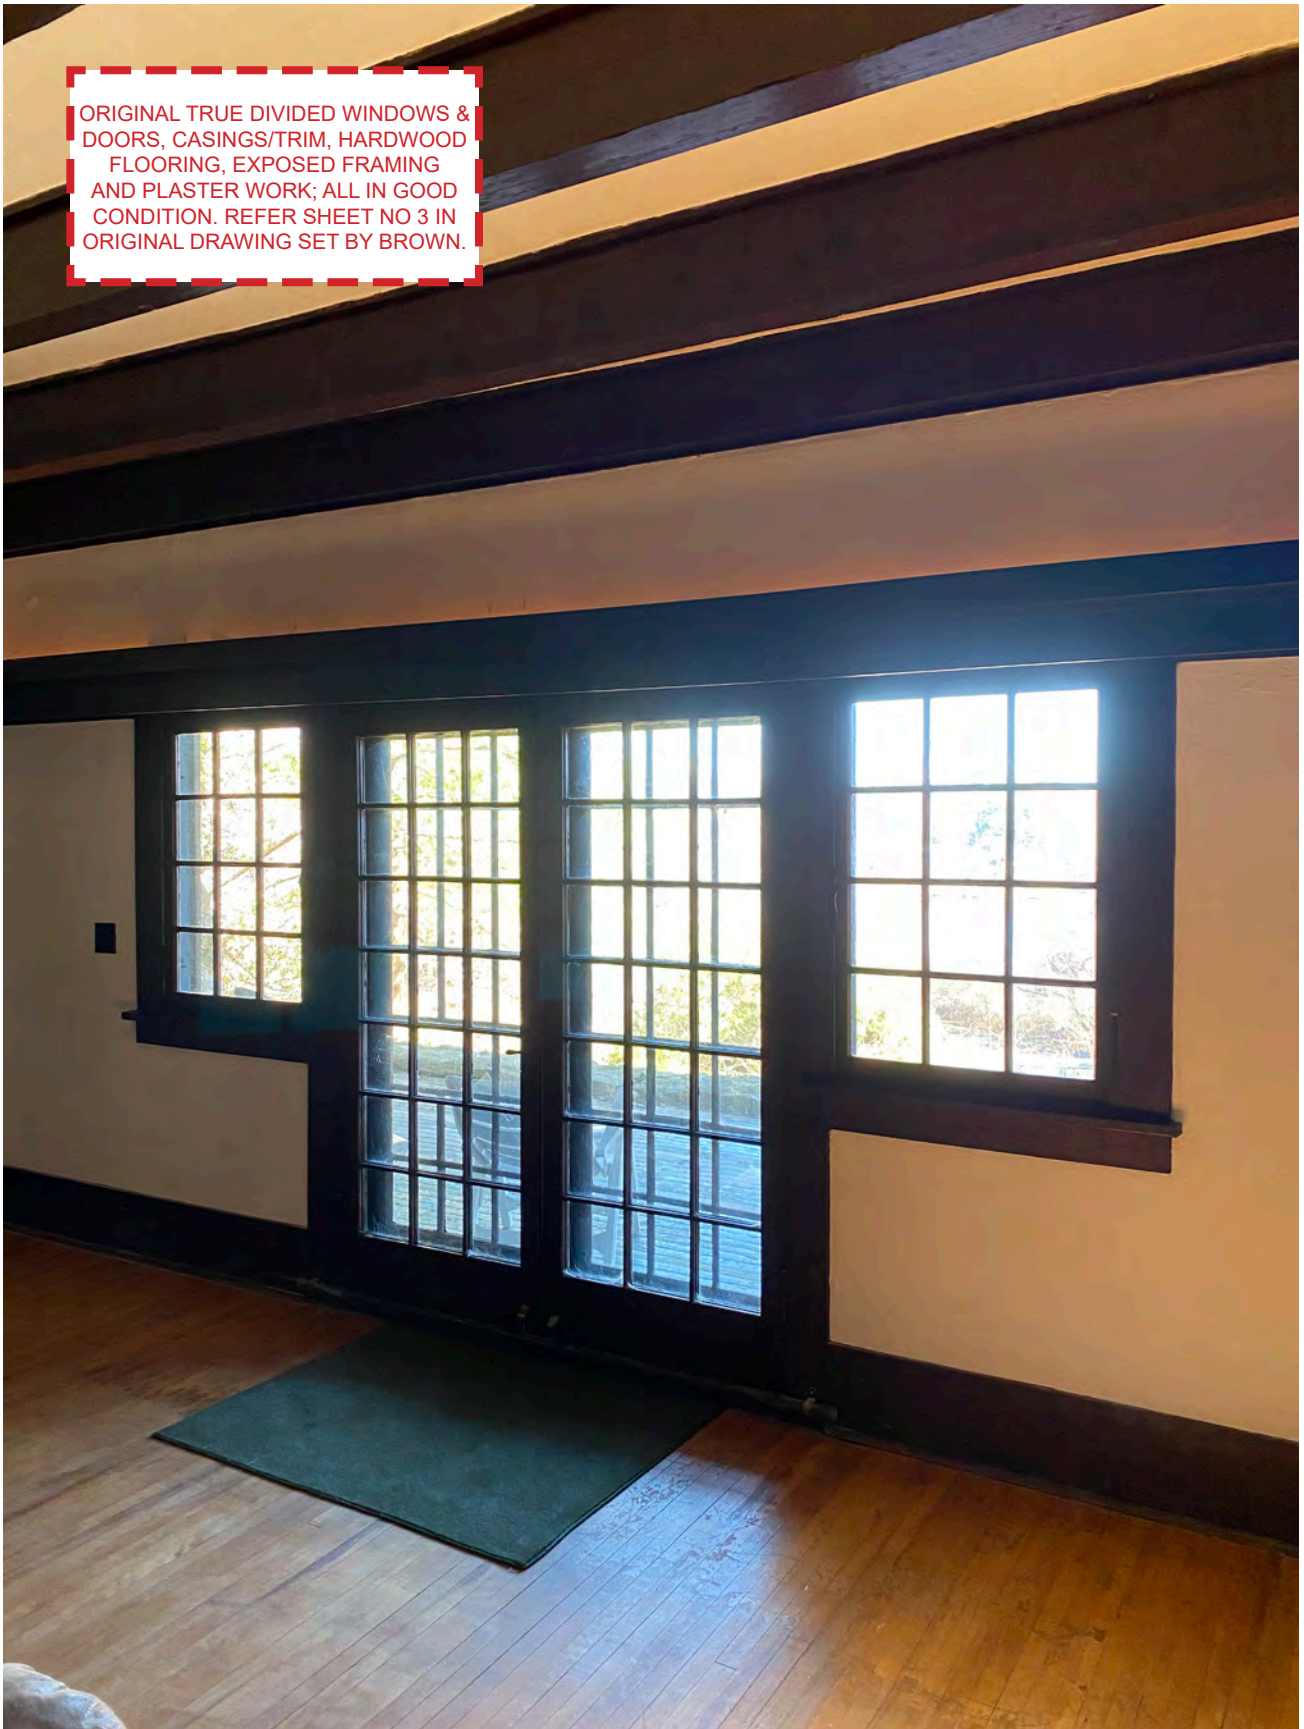
**2.16** MAIN FLOOR LIVING ROOM (EAST).

ORIGINAL TRUE DIVIDED WINDOWS & DOORS, CASINGS/TRIM, HARDWOOD FLOORING, EXPOSED FRAMING AND PLASTER WORK; ALL IN GOOD CONDITION. REFER SHEET NO 3 IN ORIGINAL DRAWING SET BY BROWN.

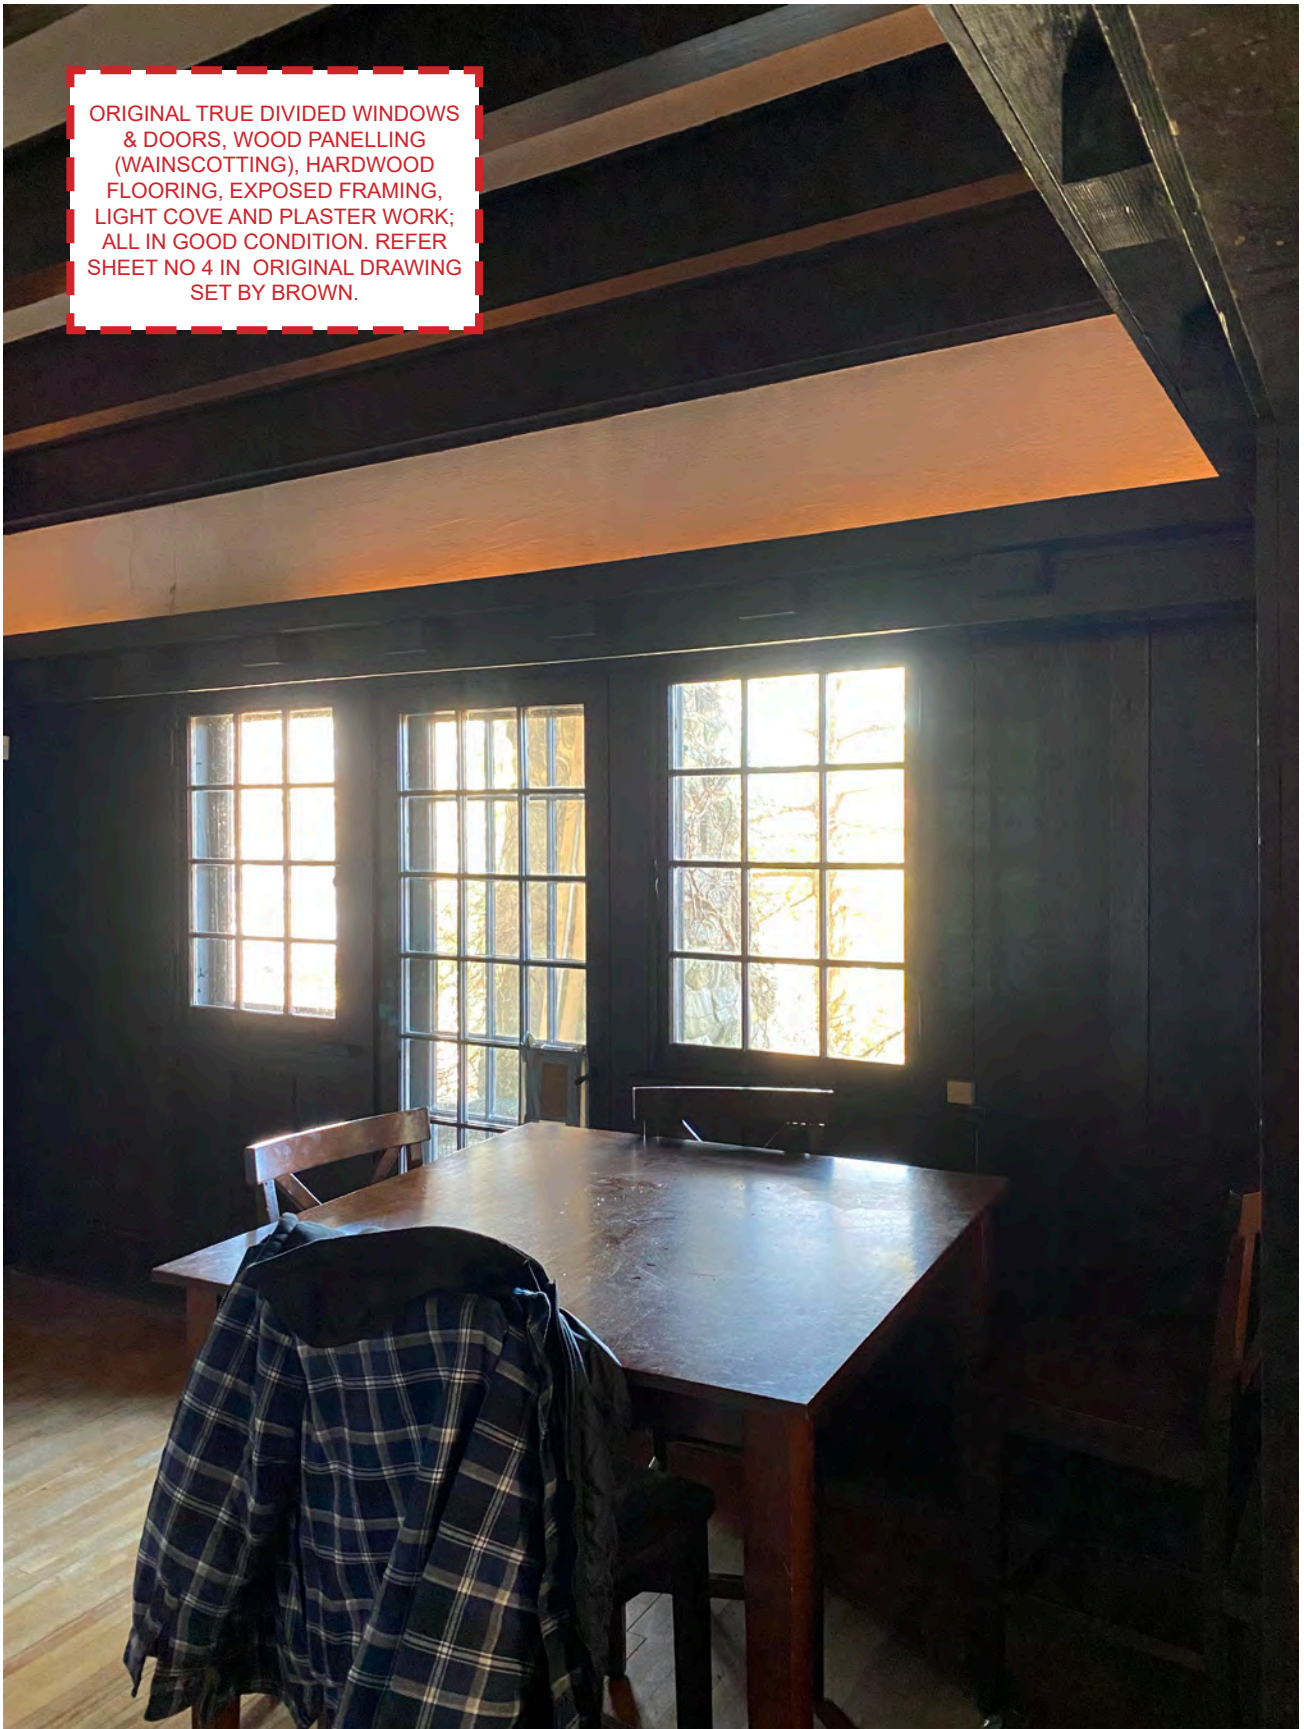
**2.16** MAIN FLOOR DINING ROOM (EAST).

ORIGINAL TRUE DIVIDED WINDOWS  
& DOORS, WOOD PANELLING  
(WAINSCOTTING), HARDWOOD  
FLOORING, EXPOSED FRAMING,  
LIGHT COVE AND PLASTER WORK;  
ALL IN GOOD CONDITION. REFER  
SHEET NO 4 IN ORIGINAL DRAWING  
SET BY BROWN.

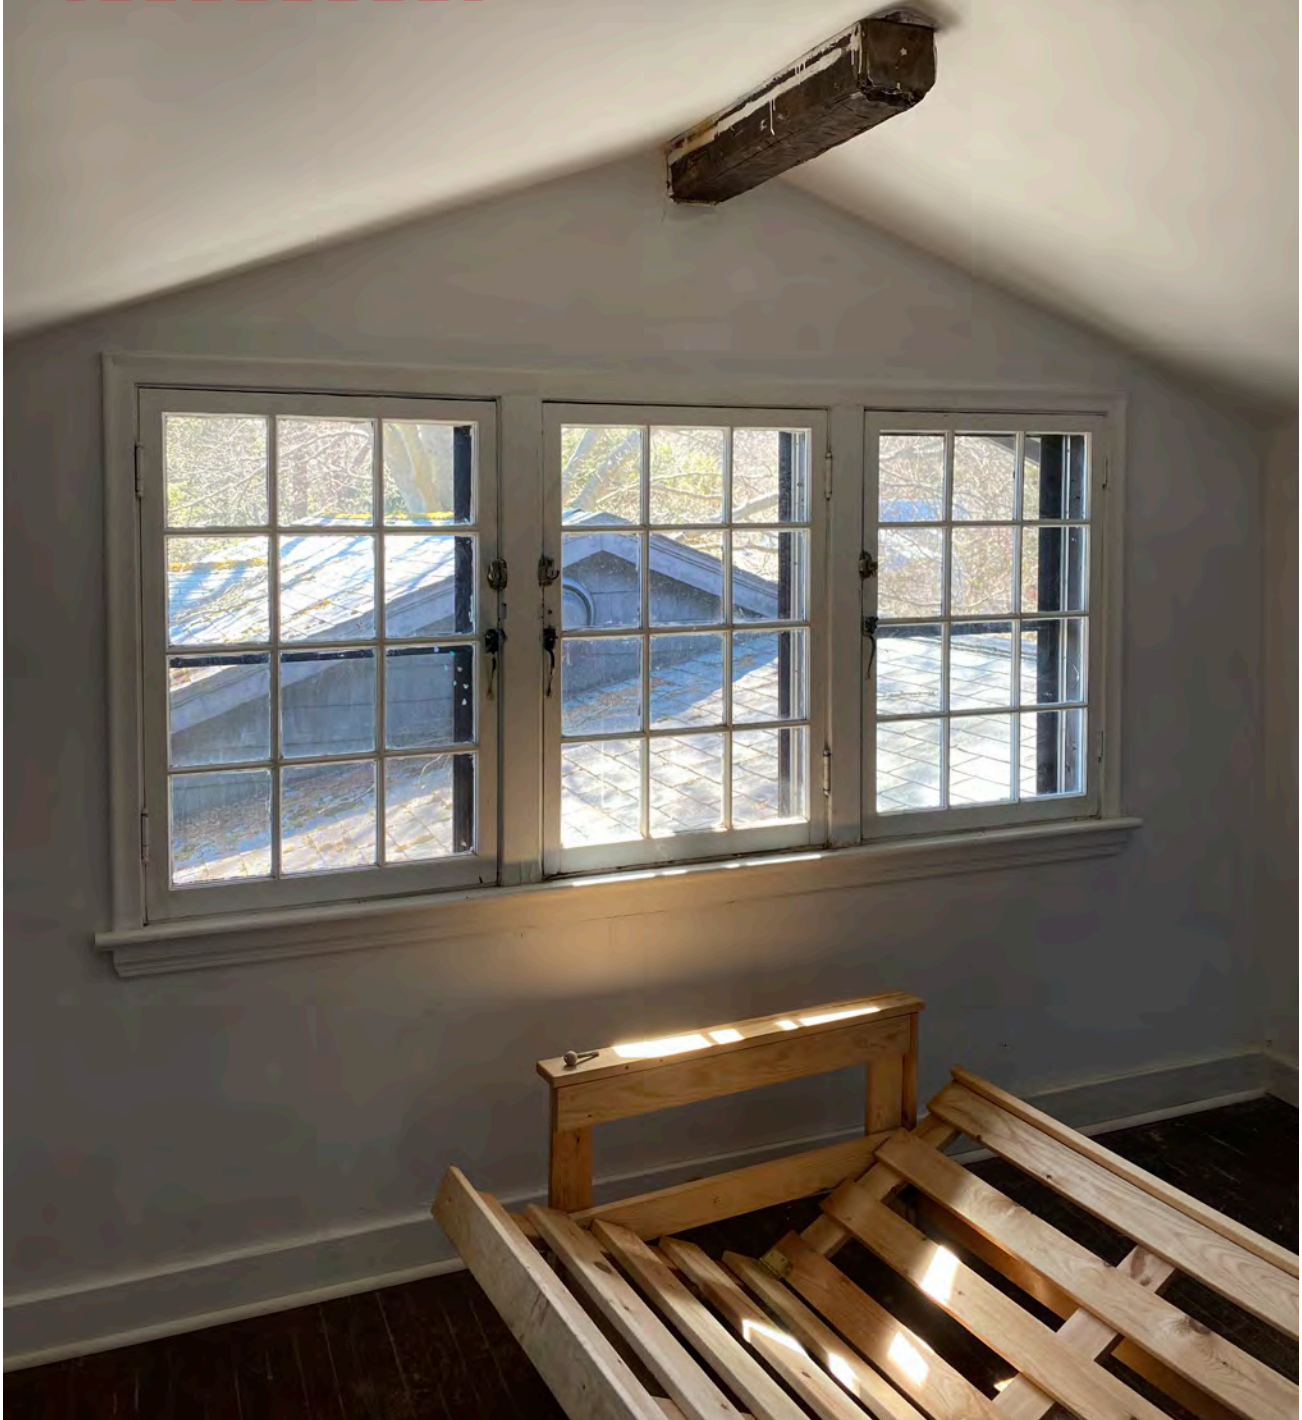
2.19 BEDROOM, UPPER FLOOR (SOUTH SIDE).

TRUE DIVIDED WINDOWS IN GOOD  
CONDITION; SOME MAINTENANCE  
AND REPAIR WORK REQUIRED.  
WINDOW SIZE AND ARRANGEMENT  
DIFFERS FROM ORIGINAL DRAWINGS  
BY BROWN - REFER SHEET NO 2  
SOUTH ELEVATION.

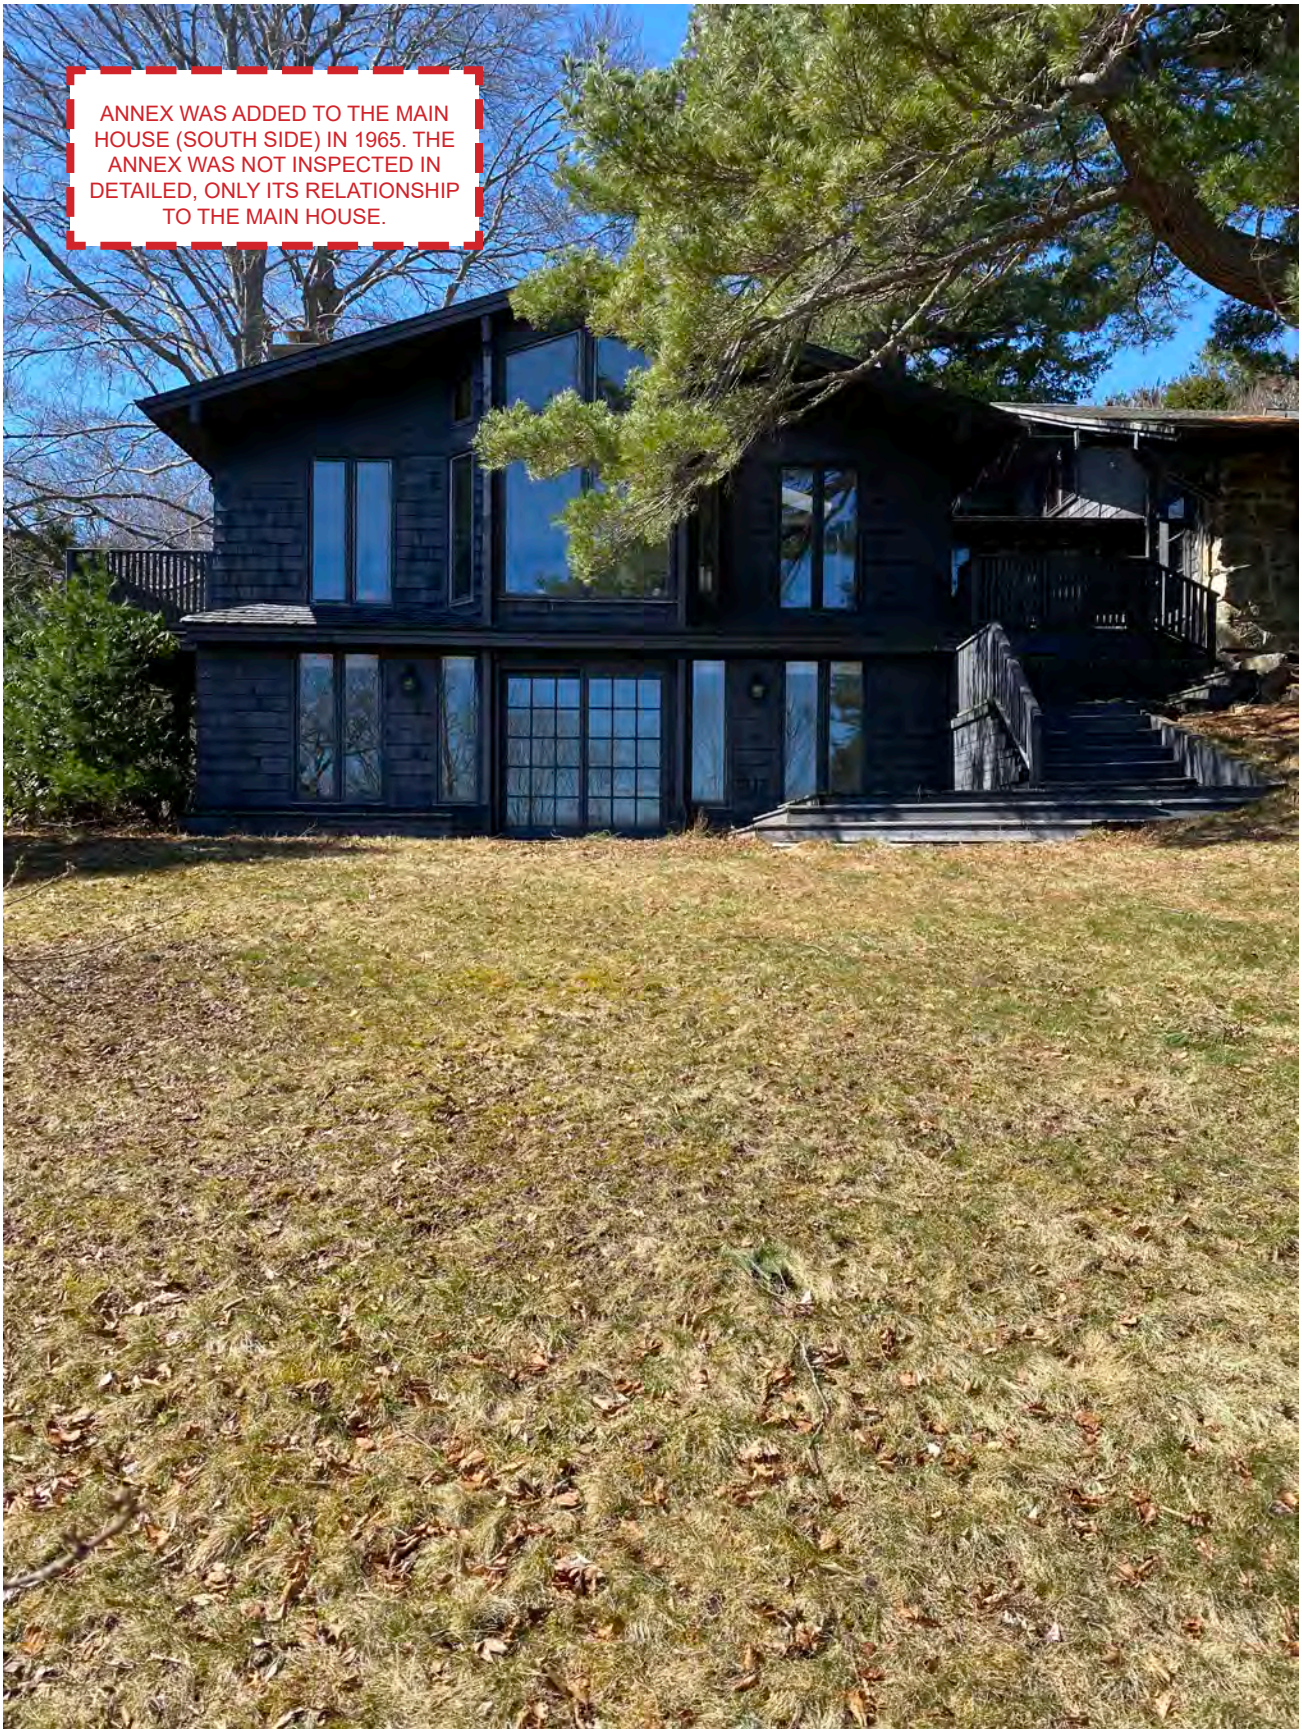
**2.20** BEDROOM, UPPER FLOOR (NORTH SIDE).

TRUE DIVIDED WINDOWS IN GOOD  
CONDITION; SOME MAINTENANCE  
AND REPAIR WORK REQUIRED.  
WINDOW SIZE AND ARRANGEMENT  
APPEARS TO MATCH ORIGINAL  
DRAWINGS BY BROWN - REFER  
SHEET NO 2 NORTH ELEVATION.  
FIFTH WINDOW IS BLOCKED OFF  
OUTSIDE BUT REMAINS IN PLACE.
