**Item No. 15.7.1**  
**Halifax Regional Council**  
**August 22, 2023**

**DATE:** July 26, 2023

**SUBJECT:** **Case H00528: Substantial Alteration to the municipally registered heritage property at 10 Kirk Road, Halifax**

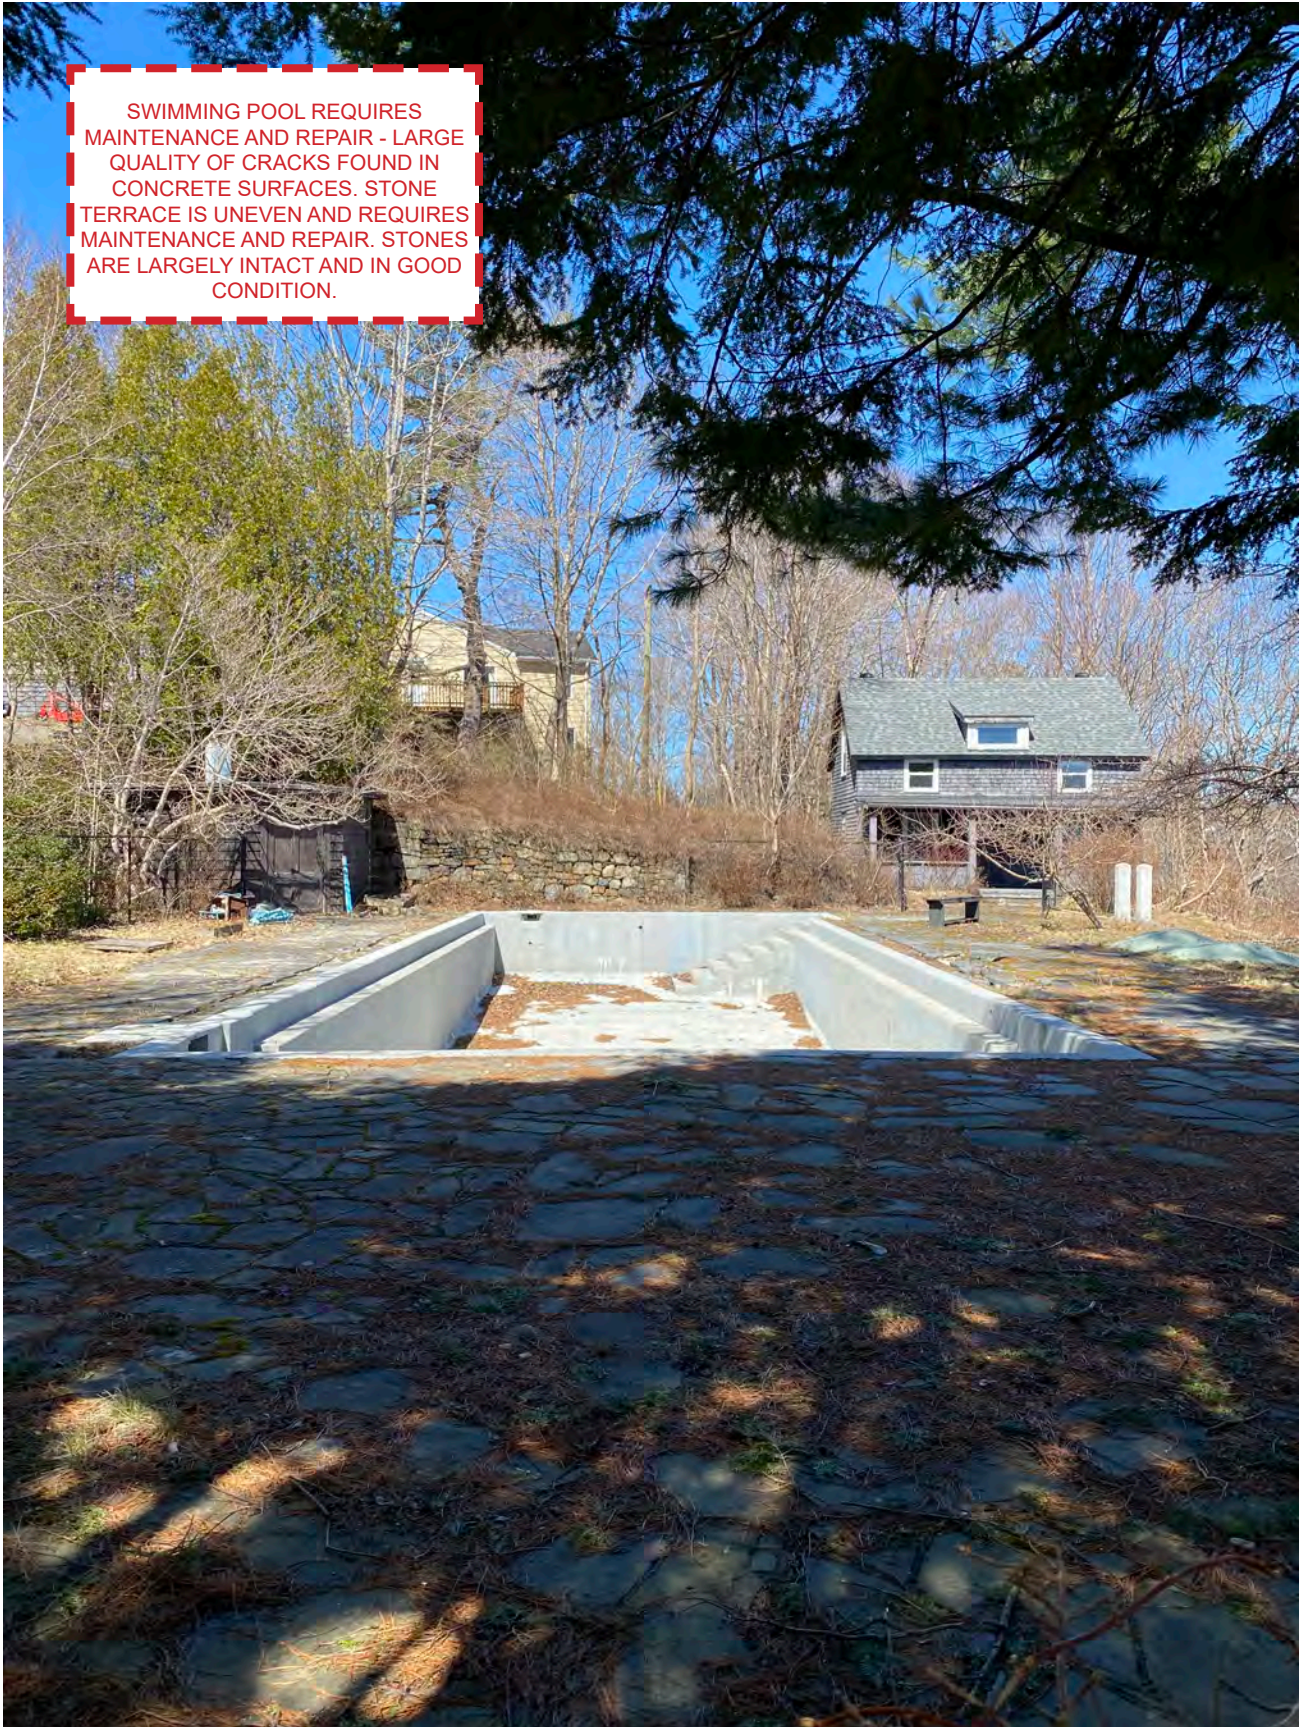
**2.23** SWIMMING POOL WITH STONE TERRACE (NORTH VIEW).

SWIMMING POOL REQUIRES MAINTENANCE AND REPAIR - LARGE QUALITY OF CRACKS FOUND IN CONCRETE SURFACES. STONE TERRACE IS UNEVEN AND REQUIRES MAINTENANCE AND REPAIR. STONES ARE LARGELY INTACT AND IN GOOD CONDITION.

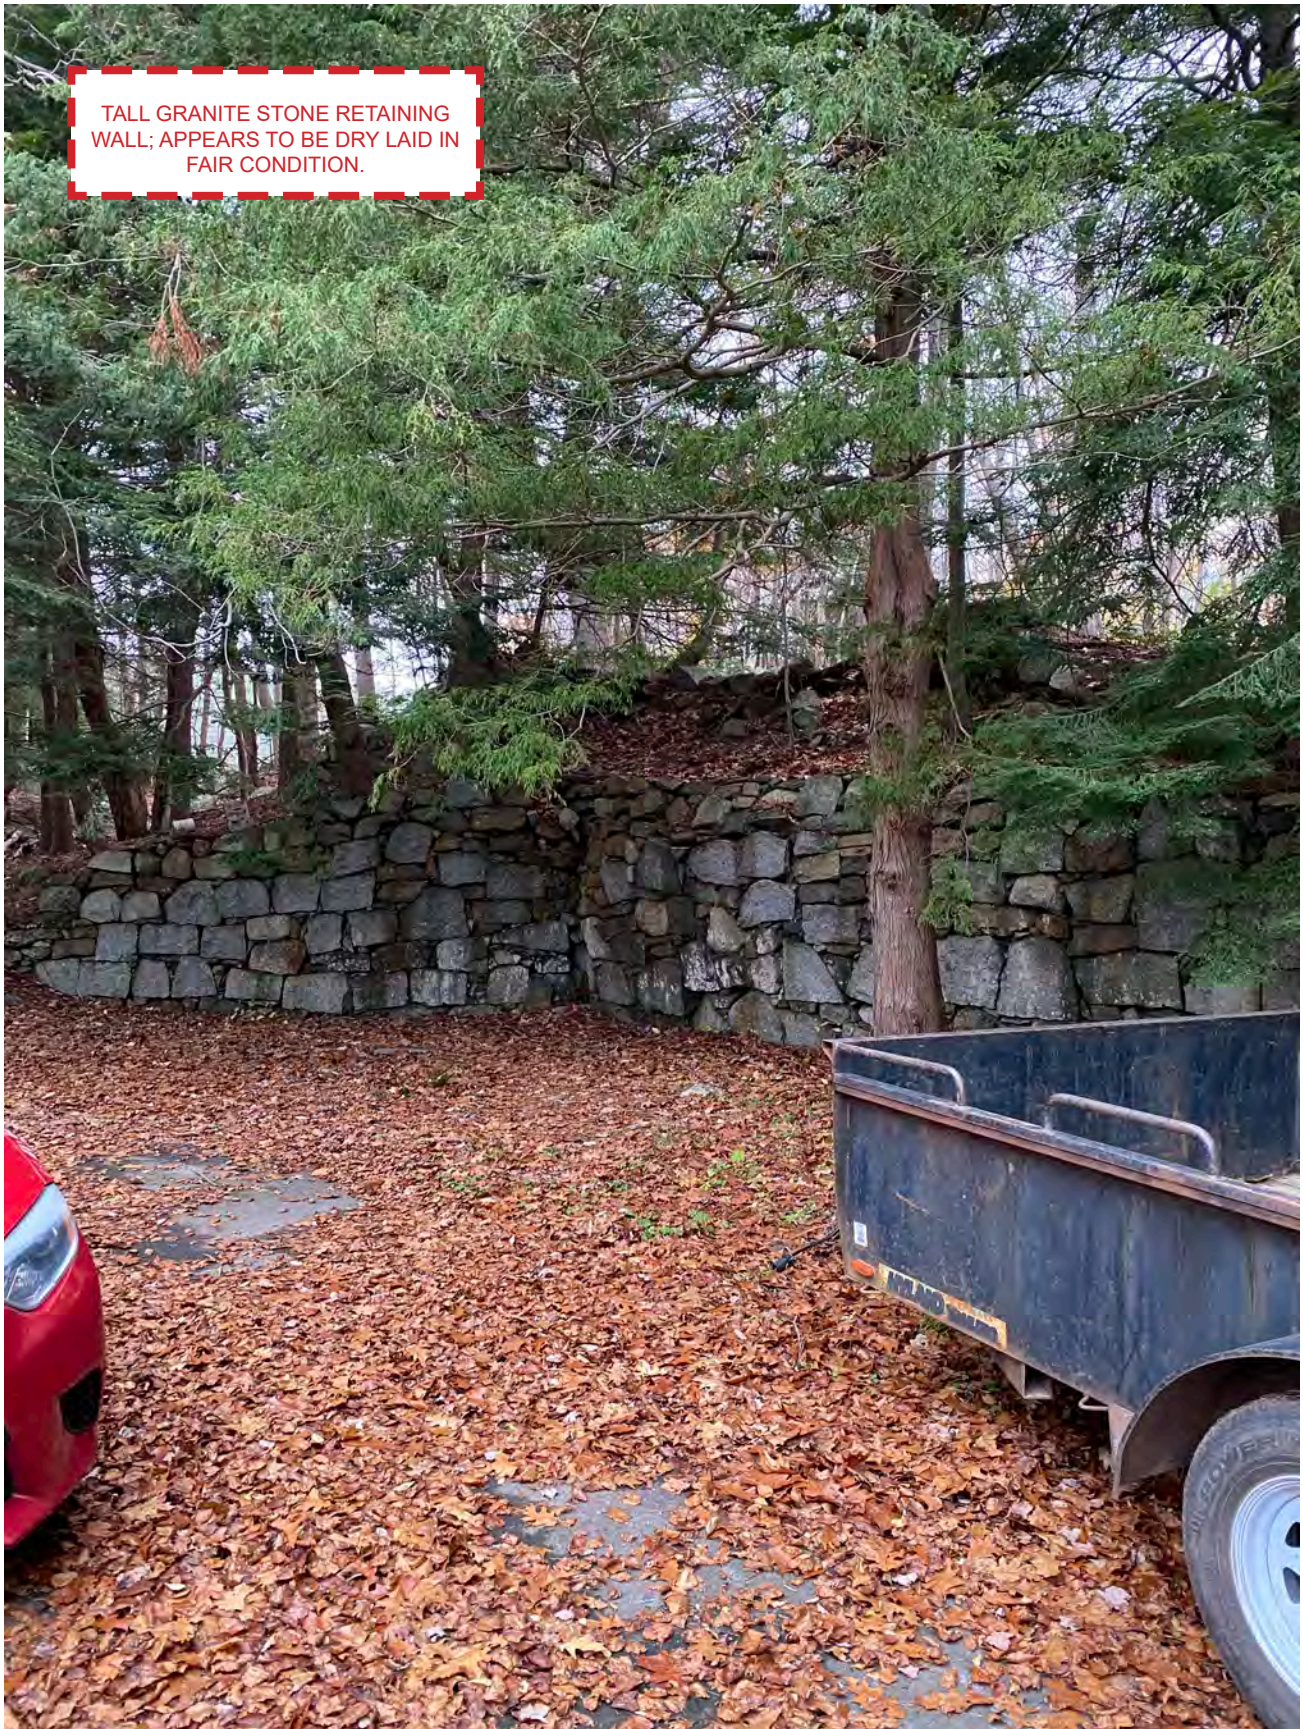
**2.27** STONE WALL NEXT TO ROOST (SOUTHWEST VIEW).

GRANITE STONE RETAINING WALL;  
APPEARS TO BE DRY LAID IN FAIR  
CONDITION - SOME FALLEN STONES.

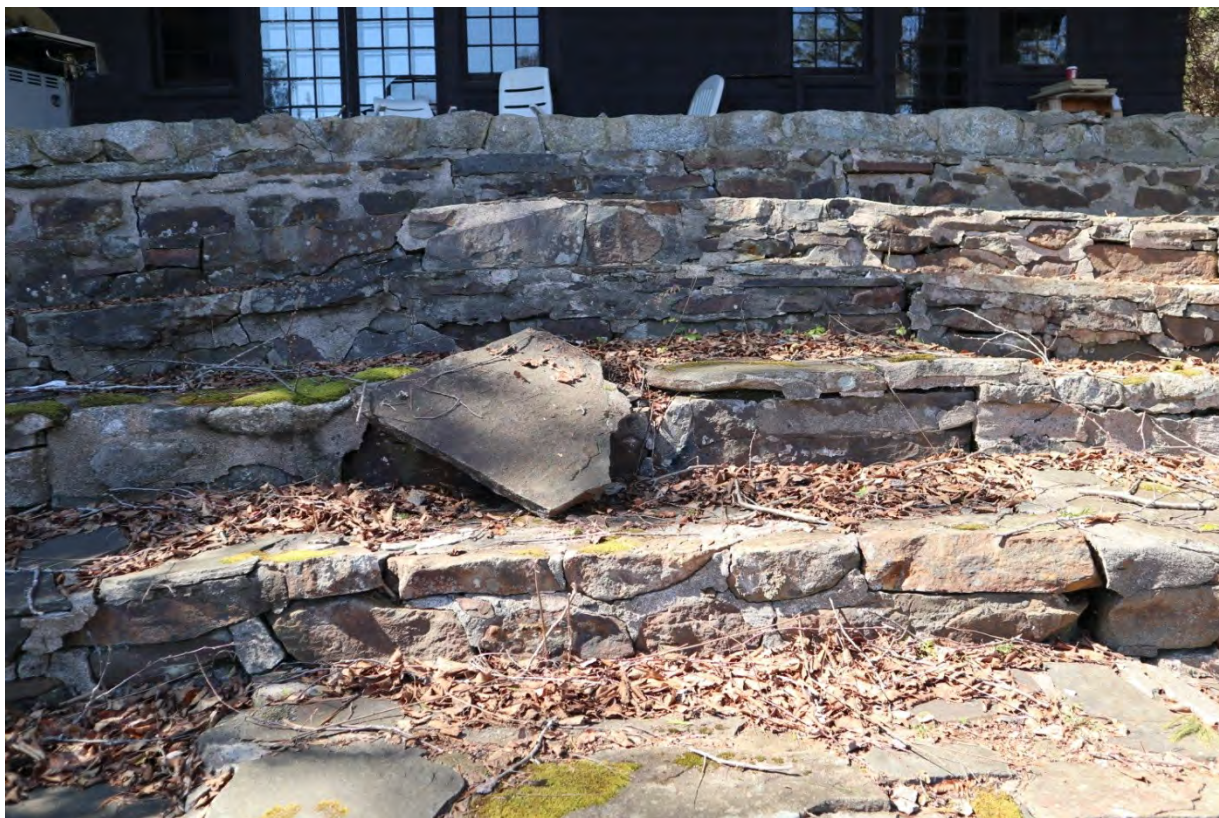
Around the building there are a number of rock walls. Some of these are for the support of rock stairs, others to support deck areas, and others simple as architectural features. In all cases you can clearly pick out the fact that these wall have failed.

These wall have all failed to some degree, with some which can be classified as not structurally sound. These will all require a total rebuild. Others will have to be realigned, and sealed in place with some type of a mortar compound.

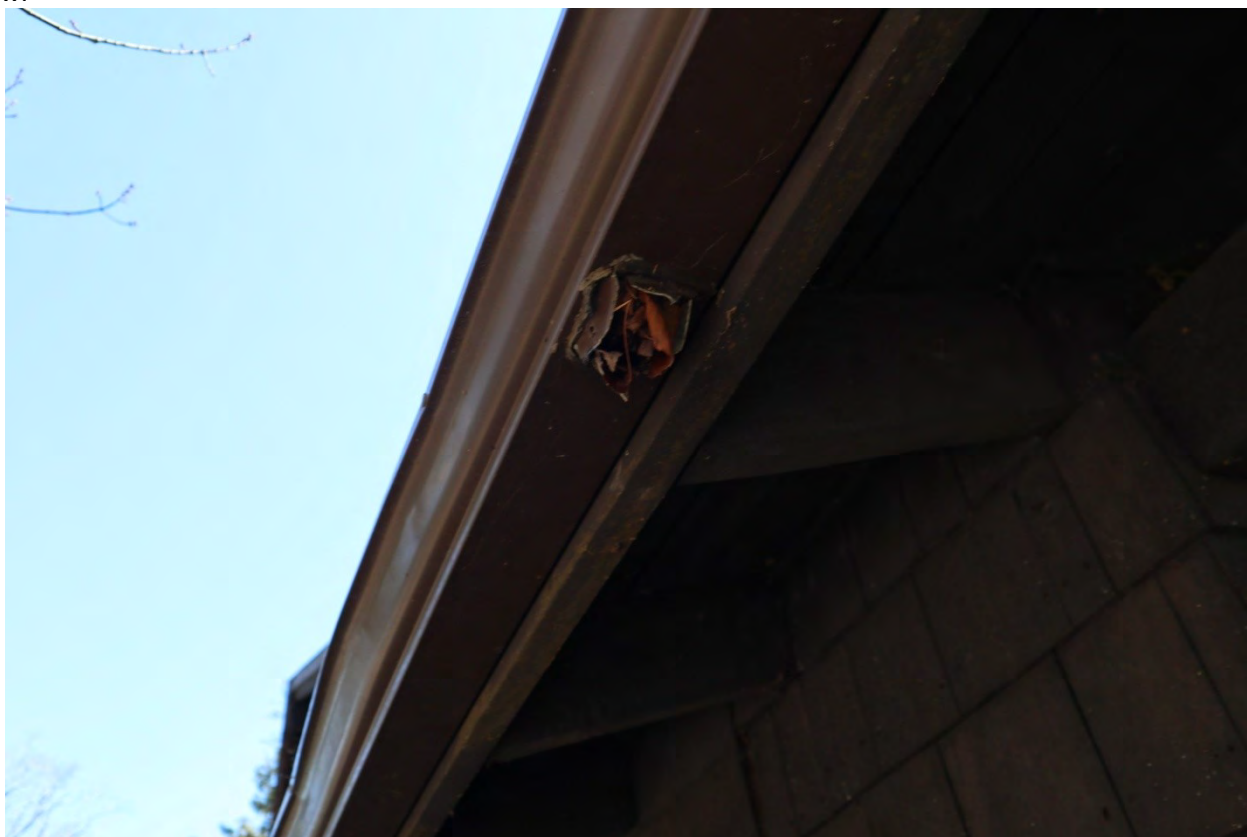
3) The gutters and downspouts were another item in very bad condition. See sample of damages in photograph below.

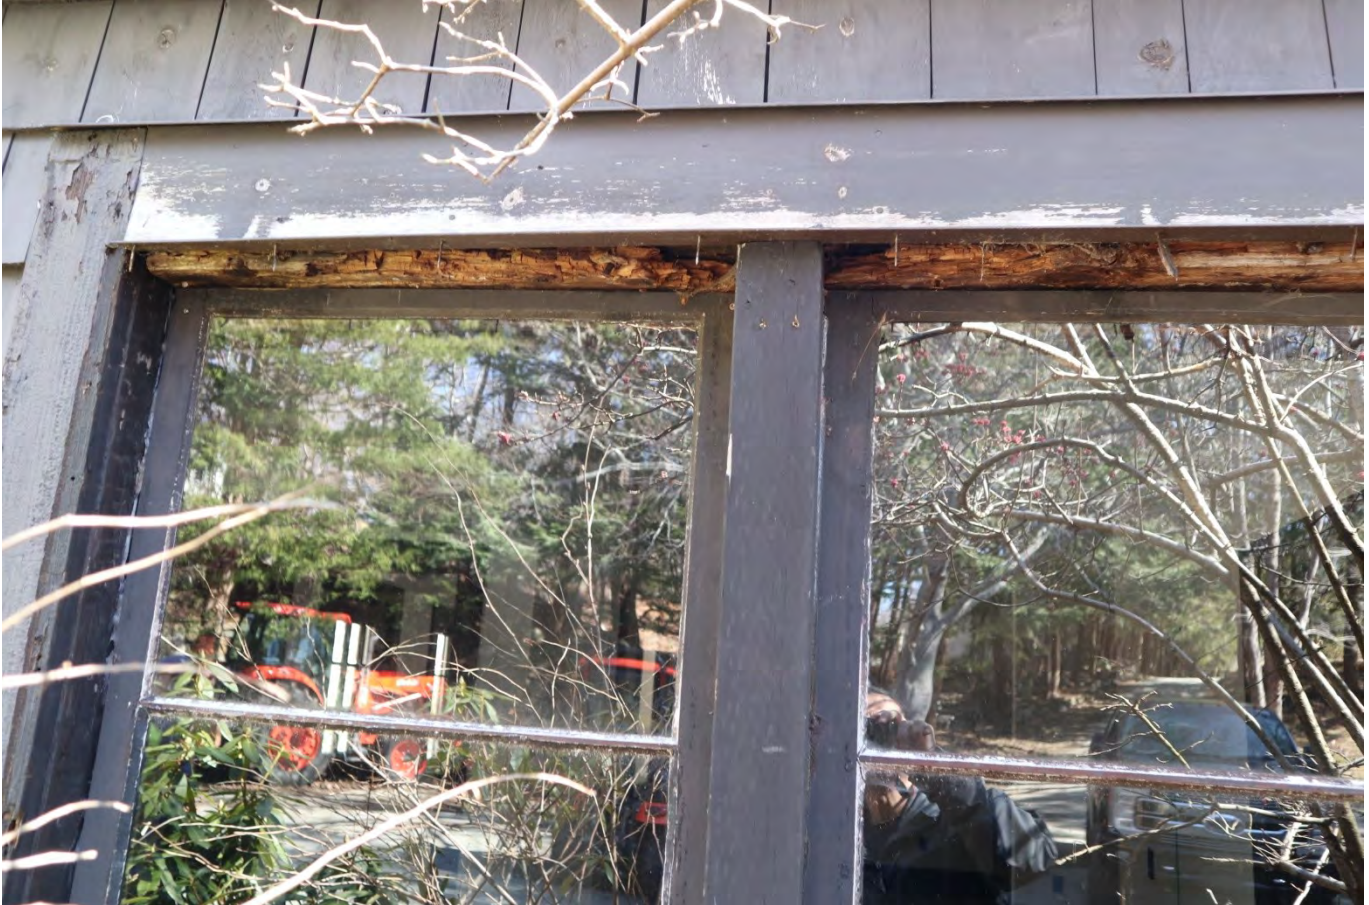
4) Another item of major concern was the rotting of the siding, windows, etc. around the building. The amount of rot varied as you inspected around the building, but most is considered as severe. This probably was effected by the direction of the most severe weather. In a variety of locations the rot is to an extreme, and must be considered as a severe problem which must be fixed. See a sample of this in the photograph below.

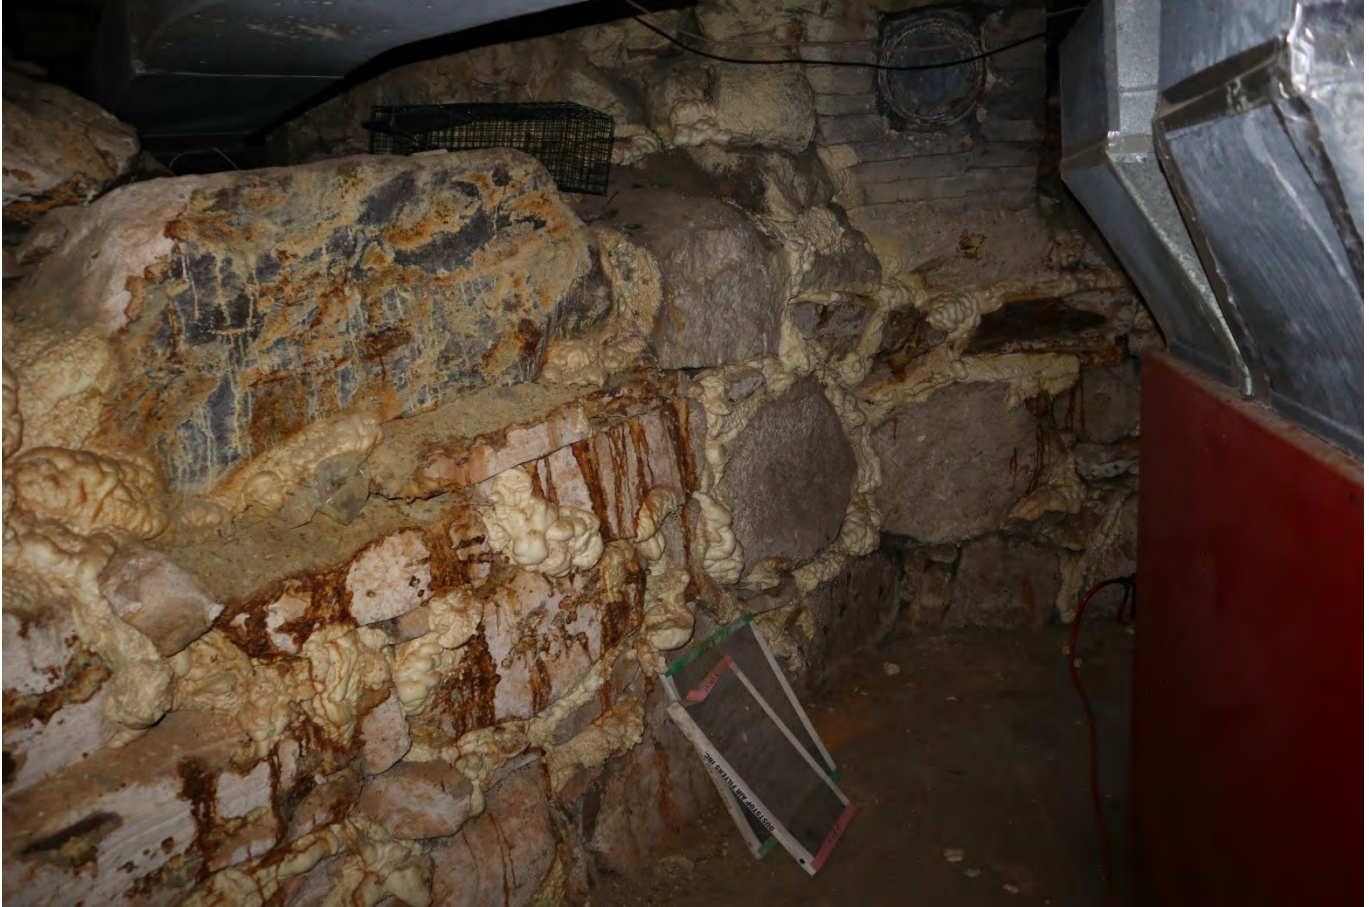
As can be seen in the photograph below, there are water stains all over the rock foundation. One can see as to how deep and clear this staining has become. This is a sign of the fact that this has been an ongoing problem extended over the life of the building.

Water entering the building can and has done a lot of damage to electrical wiring and mechanical equipment. There is visible evidence of rot on post and beams within the basement area. Earlier it was pointed out the condition of the exterior of the wood wall to top of these foundations. Basically everything which is in contact with the ground or these rock wall has rot and mold on it to some degree.

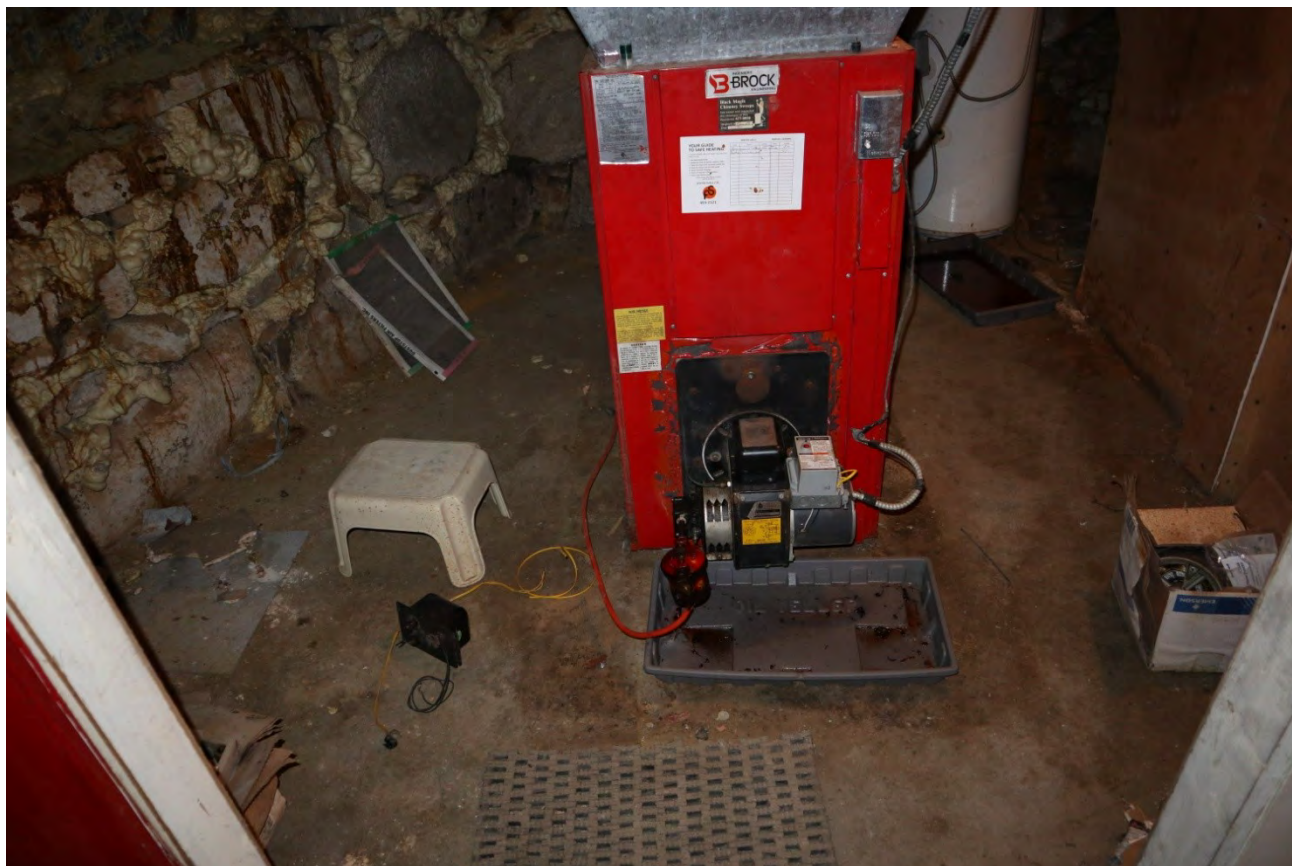
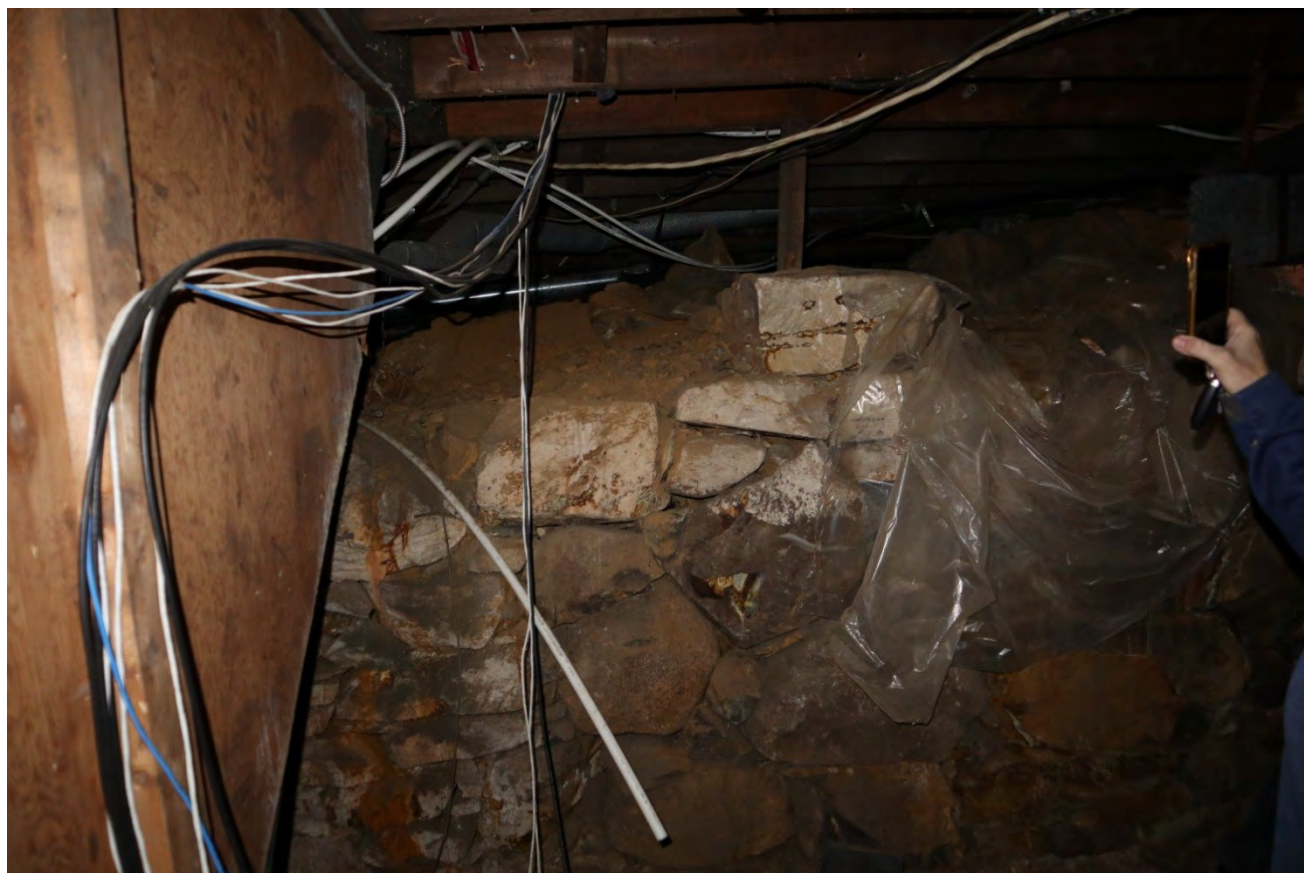
See in the photograph below, a sample of what moisture in the basement has done to the furnace for the building. The rust and corrosion are very evident all over the unit. It is unknown as to what the present operational condition is for this unit.

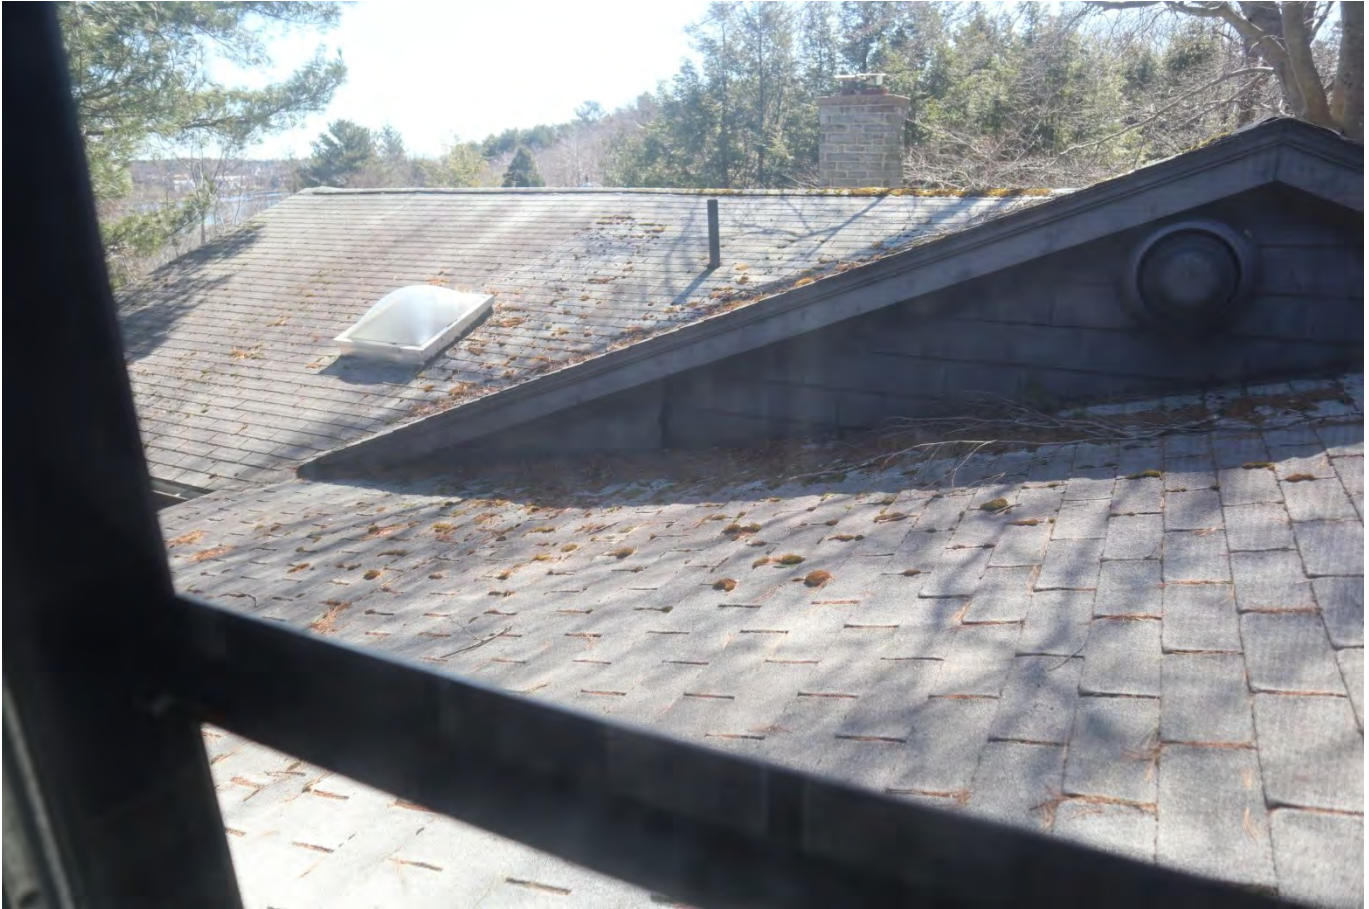
From the upper level window, one can look down over a lower roof area. This roof has what appears to be basic shingle on it. However, as can be seen in the photograph below, the roof appears to have very little slope, thus the water does not run off of it properly. This could be the cause of some of the water leaks, and should be addressed,

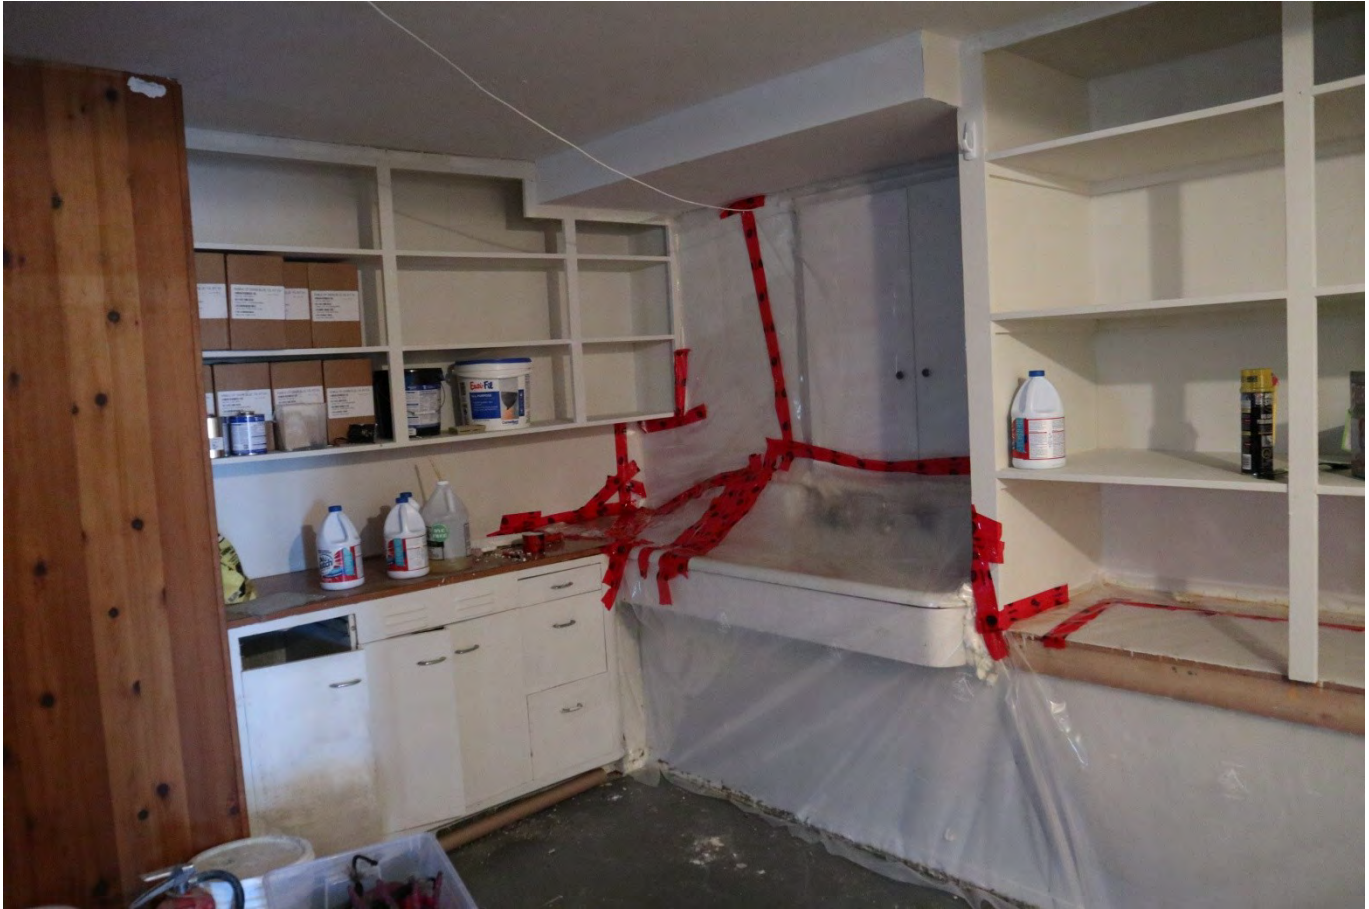
The smell could also have been flowing from the older section of the building, through the wall systems. In one area, there was plastic sheets placed as a barrier between the older and this newer section. In questioning the reasoning for the plastic covering, I was informed that this was to minimize the smell of mold and mildew coming through the dividing walls. Please see sample of this in the photograph below.

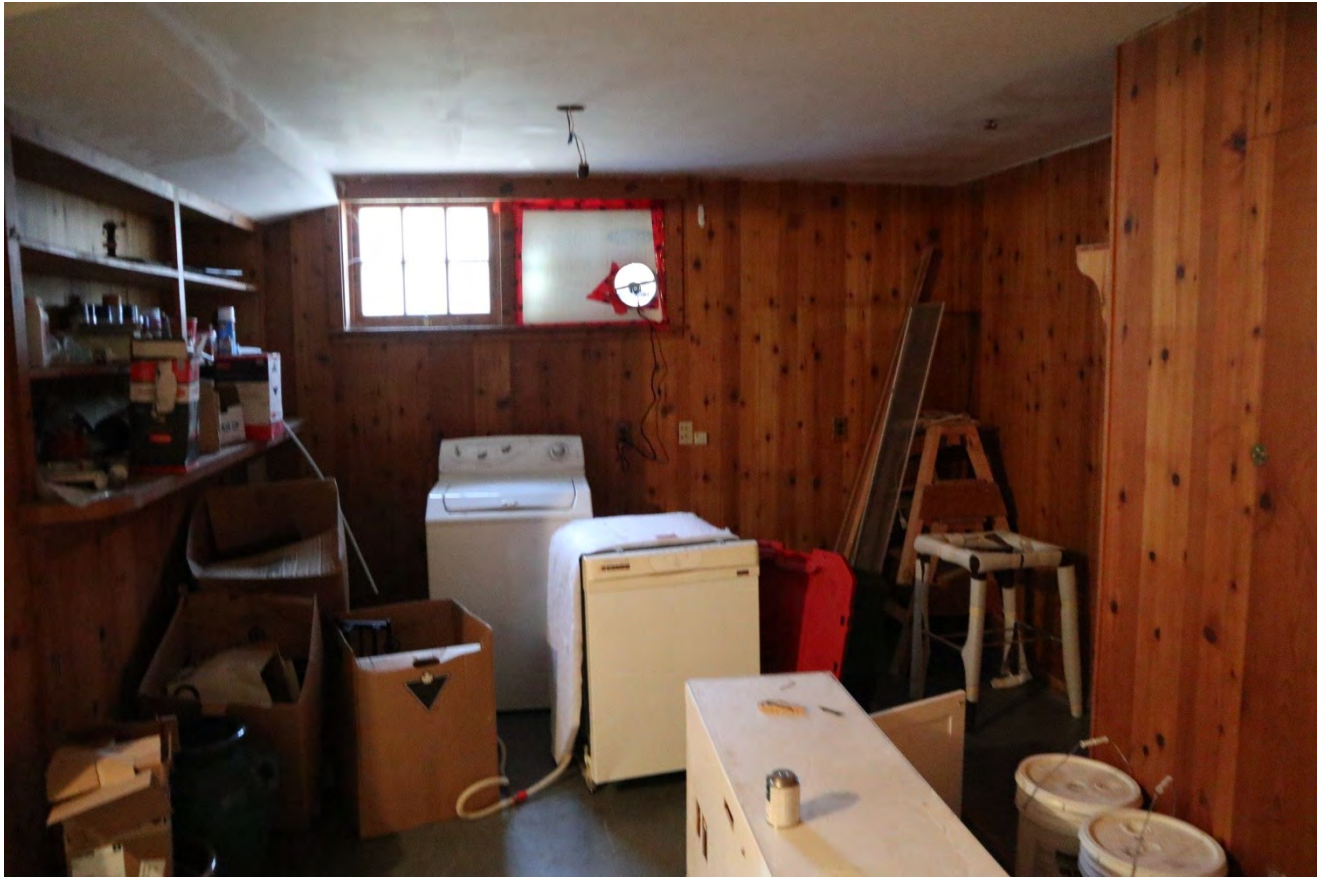
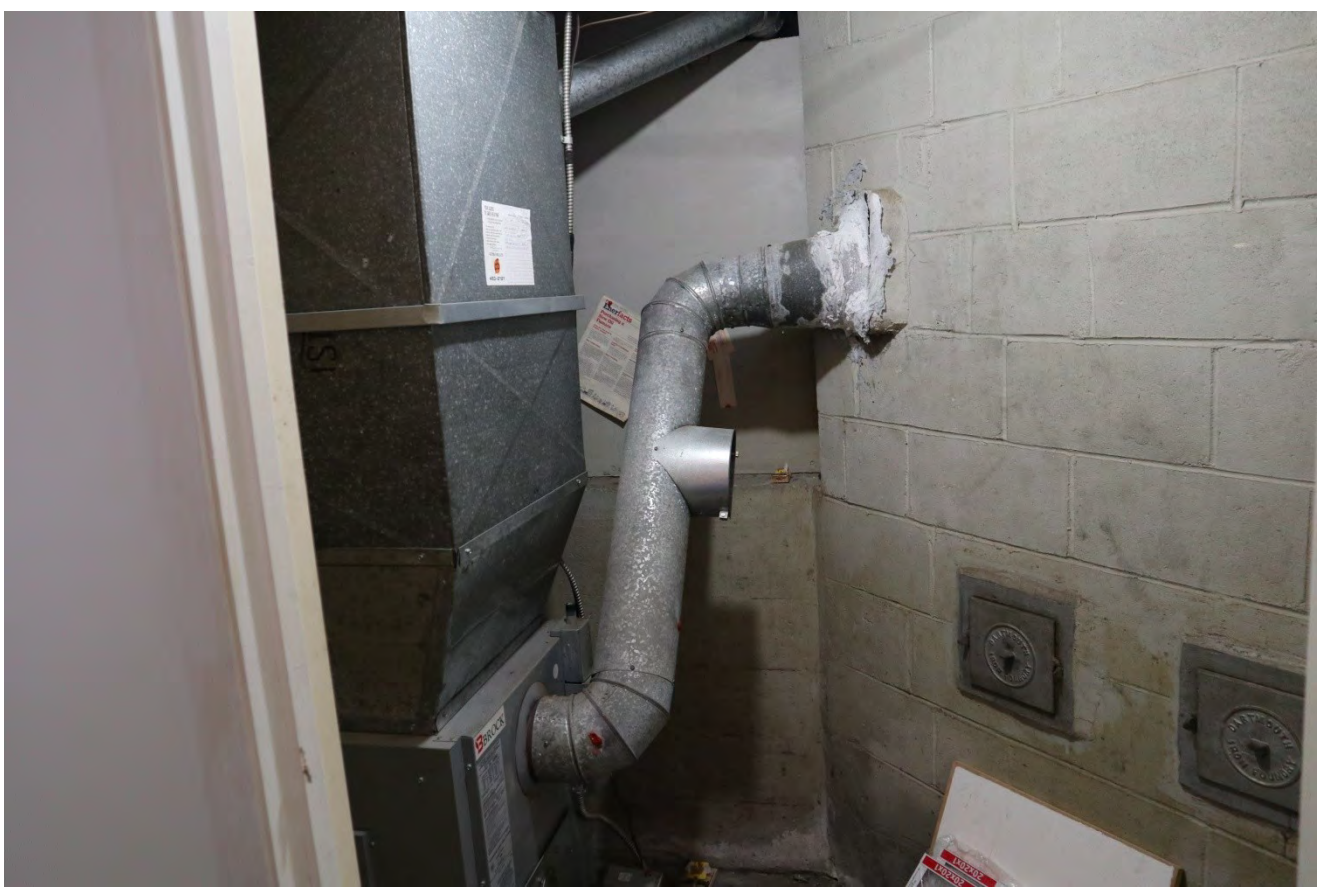
In the photograph below, you can see some of the resulting effect of the lack of heat over the years, and the present dampness in the basement. The ceiling looks to be blackened along the wall area.

In the second photograph below taken of the furnace room wall, the evidence of mold and mildew is very apparent. Please view the lower half of the concrete block wall.

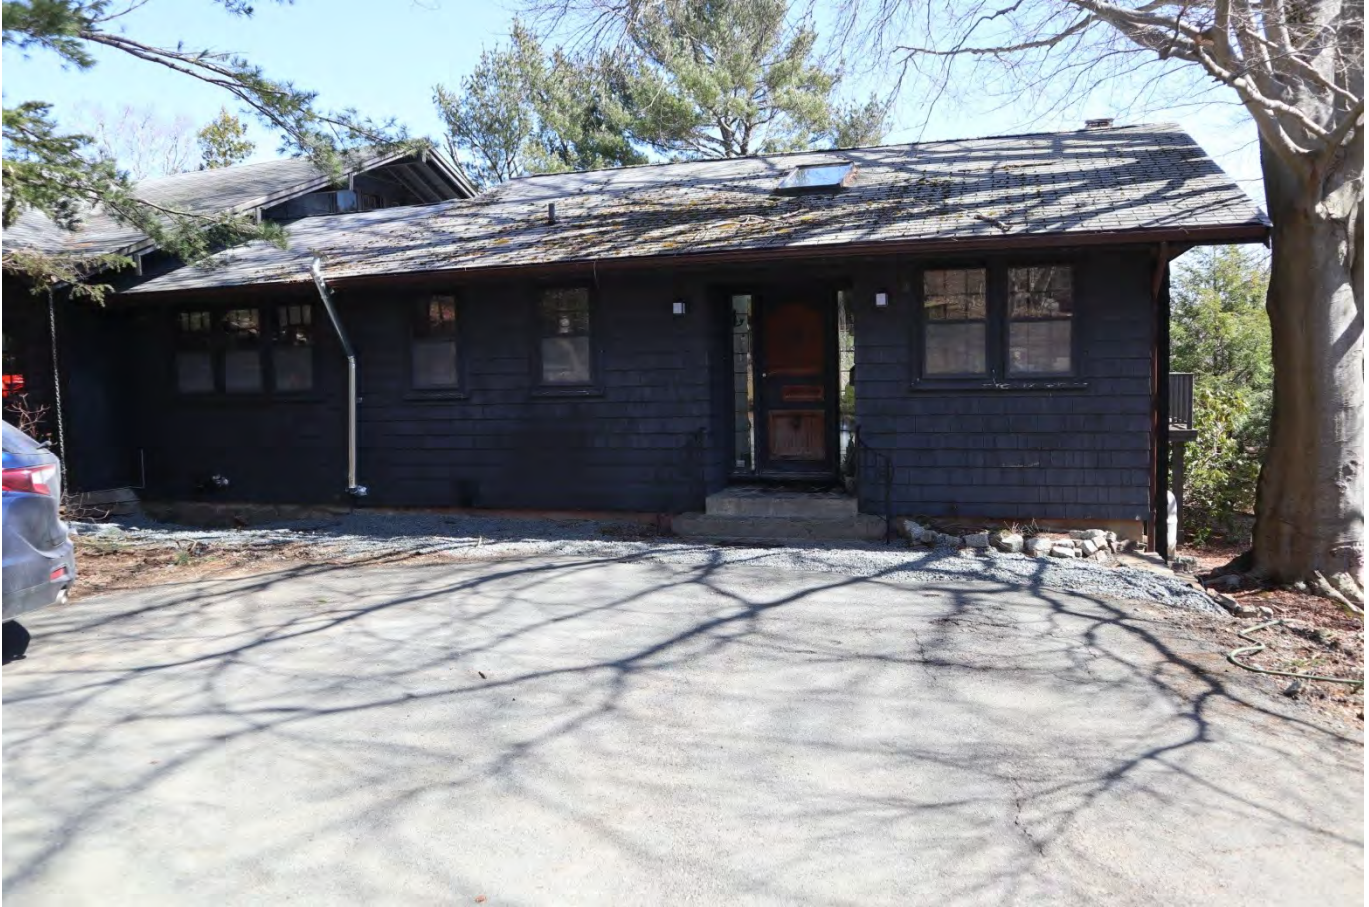
The exterior of the addition was very similar to that of the original house in terms of construction and condition. Please see the front side of this section below.

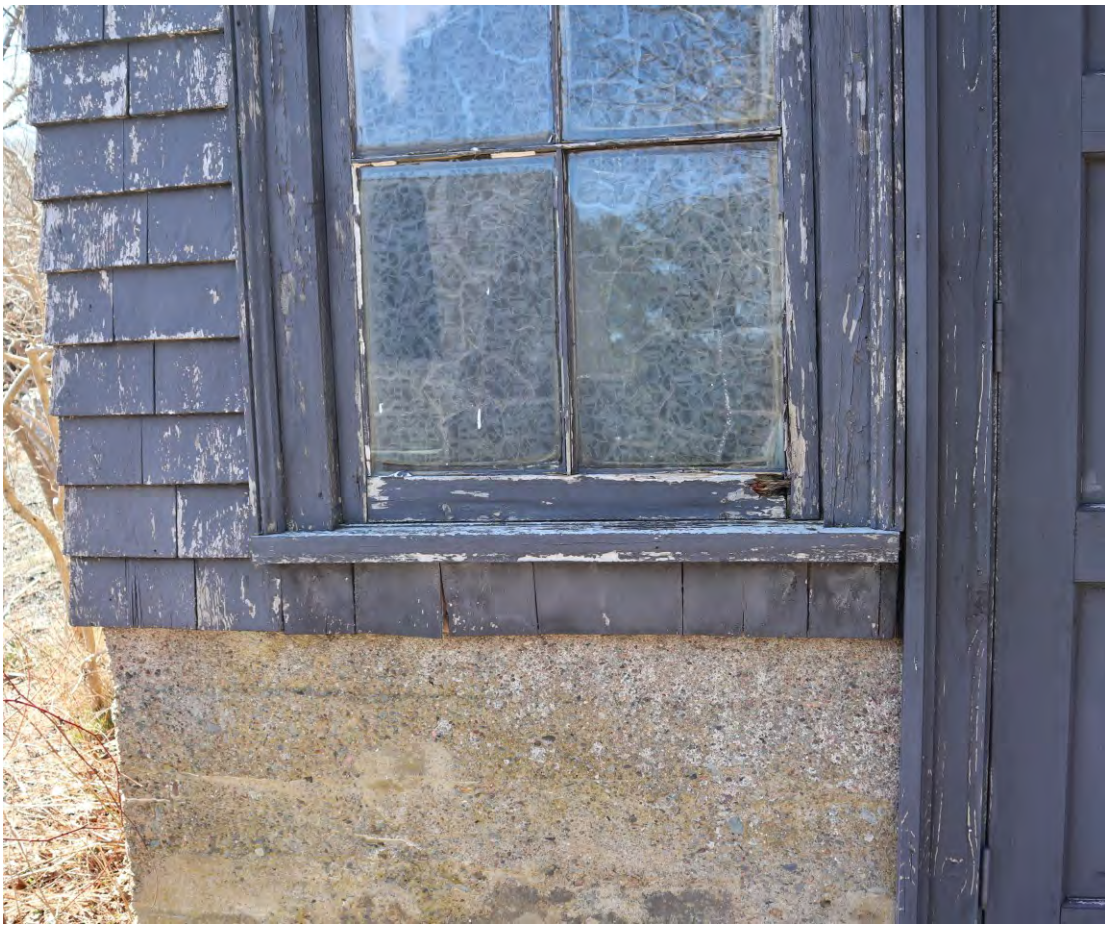
Some of the window frame openings have a storm window on the exterior. These are on the upper level of the building (main). See the second photograph below. As can be seen, this storm window is totally rusted, and the bottom pane of glass is smashed out.

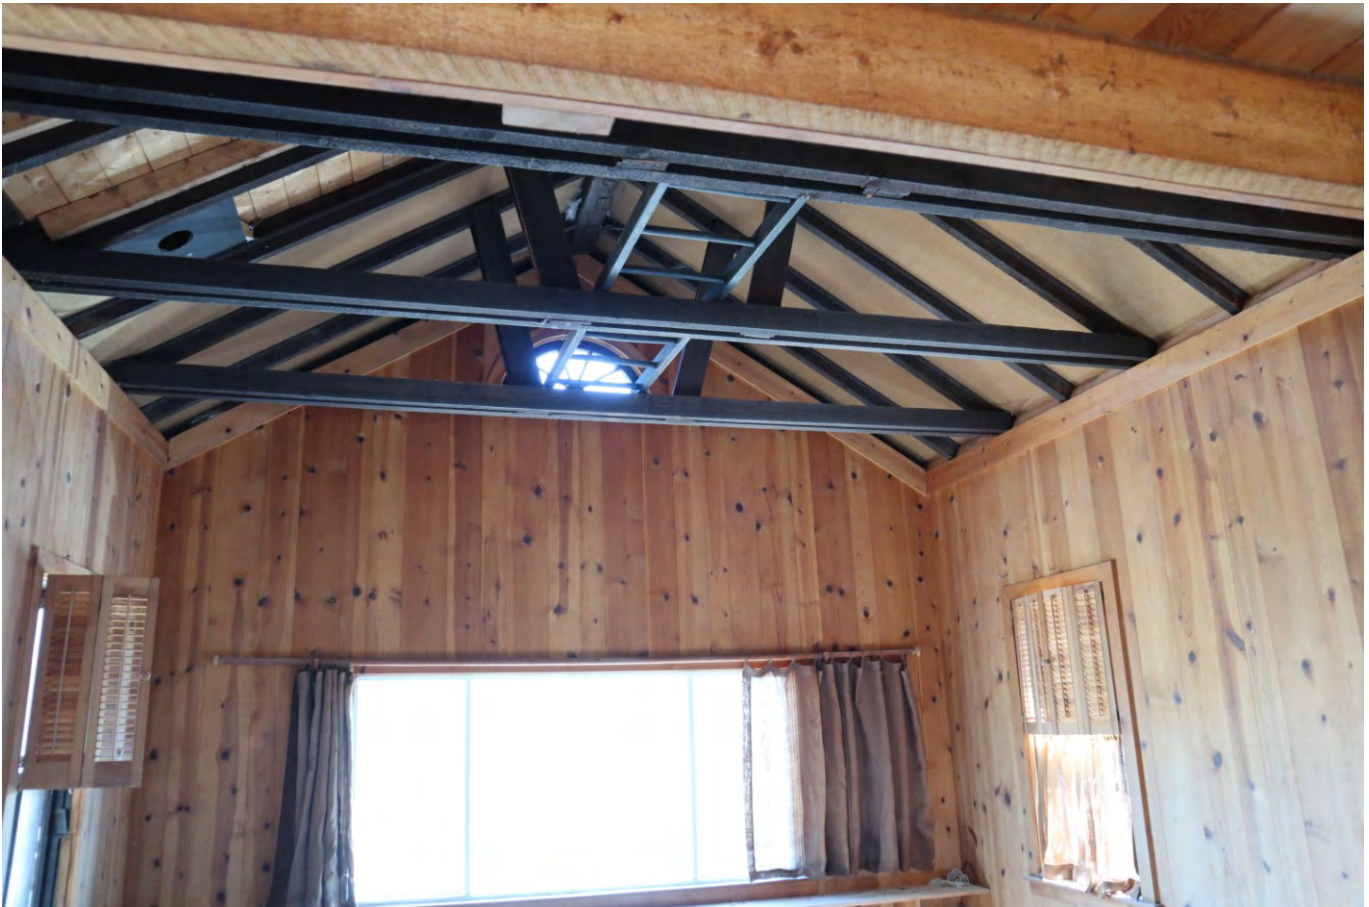
In general, the main floor of this building appears to be in relatively good conditions. See the photograph below.

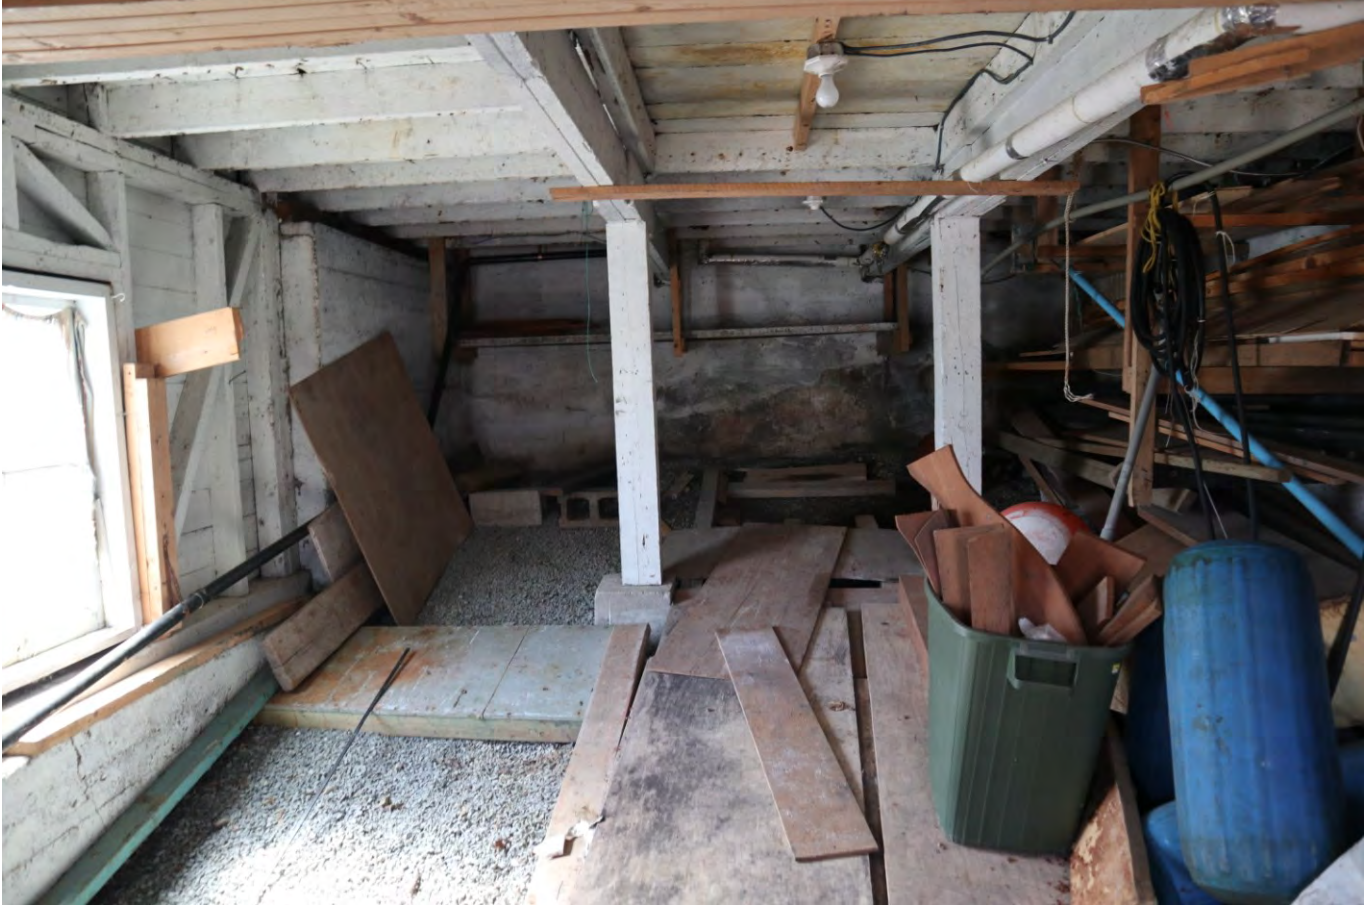
3) The ceiling of the basement area (main level floor) had several structural issues if this building is to have a residential occupancy classification. The floor joist system is not constructed strong enough to meet a residential occupancy loading, and there is a large number of floor joists which are presently resting on nailed edges. This does not meet present day codes, and all will require the addition of joist hangers to support them. Please see a view of the crawl space below.

As can be seen in this photograph, the crawl space has a sloped gravel and rock surface. There is a section of floor above, which is supported with a 2" x 4" joist (not strong enough), and one can see the color change on the back foundation wall due to the penetration of water through, over, and under this wall.
