**Item No. 15.7.1**  
**Halifax Regional Council**  
**August 22, 2023**

**DATE:** July 26, 2023

**SUBJECT:** **Case H00528: Substantial Alteration to the municipally registered heritage property at 10 Kirk Road, Halifax**

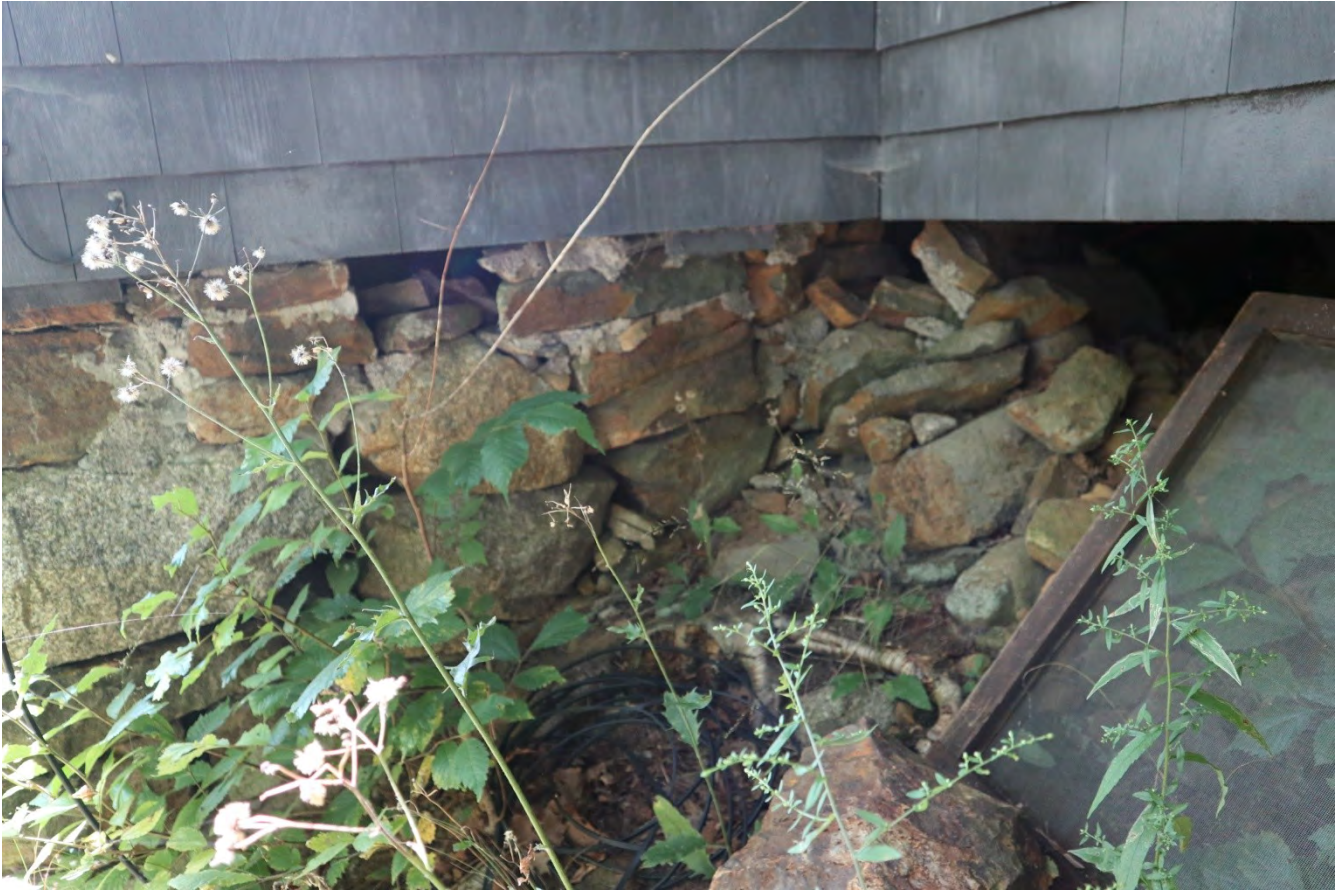
3) **The visible foundation** around the building is virtually non-existent around the exterior. See photographs below.

As is obvious in these photographs, what is there would no longer qualify as a secure foundation. It is now more along the line of a building being supported by piles of rock. There is one corner of the building which is actually supported by a few stacked concrete blocks. This is clearly shown in the photograph on the previous page.
