December 13, 2024

Shoreham Development Limited

Subject: **1226 Cole Harbour Road, Cole Harbour, NS**
Water Feature Assessment
Englobe reference: 2409710.000

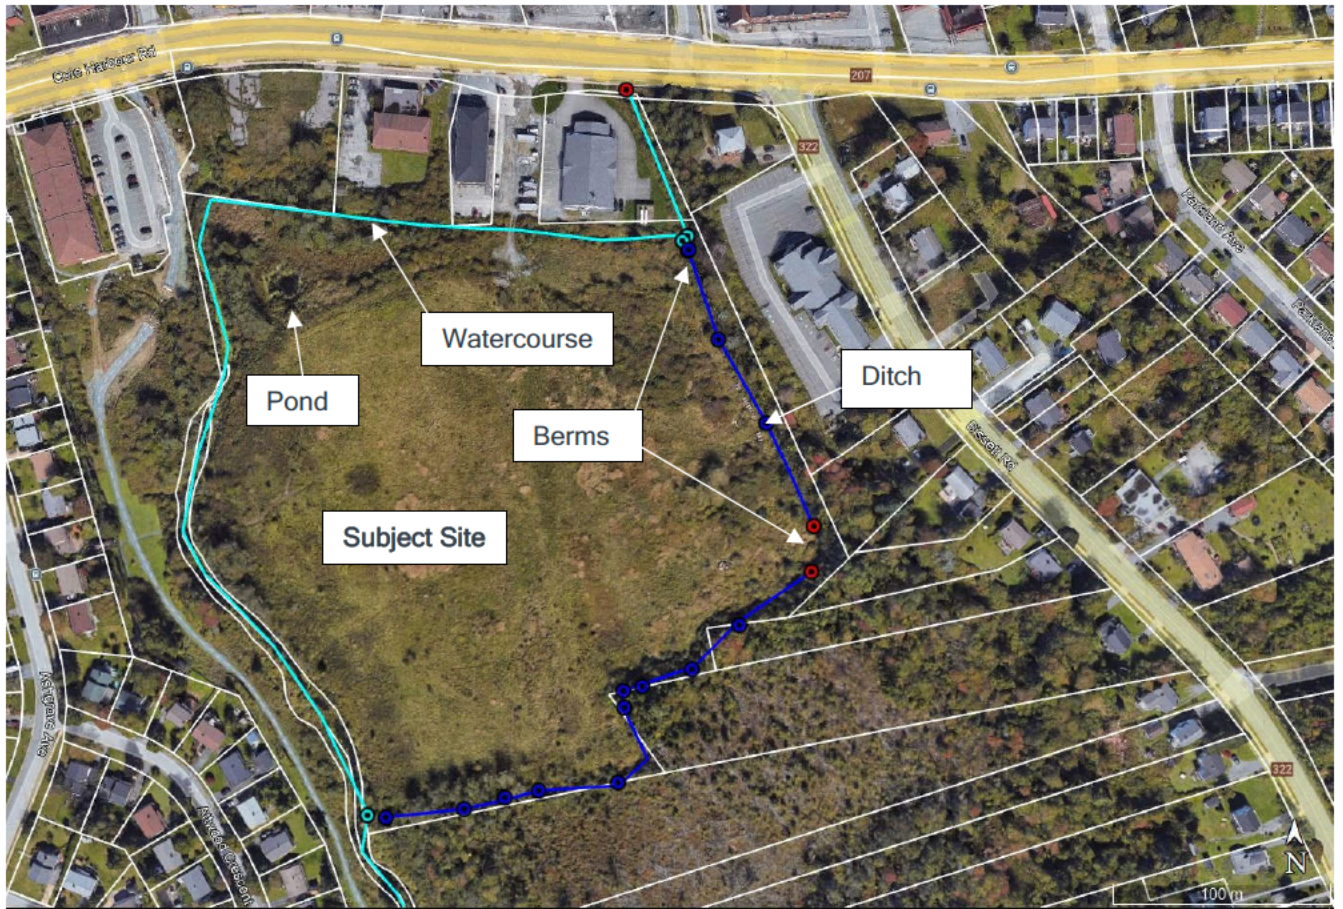
During the field assessment, there was a watercourse observed that entered from the north and extended along the north and west sides of PID No. 00403014. On the east and south side, the water feature appeared to be an artificially excavated ditch with a mucky bottom and stagnant water throughout. It was separated from the adjacent watercourse in the northeast corner of the property by a 0.6 m high berm. In the eastern corner of the property, the ditch was also completely disconnected from the rest of the more southern ditching by another 1 m high berm. The water feature along the eastern and southern property boundary appeared to be a man-made ditch, used to provide a place for on-site surface water to discharge. There were no pools, riffles nor rapids observed. A site figure including GPS points is included below.

After gathering information from desktop resources and in-person site visits, In Englobe's opinion, the water feature on the east and south side of PID No. 00403014 is not a watercourse and does not require any buffers or permits to alter.
