Heritage Impact Statement

Former St. John the Baptist Church, 1102 Purcells Cove Road

Halifax, June 2025

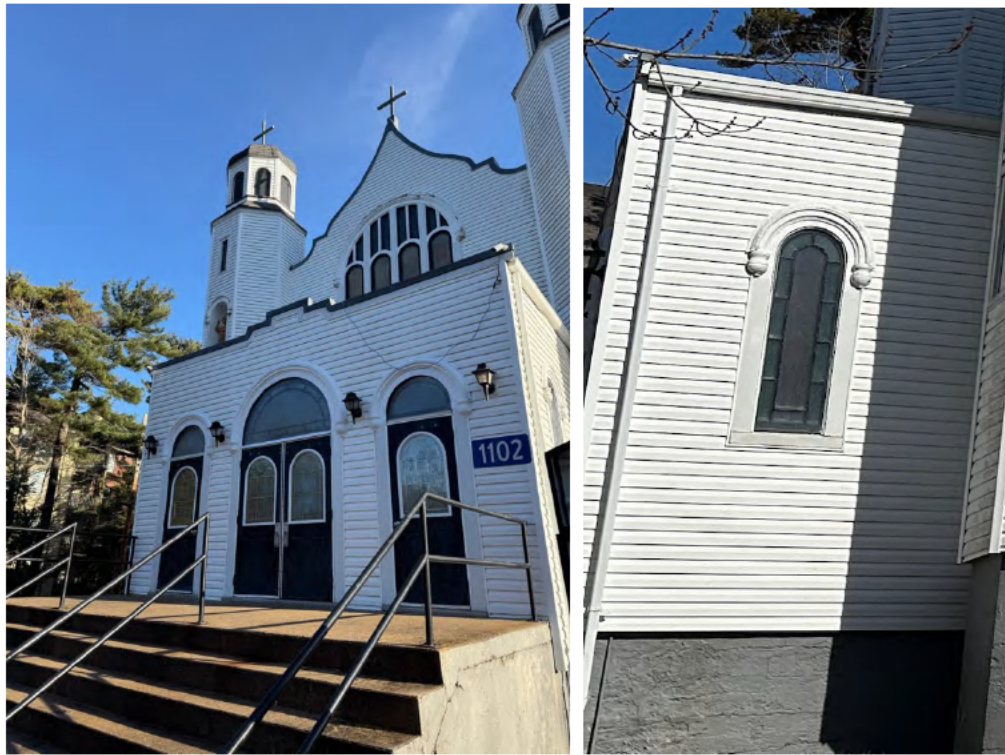
On the front, there is a larger entry vestibule added which changed the appearance of that face of the ground floor (Figure 22).

Figure 22: Entrance enclosure of front of church and side window detail

With the removal of the front addition and restoration of the entry, the components that were relocated earlier, comprising the door frames, transoms and narrow “sidelight” windows (currently facing north and south) and their surrounds, will be conserved and reinstated in their original locations. (It should be noted that the current entry doors are not original and therefore are not character-defining elements.) The former church will remain accessible with a new use of the interior space. The new use of the interior of the former church will not result in any alteration to the remaining character-defining elements.

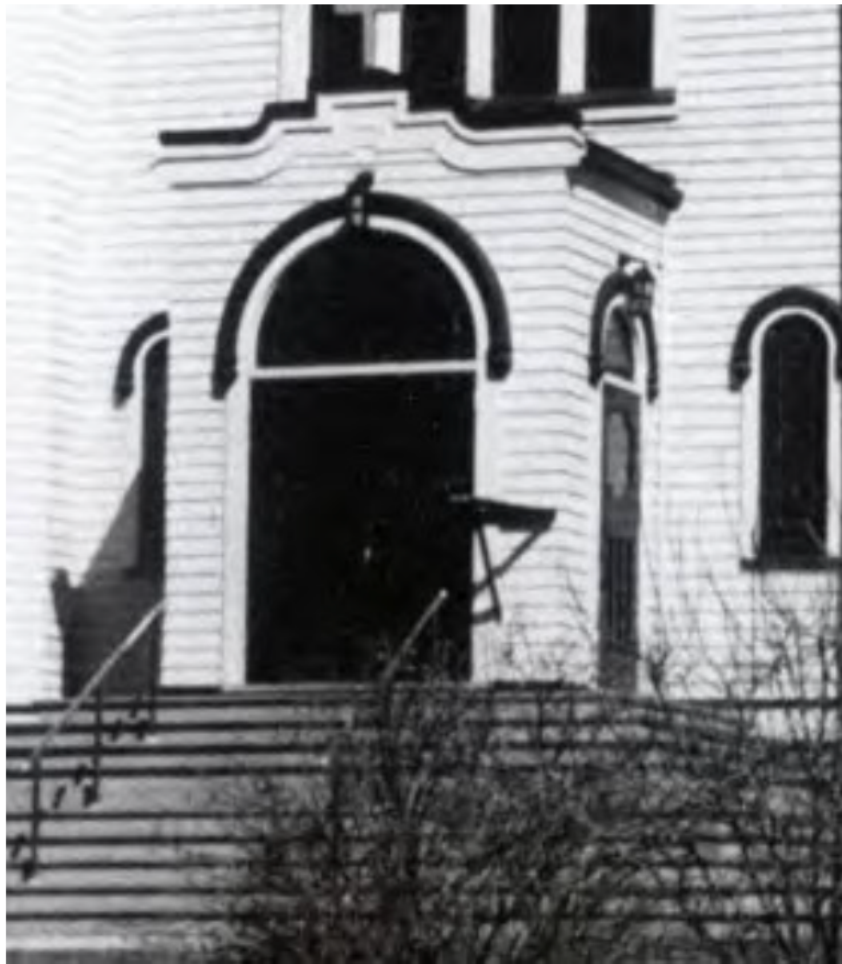
Figure 23: Original modest entry at the front with the doors reset on the newer front wall face which appear to be replacements based on glazing pattern (1954)

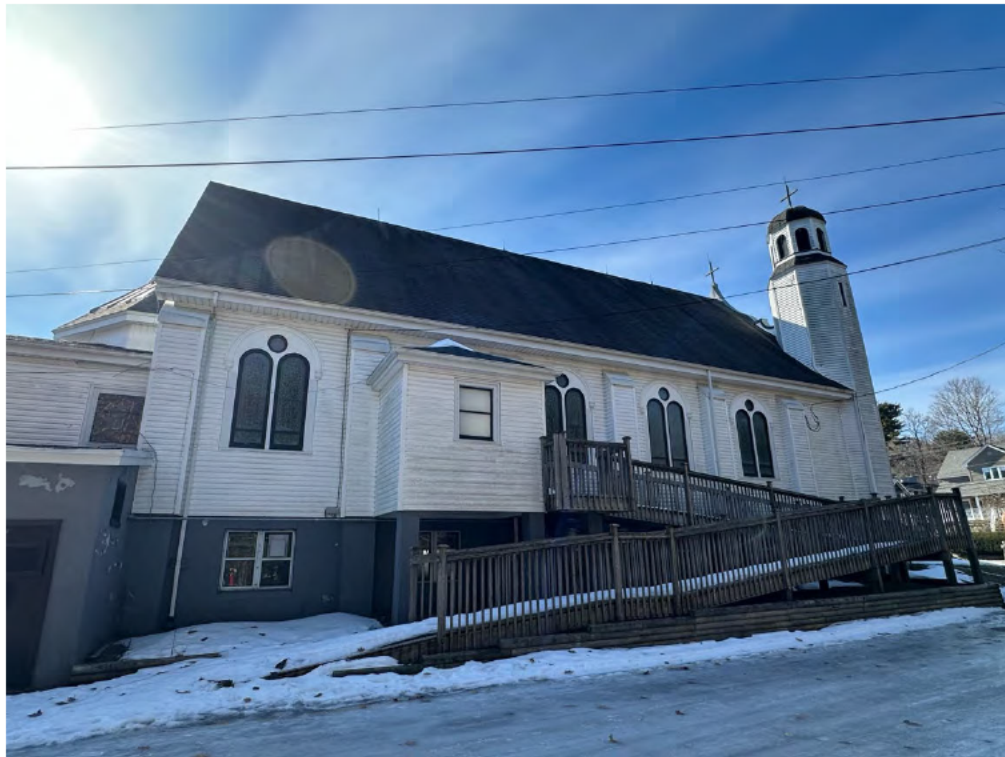
Figure 25a: Access ramp and entry bay on the north side

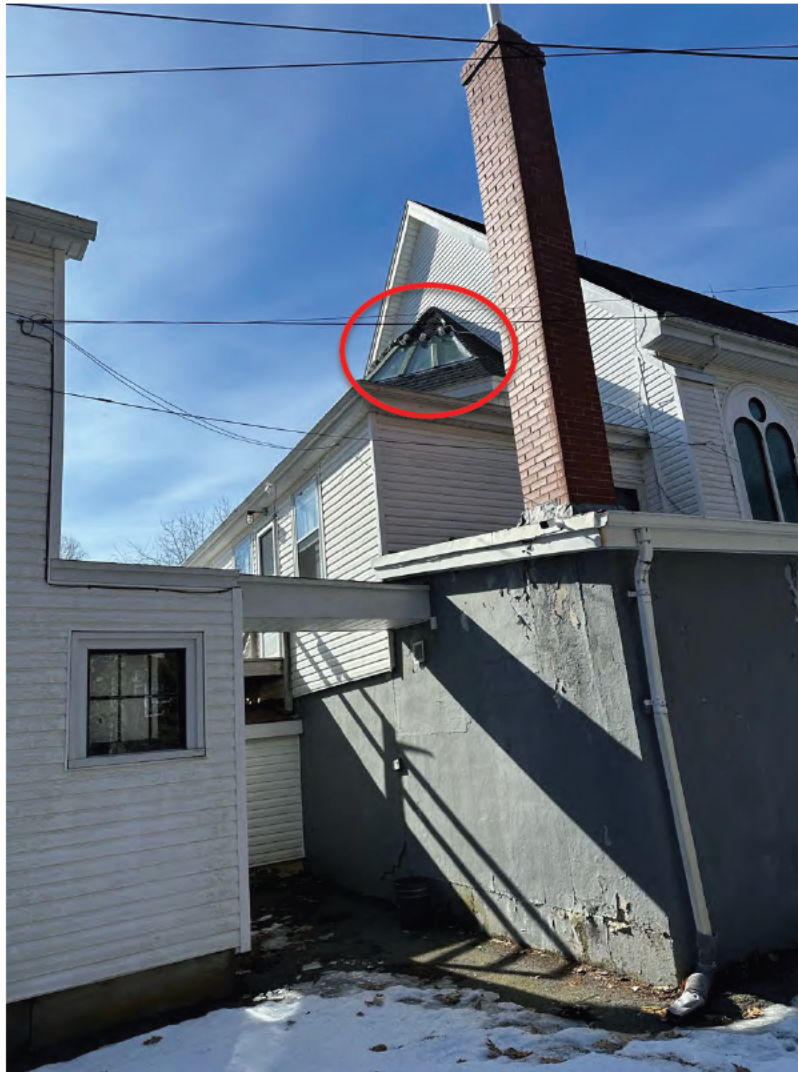
At the rear, the original bay that would have housed the altar area was enlarged. However, the structure of that bay is still evident, extending out from the roof of the newer enlargement (Figure 25).

Figure 25b: Rear additions to church with original bay still evident, seen from north side
