Heritage Impact Statement

St. Mark's Church, 5522 Russell Street, Halifax

Updated June 2024

MCLEAN HERITAGE

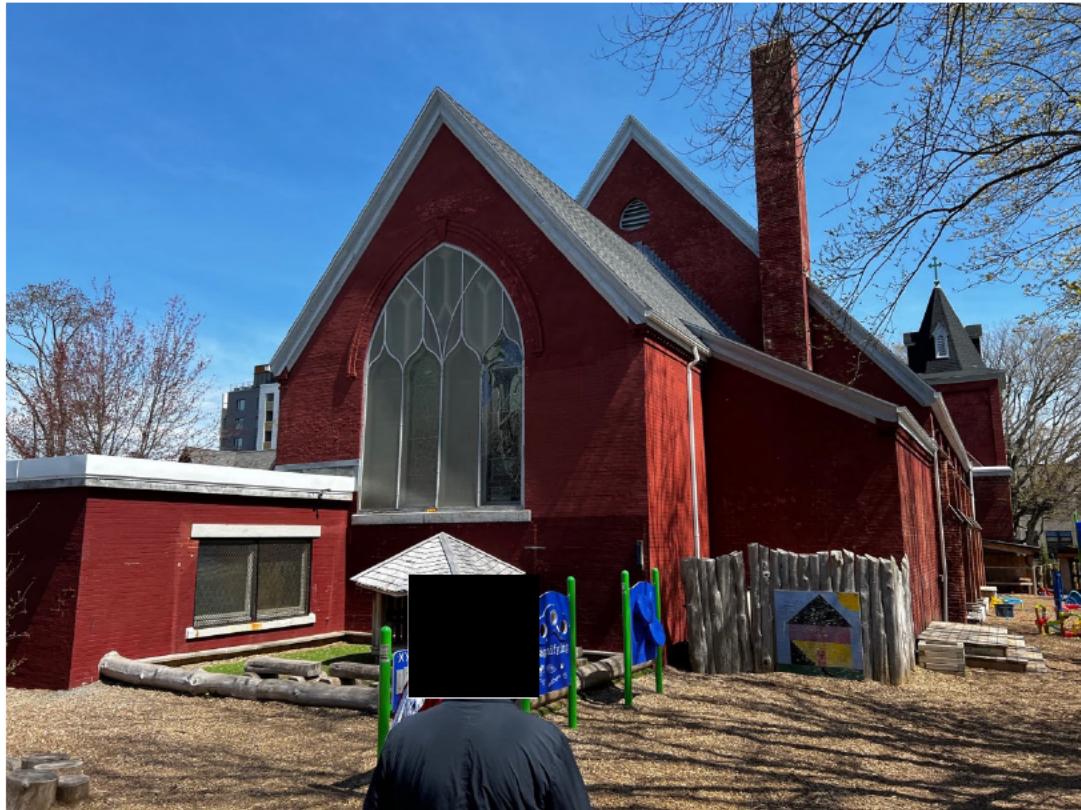
The north side includes a one-storey addition made in 1960, that expresses the evolution of the church over time. The rear has also been affected by this alteration, as it covers not only the north side but also a limited section of the rear (Figure 30d).

Figure 30d: Rear, 5522 Russell Street

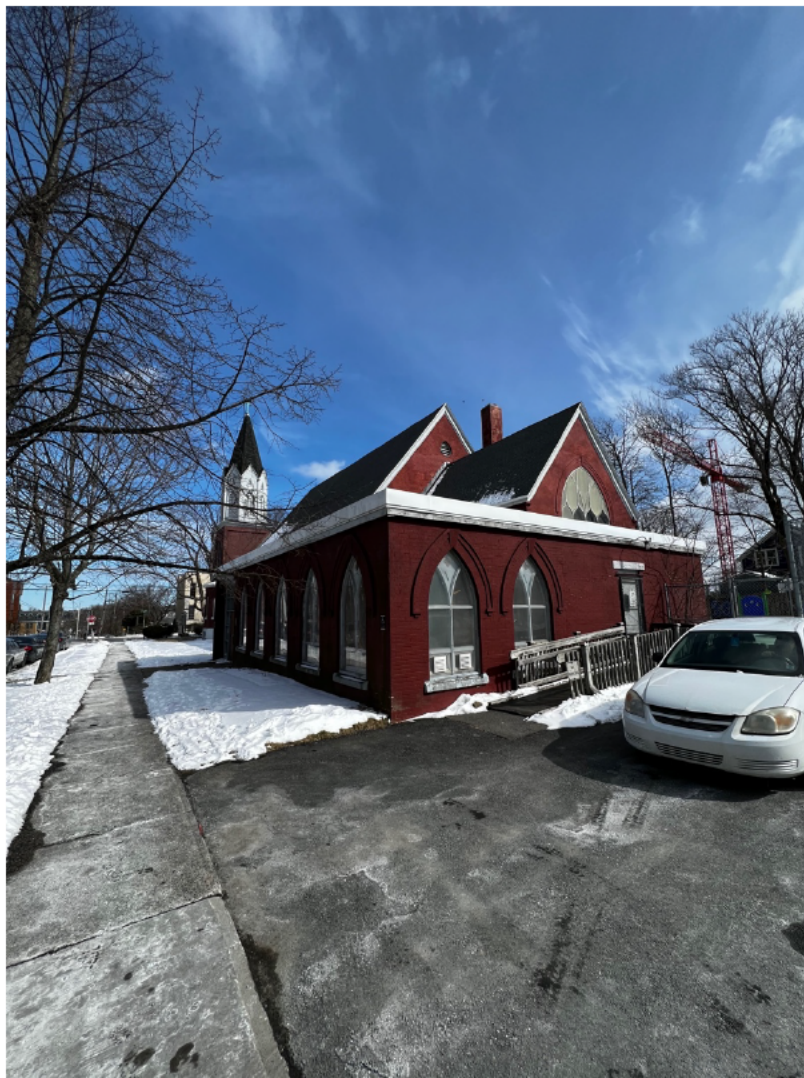
Figure 31a: Single-storey addition on the north side of 5522 Russell Street, as seen from Russell Street

This addition was made in 1960, with plans drawn up by Webber, Harrington and Weld. While it is compatible, with the use of similar colour brick and window openings that follow the other arched-peak form on the early part of the church, it is distinguishable with its flat roof and simple fenestration. This enclosure obscures an original side entry but it does not appear to affect any windows, and it notably does not interfere with the large apse window set at the rear (Figure 31b).

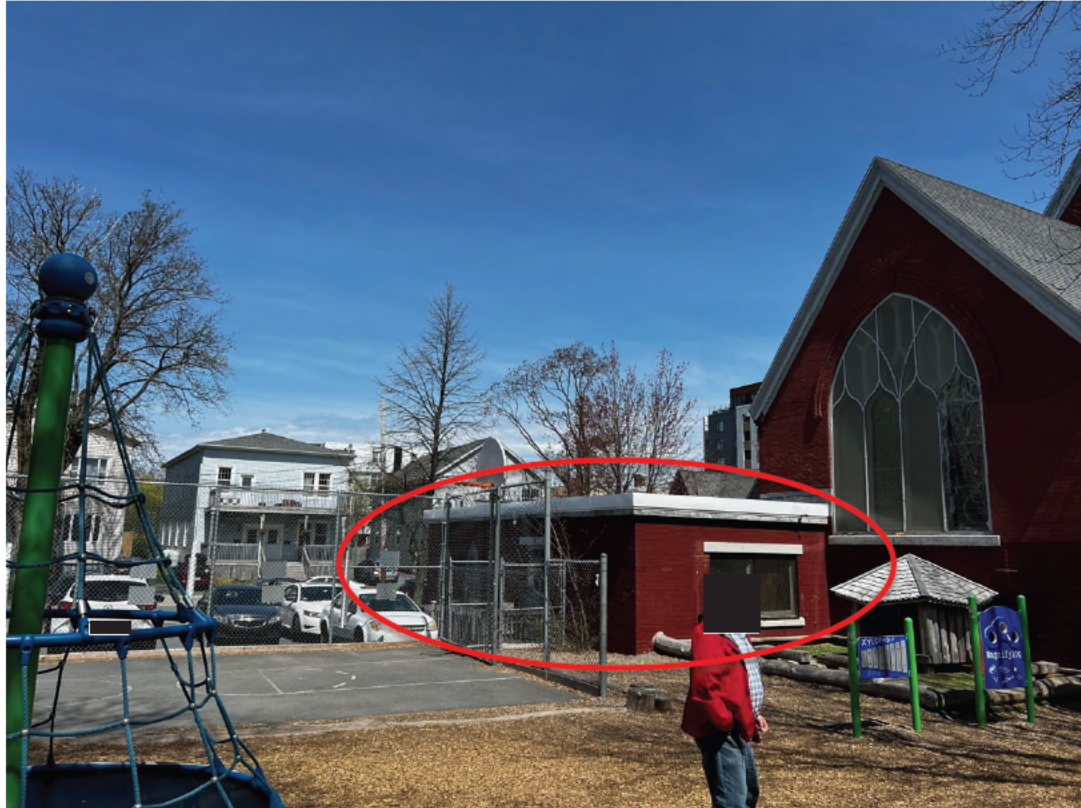
Figure 31b: Single-storey addition on the north side of 5522 Russell Street, seen from the rear and ending at the edge of the apse windows (circled)

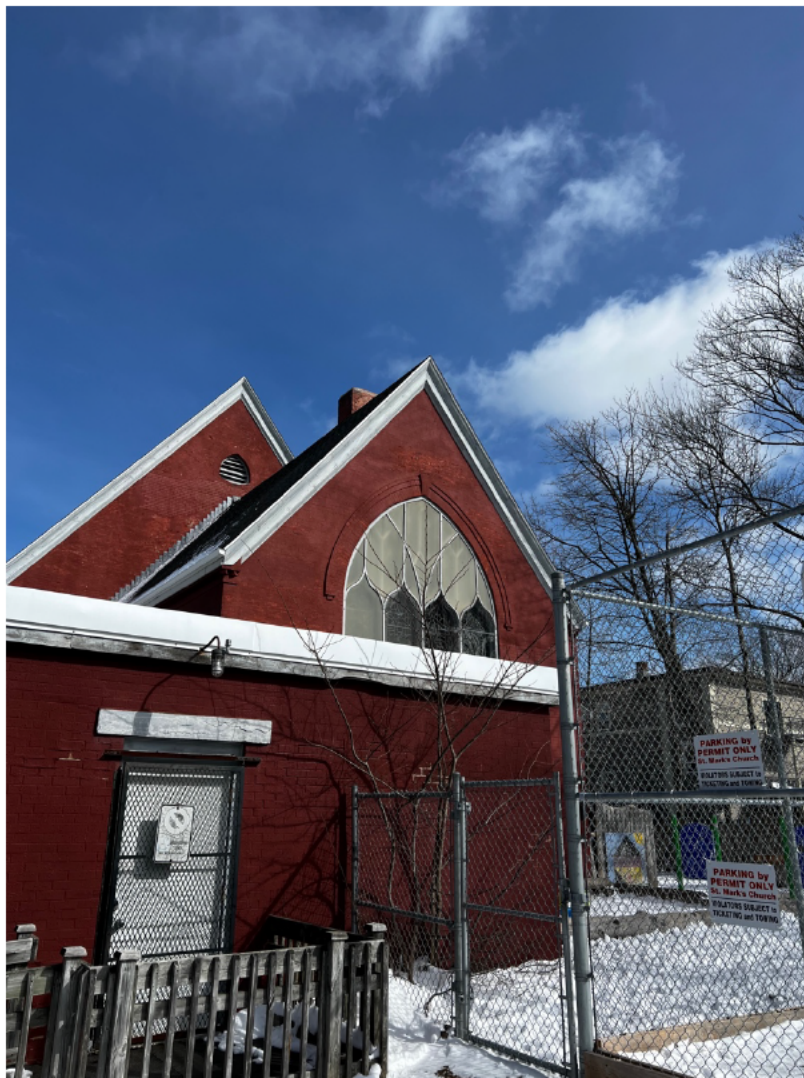
Figure 31c: Single-storey addition wrapping around the west side of 5522 Russell Street, with a single emergency exit door

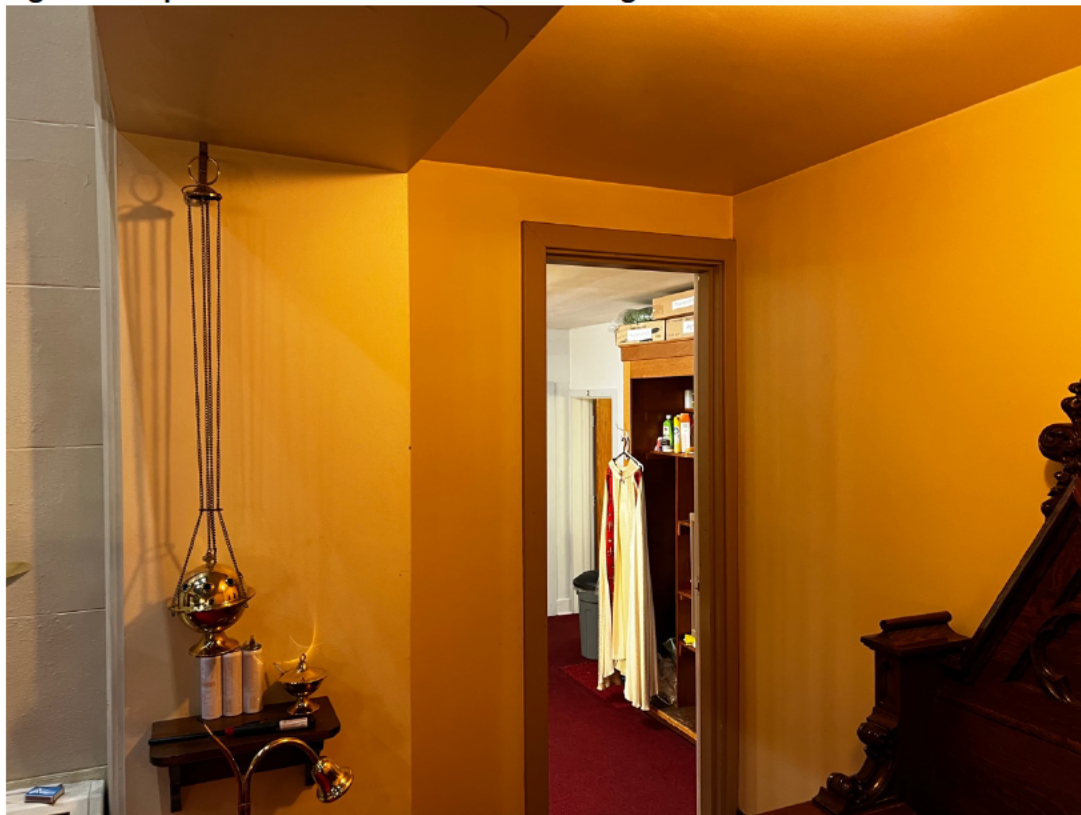
Figure 33: Opening from the apse into a side room

This addition is considered reasonably easy to reverse and it is part of the current DA proposal under review. The question that has not been possible to answer at this time is whether the original material – cladding and possibly a window or set of windows – remains behind the addition. Given its relatively low profile, it is not likely that any windows were covered up with this addition, and no evidence was found on the interior of such windows existing.

It is more likely that the material, and particularly the brick cladding, remains intact, and had it been removed it would have been costly to remove and may have compromised some of the structural integrity of the side and rear walls. Investigation will have to be undertaken to verify that the original material remains in place and to determine its condition as the project proceeds.
