53 QUEEN STREET

HERITAGE IMPACT STATEMENT

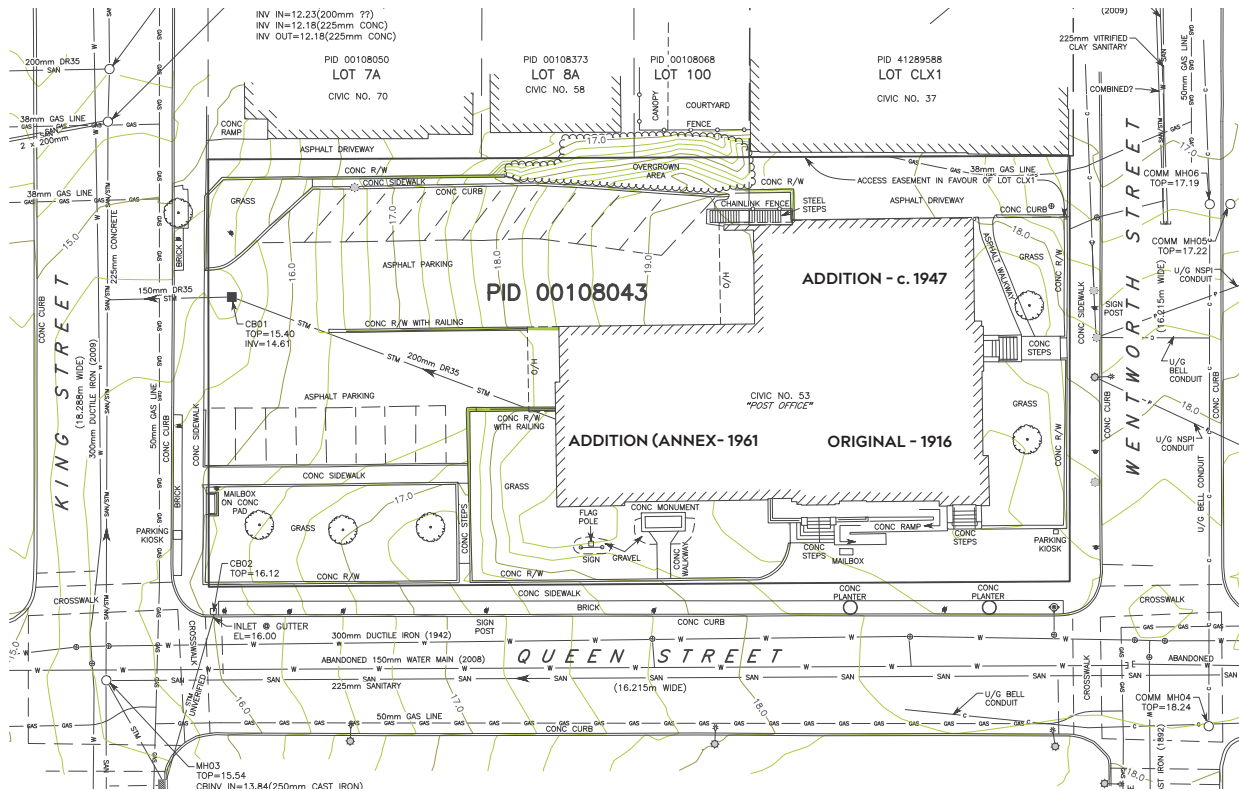
SITE SURVEY OF 53 QUEEN (EXISTING CONDITIONS, 2022)

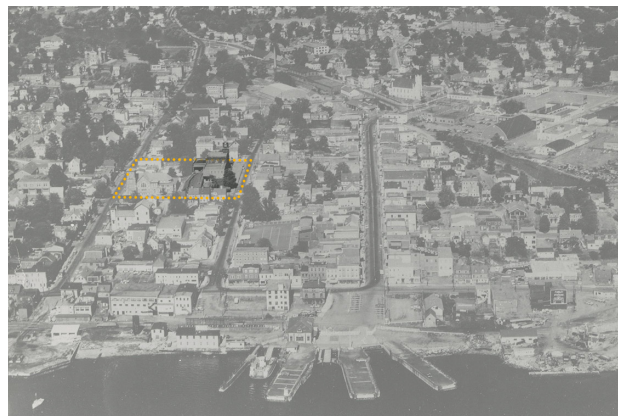
The registered heritage property is currently occupying the northeast half of the site nearest Wentworth Street. The other half of the property along King Street is currently a parking lot. Today, the unoccupied historical post office and parking area provide little public benefit, with the exception of a small grassy area on the southern corner of the site which is frequently used during the summer months. The success of this greenspace was enabled by the historical buildings set back from Queen Street, which in the past would have served as an informal community hub (see Fig. 5). This greenspace is the only active portion of the entire four-sided city block until the retail street of Ochterloney, which is home to a variety of storefronts that include Grace Methodist Church, Battery Park and Two if by Sea cafe.

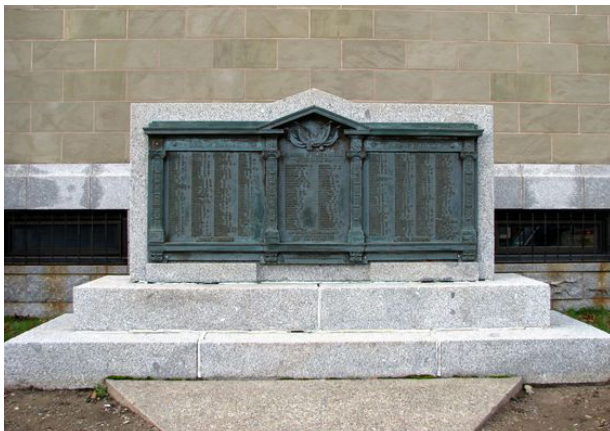
- Existing First World War Memorial to be restored and relocated on site (see Fig. 6).
- New exterior seating and lighting around the War Memorial will highlight its importance. (See drawings and renders).
- The Canada Coat of Arms, herein noted as the ‘Crest’, (see Fig. 7) and the Quaker Meeting House Plaque (see Fig. 8) facing Queen Street will be relocated and reintegrated into the new apartment building vestibule (visible from the street).

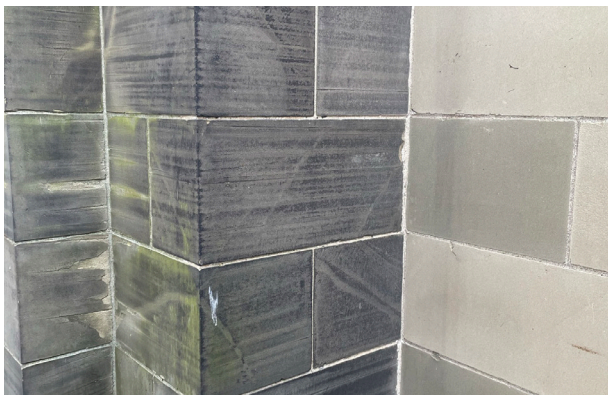
- The existing masonry will be cleaned and repointed. (see Fig. 09)
- The parapet cap flashings will be replaced to match the existing copper.
- Full renovation of the existing entry points to meet the most up to date accessibility standards by way of ramps and barrier free pathways. The existing ramp on the heritage building is too narrow and the current landings do not meet code (see Fig. 10)

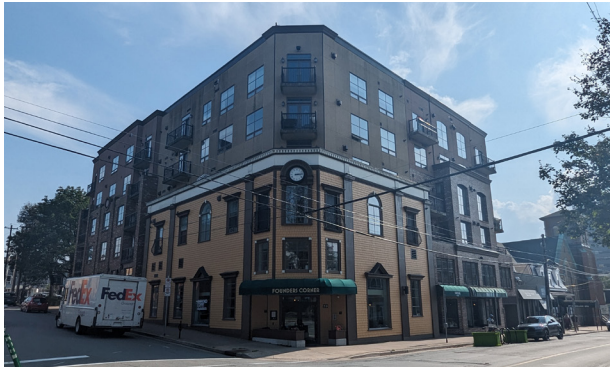
K) 70 OCHTERLONEY ST - FOUNDER'S CORNER (MIXED USE)

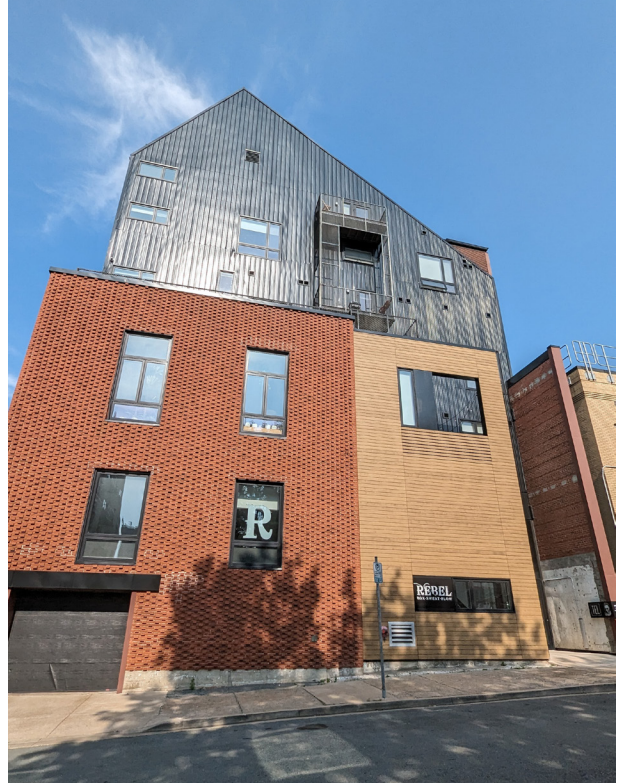
J) 36 WENTWORTH ST - TEL LOFTS (MIXED USE)

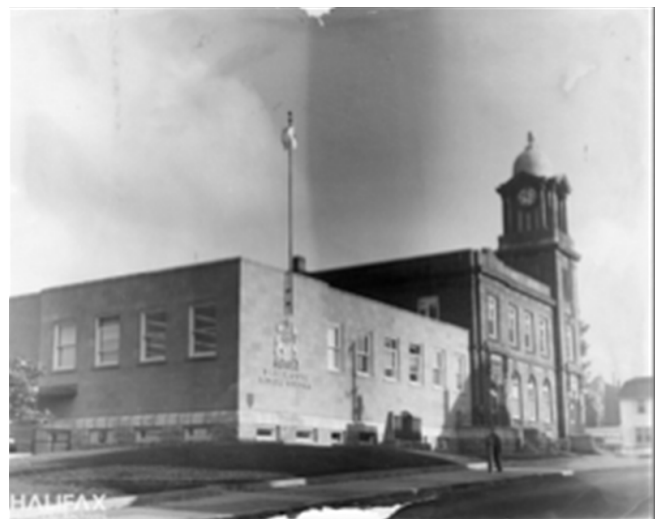
- Another noted element is the clock tower, which was removed after it fell into disrepair in 1977. The team learned of the historical clock tower through additional research and have visited the remaining clock faces that are held in HRM storage. Plans are to restore the clock mechanism and reintegrate the clock into the public space of the new development.

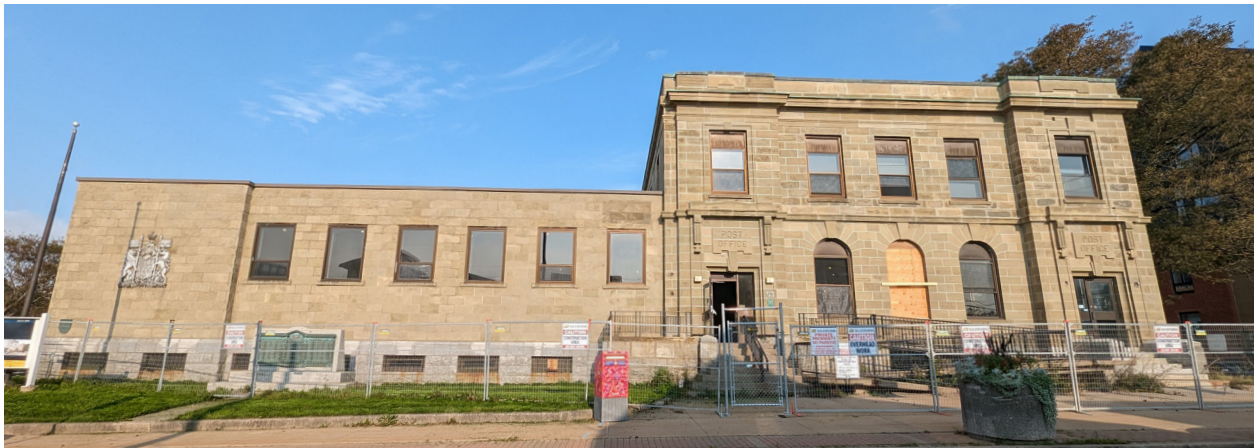
- Extended cornice line which wraps around the building
- The use of a 5-bay symmetrical facade with large voussoirs
- The use of large window sills on the first and second storeys
- A high base made from rusticated granite separated by a brick stringcourse
- The use of brickwork that fans around the first storey windows
- Prominent sandstone "Post Office" signage above inflated keystones (see Fig. 18)
- Moulded lintels and brackets above the entrance
- Masonry granite foundation (see Fig. 19)

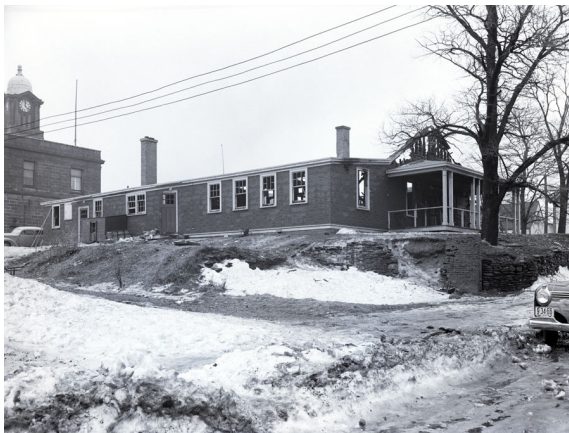
The Dartmouth Post Office once housed the first electric clock in town. It was removed in 1977 due to structural concerns. That section of the building was restructured and architectural detailing, such as the cornice line, was put in place. The Dartmouth Heritage Museum acquired the clock and currently houses it in a warehouse facility in Burnside.

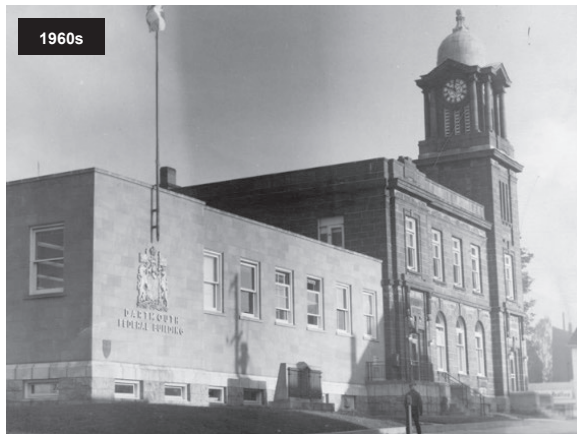
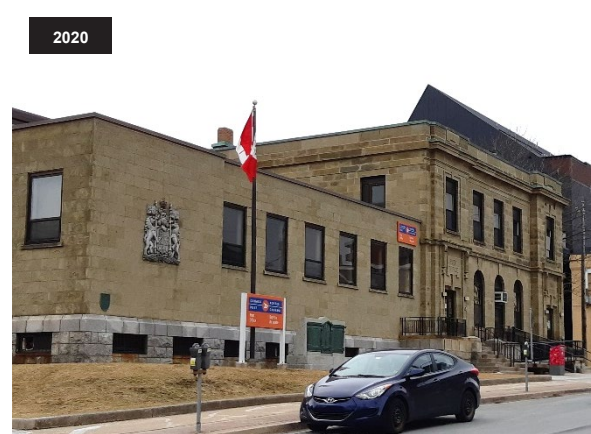
The Dartmouth Post Office addition was added to the southern portion of the building in 1941 on the former site of the Central School. Following the purchase of the Queen Street / King Street corner lot in 1959, this addition was demolished to make way for a larger one-storey addition which opened in 1961. There is also a one-storey addition to the west of the original Dartmouth Post Office, along Wentworth Street. The history of this feature is not well-known, however HRM's records indicate that it was constructed between 1947 and 1960.

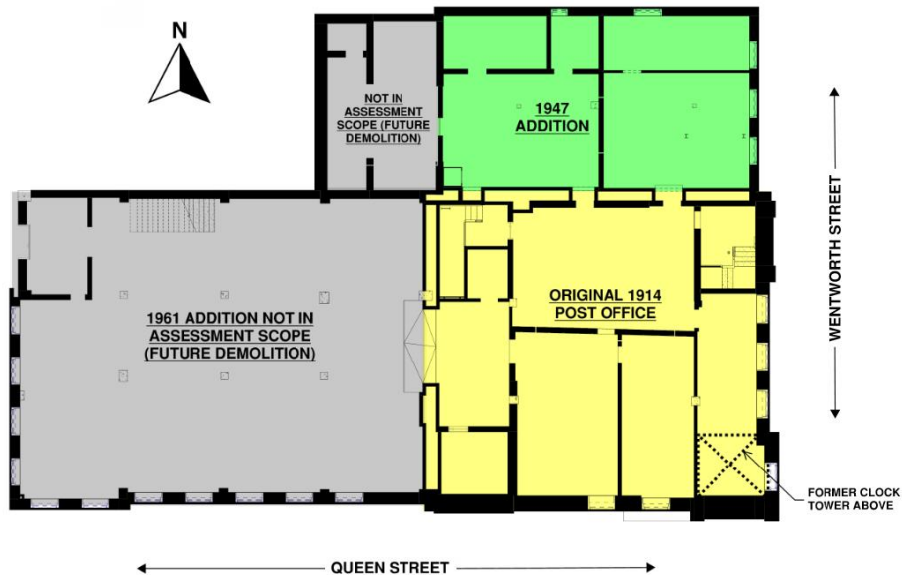
Figure 1: Key Plan – Former Dartmouth Post Office

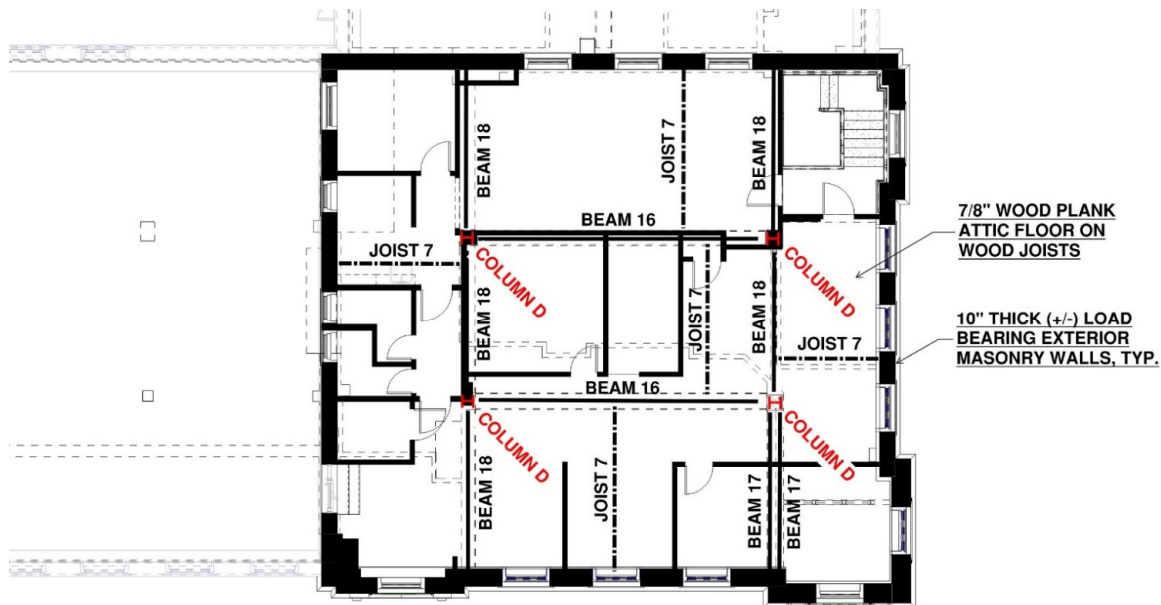
Figure 2A: Upper Roof Framing Plan. Structural elements shown in red require reinforcement, see Figure 2B.

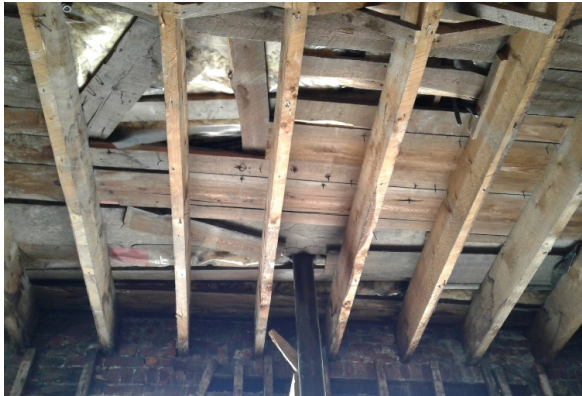
BMR Photo 4.2.A: 2"x10" timber joists with loose/damaged attic planks. Joists bearing on masonry wall (28 Feb 2022).

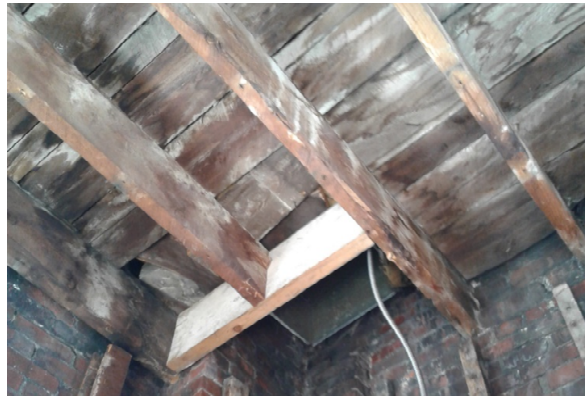
BMR Photo 4.2.B: Water stained/damaged roof joists bearing on masonry wall (28 Feb 2022).

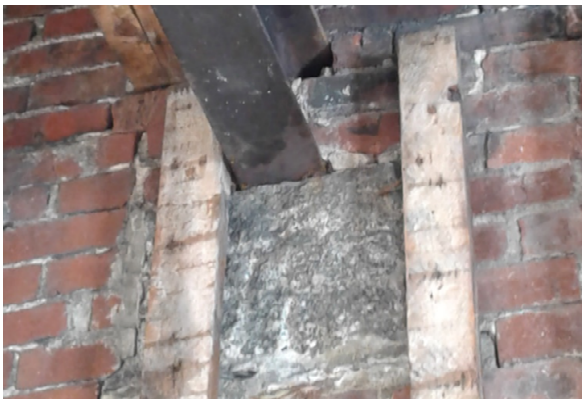
BMR Photo 4.2.C: Granite bearing block at steel girder beam within load-bearing masonry wall. Degraded mortar joints present in masonry walls (28 Feb 2022).

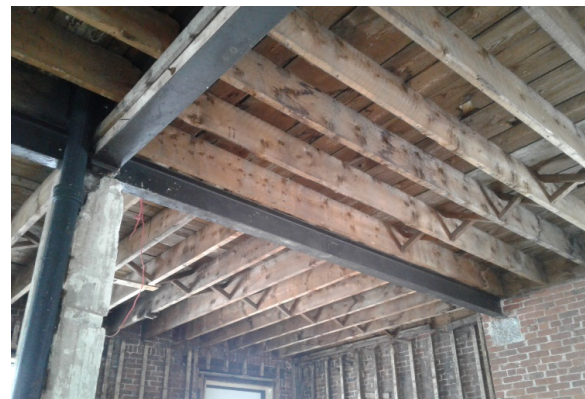
BMR Photo 4.2.D: 2"x10" timber joists supported on steel girder beams and concrete-encased W-columns (28 Feb 2022).

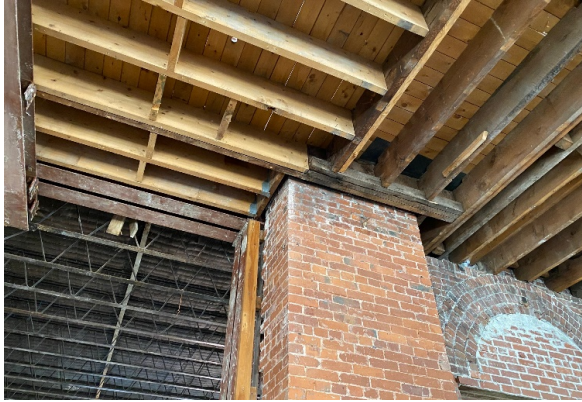
BMR Photo 4.4.A: Double 2"x12" timber header joist to be reinforced (28 Feb 2022).

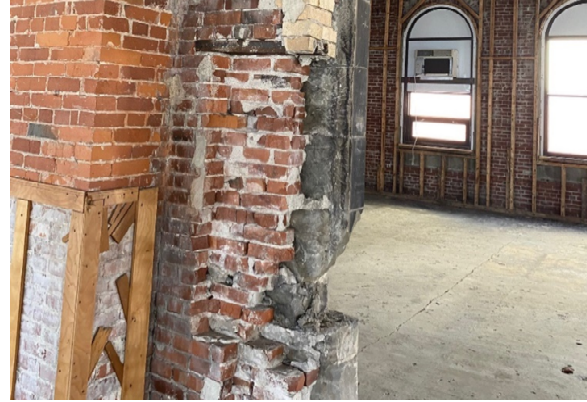
BMR Photo 4.4.B: Damaged load-bearing masonry below west end of steel header beam at 1947 addition opening (28 Feb 2022).

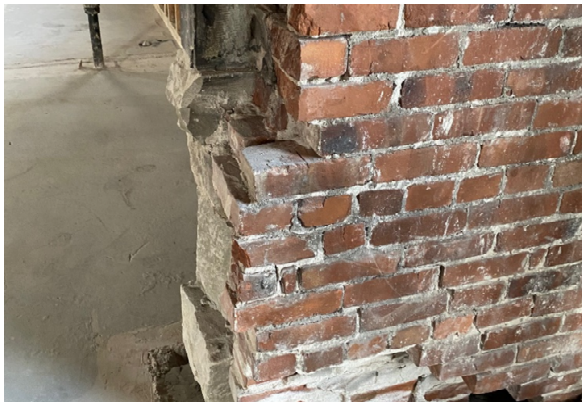
BMR Photo 4.4.C: Damaged and loose load-bearing masonry below east end of steel header beam at 1947 addition opening (28 Feb 2022).

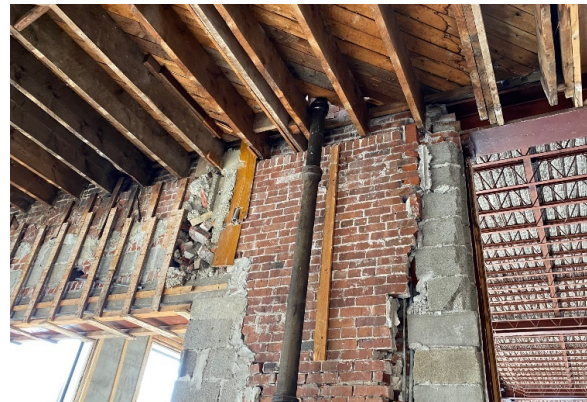
BMR Photo 4.4.D: Loose and damaged load-bearing masonry above and adjacent header beams into 1961 addition (28 Feb 2022).

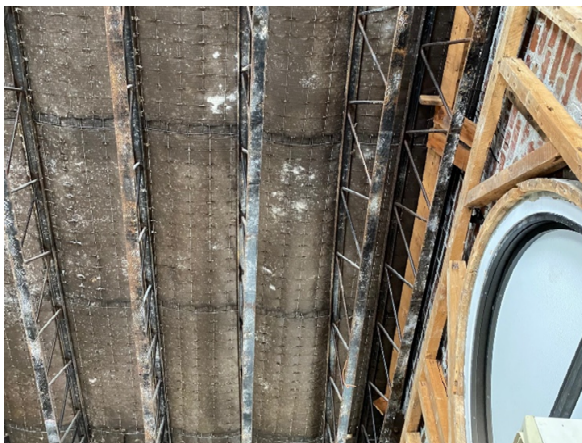
BMR Photo 4.4.E: Failed roof joists at 1947 addition shown buckled out of plane. No bracing or bridging present (28 Feb 2022).

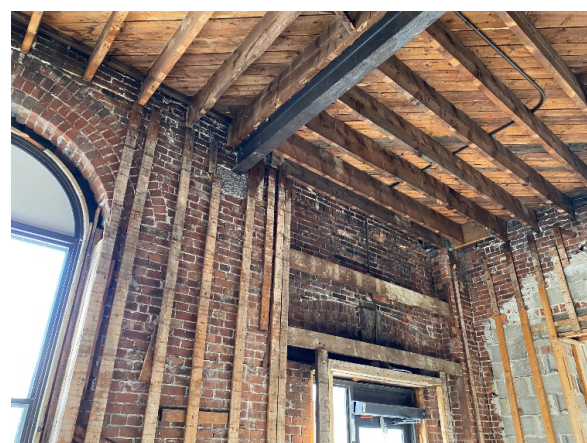
BMR Photo 4.4.F: Timber joists bearing on exterior masonry wall. Girder beam bearing on granite block (28 Feb 2022).

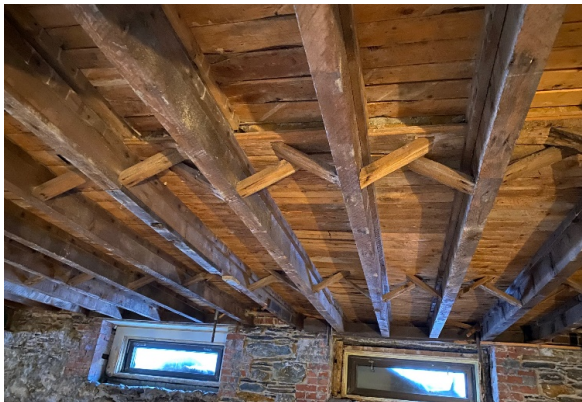
BMR Photo 4.6.A: 3"x12" floor joists with concrete infill between and cement terrazzo floor on top (1 Mar 2022).

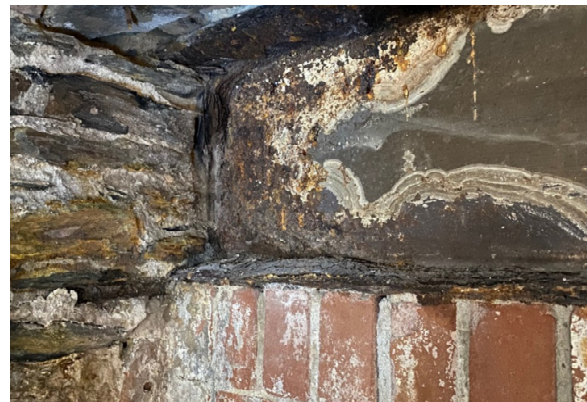
BMR Photo 4.6.B: Heavily corroded steel girder beam at foundation bearing point. **Requires immediate attention** (1 Mar 2022).

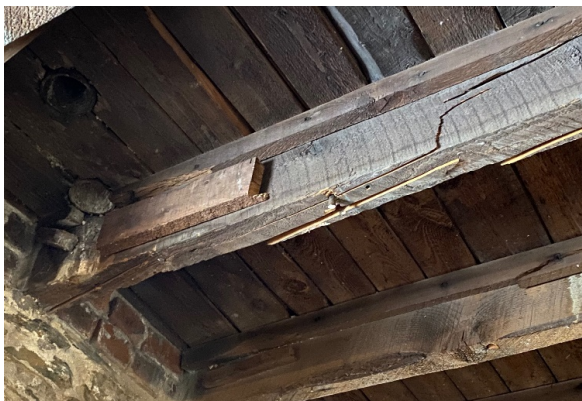
BMR Photo 4.6.C: Timber floor joist that appears to have failed at the bearing point (1 Mar 2022).

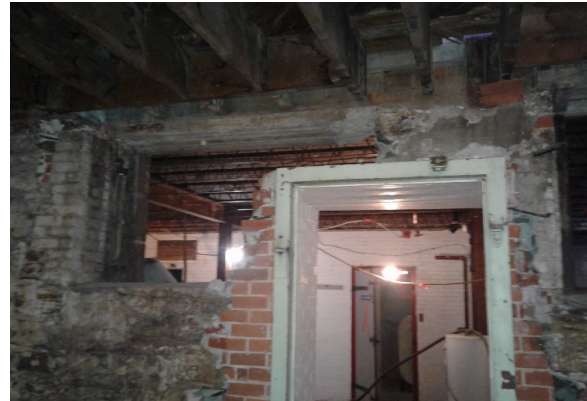
BMR Photo 4.6.D: Damaged load-bearing masonry and concrete infill with large column point load above door frame. **Requires immediate attention** (1 Mar 2022).

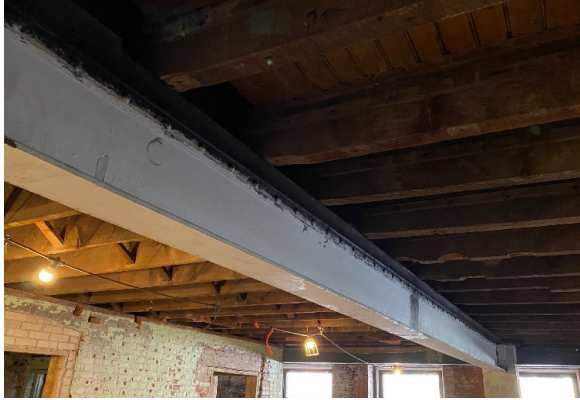
BMR Photo 4.6.E: Steel girder beam, 2"x12" joists, 3"x12" joists all require reinforcement (1 Mar 2022).

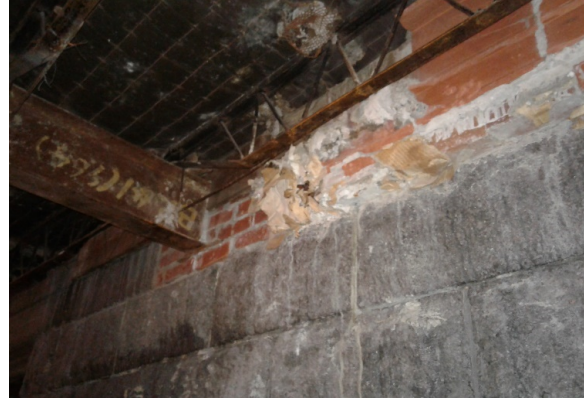
BMR Photo 4.6.F: Corroded steel floor joists and steel girder beam at 1947 addition. Recommend floor be demolished and replaced (1 Mar 2022).

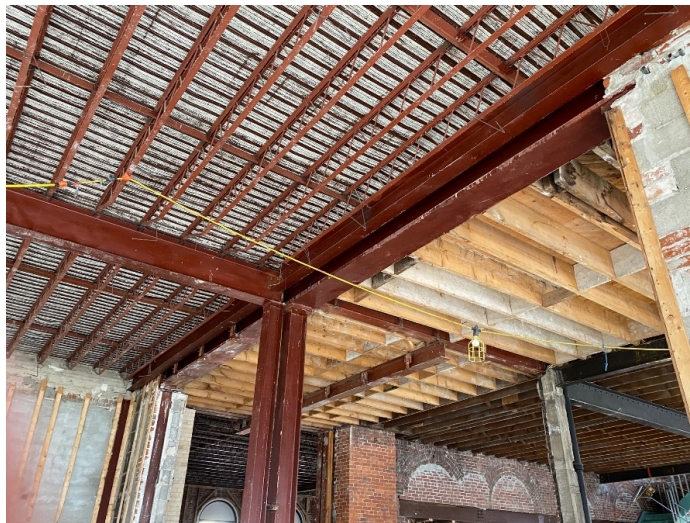
BMR Photo 5.3.A: Interface between 1961 addition to be demolished in foreground and original Post Office in background. Original load-bearing masonry and stone removed to create this opening (28 Feb 2022).

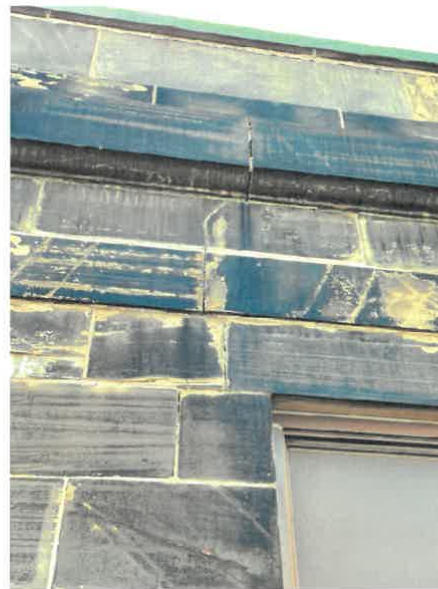
Photo No. 4 – North Elevation – Crack in sandstone above window jamb. Mortar missing in some joints.

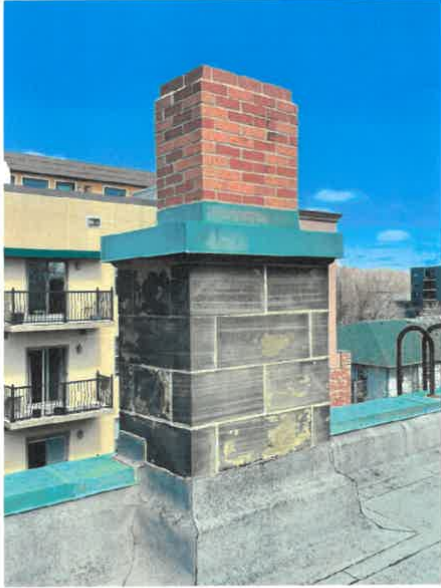
Photo No. 5 – Chimney in good condition.

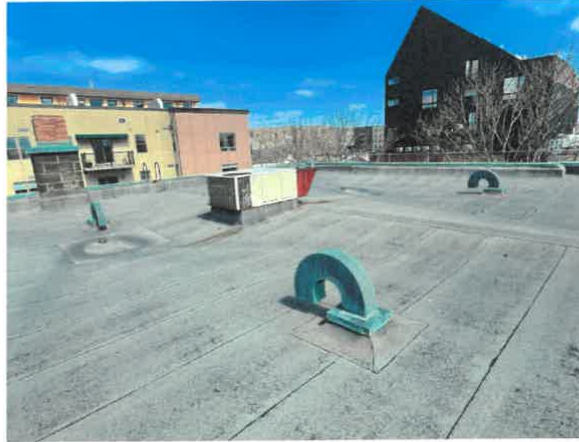
Photo No. 6 – Upper roof (1914) with slopes to drains.

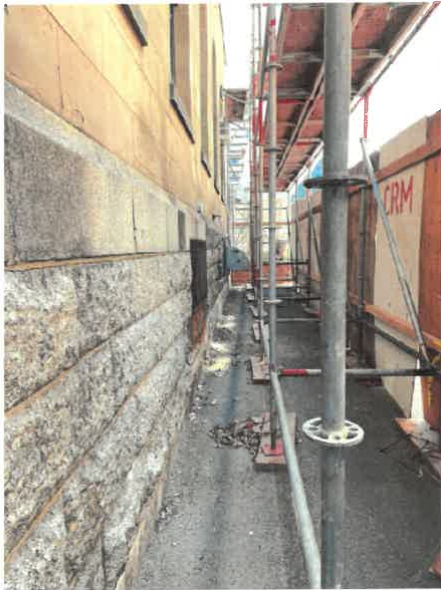
Photo No. 7 – Foundation at grade with granite facing and sandstone above.

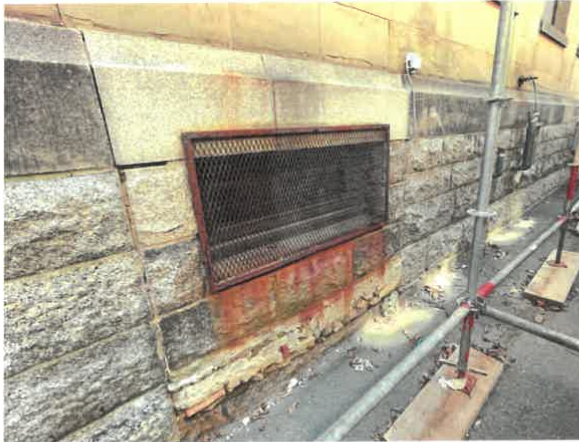
Photo No. 8 – Deteriorated joints and below sill infill at foundation wall opening.

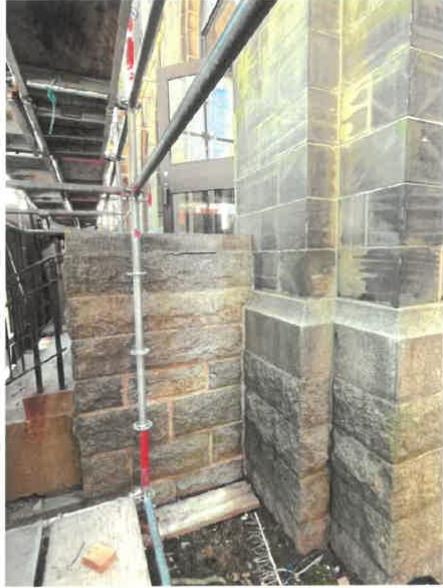
Photo No. 9 – Open joints in granite at east entry area.

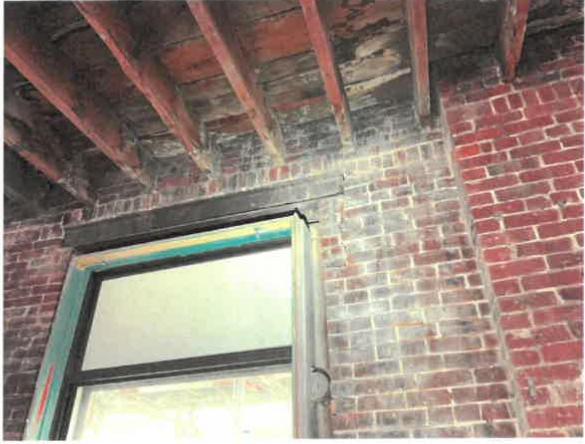
Photo No. 20 – Steel lintel over window with jamb brick cracking at window head. Note water staining of wood framing above.

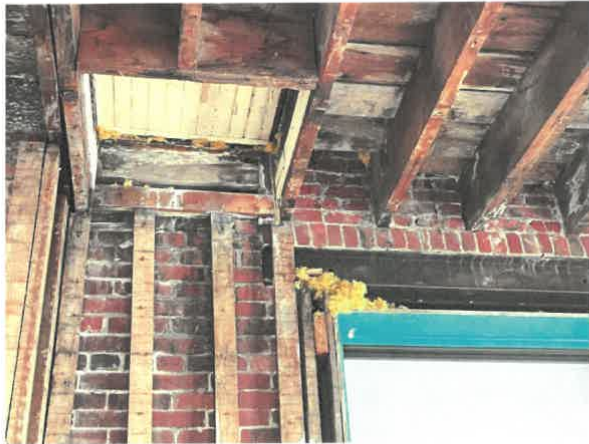
Photo No. 21 – Attic roof hatch at former Clock Tower location (South East).

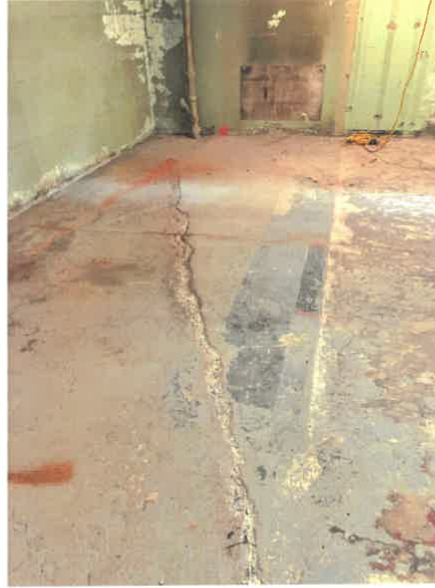
Photo No. 26 – Slab on grade crack in floor – 1947.

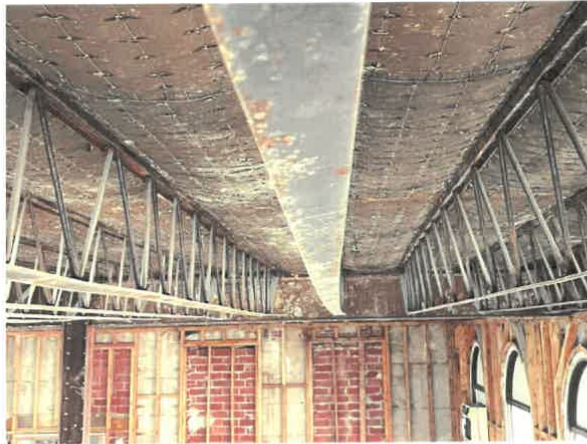
Photo No. 27 – Close view of 1947 roof joist.
