**Item No. 12.1.1**  
**Appeals Standing Committee**  
**March 6, 2025**

**SUBJECT:** Appeal Report – BLAST-2024-09274 1190 Barrington Street, Halifax

# HENRY HOUSE CONDITION REVIEW

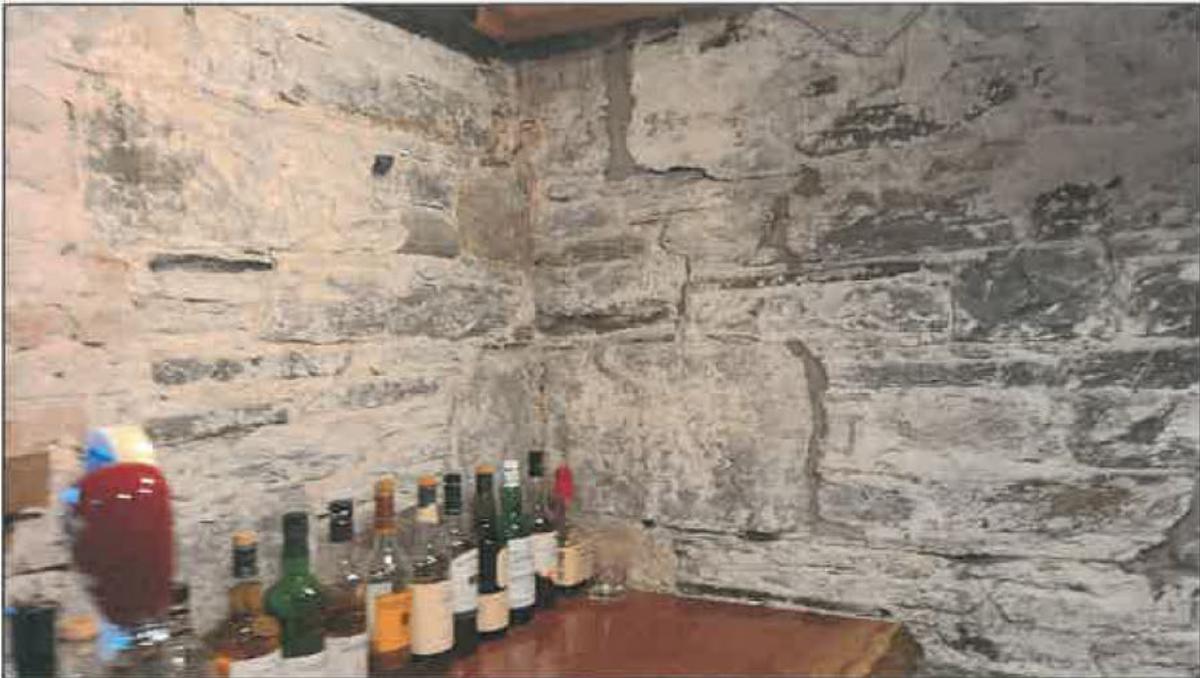
The front wall is in overall good condition (Photo 1 and Photo 2). Several areas of medium to wide mortar cracks (Photo 3) were noted with some areas of previously repaired cracks (Photo 4). The front wall appeared to be stable with no evidence of loose stones or mortar.

**Photo 1** North side and front basement wall at bar location

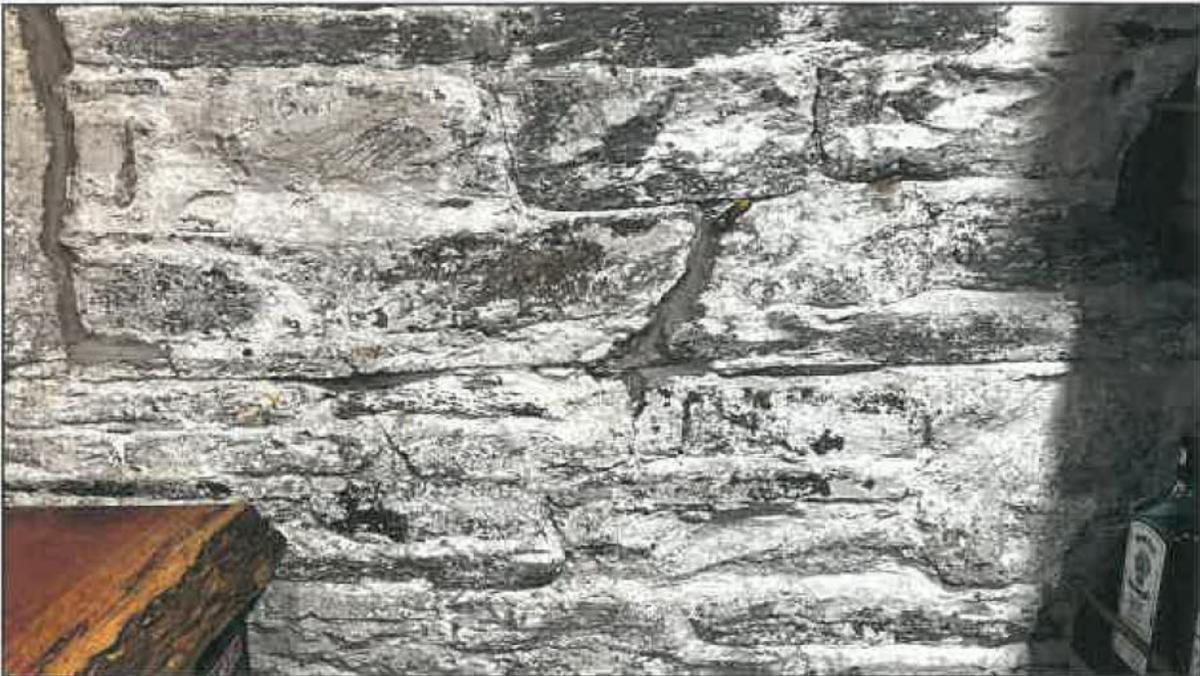
**Photo 2** Front basement wall

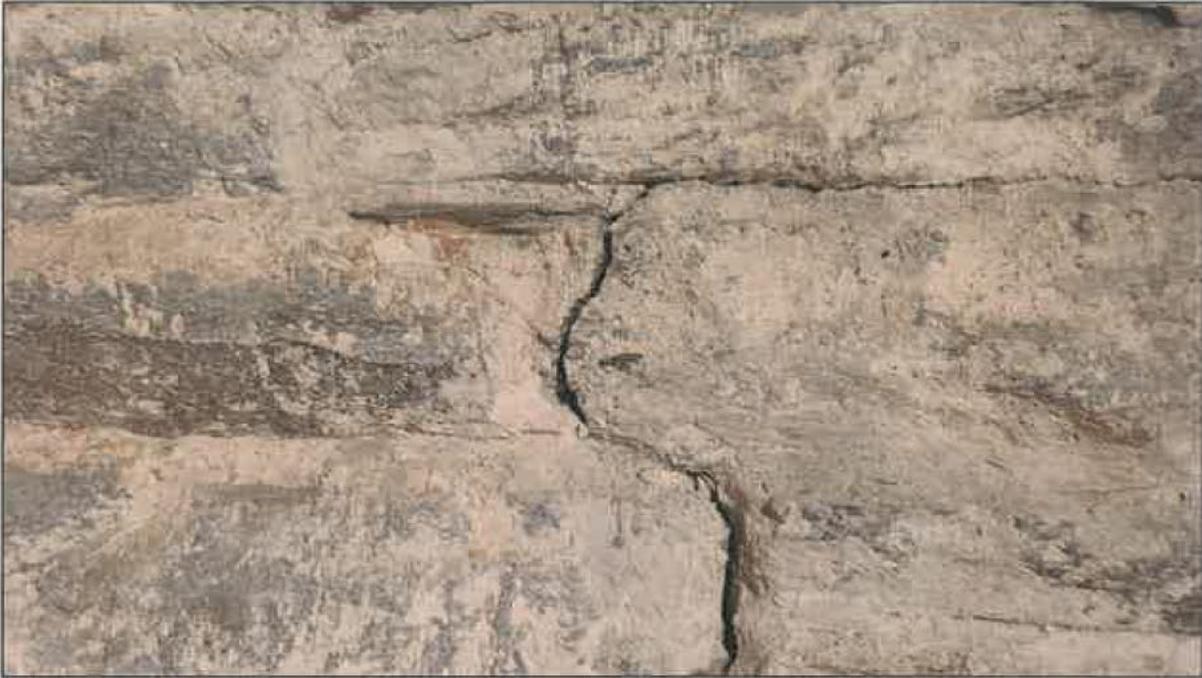
**Photo 3** Cracks in the front basement wall

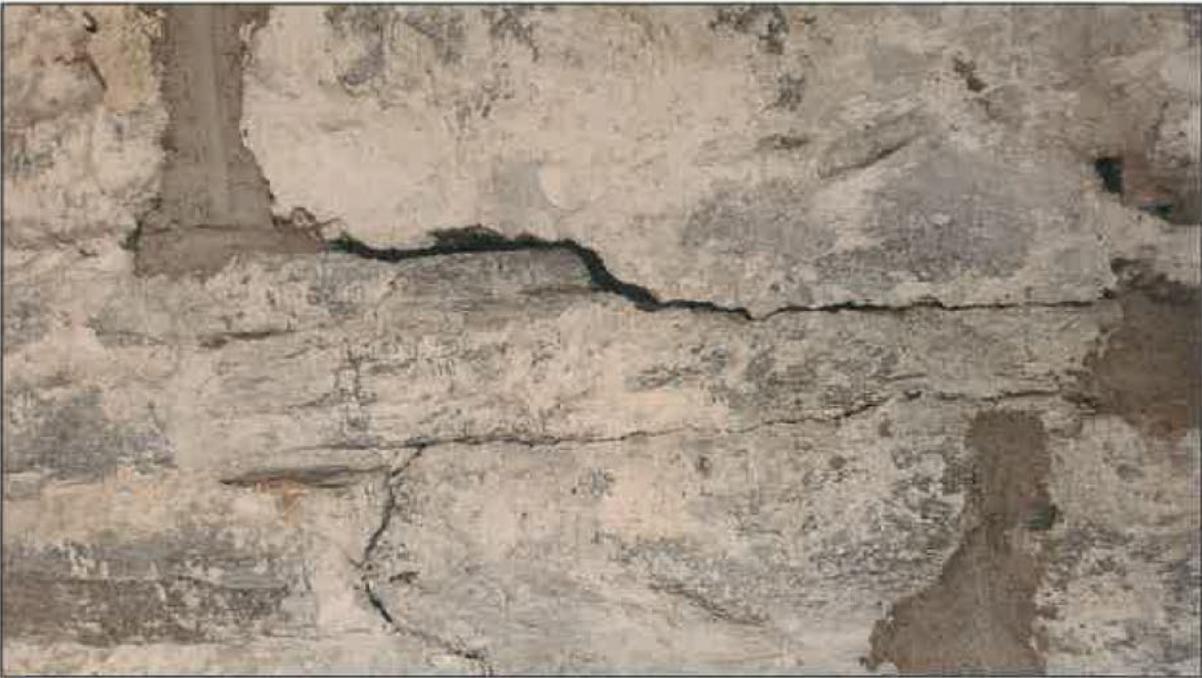
**Photo 4** Previously repaired cracks in the front basement wall

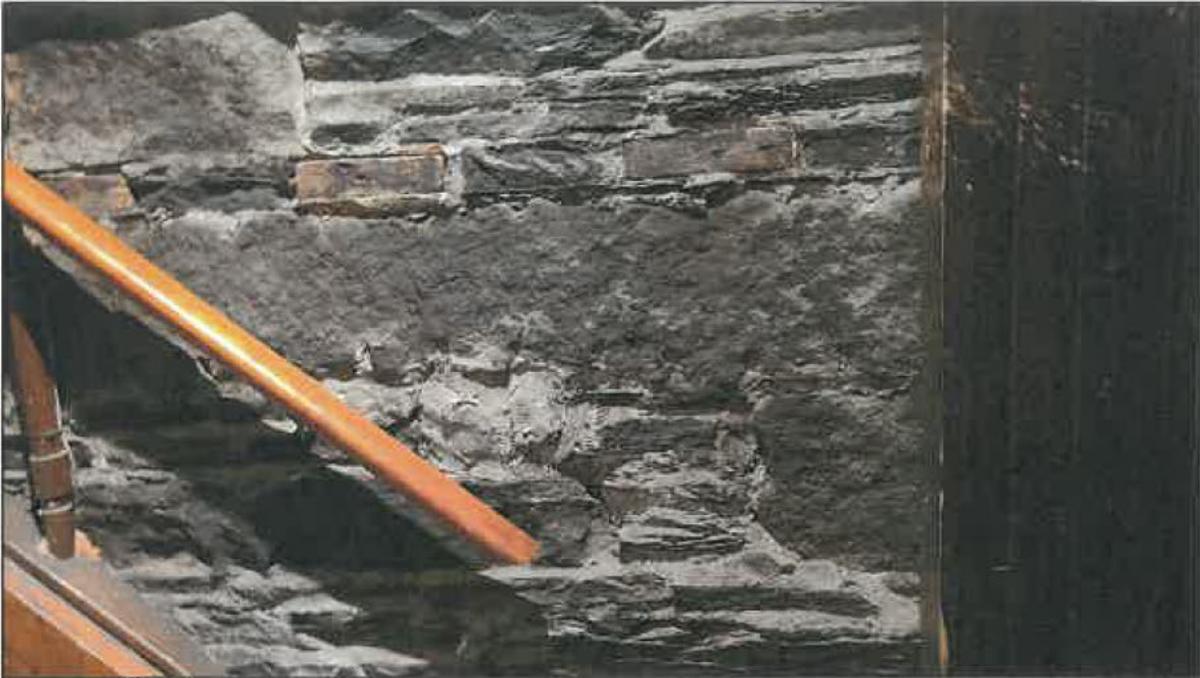
**Photo 5** Wall in stairwell leading to the main floor

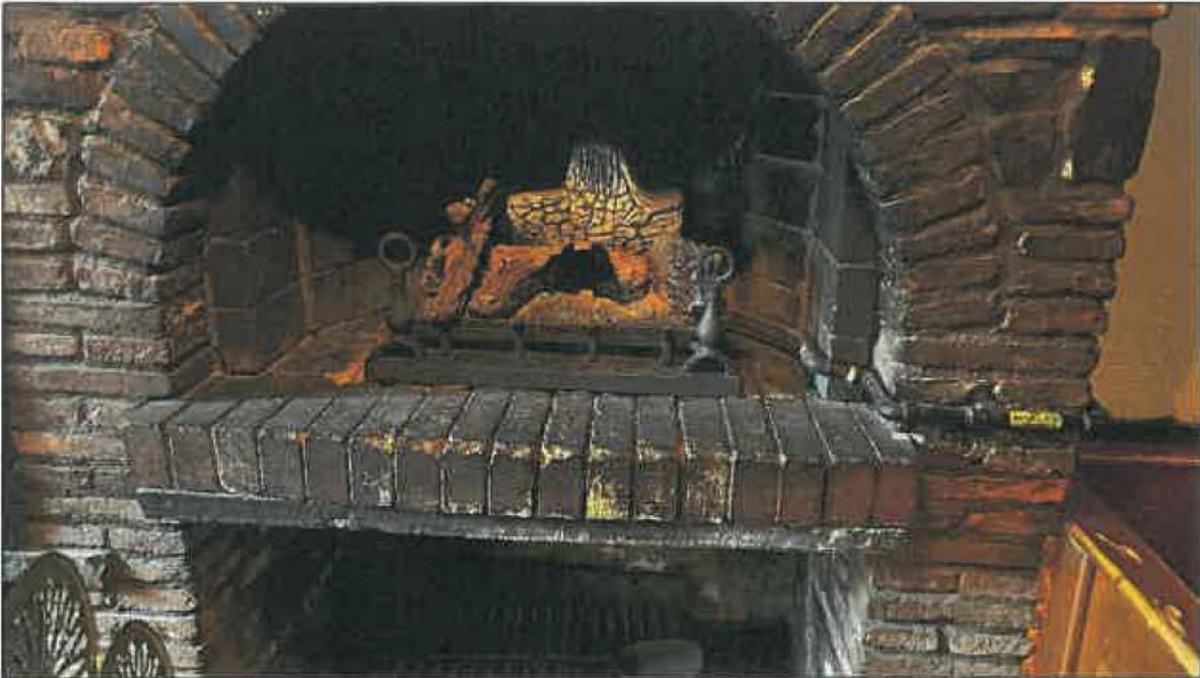
**Photo 7** Basement fireplace

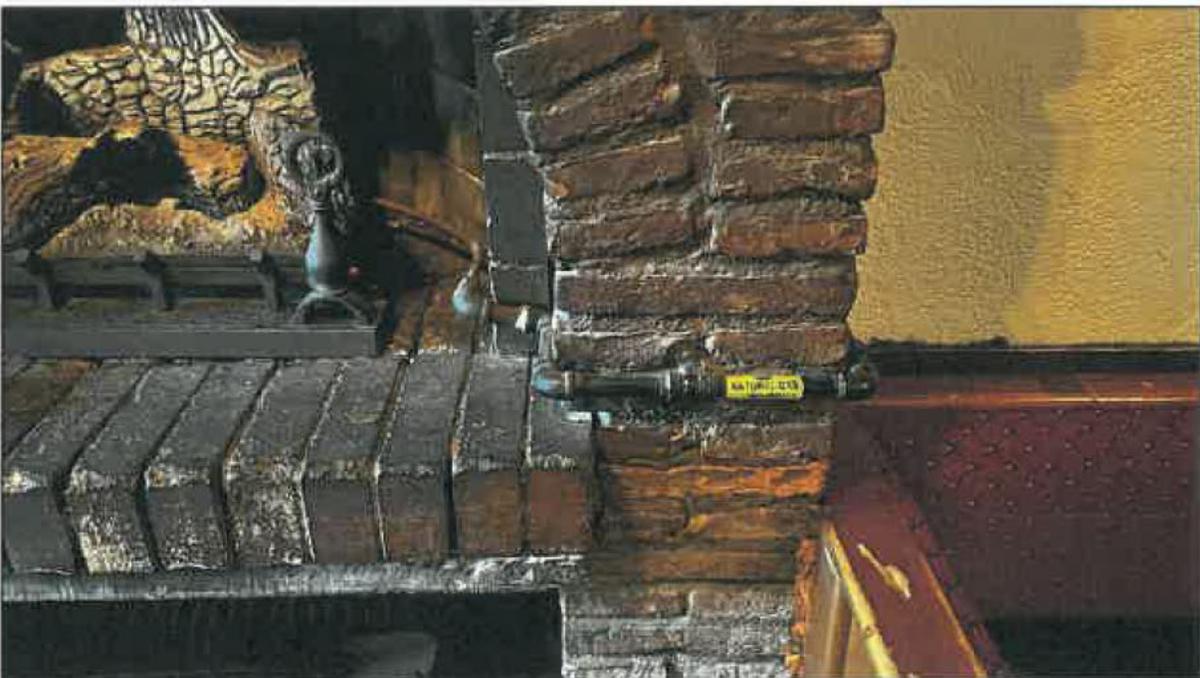
**Photo 8** Loss of mortar in exterior hearth

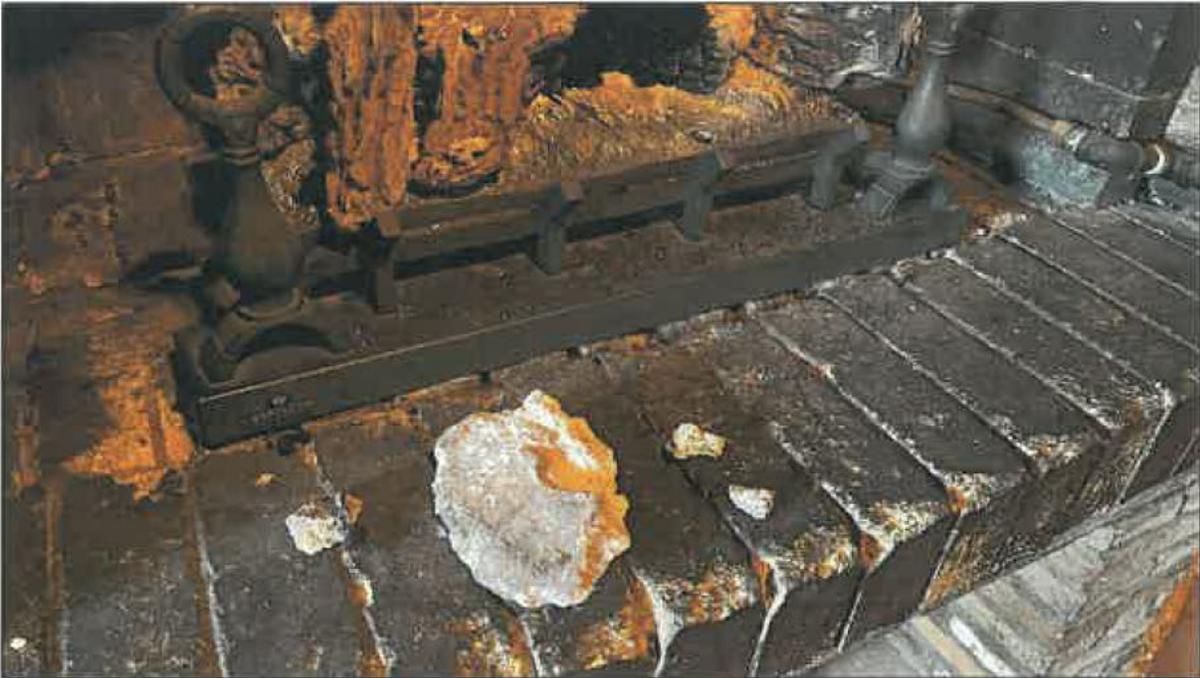
**Photo 9** Debris found in chimney after blasting

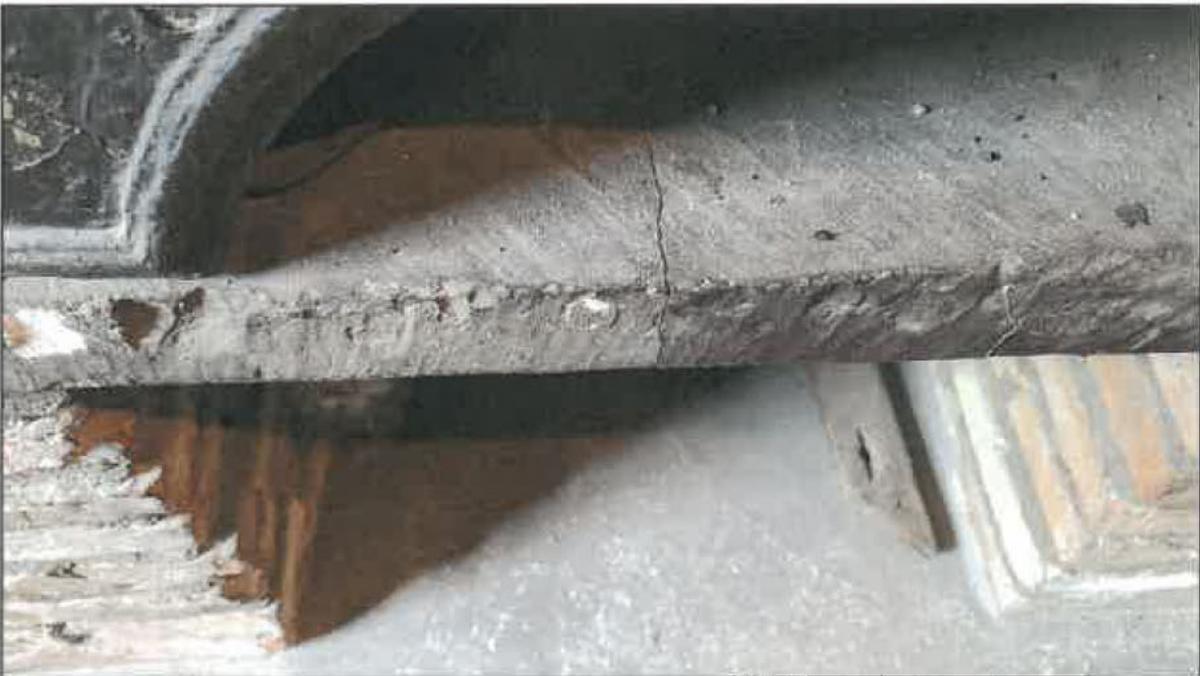
**Photo 10** Crack in stone oven base

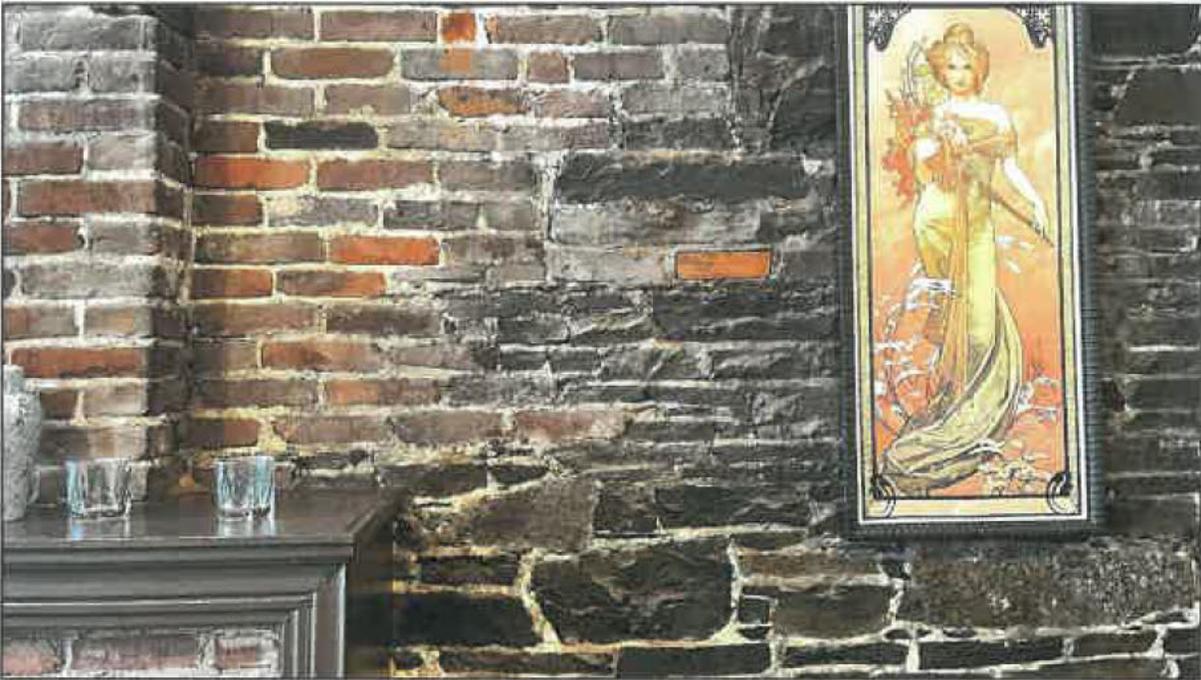
**Photo 11** Vertical and mortar step cracks on the second floor south wall

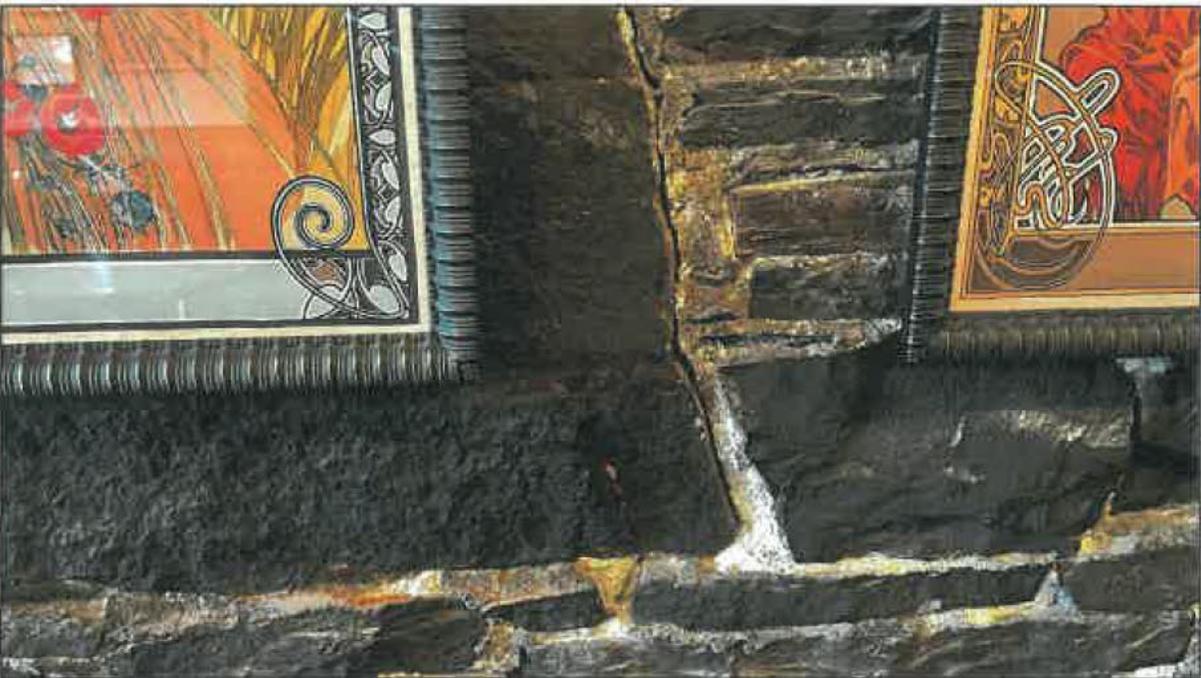
**Photo 12** Cracks on the main-floor south wall

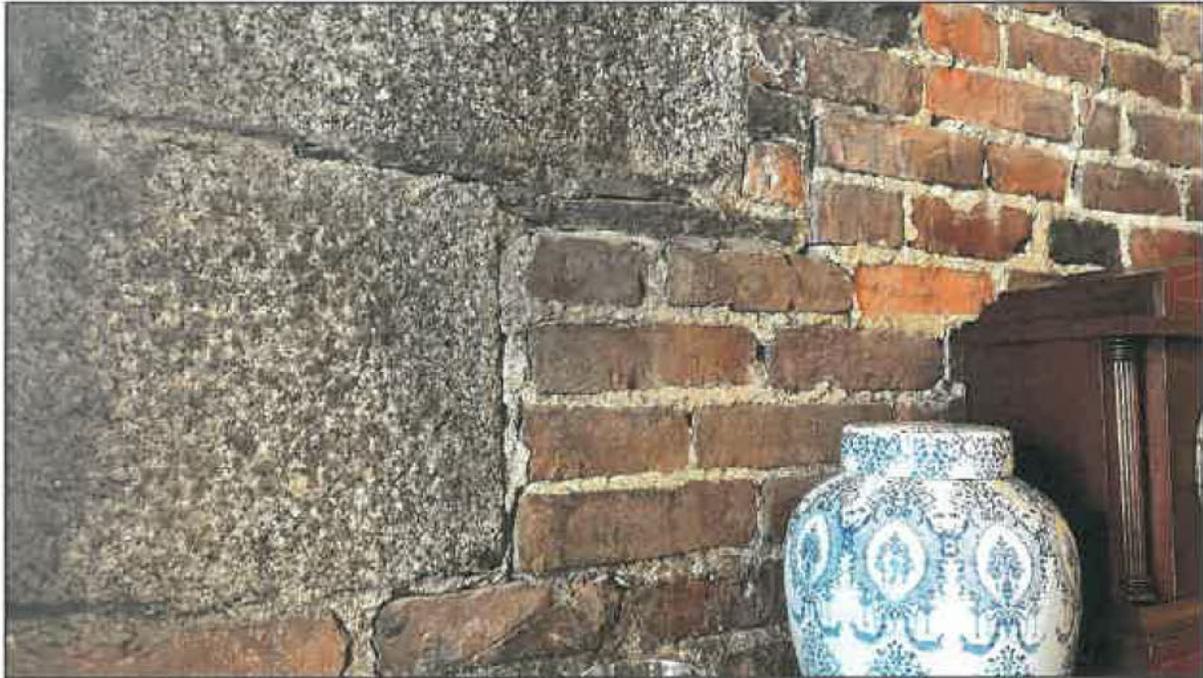
**Photo 13** General deterioration and mortar loss in south main floor wall

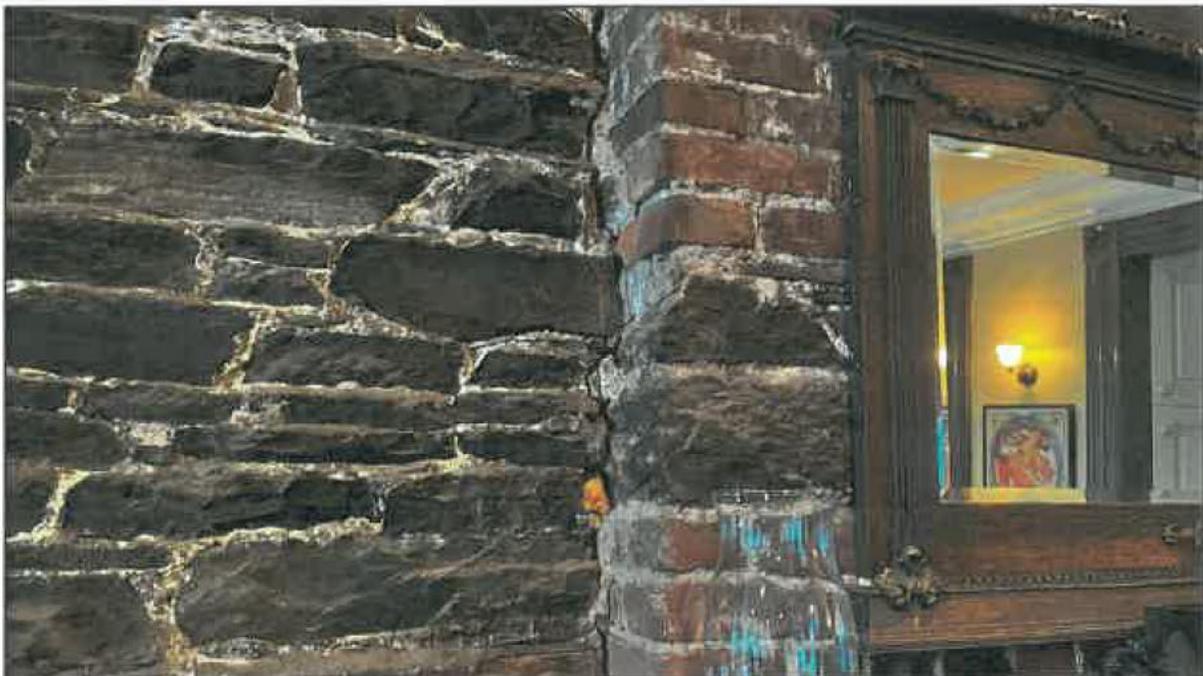
**Photo 14** Separation between wall and main floor fireplace

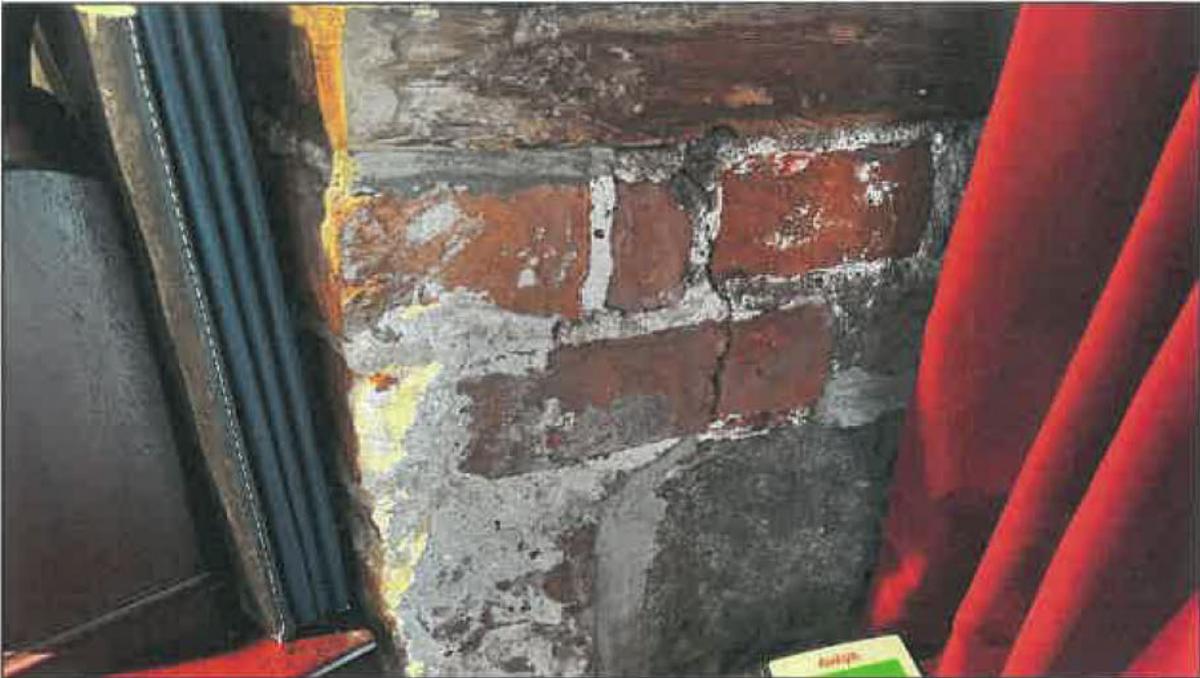
**Photo 15** Vertical cracks in rear second story wall

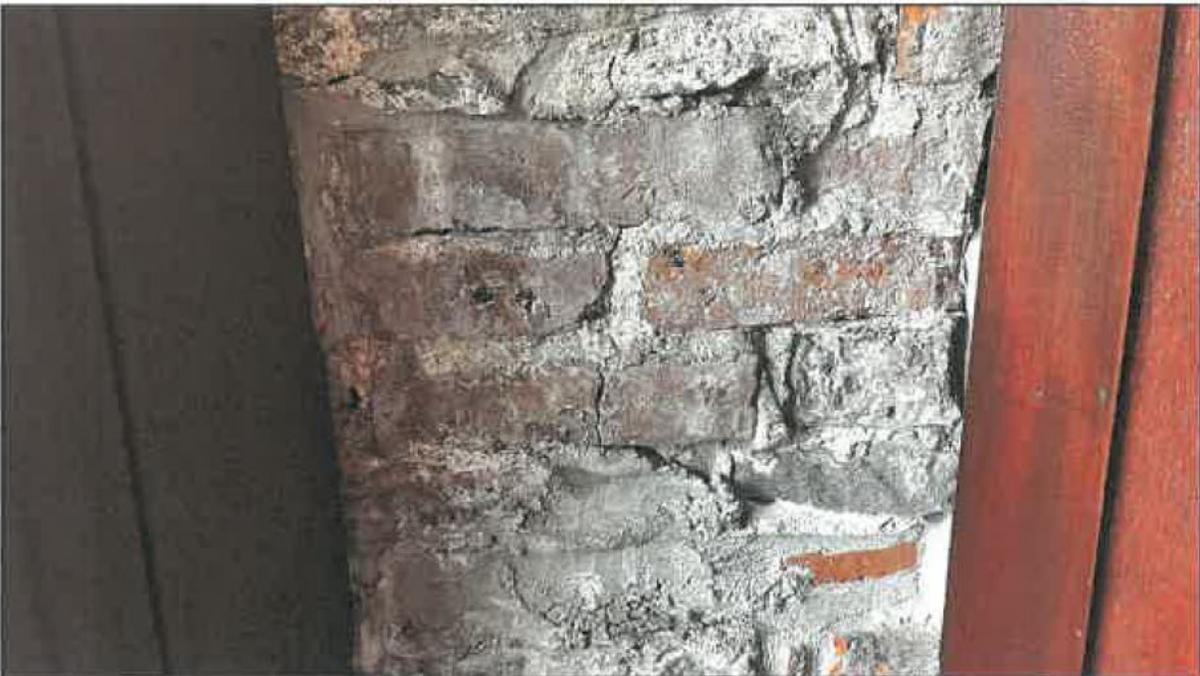
**Photo 16** Vertical cracks in south second story window well

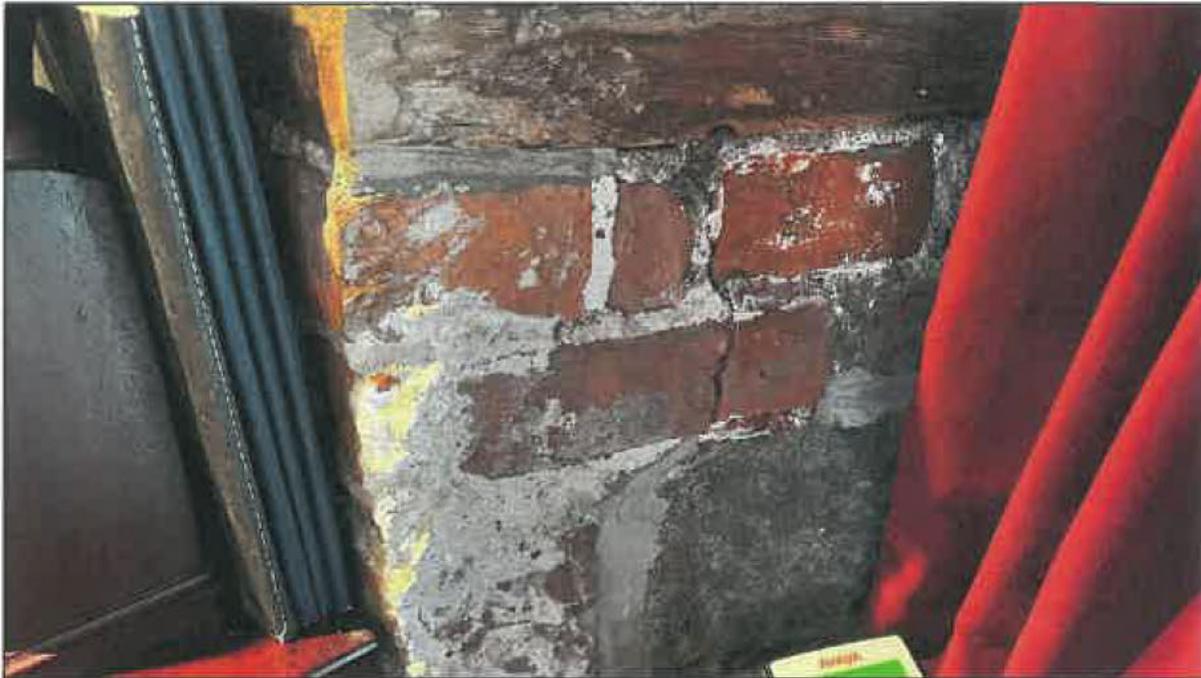
**Photo 17** Vertical cracks in rear second story wall

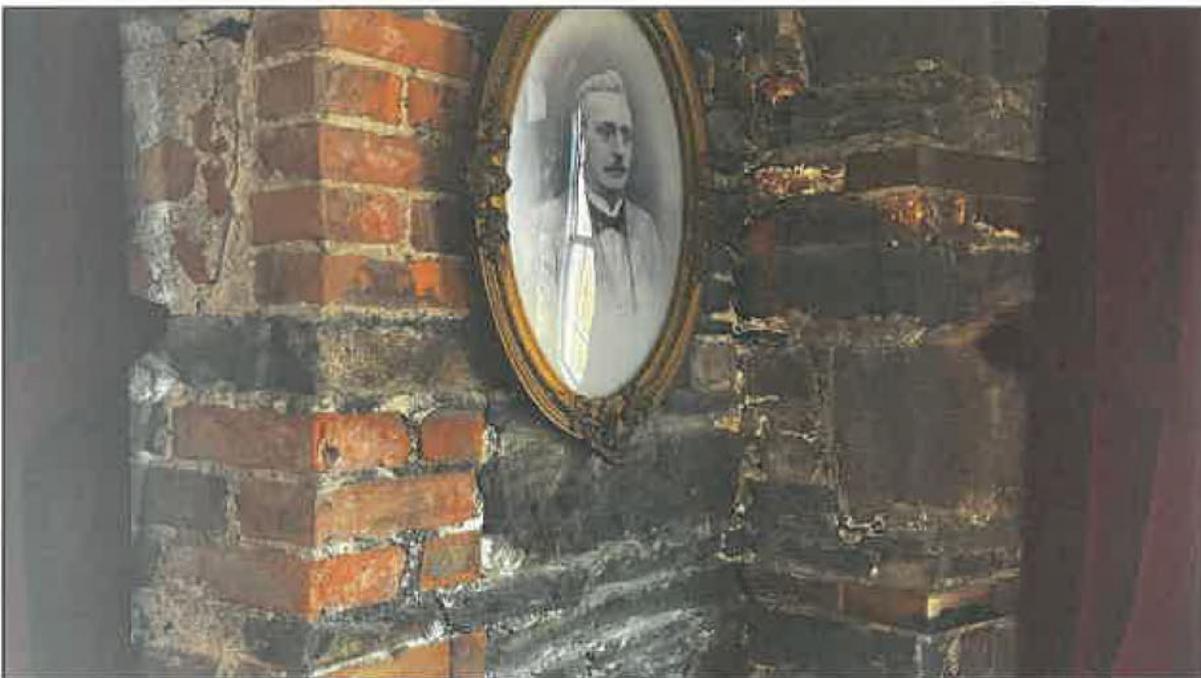
**Photo 18** Mortar cracks and deterioration on the southeast corner of the second floor

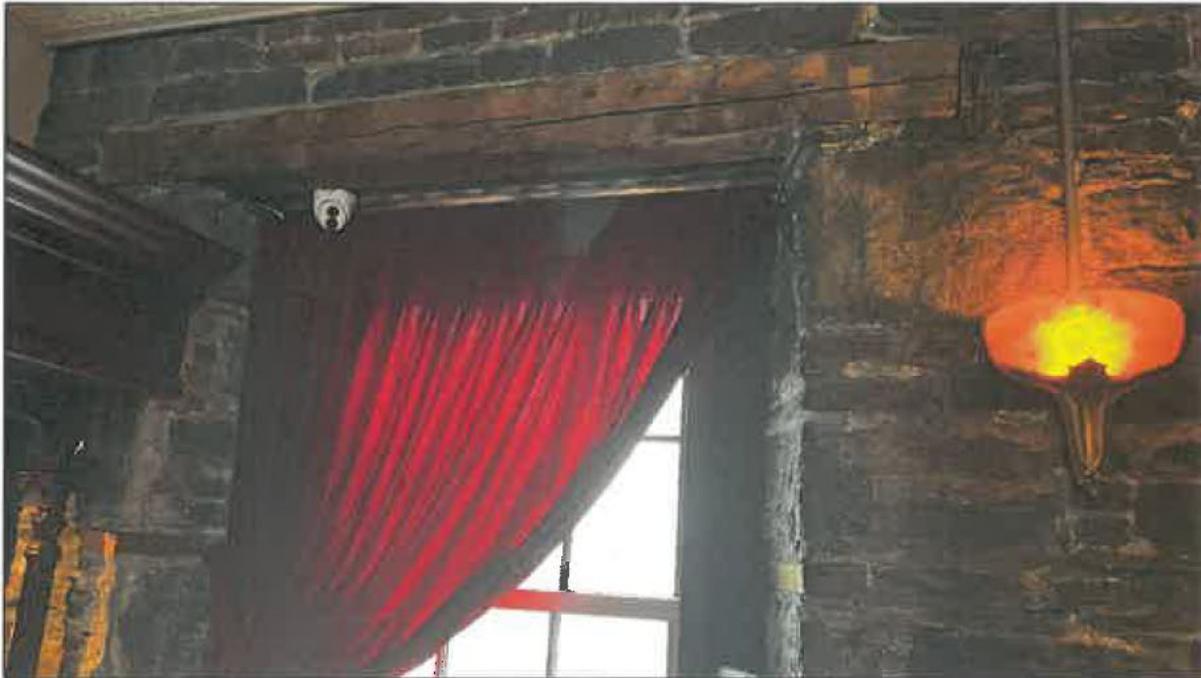
**Photo 19** Splits in second story timber lintels

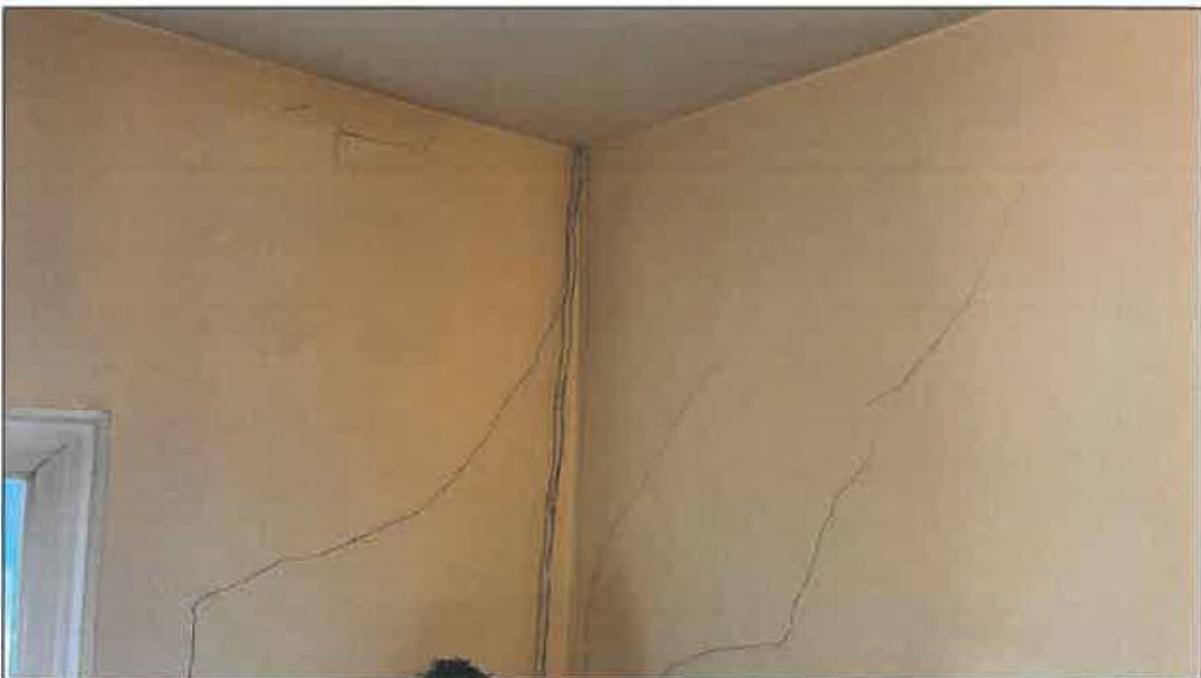
**Photo 20** Cracks in third floor plaster

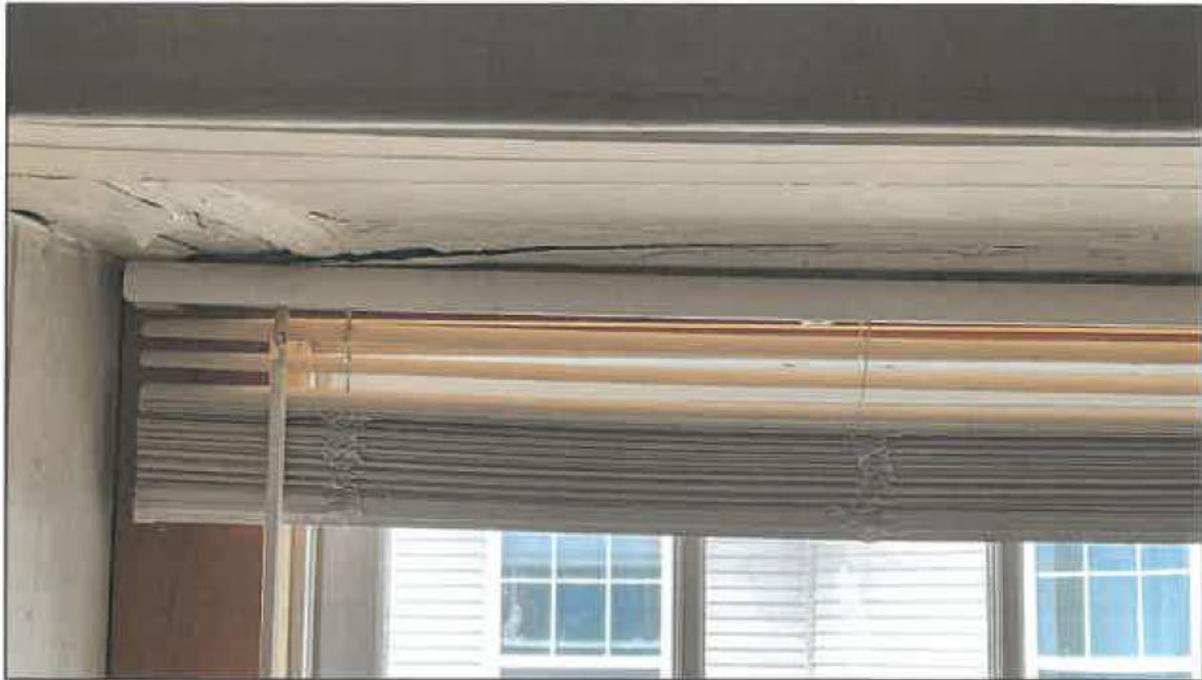
**Photo 21** Cracks around front window on third floor

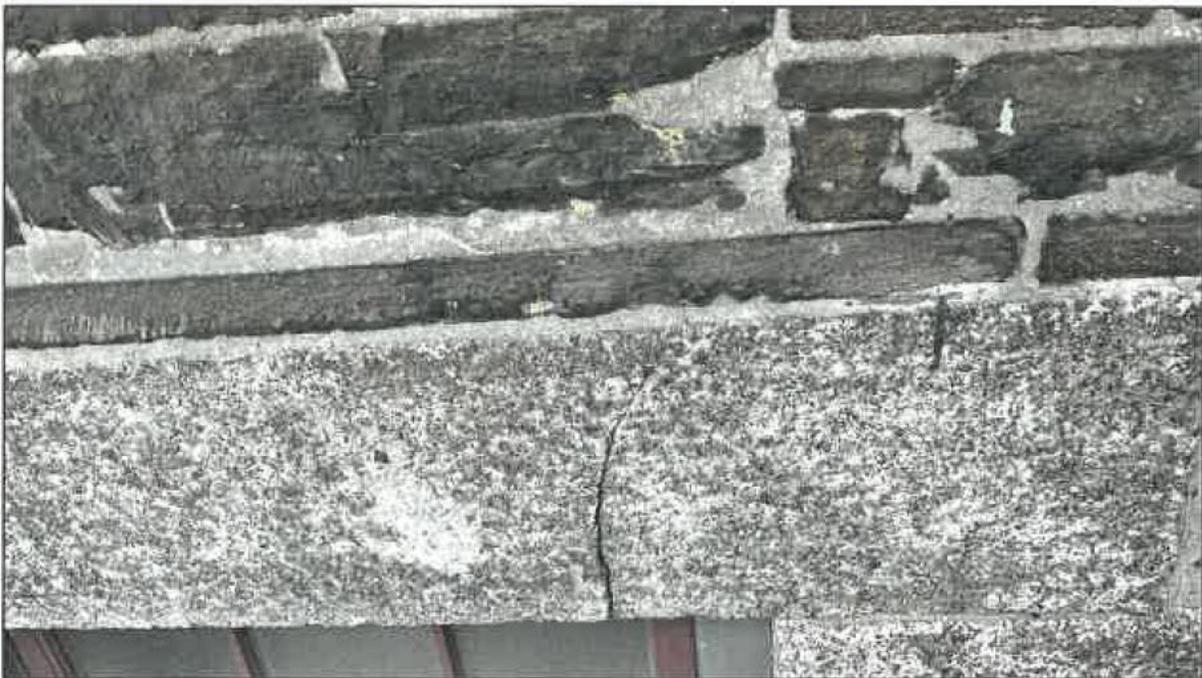
**Photo 22** Crack over basement window on exterior face of north wall

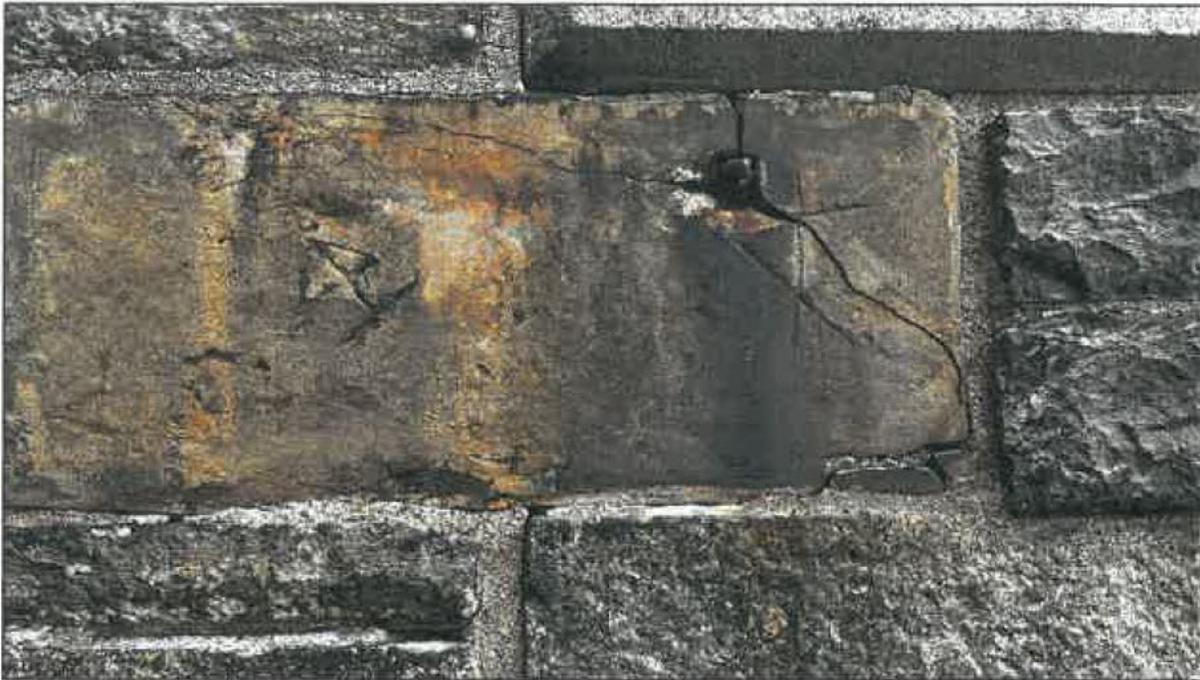
**Photo 23** Cracks through exterior stone

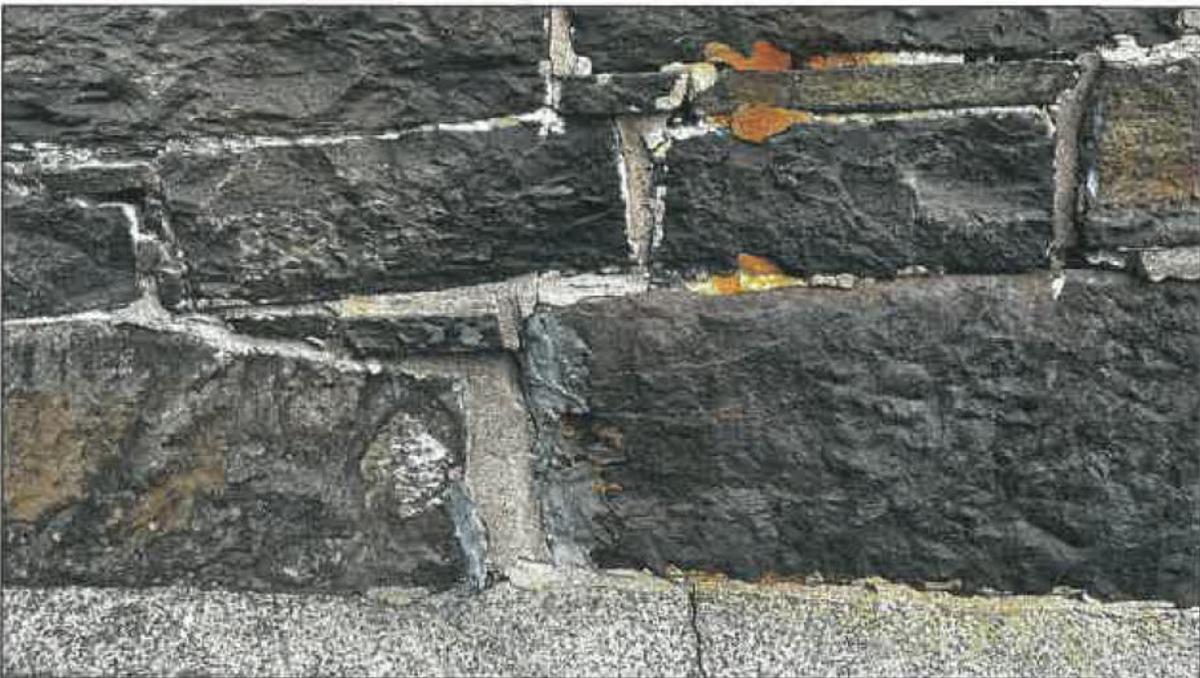
**Photo 24** General wear, mortar loss and cracks on exterior masonry face

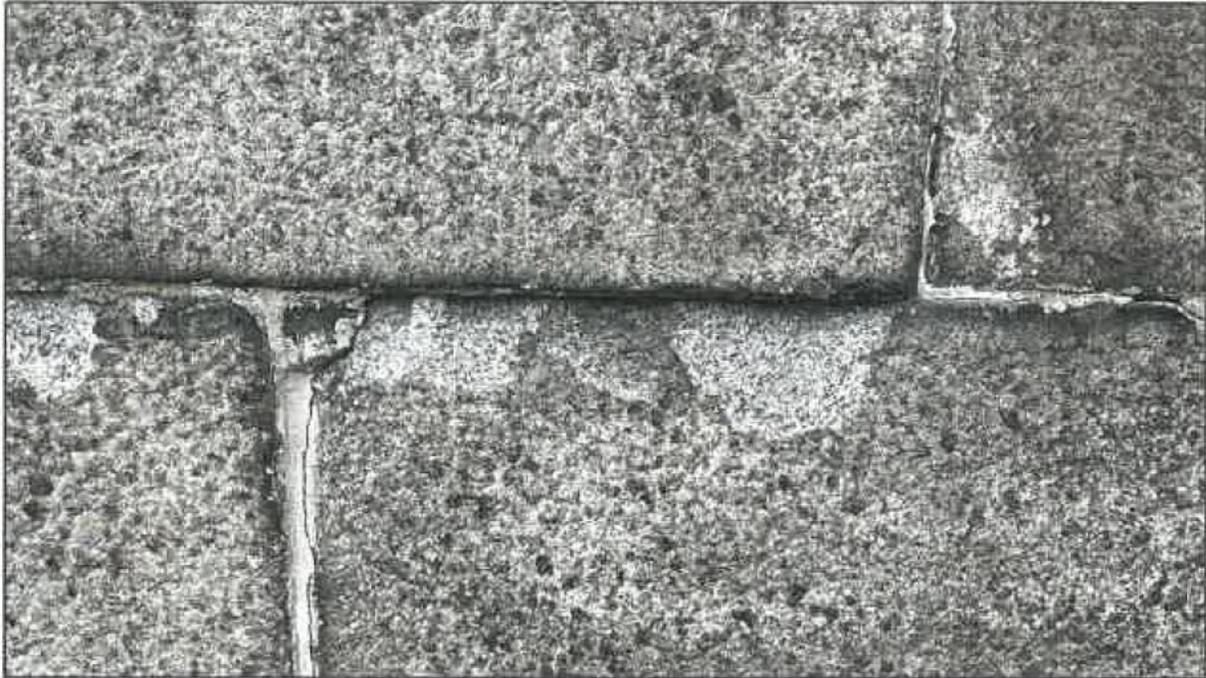
**Photo 25** Recent chips in exterior granite blocks

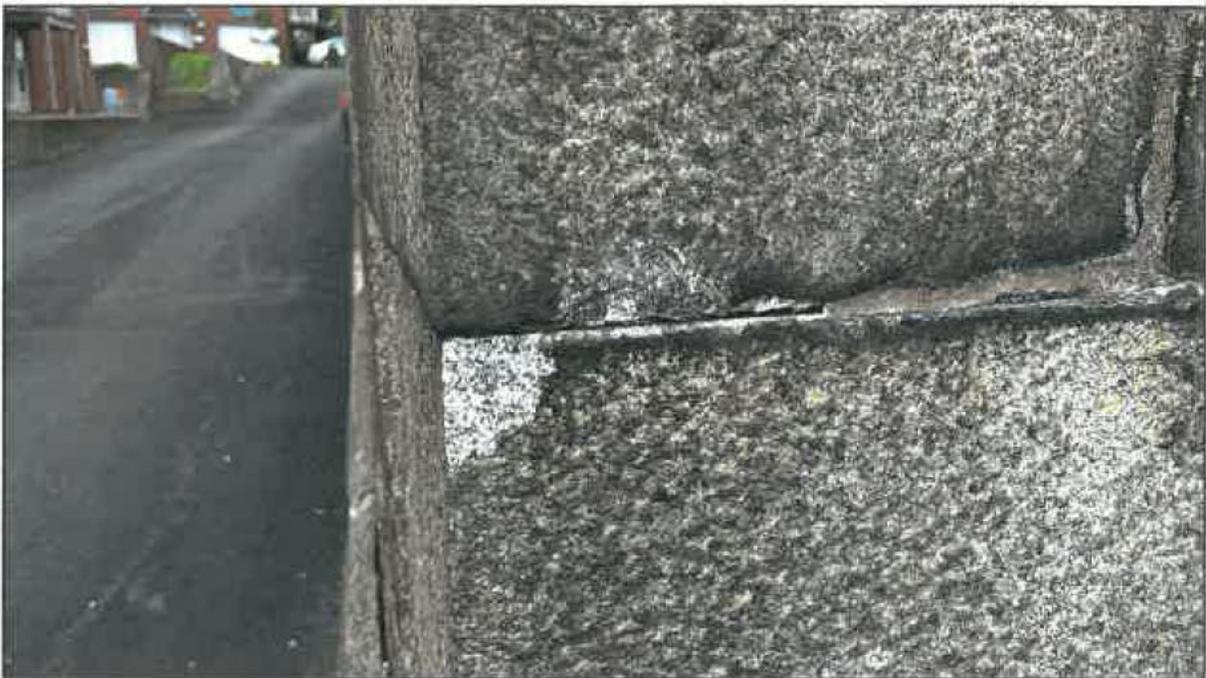
**Photo 26** Recent chip at corner of exterior granite block

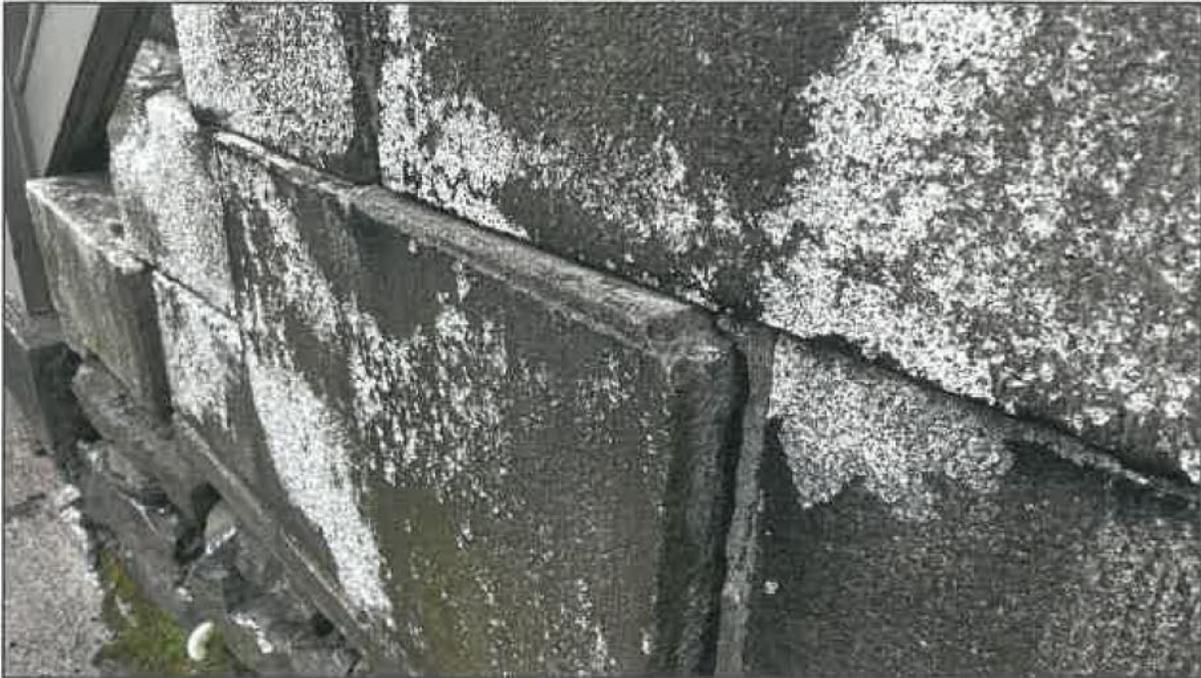
The inspection and condition review of Henry House indicated the interior and exterior was observed to be in Good to Fair condition for most areas, consistent with expectations for a well-maintained Heritage Building of similar age. Two areas are identified as in Poor condition, the entrance walkway and the exterior chimney, which are not consistent with expectations for well-maintained Heritage Building of similar age.

The opinion in the condition review was that these two areas, in particular, due to the current Poor condition, may experience some shift and/or dislodgement even if the PPV is in compliance with the blasting limits for Heritage Properties. As discussed, the limits recommended for Henry House are similar to what will be experienced daily at the building for the current operation and the risk of damage can be reduced by halting vibration generating activities at the business during blasting. Further, providing a perimeter around the stone chimney inside and outside during blasts, as recommended in the structural report, are encouraged to protect the public from falling objects that may result from blasts.

**Photo 27** Shifted and unstable front entrance stairway

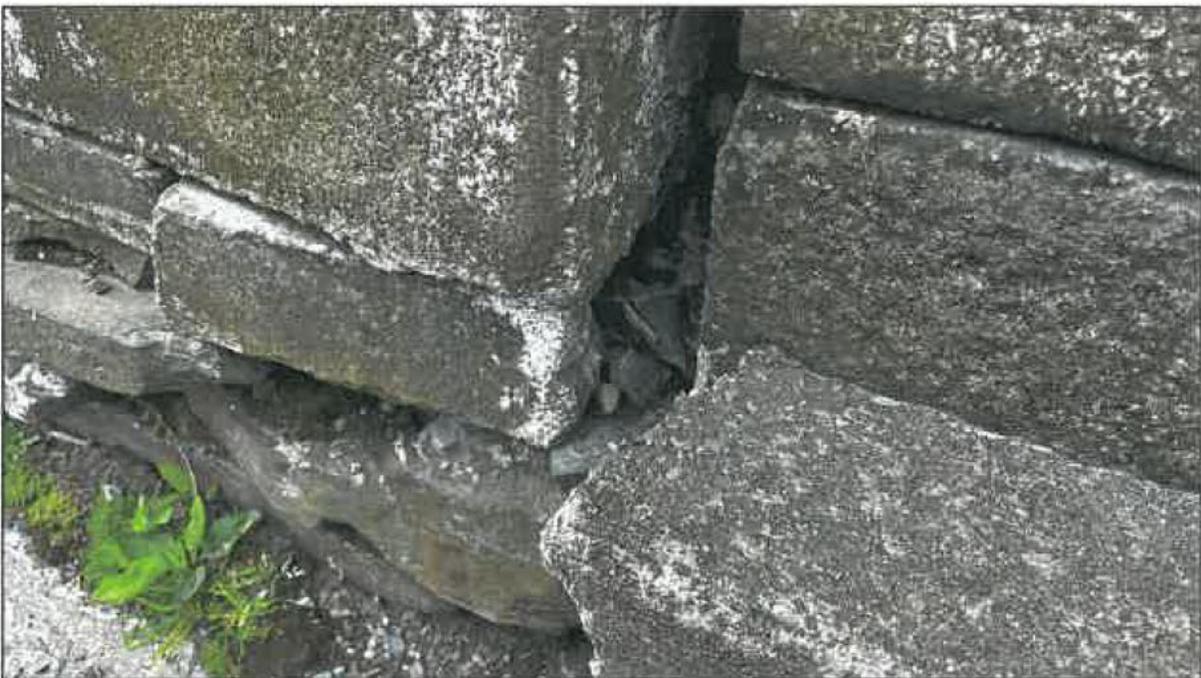
**Photo 28** Mortar loss and unstable stairway foundation
