**Item No. 12.1.1**  
**Appeals Standing Committee**  
**March 6, 2025**

**SUBJECT:** Appeal Report – BLAST-2024-09274 1190 Barrington Street, Halifax

# HENRY HOUSE CONDITION REVIEW

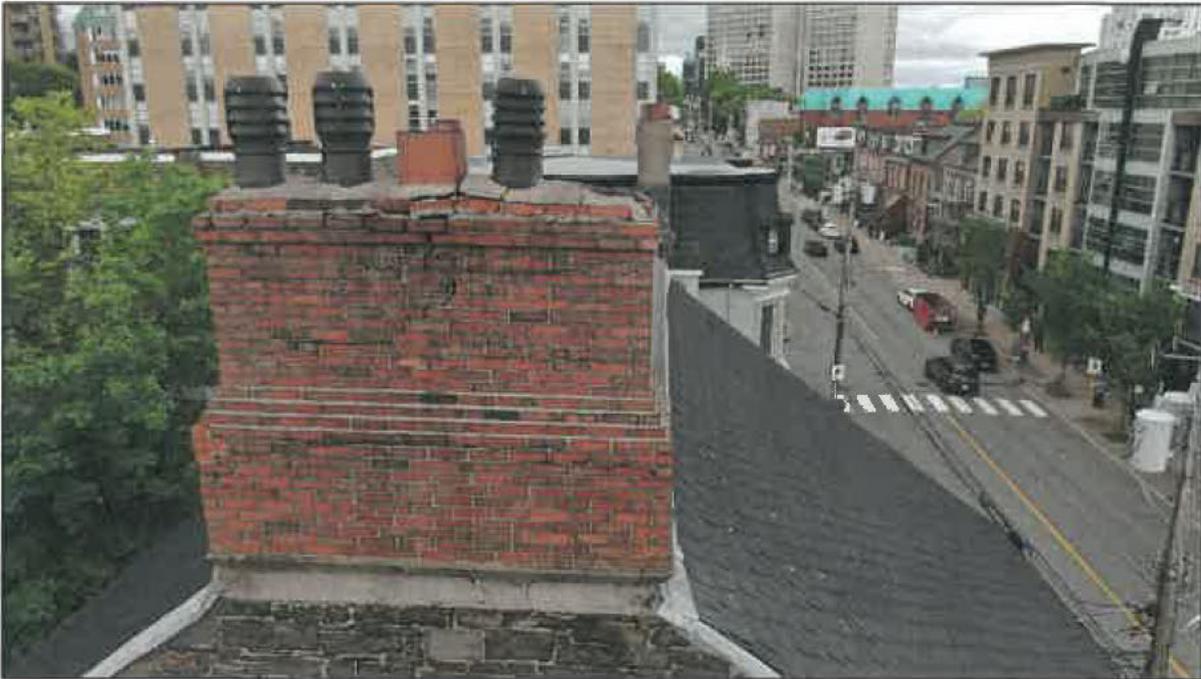
The inspection and condition review of Henry House indicated the interior and exterior was observed to be in Good to Fair condition for most areas, consistent with expectations for a well-maintained Heritage Building of similar age. Two areas are identified as in Poor condition, the entrance walkway and the exterior chimney, which are not consistent with expectations for well-maintained Heritage Building of similar age.

The opinion in the condition review was that these two areas, in particular, due to the current Poor condition, may experience some shift and/or dislodgement even if the PPV is in compliance with the blasting limits for Heritage Properties. As discussed, the limits recommended for Henry House are similar to what will be experienced daily at the building for the current operation and the risk of damage can be reduced by halting vibration generating activities at the business during blasting. Further, providing a perimeter around the stone chimney inside and outside during blasts, as recommended in the structural report, are encouraged to protect the public from falling objects that may result from blasts.

**Photo 29** Chimney deterioration, cracks and mortar loss

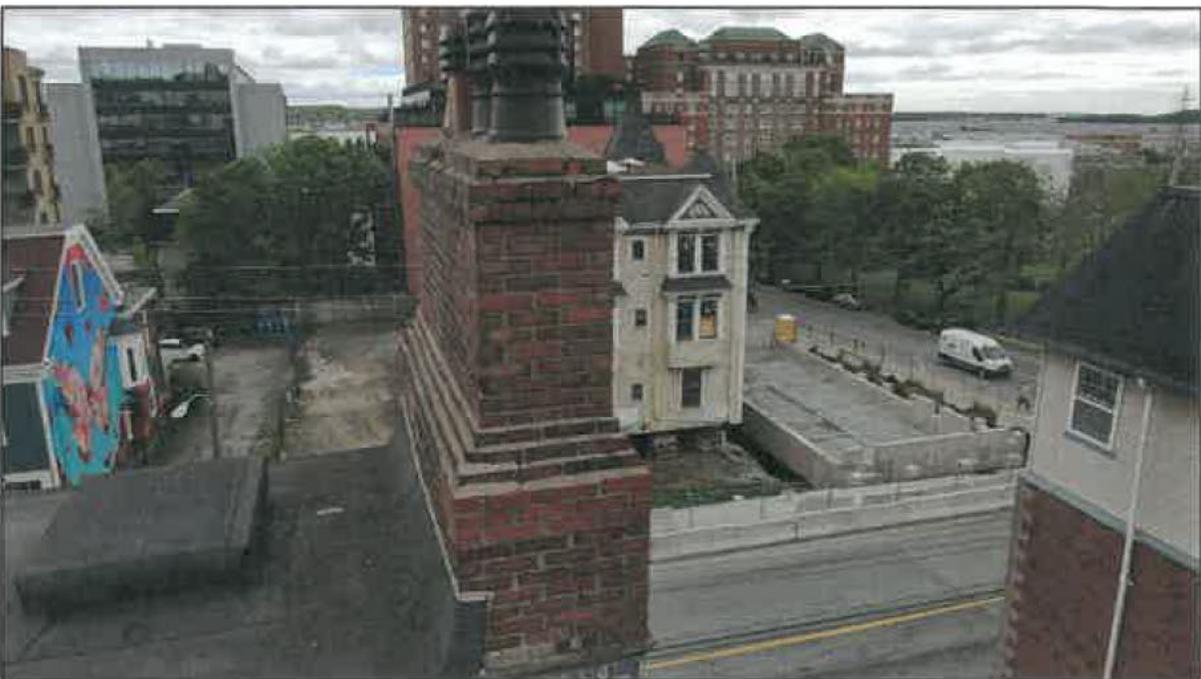
**Photo 30** Side view of chimney

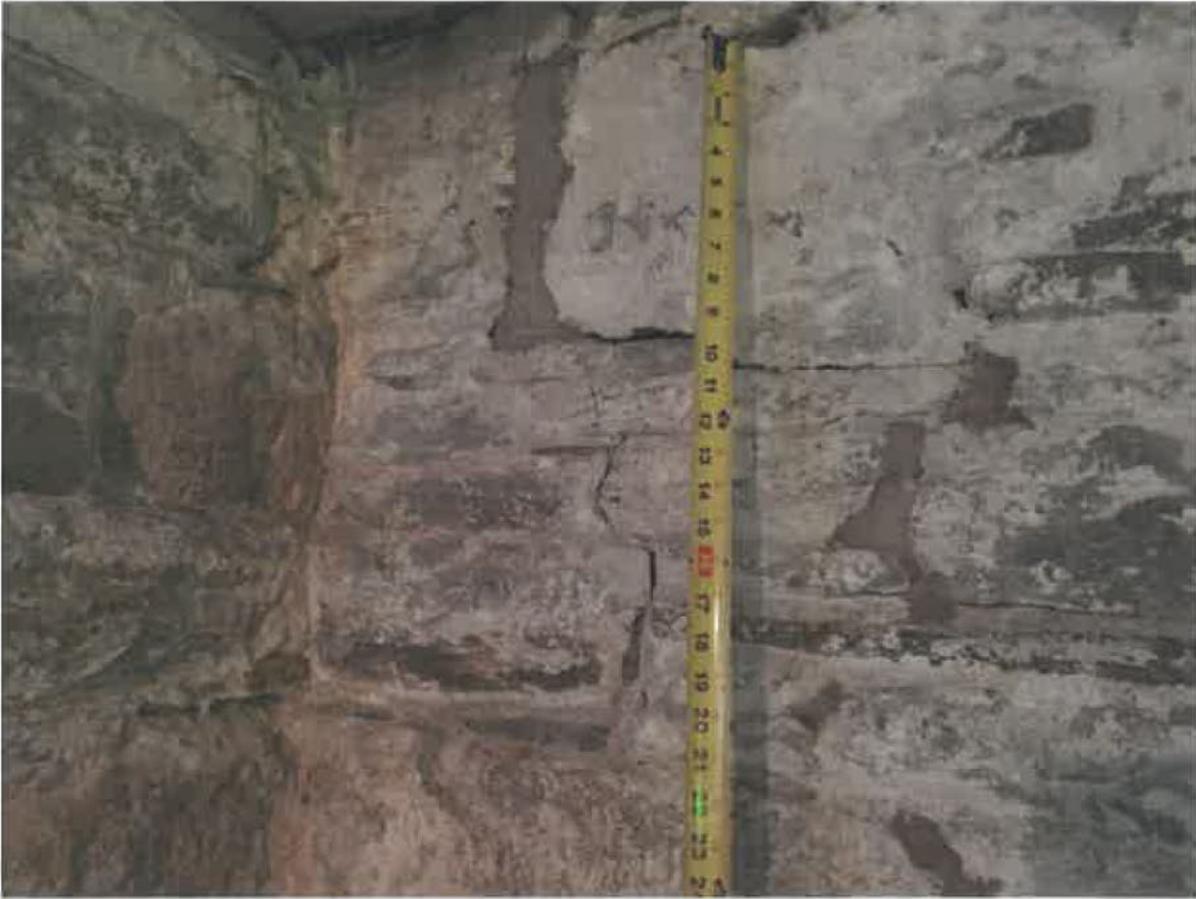
Fig 1-1 Cracking and repairs in the north-east corner of the basement.

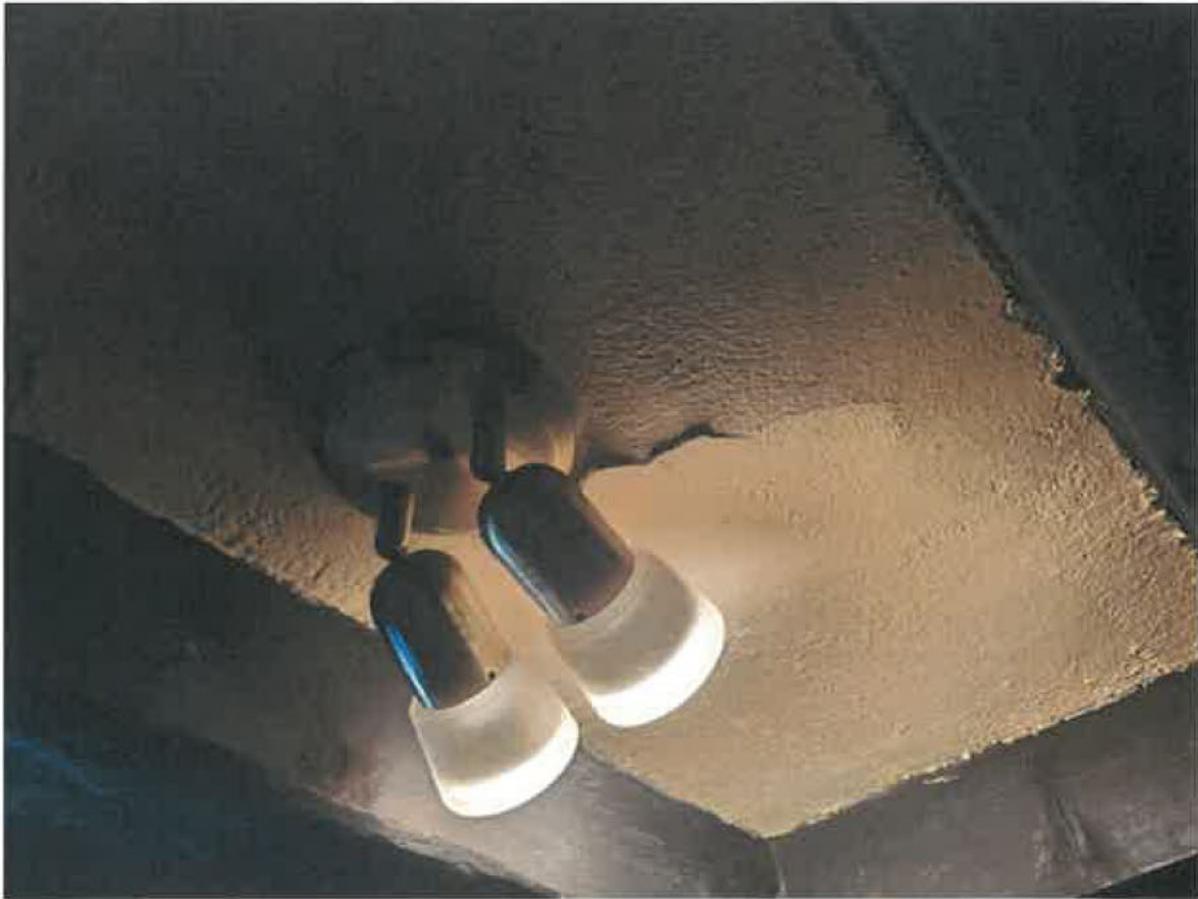
Fig 1-2 Cracking in the ceiling on the northern-eastern side of the dining section of the basement.

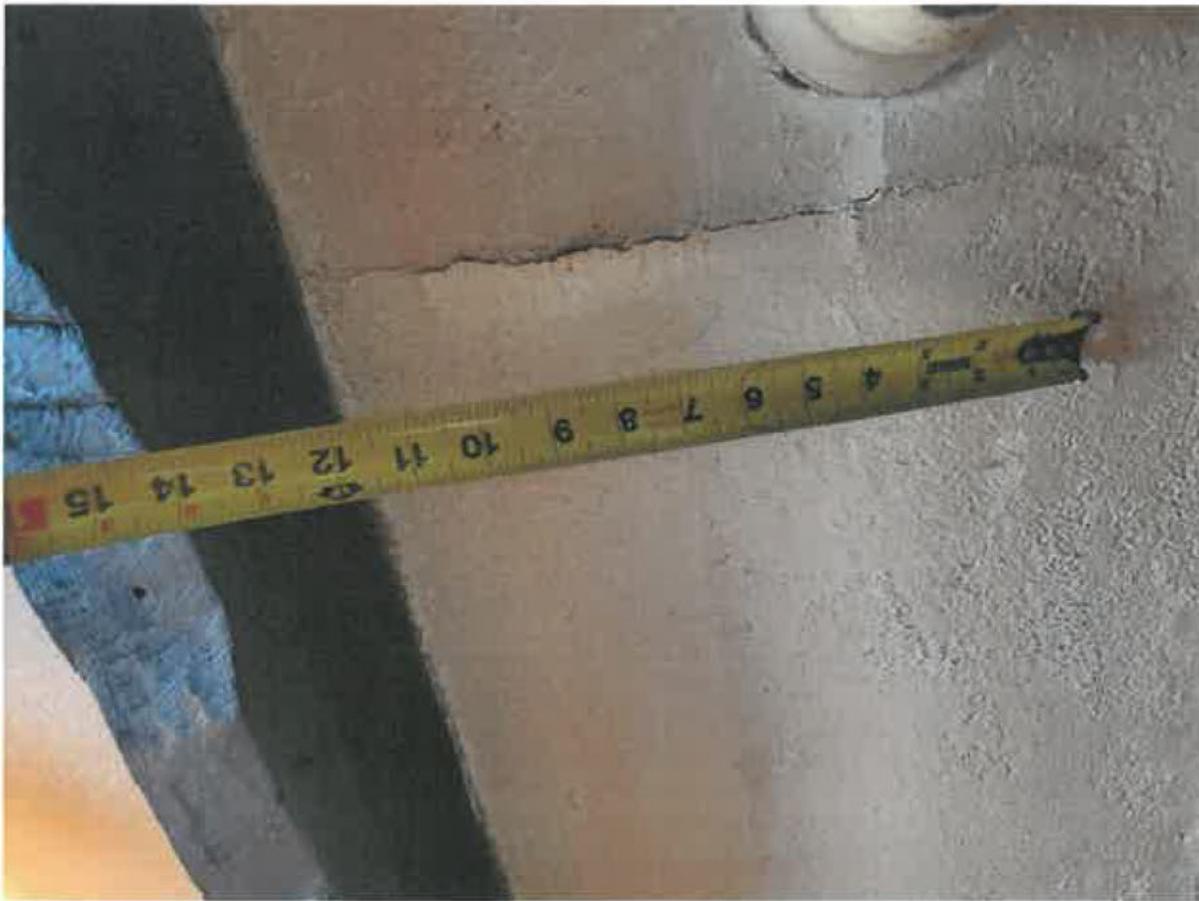
Fig 1-3 Further cracking of the ceiling in the dining area of the basement.

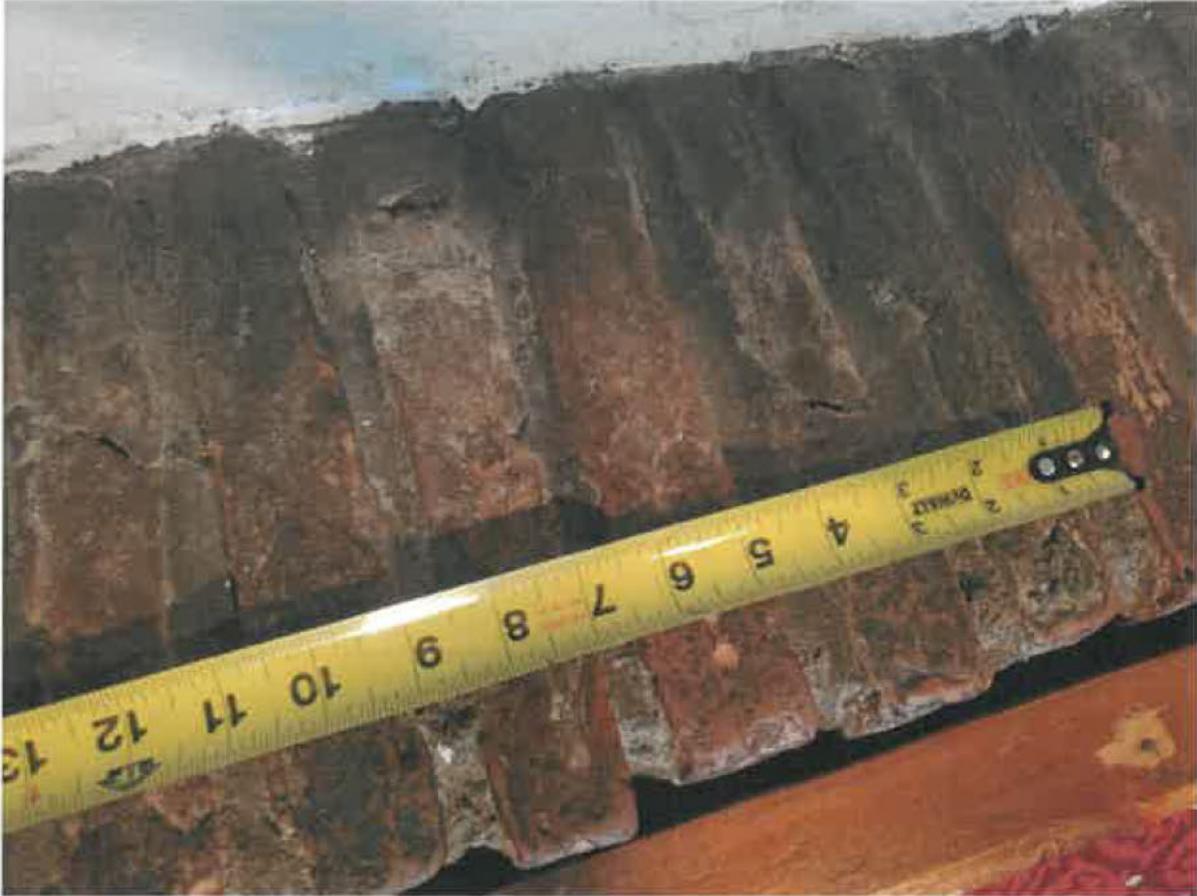
Fig 1-4 cracking of brickwork on the south-western side of the dining area in the basement.

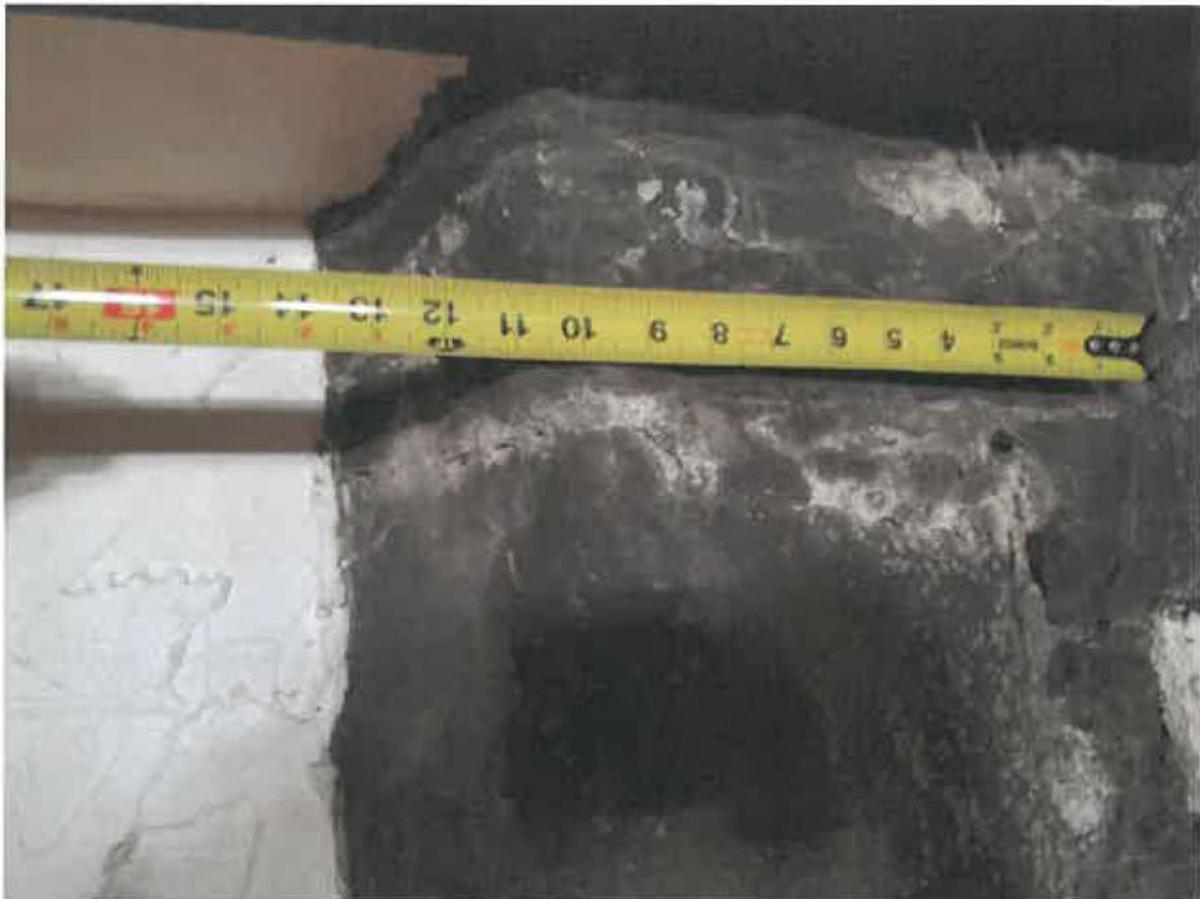
Fig 1-5 Mortar deterioration and cracking in south-western portion of dining area of the basement.

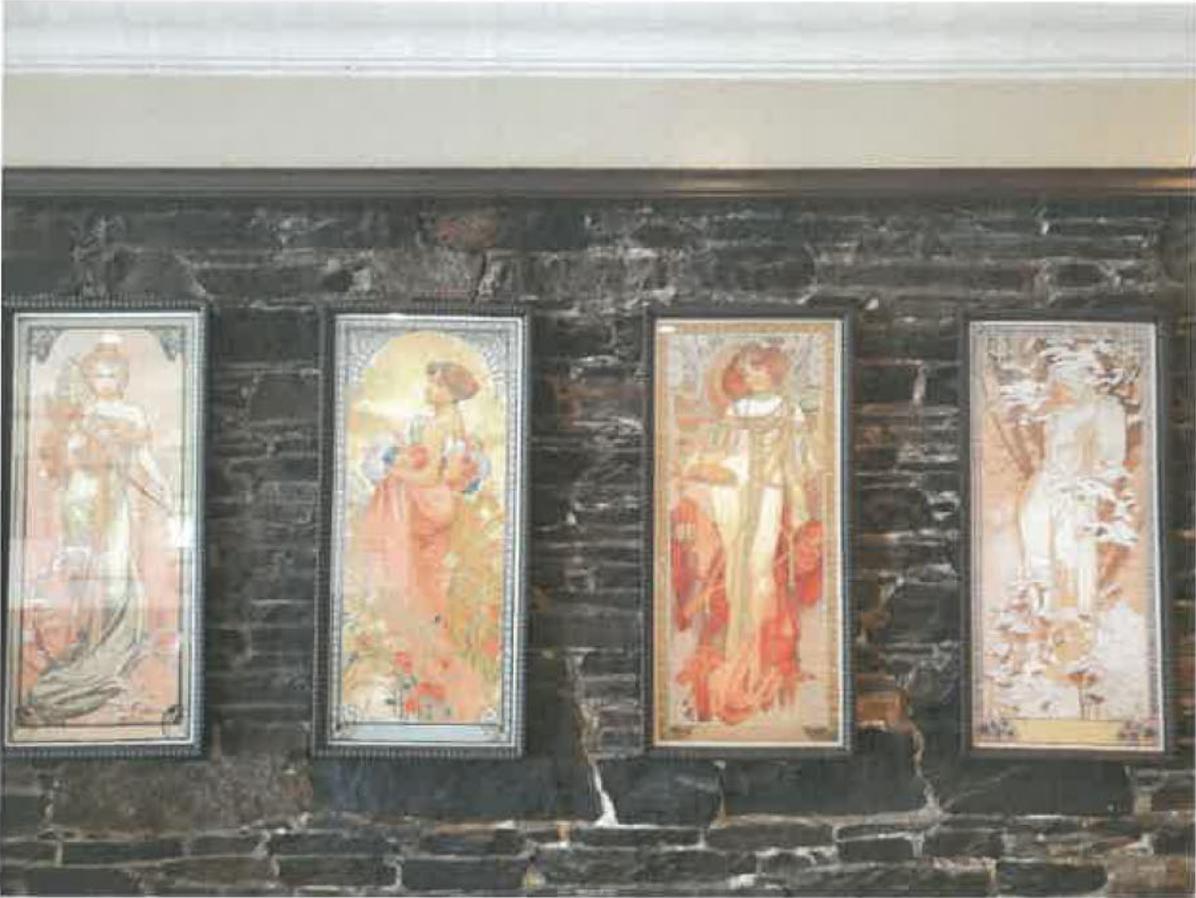
Fig 1-6 Cracking in the stone wall on the south side of the main dining room, first floor.

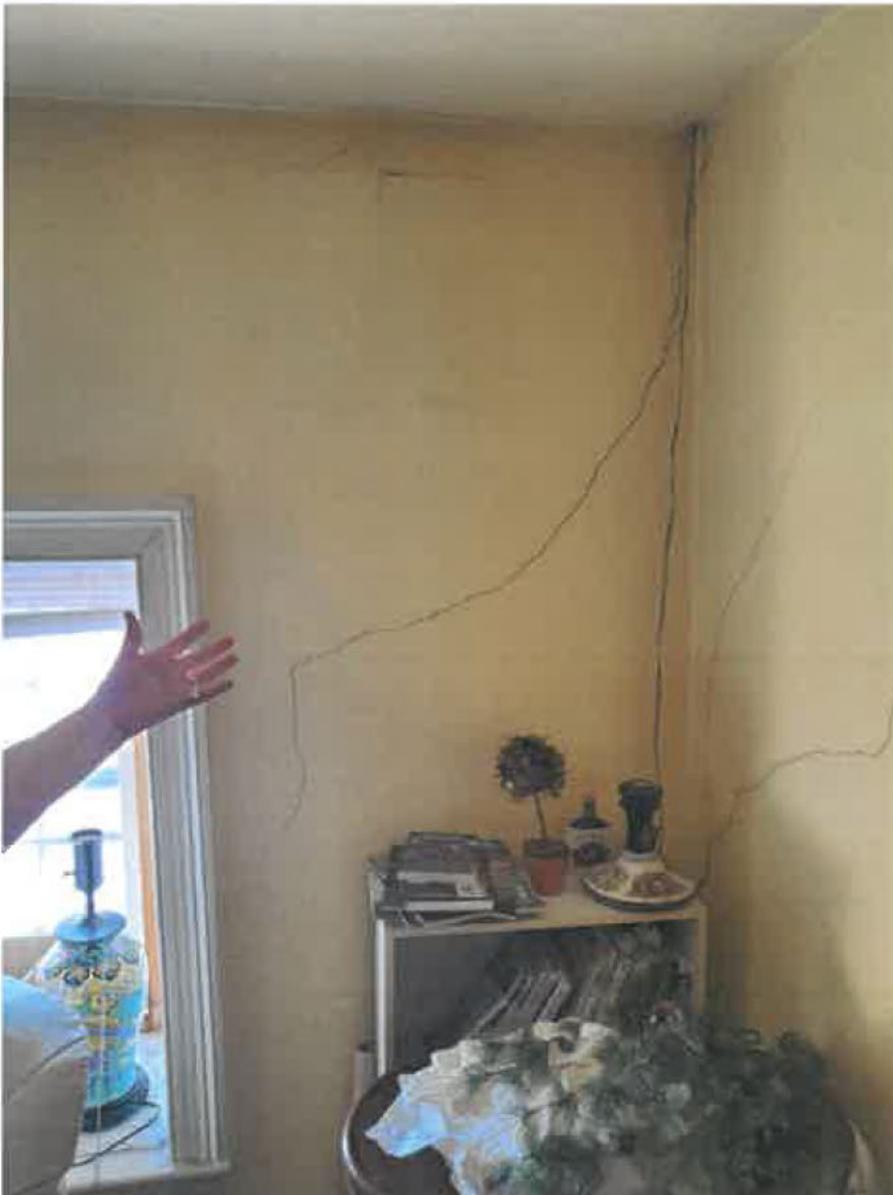
Fig 1-7 Cracking of the predominantly the southern wall on the third floor.

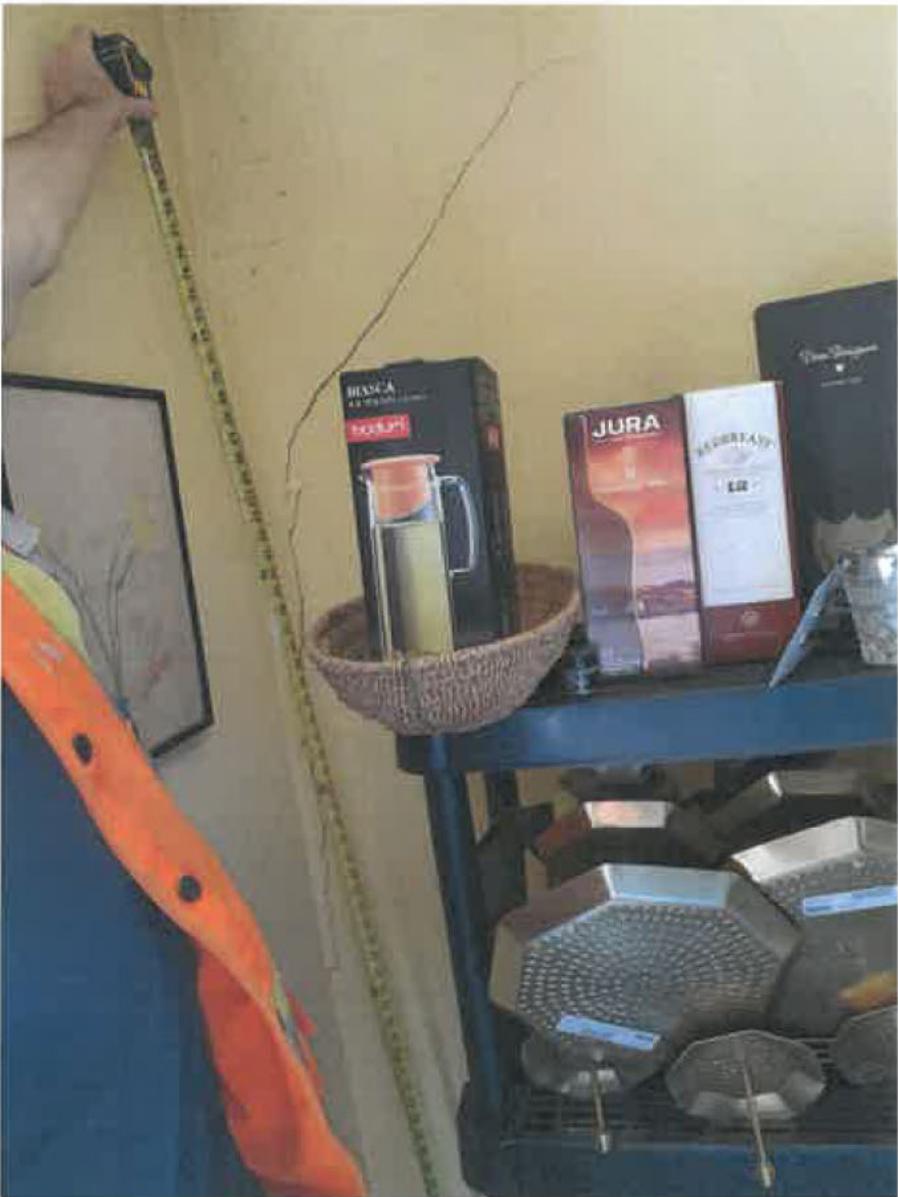
Fig 1-8 Cracking on the southern side of the third floor.

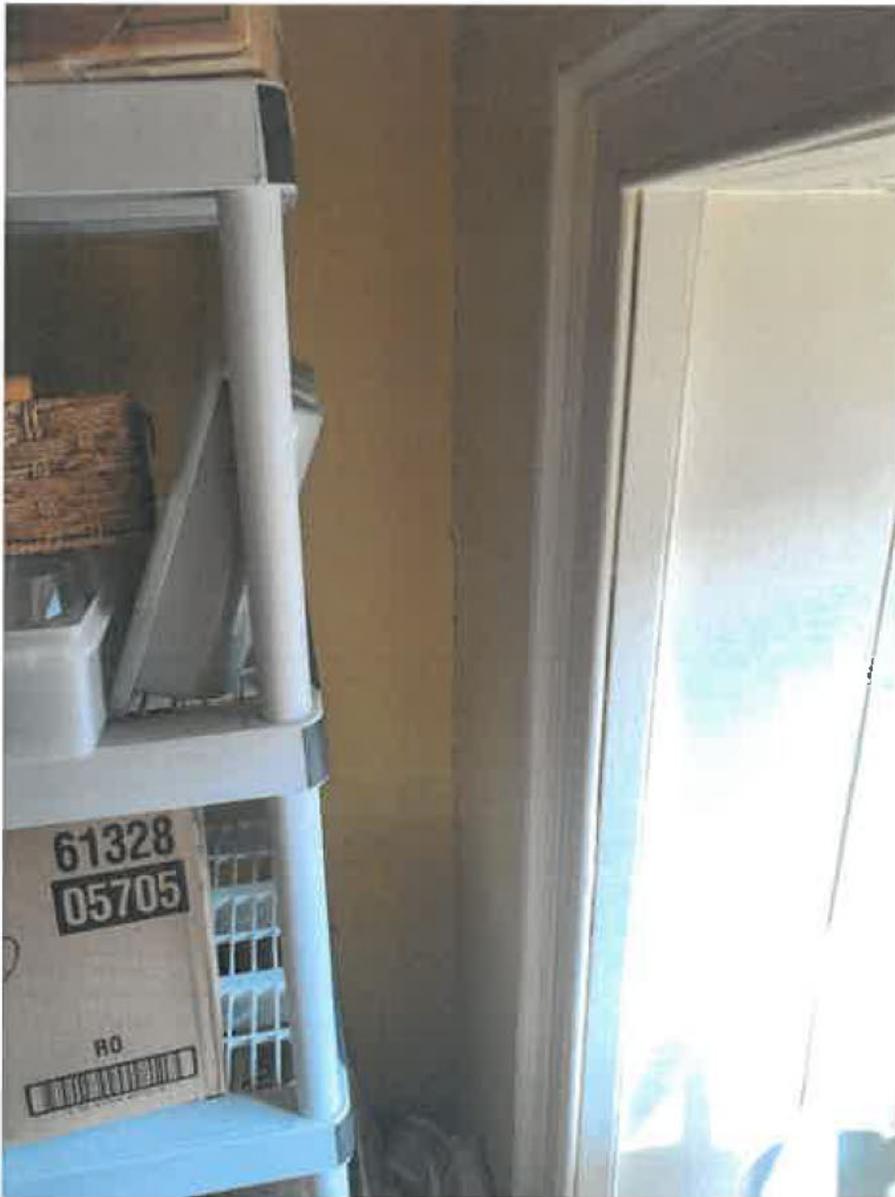
Fig 1-9 Cracking on the southern side of the third floor.

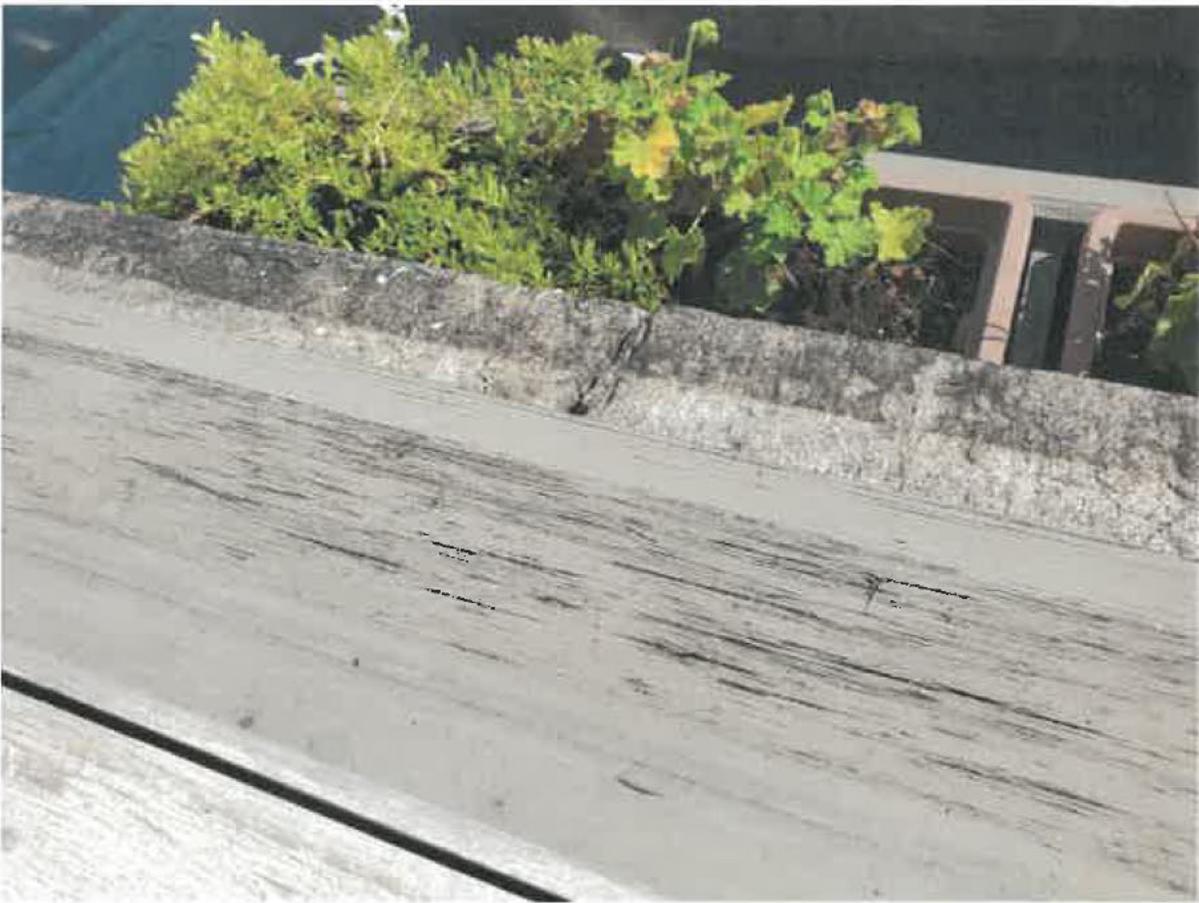
Fig 1-10 Cracking of the windowsill stone on the southern side of the second floor.

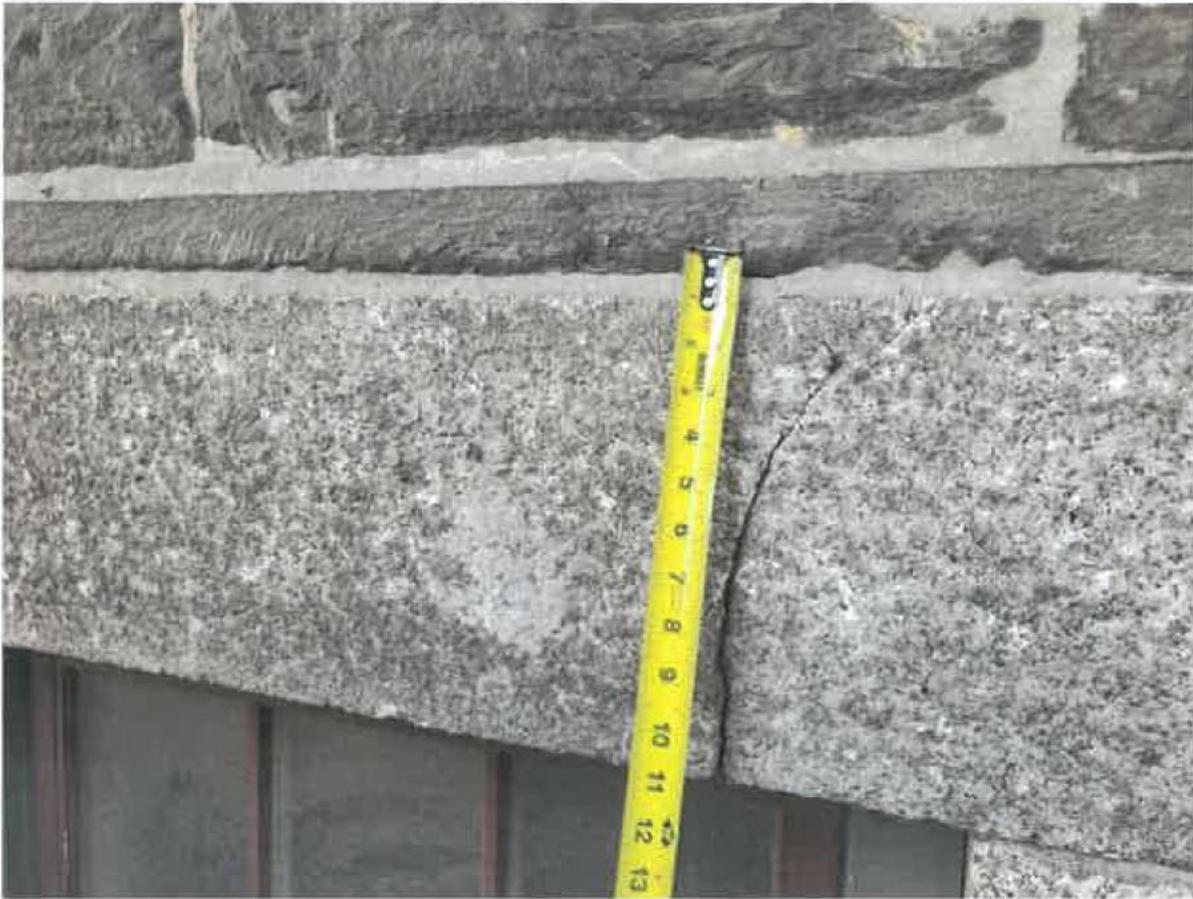
Fig 1-11 Cracking in windowsill at ground level on northern exterior of building.

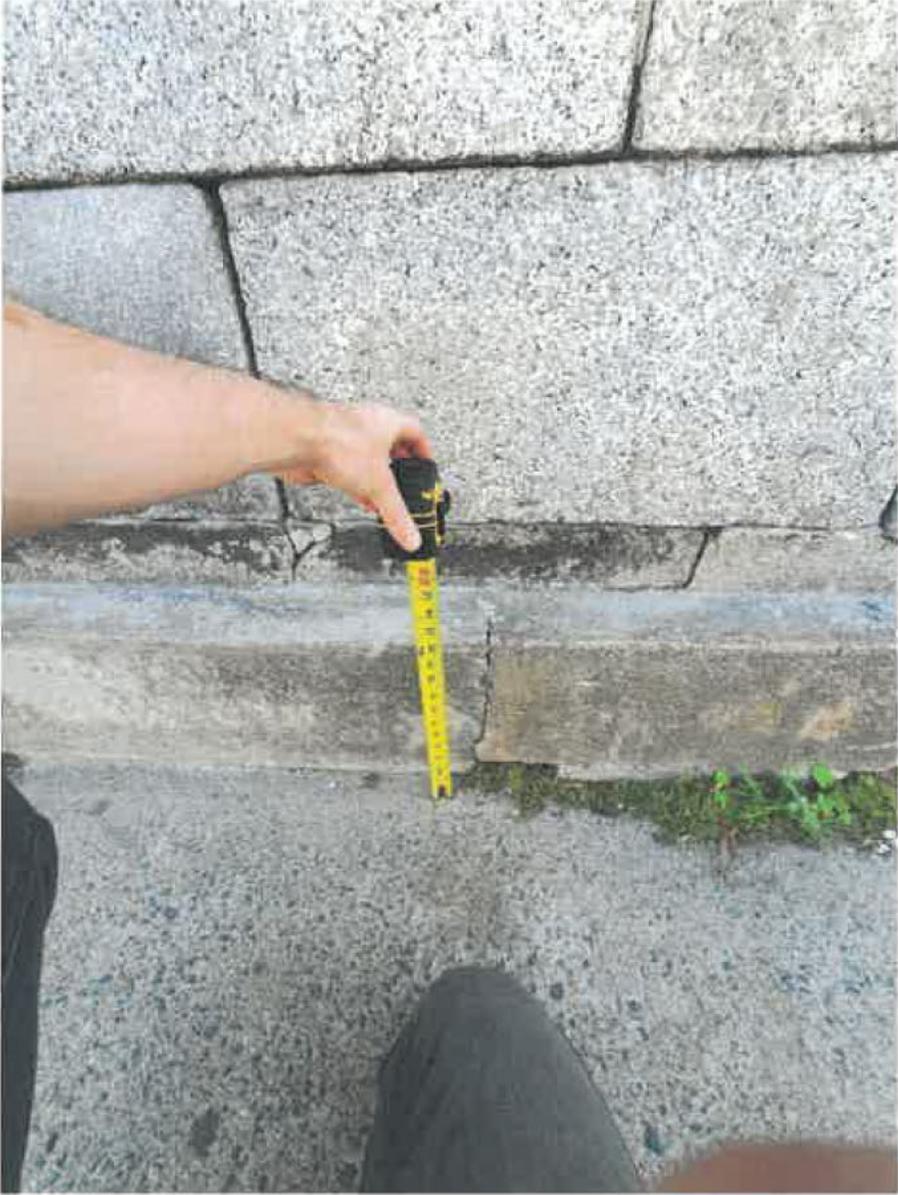
Fig 1-12 Cracking at base of building on eastern exterior of the building.

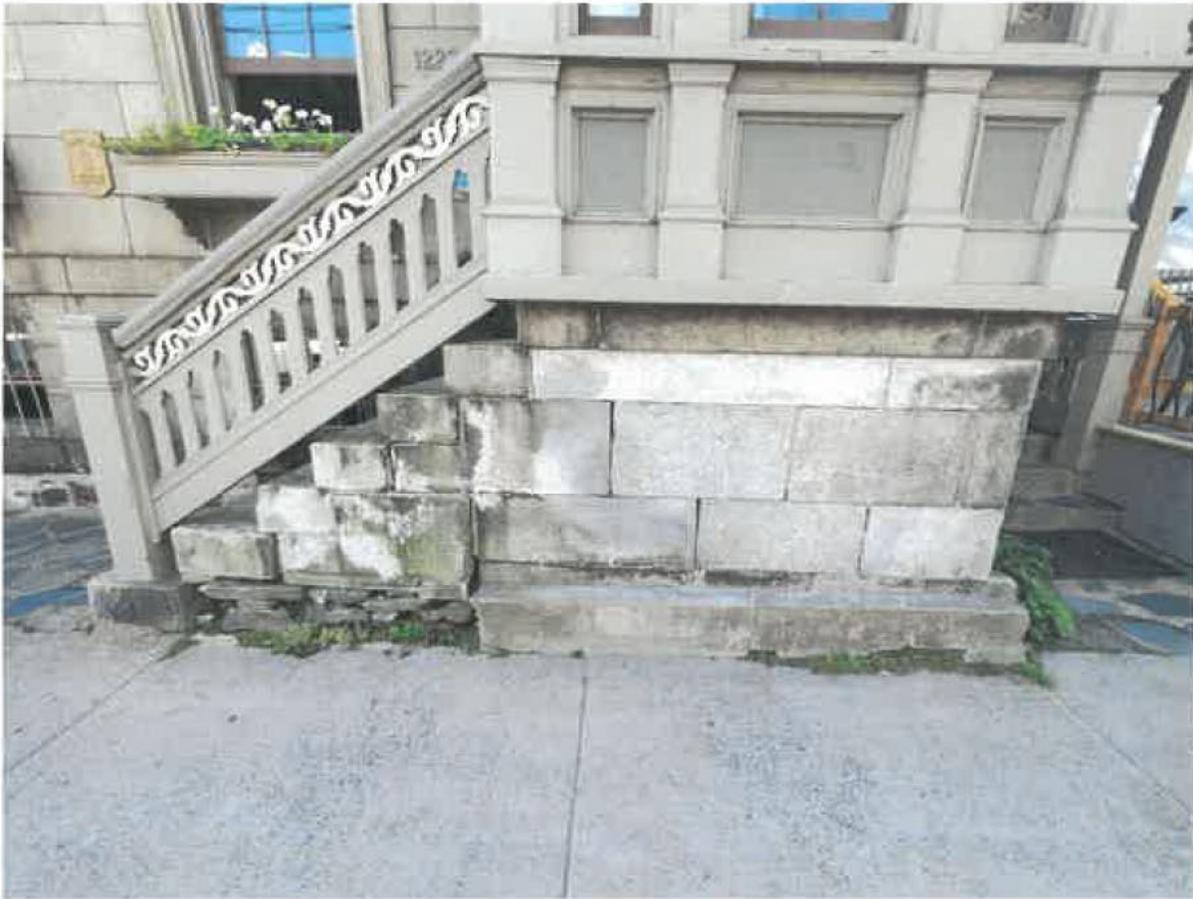
Fig 1-13 Missing mortar and zoomed out view of crack at base of building on the eastern exterior of the building.

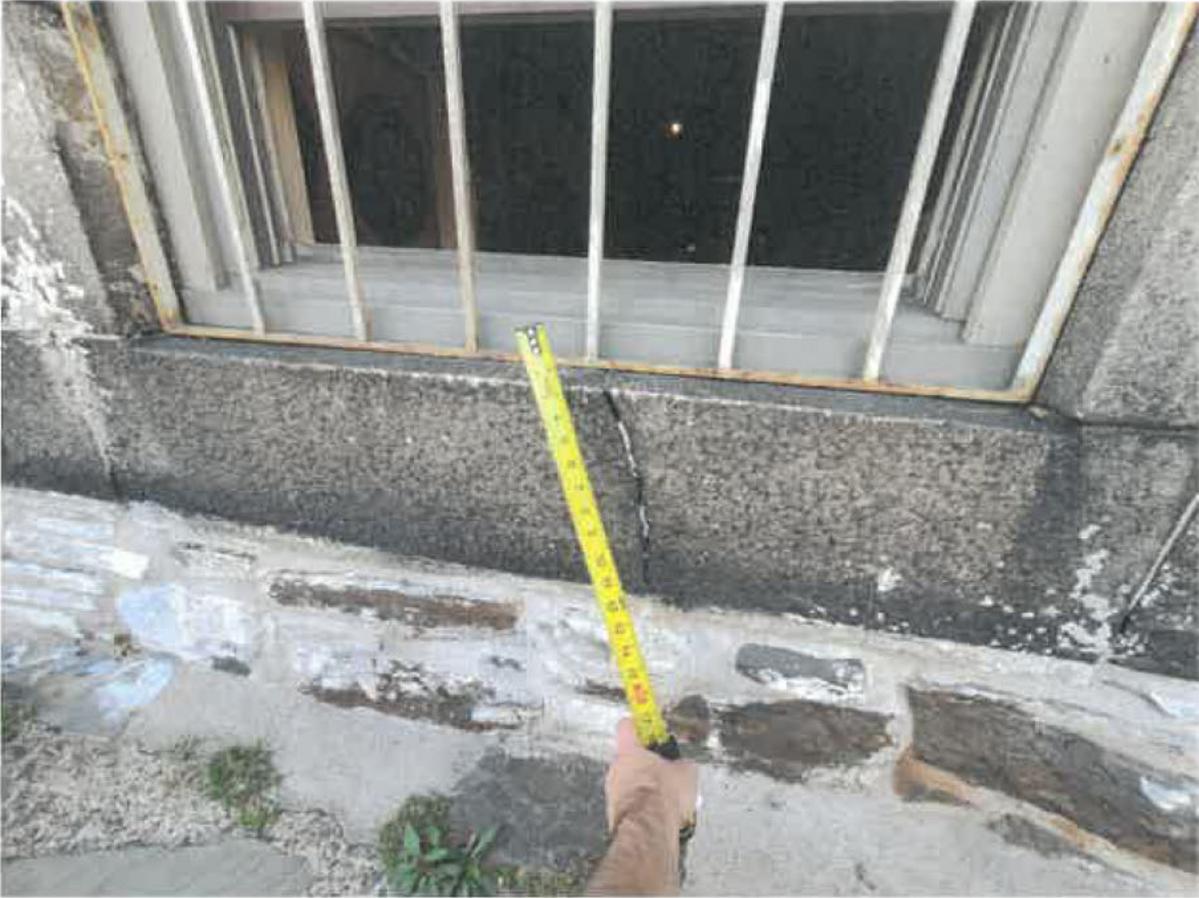
Fig 1-14 Cracking of windowsill on eastern exterior of building at ground level.

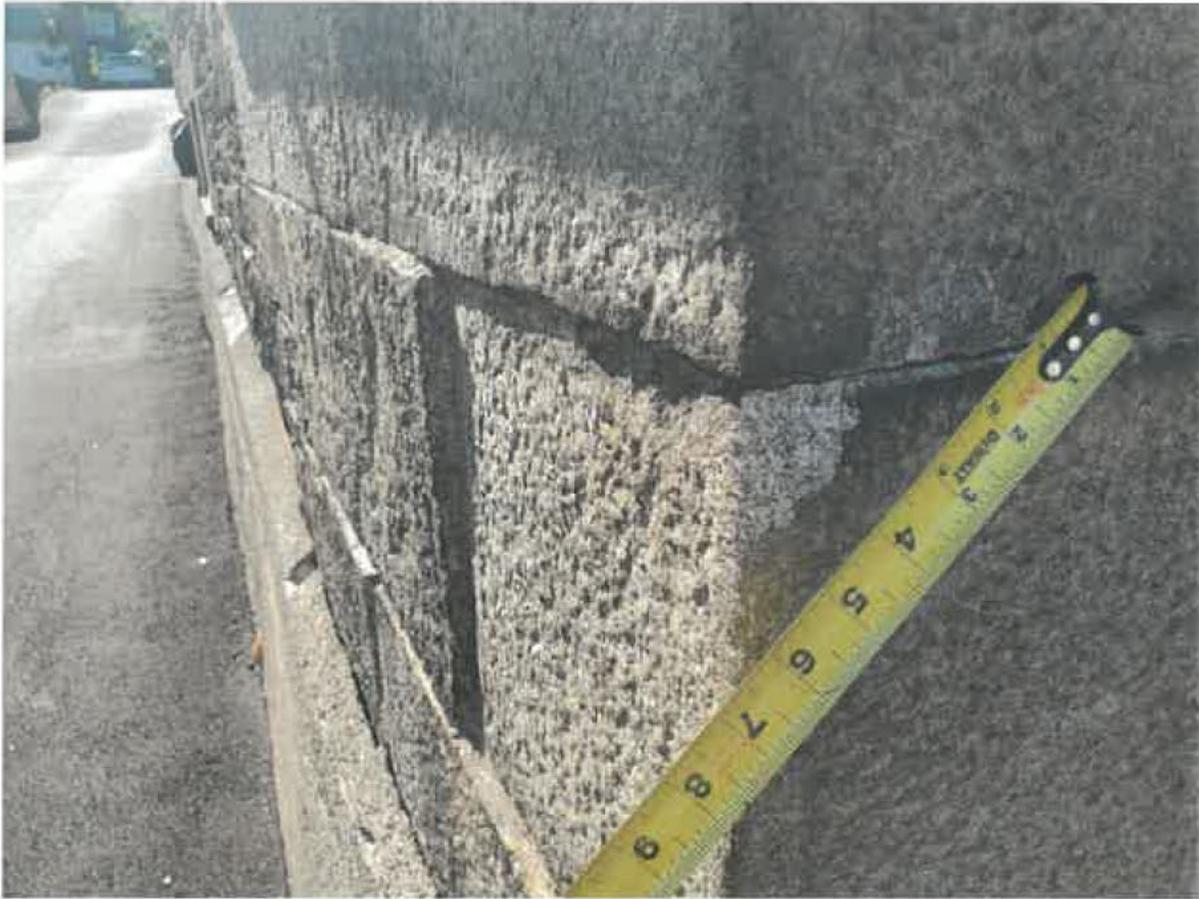
Fig 1-15 Freshly chipped stone on south-eastern corner of the exterior.

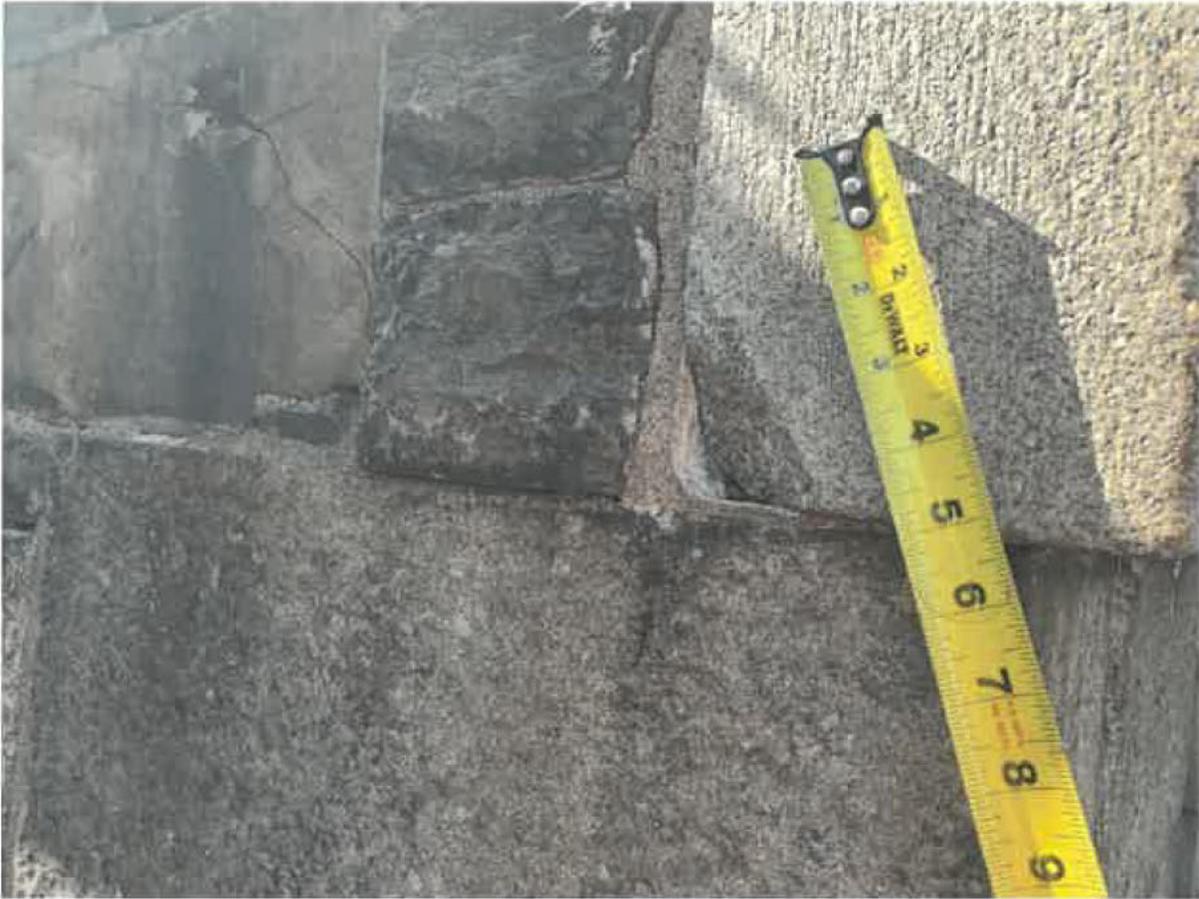
Fig 1-16 A second freshly chipped stone on the south-eastern corner of the exterior.

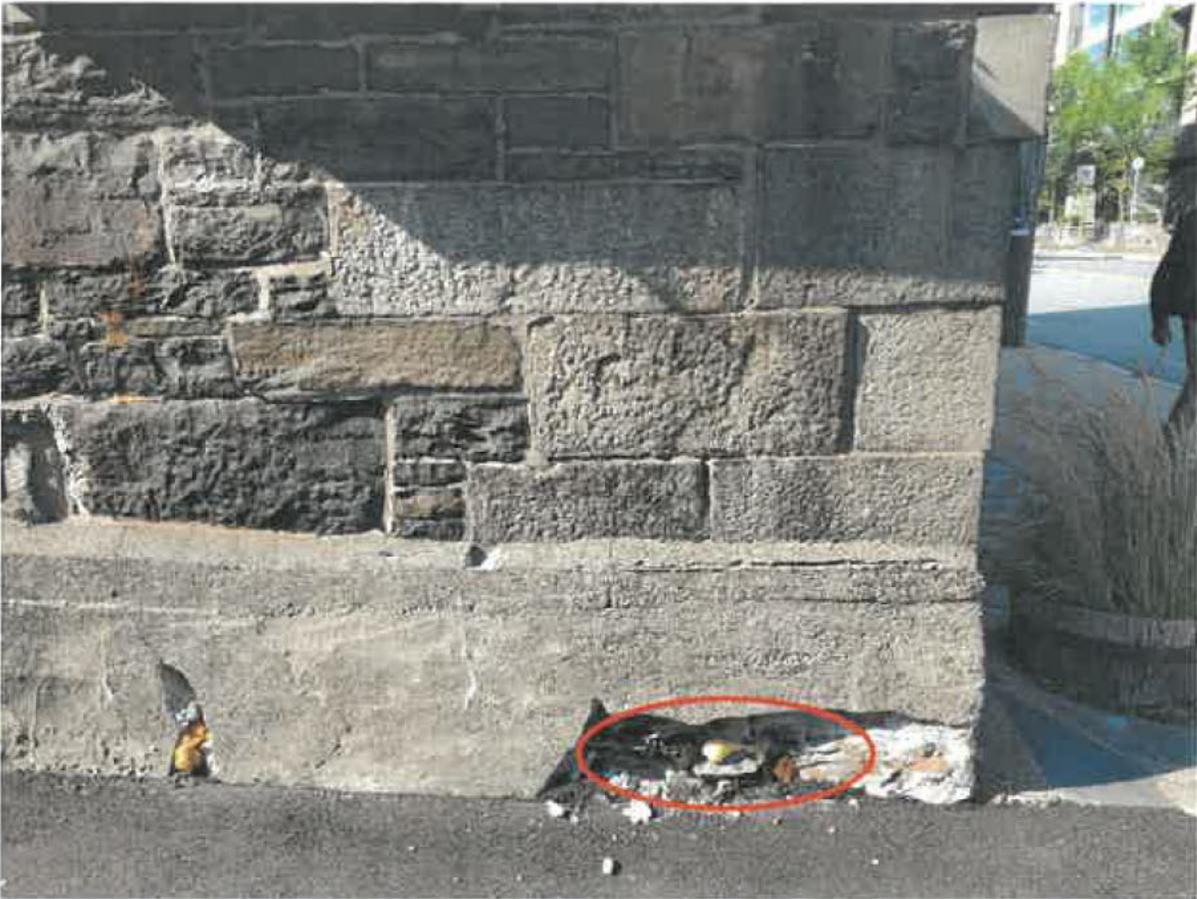
Fig 1-17 Freshly filled in cracks/gaps at base of south-eastern corner exterior.

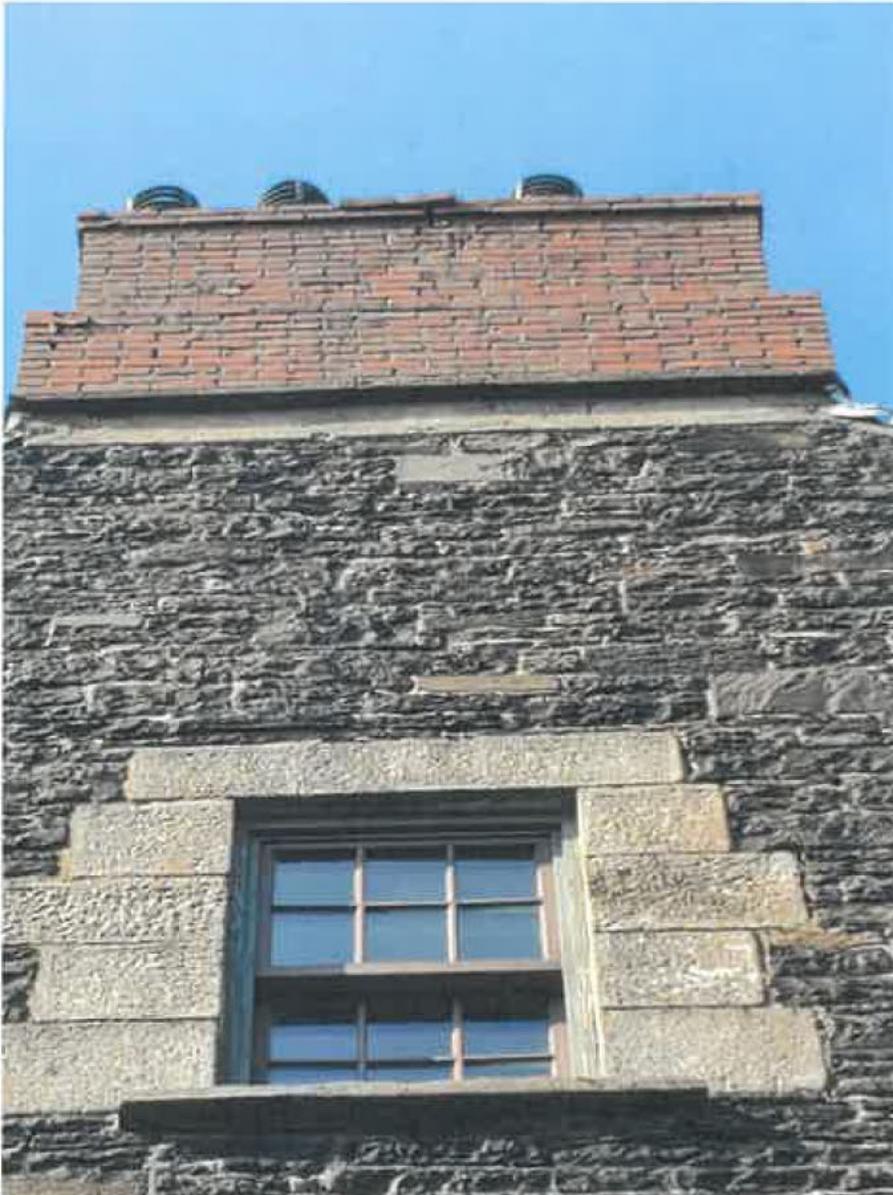
Fig 1-18 Loose overhanging bricks at top of chimney stack.
