## Heritage Impact Statement

First Baptist Church, 1300 Oxford Street

Halifax, June 2025

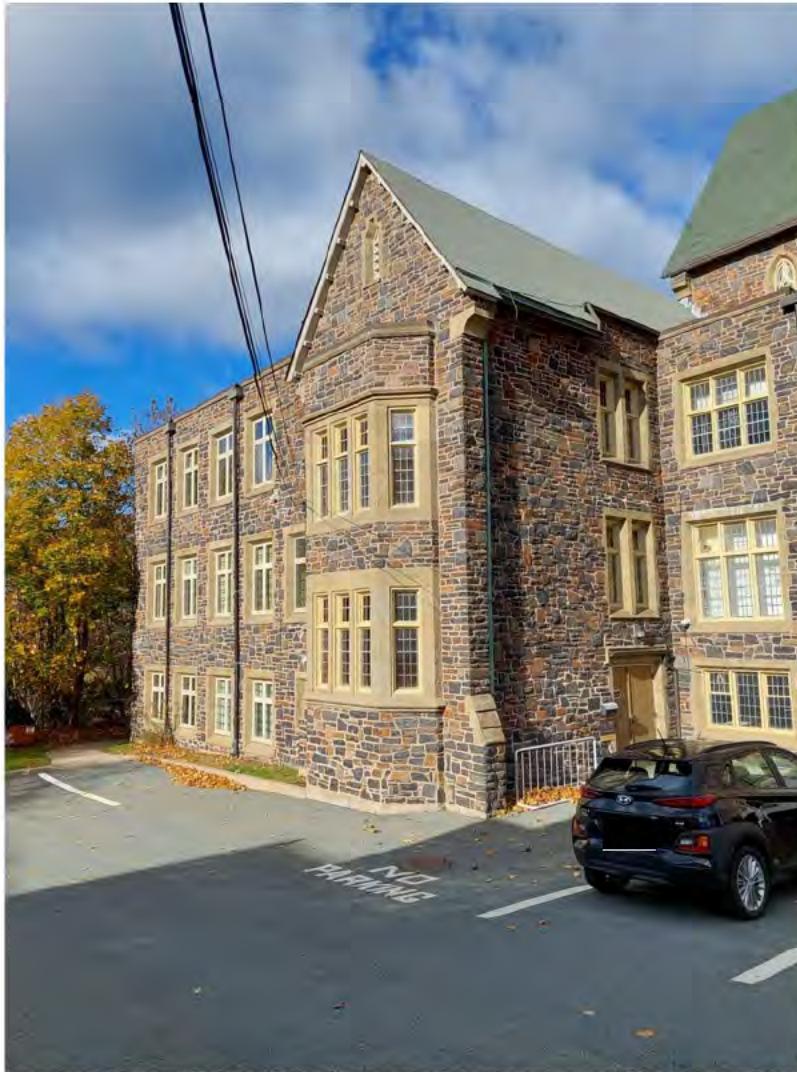
Overall, the integrity of First Baptist Church is excellent. The only notable alteration is the connection of a newer building, comprising a two-storey addition with a basement, situated primarily at the rear, but also highly visible on the south side, and on the north side, appearing as a 'wrap-around form' attached to both the rear and covering some of the east side (Figures 31 and 32).

Figure 31: Rear addition as seen wrapping around the south side, with original portion of church at top right (roof and partial wall)

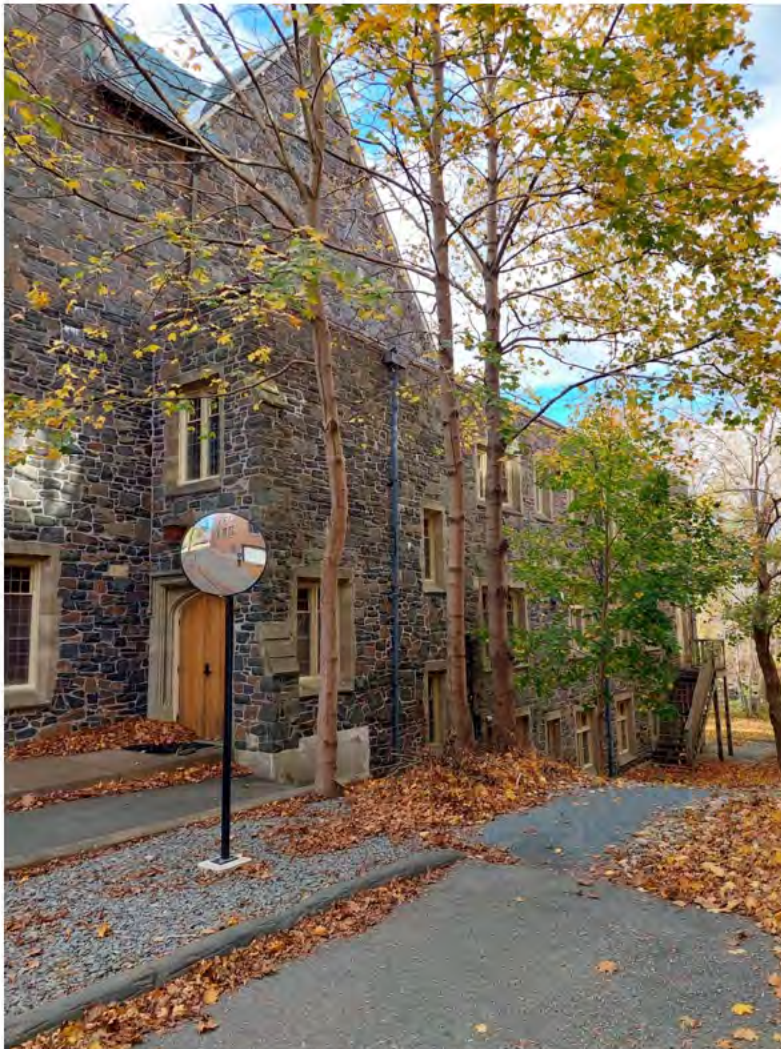
**Figure 32: Rear addition as seen wrapping around the north side**

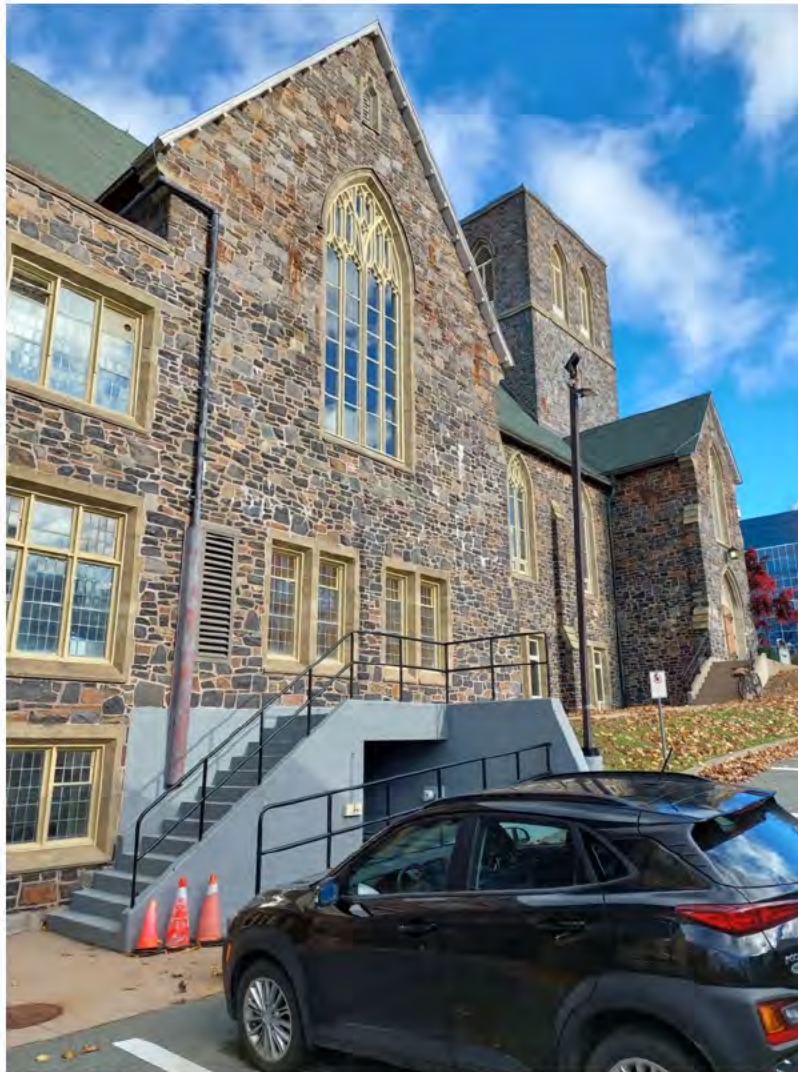
Wood frames, sills and mullions are in generally fair condition, although some are in poor condition and will need repair. These include the transept windows on all sides but particularly the south transept window. The windows have a tapered stone “trim” comprised of individual stone sections mortared in place, and poor mortar conditions were observed at the stone “trim” at the head of all windows.

**Figure 35c: First Baptist Church, 1300 Oxford Street – partial south side. South transept window, top centre.**

Action: Preservation and rehabilitation. Select repair where necessary, and in the case of the south transept window, a replacement in full (with retention and reincorporation of the glass).

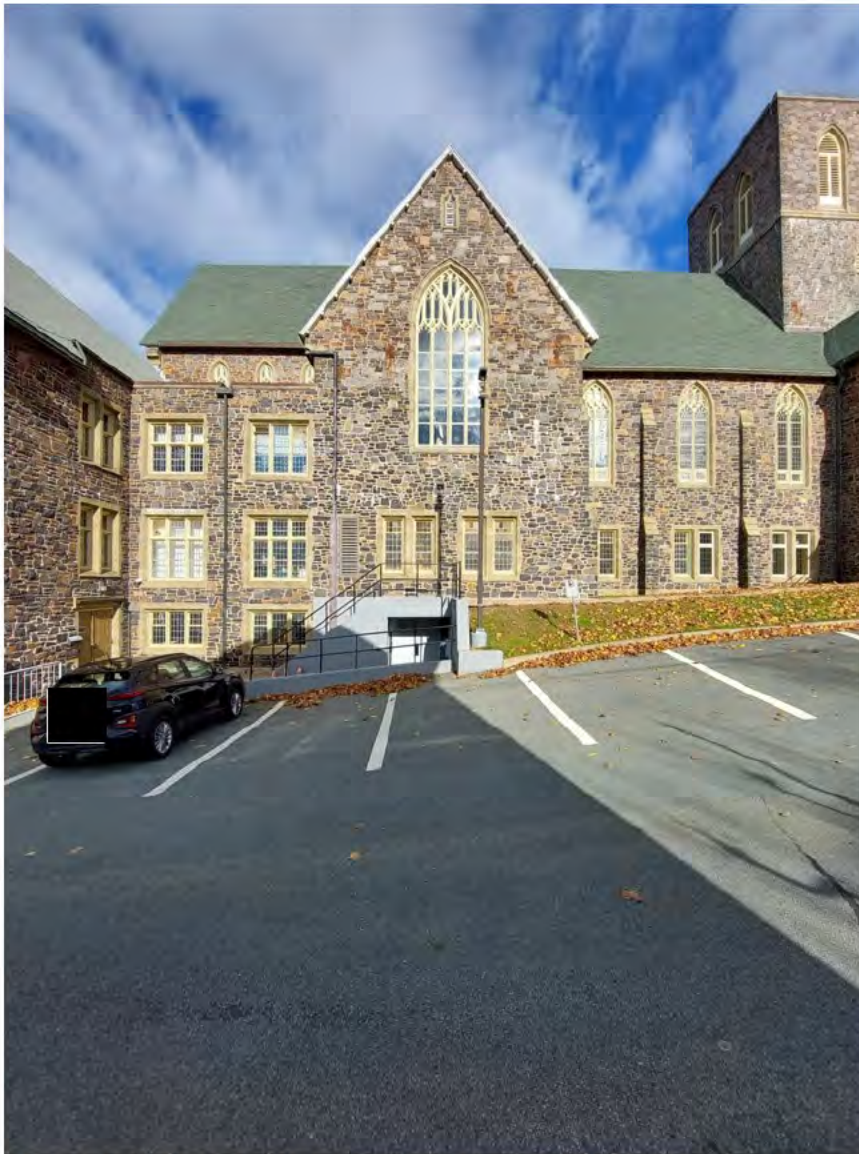
Figure 35d: First Baptist Church, 1300 Oxford Street – partial south side with connection to newer addition (far left). South transept window, centre.

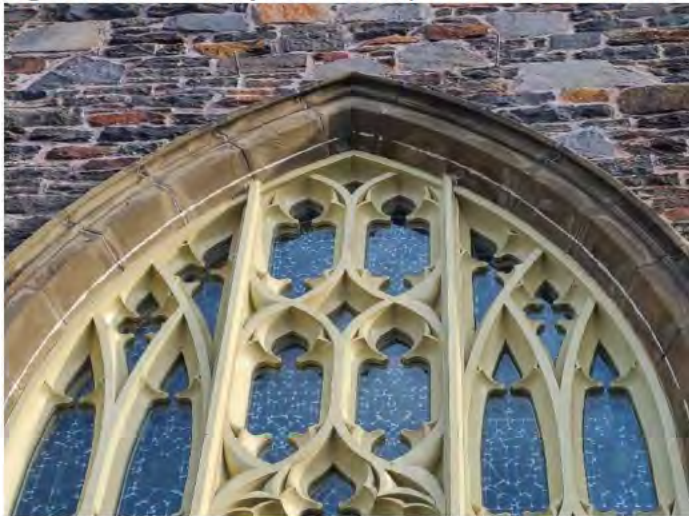
Stone, in generally good condition on all sides. Certain areas are showing signs of whitening of the mortar, which needs to be investigated further.

**Figure 35j: First Baptist Church, 1300 Oxford Street – top of west side window showing wall efflorescence and deterioration at mortar joints**
