October 23, 2023

The Birches Nursing Home
Musquodoboit Harbour, NS
c/o Eastin Projects Ltd

Subject: **Wetland Determination at The Birches Nursing Home proposed site, portion of PID No. 40192528, Musquodoboit Harbour, Nova Scotia**
Englobe reference: 2307051.001

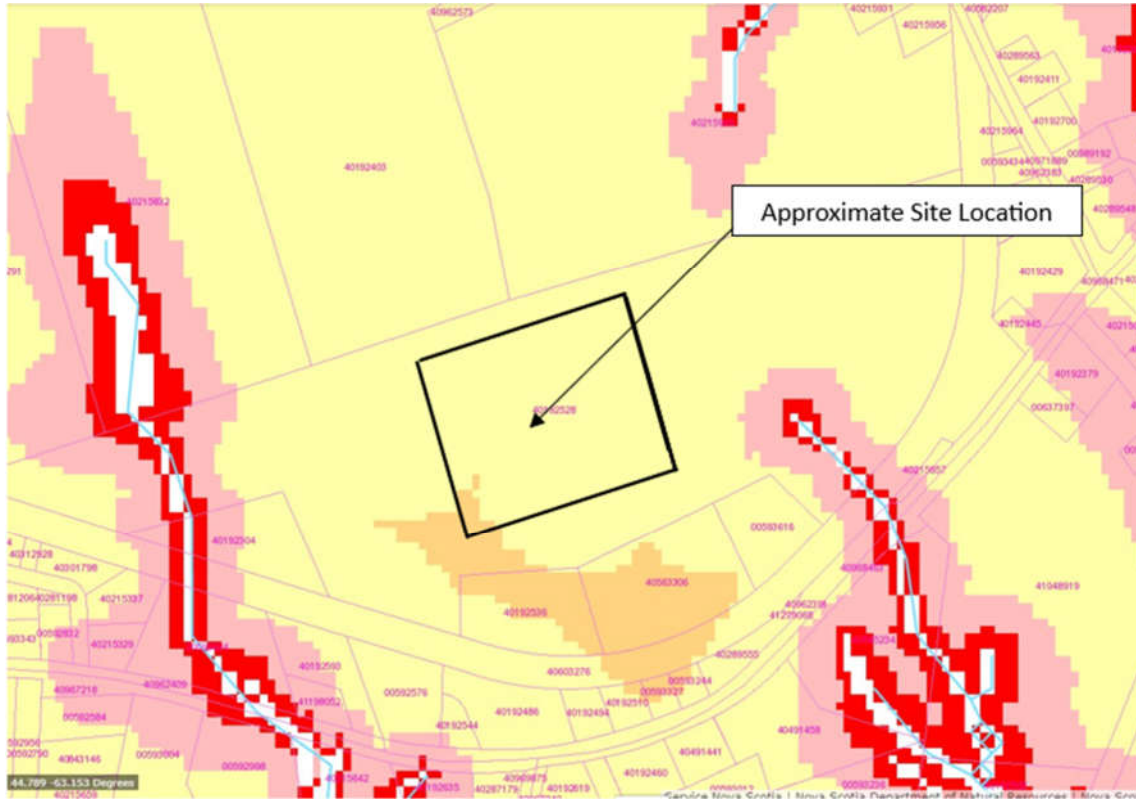
Figure 3-1 (Provincial Landscape Viewer, Wet Areas Mapping layer), with approximate location of The Birches parcel. Predicted wet areas are shown in red and pink.

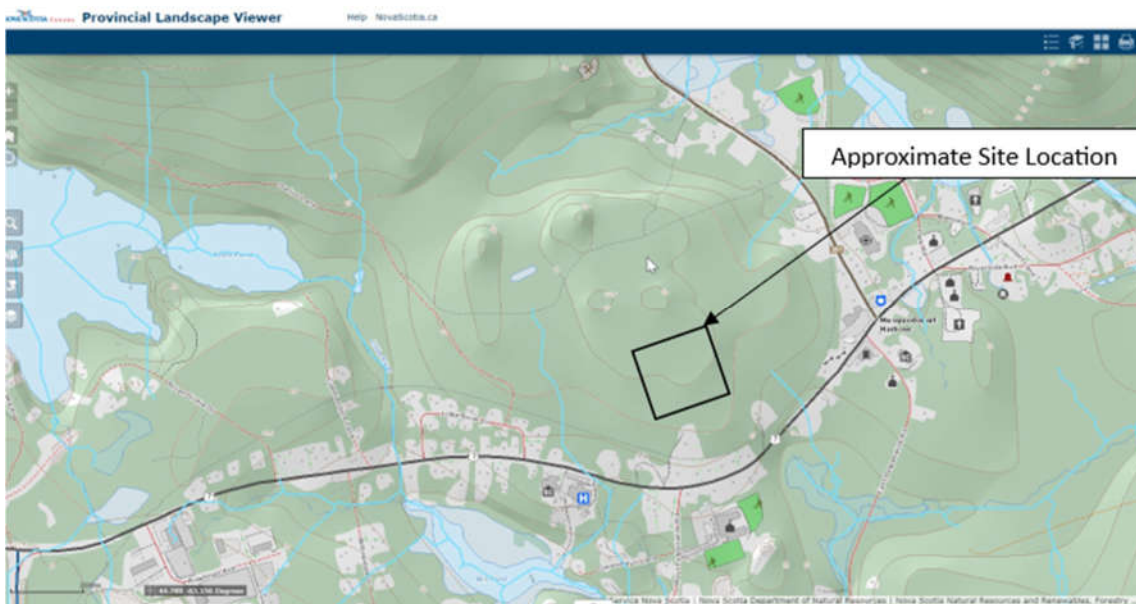
Figure 3-2 (Provincial Landscape Viewer, mapped wetlands layer), with approximate location of The Birches parcel. There are no provincially mapped wetlands on the site.

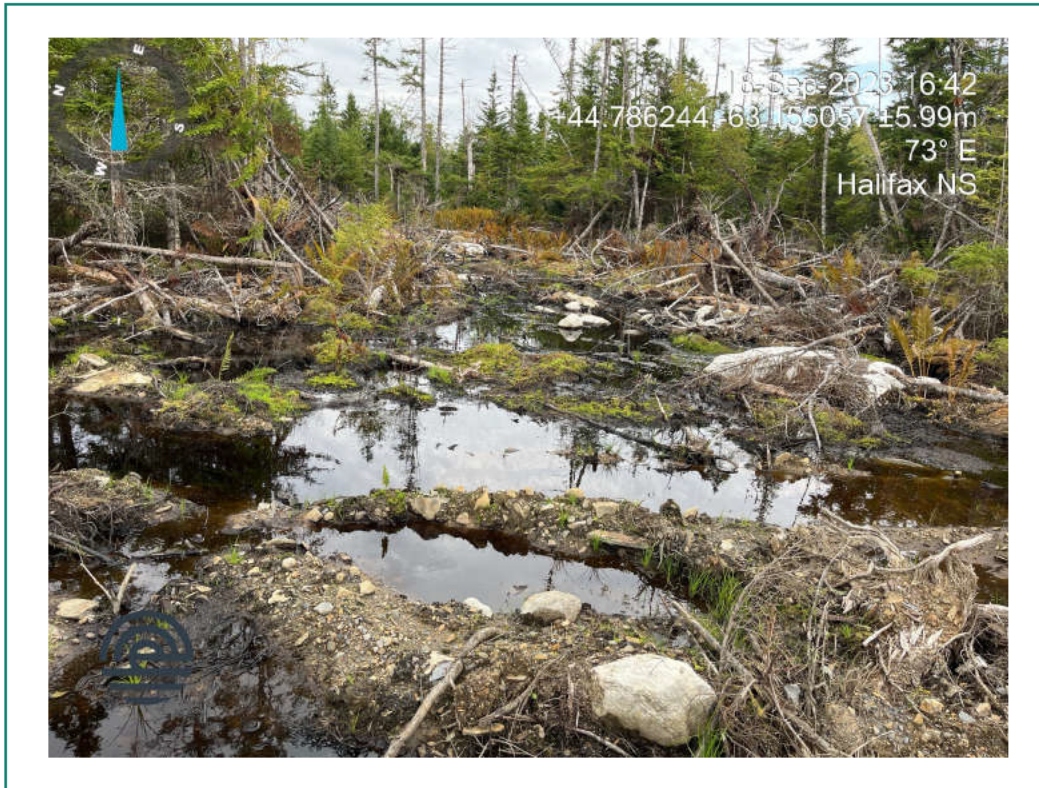
As noted during the Phase I ESA site reconnaissance, a wet area was encountered in the central/northwestern area of the parcel where the site elevation was relatively high, but the topography was fairly flat. This area was highly disturbed by tree clearing, excavator track ruts and some former test pits. Ponded water was trapped in track ruts. Throughout this disturbed, wet area, the shallow soil profile generally consisted of a thin layer of organics and peat (less than 20cm) over cobbles and boulders, with scant mineral soil between and beneath the cobbles. Manual test pits were excavated to the northwest and southeast of this wet area, and soil conditions were not hydric, with the exception of localized peaty pockets between some large boulders and beneath windblown trees. Vegetation surveys were conducted and determined that the dominant vegetation was general facultative (and therefore hydric). Water was present within the upper 30cm (indicating the presence of wetland hydrology), however considering the atypical wet conditions, the recent ground disturbance and the soil conditions in the test pits, the area was determined not to be wetland.

Photo 1: Wet area, significantly disturbed due to previous geotechnical test pit investigation. Photo taken in the central/northwest portion of the property where geotechnical machinery has made depressions in the landscape which hold water. Adjacent undisturbed areas did not appear to be wetland.

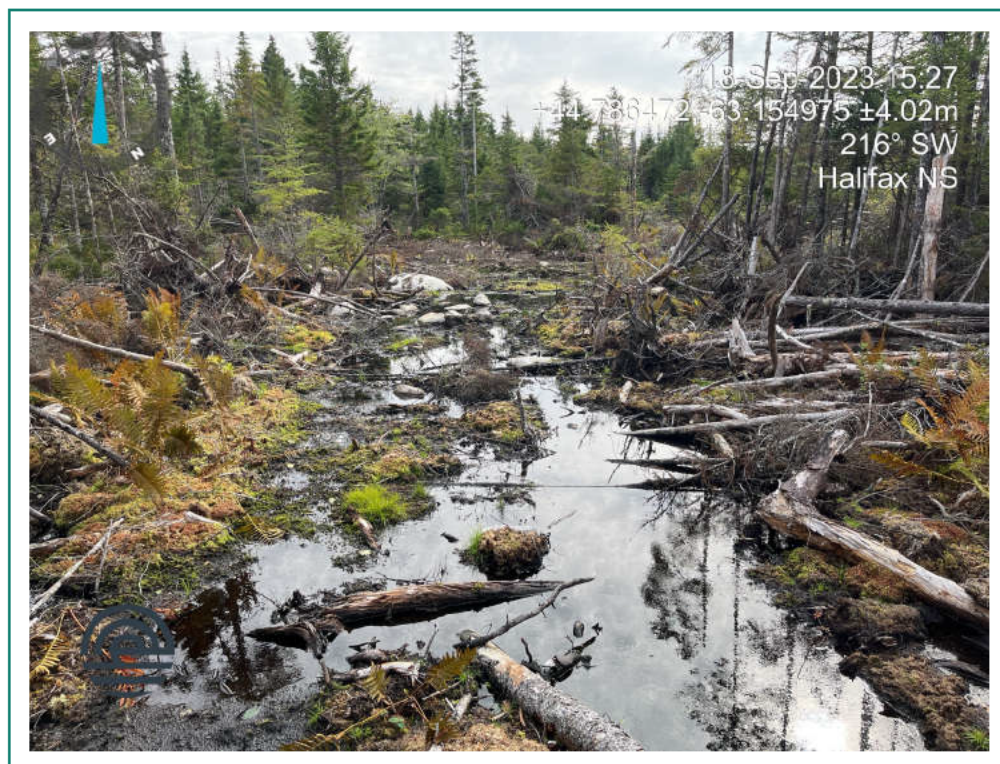
Photo 2: Wet area, significantly disturbed due to previous geotechnical test pit investigation. Photo taken in the central /northwest portion of the property where geotechnical machinery has made depressions in the landscape which hold water. Adjacent undisturbed areas did not appear to be wetland.

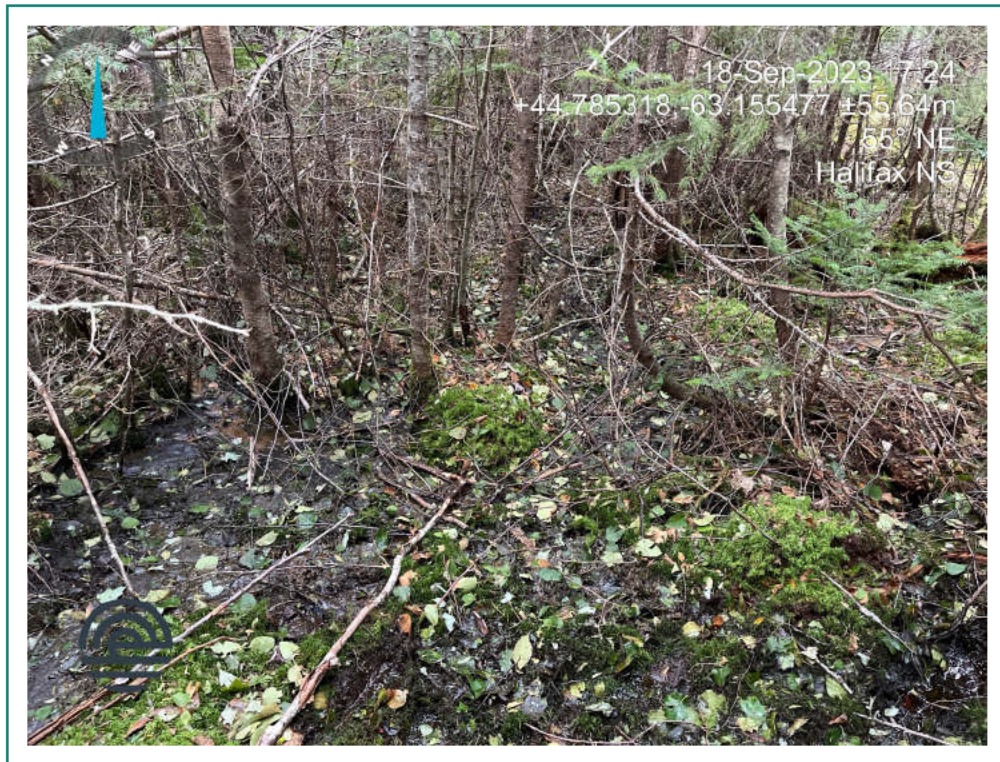
An additional wet area was identified near the southwest corner of The Birches parcel, where the ground surface sloped downward to the south. This area showed evidence of recent heavy surface water sheet flow across the ground surface. The vegetation in this area was generally facultative (and therefore wet enough to be considered hydric vegetation) and wetland hydrology was present. However, manual test pits in this area showed a relatively thin organic layer (less than 10cm) underlain by a thin dark brown mineral soil over boulders or bedrock (manual shovel refusal approximately 20cm below ground surface). The soil conditions were not deemed to be hydric, therefore this area was interpreted to be an intermittent drainage corridor and not wetland. This area drained southward onto the ATV trail on the parent parcel; the parent parcel was not fully assessed for potential wetland.

Photo 3: Intermittent drainage corridor located near the southwest corner of the study area.

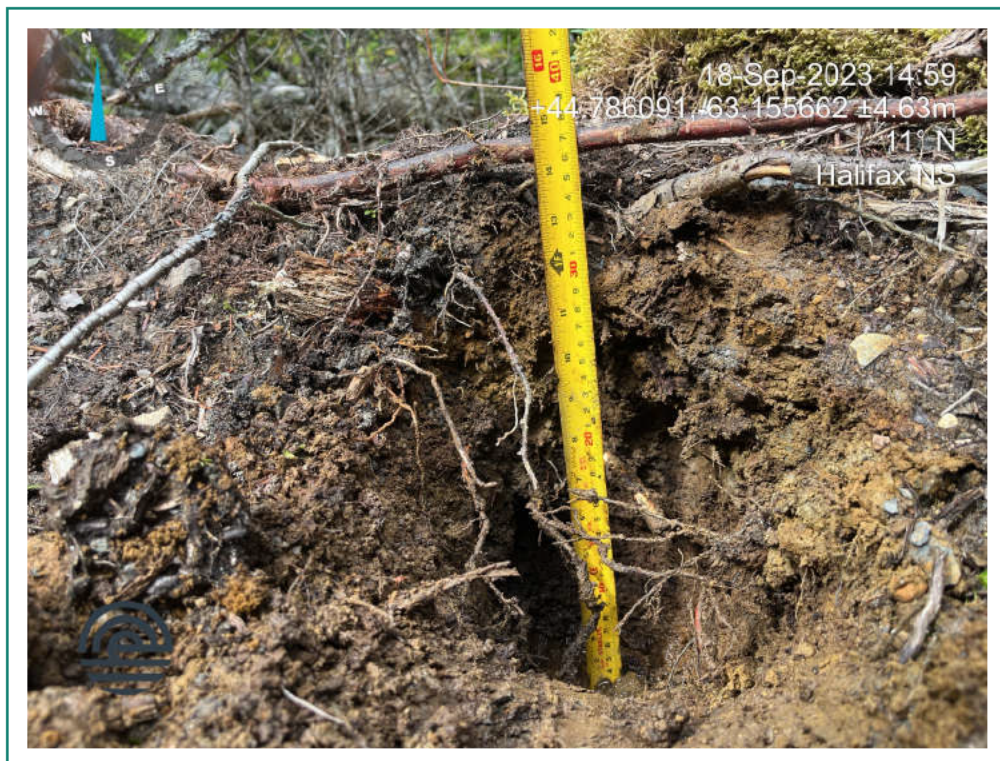
Photo 4: Test pit location showing non-hydric soil.
