June 6, 2023

**Re:** Assessment of Potential Wetlands and Slope at PID 00381715

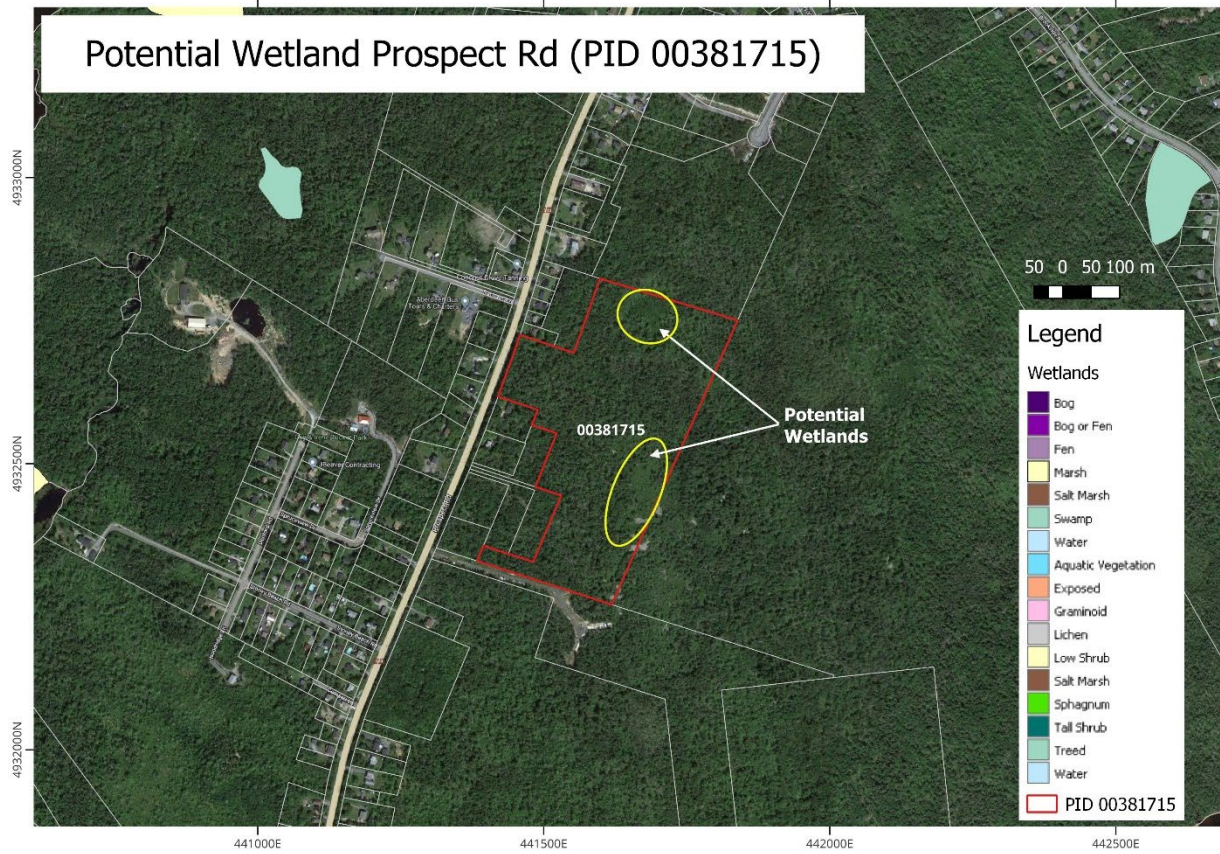
Prior to the site visit, GIS data including aerial imagery, contour, wetland, and Wet Areas Mapping (WAM) were examined to better understand the conditions at the site. While imagery showed differences in surface cover at the location of concern (exposed bedrock, changes in vegetative cover), no evidence of wetland conditions was identified in the wetland, contour or WAM data (i.e., no mapped wetlands; well to moderately-well drained area; located on a slope). In addition to the original noted location along the eastern boundary, a change in forest cover was noted in aerial imagery along the northern property boundary. Aside from these locations, no other wetlands or potential wetlands were detected on the property based on the available data.

*Airphoto with Wetlands mapping (Google Hybrid Imagery, accessed 2023; Nova Scotia Department of Natural Resources, Accessed 2023).*

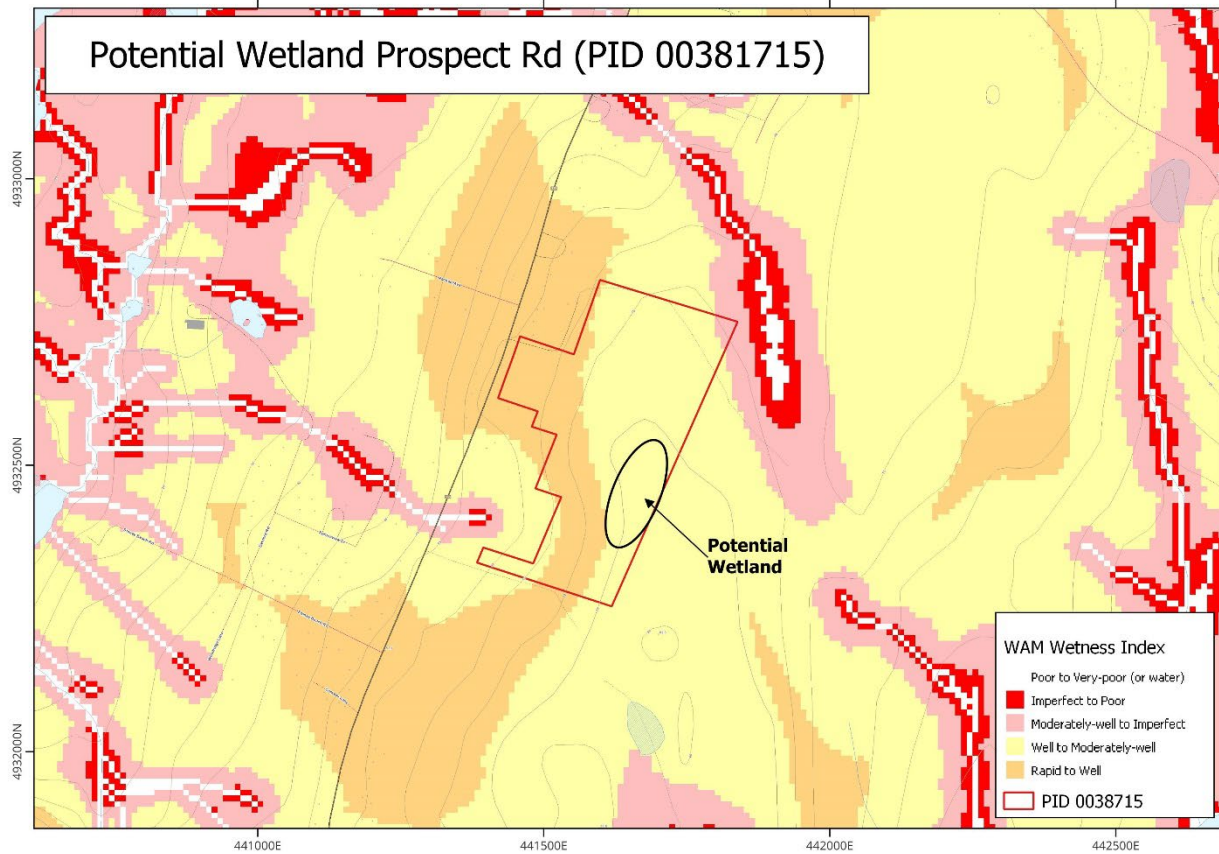
*Contour data and Wet Area Mapping (WAM) (GeoNova, Accessed 2023; NS Department of Natural Resources and Renewables, Forestry Division, Accessed 2023).*

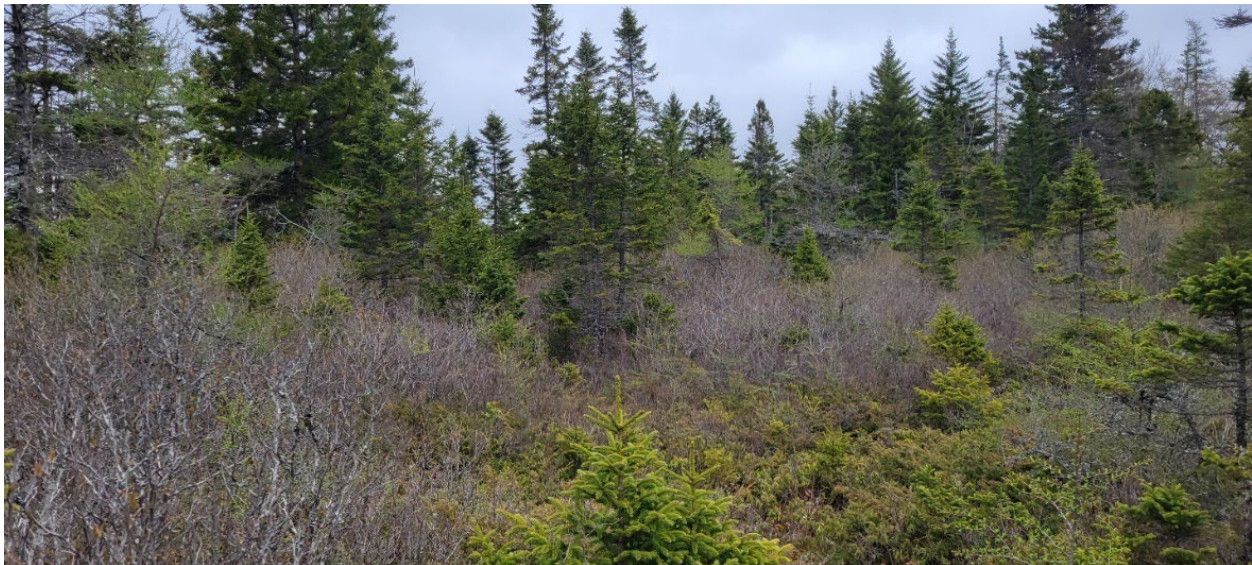
During the site visit no wetlands were identified within the property boundaries at the initial area of concern, the secondary location or during the walk to these locations. At the initial location, exposed bedrock (secondary conservation features) with adjacent barrens were identified, with plant species including typical barrens cover (Mountain Holly, Sheep Laurel, Broom Crowberry, Black Crowberry, Common Juniper, and Reindeer Lichens). These small patches of barrens can occur following forest disturbance. The small size of these relatively open patches makes them unlikely to persist as open barrens and can thus be considered an early forest successional stage which does not have conservation significance. Soils were shallow in most locations, though pockets of deeper soils were identified as is typical of barrens in the province. Indicators for hydrology and hydric soils were not observed within the area of interest. At the secondary location conditions included blowdown and young evergreen trees in the area recovering from storm damage. No wetland conditions were observed. Available mapping data and photographs of site conditions are attached.

*Looking North-east along property line~10 m from rock outcrop (44°32'34.7"N 63°44'02.1"W)*

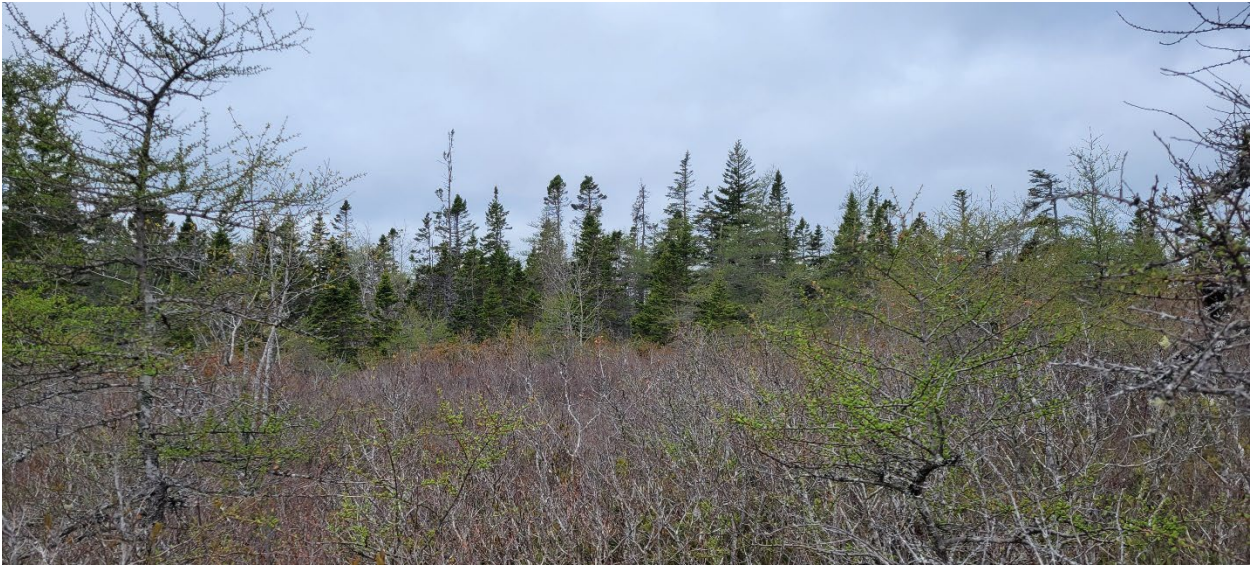
*Looking North-West across property ~10 m from rock outcrop (44°32'34.7"N 63°44'02.1"W)*

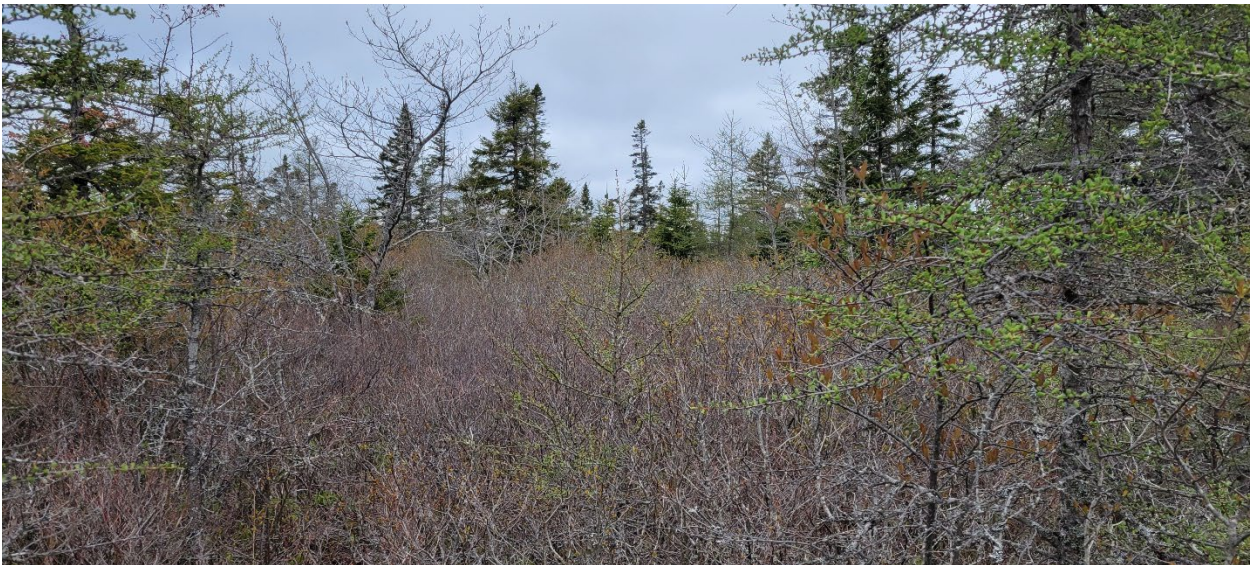
*Looking North-West across property from center of potential wetland (44°32'34.7"N 63°44'02.7"W)*

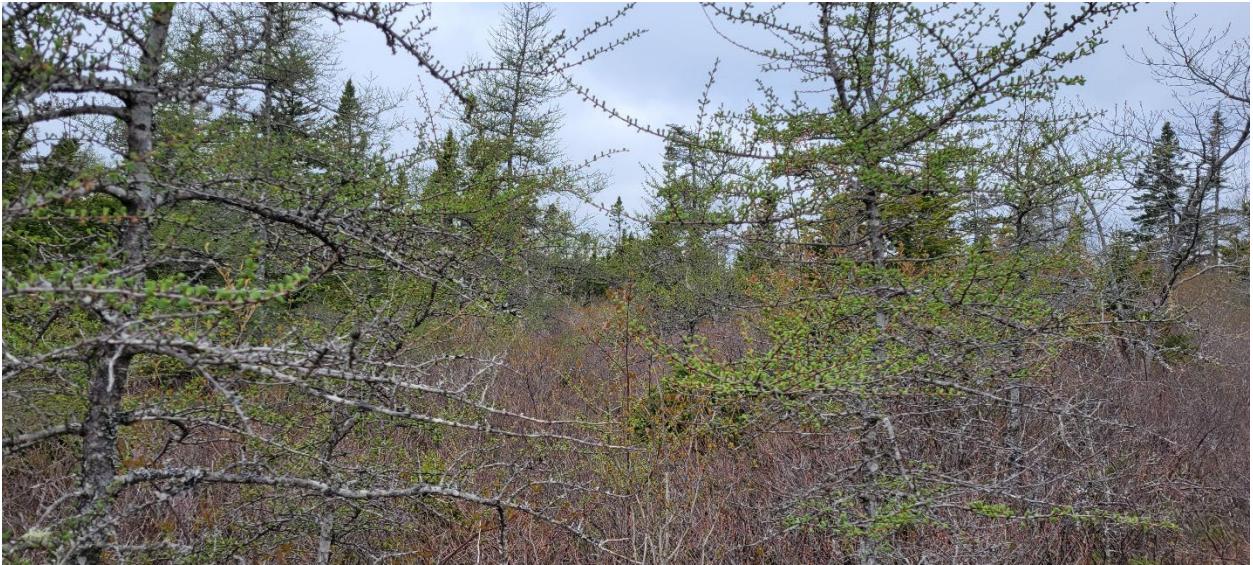
*Looking South-West parallel to property line from center of potential wetland (44°32'34.7"N  
63°44'02.7"W)*

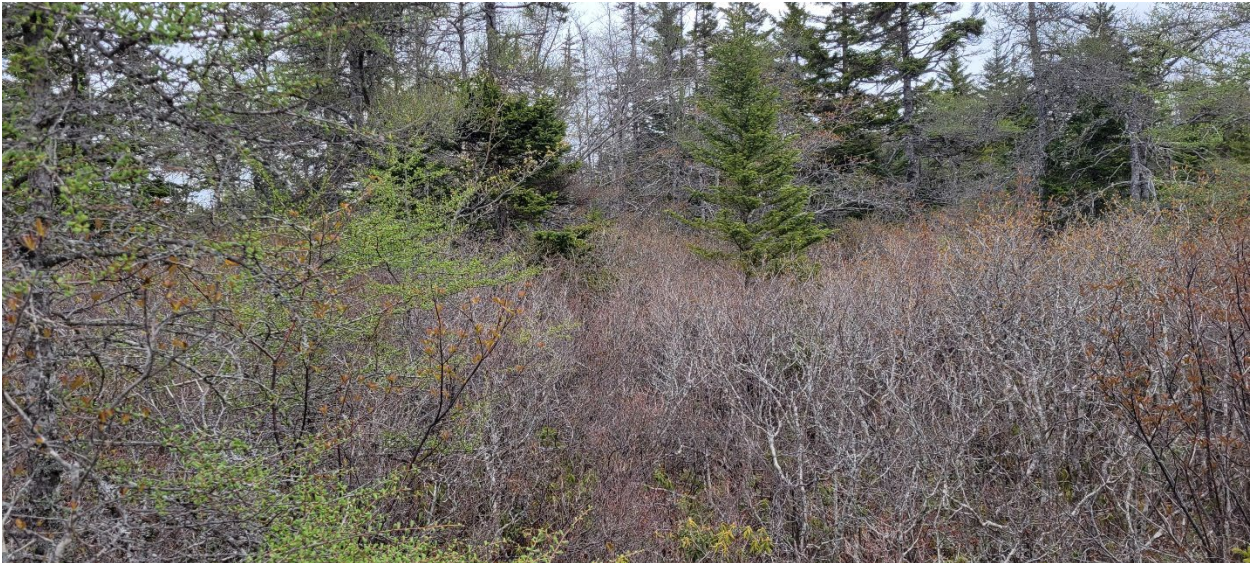
*Looking North-West across property from South-Western edge of potential wetland (44°32'33.5"N  
63°44'03.0"W)*

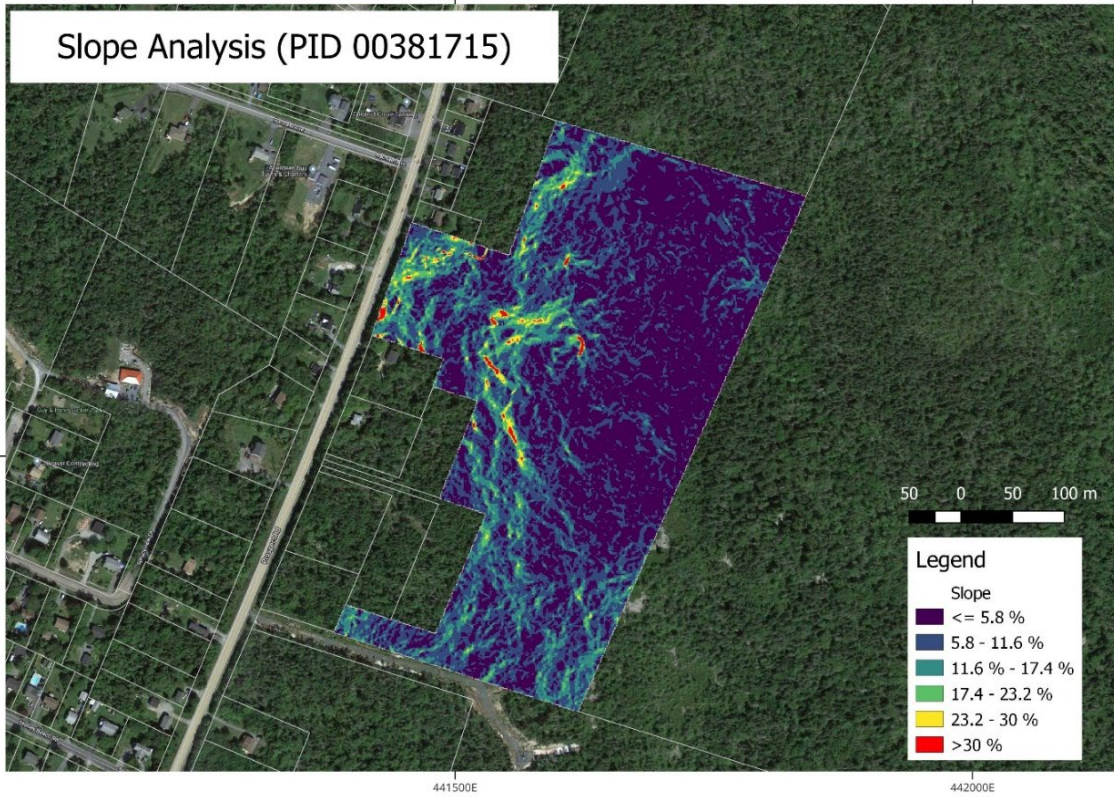
During the site visit no primary conservation features were observed. Primary conservation features (which were *not* observed) include: wetlands, riparian buffers, floodplains, natural drainage systems and detention areas, environmentally sensitive areas, archaeological sites, and areas of high ecological value. To address slopes exceeding 30% (primary conservation feature), a slope analysis was carried out using Lidar data collected in 2019 by the province of Nova Scotia. The mean slope of the property was 5%, with 320 m<sup>2</sup> of the property having slopes greater than 30%. These areas likely represent small rock faces, typical of the geology of the area. No faces exceeded 1 m in height and the largest occupied 46 m<sup>2</sup>. A map of the analysis is attached.

*Slope Analysis (Lidar DEM GeoNova, Accessed 2023).*

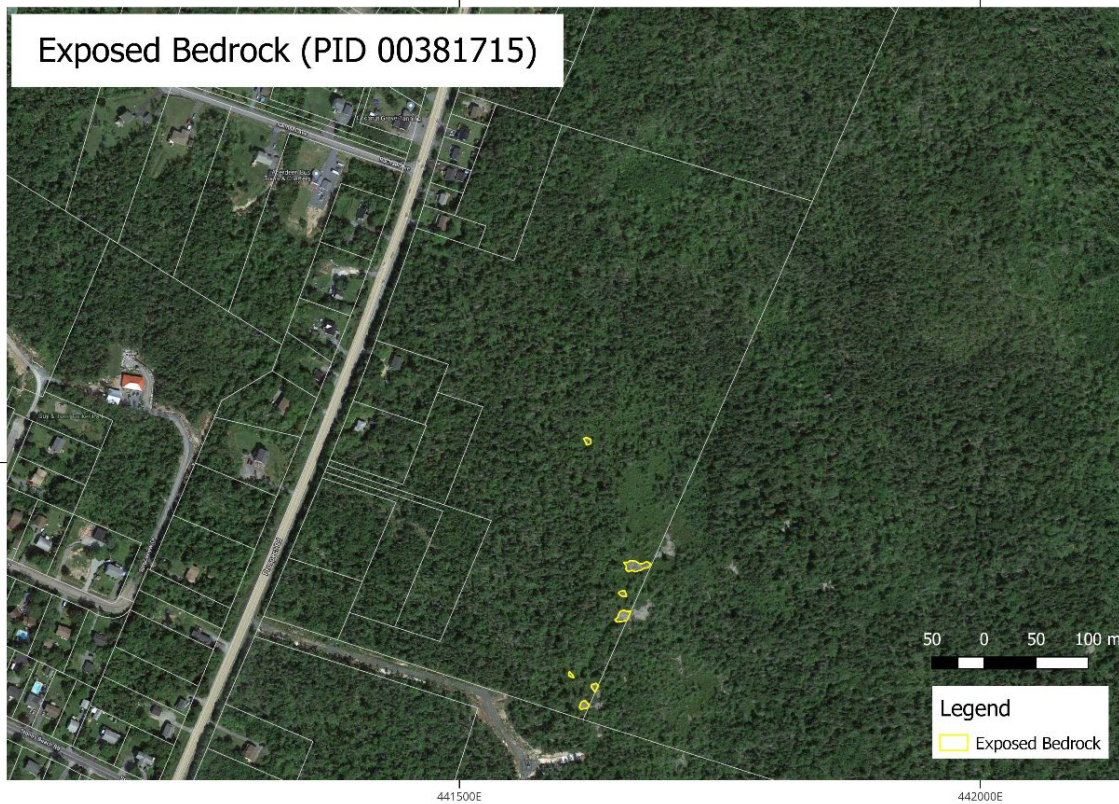
While bare rock (a secondary conservation feature) was observed, as described above, no other secondary features were observed. Secondary features include mature forest, scenic views, trails, historic sites and buildings, and other features of high cultural value. The area of bare rock (exposed bedrock), which was readily identified from aerial photography, occurred almost exclusively along the south-eastern boundary of the property where barrens were observed, and totalled 435 m<sup>2</sup>. A map of the analysis is attached.

*Location of Exposed Bedrock (Google Hybrid Imagery, Accessed 2023).*
