02: INVENTORY & ANALYSIS

This chapter provides a summary of existing Park features and an overview of each component's relevance for the comprehensive plan.

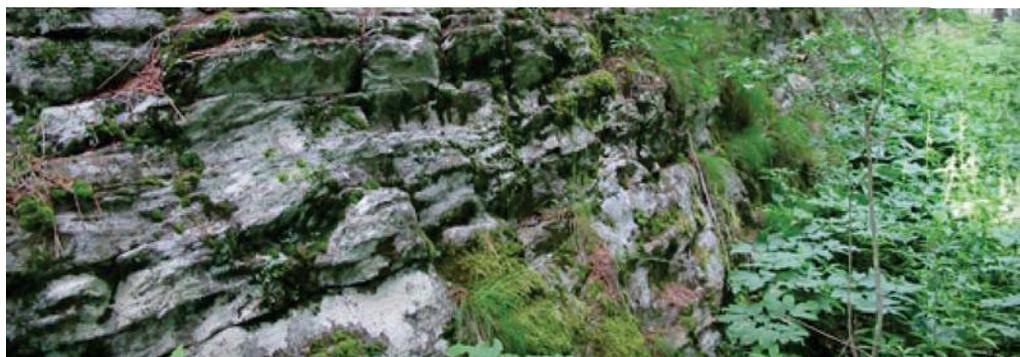
MAP 2.1: SOILS

After Hurricane Juan, Park soil types were mapped from more than 300 survey points and a visual assessment of exposure of mineral soils associated with uprooted trees (Map 2.1). Soils in the Park are derived from olive-coloured glacial till that is high in slate. Surface horizons are generally of medium texture (loam to silt loam) and either stony or very stony. Flat, grassy, near-shore areas appear to have been filled in and reshaped. In most areas of the Park, clearing, military use and farming have disturbed soils to some extent.

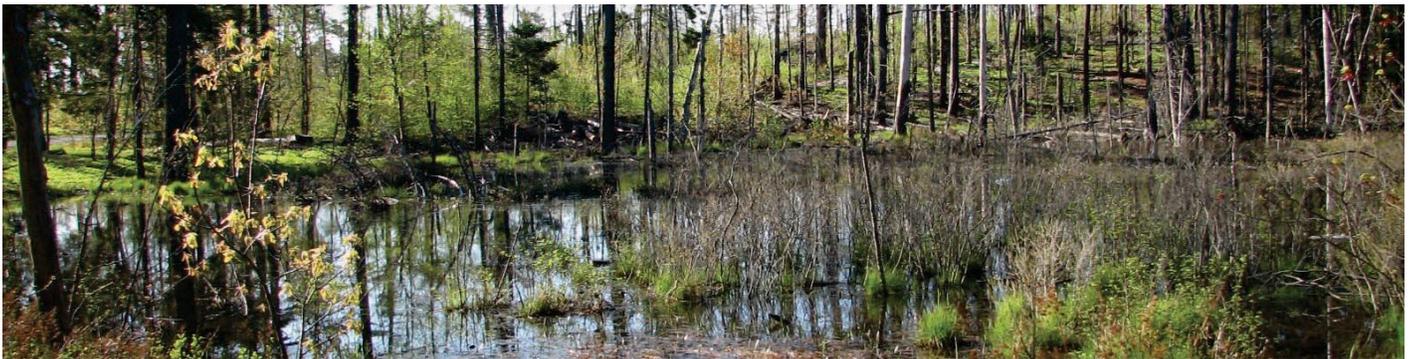
MAP 2.2: HYDROLOGY & OUTCROPS

The topography and relatively small watersheds that comprise the park do not have enough surface area to create defined surface freshwater features such as continuously running streams (Map 2.2). The only remaining permanent pond in the Park lies just south of the maintenance compound, in a small depression created by rock quarrying. The small pond has

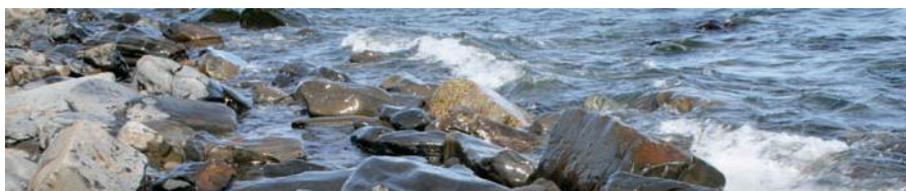
MAP 2.3: COASTAL FEATURES

Point Pleasant Park is located on the southern tip of the Halifax Peninsula, which divides the waters of the Halifax Harbour from the Northwest Arm. Saltwater defines the southern half of the Park boundary, with the Pleasant Shoal—and in particular, the area known as “Hen and Chickens”—tempering the impact of waves on the Park’s southern tip (Map 2.3). The blue arrows in this map indicate the direction of prevailing

The shoreline around Point Pleasant Park has a variable morphology, the result of different wave energy, offshore/near shore conditions and onshore topography (see Map 2.3). There are four distinct parts of the Park's shoreline, each with its own natural characteristics and each bringing different considerations to the planning process:

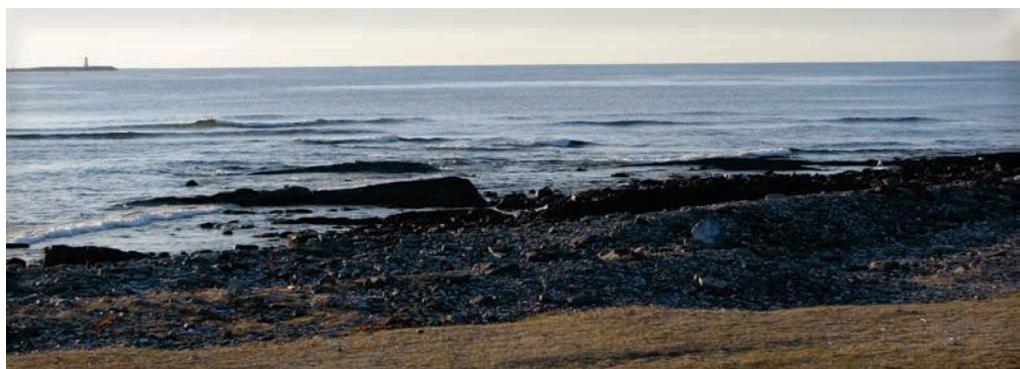
MAP 2.4: 1858 SHORELINE

Shoreline retreat (erosion) and progradation (shoreline advancement as a result of the accumulation of waterborne sediment) are normal processes along Nova Scotia's South Shore. To understand shoreline change at Point Pleasant Park over the last 150 years, the Hopkins survey of 1858 was geo-referenced with post-Juan (2003) aerial photography (Map 2.4). The Hopkins survey appears to have been accurate, because the path and structures line up well with the aerial photography; therefore, we would expect the same degree of accuracy with the shorelines.

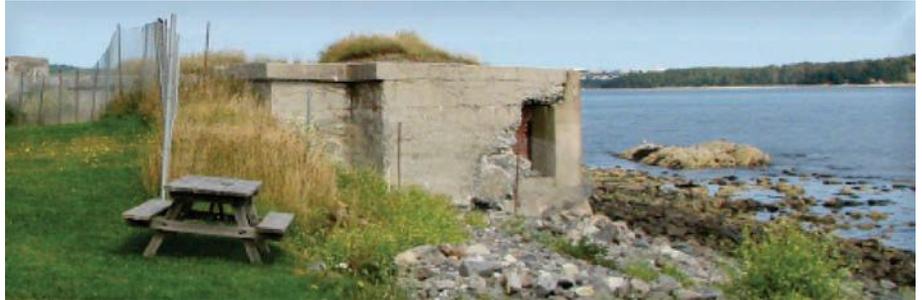
Structures at risk at Point Pleasant Battery

Significant cultural resources have been identified in this area, at risk from erosional processes. They include the first house associated with Purcell's Ferry, a summerhouse, and the North West Arm Battery and its associated resources. These would not be at risk from chronic small-scale erosion for some time, but parts of them may be at risk from a larger, more catastrophic slip-circle-type slope failure.

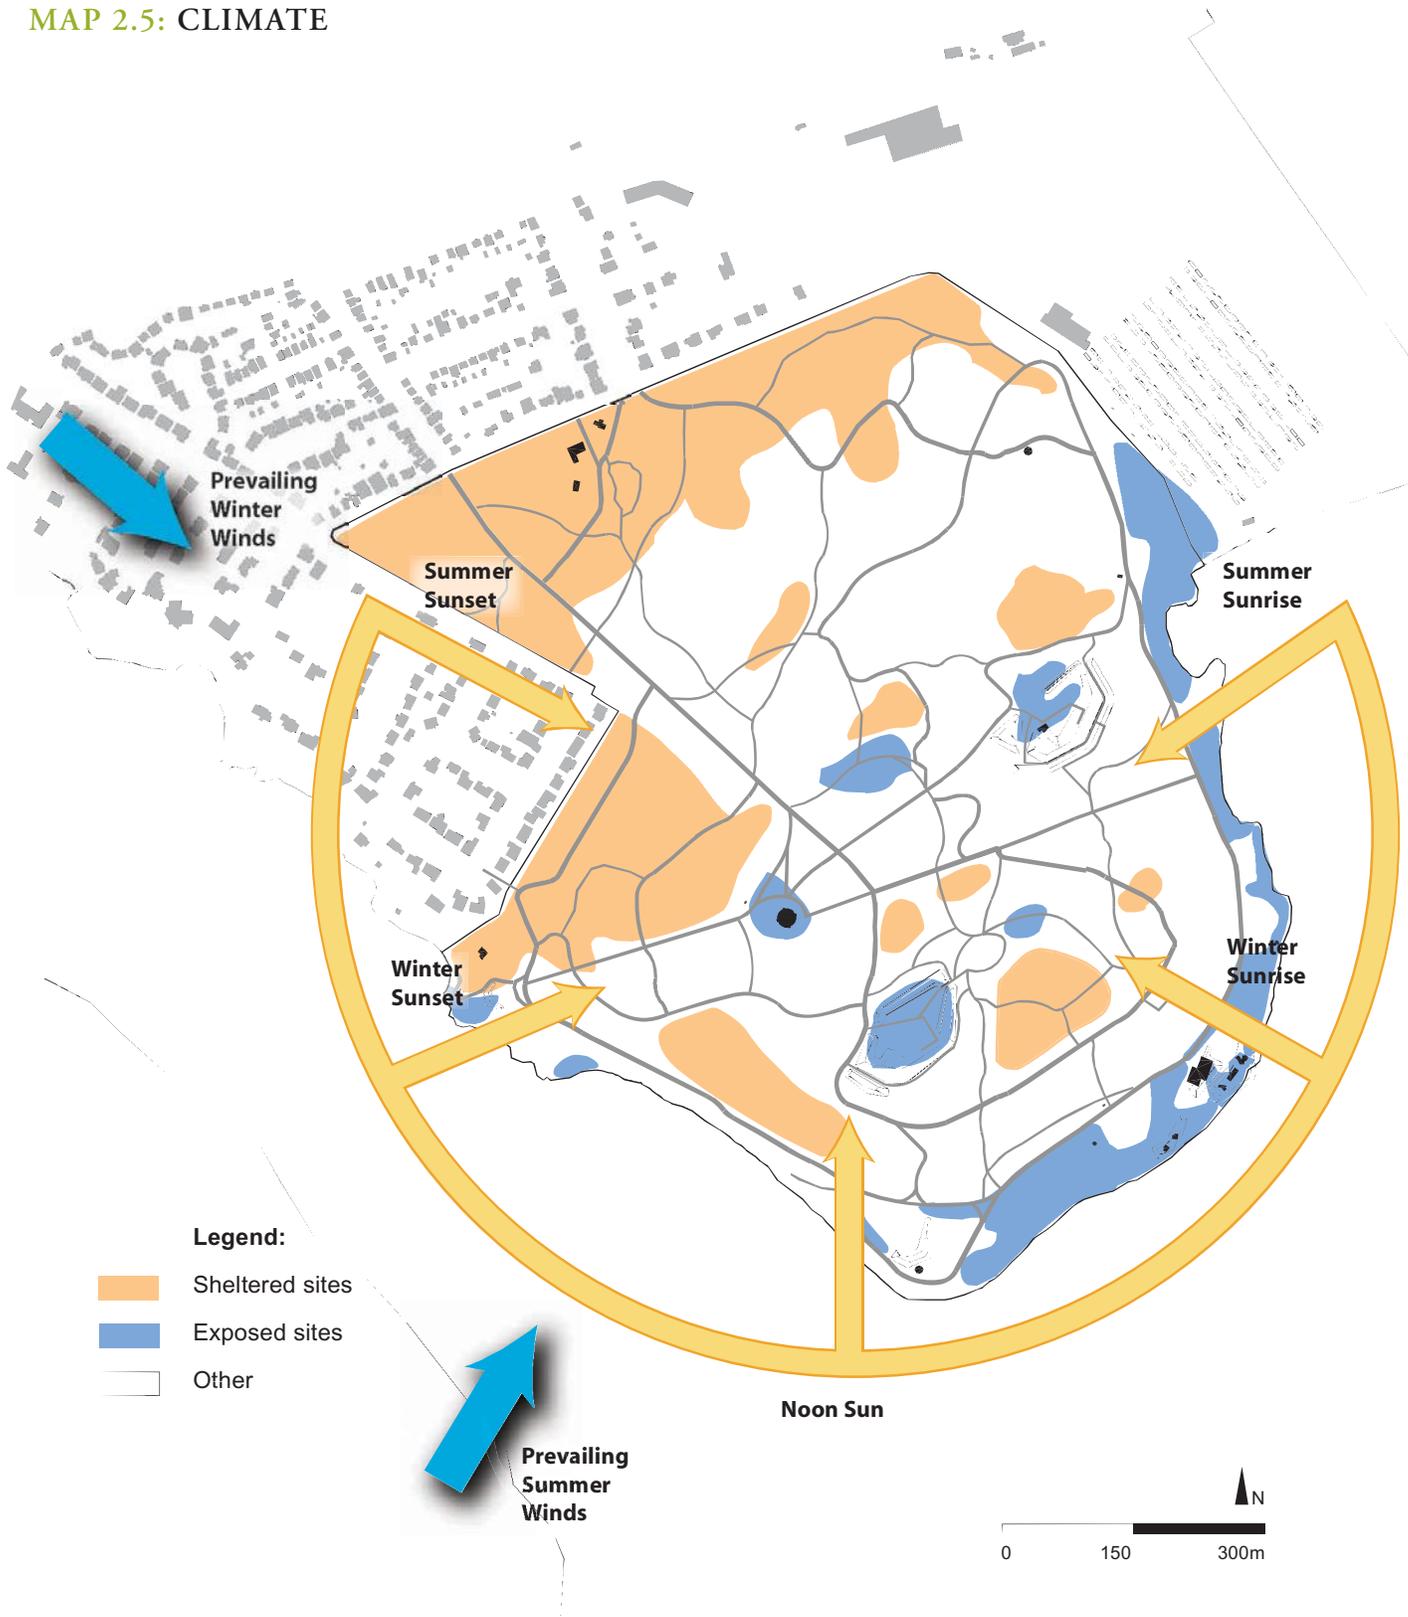
MAP 2.5: CLIMATE

Strong winter winds tend to be westerly, blowing in from the north in April and from the southwest during the summer months. Point Pleasant Park is positioned more than five kilometres inland from the southern tip of McNabs Island, providing considerable shelter from coastal winds. Near the coast, salt spray can kill all or part of trees, though vegetation development in

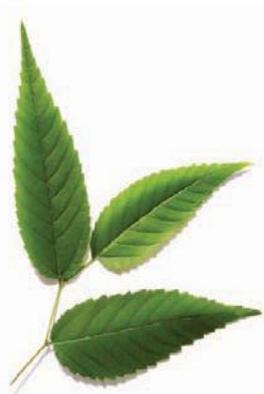
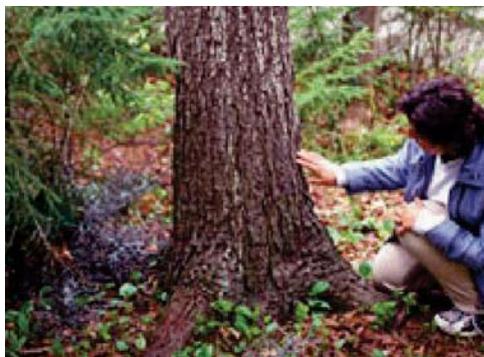
Evidence of brown spruce longhorn beetle

Three significant events during the past decade have dramatically changed the Park’s forest. The first is the invasion of the brown spruce longhorn beetle (BSLB). The BSLB is believed to have killed many mature red spruce trees through the 1990s, after which sanitation cuttings were undertaken to remove dead and dying red spruces. Second, a severe ice storm in March 2001 damaged many mature trees and led to significant fellings. Finally, by the morning of Sept. 29, 2003, after Hurricane Juan blew through the Park, roughly three-quarters of its mature trees were blown down or damaged.

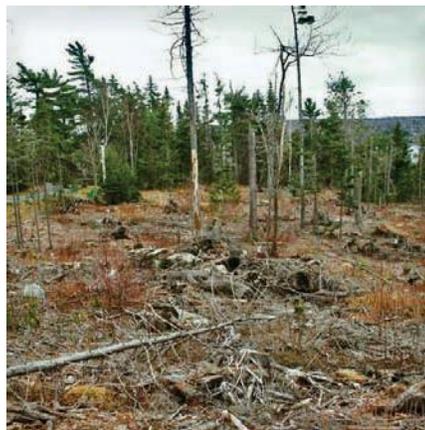
Sample area with poor distribution of conifer regeneration

- a) spatial variation of regeneration density, for each species and for all species combined, was large, both within sample areas and among them;
- b) at the sample-area level, seedling densities ranged from under 1,000 stems per hectare to more than 5,000 stems per hectare;
- c) the sample area with the worst distribution of needleleaved regeneration still had seedlings in about half of the sample plots, while the area with the best distribution had seedlings in more than 80 per cent of the sample plots;
- d) red spruce dominated the overall regeneration pattern of needleleaved species in the sample areas, with balsam fir less abundant but as widely distributed;

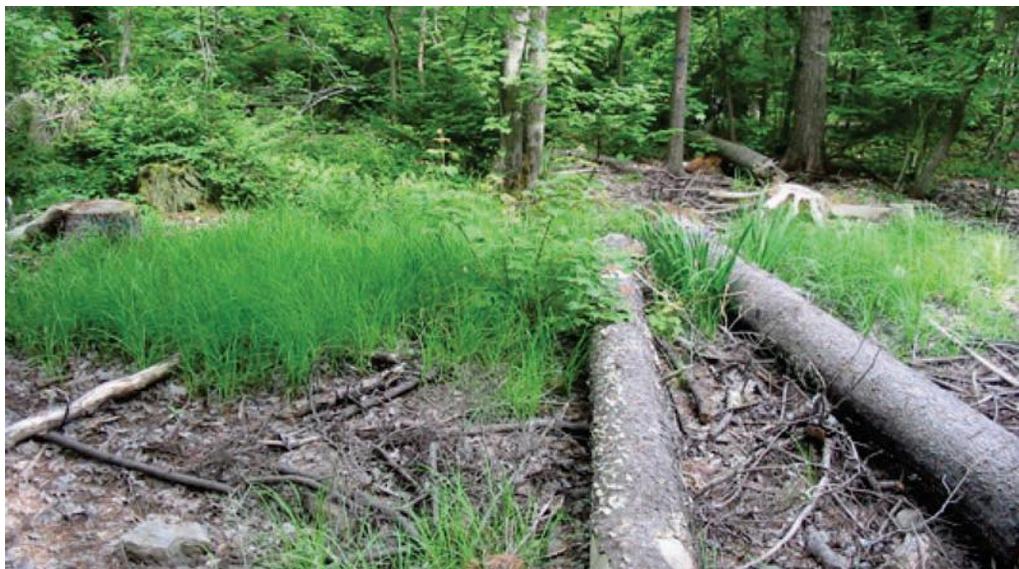
Coarse woody debris left in place

When the Park was being cleaned up after Hurricane Juan, a small research plot was kept in virtually untouched blown-down condition just south of the Cambridge Battery. This was done for two reasons: first, to facilitate the research and tracking of how the forest naturally responds to a major blowdown; and second, to provide visitors with a reminder of what the forest looked like after the hurricane.

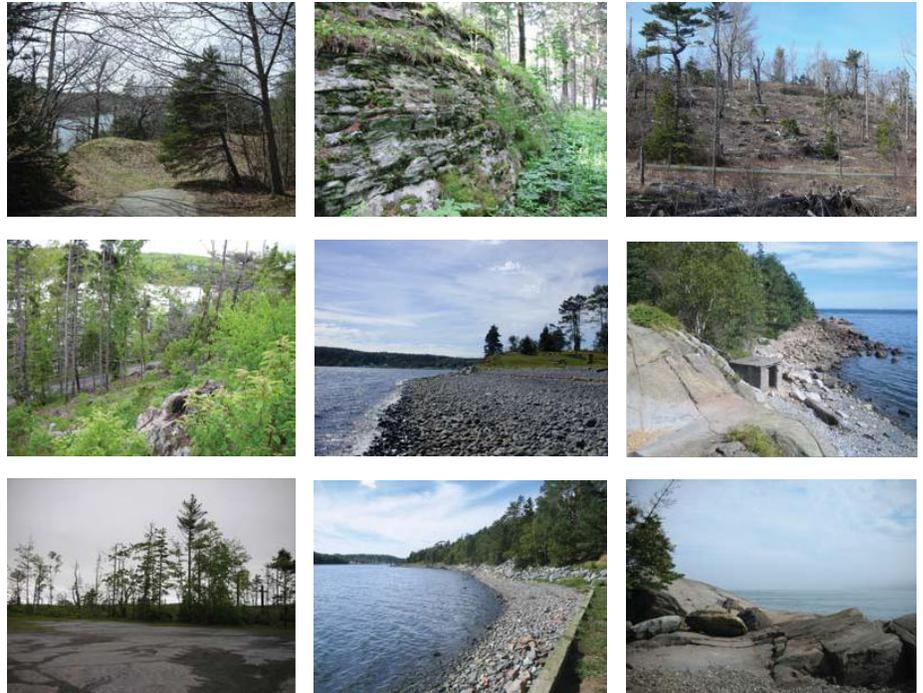
Landscape physiology

The Park’s geomorphology—the landforms and the processes that produce and modify them—is characterized by strong east–west ridges, as illustrated in recent LIDAR imagery (Map 2.6). The rugged terrain is punctuated with numerous rock outcroppings and massive boulder fields, emphasizing the strong influence of geology on the landscape. The terrain along many of the paths throughout the Park is quite steep; the combination of steep slopes and minimal topsoil layers creates challenging regeneration conditions for trees, especially along the south-facing slopes most exposed to high winds and erosion. Tree growth along those slopes is important for creating desirable microclimates throughout the Park, as well as wind protection against future storms that may threaten the forest’s health.

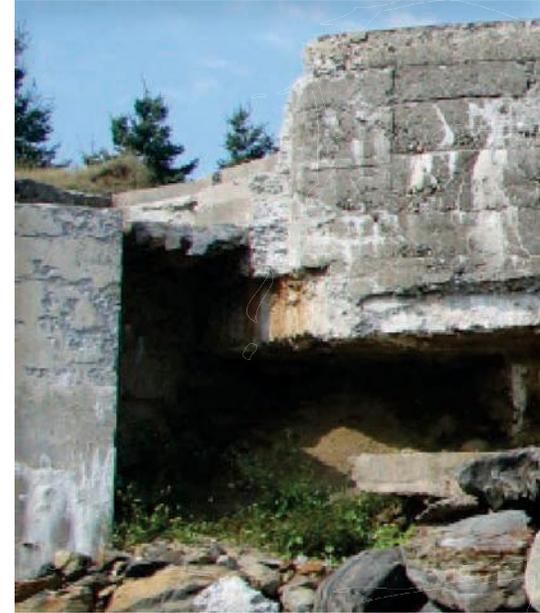
Includes 20 features, again mostly related to an 18th-to 19th-century fortification and barracks, but also including late 19th- and 20th-century concrete military structures.

Unlike North West Arm Battery, Point Pleasant Battery was extensively rebuilt in the late 19th century. None of the early fortification is visible today, although portions may be preserved within and between the more recent structures. Tree growth has never been a significant problem here, but coastal erosion has been severe, and the concrete fortification is wearing away. Part of the battery has already been entombed in an earthwork for safety reasons, and a searchlight emplacement was removed by Parks Canada

several years ago. Thus far there is no evidence that erosion has exposed earlier fortifications. Like North West Arm Battery, Point Pleasant Battery is backed by significant artifact deposits, which may be a mixture of domestic and demolition debris. Prior to Hurricane Juan, these had likely been disturbed by root growth, but the damage may have been less severe than the upheavals caused when trees were uprooted during the hurricane.

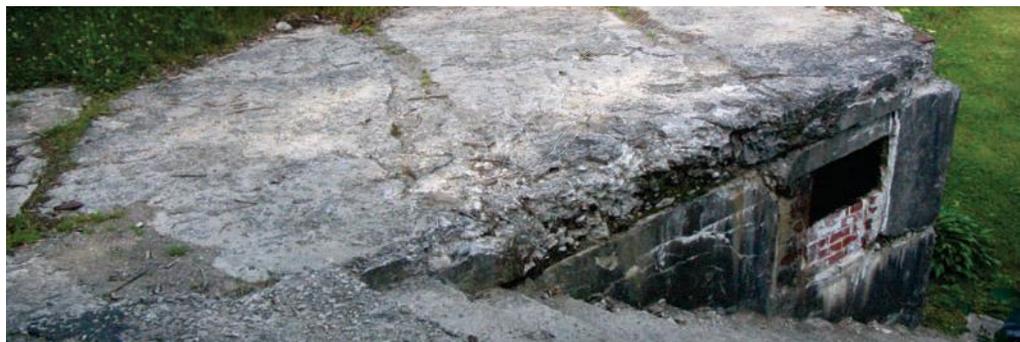
In contrast, Cambridge Battery had become heavily overgrown with trees and was already suffering progressive structural damage from root action prior to Hurricane Juan, which worsened the situation. Other historic military structures near Cambridge Battery are in various states of preservation. The foundation of the laboratory (the magazines) east of the fortification has become somewhat overgrown, though it does not appear to have suffered greatly in the hurricane. The nearby 1778 entrenchment and the 1855 campground had remained partly open, since they correspond in part to the heather patch, and therefore they appear to have suffered less damage from tree roots and upheaval. The same can be said of Walker Battery, located between Heather Road and Sailors Memorial Way, a battery erected as a field exercise in 1855.
