**SUBJECT:** **Case 18120: MPS and LUB Amendments for 348 Purcell's Cove Road, Halifax**

### SUPPLEMENTARY INFORMATION REPORT

**Re: Property Development Review**  
**348 Purcell's Cove Road**

PROJECT:  
 JENSEN PROPERTY INVESTIGATION

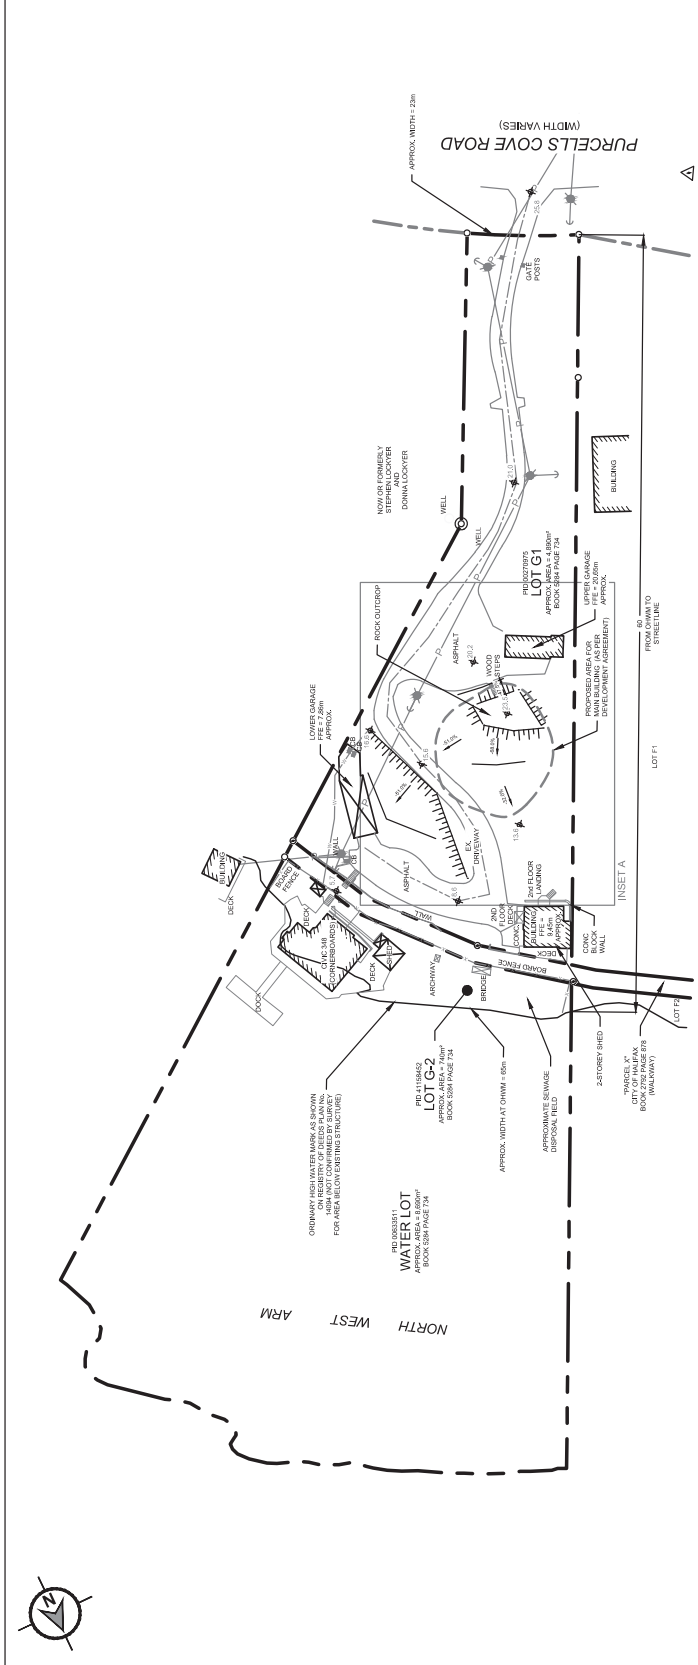
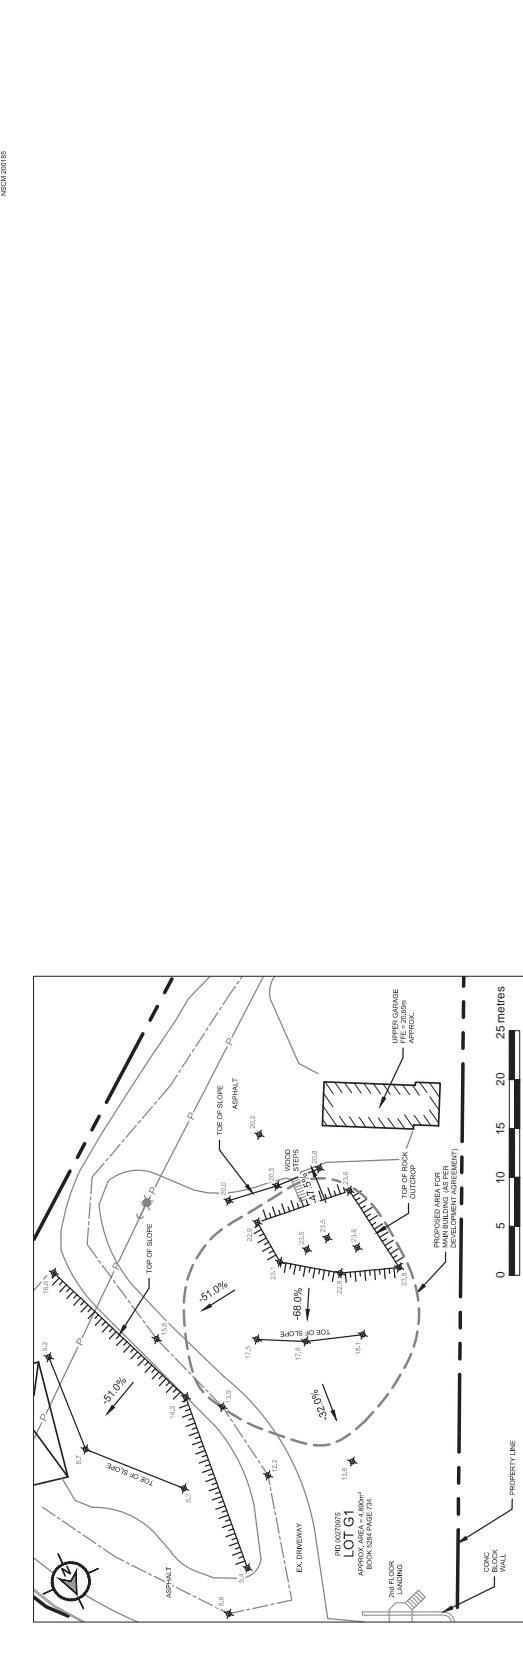
TITLE:  
 SITE PLAN

Shown on the attached Site Plan is a transposition of the *Proposed Area Main Building Location* from the 1982 development agreement. Strum has been asked by Sunrose Land Use Consulting to comment on the suitability of this location for constructing the main dwelling. Based on our review of the site as it exists today, the following issues have been identified as constraints that would have made this location difficult to construct within. Inset A on the attached Site Plan shows a greater level of detail for this area.

- a. Steep Slopes – The proposed area for the main building is located in an area with some significant and steep slopes. This area includes a rock outcrop, with slopes dropping nearly 10 m (33') from one edge of the building area to the other. The slope continues to drop outside the building area by another 5 m (16'), making the total slope elevation change 15 m (over 50'). The average slope of this area is over 50% (drops approximate 1' vertically for every 2' horizontally), with some sections being nearly vertical. Constructing a building on the sloped portion of this proposed building area would have proven to be quite challenging, likely requiring non-conventional and expensive construction techniques. The flat portion of the proposed building area is quite small, and likely not big enough for a reasonable size dwelling if any landscaped graded areas were planned immediately around the building.

Strum Consulting was engaged by Sunrose Land Use Consulting to review property development related issues for PID's 00270975 and 41158452, otherwise known as Civic 348, Purcell's Cove Road. Strum staff visited the site on July 23, 2015, and subsequently on August 6, 2015 to complete limited topographical survey. Strum has prepared a Site Plan for this lot, which is attached to this letter.

The lot in question is separated into two PID's by a Halifax Regional Municipality (HRM) walkway parcel. The combined area of the lot (both PID's) is 0.6 Ha (1.5 acres). The lot is generally narrower near the street and widens out as it approaches the Northwest Arm. A Water Lot is also associated with this lot, and is described as PID 00633511. Near Purcell's Cove Road, the lot is approximately 23 m (75') wide, widening to approximately 65 m (215') at the Northwest Arm. The total lot depth is approximately 160 m (525'). The lot slopes significantly from Purcell's Cove Road to the Northwest Arm, with the total elevation change being approximately 25 m (85'). The steepest portion of the lot exists generally from the point where the lot widens to the Northwest Arm. The Site Plan attached to this letter indicates key features of the site, as well as several elevation points across the site. Key features include a well, a sewage disposal field, a rock outcrop, two garages, a two-storey shed, and a dwelling. Also shown on the attached Site Plan is the *Proposed Area for Main Building* indicated in the 1982 development agreement for this Lot.

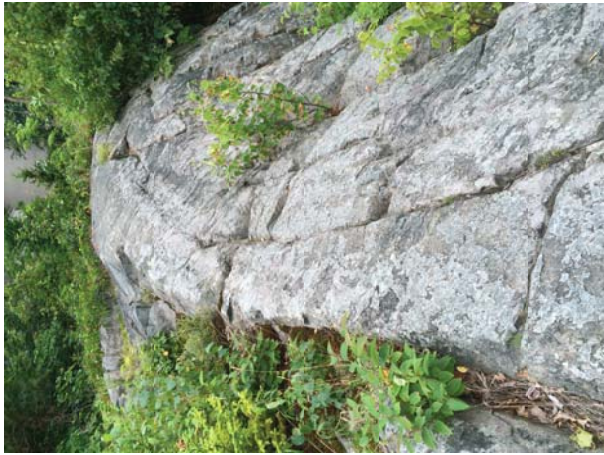
As indicated, this bedrock outcrop is a significant feature, located in the middle of the site. The bedding of the bedrock dips steeply down, away from the steep sloping face on the downward slope of the exposed rock outcrop. The orientation of the bedding, and the moderately close spacing of these discontinuities, would result in planes of weakness that would need to be addressed by engineering and construction measures in development of the site (attached Photo 1).

Photo 1: Bedding in downslope face of bedrock outcrop.

Based on review of existing geological mapping, the bedrock on the property is the Bluestone Formation, part of the Halifax Group metasedimentary unit. The Bluestone Formation is described as a grey, thinly bedded metasiltstone and slate. This is a hard or strong rock but the orientation of bedding, evident in the exposed bedrock surface, would result in planes of weakness.

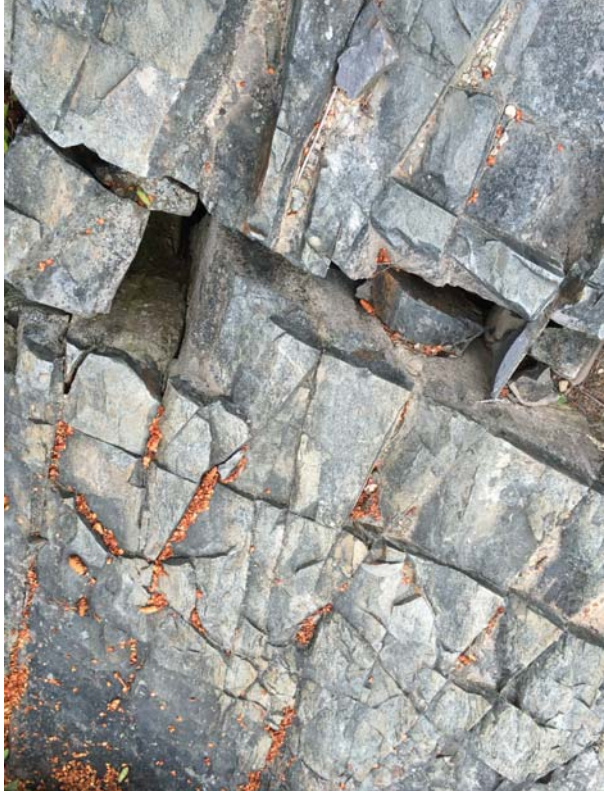
In addition to the bedding, fractures and joints are evident in the inspection of the outcrop surface resulting in a blocky structure further compromising the strength of the rock (Photo 2). This is supported by the owner's report of periodic rock falls that block the driveway from time to time. The necessity and uncertainty involved in addressing the in-situ rock outcrop could have led the designer to shift the location of site structures away from this area.

Photo 2: Blocky structure of rock in outcrop.

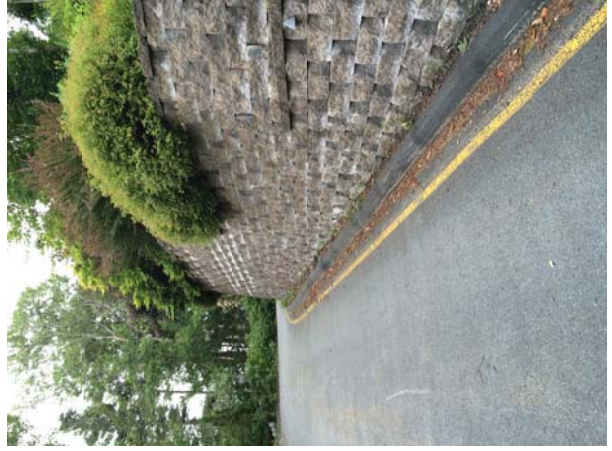
A retaining wall was constructed in an attempt to prevent rock falls from the outcrop blocking the driveway. The contractor who constructed the wall, Jim Seaboyer, was contacted to review its construction. The wall is constructed of Rockwood retaining wall blocks manufactured by South Shore Ready Mix and is 1.8 m (6') to 2.4 m (8') high over much of its length (Photo 3). Mr. Seaboyer indicated that at points the wall was extended into the outcrop for support, bearing on the bedrock. As an indication of the weak structure of the bedrock, Mr. Seaboyer said after the wall was constructed he was using a jack hammer to cut some steps in the upslope face of the outcrop. Due to the vibration, sections of the bedrock settled causing damage to parts of the retaining wall that had to be repaired.

Photo 3: Retaining wall around bedrock outcrop.
