**Bedford West Water Quality Report, Fall 2015**

## Water Quality Monitoring Program Bedford West, Bedford, NS

Fall 2015 Sampling Event

**RE: Final Report: Water Quality Monitoring Program**  
**Bedford West, Bedford, Nova Scotia – Fall 2015 Sampling Event**

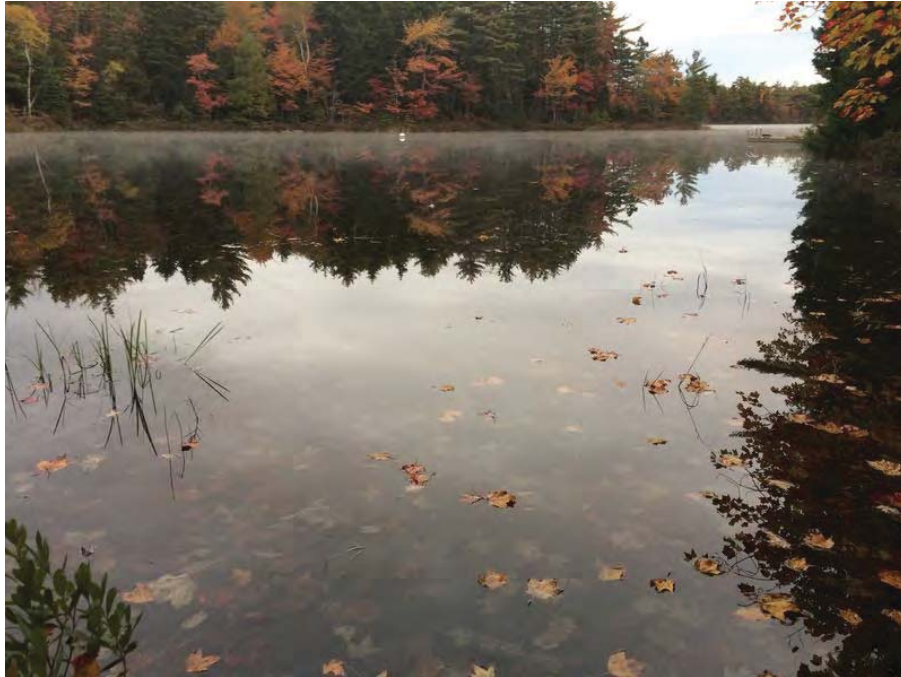
Photo 1: PML-1 Paper Mill Lake Sample Location

- ◆ KL1                11 µg/L (0.011 mg/L)
- ◆ HWY-102-2    12 µg/L (0.012 mg/L)
- ◆ LSD                95 µg/L (0.095 mg/L)
- ◆ LU                  11 µg/L (0.011 mg/L)
- ◆ PLM-1            18 µg/L (0.018 mg/L)

- ◆ KL-2                284 µg/L
- ◆ HWY-102-2    129 µg/L
- ◆ LSD                1960 µg/L
- ◆ PML-1            2320 µg/L
- ◆ PLM-2            278 µg/L

- ◆ KL-5 7 µg/L
- ◆ LSD 3 µg/L
- ◆ PLM-1 2 µg/L

- ◆ KL2 478 µg/L
- ◆ HWY102-2 714 µg/L
- ◆ LSD 4570 µg/L
- ◆ PML-1 6020 µg/L
- ◆ PLM-2 368 µg/L

- ◆ PLM-1 7 µg/L

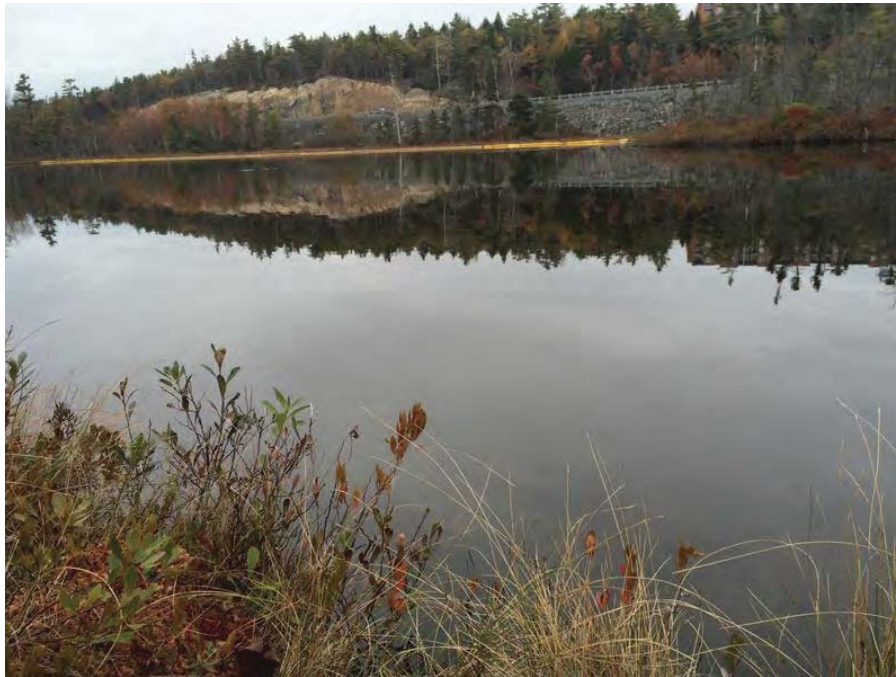
Photo 3: LU Larry Uteck Sample Location

- ◆ LU 0.176 µg/L
- ◆ PLM-1 0.146 µg/L
- ◆ PLM-2 0.145 µg/L

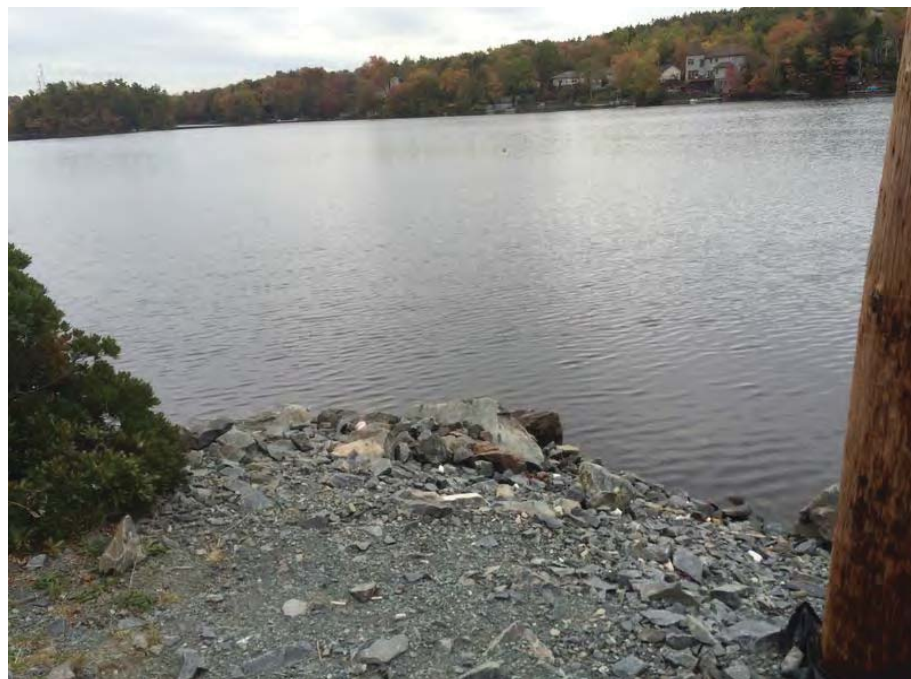
Photo 6: KL5 Kearney Lake Sample Location

- ◆ KL-1                0.187 µg/L
- ◆ KL-2                0.176 µg/L
- ◆ KI-5                0.332 µg/L

- ◆ KL-5 3 µg/L

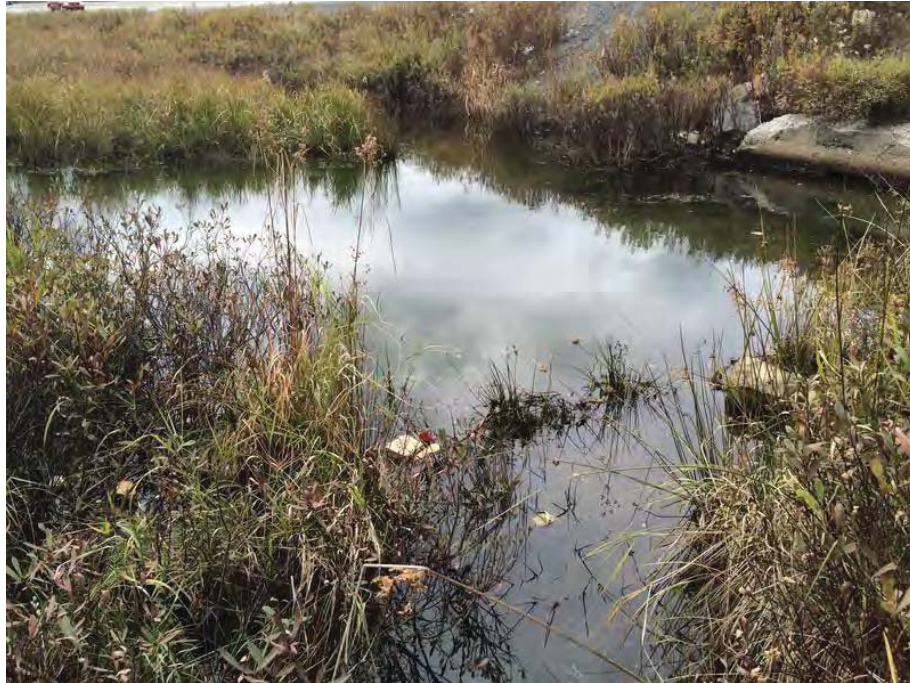
Photo 7: HWY102-2 Sample Location

- ◆ KL-2                6.28
- ◆ HWY-102-2    6.18
