Item No. 14.6.1
Halifax Regional Council
January 15, 2019

SUBJECT: **Case H00456: Substantial Alterations to municipally registered heritage properties at 5969 College Street and 1452 & 1456 Carlton Street, Halifax**

Heritage Impact Statement: 5969 College Street

Heritage Impact Statement: Carlton Victorian Streetscape

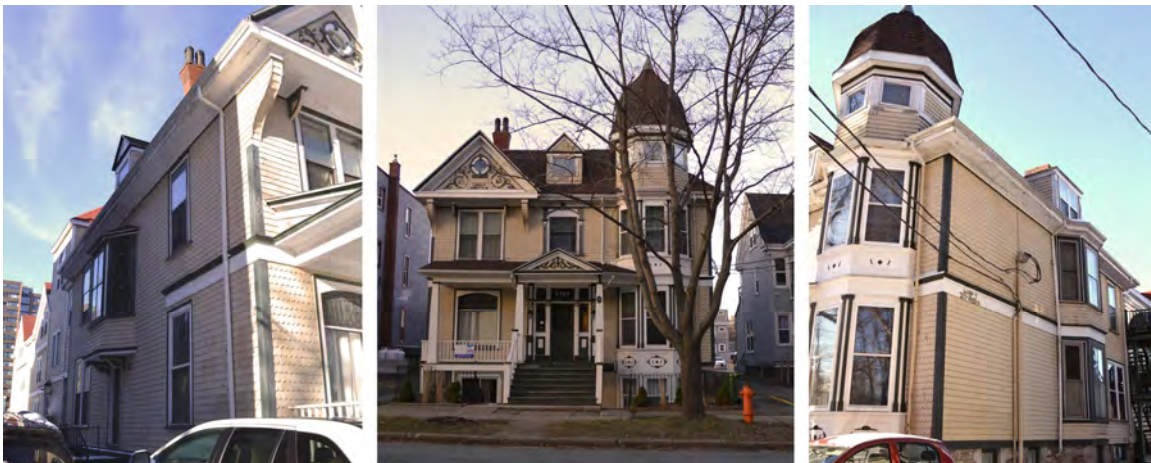
Figure 2. West, South, and East façades Gold Cure Institute, 5969 College St., photos by Architect.

- Brick and stone foundation
- Steeply pitched and complex hipped roof structure with multiple small gabled dormers with a projected pediment.
- Ornamentation is present at all gables, as well large and small elaborate brackets are used to frame both the main façade and the principle College St. window respectively.
- The eight-sided bell tower at the Southeast corner of the building with a dormered roof.
- Bay windows present at both the East and West side of the building
- Gabled roof porch entry with a center transom entrance and sidelights.

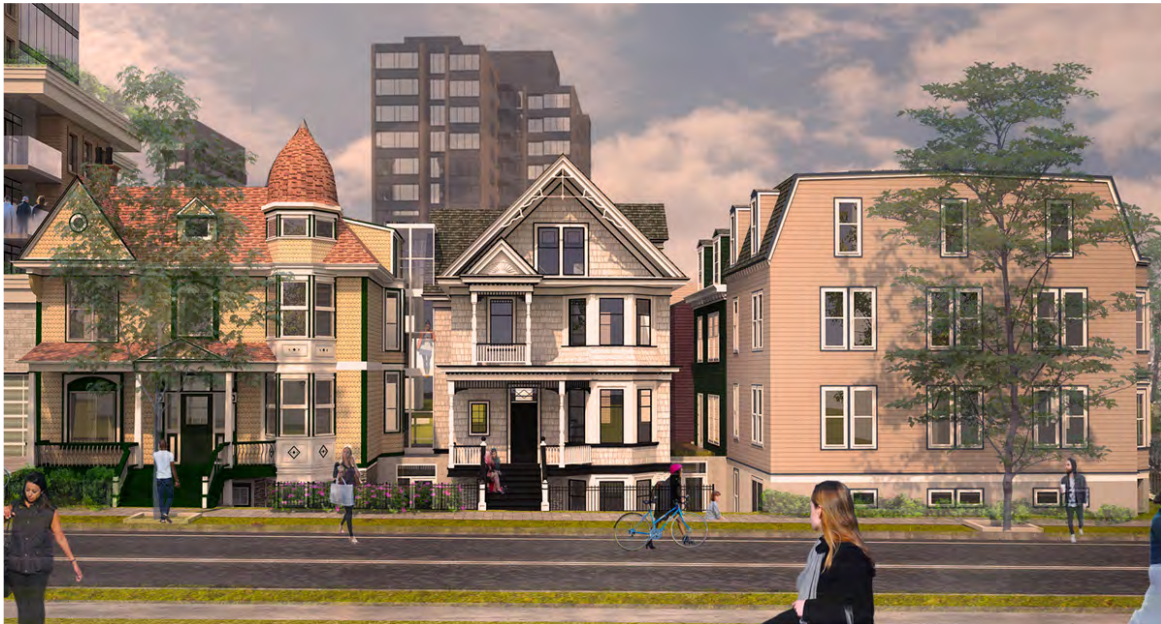
Figure 4. Proposed modification to 5969 College St., 5963 College St., 1452 & 1456 Carlton St. at ground floor, Artistic Render by Architect.

Generally, the existing buildings on the Promenade lands are to be dismantled to make way for the new construction. As a means of preserving the heritage value, it is proposed to relocate the Gold Cure Institute (5969 College) and one other Victorian era structure (5963 College) to new locations on College Street. This grouping of Victorian era structures is intended to complement and anchor the south west end of the Carlton Streetscape by carrying the scale and rhythm around the corner onto the College Street frontage and providing a transition from the heritage streetscape to the new development to the west (Figure 4).

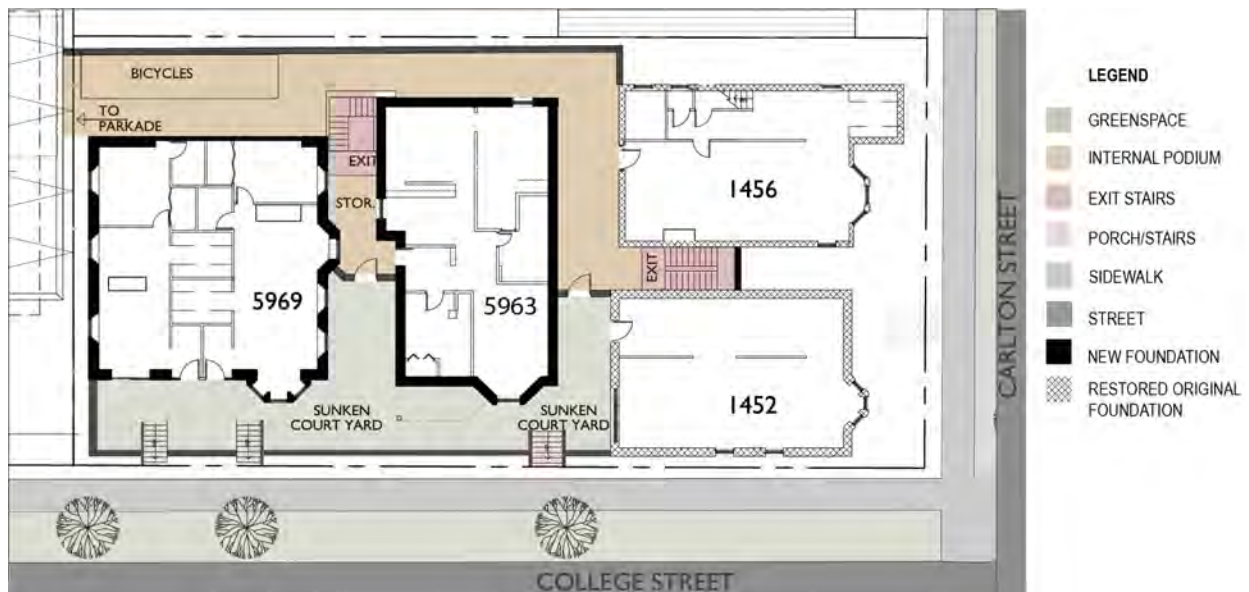
Figure 5. Proposed modification to 5659 College St., 5963 College St., 1452 & 1456 Carlton St. at basement level, by Architect.

The Promenade proposal includes the dismantling of the 1990's addition and the relocation of the original structure approximately 60 feet to the south, forming part of a grouping of Victorian era structures intended to complement and anchor the south end of the Carlton Streetscape. The building will be renovated to accommodate residential units. The new foundation for the relocated building will be integrated with the parking structure of the Promenade development, providing tenant access to underground parking and services. The relationship of the existing structure to College Street will be maintained in its new location, including the excavated courtyards that provide light and access to the units on the lowest level. This excavated courtyard does not impact the essential form of the properties but rather; this is intended to increase the functionality and financial feasibility of the rehabilitated structure. A new exit stairway to the rear of the building will provide the required second means of egress (*Figure 5*).

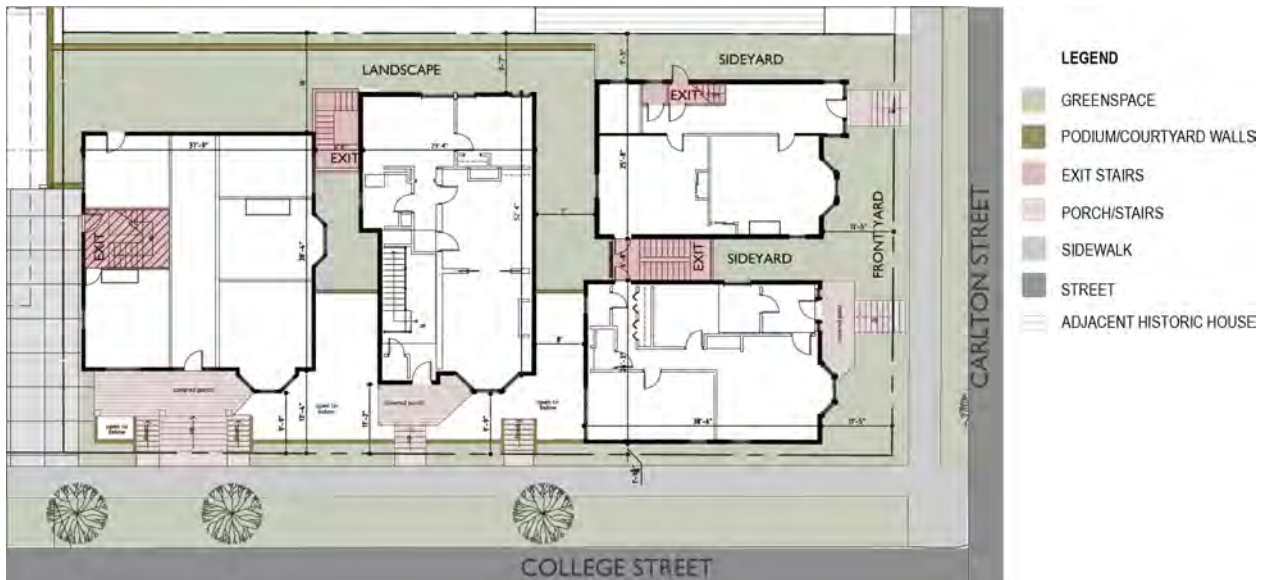
Figure 6. Proposed modification to 5659 College St., 5963 College St., 1452 & 1456 Carlton St. at ground floor, by Architect.

In accordance with the *Standards for the Conservation of Historic Places in Canada*, this approach will conserve the heritage value of the recognized historic place, the Gold Cure Institute. The program for the building will remain residential, and the interiors of the building are to be renovated to create modern residential flats. This minimal shift in building use seeks to preserve the spatial configuration of the structure that helps to define the building character. An example of this is the retention of the original side entry to the dormitory levels and using it as the principal entrance to the upper level flats.

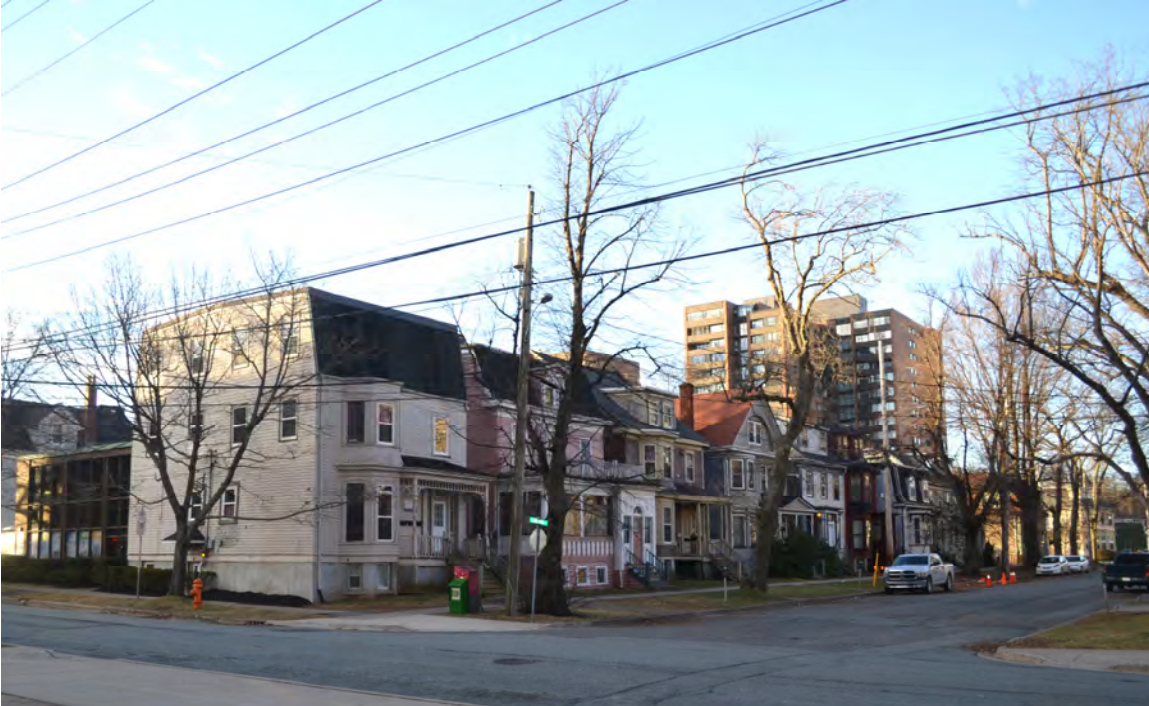
Figure 1. Photo depicting the south west corner of the Carlton Victorian Streetscape, photo by Architect.

The lands assembled for the proposed development “The Promenade Robie South” includes two of the houses of the Carlton Victorian Streetscape. 1452 Carlton and 1456 Carlton are three-storey wood frame houses located at the south end and west end of Carlton Street (*Figure 1*). The land assembly also encompasses several other Victorian era structures, including the municipally registered property at 5969 College Street, known as the Gold Cure Institute Building. Combining these properties along Carlton and College Street within the larger re-development plan will provide the resources to rehabilitate the properties, highlight the heritage qualities and refurbish the exterior envelope and details.

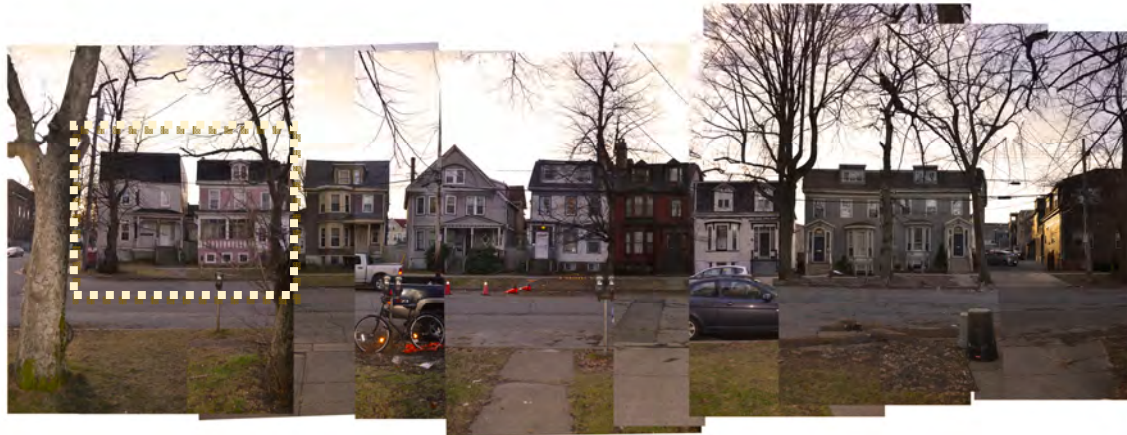
Figure 2. Photo stitch depicting the west side Carlton Victorian Streetscape, 1452 & 1456 Carleton indicated. Photos by Architect.

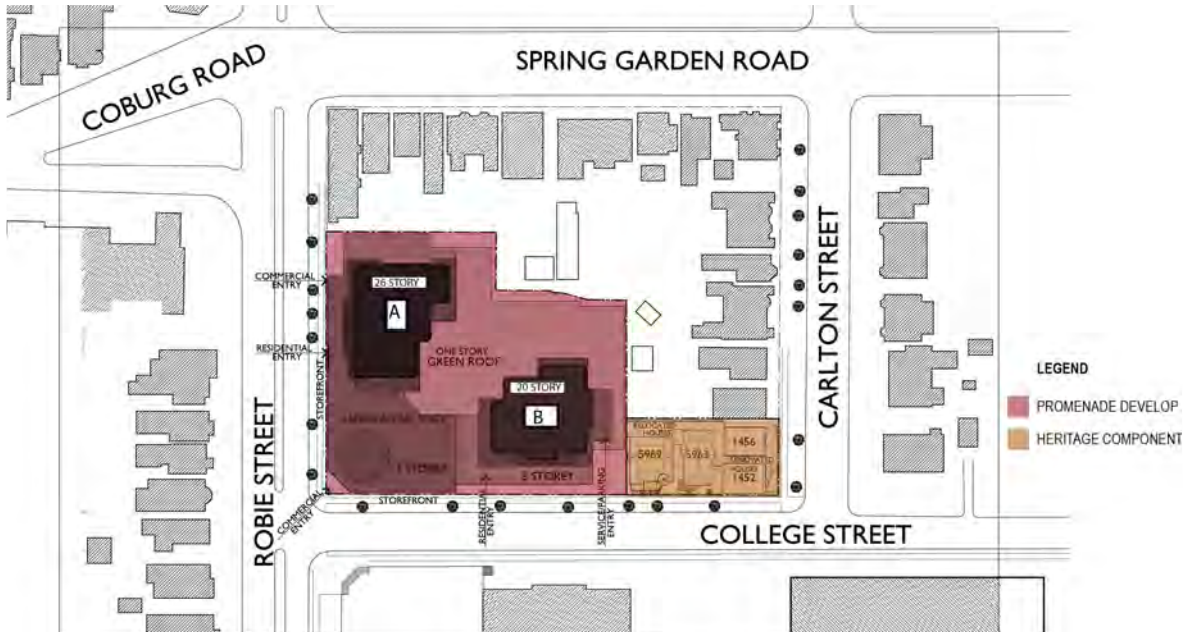
Figure 3. Development concept of The Promenade project depicting both new and rehabilitated construction areas, by Architect.

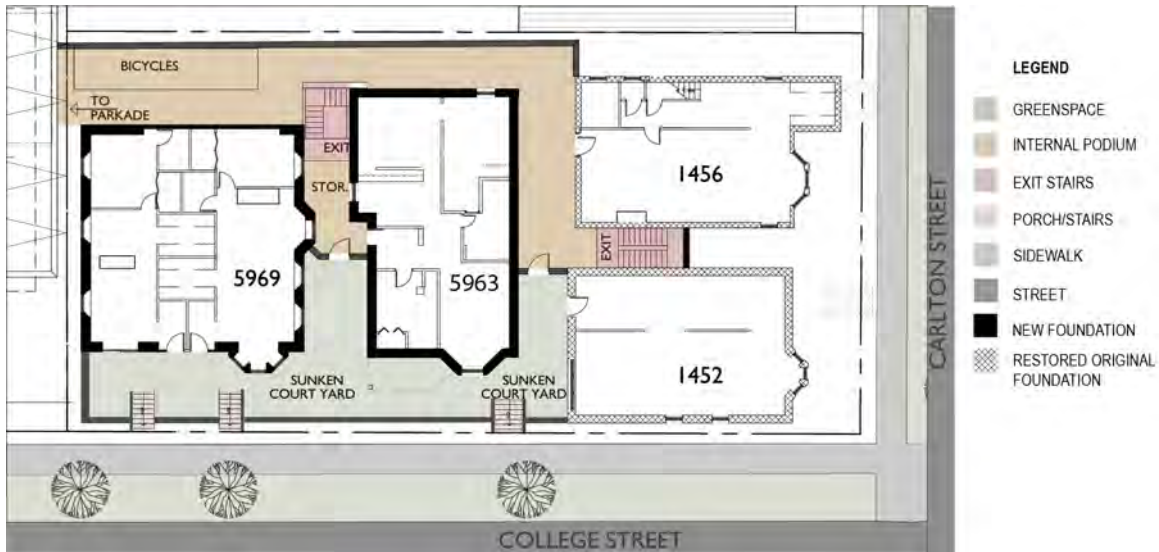
Figure 4. Proposed modification to 5659 College St., 5963 College St., 1452 & 1456 Carlton St. at basement level, by Architect.

This proposal is based on the consolidation of the 1452 and 1456 Carlton into a single property. The later additions to both buildings are to be removed to create space for the relocation of the two houses. The relocated buildings will be placed on a new foundation abutting the refurbished foundations of the two Carlton Street houses (Figure 4). This will create an indoor connection from all buildings on the corner site to the underground parkade of the new development. New glazed stair enclosures, set back from the street frontage, will be incorporated to provide the required second means of egress from the rehabilitated buildings.

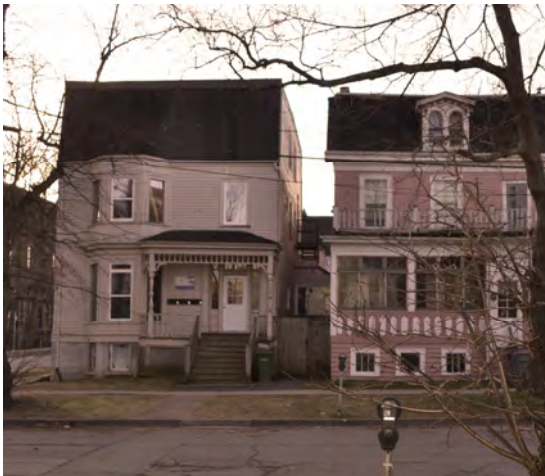
Figure 4. 1452 and 1456 Carlton St. from street
Photos by Architect.

Unlike 1452 Carlton, the 1456 Carlton structure is in very poor condition overall and has suffered a series of additions and modifications to the Carlton Street frontage (*Figures 4,5*). Extensive rehabilitation to the building will be necessary, with the reconstructed elements reflecting the original façade elements as interpreted from the limited historic documentation of the property. The porch is to be removed and the original bay window will be reconstructed. Where there is insufficient physical evidence to the original characteristics of the Carlton Street frontage, the form, detailing and materials of the new elements will be compatible with the character of the Carlton Streetscape as a whole (*Figure 6*).

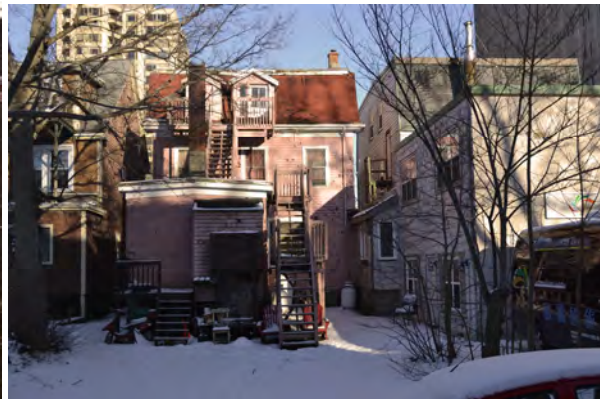
Figure 5. 1452 and 1456 Carlton St. from rear.
Photos by Architect.

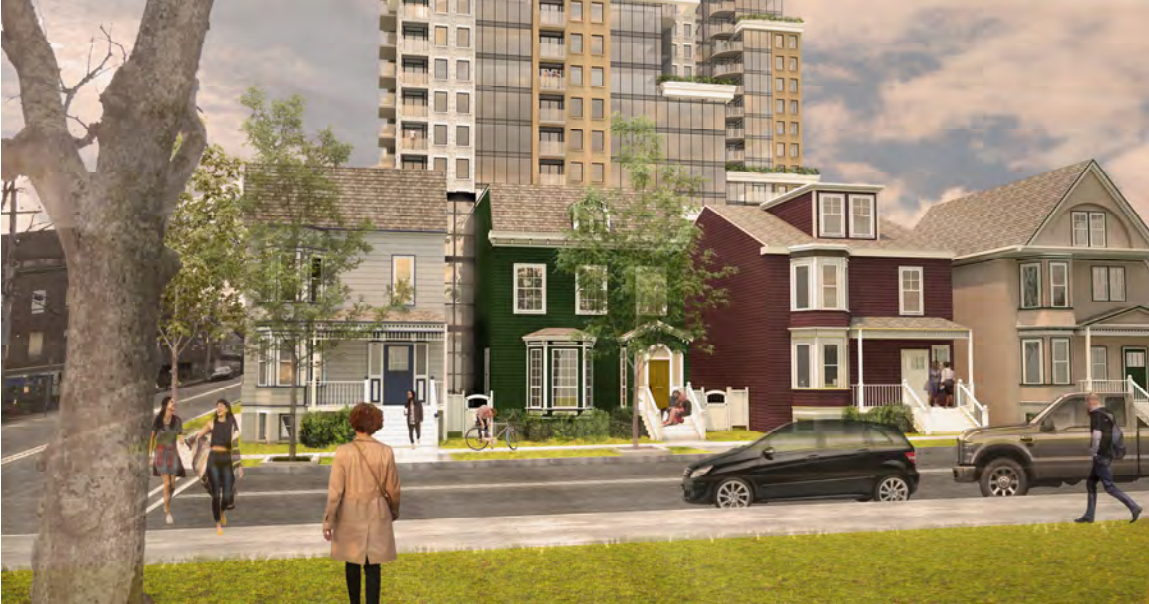
Figure 6. Proposed modification to 1452 and 1456 Carlton Street properties. Artistic Render by Architect.

A required element of the proposal is the new addition of stair enclosures, necessary for means of egress from the rehabilitated properties. One such stair will be required between the two Carlton properties, this will be created so as not to impair the essential form and integrity of the Carlton Victorian Streetscape. By locating the stair as far from the street as possible and by using a minimally visible glazed design, we will seek to make the new work both as, subordinate to and distinguishable from, the historic place as possible (Figures 6,7).

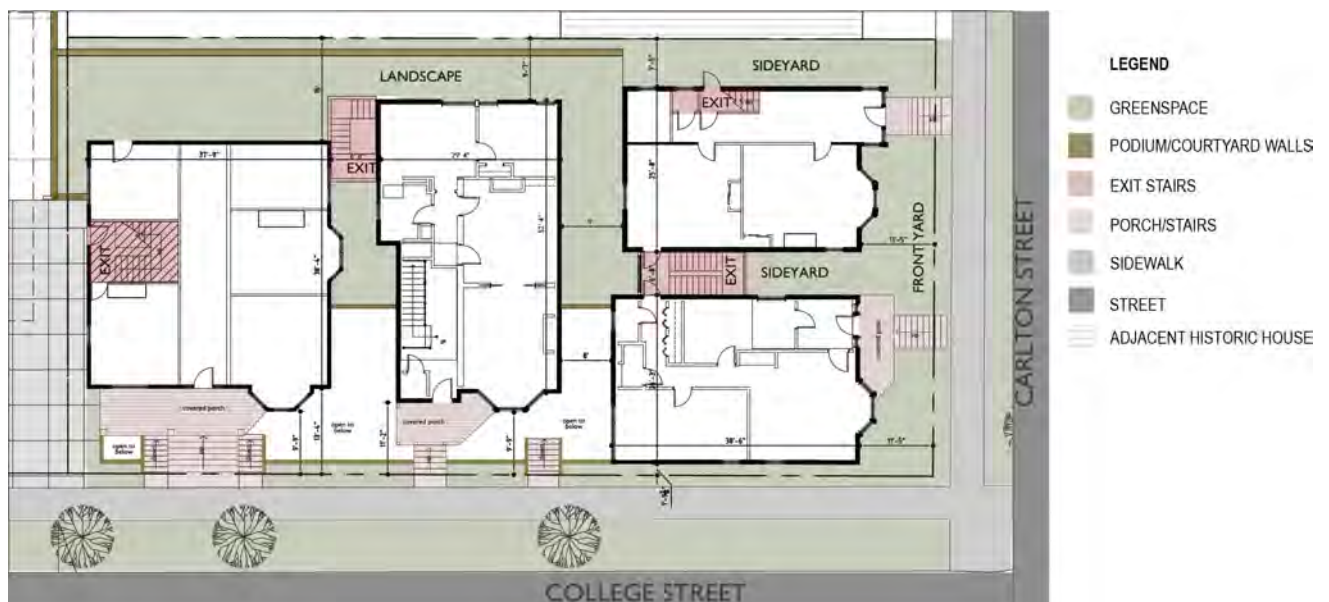
Figure 7. Proposed modification to 1452 and 1456 Carlton Street properties at ground floor, by Architect.

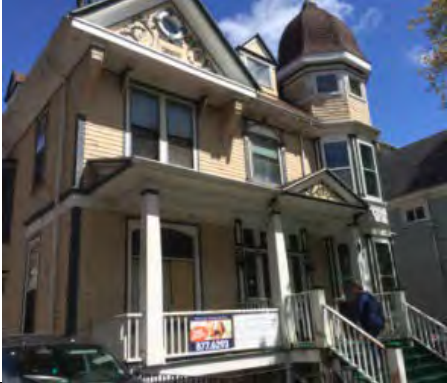
<p>Character defining element</p>	<p>Condi tion</p>	<p>Conservation recommendations</p>	<p>Comments</p>
<p>1</p>	<p>Highly ornate Queen Anne structure</p>

<p>Good</p>	<p>See detailed recommendations below</p>	
<p>2</p>	<p>Hipped roof with small gabled dormers</p>

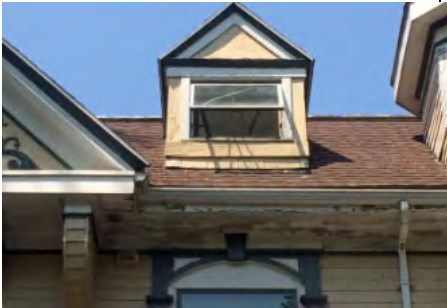
<p>Good</p>	<p>Scrape and paint all trim. Replace portions of rotten boards with like as required.</p>	<p>Dormer windows, although not original, should be retained</p>
<p>3</p>	<p>Decorative gable ornamentation</p>

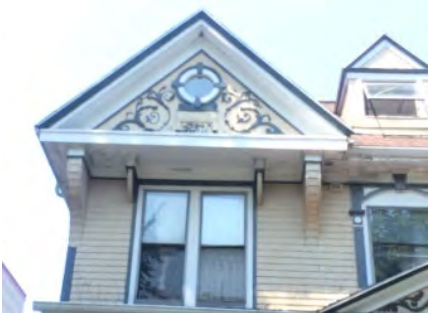
<p>Good</p>	<p>Scrape and repaint</p>

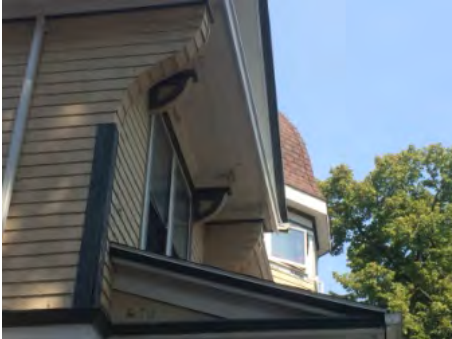
4	<p>Large brackets under the eaves on the main facade</p>

Very good	Scrape and repaint	
5	<p>Smaller brackets frame the principal College Street second floor window (see picture above)</p>	Very good	Scrape and repaint	
6	<p>Eight sided bell tower at southeast corner</p>

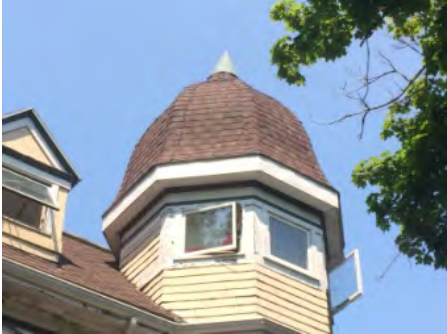
Very good	Scrape and repaint	Tower windows, although not originals, should be retained
7	<p>Windows: Except for attic, windows are original wood framed windows</p>

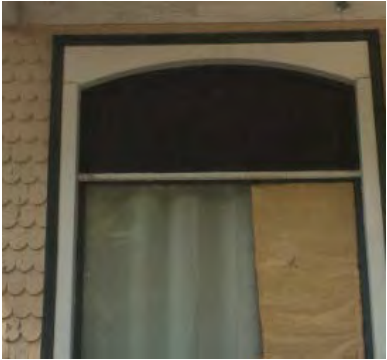
Good	Replace sashes with insert windows. Retain frames, trim etc. Fill sash balance voids with insulation.

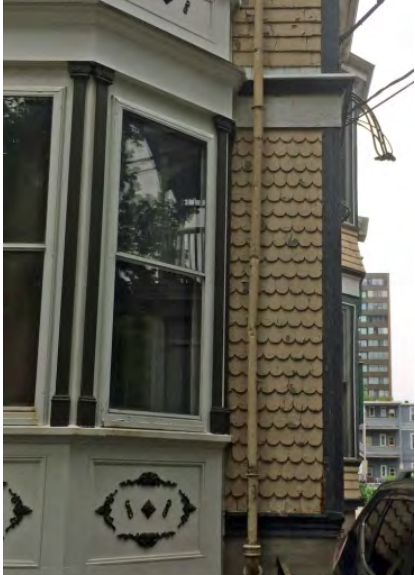
8	<p>Siding: original wood shingles including scalloped shingles on portions of main floor</p>

Good	Scrape and repaint	
9	<p>Trim: generally original.</p>

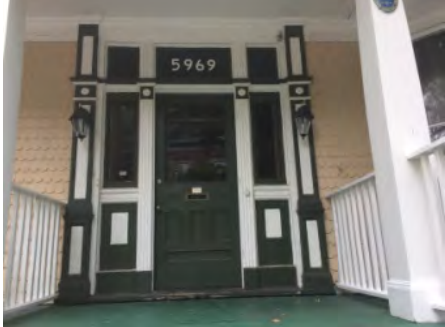
Good	Scrape and repaint. Cut in new pieces where rotten.	
10	<p>Asphalt shingle roof. This is not original but is acceptable</p>	Good	Maintain as required	
11	<p>Stone foundations</p>

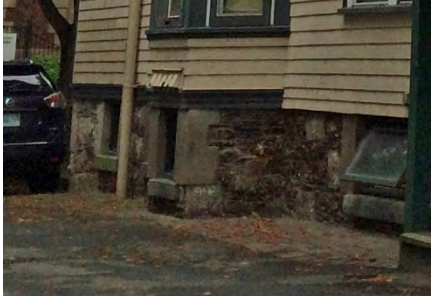
Good		Refer to item 4 below

1. Rear Wall: a rear wall elevation has been provided by Kassner Goodspeed (KG) and is approved.
2. Glass stairway: a revised elevation will be provided by KG
3. Shared foundation: this will confirm the intention to clad the exposed portions of the exposed foundation with rubble stone as previously stated.

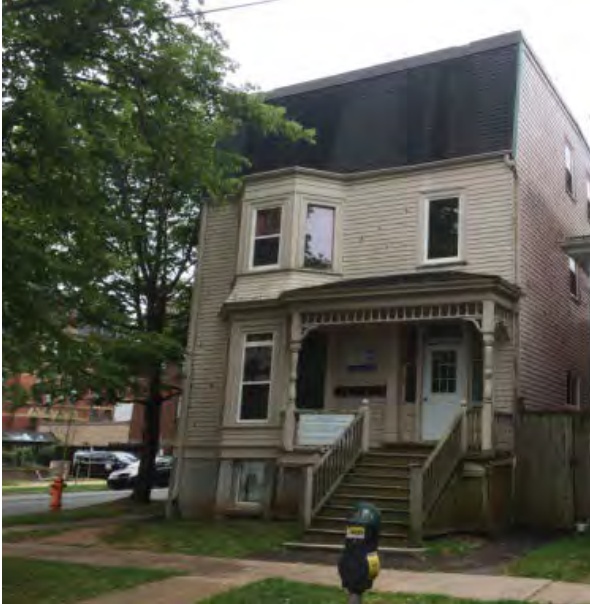
1452 Carleton Street c. 1861			
	Character defining elements of 1452 Carleton St.	Condition	Conservation recommendations	Comments
1	<p>Mansard roof with no openings</p>

Good	<p>Retain as is, however as the project design develops it may be advantageous to add a dormer window to this mansard roof. If so HRM Heritage staff will be consulted as to the appearance of this dormer.</p>	<p>This fairly plain roof and other fairly plain design features tell the story of a major fire c 1971 which required a new roof (and also new windows). These were constructed in the style of the 70's with simple, economical details.</p>
2	<p>Bay window extending to second floor on Carleton St facade (see above picture)</p>	Good	<p>Scrape and repaint. Cut in new wood to replace any rotten portions</p>	<p>Windows, although not originals, should be retained. Fixed windows could be changed back to vertical slider inserts.</p>

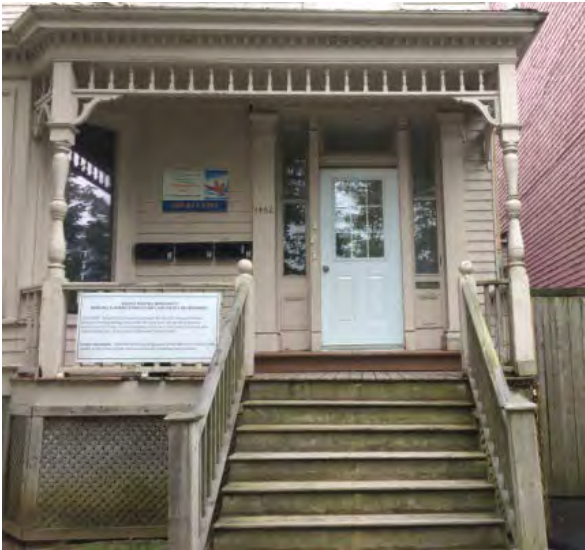
3	<p>Open porch with some gingerbread trim on Carleton St facade.</p>

Good	<p>Scrape and repaint. Cut in new wood to replace any rotten portions</p>

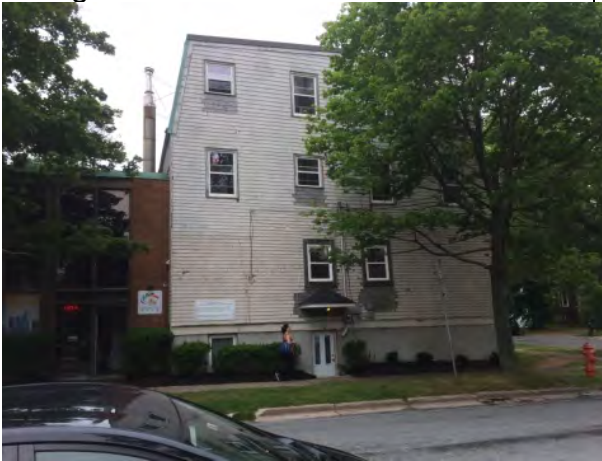
4	<p>Newer windows in original openings on College St. Facade.</p>

Good	<p>Scrape and repaint trim. Return recently reduced window sizes to former size (Lower sill height to match adjacent windows). Remove basement entrance and canopy.</p>	<p>These more modern windows help to tell the story of the c. 1971 fire. New double hung windows in the same proportions may be added to accommodate a new interior layout. If so, HRM Heritage staff will be consulted as to design. A current proposed elevation has been provided.</p>
5	<p>Wood siding –shingles</p>

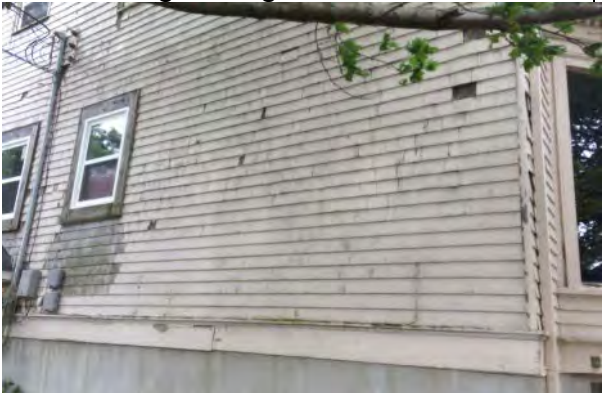
Good	<p>Scrape and repaint. Replace only where required.</p>	
6	<p>Wood trim</p>

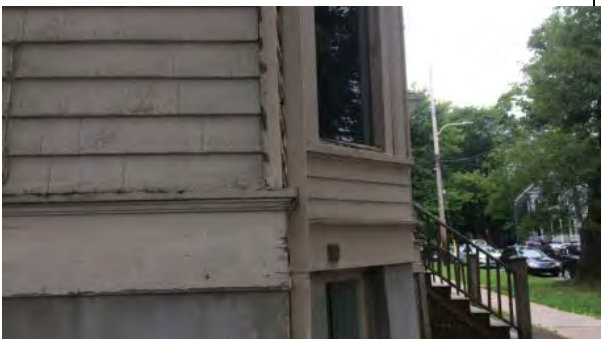
Good	<p>Scrape and repaint. Cut in new pieces to replace any rotten boards.</p>	
7	<p>Elaborate front entry</p>

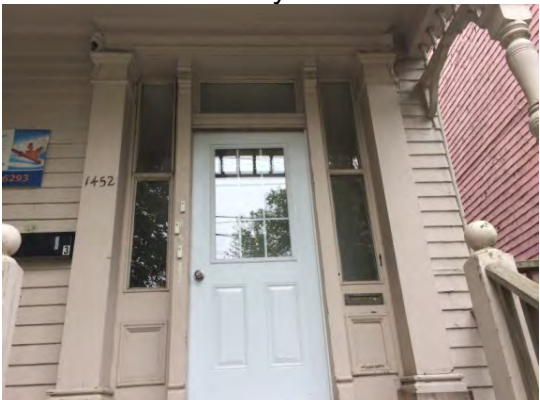
Very good	<p>Scrape and repaint. Replace new door with a more compatible version</p>

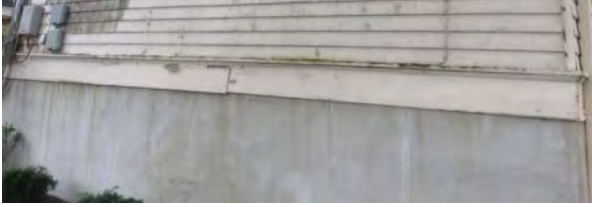
8	Asphalt shingle roof. This is not original but is acceptable	Good to very good	Maintain as required	
9	<p data-bbox="142 170 750 210">Parged rubble stone foundations</p>

Good	Retain on Carleton and College St facades. Infill door opening.

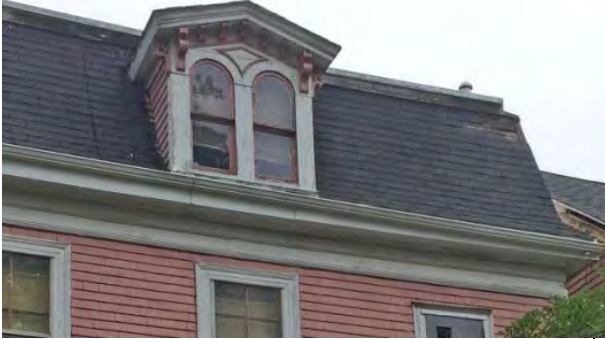
1456 Carleton Street c.1685			
	Character defining elements of 1456 Carleton Street	Condition	Conservation recommendations	Comments
1	<p>Mansard roof with one bay dormer with two round headed windows and brackets and trim</p>

Fair	Scrape and paint.	Replace window sash with new insert window, retain trim.
2	<p>Three bay second floor, two windows and one door to the roof of the porch</p>

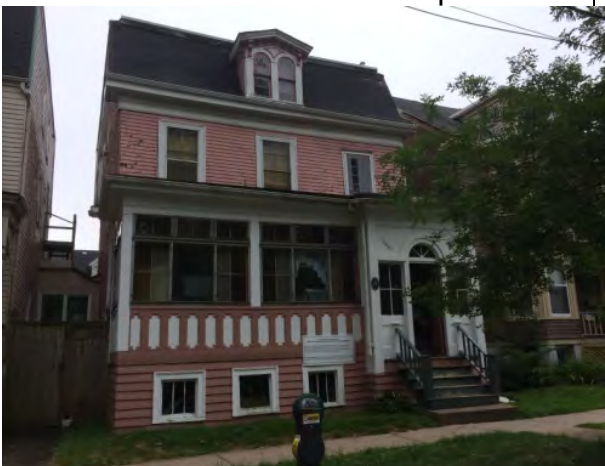
Fair	<p>Scrape and repaint. Cut in new wood to replace any rotten portions Replace door with a window and trim to resemble original.</p>

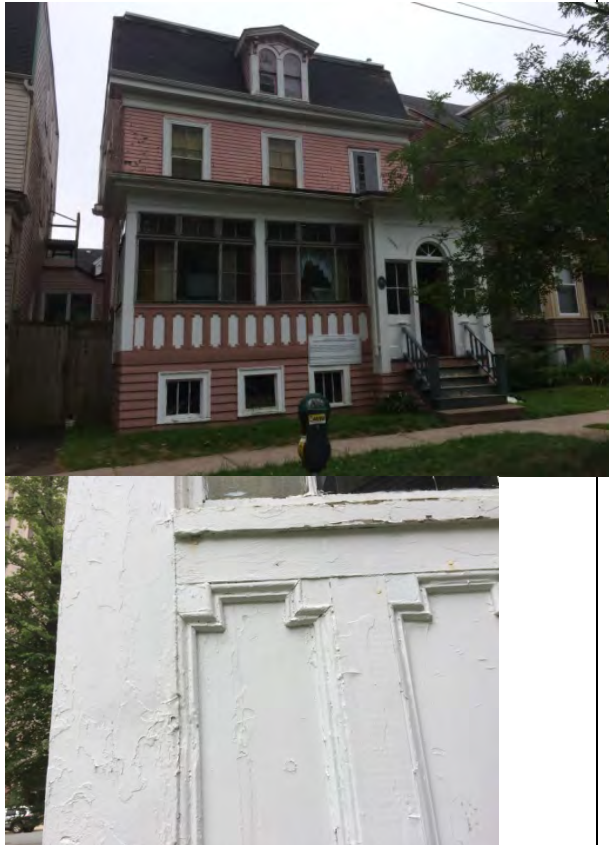
<p>3</p>	<p>A glassed in verandah extends across entire front with an entrance porch which is slightly distinct from the verandah. The verandah is not original and will be removed and replaced with a single bay window, similar to other bay windows on the street. An elevation will be provided. The front entry porch will be retained. The south elevation of the entry porch will be restored as required to match original.</p>

<p>Trim and panels on north side of entrance porch, probably original.</p>	<p>Fair</p>	<p>Scrape and repaint. Cut in new wood to replace any rotten portions.</p>	
<p>4</p>	<p>Windows on Carleton Street facade</p>

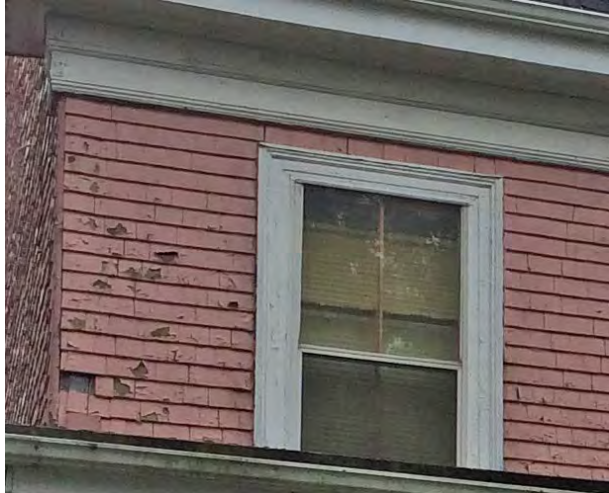
<p>Fair</p>	<p>Scrape and repaint trim. Replace window sashes with insert windows and fill counter-weight cavities with insulation.</p>

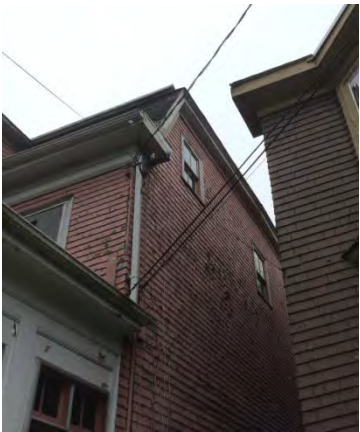
5	<p>Windows on Side walls</p>

Poor	<p>Replace sashes with insert windows. Replace window box and trim where rotten.</p>	
5	<p>Wood shingles on Carleton Street facade</p>	Poor	<p>Scrape and paint.</p>	<p>Replace rotten shingles new to match existing. Infill to match existing around new bay window.</p>
6	<p>Wood siding & shingles on side walls</p>

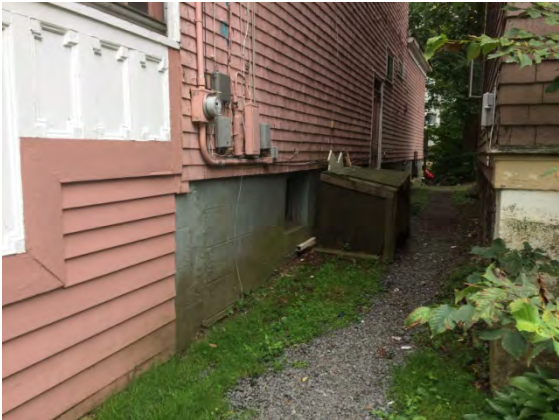
Poor	<p>These side wall will be retained if possible. They may have to be completely rebuilt due to their poor condition. If so they will be replaced to match the existing appearance in form and materials.</p>	<p>With the exception of the side walls of the entrance and front porch the side walls of the main building are not considered to be a vital part of the Early Victorian Streetscape</p>
7	<p>Wood trim on Carleton Street facade. Small amount of decorative wood trim, no gingerbread or brackets.</p>

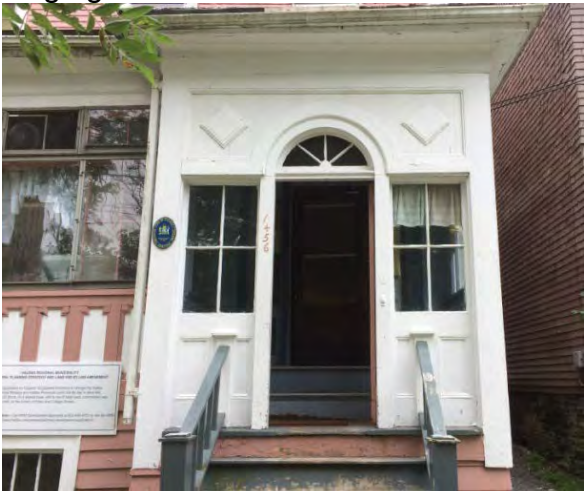
Fair	<p>Scrape and repaint. Cut in new wood to replace any rotten portions.</p>	<p>Restore south side of entry porch after verandah is removed.</p>

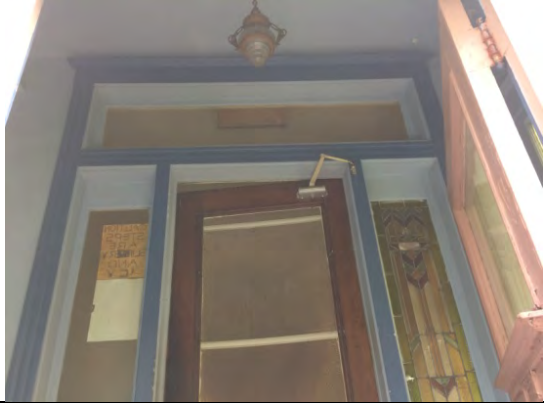
8	<p>Elaborate front entry at inner wall of entrance porch.</p>

Good	Scrape and paint	
9	<p>Asphalt shingle roof.</p>

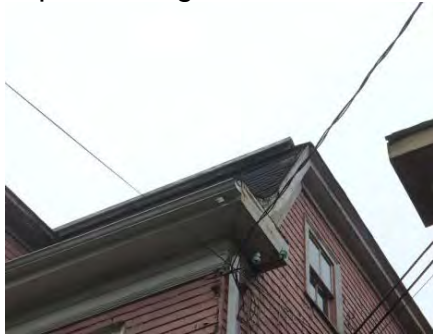
Poor	<p>Replace with new. Replace contemporary eave trim with a more compatible trim.</p>	<p>Asphalt shingles are not original but are acceptable.</p>
10	<p>Parged foundations</p>

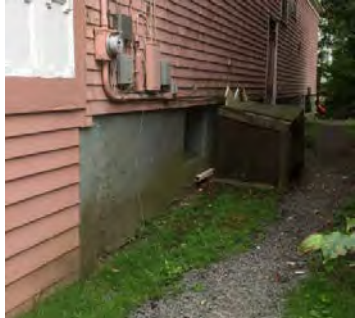
Fair	<p>Retain or rebuild to match exterior appearance</p>

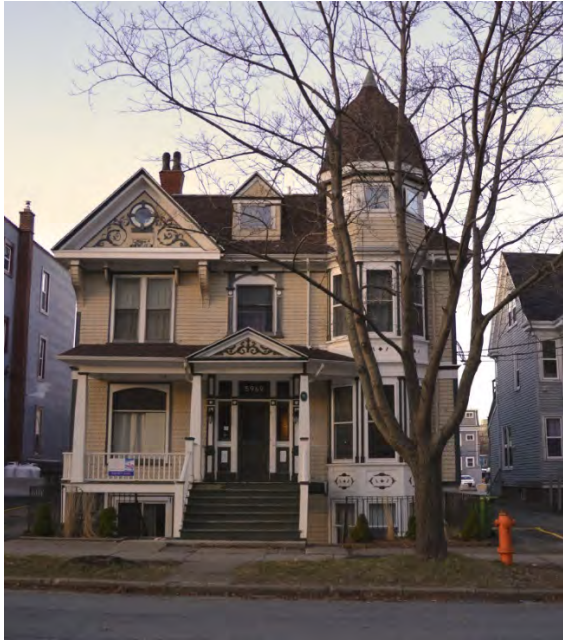
Gold Cure Institute: 5969 College Street, Halifax (1894)

Character Defining Elements:

The two and a half storey wood frame late Victorian structure exhibits character-defining elements typical of the Queen Anne style:

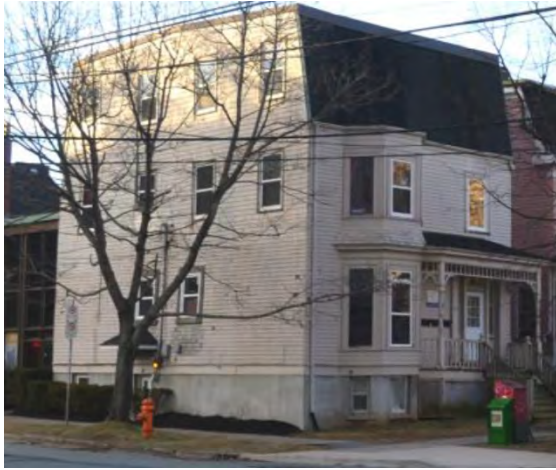
Victorian Streetscape: 1452 Carlton Street, Halifax (c. 1861)

Character Defining Elements:

The two-and-a-half storey wood frame Victorian structure exhibits the following character-defining elements:

- Wood frame structure with shingle cladding;
- Roof with steep mansard sides at the front and rear;
- Double bay window;
- Window on upper storey at front;
- Side hall entrance plan raised above grade with door surround including transom and sidelights;
- Porch with roof and stairs.

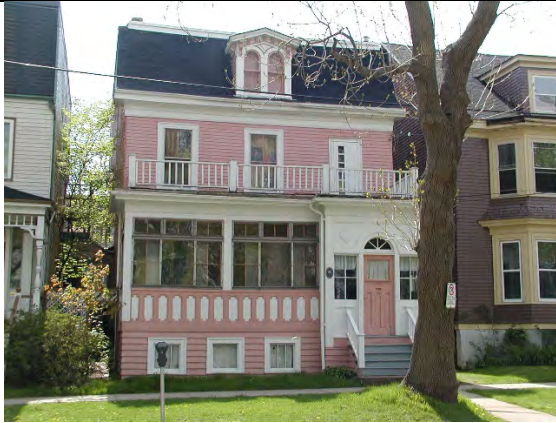
Victorian Streetscape: 1456 Carlton Street, Halifax (c. 1865)

The two-and-a-half storey wood frame Victorian structure exhibits the following character-defining elements:

- Wood frame structure with shingle cladding;
- Roof with bell-cast mansard sides and cornice at the front and rear;
- Central gable dormers at the front and rear with brackets and narrow twin round-headed windows in the front dormer;
- Prominent cornice;
- Three windows on upper storey at the front and rear;
- Side hall entrance plan raised above grade;
- Porch with roof and stairs.

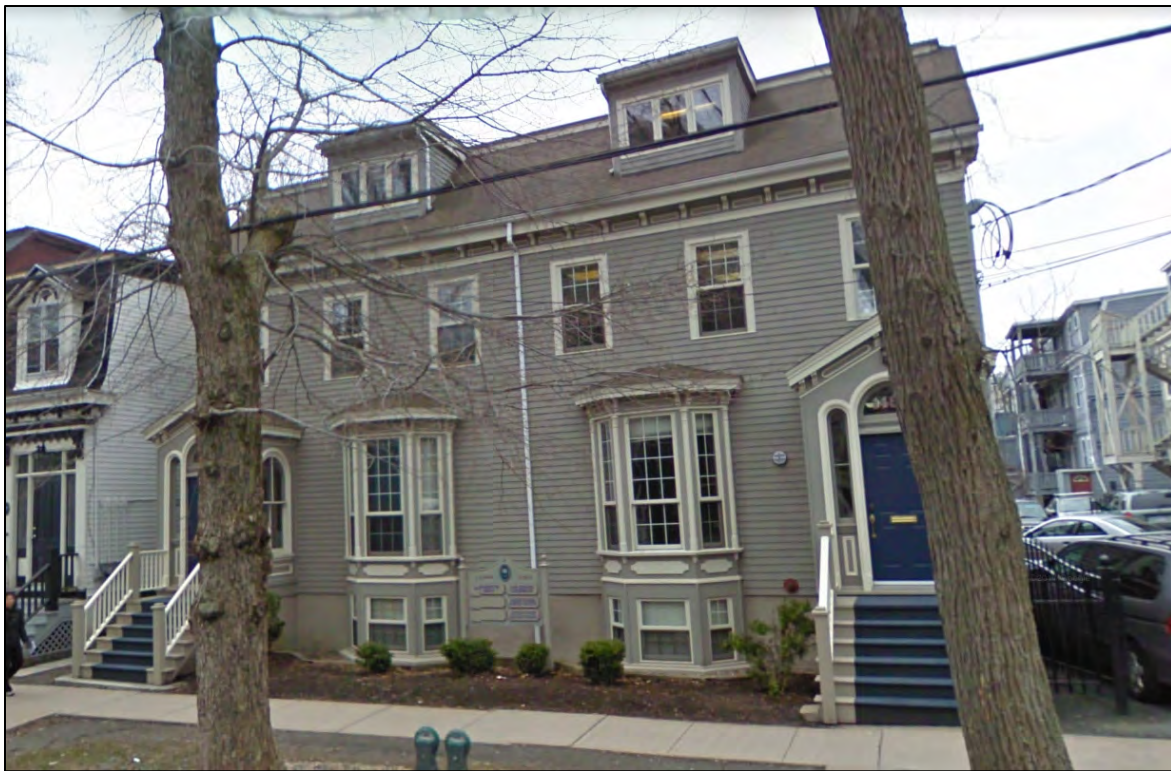
Figure 2: Twin buildings within the Early Victorian Streetscape at 1480-84 Carlton Street are of similar age as the building at 1456 Carlton Street and include single-storey bay windows alongside covered front porches (Google Street View, April 2009).
