**Lake Banook and Lake
Micmac 2018 Post-Harvest
Aquatic Vegetation Monitoring
Report**

Prepared for:
Halifax Regional Municipality
Energy & Environment
2nd Floor Alderney Gate
40 Alderney Dr.
Dartmouth Nova Scotia
B2Y 2N5

Prepared by:
Stantec Consulting Ltd.
102-40 Highfield Park Drive
Dartmouth NS B3A 0A3

February 1, 2019

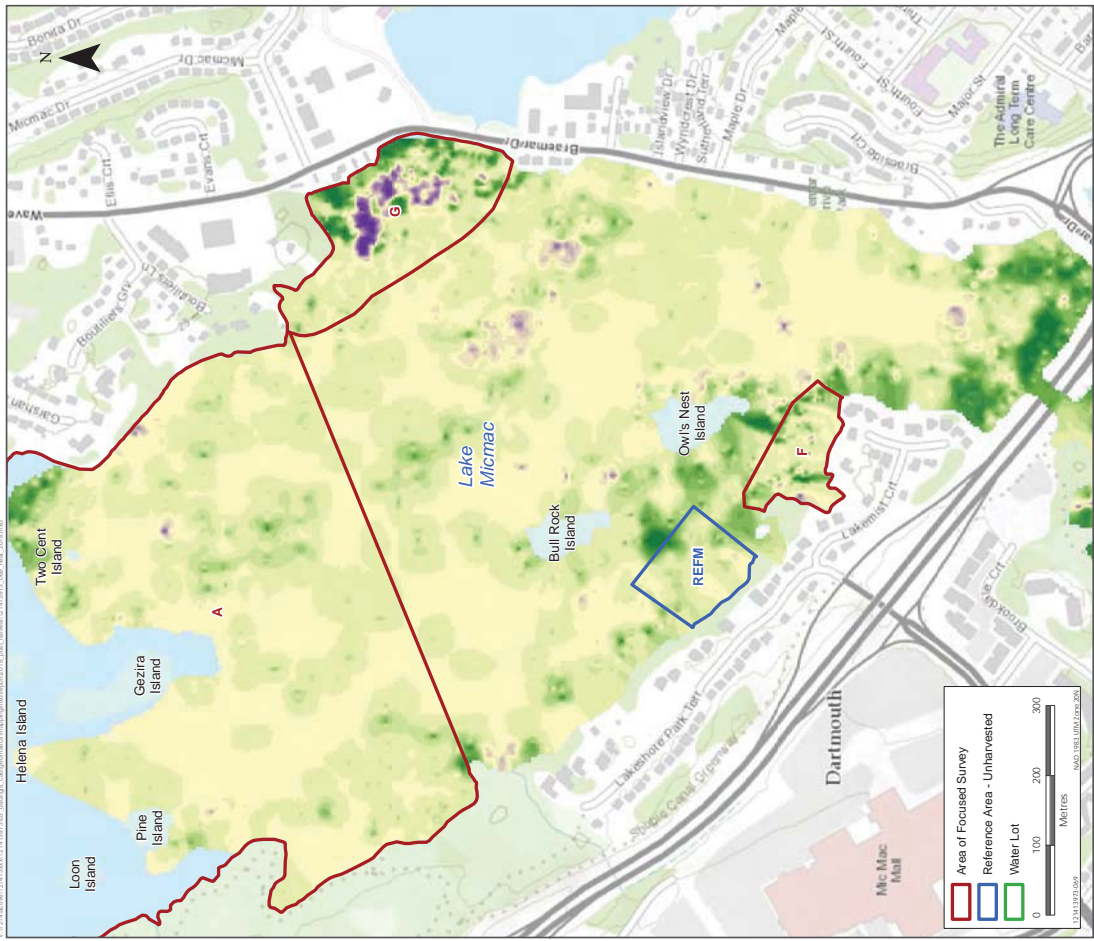
Change in Percent Cover: 2018 Post-Harvest to 2018 Pre-Harvest - Lake Micmac

Change in Percent Cover: 2018 Post-Harvest to 2018 Pre-Harvest - Lake Banook

Comparing Lake Micmac SAV coverage from pre-to post-harvest in 2018 depicted similar observations to previous years' surveys, with sporadic increases and decreases in vegetation coverage being observed throughout the lake (Figure 5). In Area G where the harvester was active, decreases in vegetation coverage can be seen. Conversely, zones of increase can be seen in the nearshore region of Area G, a small portion of Area F, as well as in the southern portion of the lake near the outlet to Lake Banook (Figure 5). Patterns of vegetation stasis were also evident in REFM, which was not subject to harvesting activity. Graphical examination of these trends in SAV percent cover further highlighted the generalized increase in the value as well as variation in percent cover responses for both lakes (Figures 6 and 7; Appendix B).

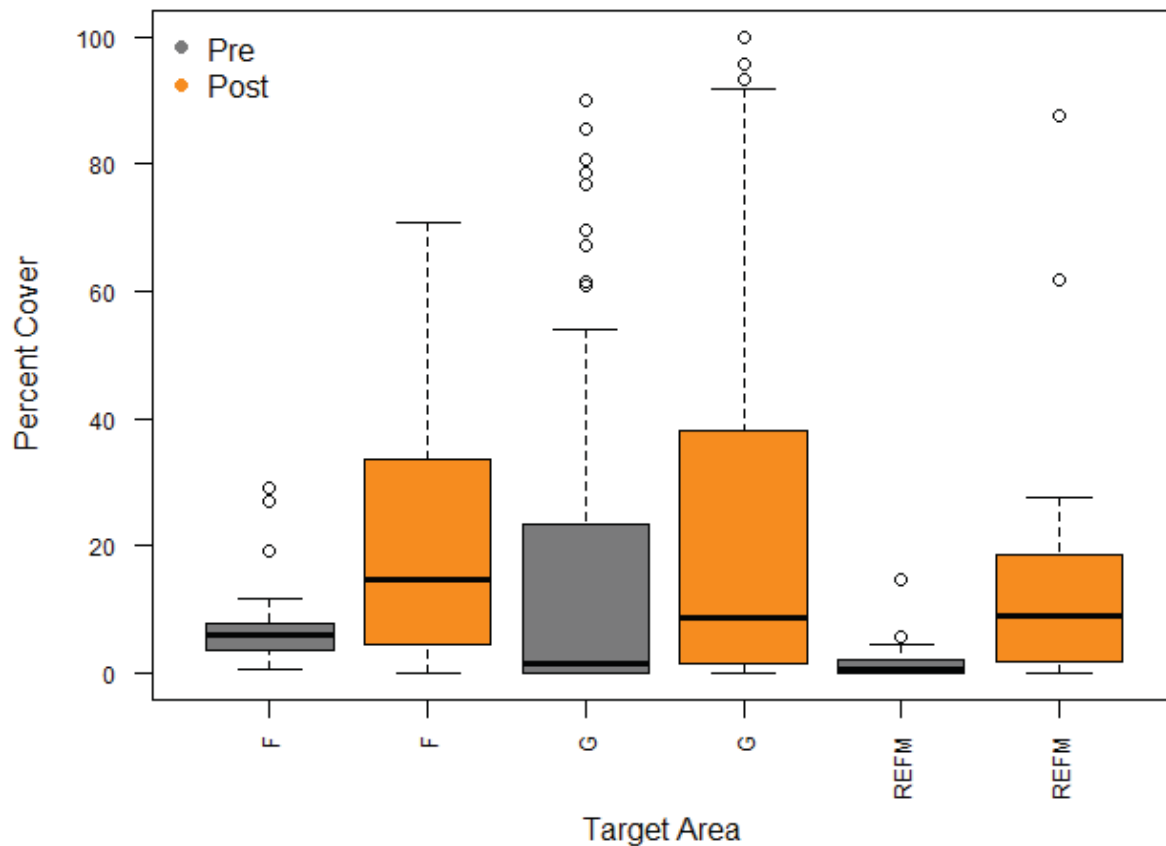
Figure 7 Boxplots of SAV Percent Cover Areas in Lake Micmac for 2018 Pre- vs. Post-Harvest

Note: The centre line is the median. Ends of the box indicate the lower and upper quartiles. Ends of the whiskers indicate the quartile ± 1.5 x interquartile spread. Open circles indicate values falling outside the quartile ± 3 x interquartile spread. REF M = Reference Area M.

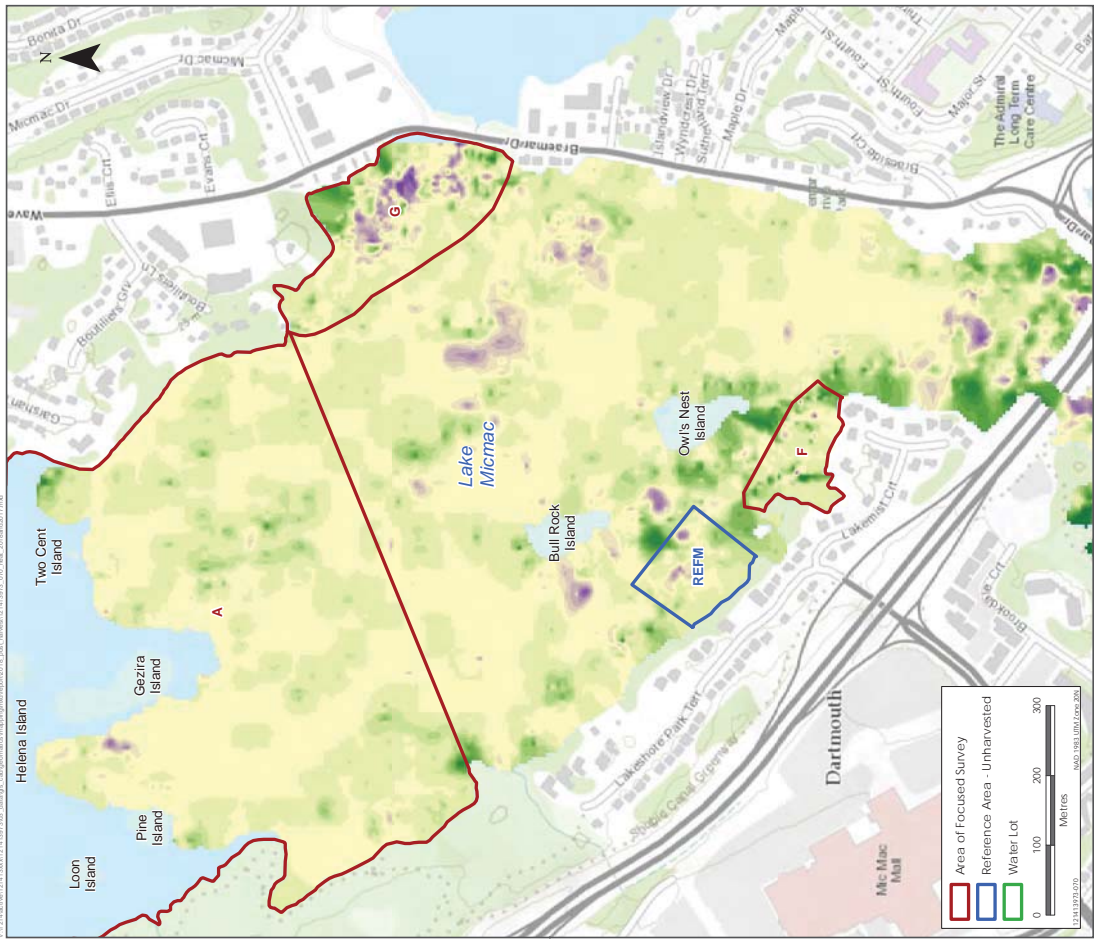
Change in Percent Cover: Post-Harvest 2018 to 2017 Post Harvest– Lake Banook and Lake Micmac
Figure 8

Representative comparisons to assess inter-annual trends potentially related to harvesting activity must be made between comparably timed surveys, such as those late-summer, post-harvest surveys which occurred from 2015-2018 in Lake Banook (as well as data from 2014 initial survey prior to harvesting) and 2015-2018 in Lake Micmac. When comparing SAV percent cover post-harvest between 2018 and 2017 in Lake Banook (Figure 8), substantial areas of increase were prevalent in all Target Areas particularly in Areas C and H, adjacent to Paddler's Cove, as well as the nearshore area between Areas D and E. This result contrasts greatly with the distinct SAV declines that had been observed from 2017-2016 (Appendix C; Stantec 2017b). Meanwhile, post-harvest data from 2018-2017 in Lake Micmac showed an overall similar trend to past surveys in which diffuse increases and decreases in SAV coverage can be seen in target harvest Areas F and G as well as in the reference area, REFM (Figure 8).

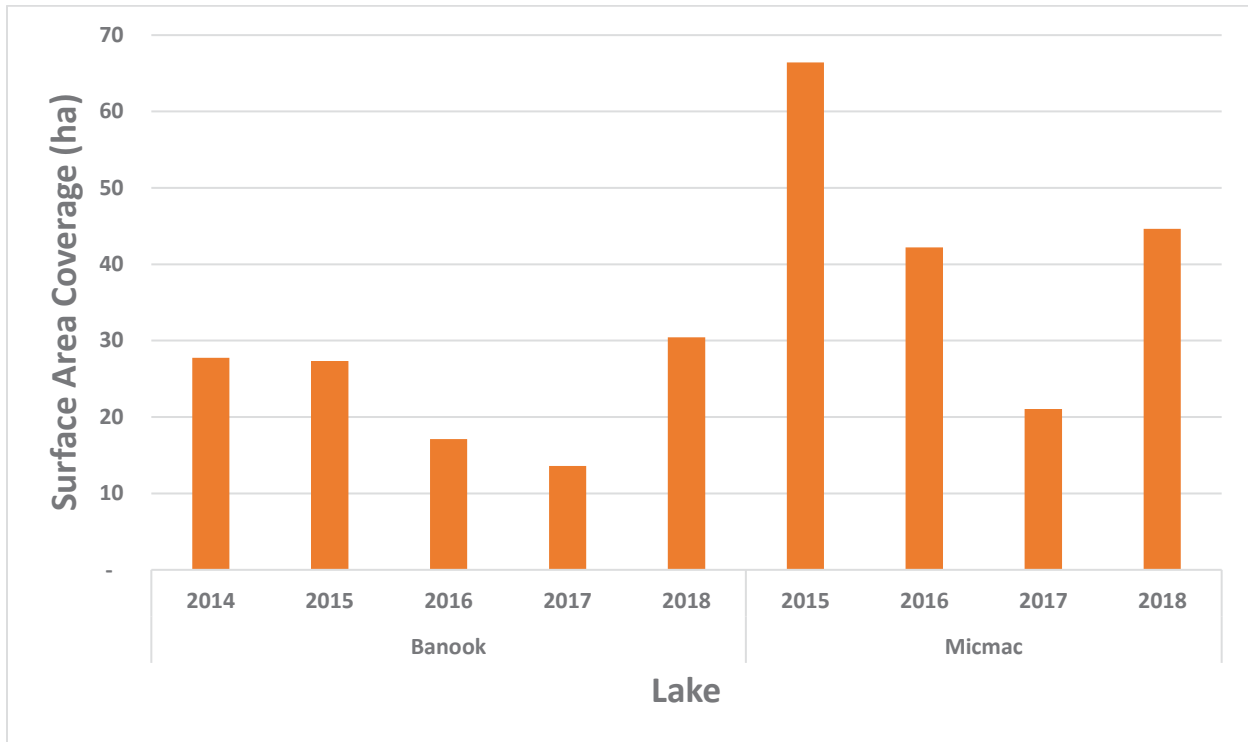
Figure 13 Temporal Trends (2015-2018) of Total Surface Area Coverage by Plants– for Lake Banook and Lake Micmac

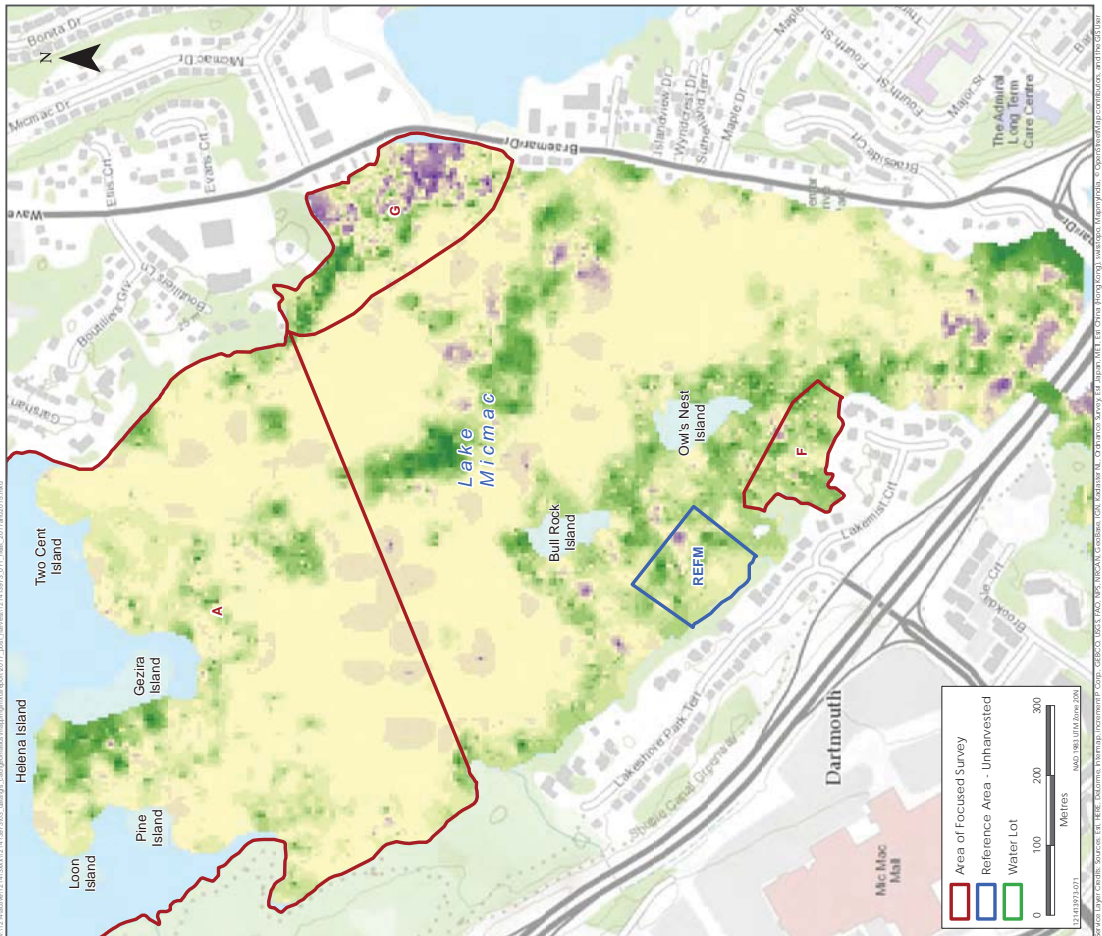
Figure C-4

Change in Percent Cover: Post-Harvest 2017 to 2015 - Lake Micmac

Change in Percent Cover: Post-Harvest 2017 to 2015 - Lake Banook

When looking at post-harvest data trends in Lake Banook between 2017 to 2015 (Figure C-4), there was a general decrease in vegetation coverage throughout most of the Target Harvest Areas as well as the majority of the lake. There were some increases in vegetation coverage noted when comparing these two years of data including parts of Area B as well as Reference Area B (REFB). Increases in vegetation were also noted in southern portions of the lake as well as the area west of Area H. When comparing post-harvest data from Lake Micmac from 2017 to 2015, there is an overall trend towards decreasing vegetation coverage throughout a majority of the lake with exceptions to Area G as well as the southern portion of the lake in the vicinity of the outlet to Banook (Figure C-4).

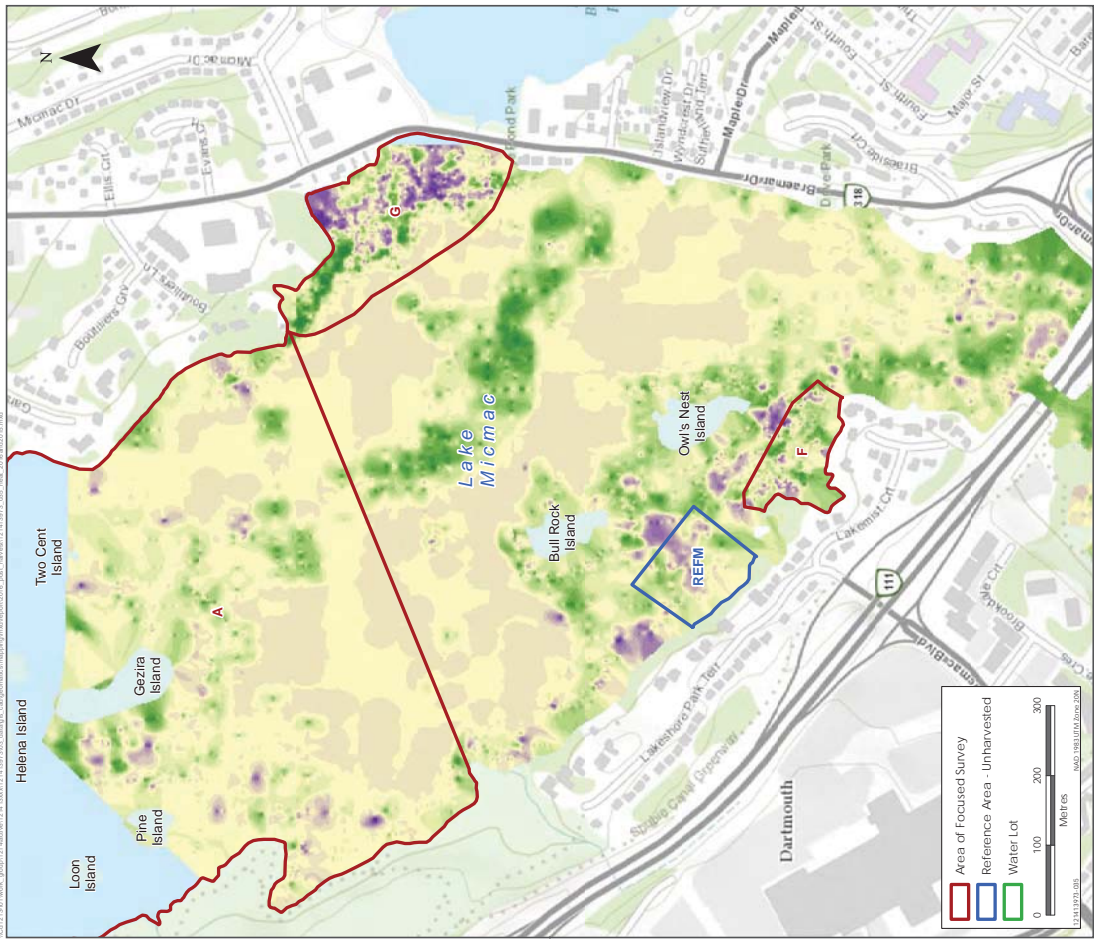
Figure C-6

Change in Percent Cover: Post-Harvest 2016 to 2015 - Lake Micmac

Change in Percent Cover: Post-Harvest 2016 to 2015 - Lake Banook

When comparing SAV percent cover post-harvest between 2016 and 2015 in Lake Banook, there was a trend towards decreasing vegetation coverage in most nearshore areas of the lake (Figure C-6). Major decreases in SAV coverage can be seen in the northern-most areas of the lake, particularly in proximity to Graham Grove Park and in Area B (Figure C-6). Similarly, in the nearshore areas along the eastern and western shorelines in the southern end of the lake, SAV coverage decreased greatly. In contrast, vegetation coverage has increased significantly in Paddler's Cove (Area C) as well as in Area H and the waters in their immediate vicinity. Furthermore, there seems to be sporadic increases in SAV coverage from 2015 to 2016 in shallow waters of the western portion of the lake adjacent to Brookdale Crescent (REFB, Figure C-6). From 2015 to post-harvest 2016 in Lake Micmac, there were decreases in SAV coverage throughout most of the lake (Figure C-6). There are three notable increases in SAV coverage, one throughout Area G and sporadic increases south of Bulls Rock Island and Owl's Nest Island (Figure C-6). Additionally, an area of dense SAV observed in 2015 (Stantec 2015c) along a shallow ridge running southeasterly through the middle of Lake Micmac greatly declined in 2016 (Figure C-6).
