**Management of  
Submerged  
Aquatic  
Vegetation in  
Lake Banook &  
Micmac**

**RWAB, March 13, 2019**

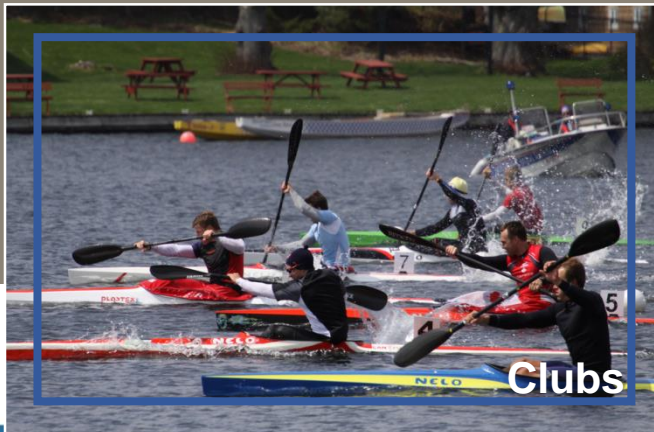
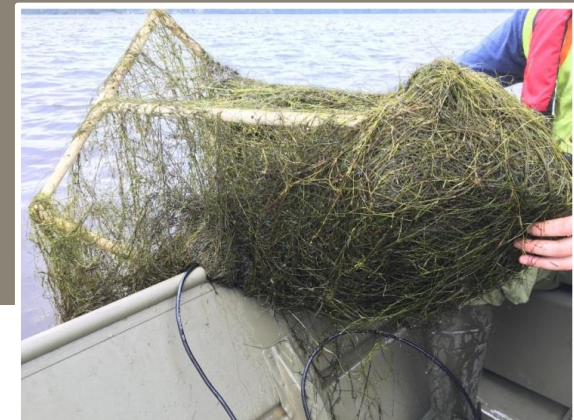
- Complaints of excessive aquatic vegetation interfering with recreation started in 2009
- By 2010 paddlers, motorized boaters and swimmers were being adversely affected
- In 2013 Stantec was contracted by HRM to assess causes and determine potential solutions

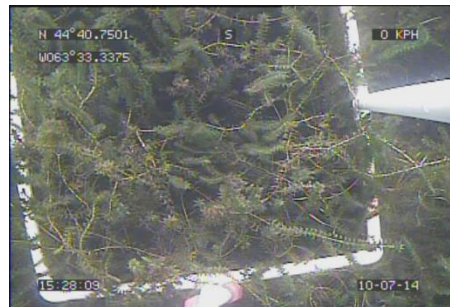
# Vegetation Mapping

Stantec single beam acoustics  
plus underwater video

- Bathymetry
- Percent Cover
- Canopy Height

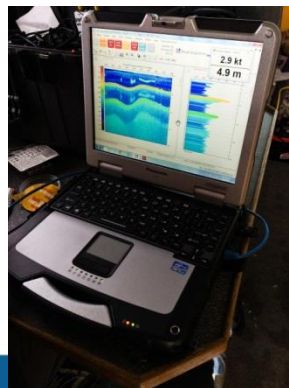
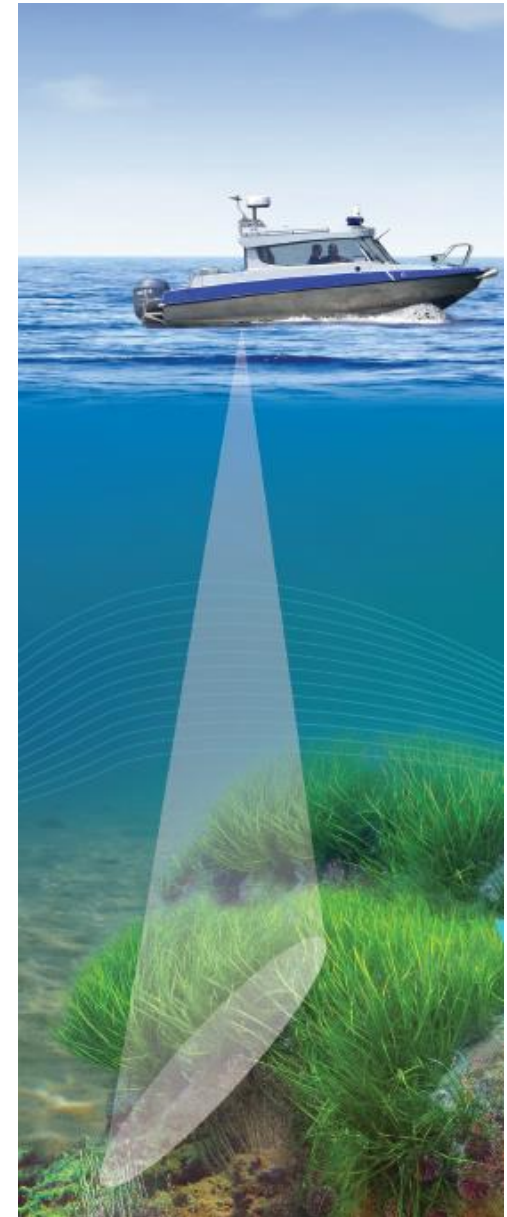
## Accuracy

- Range: 1.7 cm  $\pm$  0.2% of depth
- Positional: < 3 m, 95% typical

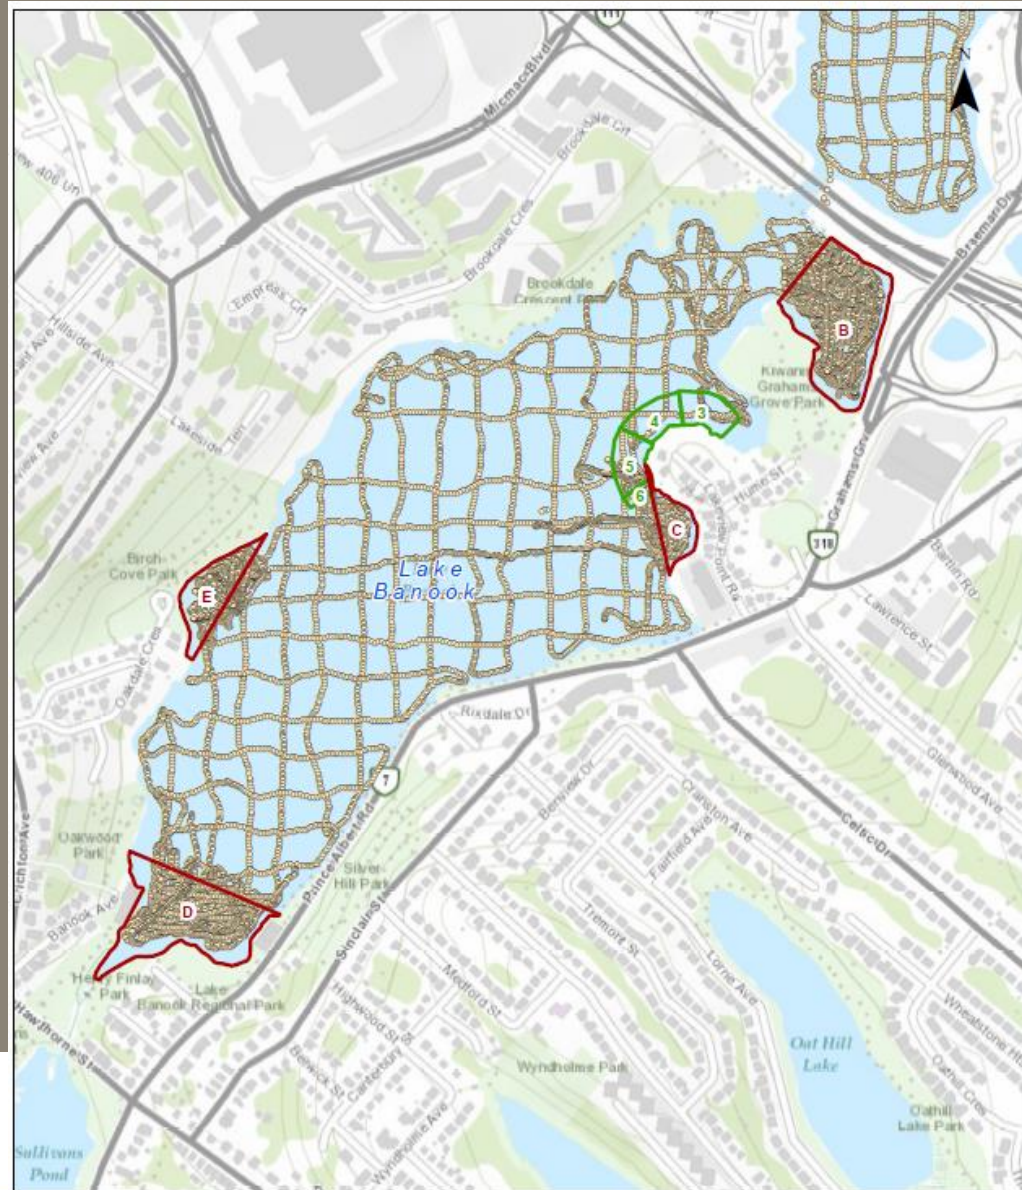
# Sampling Grid – Lake Banook

- Generalized Acoustic surveys via vessel based transects spaced 50 m apart
- Focused Acoustic via vessel based transects spaced 10 m apart in targeted harvest areas:
  - Banook – 6 Target Areas
  - Micmac – 2 Target Areas
- Along select transects underwater video was collected for ground truthing

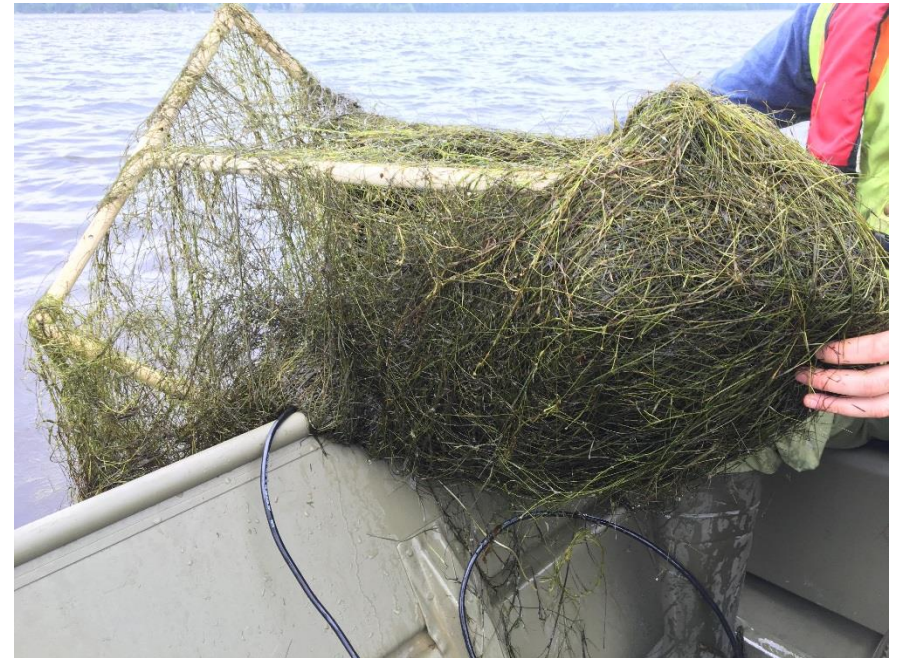
# Canopy Height

- **Lake Banook:**
  - Post harvest canopy heights are noticeably lower than before the harvest
  - Vegetation heights increased in areas where harvesting did not occur
- **Lake Micmac:**
  - Similar trends found with decreased vegetation heights in targeted areas.

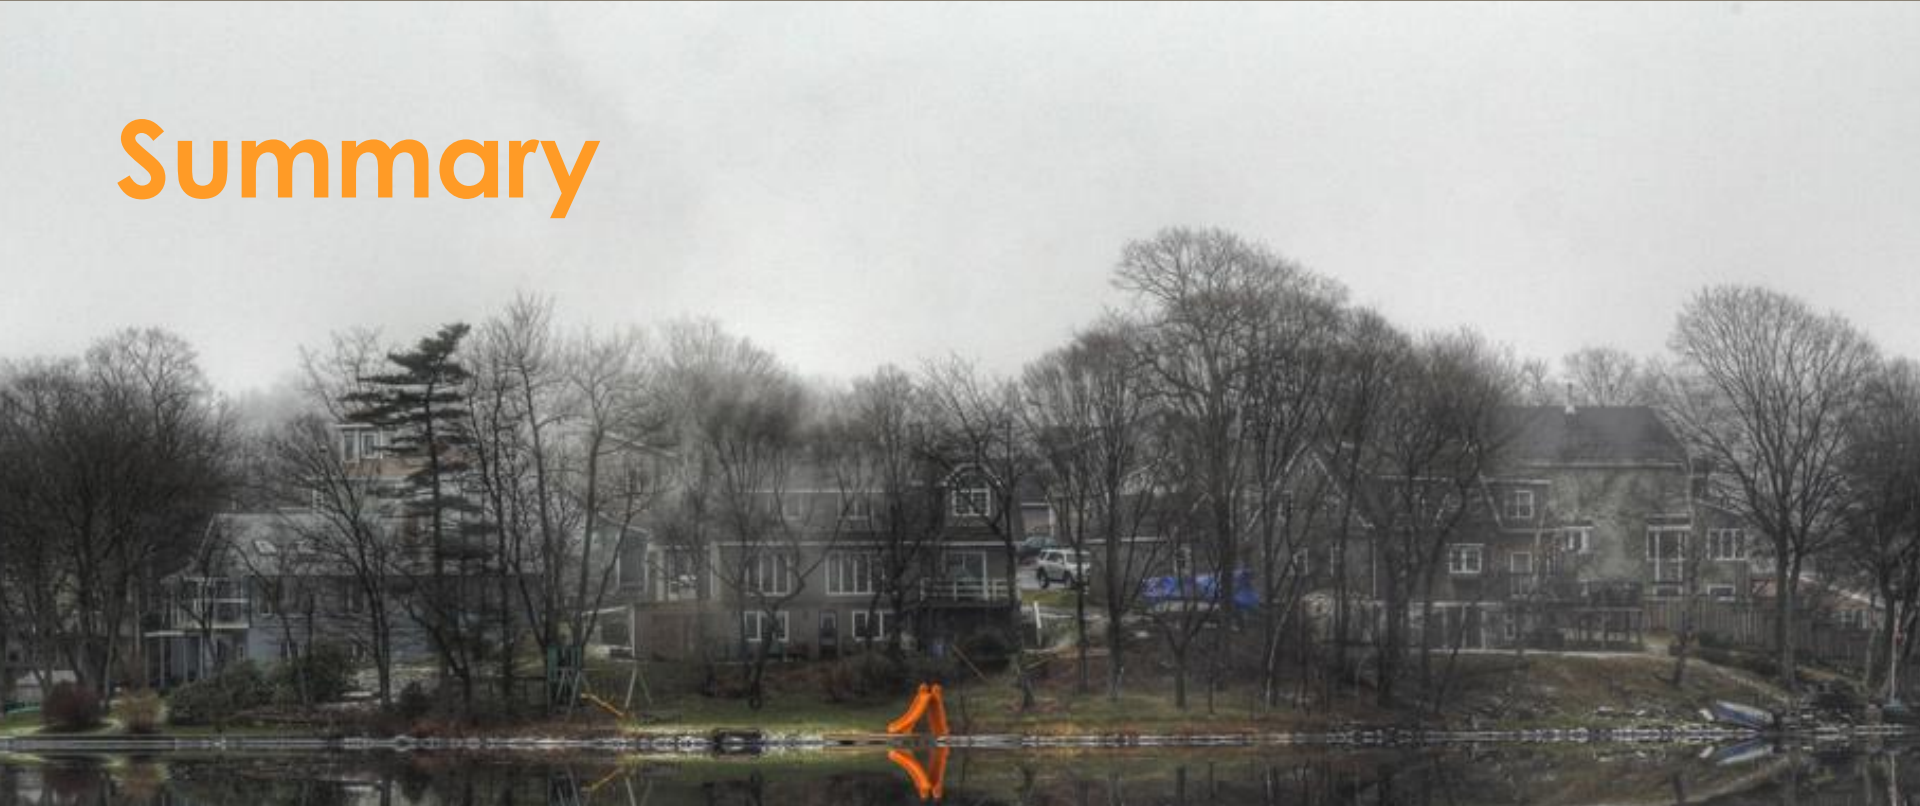
- **Multi-year contracts concluded in 2018**
  - **Overall assessment: mechanical weed harvesting has been operationally effective, but not ecologically effective**
  - **All major paddling events have been unaffected by weed growth**
  - **Continued management will be required**
