Road Safety in HRM

Moving on from the blame game

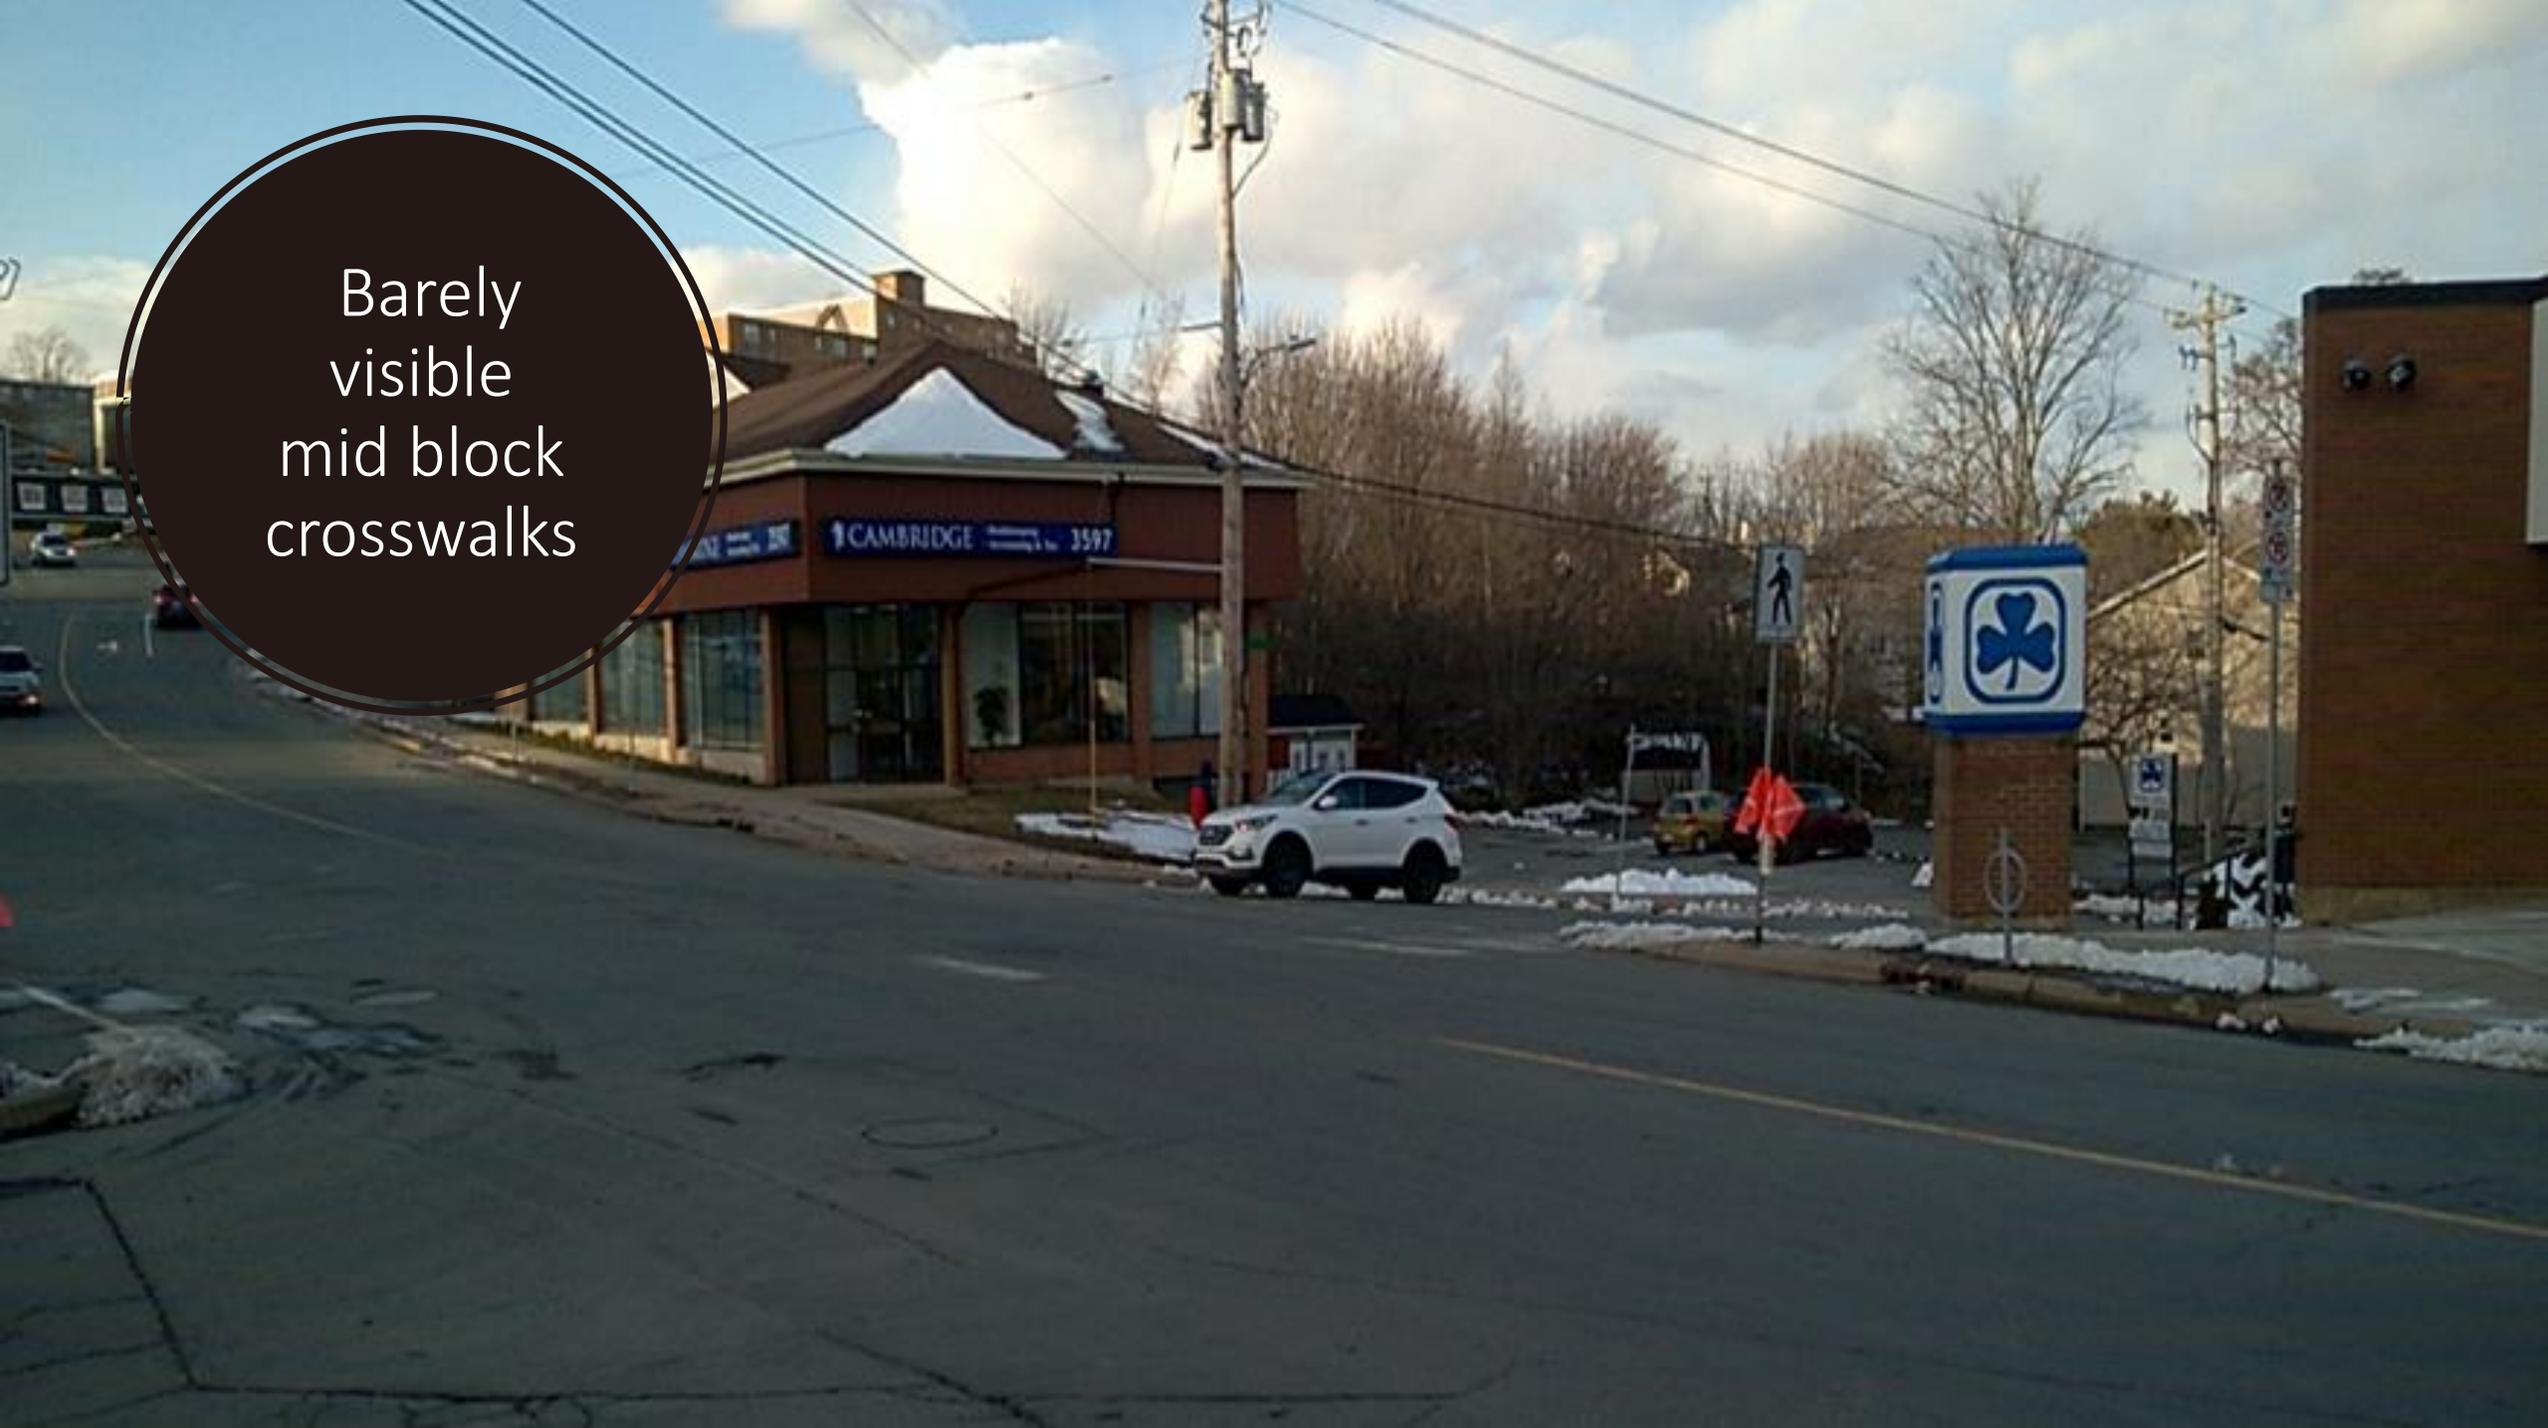
Barely  
visible  
mid block  
crosswalks

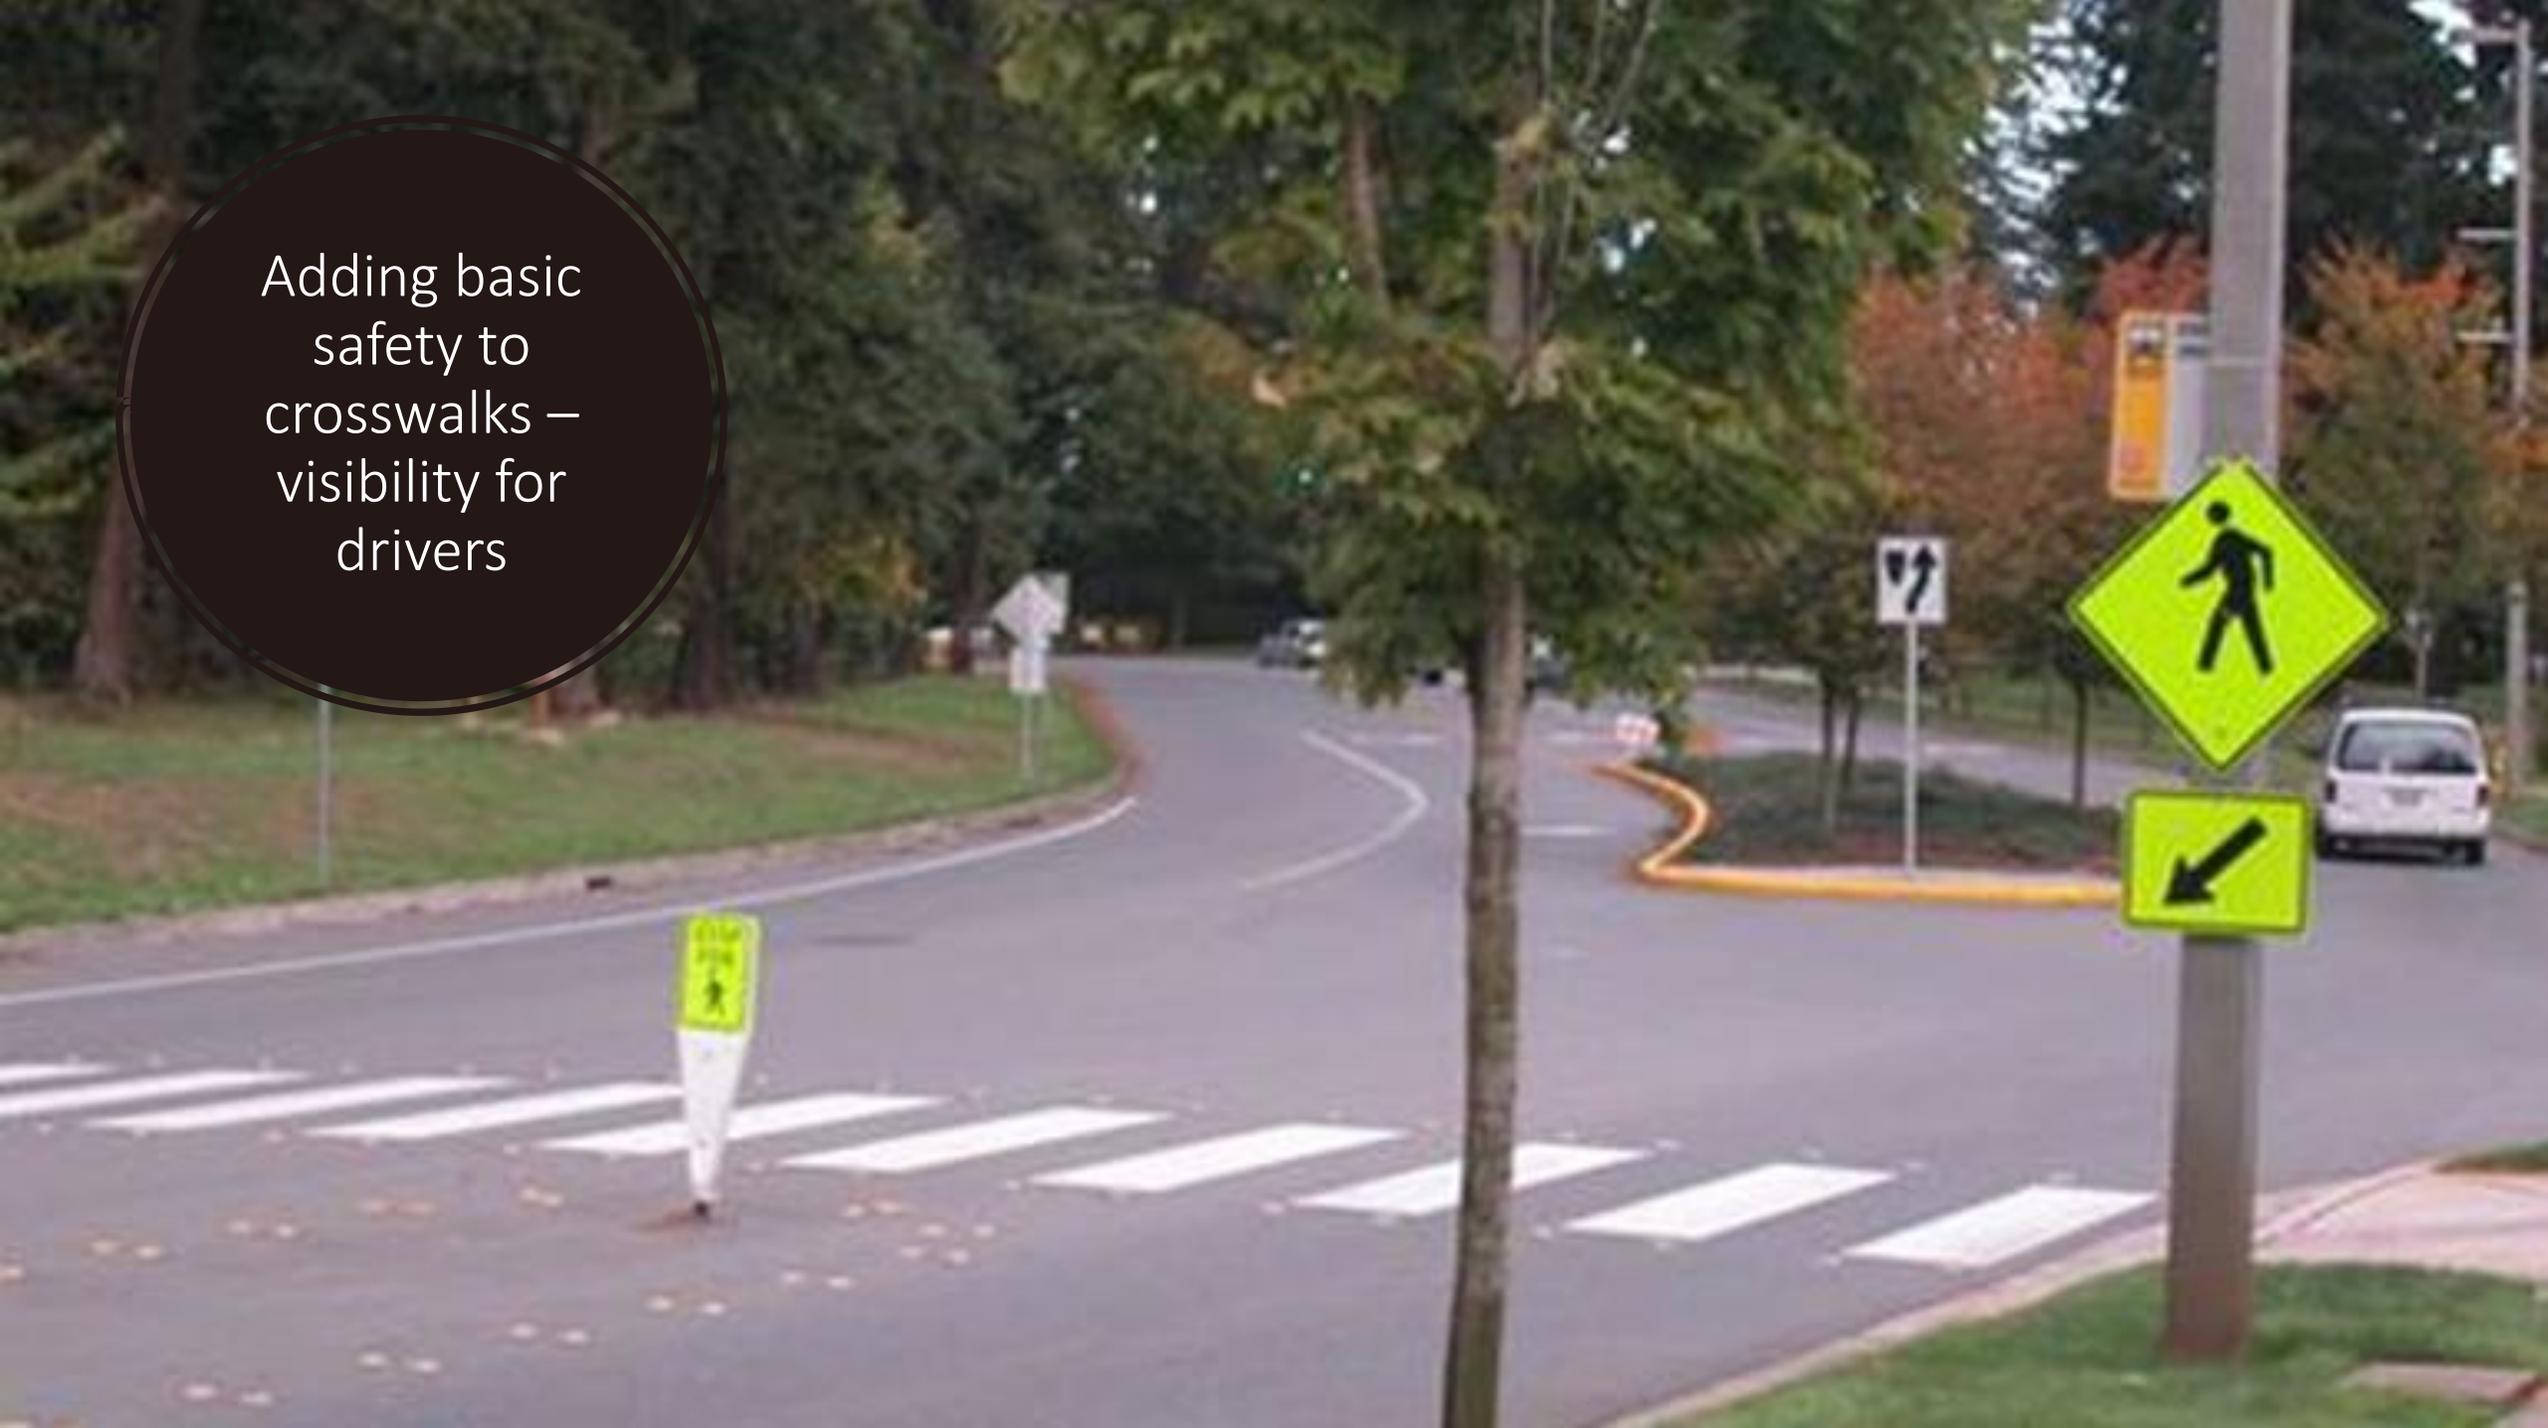
Adding basic  
safety to  
crosswalks –  
visibility for  
drivers

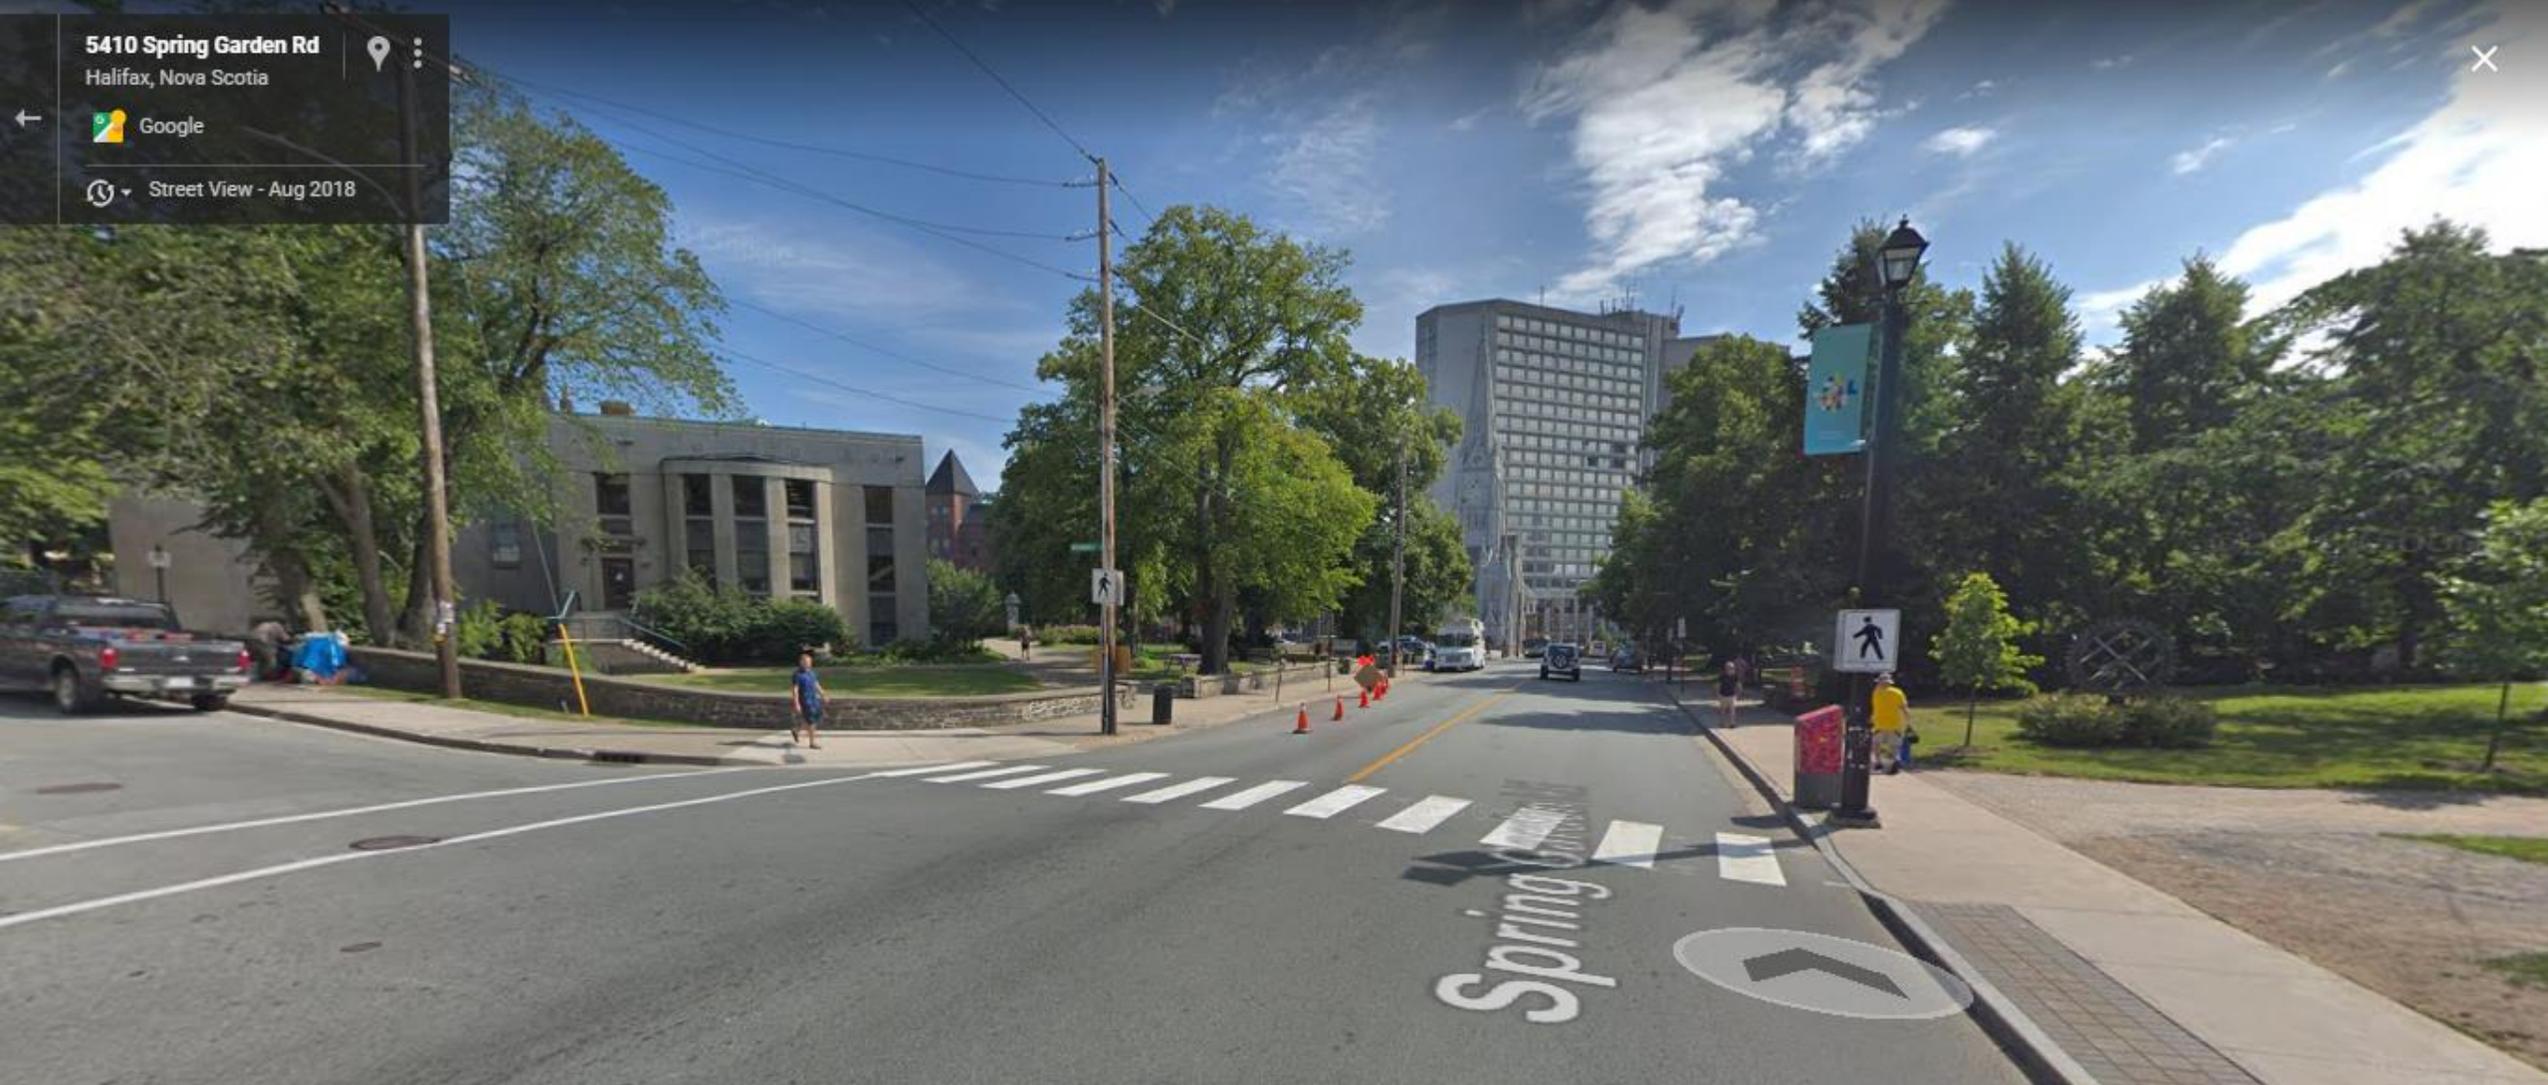
Vulnerability on wide intersection crosswalks

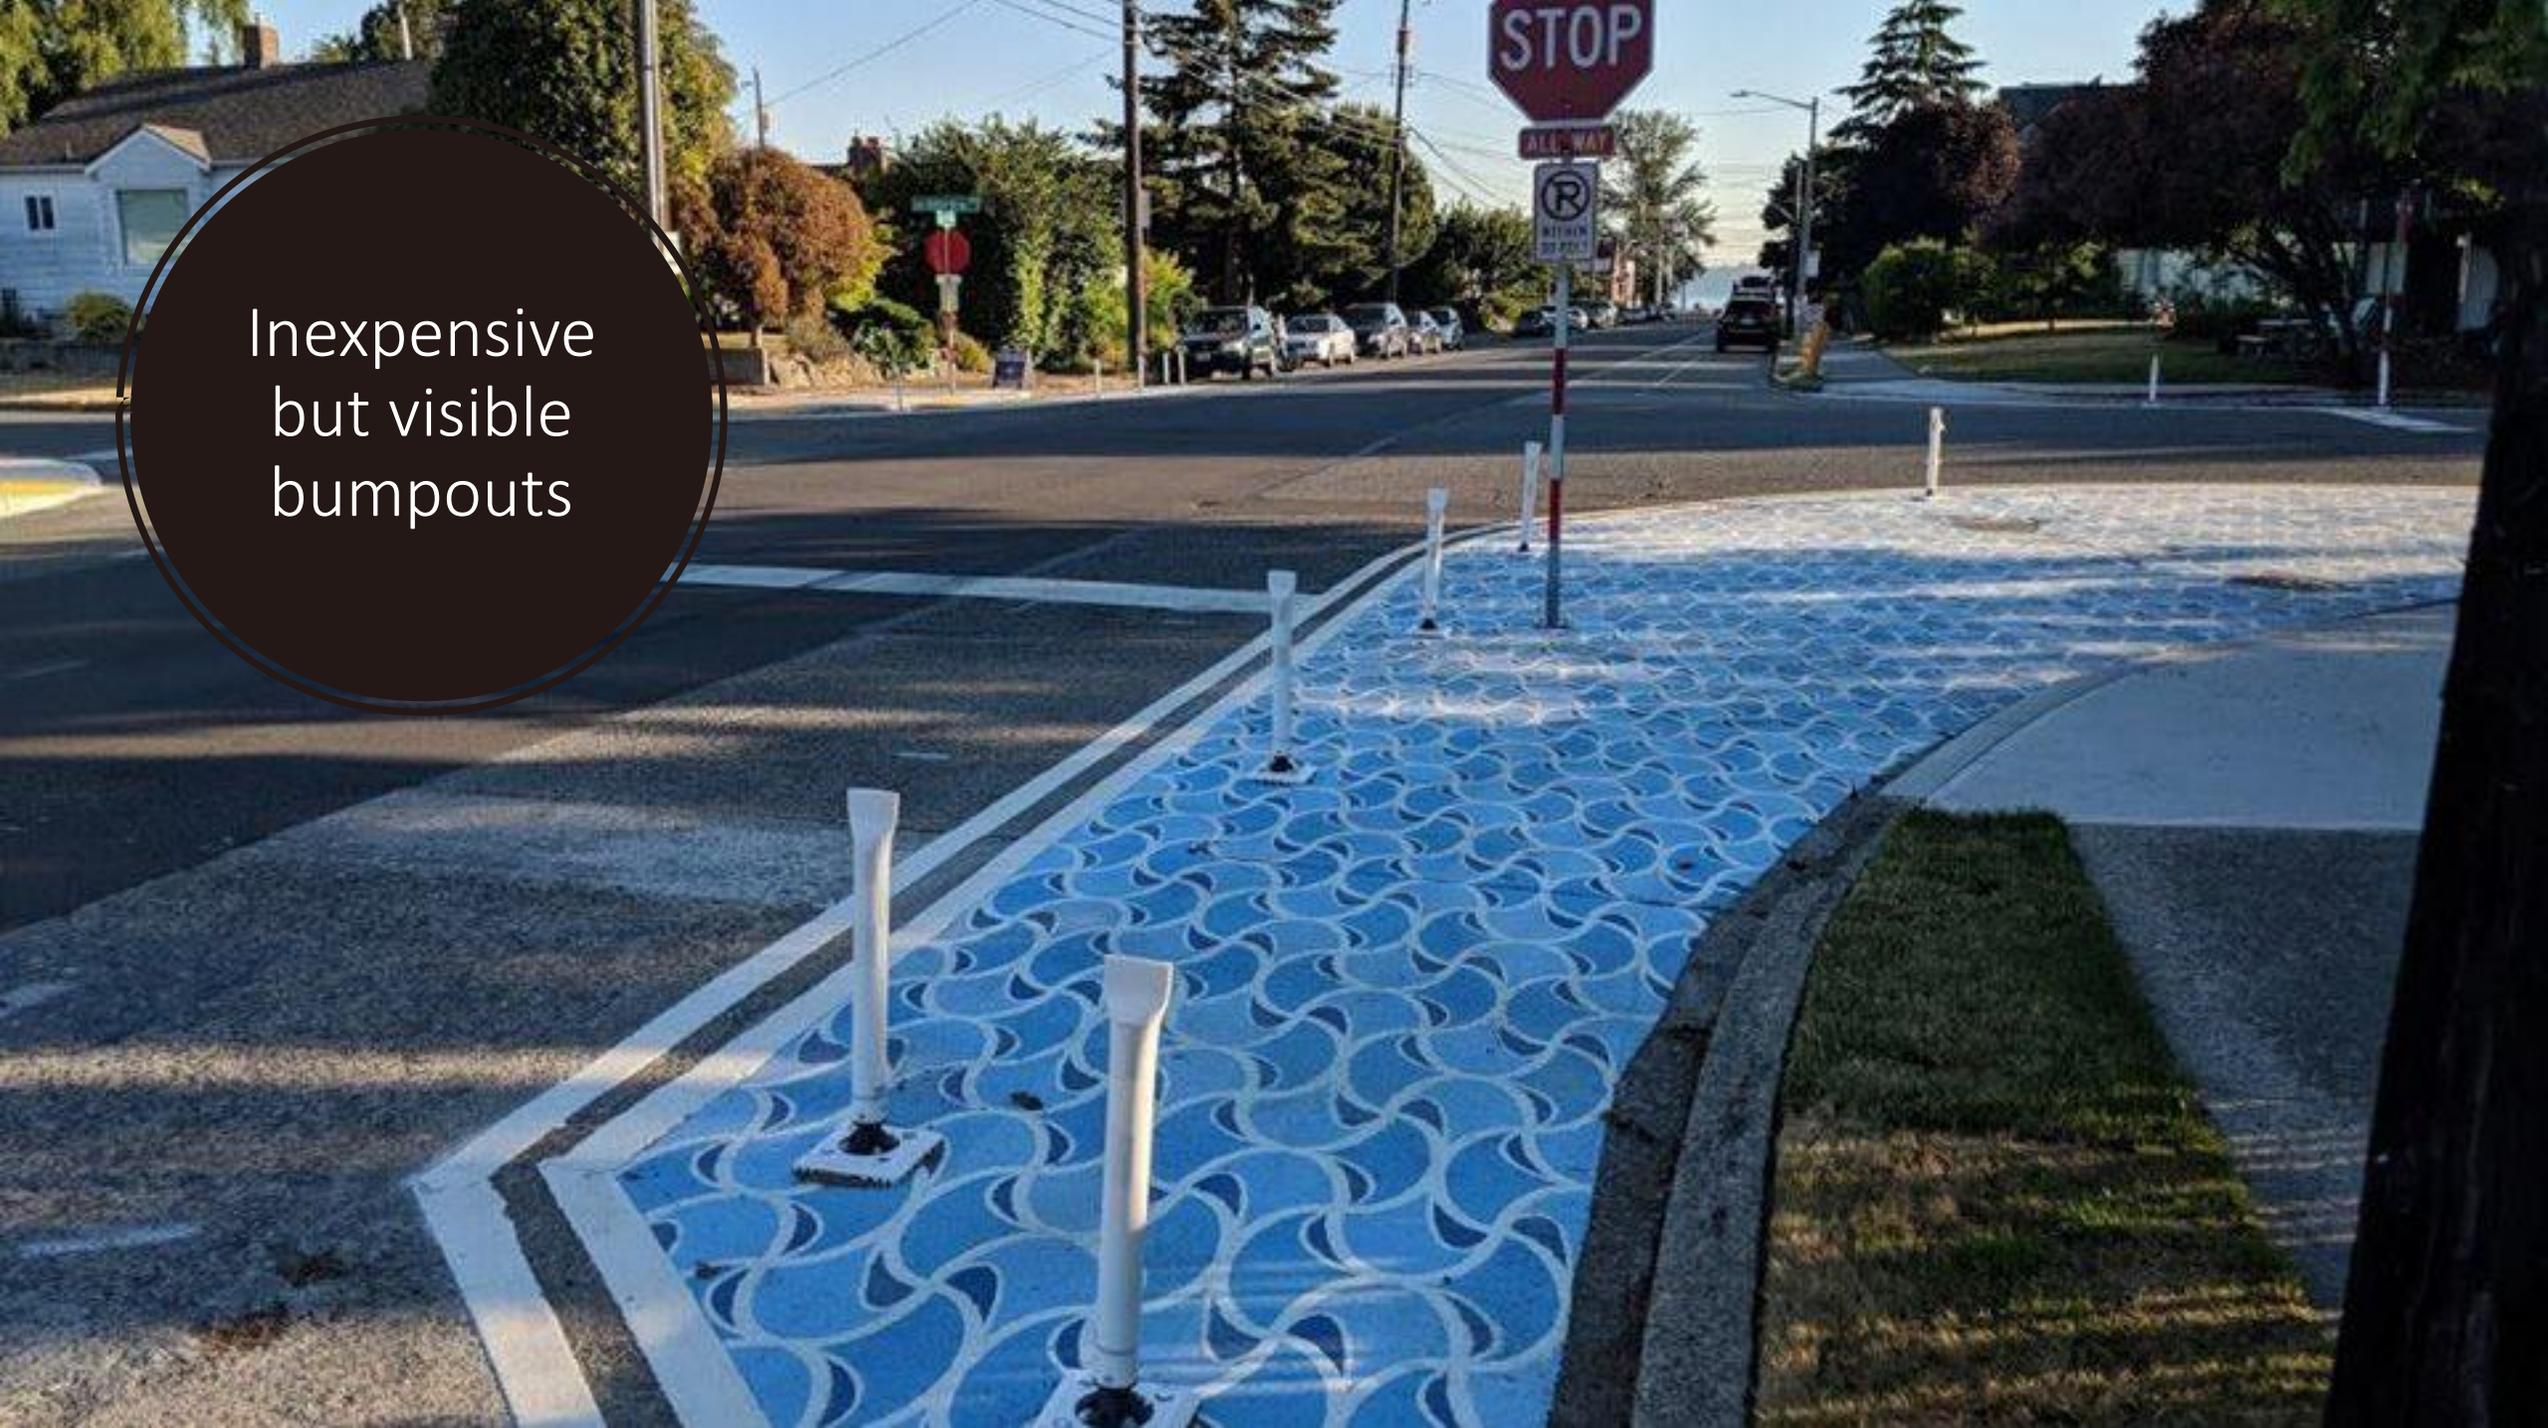
Inexpensive  
but visible  
bumpouts

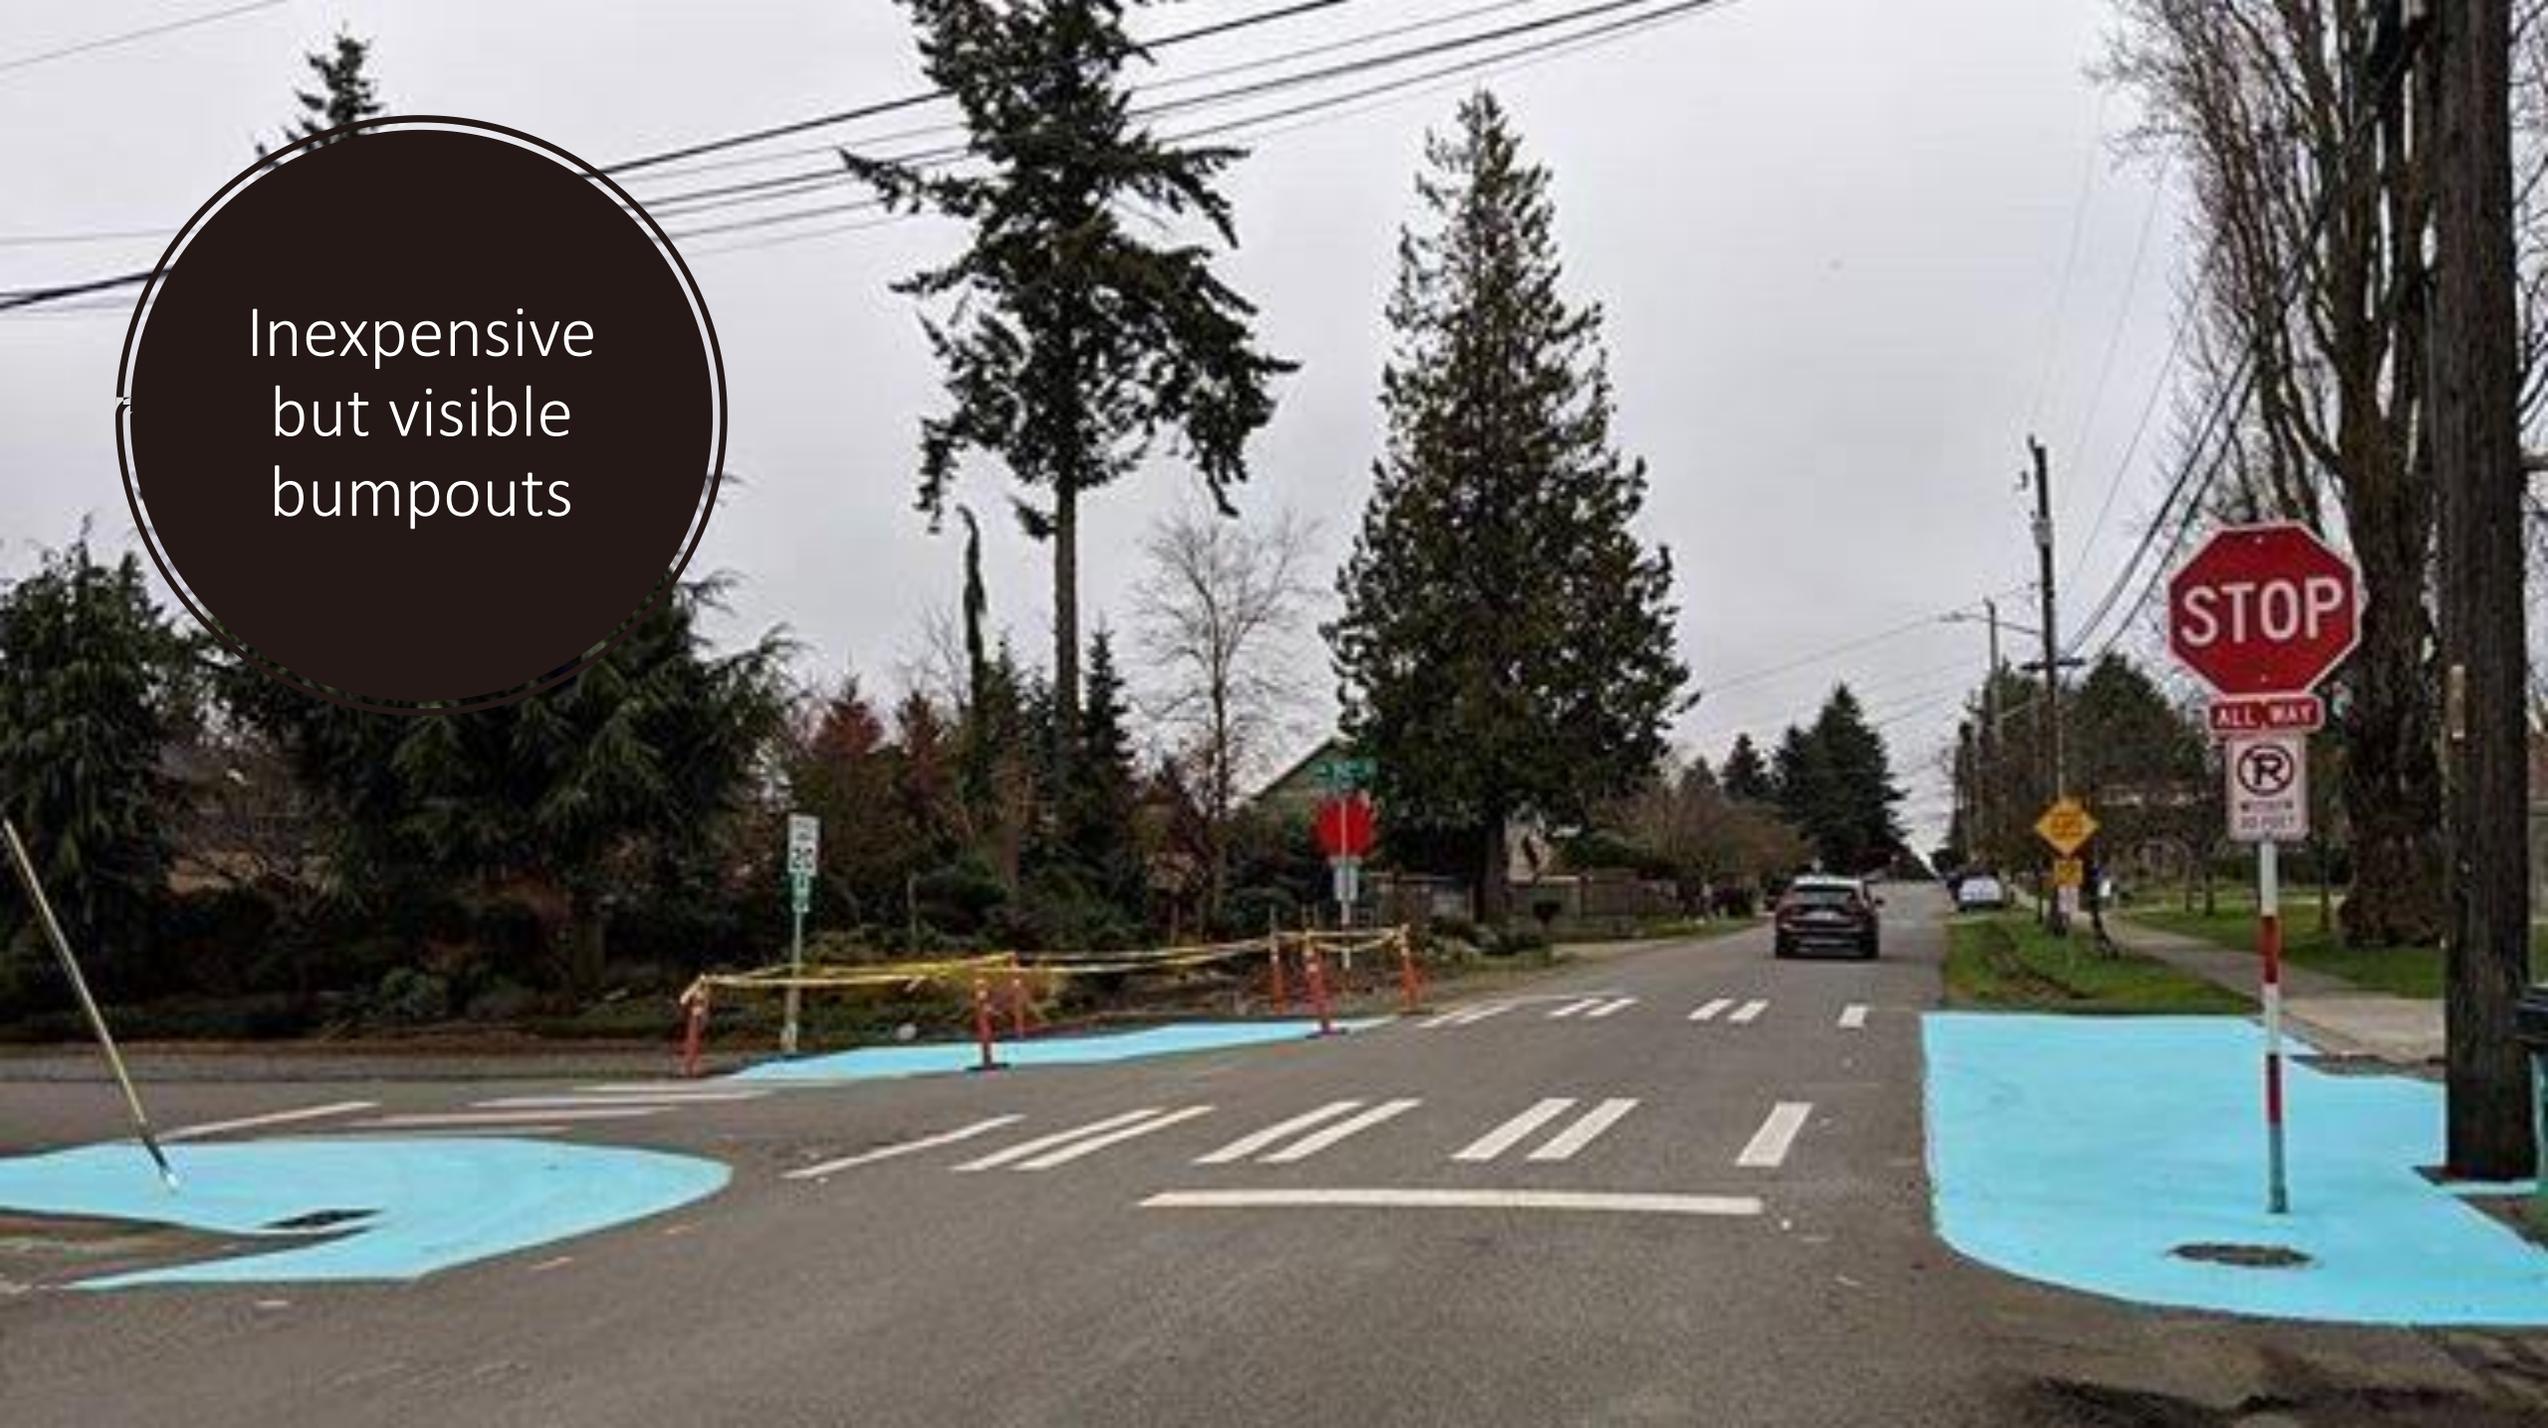
Inexpensive  
but visible  
bumpouts

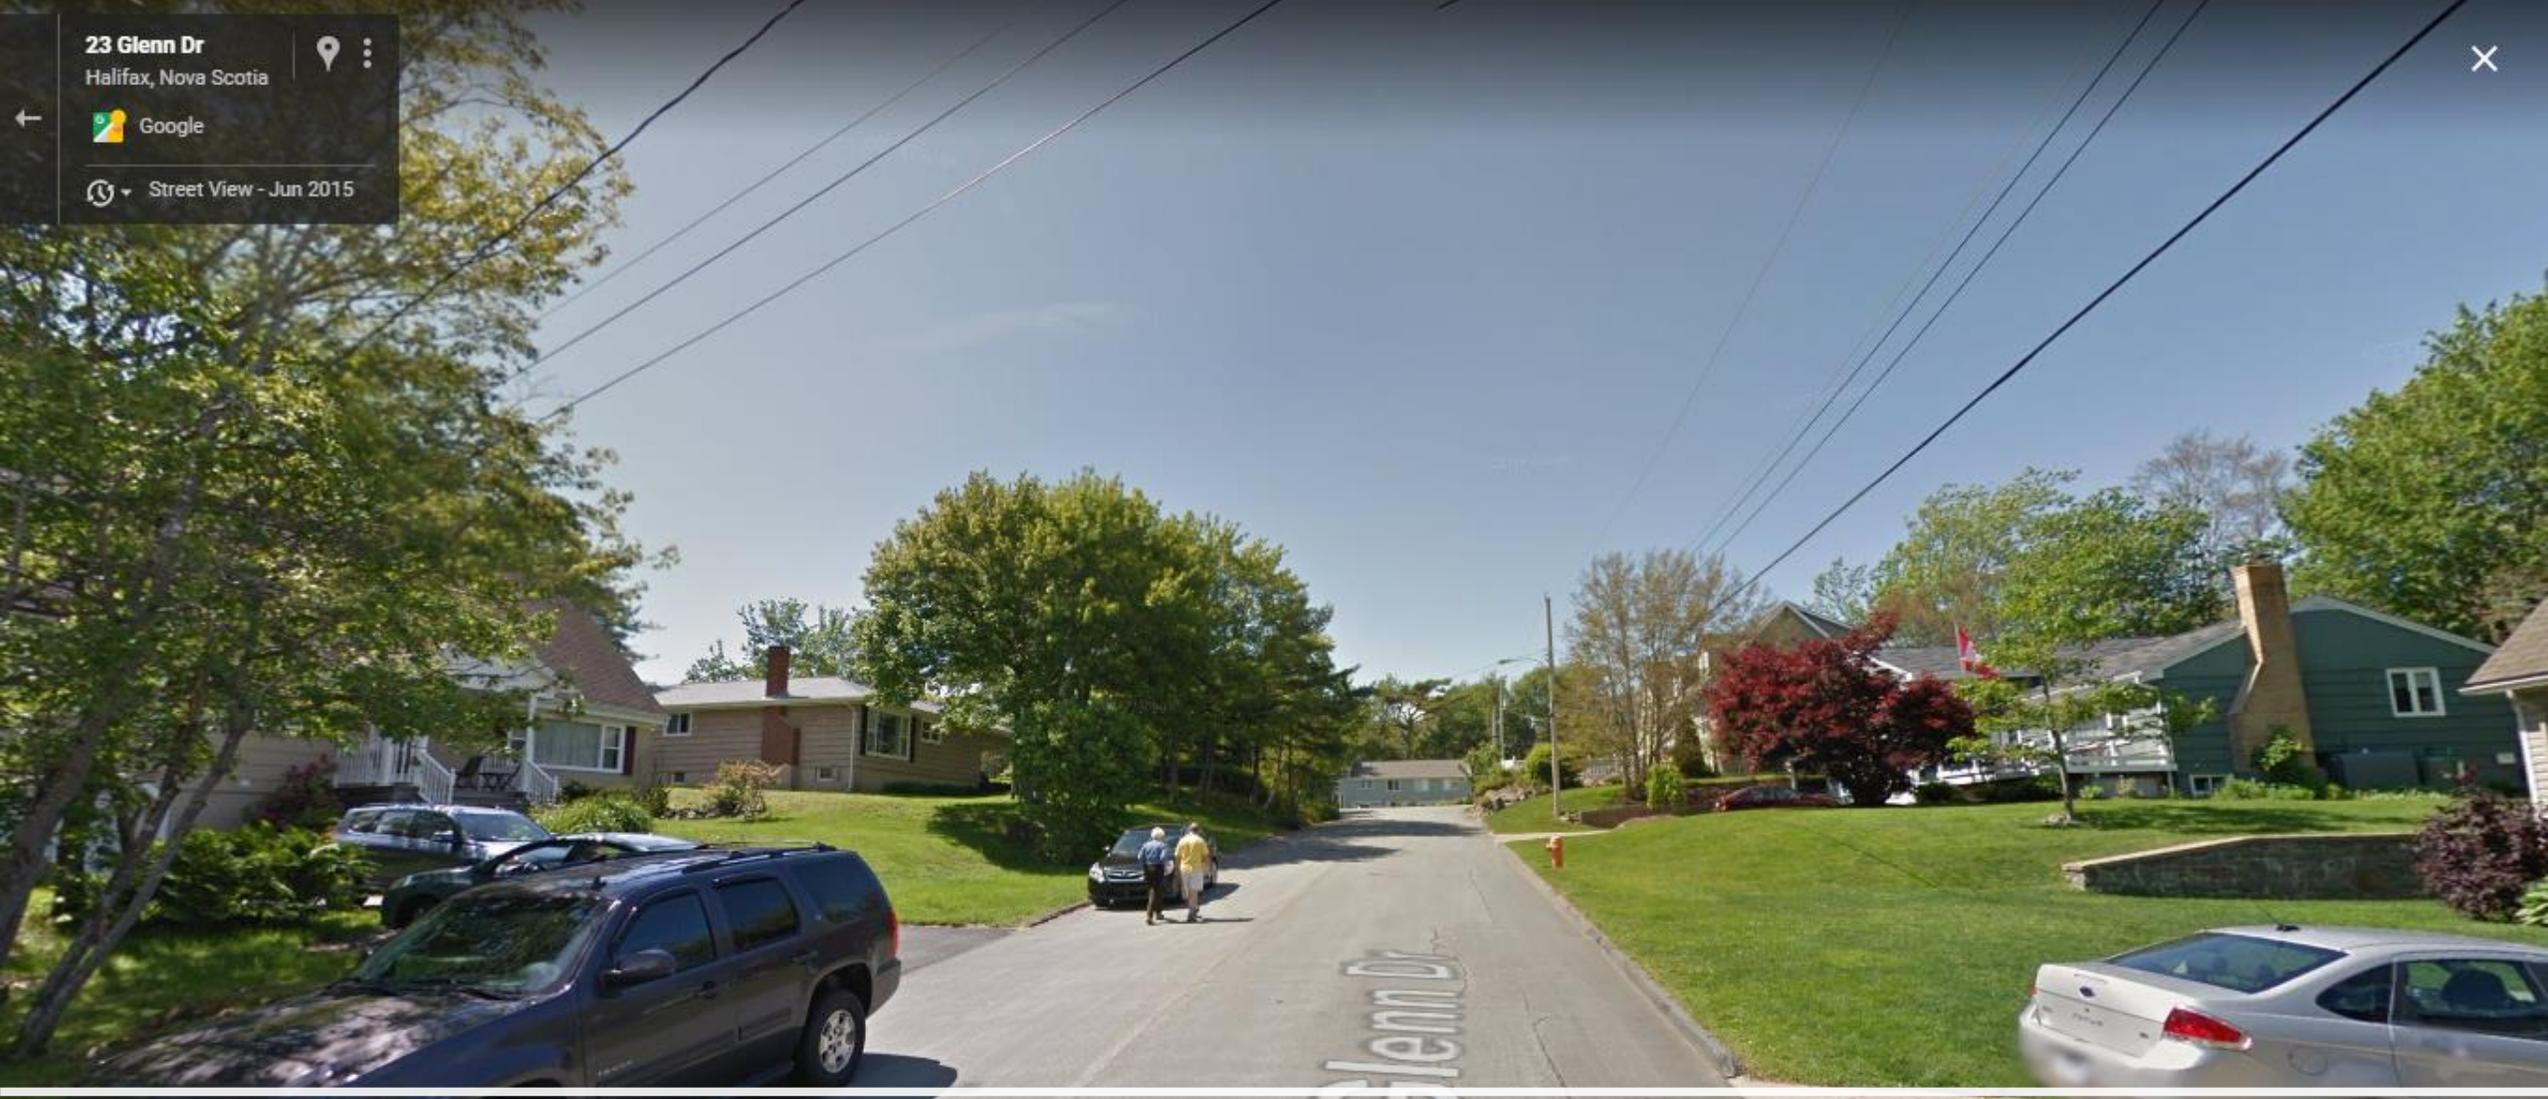
No sidewalks + parked cars

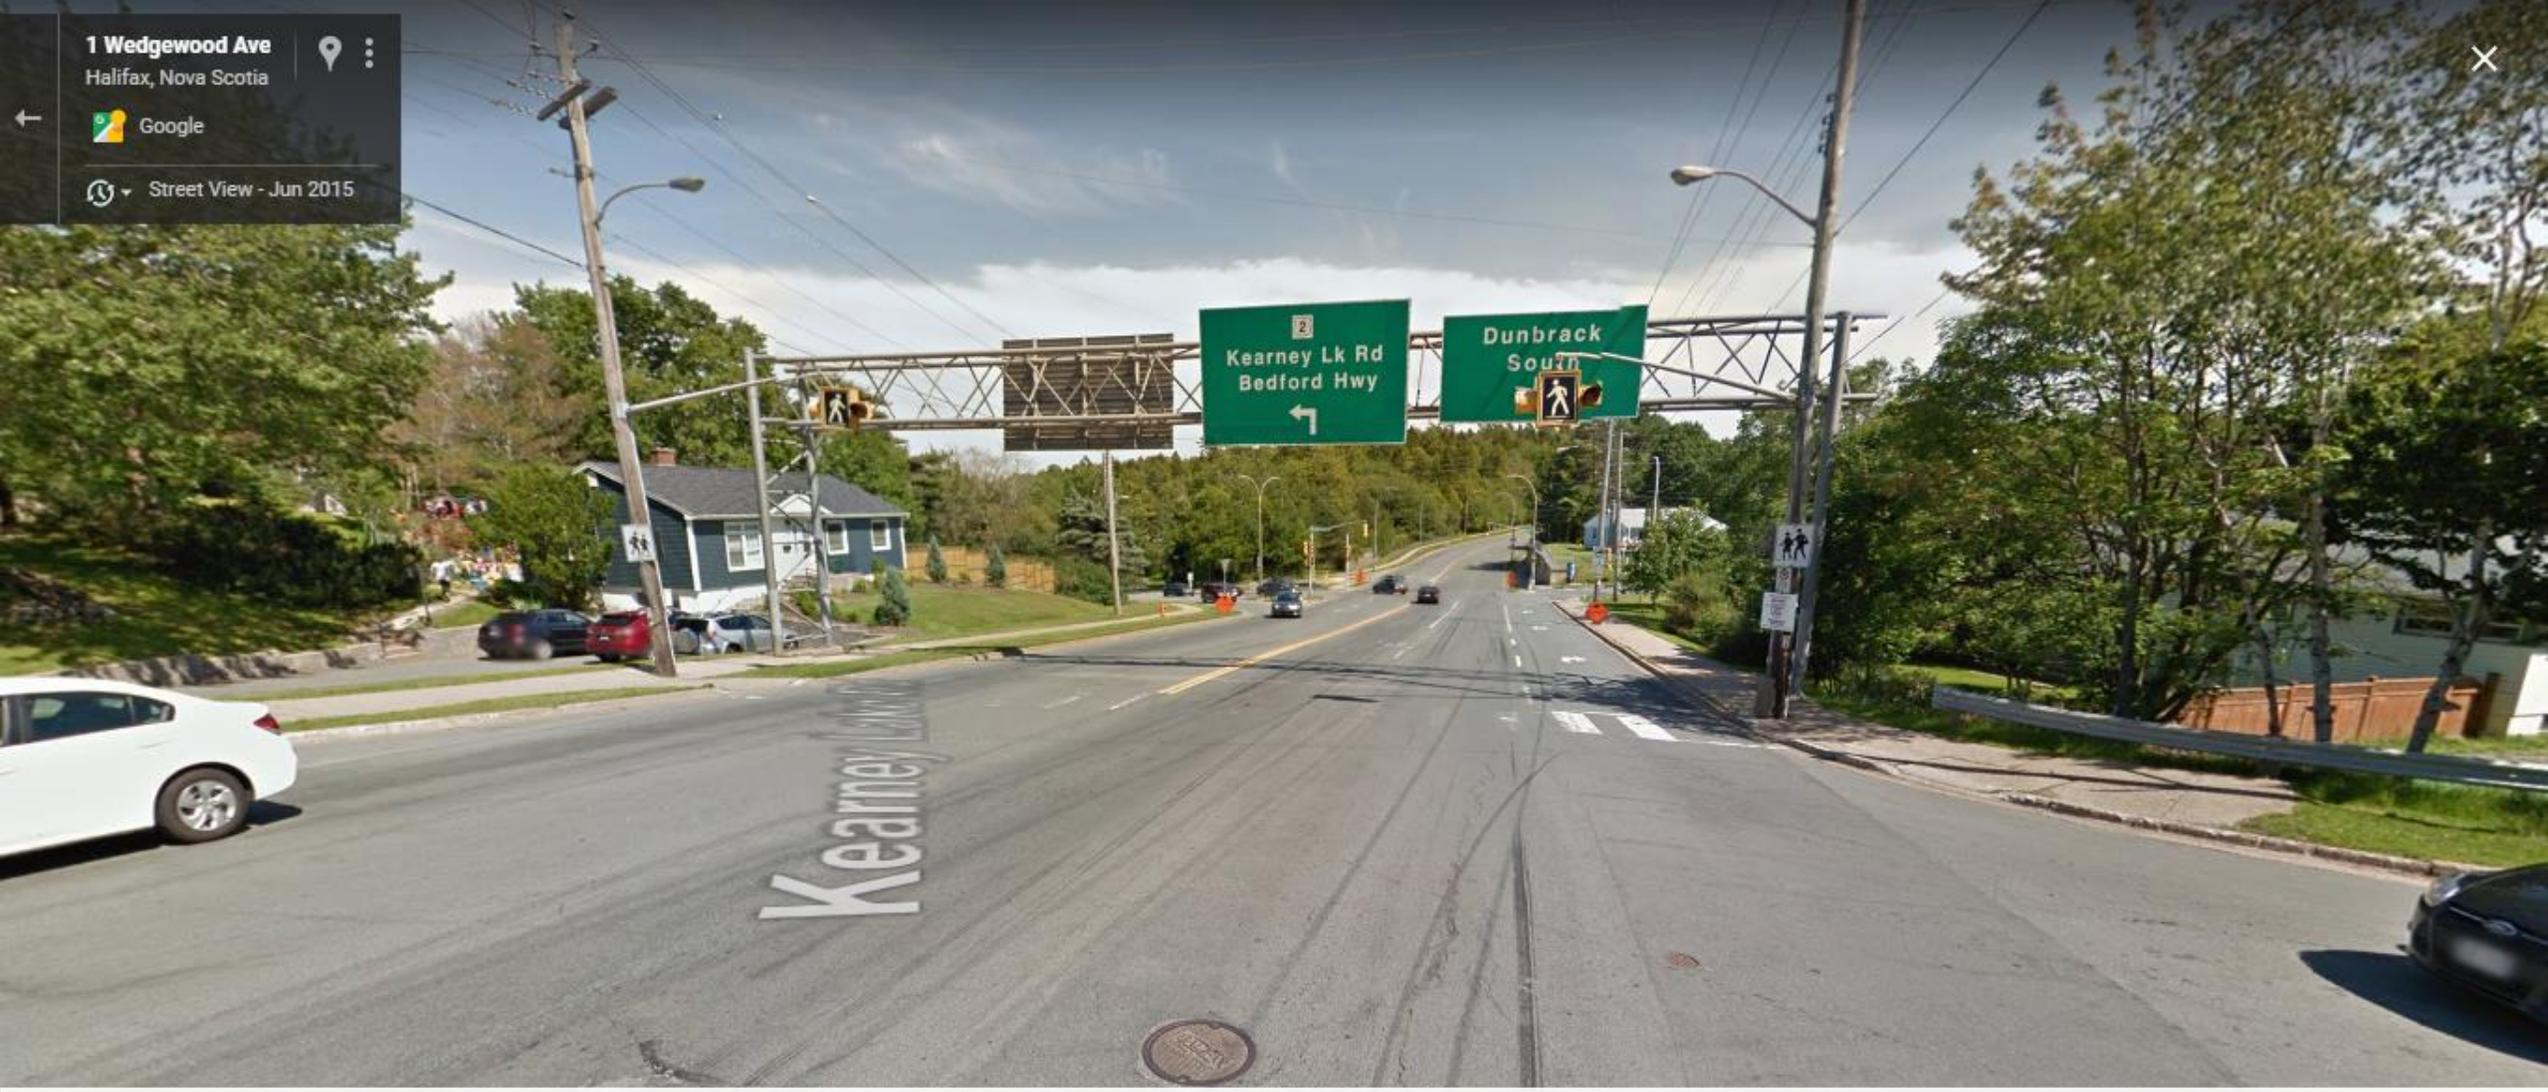
4 -5 lane crosswalks – no protection from speeding traffic
