Road Safety in HRM

Moving on from the blame game

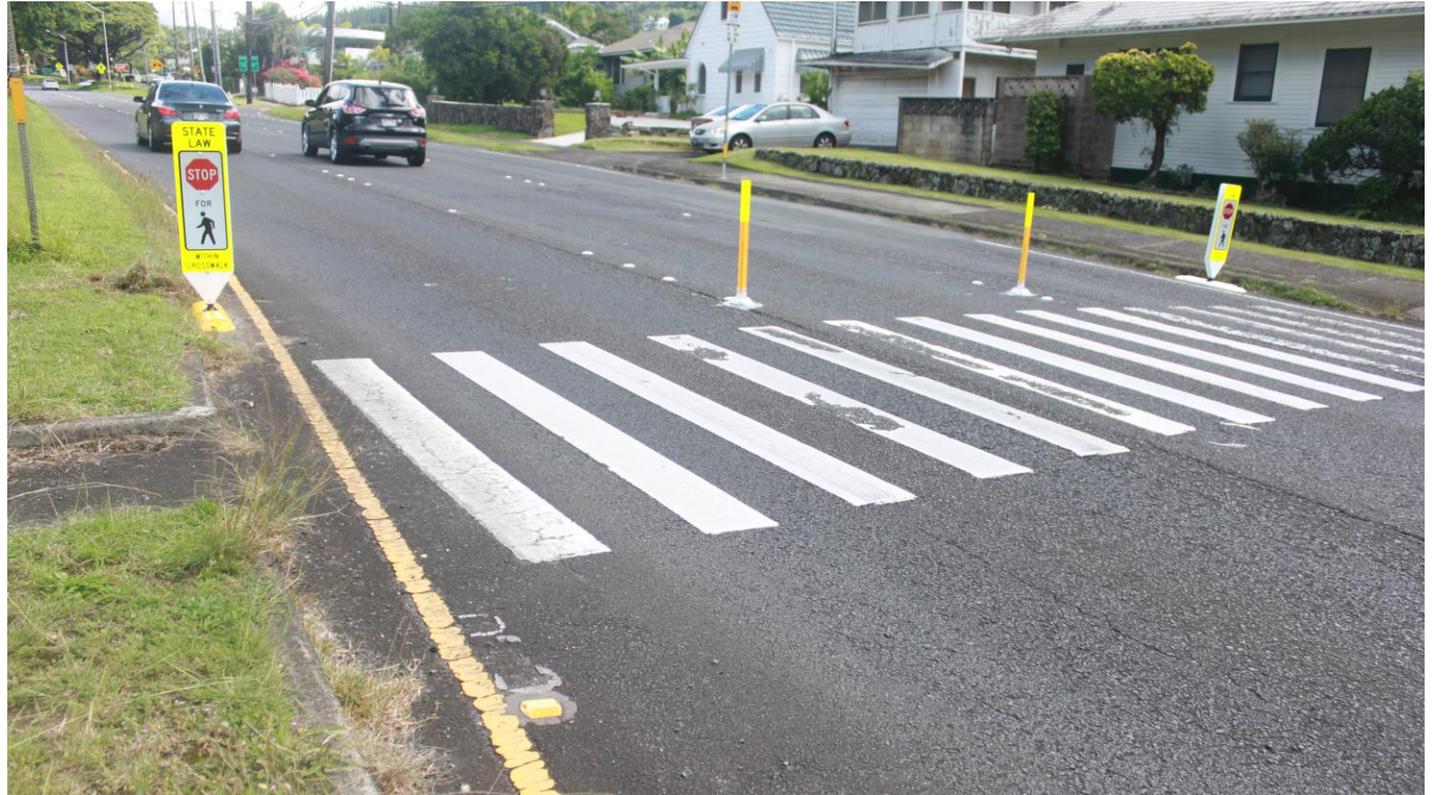
Adding  
visibility within  
driver  
sightlines

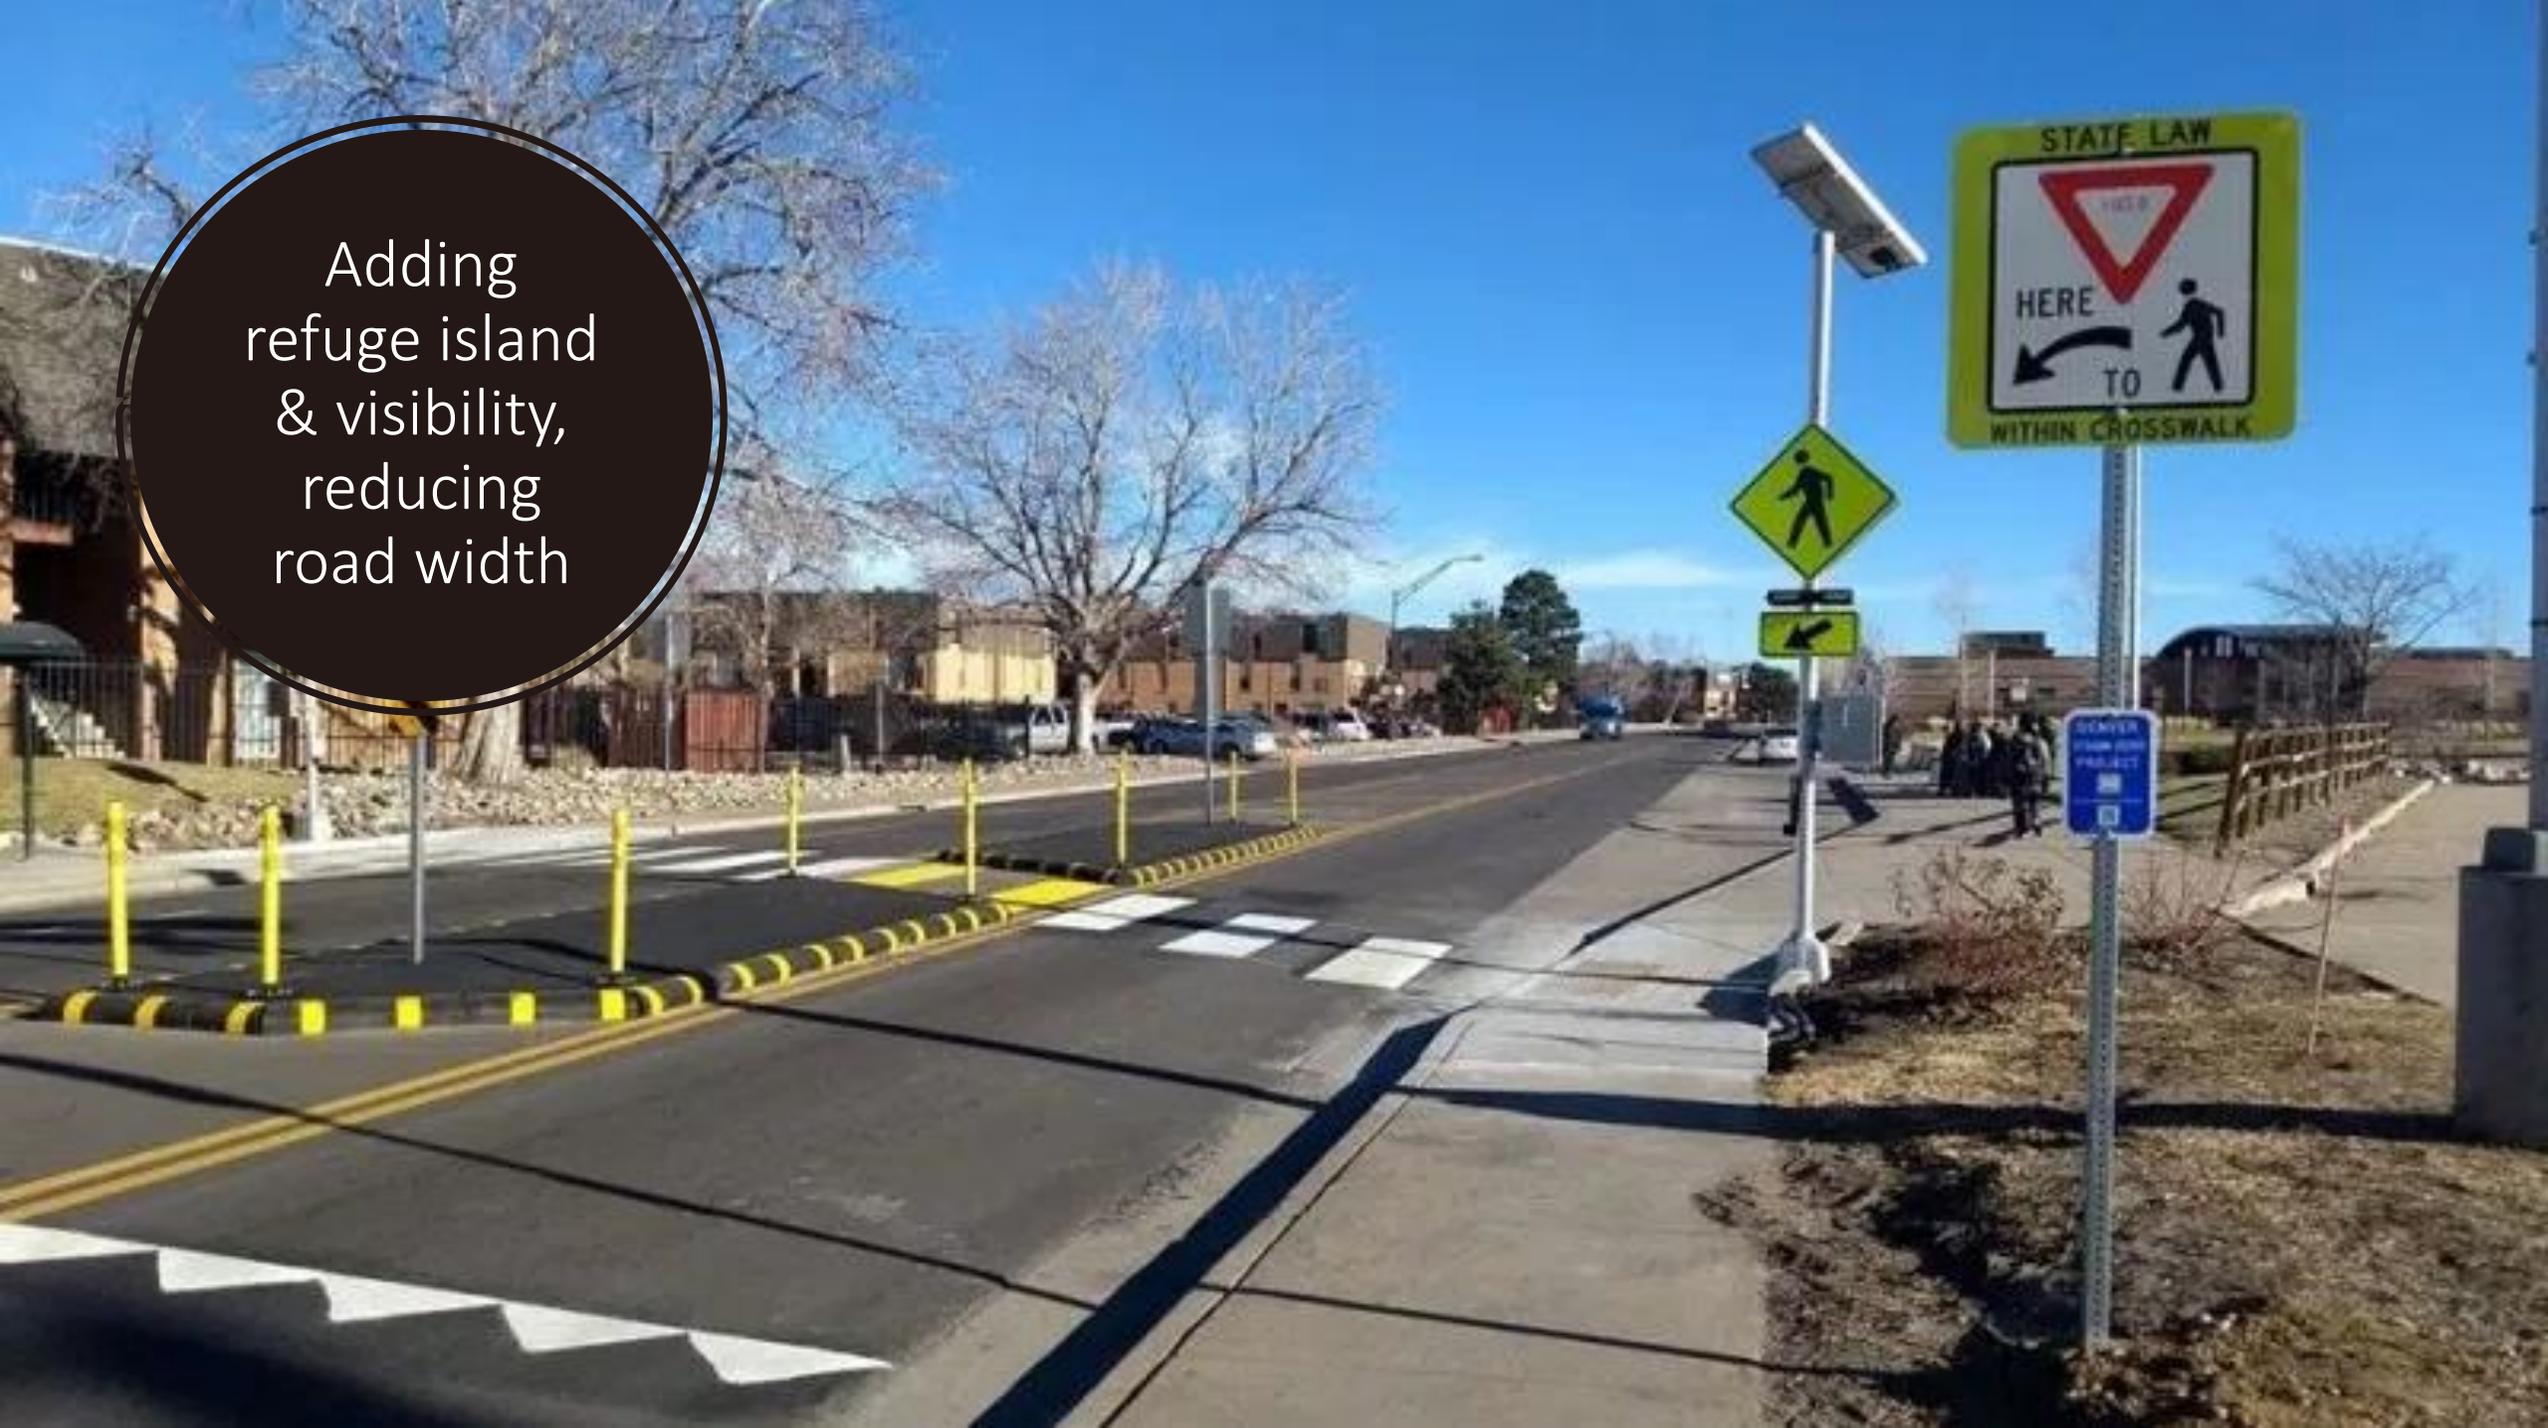
Adding  
refuge island  
& visibility,  
reducing  
road width

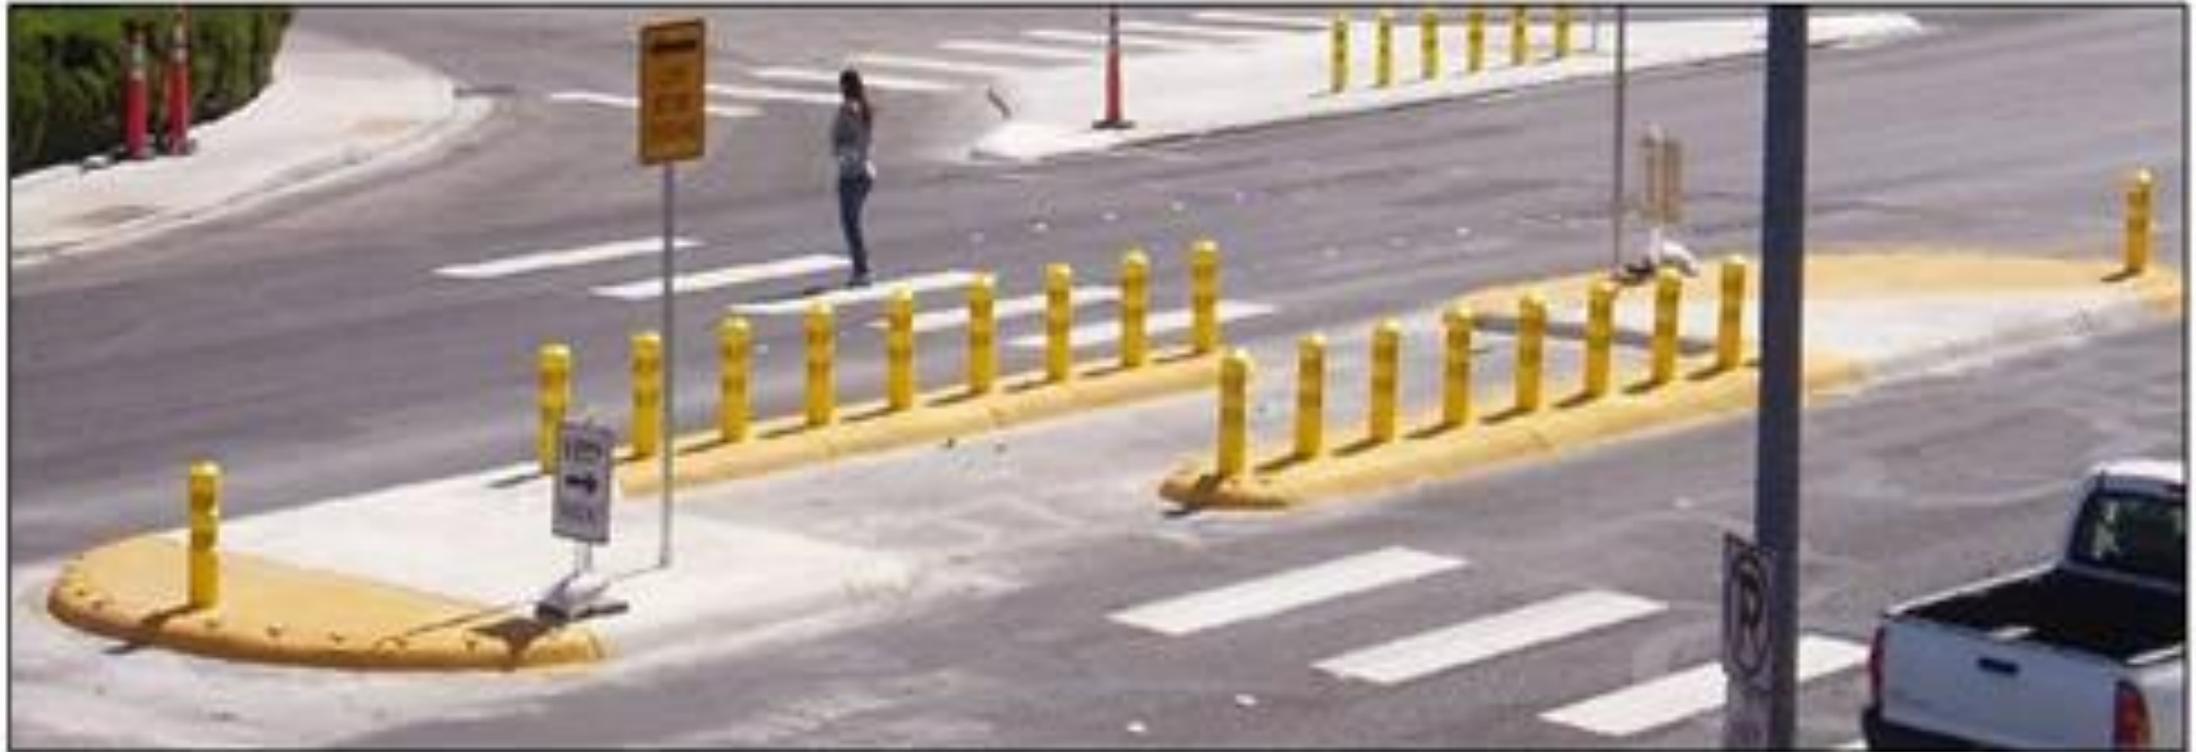
# Offset refuge island

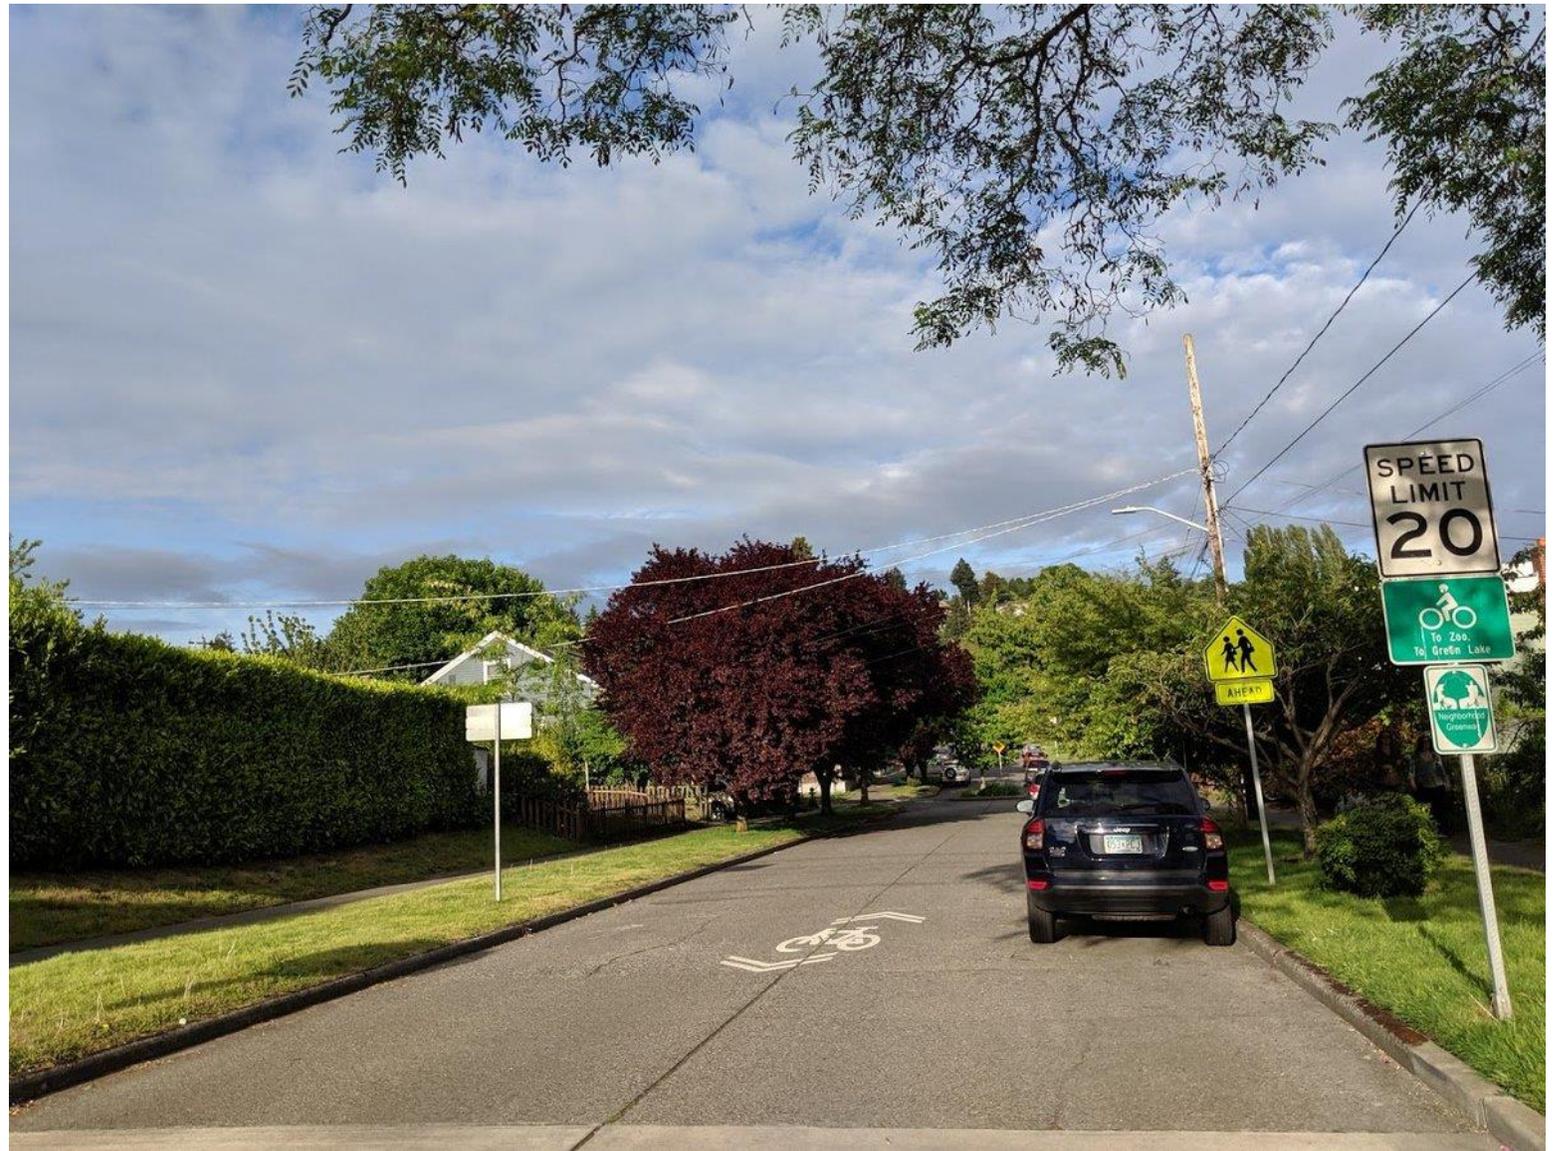
20mph roads &  
quick fixes =  
Seattle reduces  
traffic fatalities by  
37% to 5, versus  
our 14.
