## **Armco Capital**

### **Phase I Environmental Site Assessment PID No. 41071069 Snowberry Court, Middle Sackville, NS**

## **Report**

Ref. N°: P-0013149-0-02-200

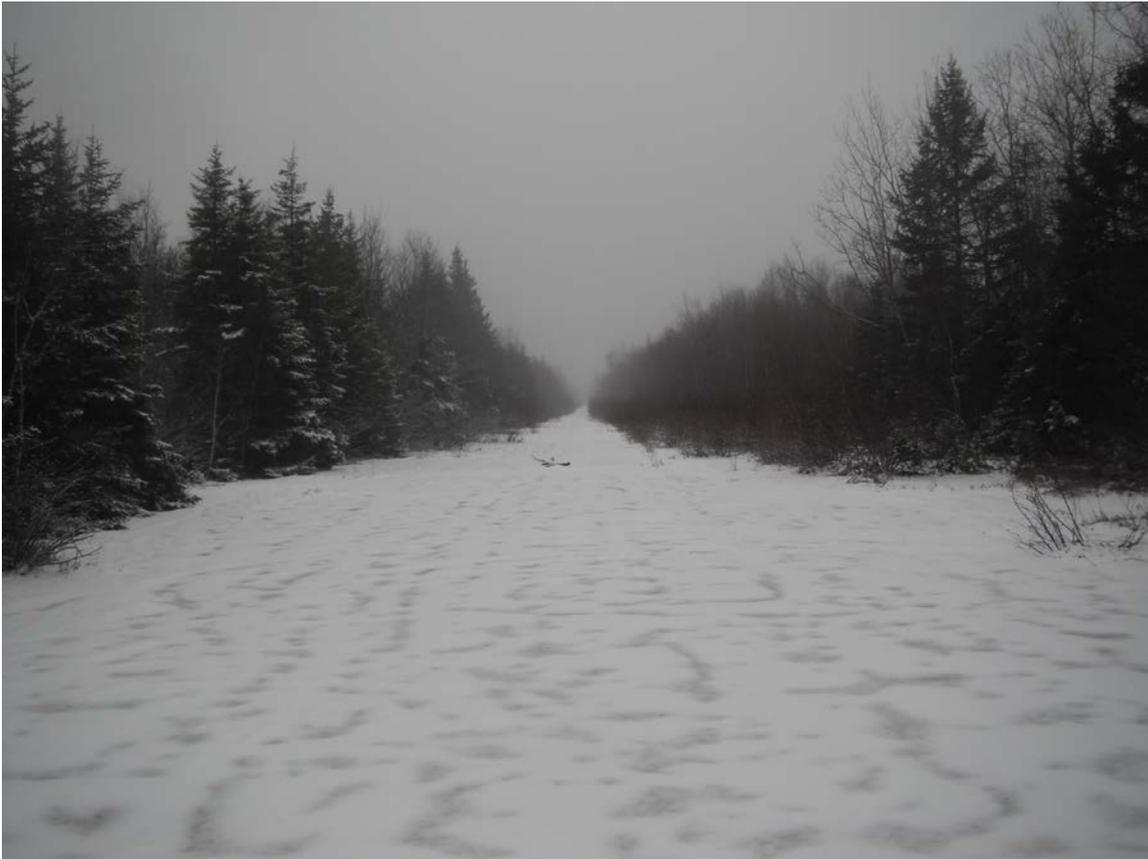
Photo 1: View (facing southwest) of the former drag strip on the subject property. (December 19, 2017)

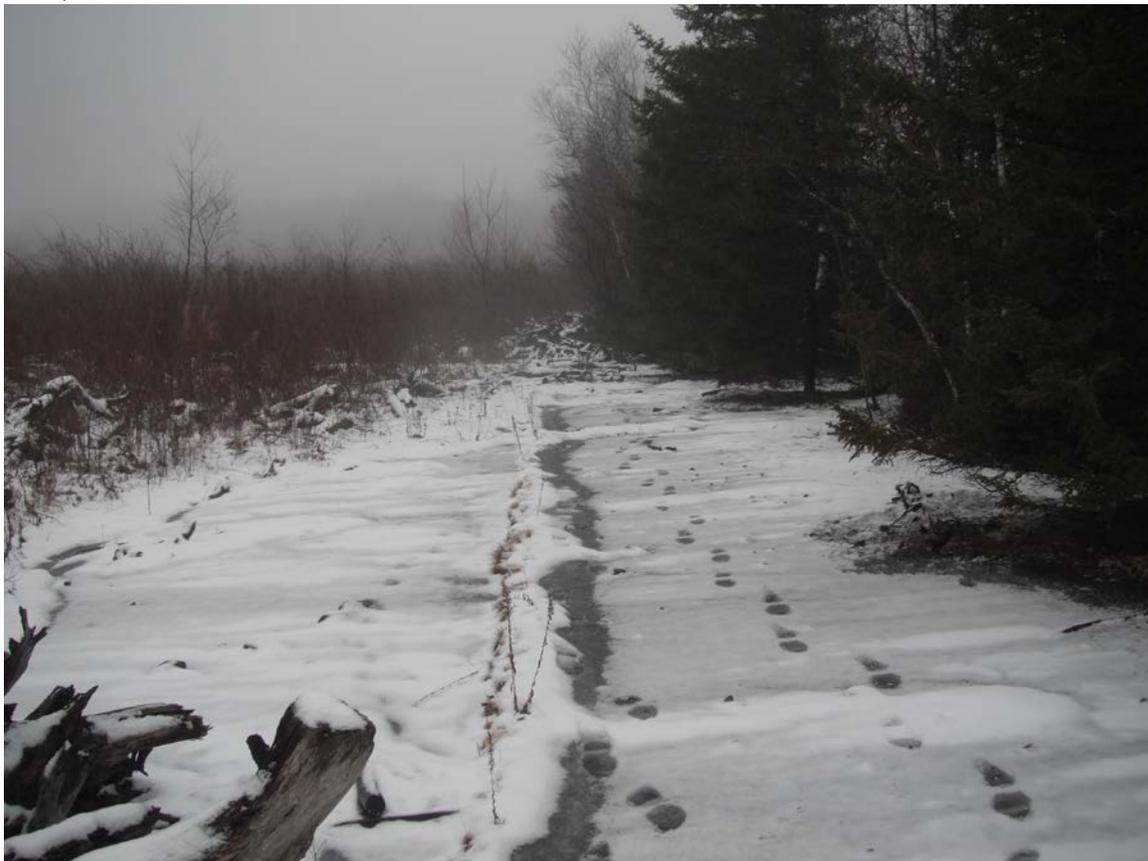
Photo 2: View (facing southwest) of portion of the oval track on the subject property. Note the grubbings to the left of the track (December 19, 2017)

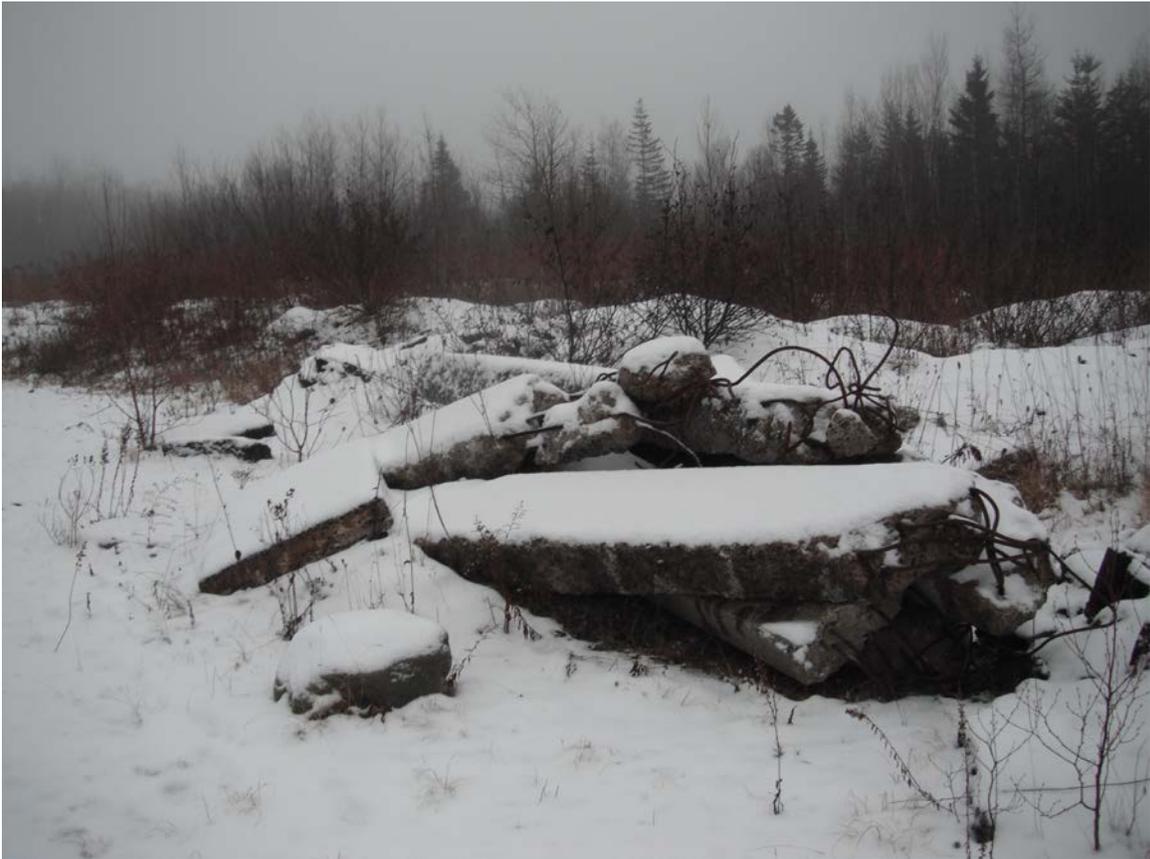
Photo 3: View (facing north) of concrete debris observed on the property. Note the overgrown fill mounds behind the debris. (December 19, 2017)

Piles of fill material containing soil, concrete, asphalt, grubbings and other material were observed on the drag strip, in the center of the oval track and along the roadways on the property. As the nature and origin of the fill material is unknown, we recommend a Phase II ESA be undertaken to assess the potential for environmental contamination related to the fill.

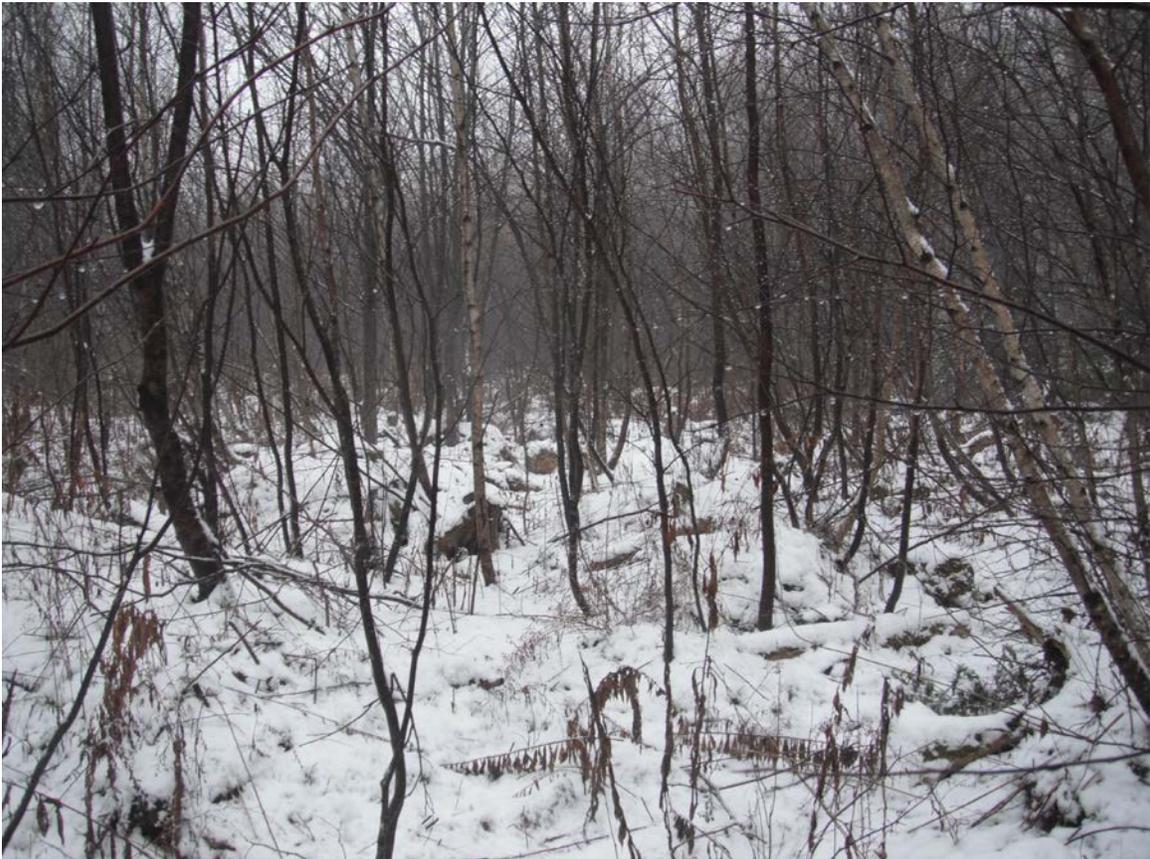
Photo 4: View (facing east) of overgrown fill mounds on the drag strip. (December 19, 2017)

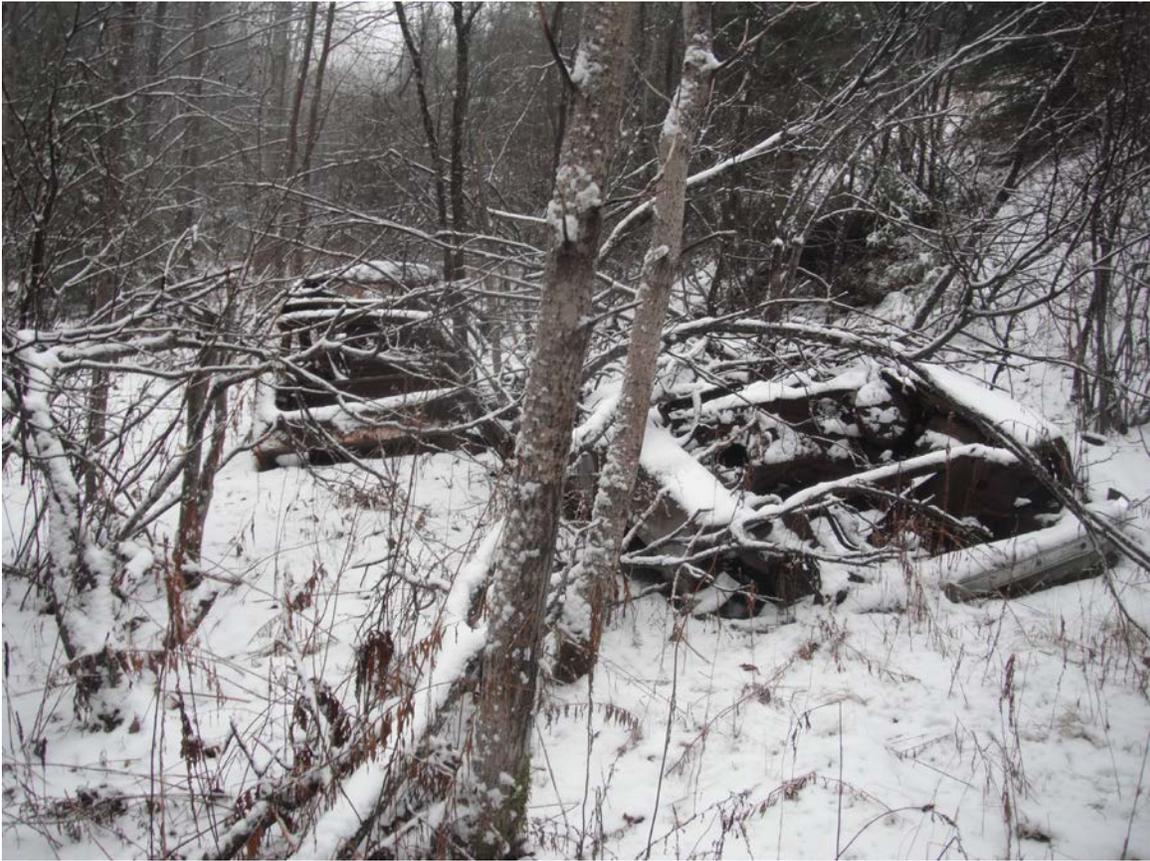
Photo 5: Derelict cars observed on the east side of the drag strip (facing south). (December 19, 2017)

A former auto scrapyard was observed in the northwest portion of the property in the 1973 and 1974 aerial photographs. Piles of fill material containing soil, concrete, asphalt, grubbings and other material were observed on the drag strip, in the center of the oval track and along the roadways on the property. We recommend a Phase II ESA be undertaken to assess the for potential environmental contamination related to the auto yard and fill material.

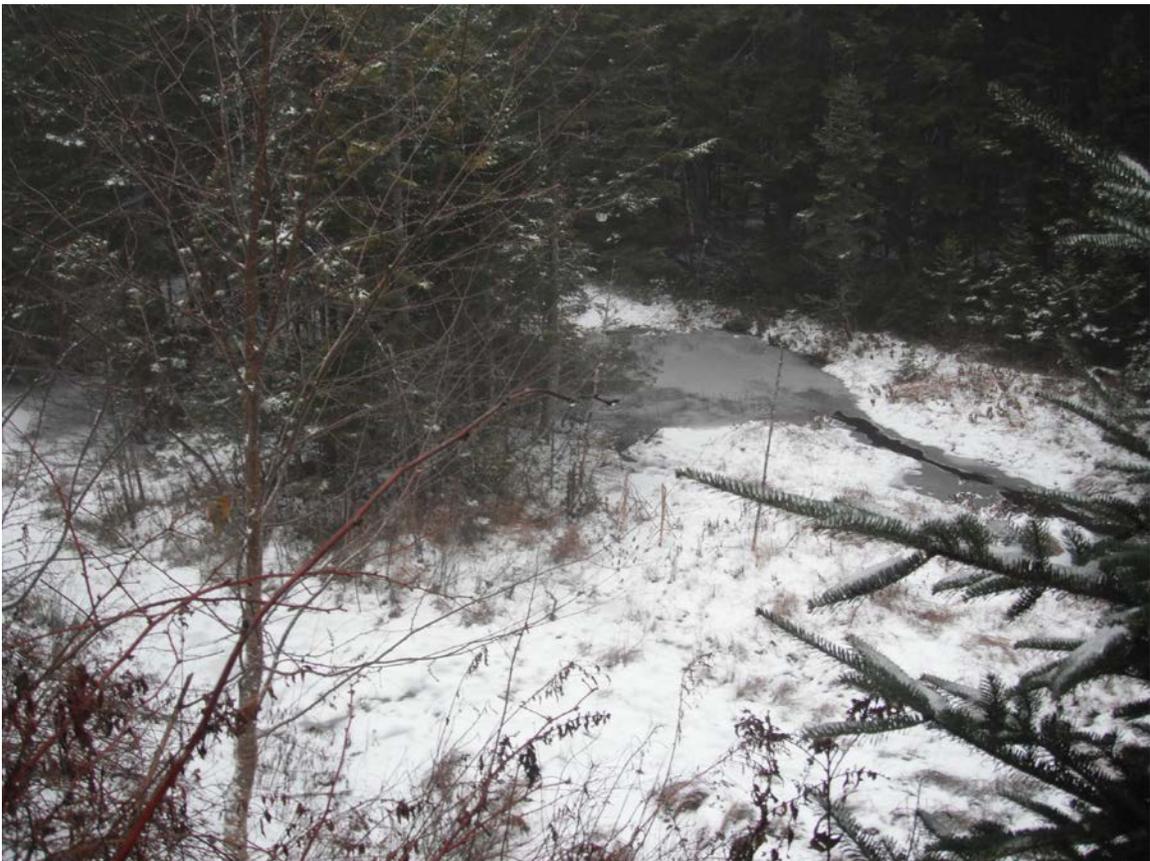
Photo 6: Impounded water observed on the west side of the drag strip (facing west). (December 19, 2017)

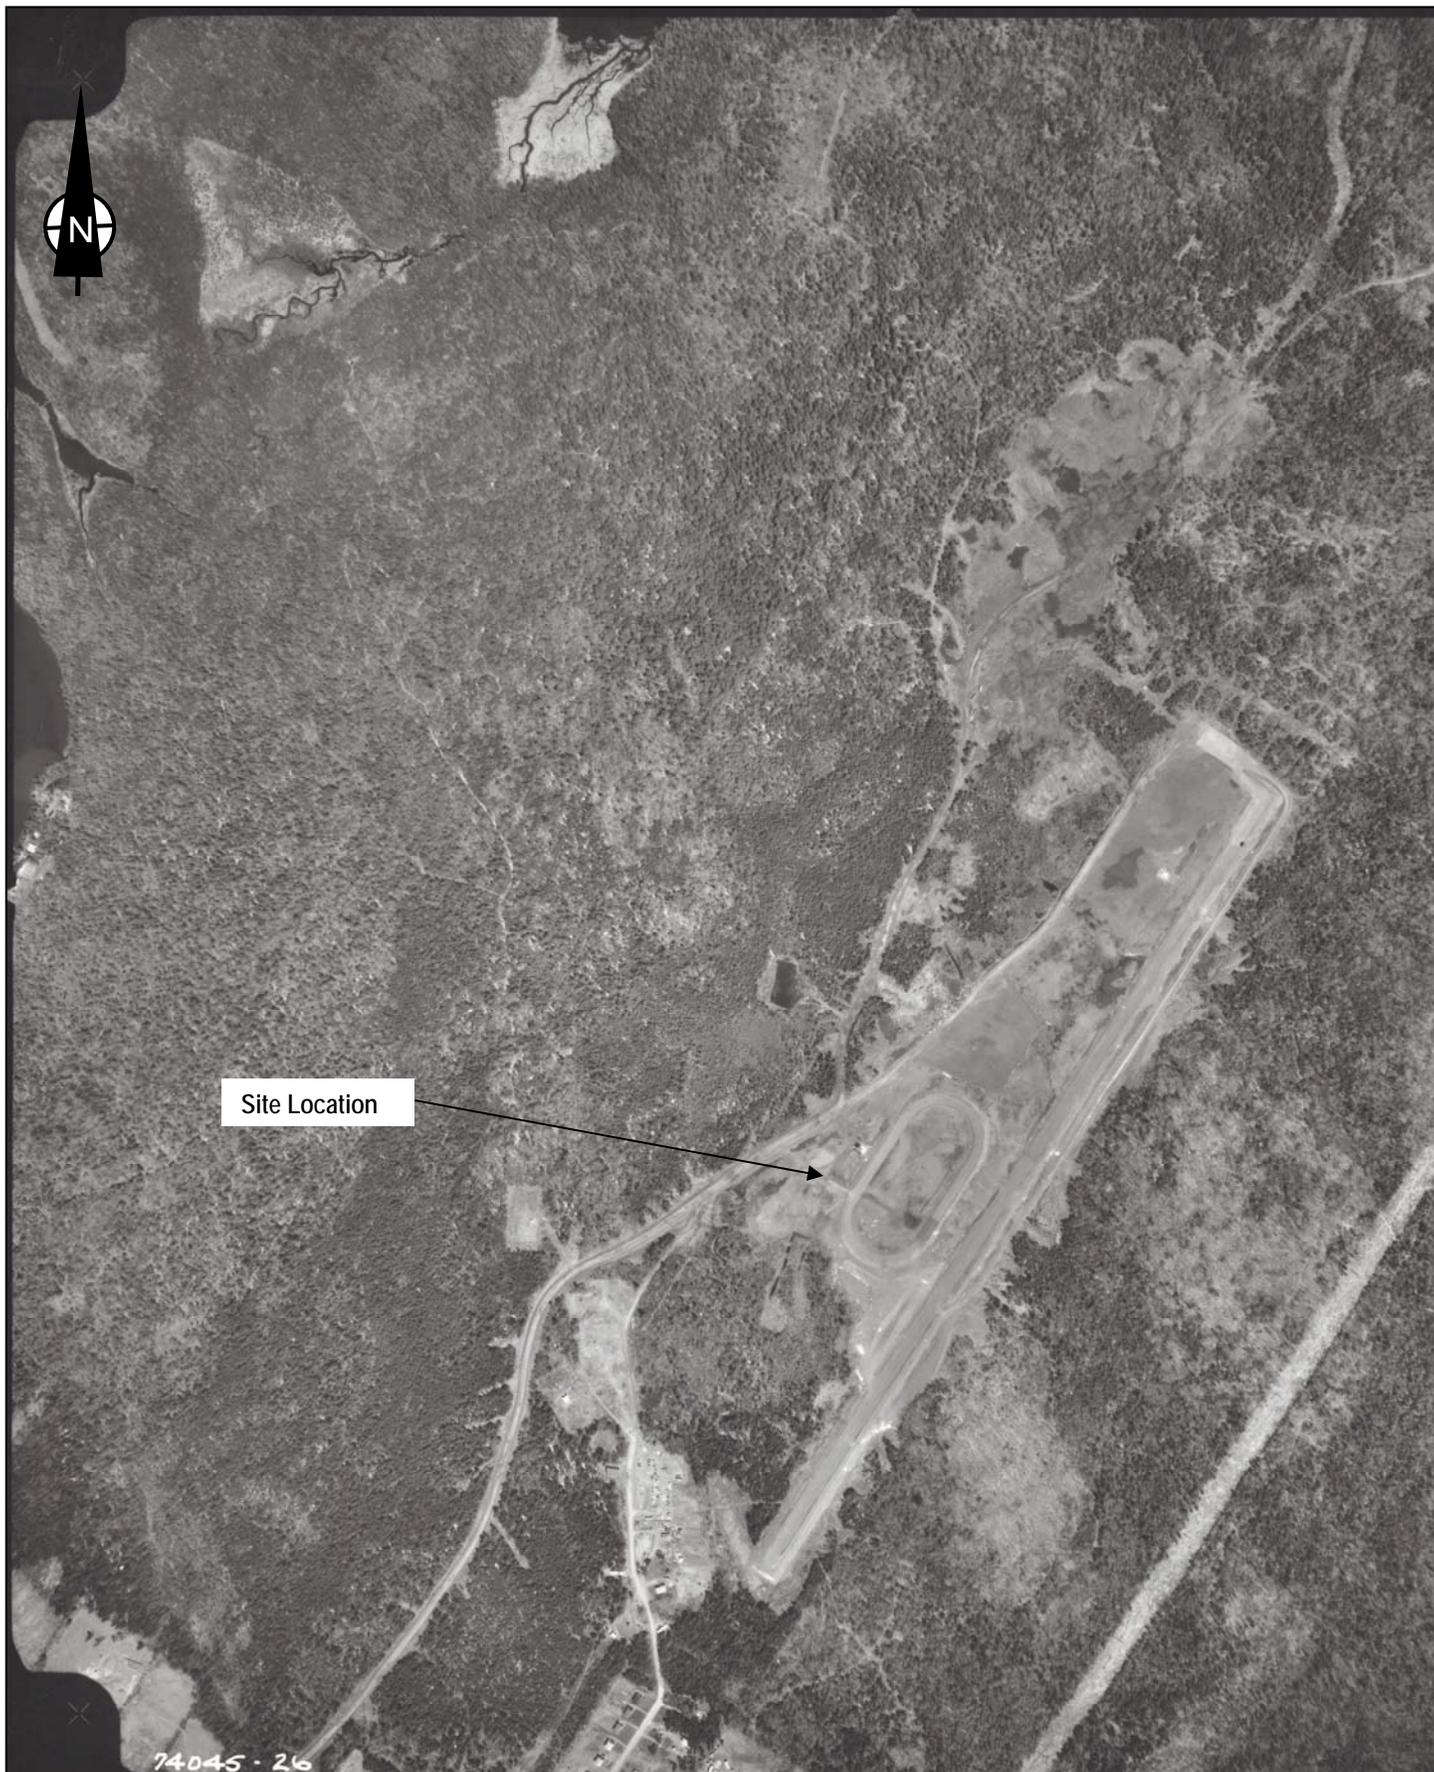
Job No.: P-0013149-0-02-200 Date: January 2018 Scale (Approx.): 1:10,000	1974 - Aerial Photograph Phase I Environmental Site Assessment PID No. 41071069 Snowberry Court, Middle Sackville, NS	Plate 3-1
---	--	---	-----------

A former auto scrapyards was observed in the northwest portion of the property in the 1973 and 1974 aerial photographs. Piles of fill material containing soil, concrete, asphalt, grubbings and other material were observed on the drag strip, in the center of the oval track and along the roadways on the property. We recommend a Phase II ESA be undertaken to assess the auto yard and fill material for potential environmental contamination.
