SUBJECT: **Case H00484: Request to Include 2500 Creighton Street, Halifax in the Municipal Registry of Heritage Properties**

The Morris House is a wooden Georgian building closely associated with the Morris Family, who were notable surveyors active during the early history of Halifax and the era of British Colonial settlement in Nova Scotia. The structure dates to the early 1760s, making it the oldest wooden dwelling, and the fifth oldest structure in Halifax Regional Municipality. Notably it was moved three times, having originally been built on the corner of Hollis and Morris Streets in Downtown Halifax, and now situated on the corner of Charles and Creighton Streets in the North End of Halifax after a highly publicized relocation effort in January of 2013.

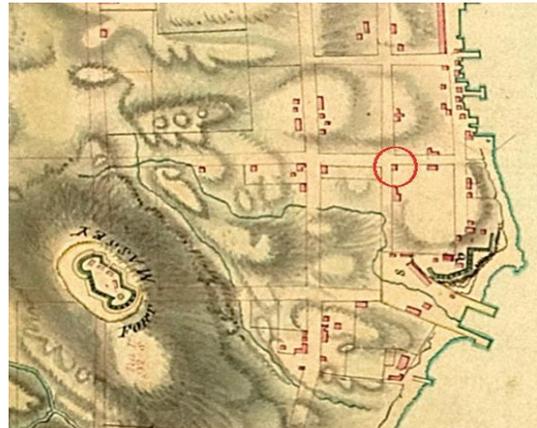
Figure 1: Charles Blaskowitz's map Halifax (1784).
The red circle shows the Morris House.

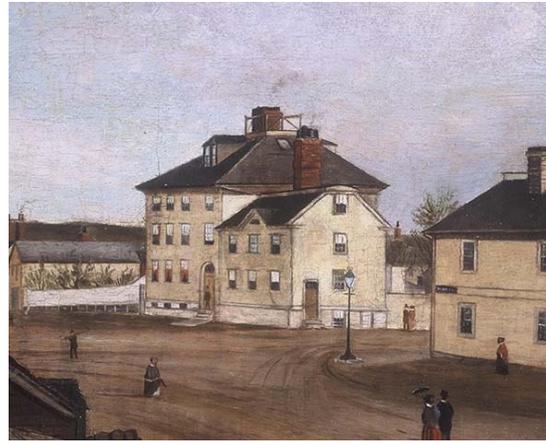
Figure 3: 1840s watercolour of Morris House by J.S. Clow

The Morris House was designed in the Georgian architectural style which is defined by simplicity and symmetry. Emblematic of Georgian residential buildings built in Halifax between the mid-18th and the mid-19th Centuries, the house has a truncated roof and a five-sided Scottish dormer. Two-over-Two hung windows are evenly spaced horizontally across the sides of the building, and it is clad in wood shingles. An 1840s watercolour painting (fig. 3) of the building clearly shows a simple entrance door and central gable dormer which has since been removed.

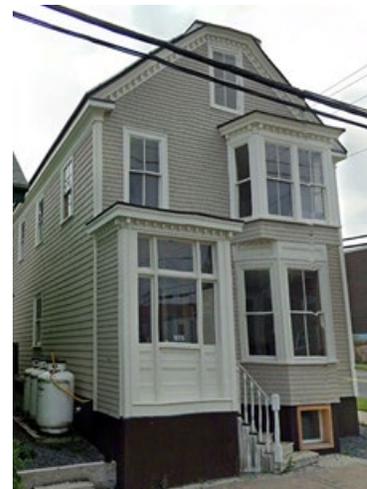
Figure 4: Current view of Morris House at its Creighton Street location

In the 1890s several Victorian features were added to the front of the building (see fig. 4). These include decorative dentils under the eave, a raised entrance with box porch, and a unique two-storey bay window that is three-sided on the first floor and four-sided on the second. Despite the addition of the Victorian features, the house retains a dominant Georgian style.

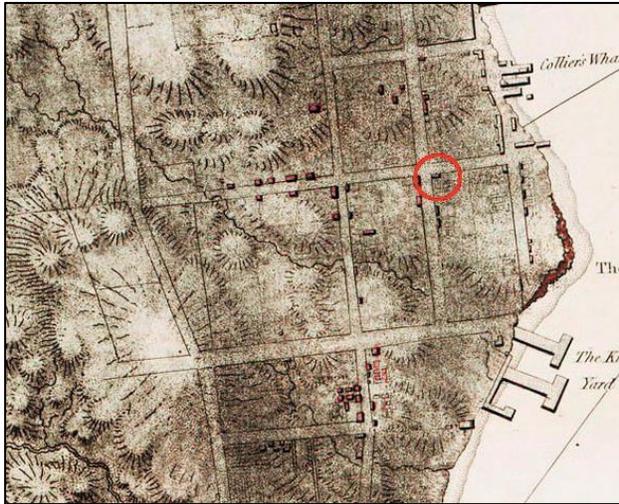
Figure 3: J.F.W. Des Barres Map of Peninsular Halifax (1777) showing south suburb depicting the Morris Building as the sole occupant of the of the lot. Building circled. Source: Heritage Assessment Report by Dr. Allen B Roberson

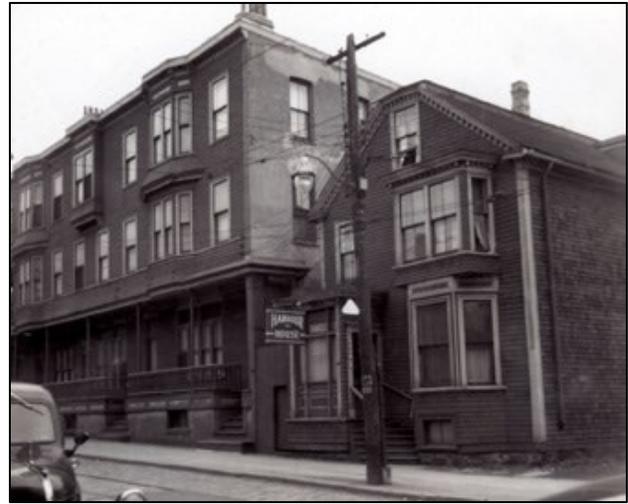
Figure 4: The Morris House at 1273 Hollis Street in April 1953 next to the Victoria Hotel. Source: The Griffin, June 2013, volume 38, No.2 ISSN 0384 7335

In 1898 the Morris House was moved about 30 meters south along Hollis Street to make way for construction of the Victoria Hotel, where it remained until 2009. Throughout that time it was variously used as a private residence, hotel and rooming house.

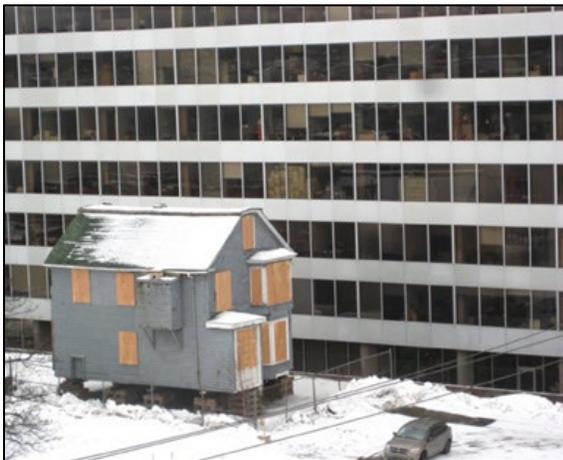
Figure 5: Morris House - 2009. Located on Nova Scotia power lands. Source: The Griffin, June 2013, 38, No.2 ISSN 0384 7335

In December of 2009 the building was slated for demolition to make way for the construction of an apartment complex. Through the efforts of volunteer groups including the Heritage Trust of Nova Scotia and the Ecology Action Centre, funds were raised to temporarily move the building to a neighbouring lot owned by Nova Scotia Power. During that time the building was the subject of several research projects by students at Mount Allison, St. Mary's and Dalhousie Universities and the Nova Scotia Community College. One such project consisted of dendrochronological research (age analysis of wood construction materials) to try and establish an accurate year that the building was constructed. The research suggested that the

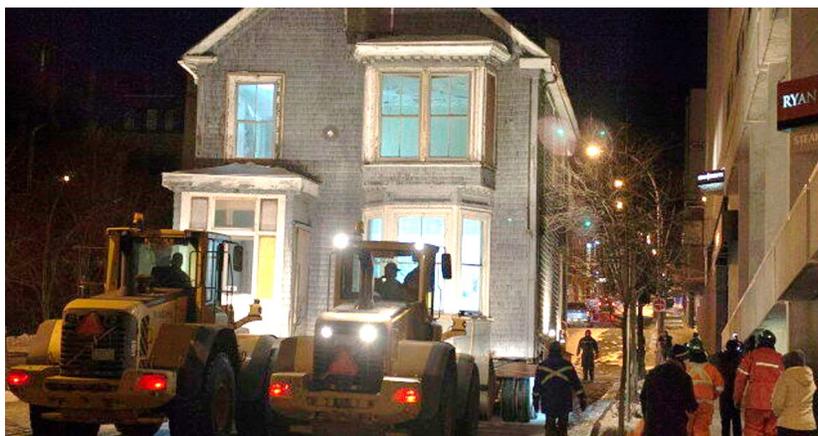
Figure 7: Morris House moving up Sackville Street, Halifax on January 25th 2013. Photo by Michael Tutton, of The Canadian Press. Courtesy Huffington Post

The relocation of the Morris House to Creighton Street during the late evenings of January 25th and 26th 2013 was in itself an important event, extensively covered by national news media and the subject of an HGTV reality docuseries called "Monster Moves". The move was completed by the firm of S. Rushton of New Glasgow, who placed the building on a flatbed trailer using a series of hydraulic jacks. Two excavators were used in addition to a tractor-trailer to push the house up the steep incline of Sackville Street.

The process was made more challenging by the number of overhead wires that had to be temporarily moved. Nova Scotia Power donated the time of dozens of line crews to undertake this work through the two-day process. The house was finally placed on a prepared foundation at 2500 Creighton Street on January 26th 2013 amid a crowd of onlookers and media.

It should be noted that because of the brick nogging, the Morris House weights 80 tons, which is quite heavy for a building of its size. The weight of the Morris House posed a challenge during its various moves, especially in 2013 when the building had to be hauled up Sackville Street in Downtown Halifax. Currently the building sits on a cement foundation. However, originally the building would have had a stone foundation.

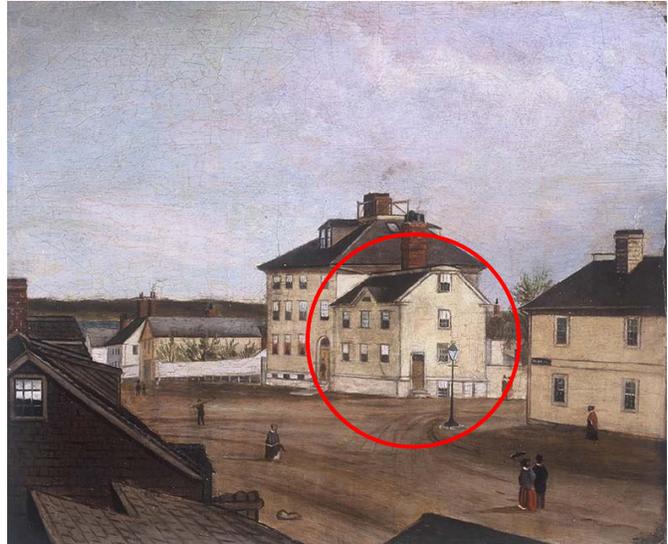
Figure 8: Image of 1237 Hollis street C. 1840: J.S Clow watercolour depicting the Morris mansion (centre) and office (circled) at the intersection of Hollis and Morris street. (Original at NSARM)

An early 1840s watercolour by J.S. Clow (fig. 8) depicting the office at the corner of Hollis and Morris Street (fig. 8) shows this simple Georgian design prior to the addition of Victorian elements later in the 19th Century. The roofline facing Morris Street had a strong triangular gable dormer that was later removed. The placement of the windows is very symmetrical, with two floors of 3 windows all evenly spaced. The side of the building which faces Hollis Street had windows on all floors which were evenly centered on the wall. The right side of the roof has a Scottish dormer which cannot be seen in the painting.

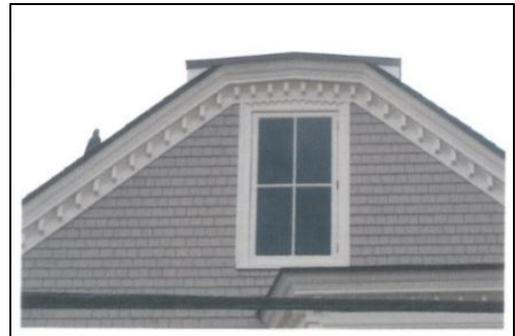
Figure 9: Truncated narrow flat roof with dentils under eave. Source: Heritage Assessment Report – Dr. Allen B. Robertson

The character-defining elements of the Morris House include:

- Truncated, pitched roof;
- Wood shingle cladding;
- Five-sided Scottish dormer;
- c.1890 front bay windows;
- c.1890 enclosed front porch;
- Wooden hung, sash windows with divided lights;
- Cornerboards and returns; and
- Dentils under eave.

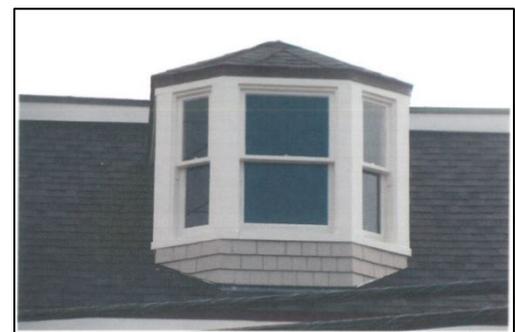
Figure 10: Scottish dormer. Source: Heritage Assessment Report – Dr. Allen B. Robertson

- truncated, pitched roof;
- wood shingle cladding;
- five-sided Scottish dormer;
- c.1890 front bay widows;
- c.1890 enclosed front porch;
- wooden hung, sash windows with divided lights;
- cornerboards and returns; and
- dentils under eave.
