Cobequid Rd and Glendale Ave

MicroTraffic Video Diagnostic Findings and Recommendations

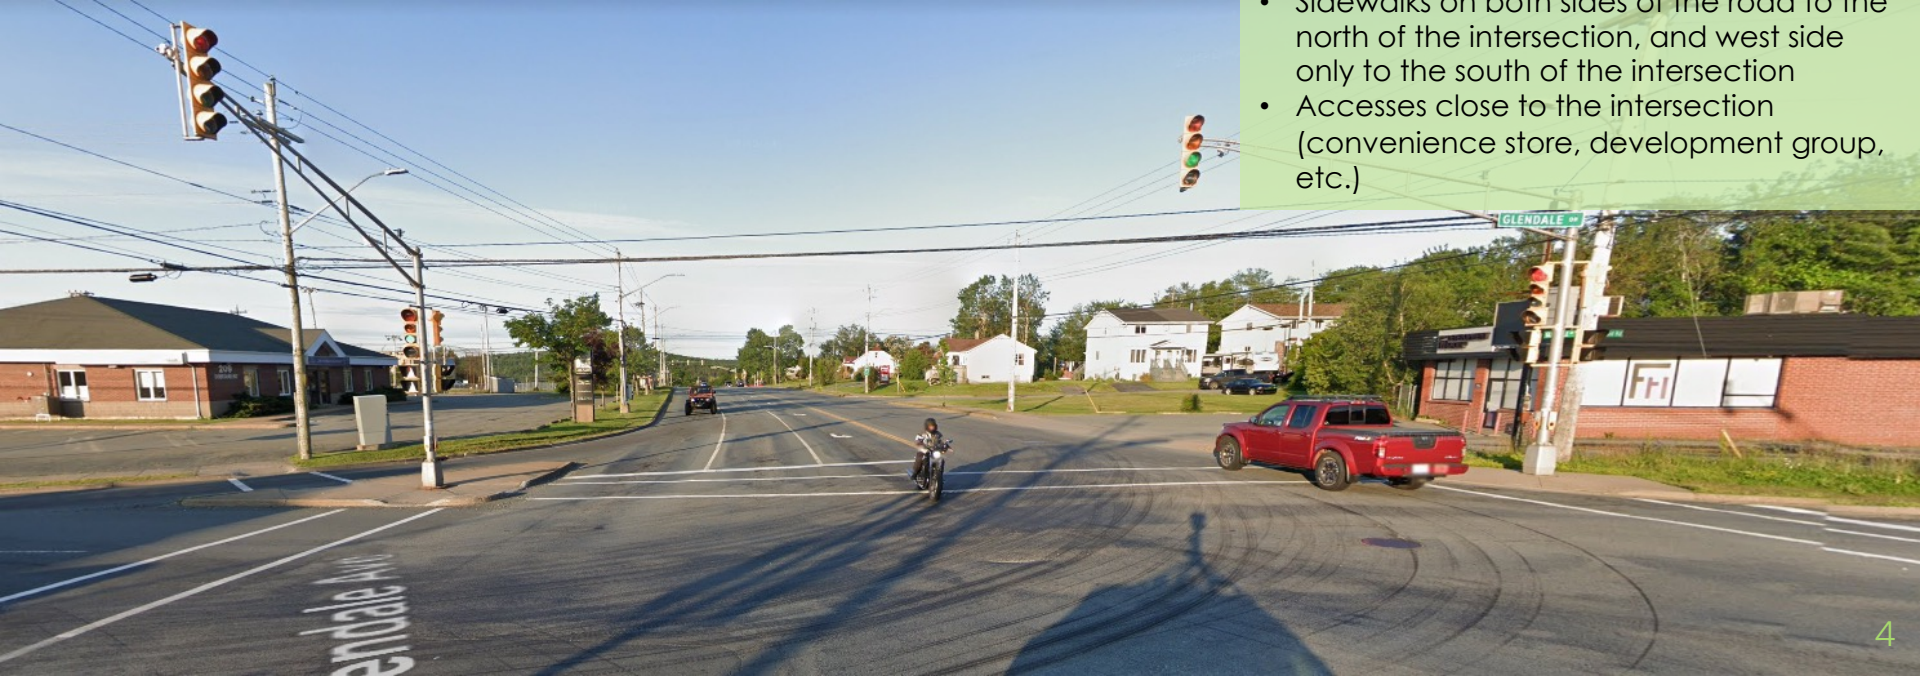
Cobequid Rd. Looking South

- Two through lanes and a left turn auxiliary lane
- Right turn channelization island for NBR
- 50 km/h posted speed limit
- Three signal heads NB and SB (one nearside)
- Left turn signalization: protected/ permissive
- No reflective back plates on signals
- Sidewalks on both sides of the road to the north of the intersection, and west side only to the south of the intersection
- Accesses close to the intersection (convenience store, development group, etc.)

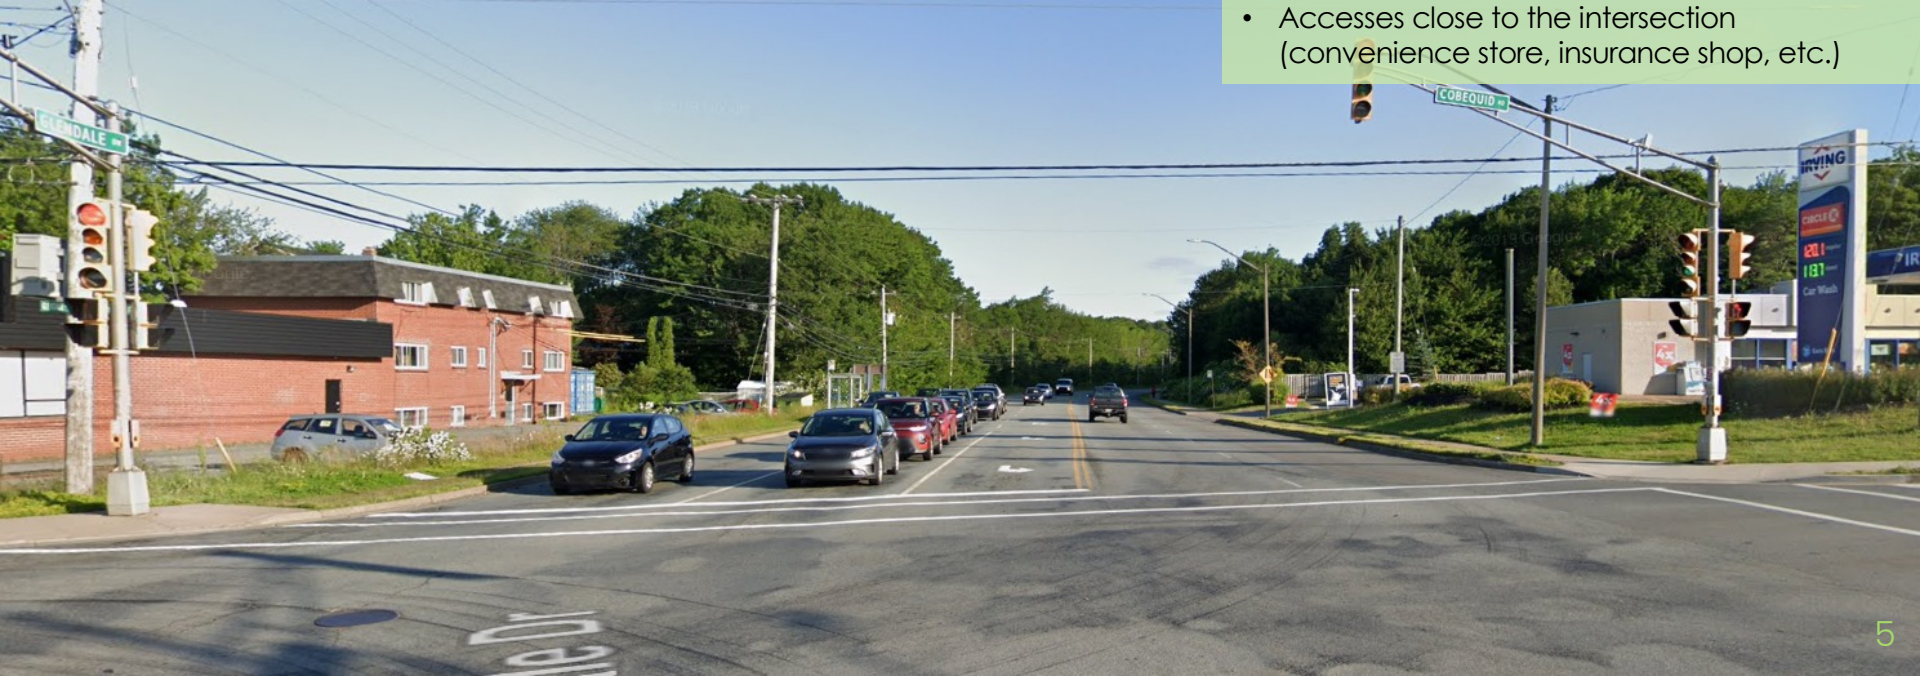
Glendale Dr. Looking West

- Two through lanes and a left turn auxiliary lane
- Right turn channelization island for WBR
- 60 km/h posted speed limit
- Three signal heads EB and WB (one nearside)
- Left turn signalization: protected/ permissive
- No reflective back plates on signals
- Sidewalks are discontinuous, one is located on the north side west of the intersection and the south side east of the intersection
- Accesses close to the intersection (convenience store, insurance shop, etc.)

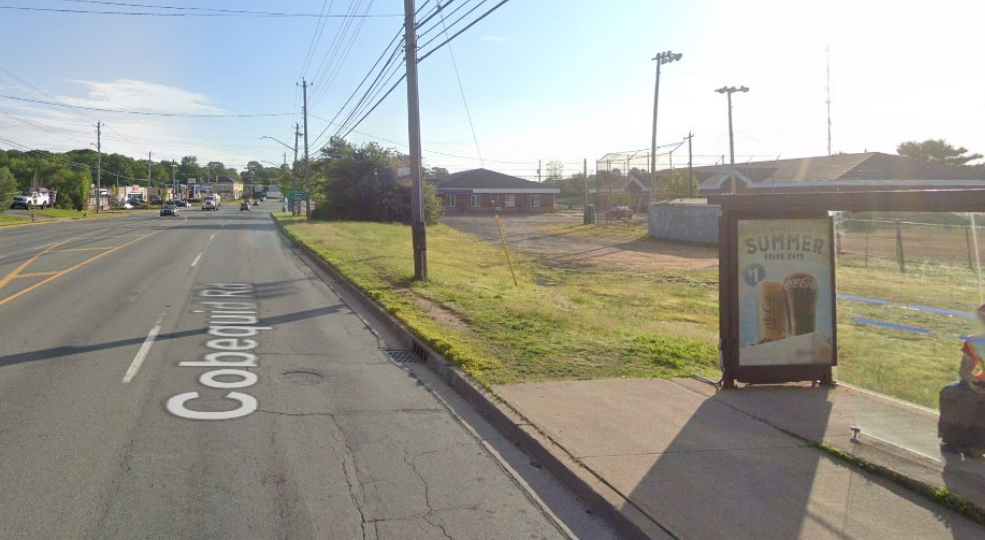
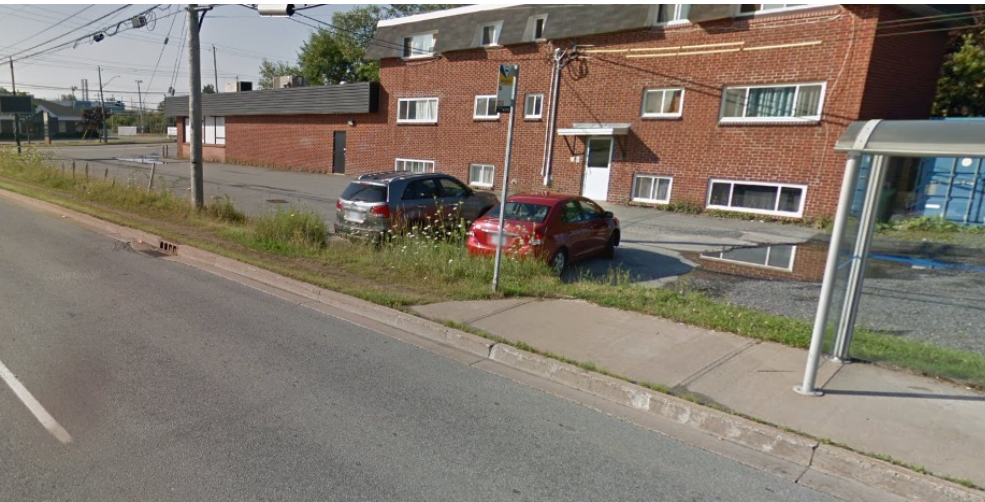
Discontinuous sidewalks on Cobequid south of the intersection (top photo) and on Glendale west of the intersection (bottom photo). Based on the grass conditions, there is pedestrian desire for a sidewalk. Sidewalk connectivity improvements are also important for road users with mobility impairments.

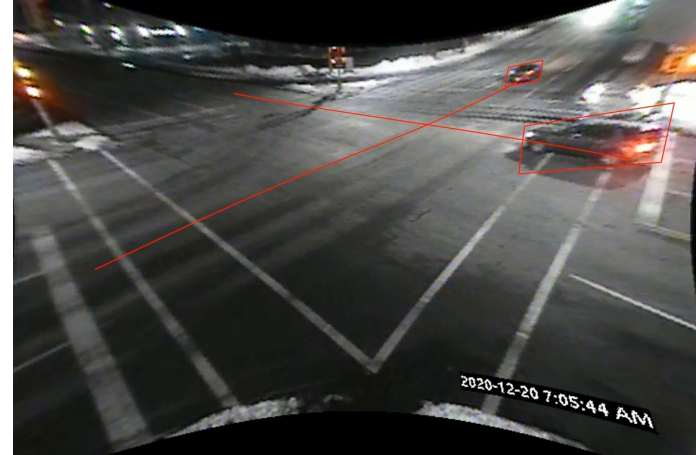
- 1 through vs through conflict was detected during the 73-hour analysis period (east-through vs south-through).
- 2 Left-Turning vs Through Vehicle from Left conflicts were detected (south-left vs west-through).
- These conflict types require a signal violation, which are typically infrequent events.

Signal Violation: south-through vs east-through

Key Issue	Recommendation
<p>Angle Vehicle events:</p> <ul style="list-style-type: none">• 14% of collisions were for angle collisions and 3 conflict events were detected in the 73-hour analysis period. These events included vehicular signal violations. The secondary signal head is located at the far side of the intersection at a lower elevation and may not be easily visible to drivers.	<p>Add reflective backplates to all signals.</p> <p>Upgrade and lenses <300mm to 300 mm.</p> <p>Consider increasing all-red clearance intervals; ensure technical guidance is followed at a minimum.</p>

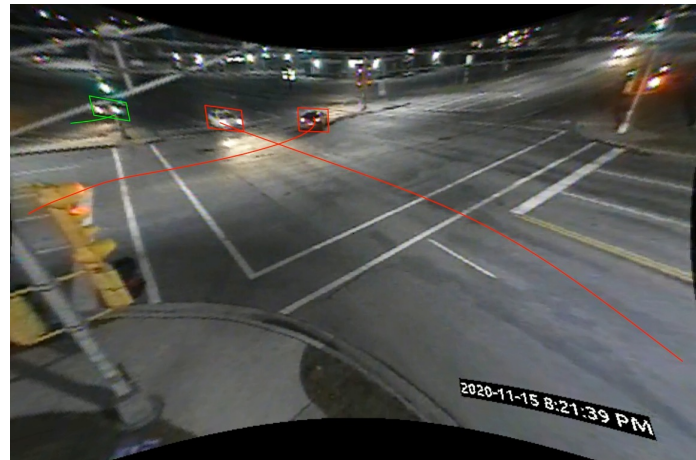
Signal Violation: south-left vs west-through

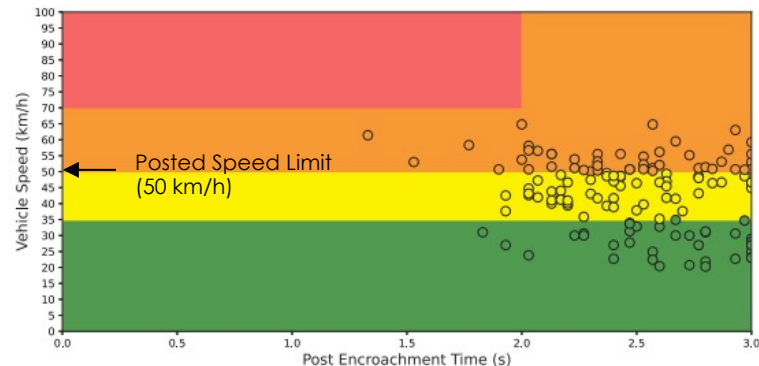
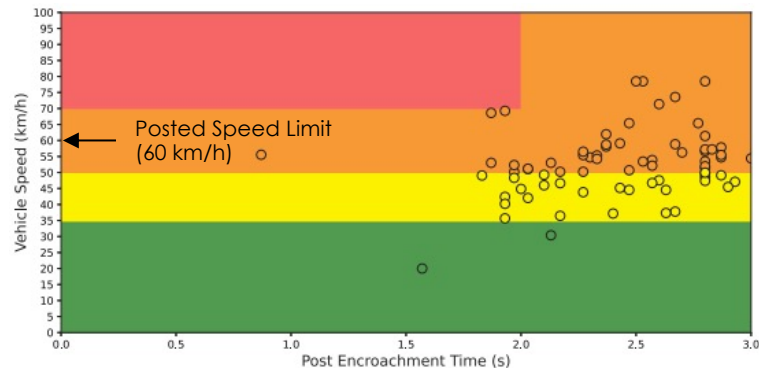
- Several left turn across path conflicts were detected during the 73-hour analysis period, as follows:
 - 88 North-Left vs South-Through conflicts
 - 136 South-Left vs North-Through conflicts
 - 73 East-Left vs West-Through conflicts
 - 149 West-Left vs East-Through conflicts
- The signalization is protected/permmissive for left turn movements.
- These conflict events were distributed throughout the day, typically with highest frequencies between 12:00 and 16:00.
- On a per capita basis, the involvement rate in left turn conflicts is lower at this intersection than for similar intersections with protected-permissive phasing in North America.

The LTAP conflict data, for example South-left vs North-through (above) and East-Left vs West-through (below), shows several conflicts occurring with through vehicle speeds exceeding the posted speed limit (up to 80 km/h).

At impact speeds above 60 km/h, opposing drivers have a >65% chance of a severe injury (MAIS 3+), which increases to >95% at 80 km/h.

Key Issue	Recommendation
<p>Pedestrian Safety:</p> <ul style="list-style-type: none">• Although minimal pedestrian conflicts were detected during the 73-hour analysis period, nearly 200 pedestrians crossed the intersection in a 24-hour period. The West Crossing is the most commonly used crossing.• There appears to be a demand for sidewalk connectivity on E side of S leg and W side of N leg, connected to transit stops.	<p>Connect and extend sidewalks</p> <p>Provide centreline hardening / left turn traffic calming.</p> <p>Reconstruct RT channels as smart rights.</p>
<p>Left Turn Across Path (LTAP):</p> <ul style="list-style-type: none">• LTAP collisions make up nearly 50% of all collisions• 446 LTAP conflicts were detected during the 73-hour analysis period, with several occurring at vehicle speeds exceeding posted speed limits• Permissive/protected signalization• The conflict frequency high. At the same time, the conflict rate is low. There are 3 injury collisions with left turns including 1 pedestrian.	<p>Extend the protected portion of the phase,</p> <p>Convert to protected only operation,</p> <p>Reduce Glendale posted speed limit.</p>

<p>High Speeds:</p> <ul style="list-style-type: none">• 172 high-risk conflicts (impact vehicle speed >50 km/h) were detected during the 73-hour analysis period. The open cross section and arterial feel Westbound on Glendale may contribute to higher operating speeds• Speed moderation techniques should be considered along this corridor.	<p>Glendale posted speed limit reduction to 50 km/h</p>

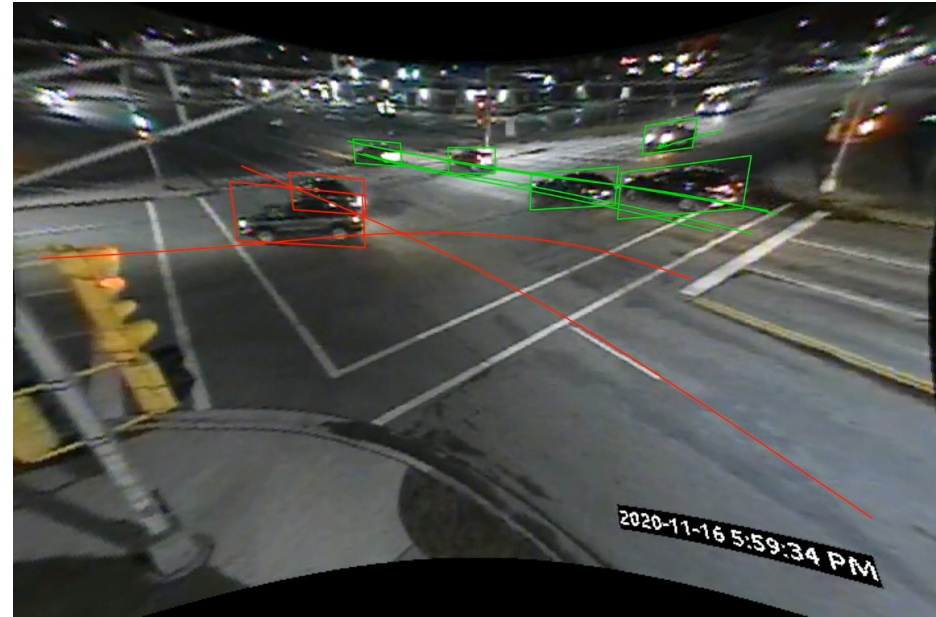
East-left vs West-through: PET = 0.9s, vehicle speed: 55 km/h

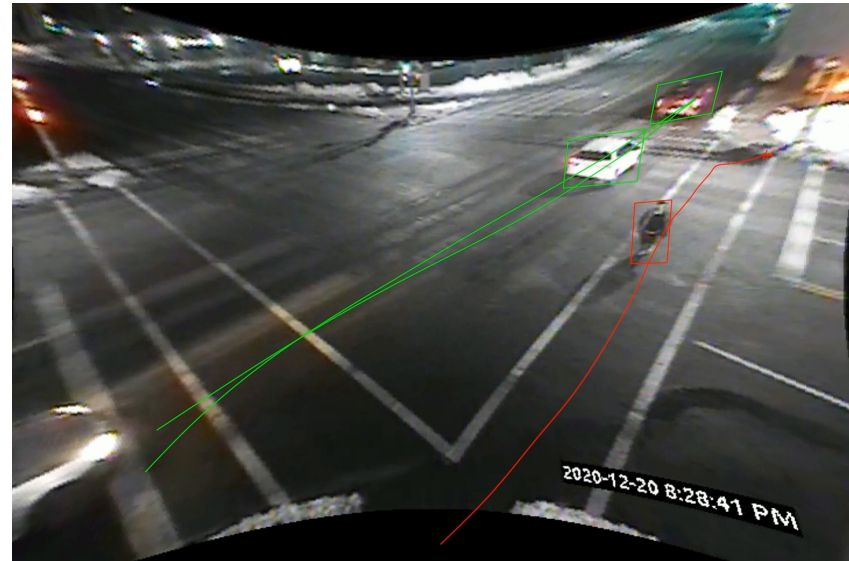
- Right hook conflicts in the right turn channels (NBR and WBR) and near-side conflicts were not measured due to camera placement and limited approach view.
- No cyclist conflicts were detected during the 73-hour analysis period. However, the video collection occurred in Nov/Dec and the 24-hour cyclist counts indicate a low volume of cyclists crossing the intersection.
- 1 low-risk pedestrian right-hook conflict was detected, this occurred in dark conditions and at low, controlled speeds.

Pedestrian South Right-Hook:
T2 = 2.9s, vehicle speed = 10 km/h
