Main St and Major St

MicroTraffic Video Diagnostic Findings and Recommendations

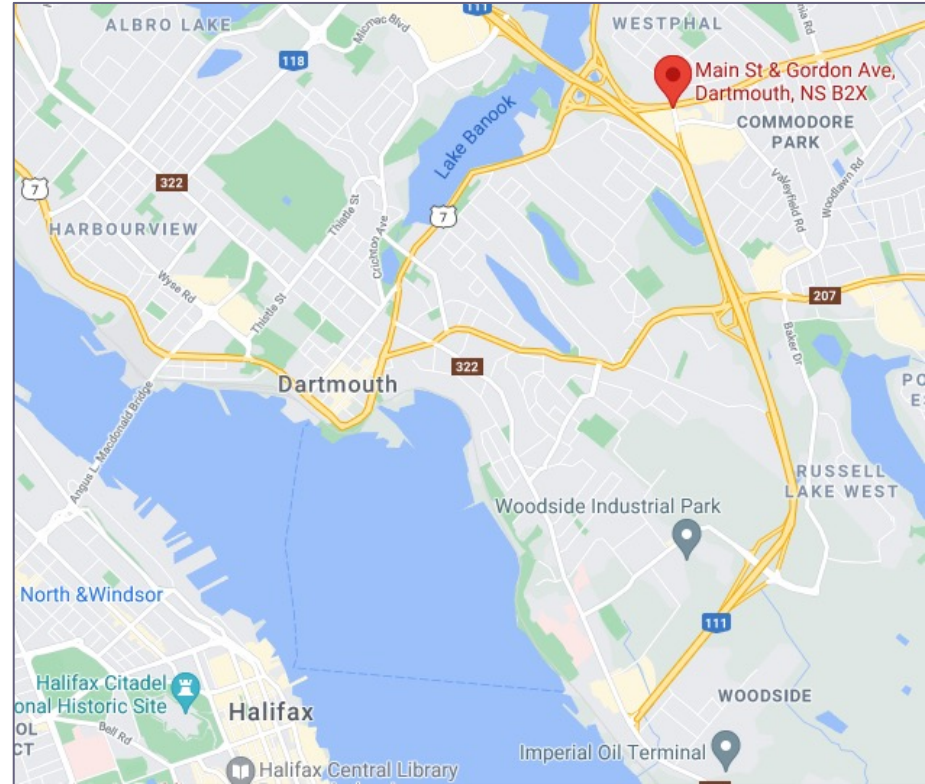
- Main St and Major St is located in Dartmouth, across the inlet from downtown Halifax.
- Main St is the portion of Highway 7 that runs East from the interchange with Highways 111 and 318.
- Major St provides access from the Westphal neighbourhood to the Tacoma Plaza shopping mall. South of Main St, Major St transitions to Gordon Ave and the off ramp from highway 111.
- The land use directly surrounding the intersection is primarily mixed commercial establishments. North of the intersection is single-family residential homes.
- Video analytics indicates that the intersection is used by approximately 15 cyclists, 420 pedestrians, and 41,200 vehicles per day from 5:00-24:00. Note that the counts were completed in November when VRU volumes may be depressed.

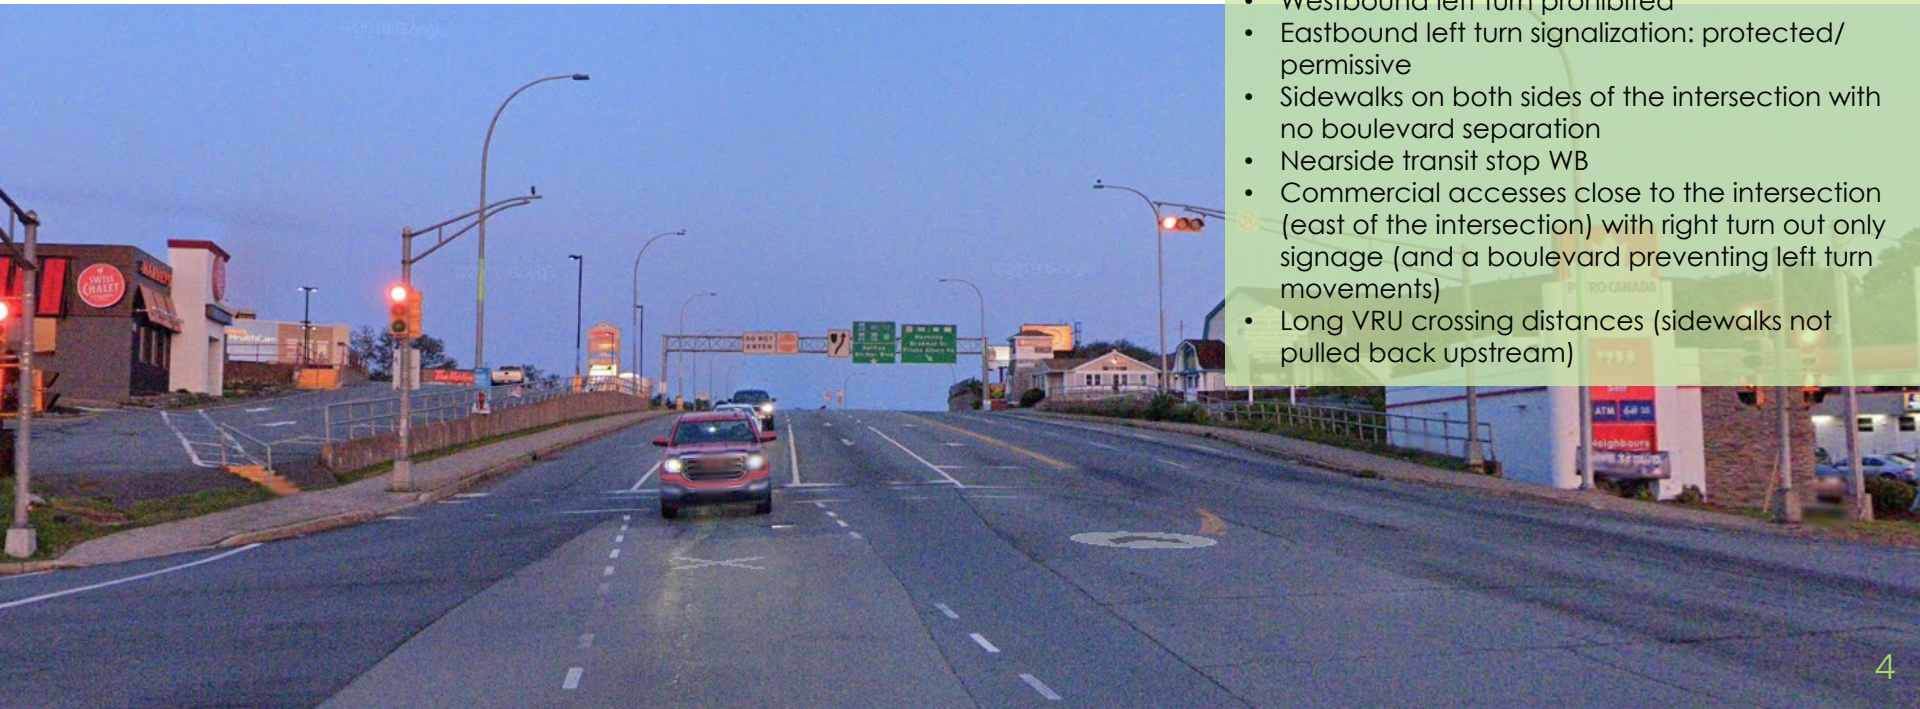
Main St. Looking West

Main St. Features:

- Eastbound: Left turn auxiliary lane, two through lanes and a right turn lane with a short diamond lane in the receiving east cross section
- Westbound: Two through lanes
- High EB/WB right turn radii (high speed)
- 50 km/h posted speed limit
- Five signal heads EB and WB (one nearside each)
- No reflective back plates on signals
- Westbound left turn prohibited
- Eastbound left turn signalization: protected/ permissive
- Sidewalks on both sides of the intersection with no boulevard separation
- Nearside transit stop WB
- Commercial accesses close to the intersection (east of the intersection) with right turn out only signage (and a boulevard preventing left turn movements)
- Long VRU crossing distances (sidewalks not pulled back upstream)

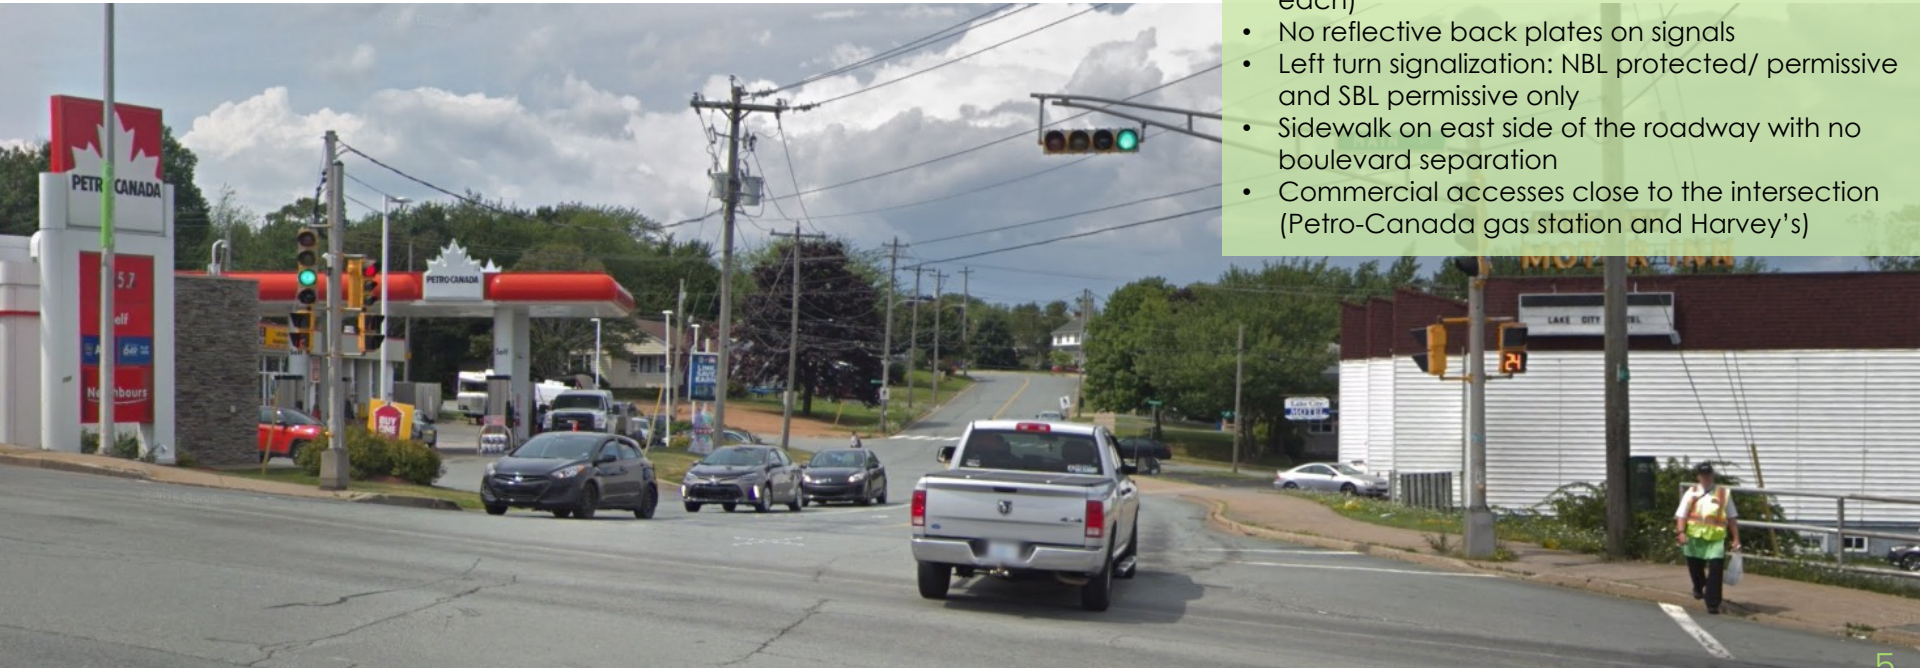
Major St. Looking North

Major St. Features:

- One through lane and one left turn auxiliary lane. Southbound receiving lane is ~7.5m wide
- High NB right turn radius (high speed)
- Sightline limitations between southbound vehicles and VRUs on the sidewalk (NW quadrant) due to topography and Petro-Canada signage
- 50 km/h posted speed limit (assumed)
- Three signal heads NB and SB (one nearside each)
- No reflective back plates on signals
- Left turn signalization: NBL protected/ permissive and SBL permissive only
- Sidewalk on east side of the roadway with no boulevard separation
- Commercial accesses close to the intersection (Petro-Canada gas station and Harvey's)

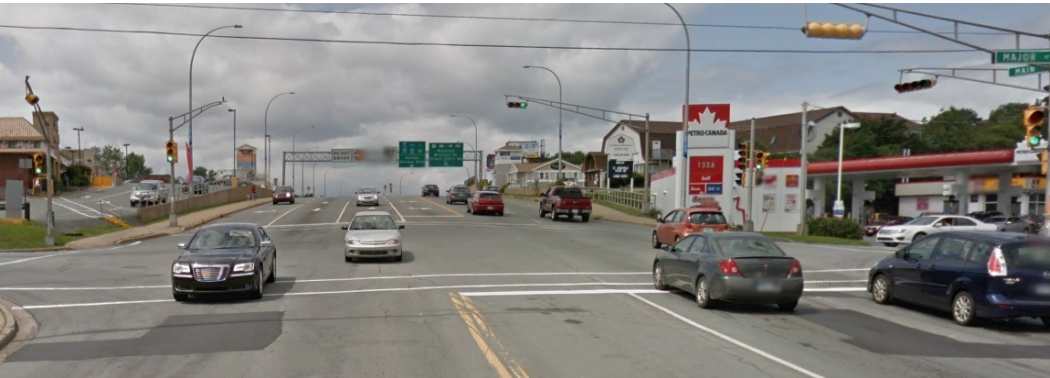
Google Streetview from July 2018 shows previous WB cross section and permissive left turn. This layout is shown in the aerial imaging.

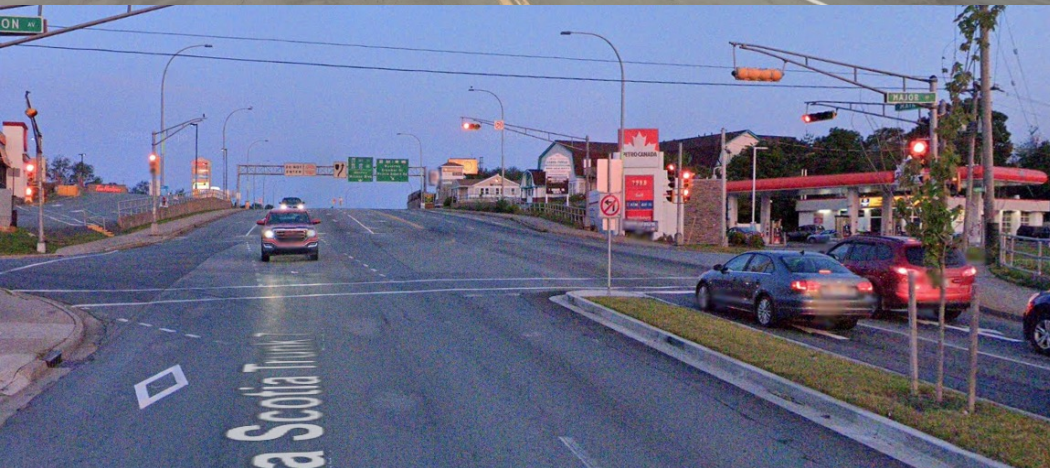
Google Streetview from July 2019 shows re-configured cross section with prohibited left turn movement, a boulevard and a small diamond lane.

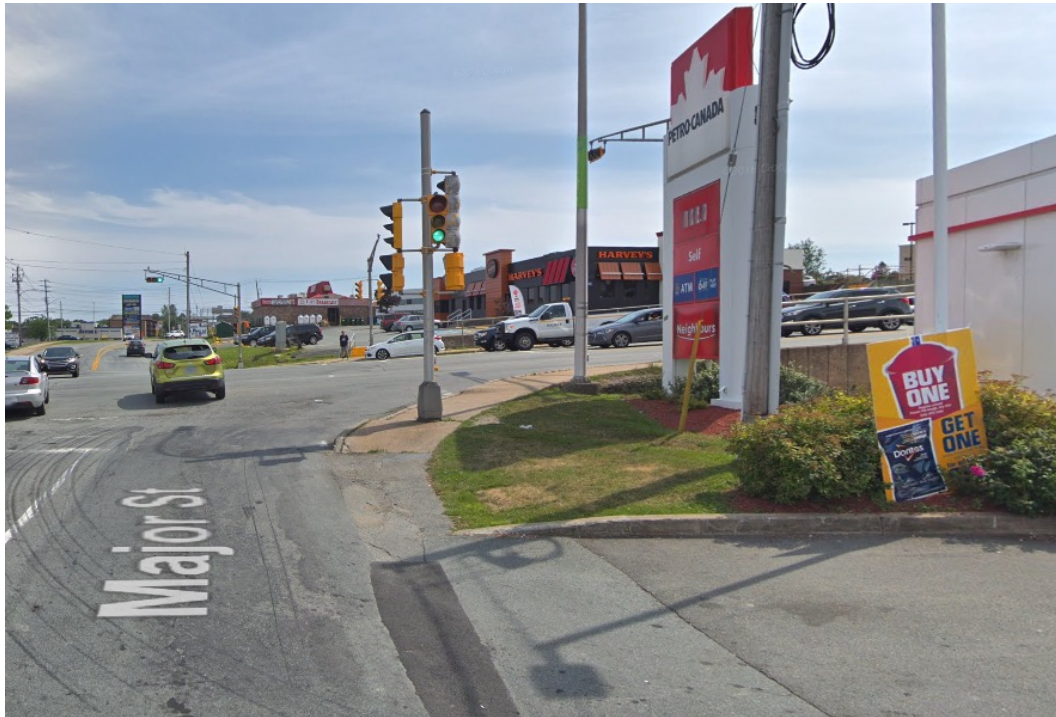
Left: Sightline from southbound vehicles to vulnerable road users approaching the North Crosswalk from the west is obstructed due to Petro-Canada sign and building. With the downhill slope approaching the intersection, cyclists, pedestrians and e-scooters may be moving faster than expected by drivers.

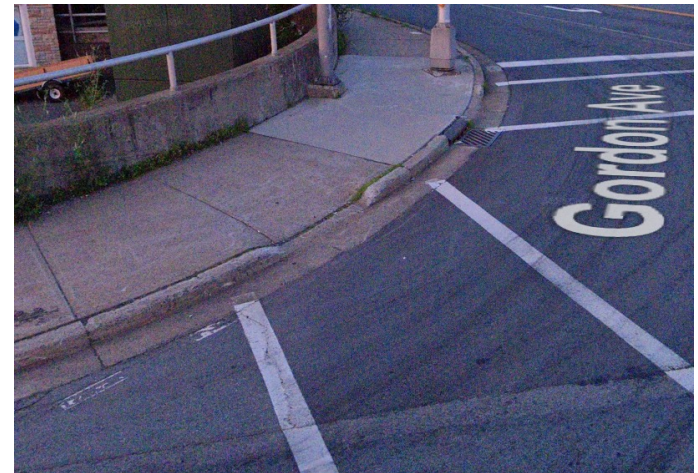
Below: Curb cuts are narrow and without a tactile surface. Pedestrians with mobility limitations may have difficulty using the crossing. Tactile surfaces improve safety for pedestrians with visual impairments.

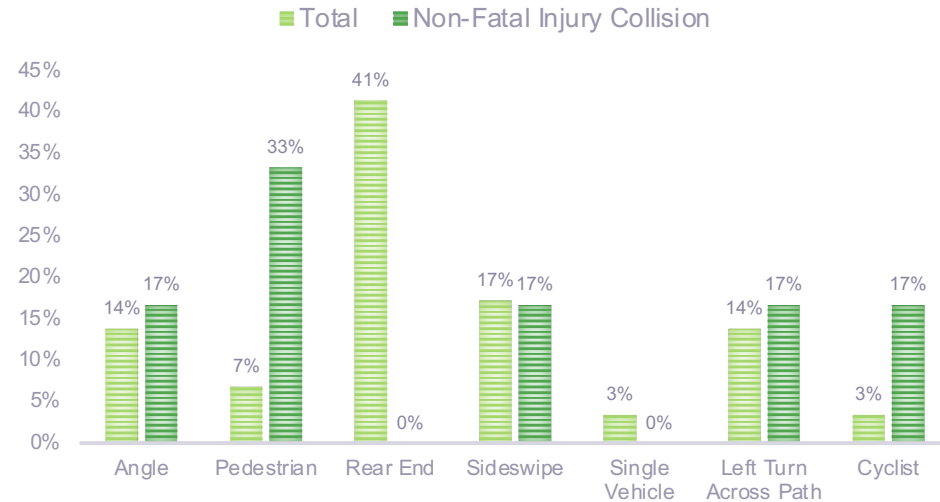
CONFIGURATION DISTRIBUTION OF COLLISIONS

- The provided collision data included 29 collision records from January 1, 2018 to April 12, 2021. Of the 29 records, 21% were classified as non-fatal injury collisions and 79% as property damage only collisions.
- Collisions with cyclists that were listed as property damage only were modified to non-fatal injury collisions.
- The collisions were classified into the general descriptions shown in the adjacent figure based on the initial impact type and provided directional information.

- Pedestrian collisions represent 33% (2 events) of the non-fatal injury collisions. The pedestrian collisions involved a westbound-right vehicle and a southbound-through vehicle (reversing when it hit the pedestrian). The 1 cyclist collision involved a westbound-left vehicle (but WBL has now been prohibited, effectively mitigating this risk).
- Left turn across path collisions represent 14% (4) of total collisions and 17% (1) of the non-fatal injury collisions. The direction distribution is 25%, 25%, and 50% for Eastbound-left, Westbound-left, and Northbound-left respectively.
- Rear End collisions represent 41% of total collisions. 56% of the collision events with known directions involved westbound vehicles.

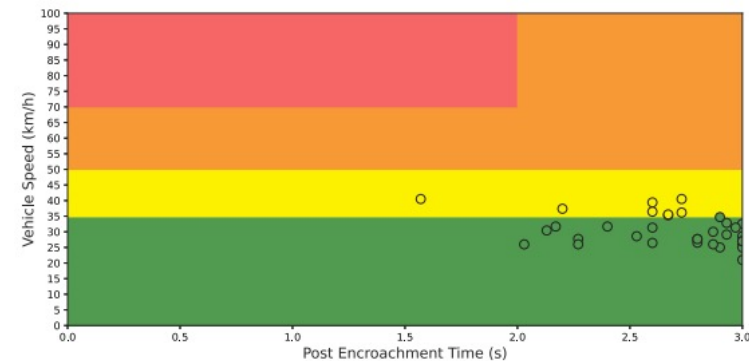
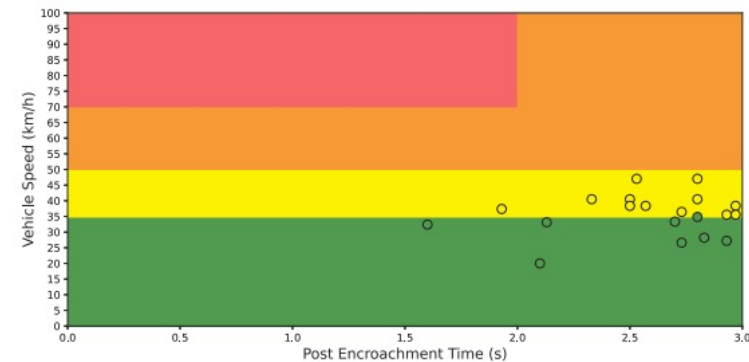
North-left vs South-through (above) and South-Left vs North-through (below) conflict data indicates that the majority of events are occurring at speeds less than 40 km/h, below the assumed speed limit of 50 km/h.

The conflict events most frequently occurred around 12:00pm and at peak PM hours (no conflicts were detected between 21:00 and 7:00 during the 57-hour analysis period).

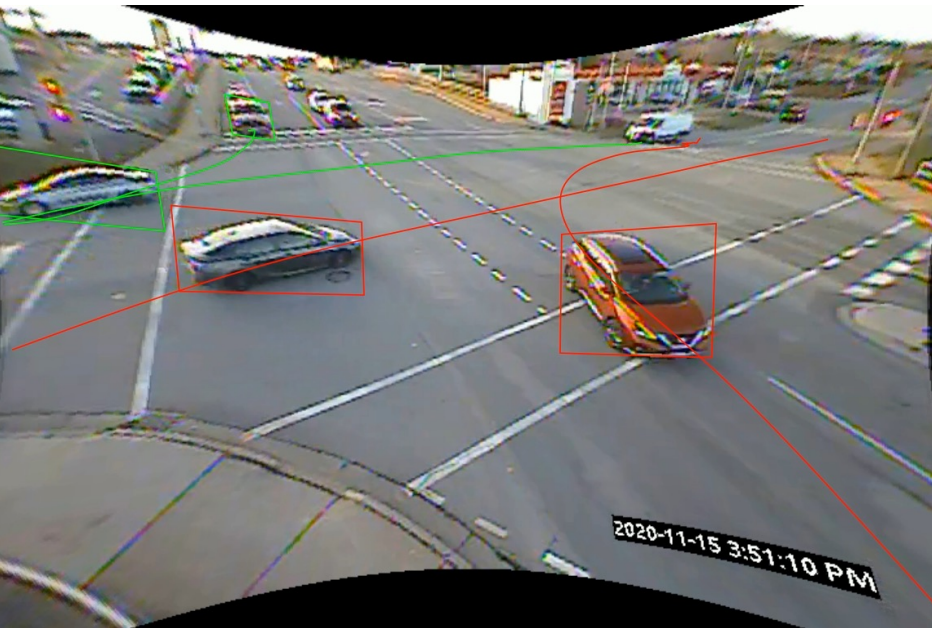
South-left vs North-through: PET = 1.9s, vehicle speed = 37 km/h

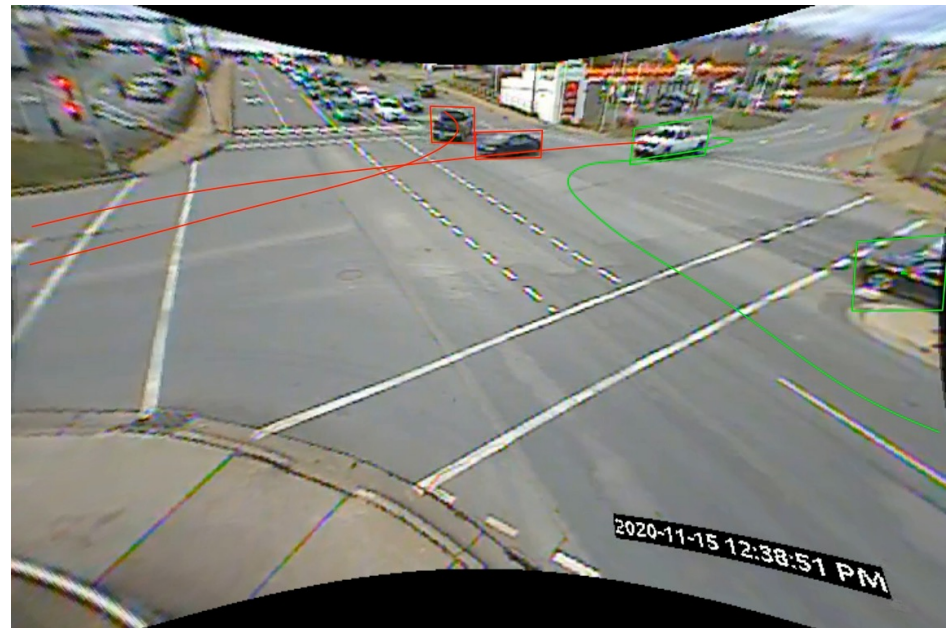
North-left vs South-through: PET = 1.6s, vehicle speed = 41 km/h

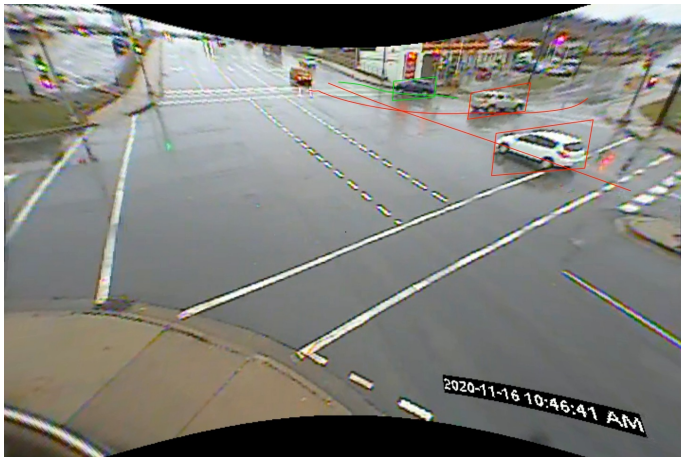
- High WBT speeds are evident in the EBL vs WBT conflict data, greatly exceeding the 50 km/h speed limit heading towards the on ramps. At impact speeds above 80 km/h, drivers in opposing vehicles have a >95% of a severe injury (MAIS 3+).
- 61 High-Risk events were detected for East-left vs West-through. When comparing the conflict rate of EBL vs WBT events to benchmark values for similar sites across North America, EBL drivers at Main and Major are 1.2x more likely to be involved in a high-risk conflict event.

East-left vs West-through: PET = 1.9s, vehicle speed = 66 km/h

<p>Left Turns</p> <ul style="list-style-type: none"> EBL vs WBT conflicts were frequent and high severity due to WBT speed WBL conflicts and movements occur despite prohibition. 	<ul style="list-style-type: none"> See high speed recommendation above Improve no WBL signage

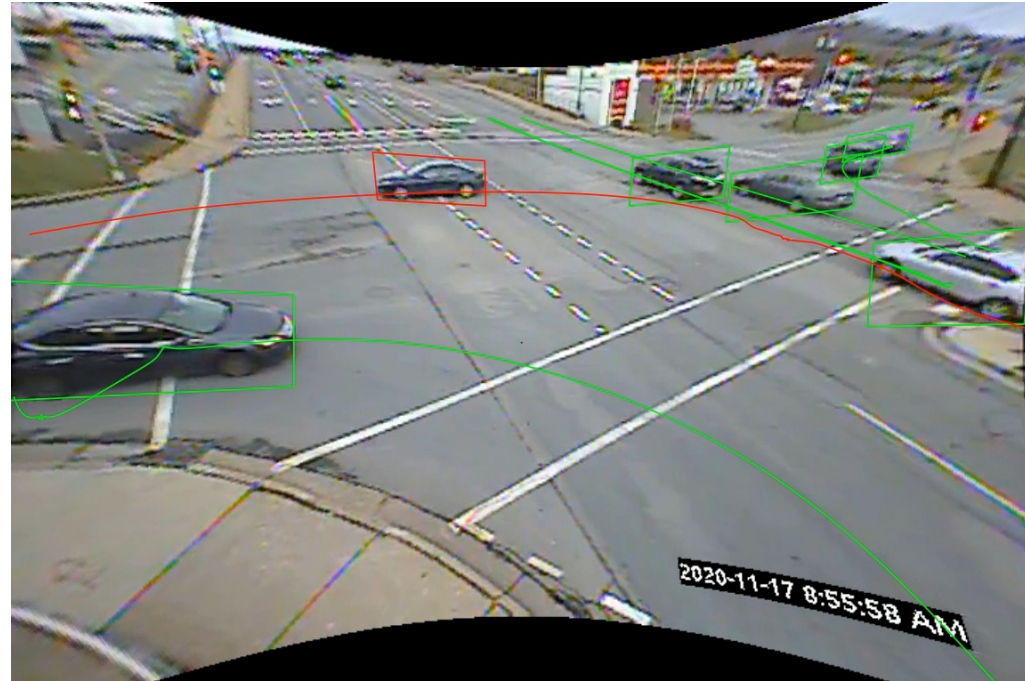
- WBL is a restricted movement at the intersection. According to Google Streetview, the intersection cross section was re-configured and this movement was restricted between July 2018 and July 2019.
- Turning Movement Counts from 5:00-24:00 conducted in November 2020 indicated that 7 vehicles violated this restriction.
- 3 conflicts were detected during the 57-hour analysis period (2 medium and 1 high-risk). Due to the low volume of left turning vehicles, nearly 15% of all WBL vehicles were involved in a conflict event.

West-left vs East-through: PET = 2.8s, vehicle speed = 69 km/h

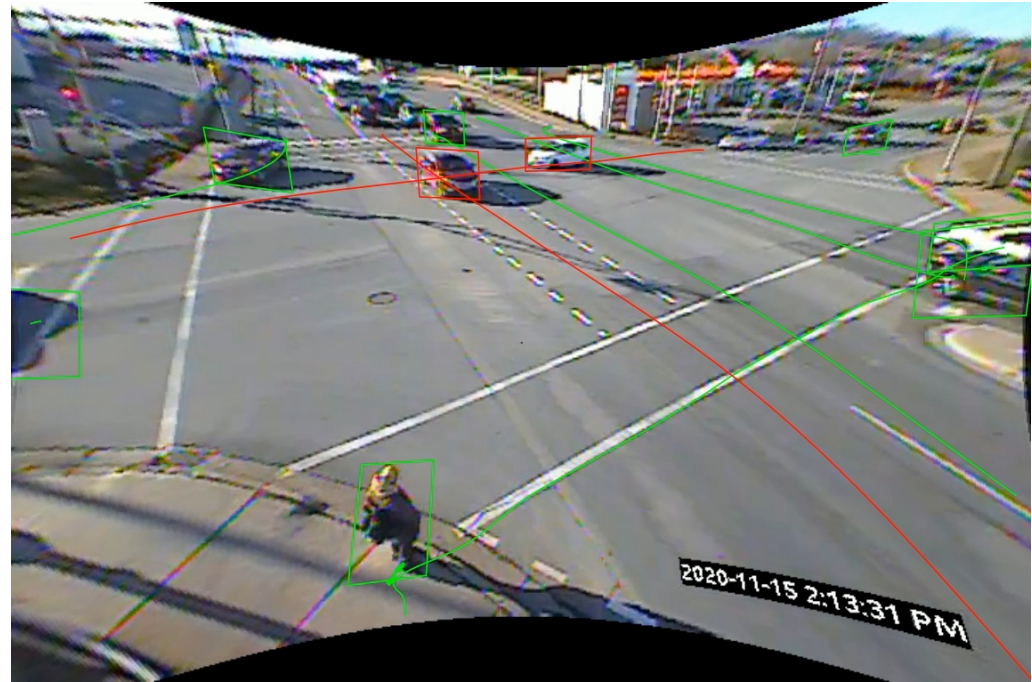
- Traffic lights were down with flashing red in all directions on November 15, 2020 from 14:08:23-14:50:45.
- Several conflicts were detected during this period but were not included in the Risk Diagnostic Report as they do not represent typical operating conditions.

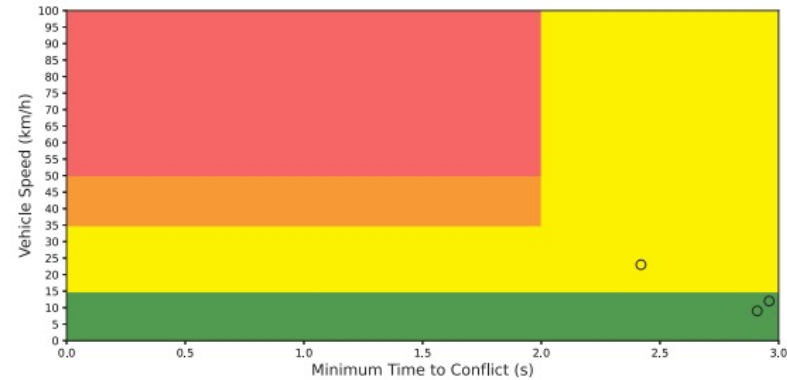
Pedestrian East-Right Hook data shows a conflict occurring with a through vehicle speeds >20 km/h. At impact speeds of 20 km/h, pedestrians have a 10% chance of a severe injury (MAIS 3+).

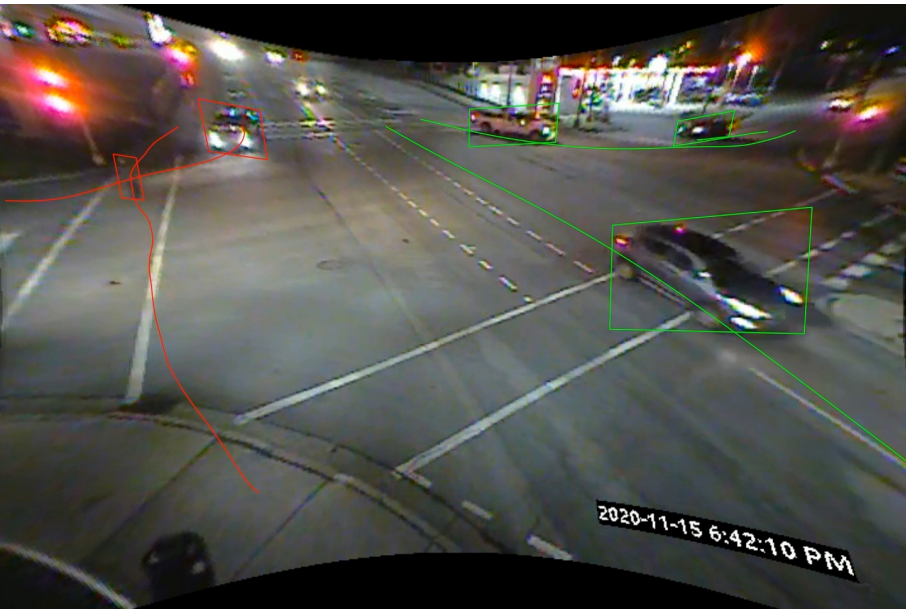
Pedestrian East-Right Hook: $T_2 = 2.4s$, vehicle speed = 23 km/h

Pedestrians are difficult to detect in low light conditions, especially when wearing dark clothes.

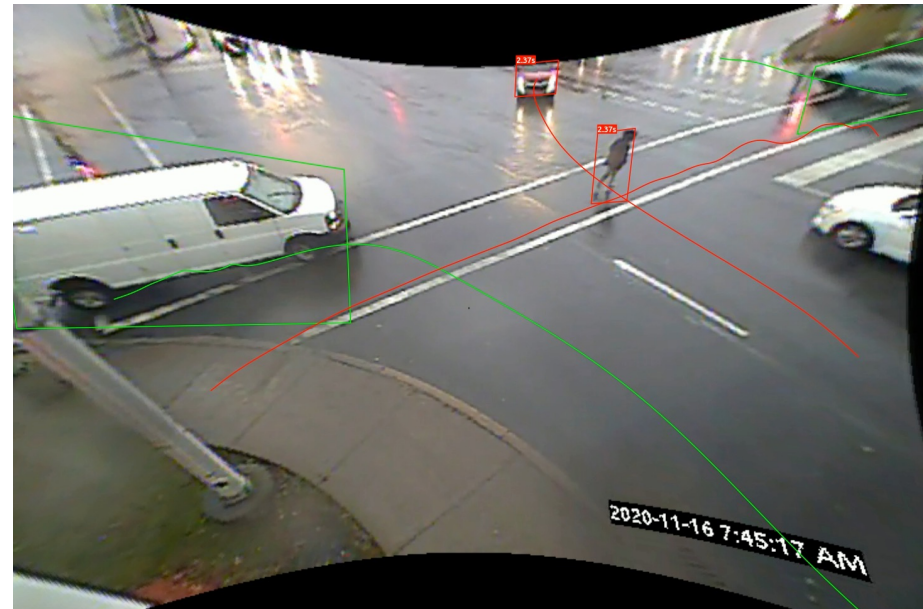
Pedestrian South-Left Hook: $T_2 = 2.4s$, vehicle speed = 15 km/h

The southbound-left vehicle approach visibility was restricted due to camera placement. This may have limited south-left hook conflict detection. Pedestrians are exposed to vehicles over a long crossing distance on Main. 16
