Chebucto Rd and Oxford St

MicroTraffic Video Diagnostic Findings and Recommendations

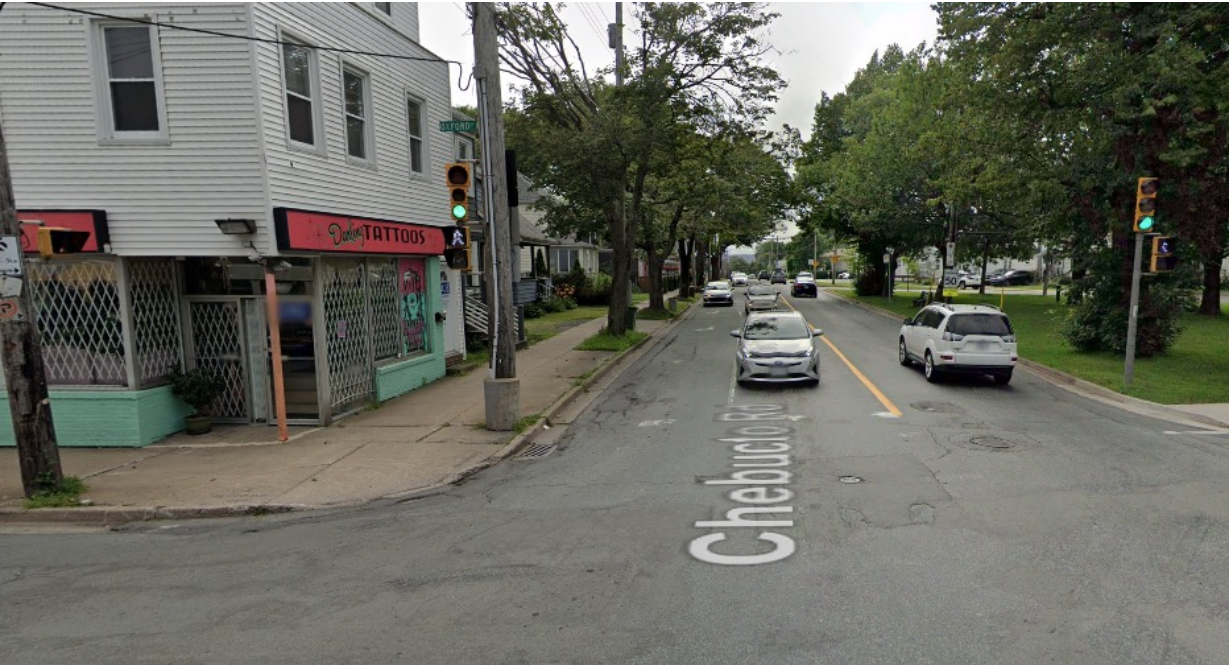
Chebucto Rd. Looking West

Chebucto Rd. Features:

- Eastbound: One through lane and one right turn auxiliary lane
- Westbound: One through lane
- Driveway accesses close to the intersection (south side of the road)
- Far side bus stop westbound and eastbound
- 50 km/h posted speed limit, 30 km/h when children present
- Two signal heads EB and WB with no reflective back plates – at same elevation and relatively low.
- Pedestrian countdown timers
- Eastbound left turns not permitted, westbound left turns are permissive only signalization
- Right turn on red is not restricted
- Narrow diagonal crosswalk curb cuts (NE, SW, SE) with no tactile surfaces.
- Sidewalks on both sides of the road east of the intersection and south side only west of the intersection.
- Hydro poles and trees located <0.5m away from the roadway
- Pedestrian corridor ~70m east of the intersection

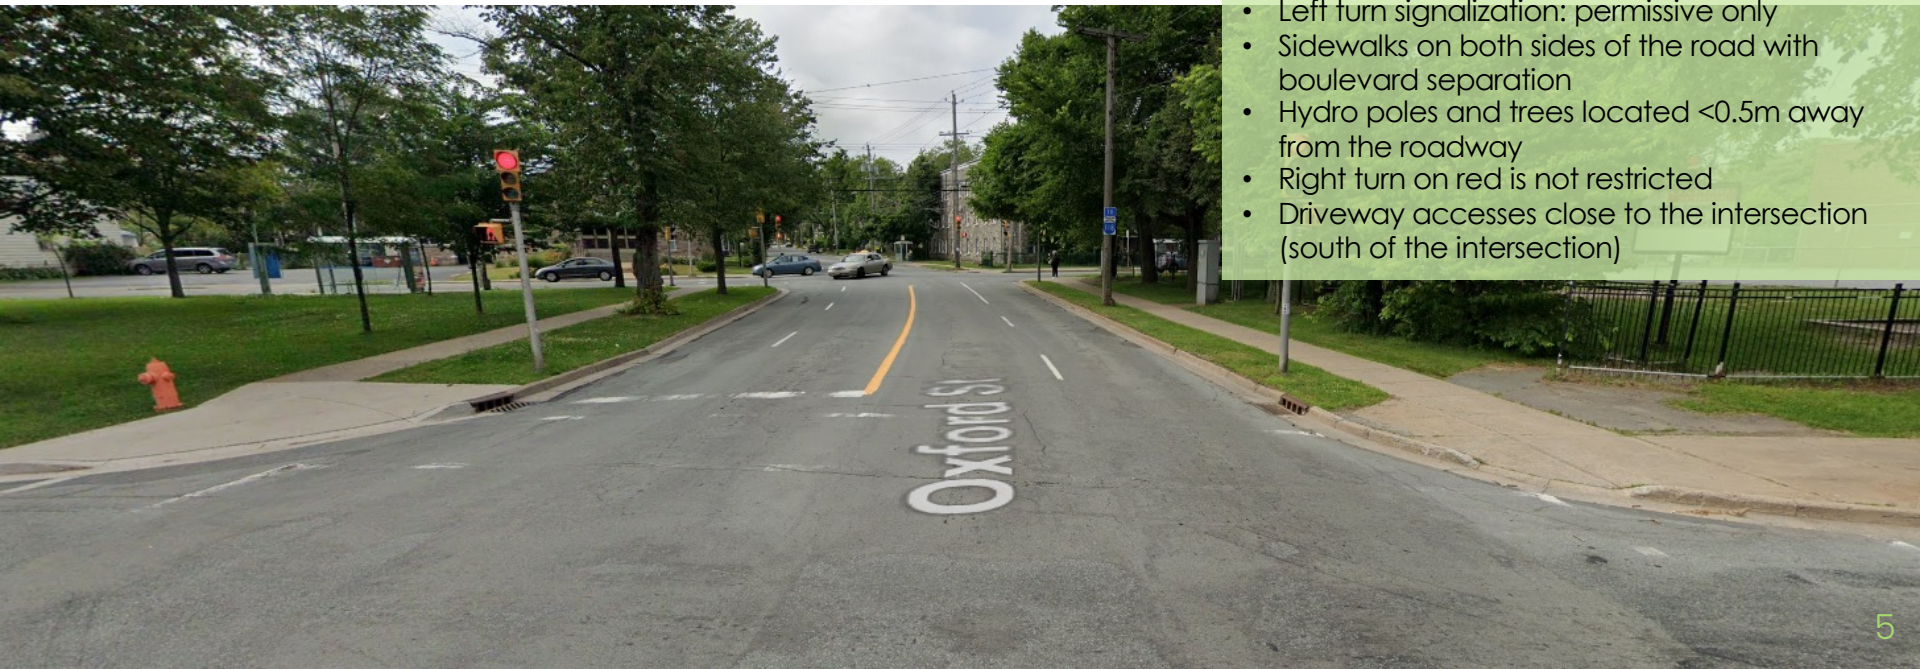
Oxford St. Looking North

Oxford St. Features:

- Two through lanes NB/SB
- Adjacent intersection (at North St) is ~30m to the north.
- 50 km/h posted speed limit, 30 km/h when children present
- According to July 2019 Google Streetview, no pedestrian countdown timers (NB/SB)
- Two signal heads each NB and SB (cantilevered over lane in SB direction only)
- No reflective back plates on signals
- Left turn signalization: permissive only
- Sidewalks on both sides of the road with boulevard separation
- Hydro poles and trees located <0.5m away from the roadway
- Right turn on red is not restricted
- Driveway accesses close to the intersection (south of the intersection)

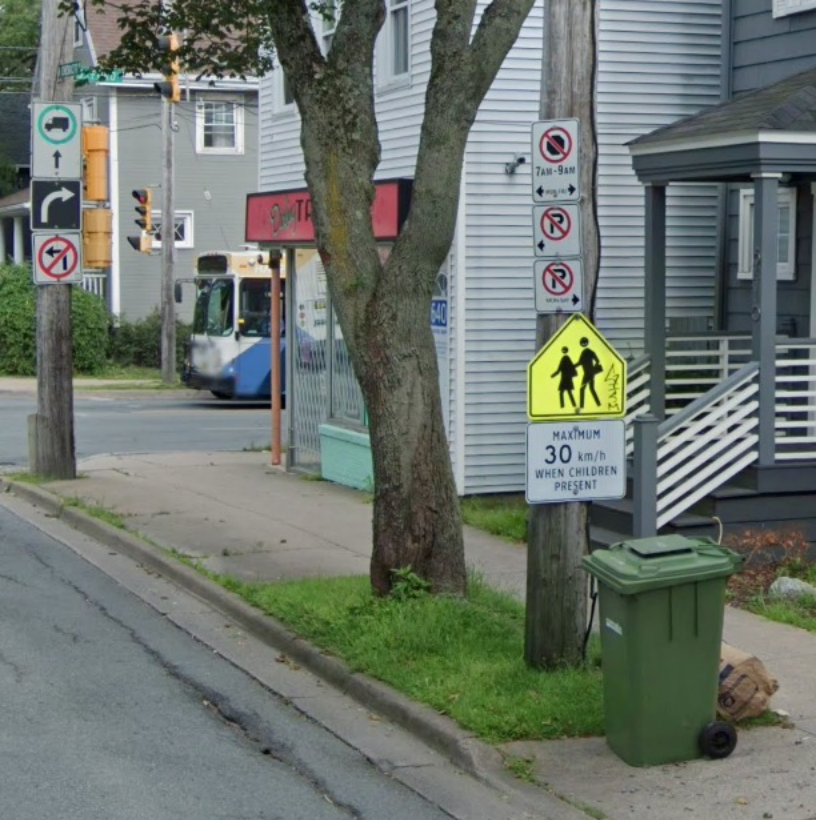
Several signs are clustered near the intersection, which may overload drivers and cause them to miss key information (30 km/h speed limit, no left turn, right turn only). Important 30 km/h school zone speed sign has small font and is placed low on the pole and may be outside the primary line of sight for drivers.

Key Issue	Recommendation
<p>VRU Safety:</p> <ul style="list-style-type: none">• An elementary school is located on the NE quadrant, indicating that young pedestrians may be cycling or walking across the intersection.• Sightlines between drivers and VRUs are limited at some locations due to buildings and vegetation (EBR and NBR).• Previous collision data records 2 southbound-left hook collisions and 1 southbound-through collision.• Conflict data indicates clusters of VRU north-left hook conflicts for PED/CYC, as well as a few east-right and west-right hook conflicts.• Some conflict clips indicate that permissive left turning drivers did not initially observe pedestrians crossing with the right-of-way and encroached on their crossing area.• Several conflicts were detected at speeds greater than 30 km/h. The 30 km/h school zone signs are infrequently placed and may be missed by drivers due to other sign clutter and low placement on pole (especially for trucks). <p>General improvements to pedestrian visibility at the crossing would be valuable, especially considering the young pedestrian use and surrounding residential areas.</p>	<ul style="list-style-type: none">• Improve emphasis on 30 km/h school zone<ul style="list-style-type: none">• More signs with larger font• Speed feedback signs• 24-7 applicability vs ambiguous 'when children present'• Physical calming measures• Added speed signs or feedback signs along Chebucto• Add NB/SB ped countdown timers• Check illumination levels for compliance with TAC 2006 Guide, and in particular trim interfering vegetation on NE quadrant.• Consider restricting right turn on red and introducing leading pedestrian interval.• Add zebra crosswalk markings.

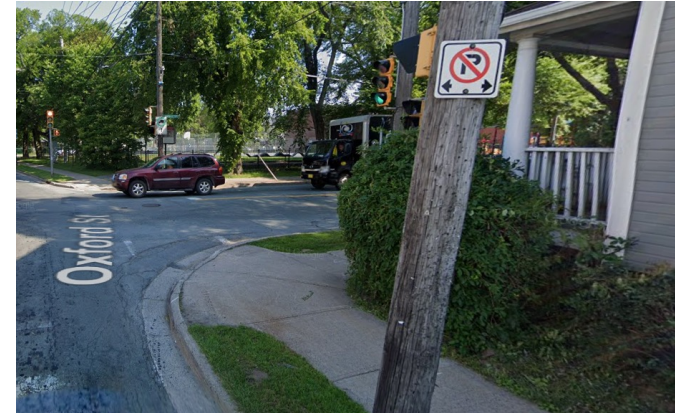
Sightlines to VRUs-
Above: Poor sightline between northbound vehicles and westbound approaching vulnerable road users due to vegetation and house close to the intersection.

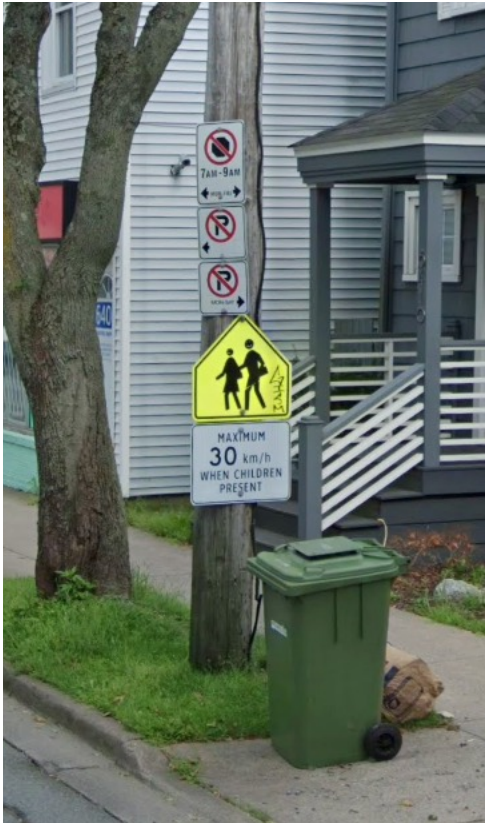
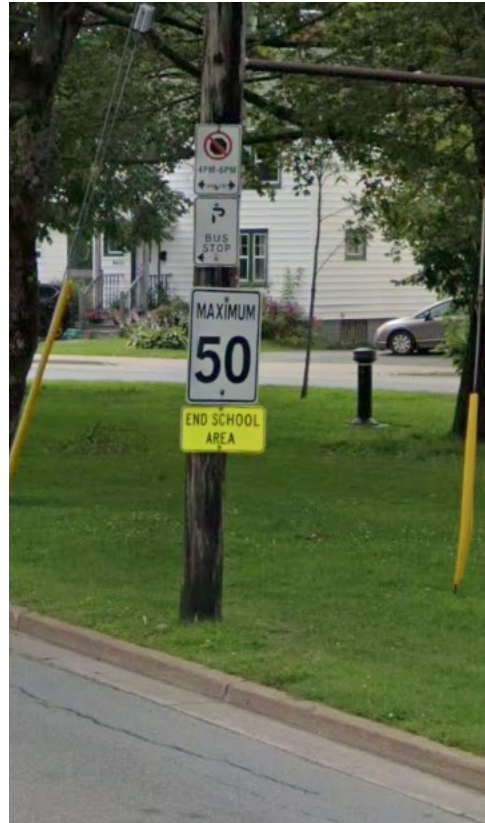
Left: There is also a reduced sightline between eastbound vehicles and the south crosswalk (hydro pole) and pedestrians approaching from the south.

The school zone begins at the start of Chebucto (at Windsor St). and ends after Oxford.

Two schools, two music schools and a community center are located along this portion of Chebucto.

No additional signage is placed to remind drivers of reduced speed limits and small font is used on the 30 km/h sign.

At speeds of 50 km/h, there is a >80% chance of severe injury to a pedestrian (MAIS 3+).

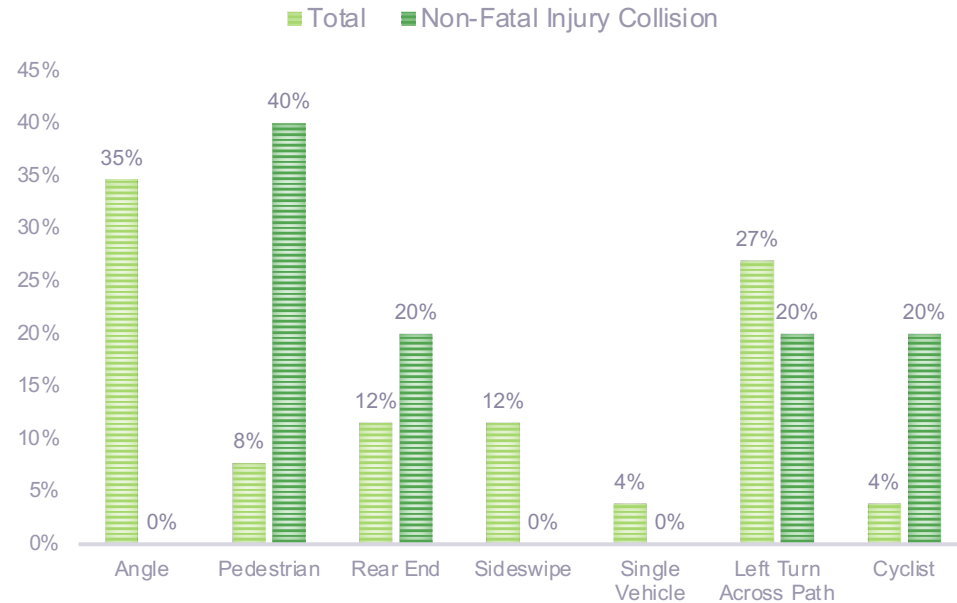
CONFIGURATION DISTRIBUTION OF COLLISIONS

- The provided collision data included 26 collision records from January 1, 2018 to April 12, 2021. Of the 26 records, 19% were classified as non-fatal injury collisions and 81% as property damage only collisions.
- Collisions with cyclists that were listed as property damage only were modified to non-fatal injury collisions.
- The collisions were classified into the general descriptions shown in the adjacent figure based on the initial impact type and provided directional information.

The collision data revealed the following key points:

- Pedestrian collisions represent 40% (2 events) of the non-fatal injury collisions. The pedestrian collisions involved a southbound-left vehicle and a southbound-through vehicle (nearside); both events list that the pedestrians were crossing without the right-of-way. The 1 cyclist collision included a southbound-left vehicle.
- Left turn across path collisions represent 27% (7) of total collisions and 20% (1) of the non-fatal injury collisions. The direction distribution is 14%, 14%, and 71% for Westbound-left, Southbound-left, and Northbound-left respectively.
- Angle collisions represent 35% of total collisions. Red light running was listed as a contributing factor for every event that involved two through vehicles. The red light running vehicles were in the eastbound direction (5), the westbound direction (2) and the southbound direction (1).

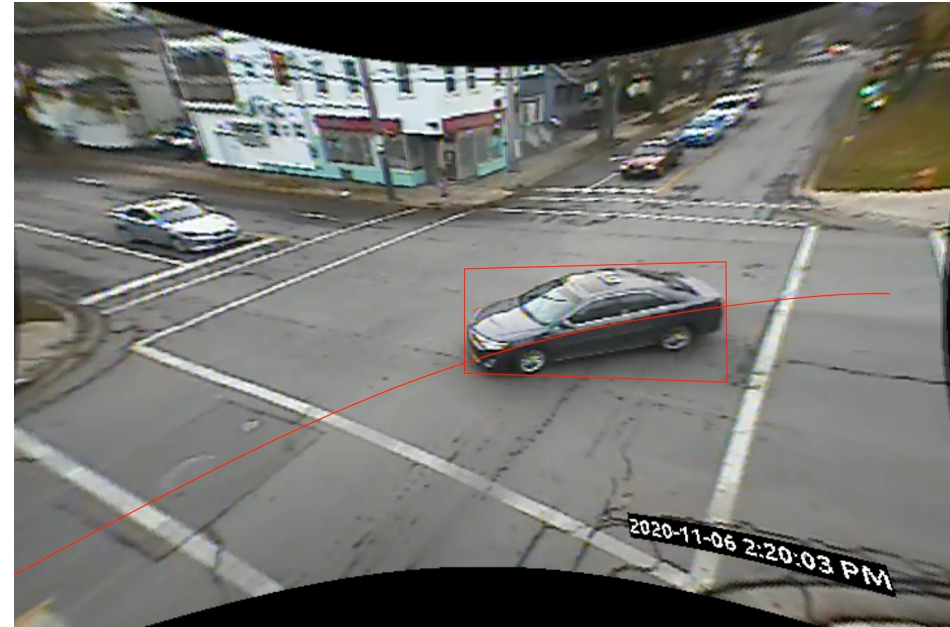
- 2 left-turning vs through from left conflicts were detected during the 47-hour analysis period (north-left vs east-through and south-left vs west-through).
- These conflict types typically occur at the end of a signal phase at relatively low through vehicle speeds.
- No through vs through right-angle conflict configurations were detected during the 47-hour observation period.

South-left vs West-through: PET = 3.0s, vehicle speed 25 km/h
(low risk conflict)

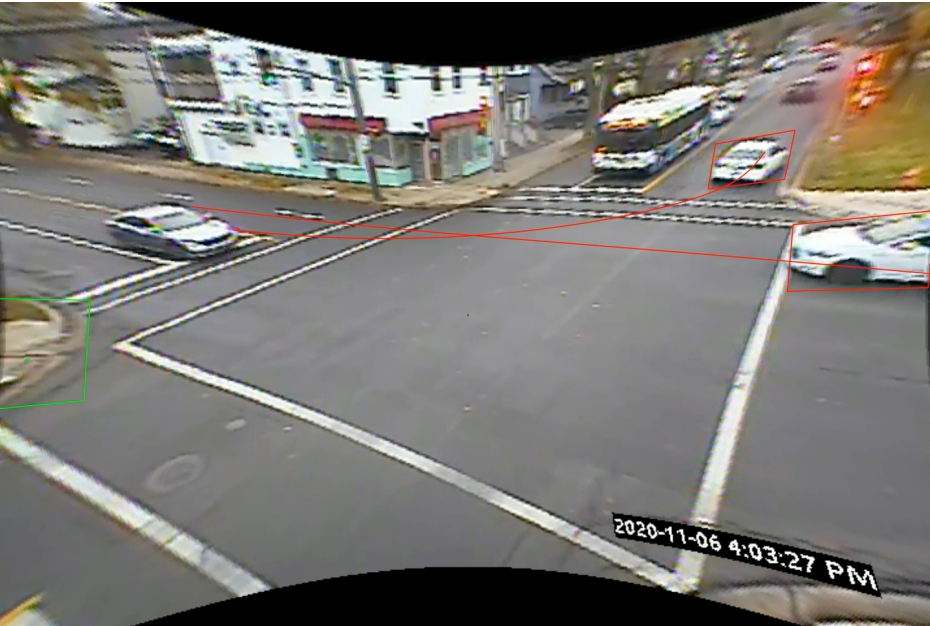
North-left vs South-through: PET = 2.5s, vehicle speed 50 km/h

Key Issue	Recommendation
<p>Left Turn Across Path (LTAP):</p> <ul style="list-style-type: none">• LTAP collisions make up nearly 30% of all collisions. NBL vs SBT is the most prominent configuration.• 194 LTAP conflicts were detected during the 47-hour analysis period. NBL vs SBT is also the most prominent conflict configuration.• North-Left turning vehicles were involved in nearly 20 conflict events with VRUs.	<ul style="list-style-type: none">• NBL could be considered for protected or protected-permissive phasing. Primary goal would be reducing chance of secondary conflicts with VRUs.• Alternatively, the VRU strategies on previous slide may be sufficient.
<p>Red light running:</p> <ul style="list-style-type: none">• Angle collisions make up 35% of all collisions. Red light running was listed as a contributing factor for every event that involved two through vehicles (primarily in EB and WB directions).• No through vs through conflicts were detected in the 47-hour analysis period, but general improvements to signal visibility would be valuable.• The signals do not have a reflective backplate and are not cantilevered over the travel lane. Sunlight glare may cause signal perception failure at certain times of day.	<ul style="list-style-type: none">• Cantilever arm on signals• Signal back plates with reflective edge• Provide signals at higher elevations and more than one elevation, especially in EB and WB directions

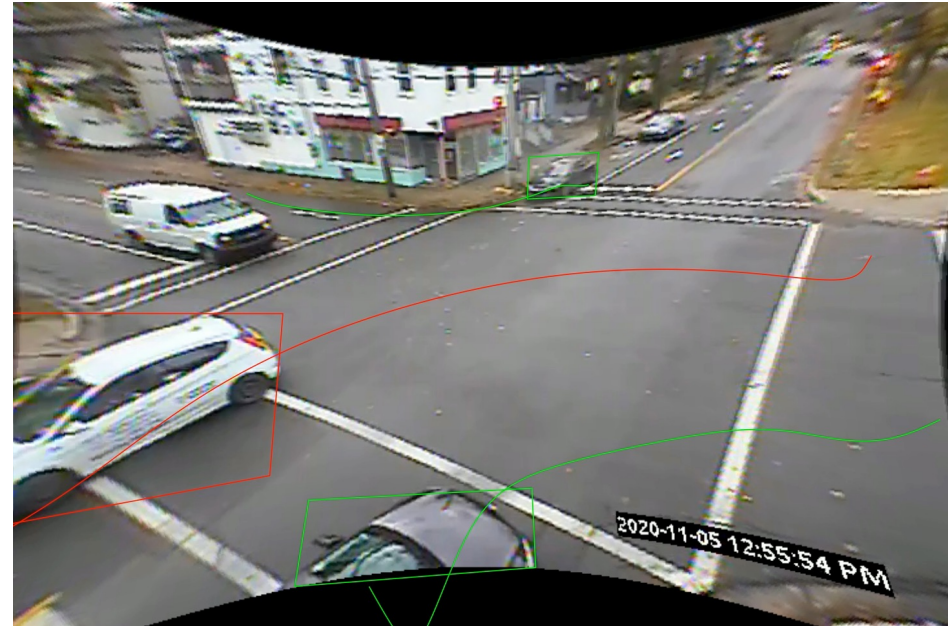
South-left vs North-through: PET = 2.0s, vehicle speed 54 km/h

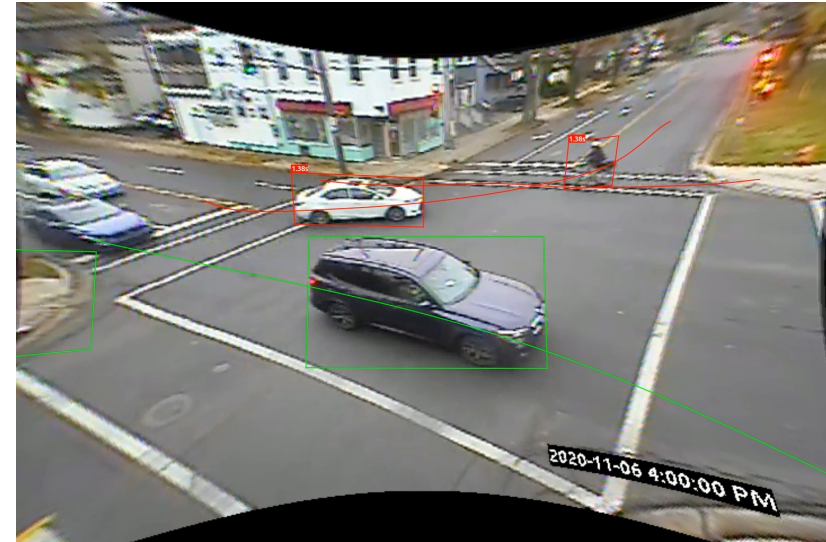
- A relatively low volume of cyclists were recorded in the exposure counts (<20 per crossing). Despite this, 8 north-left hook cyclist conflicts were detected during the 47-hour analysis period. Nearly 7% and 11% of all cyclists using the west crossing were involved in medium-risk and low-risk north-left hook conflicts, respectively.
- 10 north-left hook pedestrian conflicts were detected during the analysis period. 1.5% of all pedestrians using the west crossing were involved in a medium-risk conflict.
- Conflict events with vehicle impact speeds exceeding 20 km/h were detected. At these speeds VRUs have a >10% chance of a severe injury (MAIS 3+).
- The VRU conflicts were distributed throughout the day from 8:00am – 20:00pm.

Cyclist North-Left Hook: $T_2 = 1.4s$, vehicle speed = 16 km/h

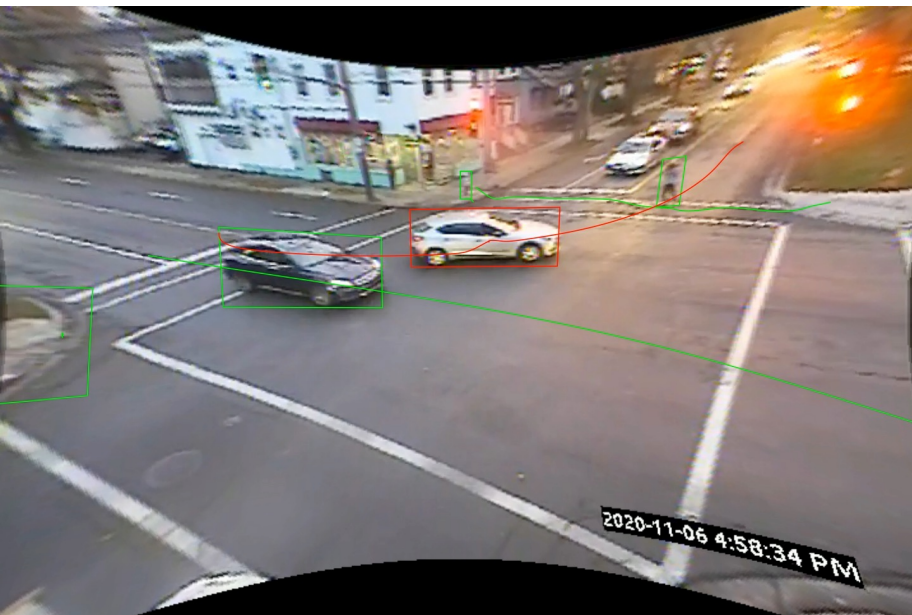
Pedestrian North Left-Hook: $T_2 = 2.9s$, vehicle speed 13 km/h

The driver initiated the left-turn without checking for crossing pedestrians. Delay from the pedestrian crossing with the right-of-way resulted in a conflict event with an oncoming southbound through vehicle.

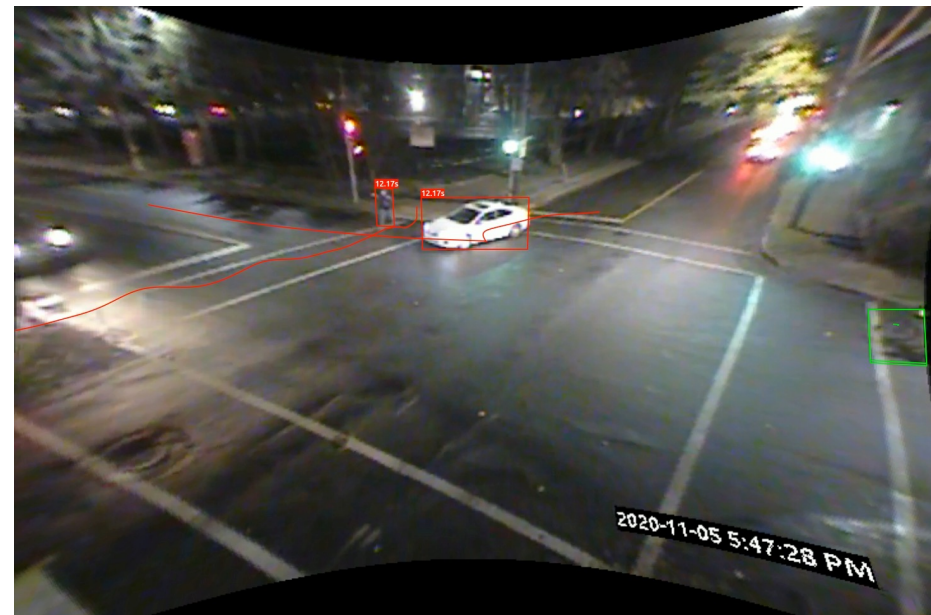
Pedestrian West Right-Hook: $T_2 = 2.9s$, vehicle speed 9 km/h

Low light conditions and low contrast sensitivity make pedestrians harder to detect by drivers.

Vegetation interferes with street light and casts shadow on crossing area at NE quadrant
