# Spring Garden Rd and South Park St

MicroTraffic Video Diagnostic Findings and Recommendations

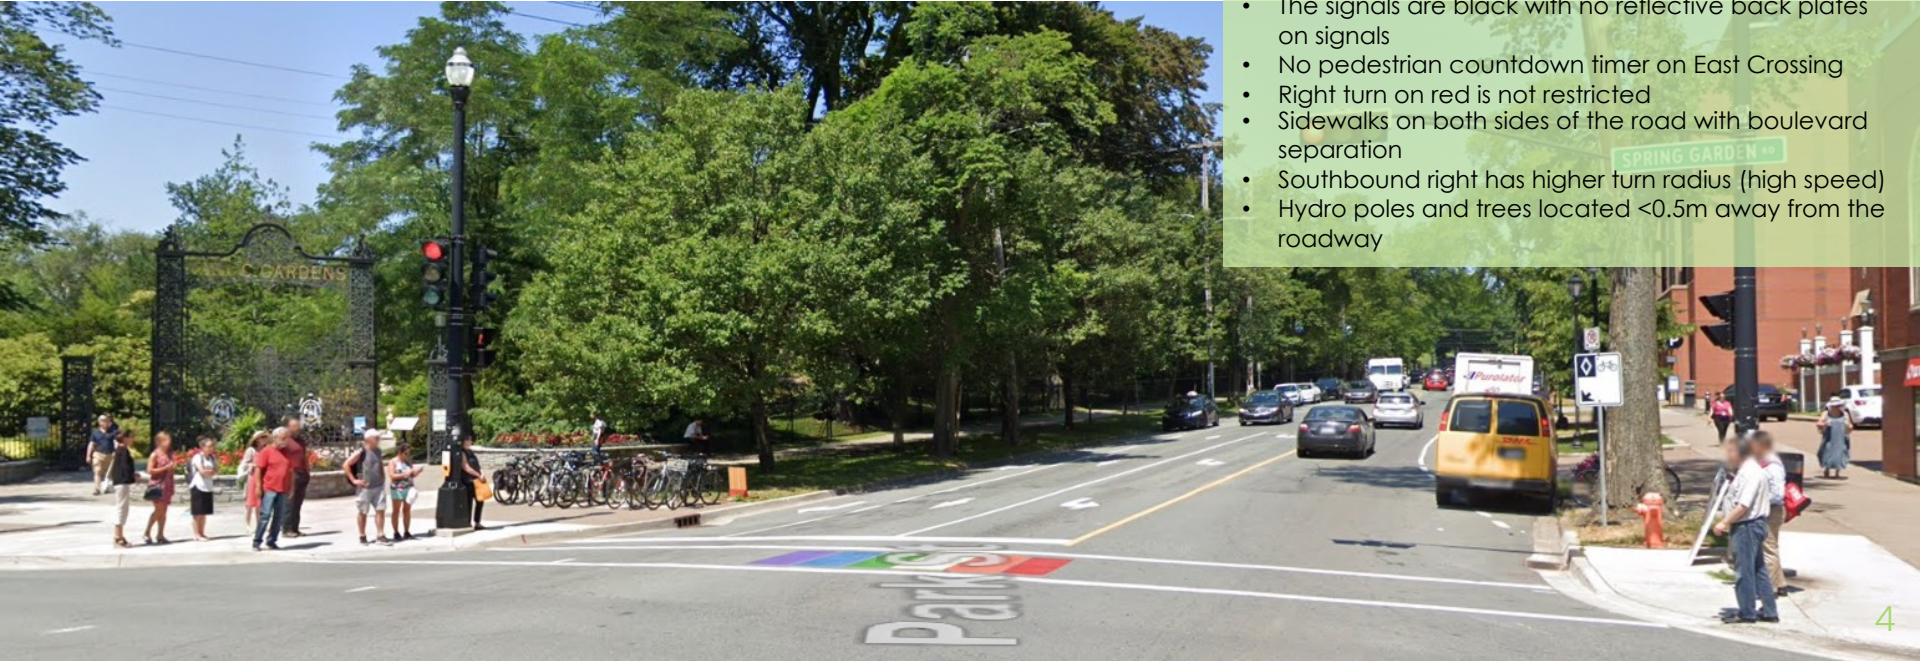
## South Park St. Looking North

### South Park St. Features:

- Cross section according to Google Street View July 2019- Northbound: One shared through lane and right turn lane and a left turn lane. Southbound: One through lane, one right turn lane and one left turn auxiliary lane
- Green painted bike lane striping and far-side left turn bike box NB/SB (not shown in Google Street View)
- 50 km/h posted speed limit (assumed)
- Northbound and southbound left turn signalization permissive-only
- Three signal heads NB and SB (one nearside each)
- Nearside transit stop NB and farside transit stop SB
- The signals are black with no reflective back plates on signals
- No pedestrian countdown timer on East Crossing
- Right turn on red is not restricted
- Sidewalks on both sides of the road with boulevard separation
- Southbound right has higher turn radius (high speed)
- Hydro poles and trees located <0.5m away from the roadway

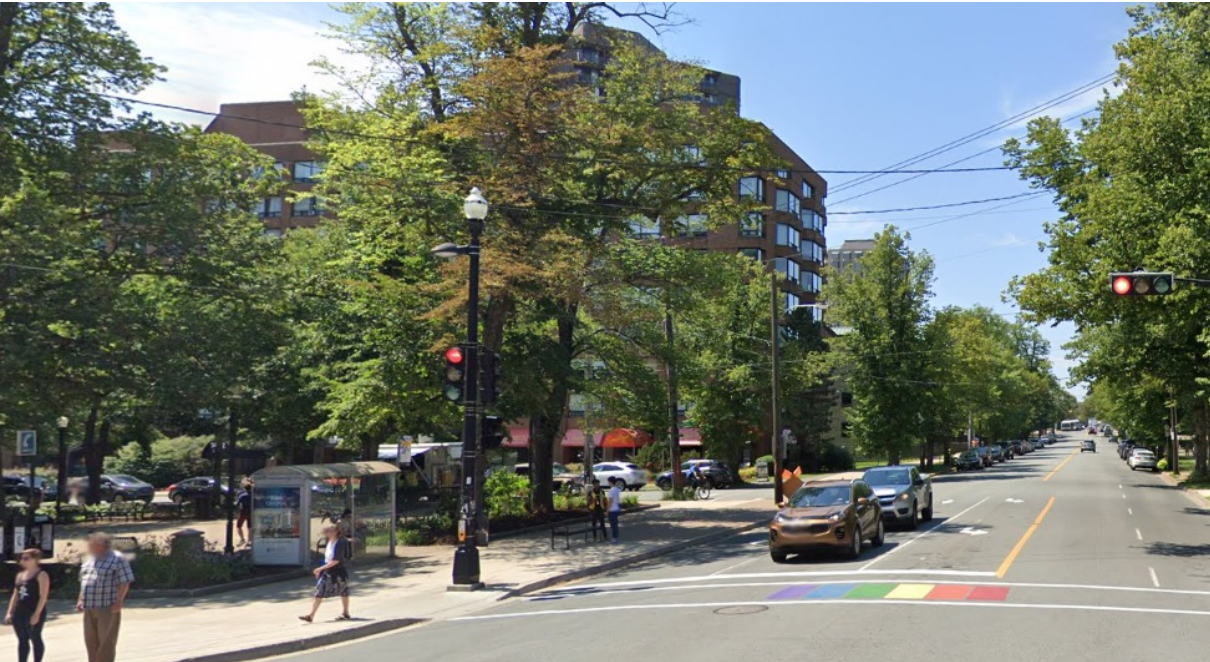
## Spring Garden Rd. Looking West

### Spring Garden Rd. Features:

- Cross section according to Google Street View July 2019- Westbound: two through lanes. Eastbound: one through lane, one left turn auxiliary lane and one right turn lane
- 50 km/h posted speed limit
- Eastbound and westbound left turn signalization permissive-only
- Three signal heads EB and WB (one nearside each direction)
- Nearside transit stop EB and WB
- The signals are black with no reflective back plates on signals
- Pedestrian countdown timers on north and south crossings
- Right turn on red is not restricted
- Sidewalks on both sides of the road
- Hydro poles and trees located <0.5m away from the roadway

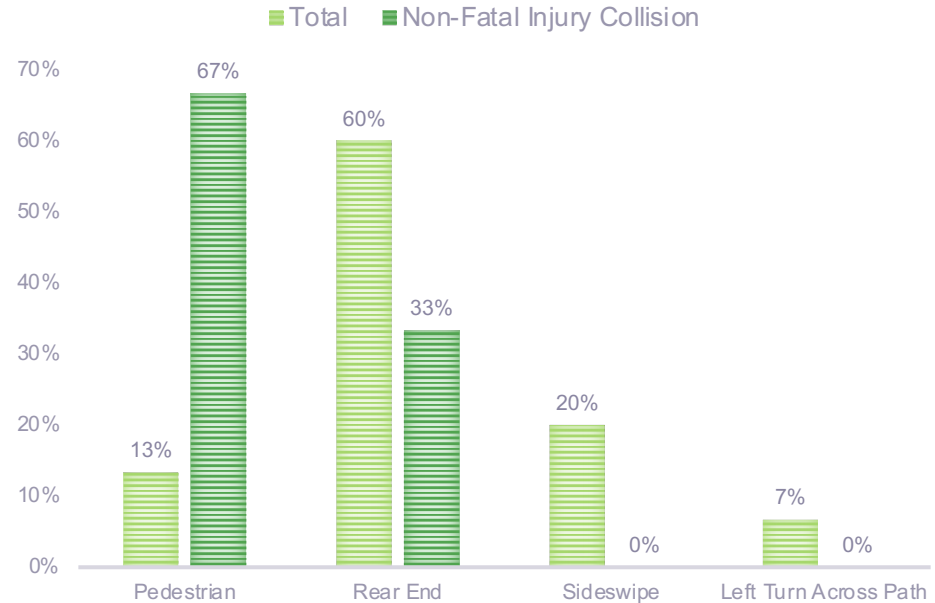
## CONFIGURATION DISTRIBUTION OF COLLISIONS

- The provided collision data included 15 collision records January 1, 2018 to April 12, 2021. Of the 15 records, 3 (20%) were classified as non-fatal injury collisions and 12 (80%) as property damage only collisions.
- The collisions were classified into the general descriptions shown in the adjacent figure based on the initial impact type and provided directional information.

The collision data revealed the following key points:

- Pedestrian collisions represent 67% (2 events) of the non-fatal injury collisions. The pedestrian collisions involved a westbound-right vehicle and a southbound-left vehicle.
- Rear End collisions represent 60% of total collisions and 33% of the non-fatal injury collisions. Of the known directions, the distribution was equally split between the North/South and East/West directions.

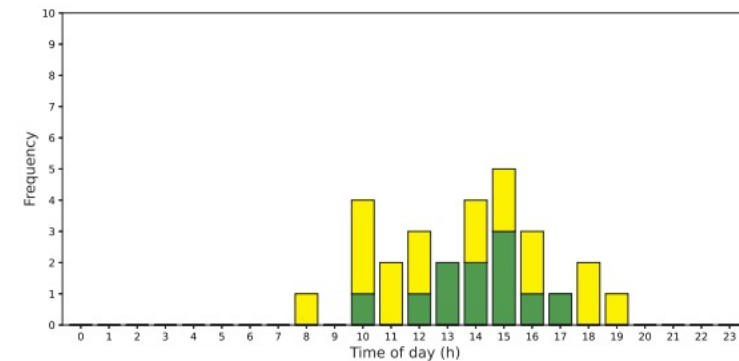
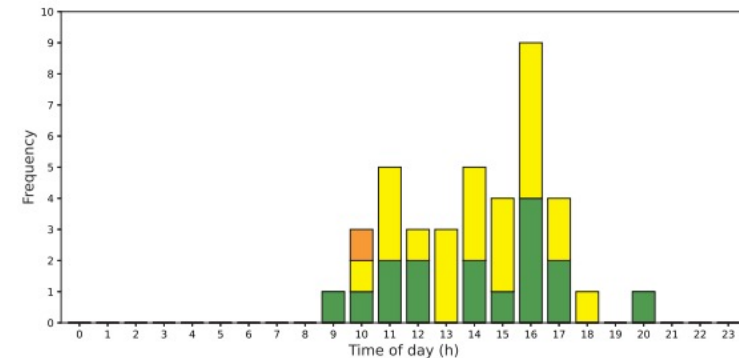
- Through vehicle vs through vehicle and left-turning vehicle vs through vehicle from left configurations were measured, but no conflicts were detected during the 47-hour analysis period. These conflict types require a signal violation, which are typically infrequent events (or they occur at low speeds at the end of a signal phase).
- Several left turn across path conflicts were detected during the 47-hour analysis period, as follows:
  - 39 North-Left vs South-Through conflicts
  - 28 South-Left vs North-Through conflicts
  - 18 East-Left vs West-Through conflicts
  - 11 West-Left vs East-Through conflicts
- Only one of the left turn across path conflicts was high risk, but left turn conflicts and VRU conflicts are happening together (see subsequent videos).
- The signalization is permissive-only for all left turn movements

South-left vs North-through (above) and North-left vs South-through (below) data shows that left turn across path conflicts are spread throughout the day with a higher frequency of detected conflicts at peak PM periods.

The only high-risk vehicle-vehicle conflict was detected for NBL vs SBT with a through vehicle impact speed of approximately 55 km/h. At these impact speeds there is a 50% chance of severe injury (MAIS 3+) to the opposing turning driver.

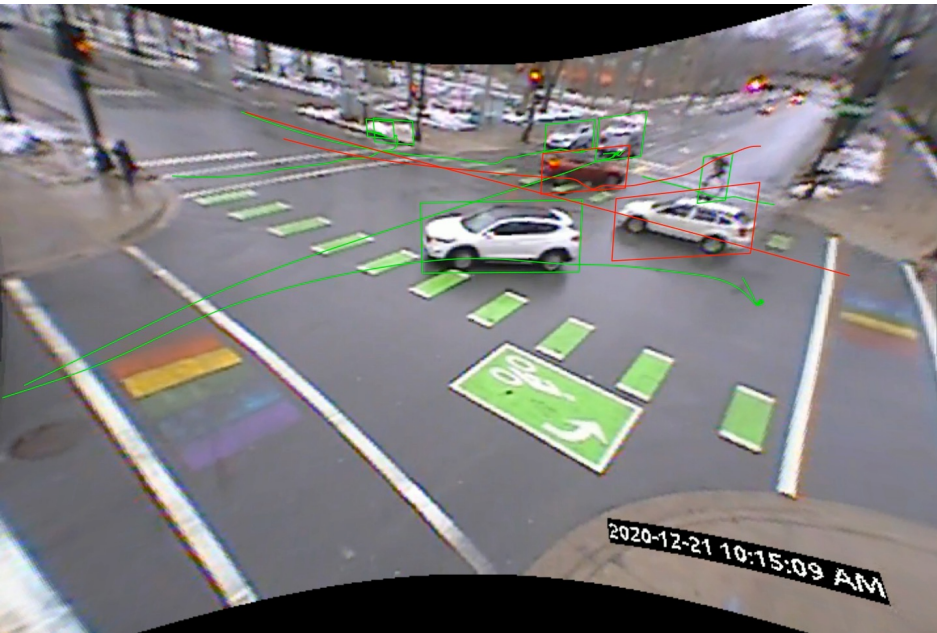
North-left vs South-through: PET = 2.3s, vehicle speed = 53km/h

The left turning driver did not notice the crossing pedestrian until they initiated their permissive left turn movement. As they yielded to the right-of-way pedestrian, they were placed in conflict with an oncoming through vehicle.

Key Issue	Recommendation
<p><b>Pedestrian Safety:</b></p> <ul style="list-style-type: none"><li>• There is a very high volume of pedestrians crossing the intersection due to its proximity to several points of interest (Halifax Citadel, public gardens, commercial establishments along Spring Garden, etc.).</li><li>• 2 pedestrian collisions were recorded in the collision data, involving a westbound-right vehicle and a southbound-left vehicle</li><li>• Nearly 40 conflicts were detected for pedestrians, generally including turning vehicles.</li><li>• Southbound right has a fairly high turn radius, allowing vehicles to complete their turns at higher speeds.</li><li>• There are several uncontrolled pedestrian crosswalks and midblock crossing desire lines along Spring Garden, east of the intersection.</li><li>• Considering the above, general improvements to pedestrian safety and visibility would be valuable at this location.</li></ul>	<p>Include ped countdowns all 4 crossings if not yet done.</p> <p>Add LPIs to any crosswalks that do not have them (from Google, it appears that the north crosswalk has an LPI).</p> <p>Restrict RTOR</p> <p>Reduce operating speed to 30 to 40 km/h due to multimodal nature of corridor.</p> <p>Provide centerline median hardening using vertical delineator posts to calm through and left turn speeds.</p> <p>Consider low cost curb extensions using vertical delineator posts that further reduce right turn radius.</p> <p>Consider left turn prohibitions or protected only left turns in areas like this with high pedestrian activity.</p>

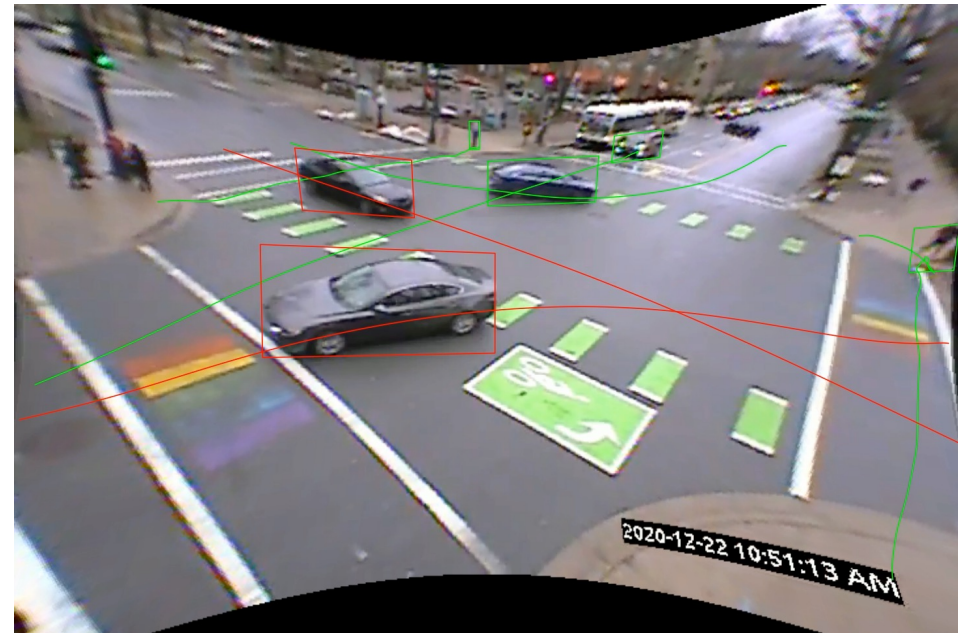
South-left vs North-through: PET = 1.9s, vehicle speed = 44km/h

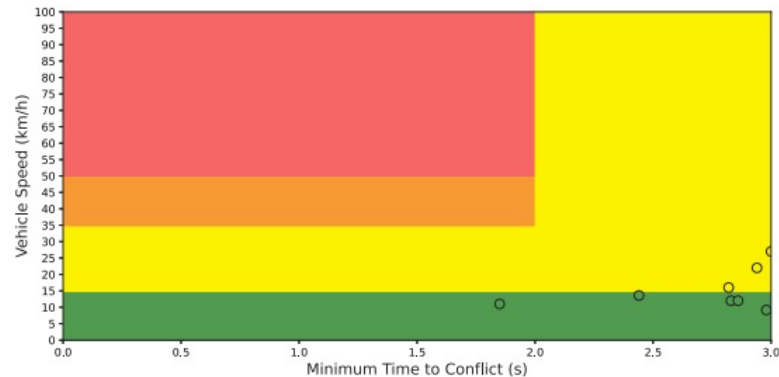
- Near-side VRU conflicts were not measured due to camera placement and limited approach view.
- *North crossing conflicts (north far-side, west-right and east-left) were not measured due to lens distortion at the edge of the camera.*
- 1 cyclist conflict was detected during the 47-hour analysis period for a north-left hook. The video collection occurred in December and the 24-hour cyclist counts indicate a low volume of cyclists crossing the intersection.
- Several pedestrian conflicts were detected during the 47-hour analysis period, as follows:
  - 8 North-Left Hook conflicts
  - 13 North-Right Hook conflicts
  - 11 East-Right Hook conflicts
  - 3 South-Left Hook conflicts
  - 1 South-through Far side conflict
  - 3 West-left Hook conflicts

Pedestrian North-Left Hook conflict data show conflicts occurring with through vehicle speeds of nearly 30km/h.

At impact speeds of 30 km/h, pedestrians have a 25% chance of a severe injury (MAIS 3+).

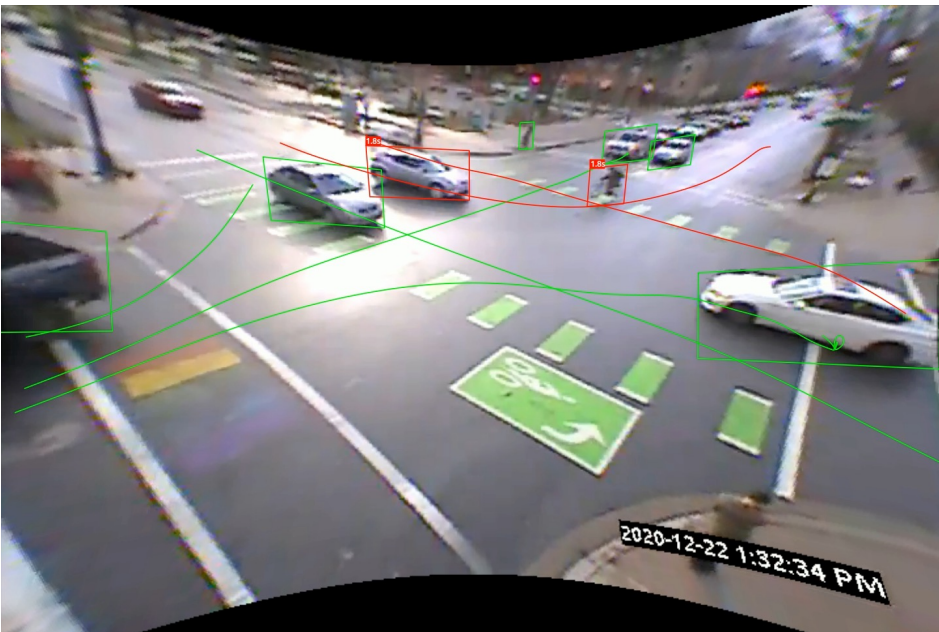
Cyclist North-Left Hook:  $T_2 = 1.8s$ , vehicle speed = 17 km/h

Cyclists on the painted bike lane can travel at higher speeds (cyclist speed = 17 km/h). Additionally, there is less lateral offset between the bike lane and turning vehicles, placing cyclists at higher risk of conflict. In this event, the driver was aware of approaching cyclist and waited prior to initiating their left turn. The green pavement markings increase driver awareness of cyclists in the intersection.

Key Issue	Recommendation
<p><b>Cyclist Safety:</b></p> <ul style="list-style-type: none"><li>• 1 conflict with a cyclist was detected, involving a north-left vehicle. The December cyclist volumes were low and may not be indicative of typical volumes at the intersection.</li><li>• The green painted pavement markings and bike boxes improve the visibility of cyclists crossing the intersection.</li><li>• However, the bike lane is placed adjacent to vehicle turn lanes with no lateral or physical separation between vehicles driving at a 50 km/h posted speed limit (cyclists impacted by a vehicle at this speed have a &gt;80% chance of severe injury). Several conflict clips with pedestrians showed vehicles initiating their turns prior to recognizing a present VRU. These vehicles typically encroached on the bike lane before yielding.</li><li>• Safety improvements to slow turning vehicles and further improve cyclist visibility would be valuable if this intersection is more utilized by cyclists in the warmer months.</li></ul>	<p>Suggestions for pedestrians are also applicable to mitigate cyclist risks.</p> <p>The issue of permissive left turn vehicles pausing in the bike lane to yield to pedestrians after clearing opposing vehicular travel lanes can only be solved by left turn prohibition, protected only left turns, or further increasing the crosswalk setback (and we would not recommend the latter).</p>

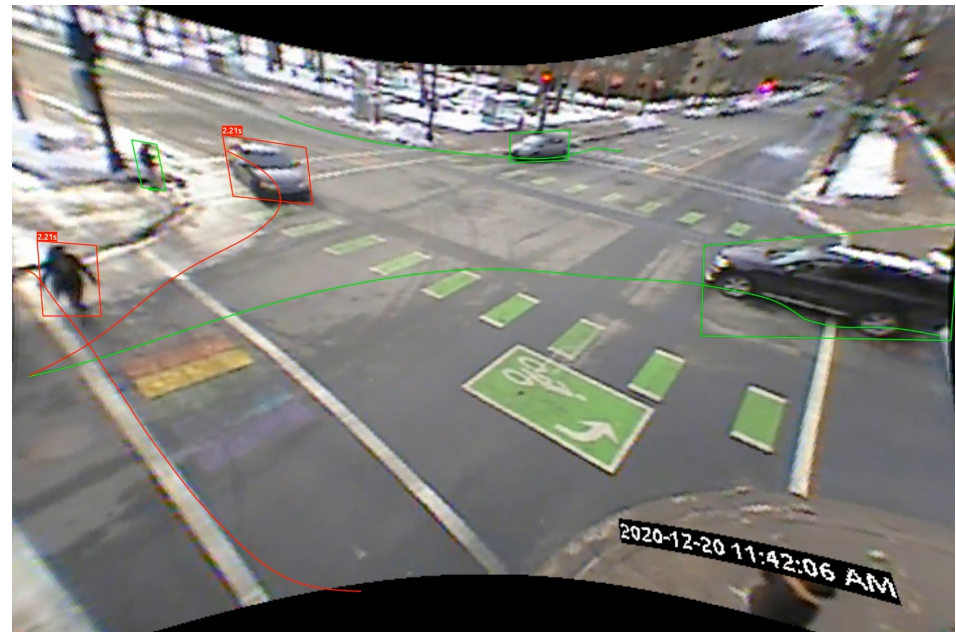
Pedestrian North-Right Hook:  $T_2 = 2.2s$ , vehicle speed = 19 km/h

The right turning driver approached the intersection and initiated their turn at a higher speed; however, the lateral offset between vehicle travel lanes and the crosswalk provided sufficient space for the vehicle to observe the pedestrian, slow down and yield.

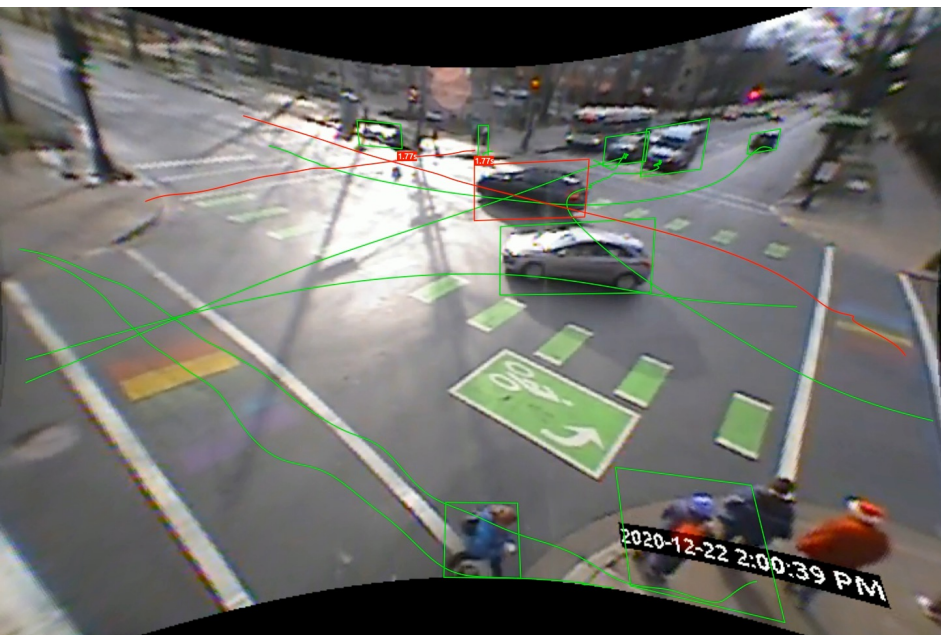
Pedestrian South-through Far-side:  $T_2 = 1.6s$ , vehicle speed = 27km/h

The pedestrian violated the signal and came in close conflict with higher speed southbound vehicle. If the driver had not been attentive, this could have been a severe collision.

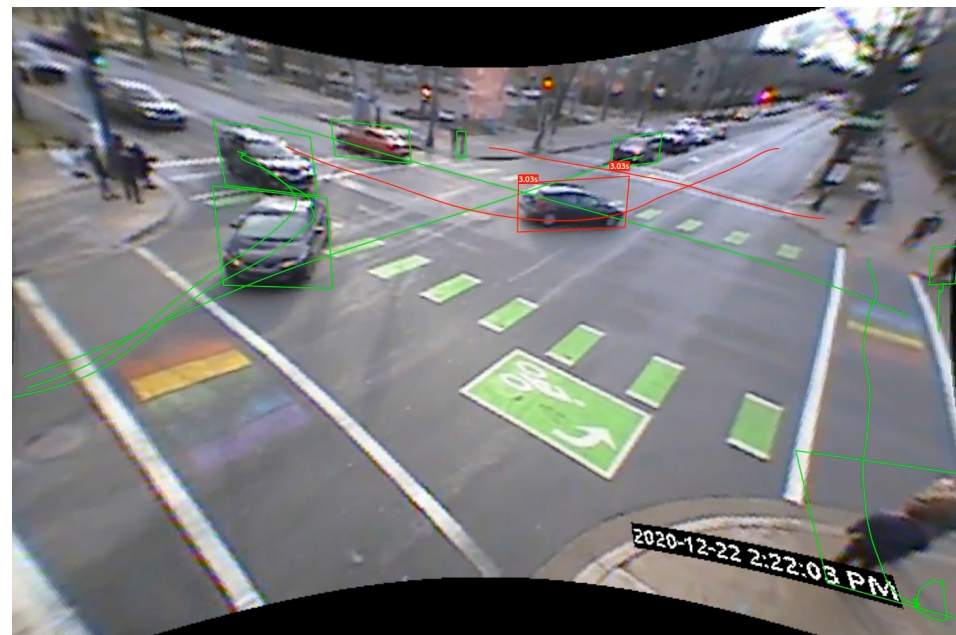
Pedestrian North-Left Hook:  $T_2 = 1.9s$ , vehicle speed = 11km/h

The left turning driver did not notice the crossing pedestrian until they initiated their permissive left turn movement. The lateral offset between travel lanes and the crosswalk provided sufficient space for the vehicle to slow and yield to the pedestrian, otherwise this may have been a higher risk event.
