Dunbrack St and Lacewood Dr

MicroTraffic Video Diagnostic Findings and Recommendations

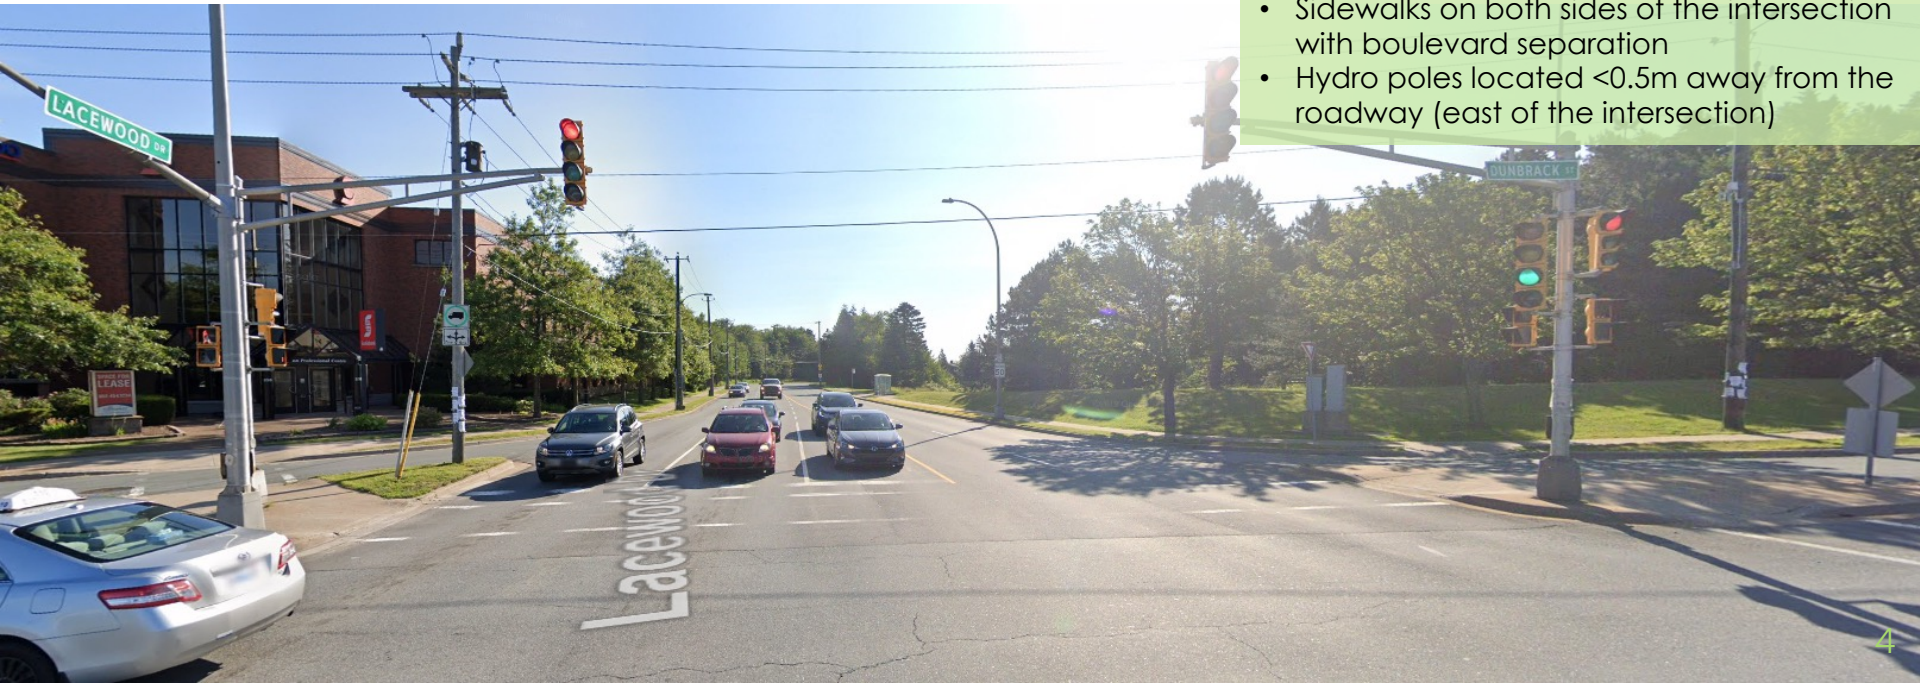
Lacewood Dr. Looking East

Lacewood Dr Features:

- Two through lanes and a left turn auxiliary lane
- Right turn channelization islands
- 50 km/h posted speed limit
- Four signal heads EB (one nearside) and five signal heads WB (one nearside)
- Left turn signalization: EBL protected/ permissive and WBL permissive only
- No reflective back plates on signals
- Sidewalks on both sides of the intersection with boulevard separation
- Hydro poles located <0.5m away from the roadway (east of the intersection)

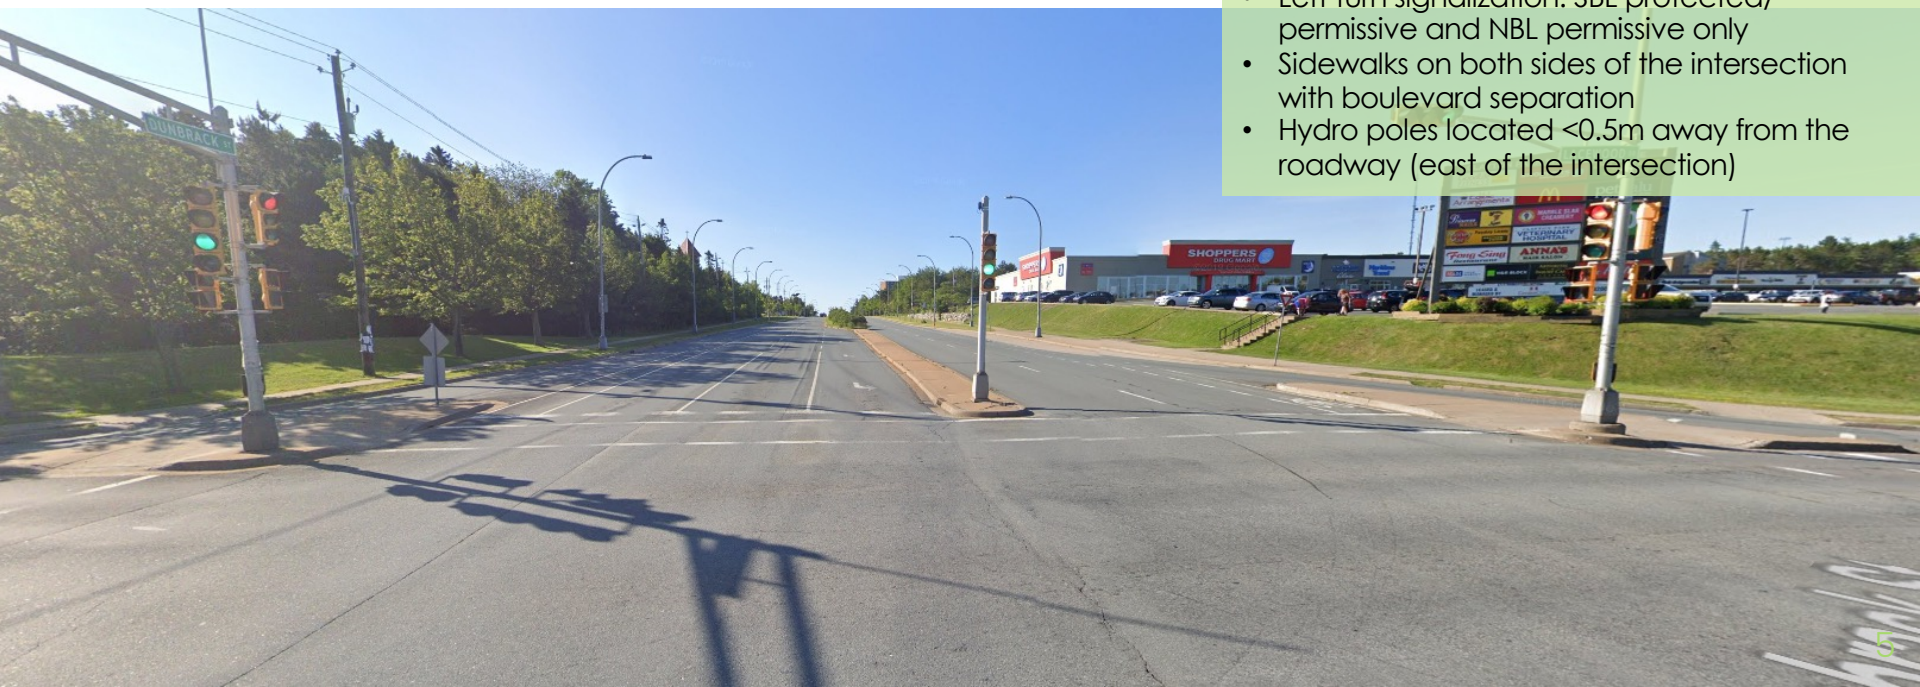
Dunbrack St. Looking South

Dunbrack St Features:

- Two through lanes, a left turn auxiliary lane and a right turn auxiliary lane
- Painted bike lane (<1.5m wide) with dashed mixing zone adjacent to the travel lane.
- Right turn channelization islands
- 60 km/h posted speed limit
- Three signal heads SB and three signal heads NB (one nearside)
- No reflective back plates on signals
- Left turn signalization: SBL protected/ permissive and NBL permissive only
- Sidewalks on both sides of the intersection with boulevard separation
- Hydro poles located <0.5m away from the roadway (east of the intersection)

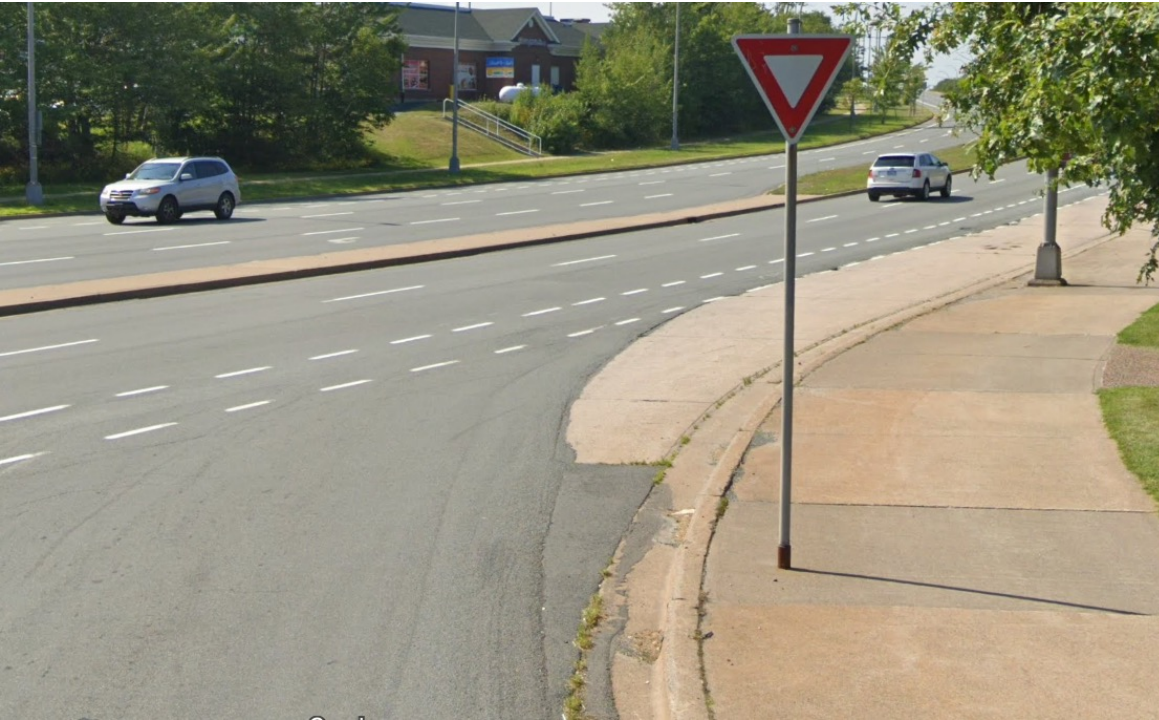
Eastbound-Right and Westbound-Right have approximately 50m of an acceleration lane available for merging; however, differences in road surface type/colour may lead to poorly utilized use of the lane.

The yield sign may also contribute to driver lane use confusion, although it is recognized that the available acceleration length may be insufficient in Nova Scotia for it to be considered a merge condition.

The lane extension also presents a longer mixing zone for cyclists using the painted bike lane.

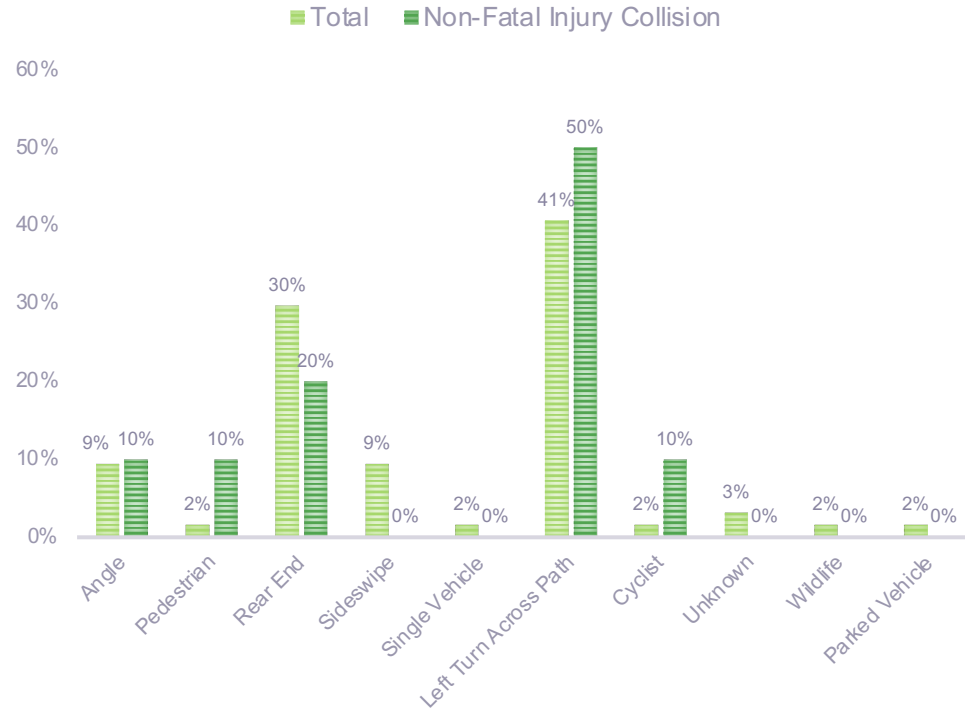
CONFIGURATION DISTRIBUTION OF COLLISIONS

- The provided collision data included 64 collision records from January 1, 2018 to April 12, 2021. Of the 64 records, 16% were classified as non-fatal injury collisions and 84% as property damage only collisions.
- The collisions were classified into the general descriptions shown in the adjacent figure based on the initial impact type and provided directional information.

The collision data revealed the following key points:

- Pedestrian and cyclist collisions represent 20% of the non-fatal injury collisions (1 pedestrian and 1 cyclist event). The pedestrian collision occurred at the access to the Sobey's parking lot (NW quadrant) and not directly at the intersection. The cyclist collision involved a northbound-left vehicle. *It is possible for NBL drivers to not see SB cyclists past vehicles in the SB through lanes, and also possible for NBL vehicle drivers to underestimate the speed of SB cyclists on a downgrade.*

- Left turn across path collisions represent 41% of total collisions and 50% of the non-fatal injury collisions. Of the known directions, the distribution was 28%, 24%, 20% and 28% for Eastbound-left, Westbound-left, Southbound-left and Northbound-left respectively.

- Angle collisions represent 9% of total collisions and 10% of the non-fatal injury collisions. 83% of the angle collisions (5 events) involved an eastbound vehicle running a red light; the remaining events (1) involved a westbound vehicle running the red light.

- Rear End collisions represent 30% of total collisions and 20% of the non-fatal injury collisions. Of the known directions, the distribution was 13%, 33%, 40% and 13% for Eastbound, Westbound, Southbound and Northbound respectively. The southbound concentration corresponds with SB downgrade.

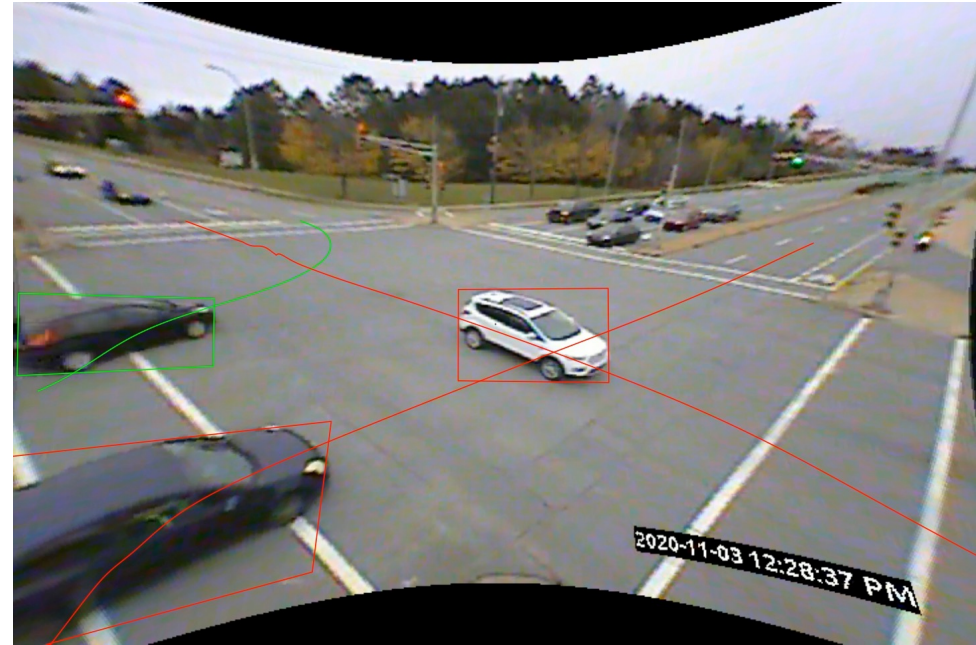
- 5 through vs through conflicts were detected during the 51-hour analysis period (west-through vs south-through).
- These conflict types require a signal violation, which are typically infrequent events.
- No other right-angle conflict configurations were detected during the 51-hour observation period.
- SB vehicles on downgrade: review clearance, conspicuity, friction.
- Video shown: SBT blocked by NBL at end of phase (NBL permissive only)

South-through vs East-through: PET = 1.8s, vehicle speed 25 km/h

Key Issue	Recommendation
<p>Angle/ Through vs Through vehicle events:</p> <ul style="list-style-type: none">• 9% of collisions were for angle collisions. The majority involved EB vehicles running a red-light.• 5 conflict events were detected in the 51-hour analysis period for south-through vs west-through vehicles. Typically these occurred at a phase change at low vehicle speeds.• Signal perception improvements would be valuable, especially in the EB/WB directions when sun glare may contribute to signal perception failure.	<p>Add reflective backplates to all signals.</p> <p>If any signal heads have lenses < 300mm consider upgrading to 300mm.</p> <p>Review all red clearance times; ensure technical guidance is followed at a minimum. Especially consider the end of SB phase for potential lengthening.</p> <p>Install signal ahead warning signs on SB approach about 200 m upstream of intersection.</p>

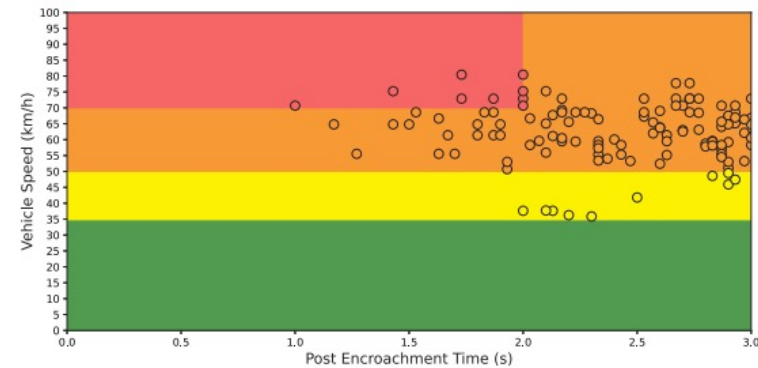
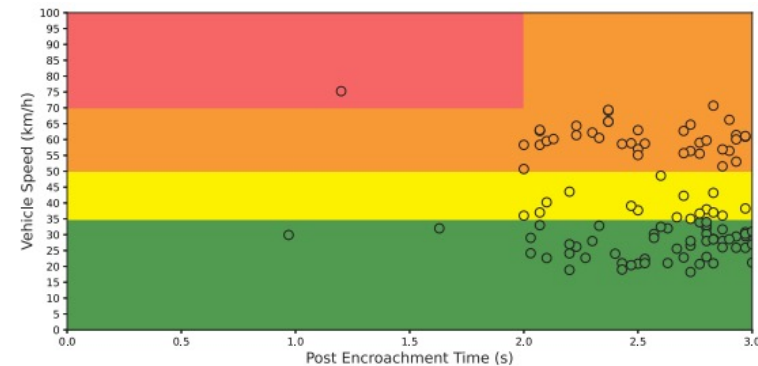
- Several left turn across path conflicts were detected during the 51-hour analysis period, as follows:
 - 122 North-Left vs South-Through conflicts
 - 109 South-Left vs North-Through conflicts
 - 156 East-Left vs West-Through conflicts
 - 71 West-Left vs East-Through conflicts
- The signalization is protected/permissive for SBL and WBL and permissive only for NBL and WBL turn movements.
- 103 High-Risk and 9 Critical-Risk events were detected for North-left vs South-through. When comparing the conflict rate of NBL vs SBT events to benchmark values for similar sites across North America, NBL drivers at Dunbrack and Lacewood are 1.7x more likely to be involved in a high-risk conflict event.

North-left vs South-through (above) and South-Left vs North-through (below) conflict data shows several conflicts occurring with through vehicle speeds exceeding the 60 km/h posted speed limit (up to 80 km/h).

At impact speeds above 60 km/h, opposing drivers have a >65% chance of a severe injury (MAIS 3+), which increases to >95% at 80 km/h.

Key Issue	Recommendation
<p>Left Turn Across Path (LTAP):</p> <ul style="list-style-type: none">• LTAP collisions make up nearly 41% of all collisions• 458 LTAP conflicts were detected during the 51-hour analysis period. A high number of conflict events were detected for both the permissive only phasing (NBL and WBL) and the protected-permissive phasing (SBL and EBL).	<p>Protected only phasing for all left turns</p>
<p>Pedestrian Safety:</p> <ul style="list-style-type: none">• No pedestrian collisions were reported directly at the intersection; however, several left hook conflicts were detected during the 51-hour analysis period.• More than 550 pedestrians were recorded crossing the intersection in the 24-hour counts indicating there is a higher risk exposure for pedestrians.• Pedestrian visibility enhancements may help remove latent pedestrian safety risk at the intersection.• Although right turn channels were not covered by video, we note that they are designed for high speed right turns which is a risk factor for pedestrians.	<p>Protected only phasing for all left turns.</p> <p>Check illumination vs TAC 2006 Guide. We did not do a lighting analysis but it seems that orientation of luminaires with respect to the crosswalks could be improved.</p> <p>Crosswalk striping with durable zebra markings.</p> <p>Extension of east median bullnose could calm EBL and NBL speeds.</p> <p>Consideration should be given to smart right channels for lower speed right turns.</p>

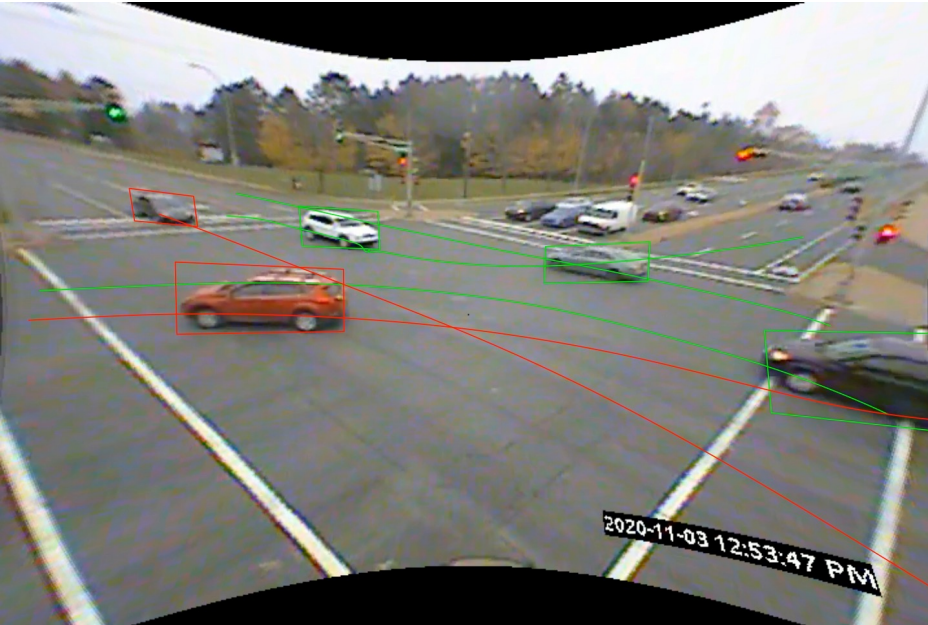
East-left vs West-through: PET = 2.1s, vehicle speed 50 km/h

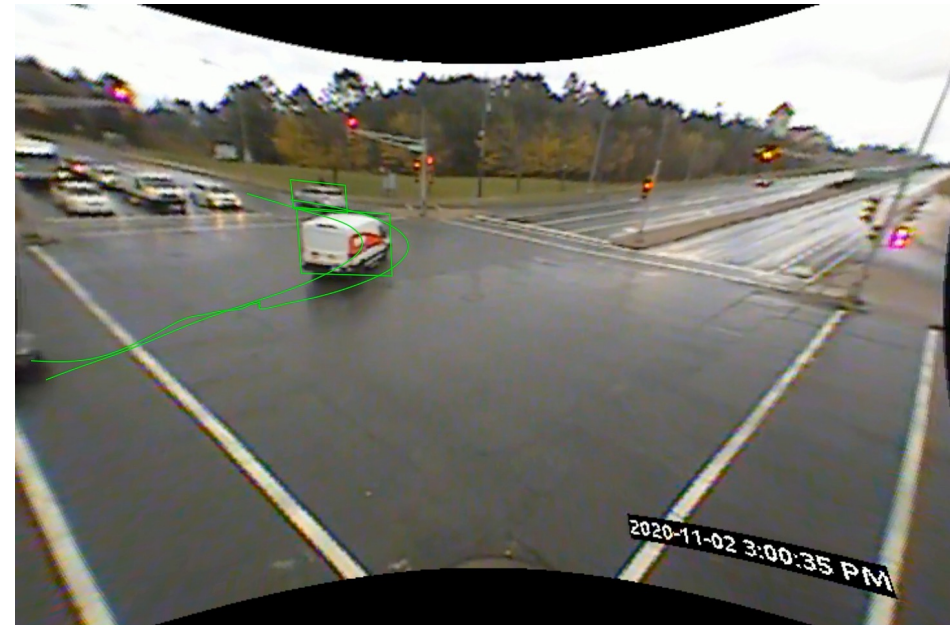
South-left vs North-through: PET = 1.2s, vehicle speed 75 km/h

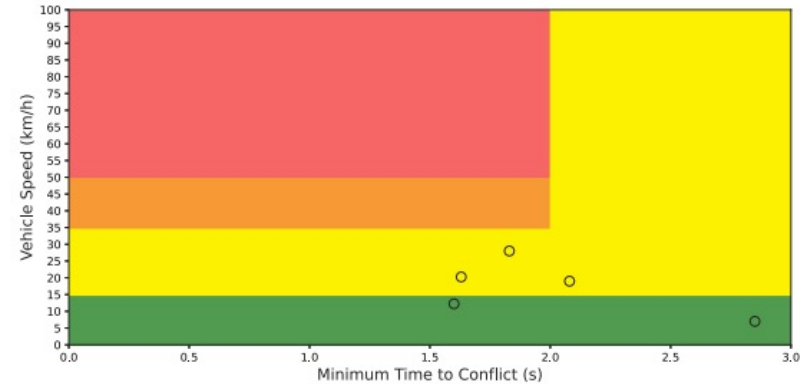
- Right hook conflicts and near-side conflicts were not measured due to camera placement and limited approach view.
- No cyclist conflicts were detected during the 51-hour analysis period. However, the video collection occurred in Nov/Dec and the 24-hour cyclist counts indicate a low volume of cyclists crossing the intersection.
- Several pedestrian left-hook conflicts were detected during the 51-hour analysis period, as follows:
 - 1 North-Left Hook conflict
 - 5 South-Left Hook conflicts
 - 1 West-Left Hook conflict
- All of the pedestrian conflict events happened between 15:00 and 21:00. In dark conditions vulnerable road users are more difficult for drivers to detect, especially when wearing dark clothing.

Pedestrian South-Left Hook conflict data show conflicts occurring with through vehicle speeds of nearly 30km/h.
At impact speeds of 30 km/h, pedestrians have a 25% chance of a severe injury (MAIS 3+).

- On multiple occasions, the left turning driver did not notice the crossing pedestrian until they initiated their left turn movement. As vehicles yield to the right-of-way pedestrian, they become exposed to a potential conflict with oncoming through vehicles.

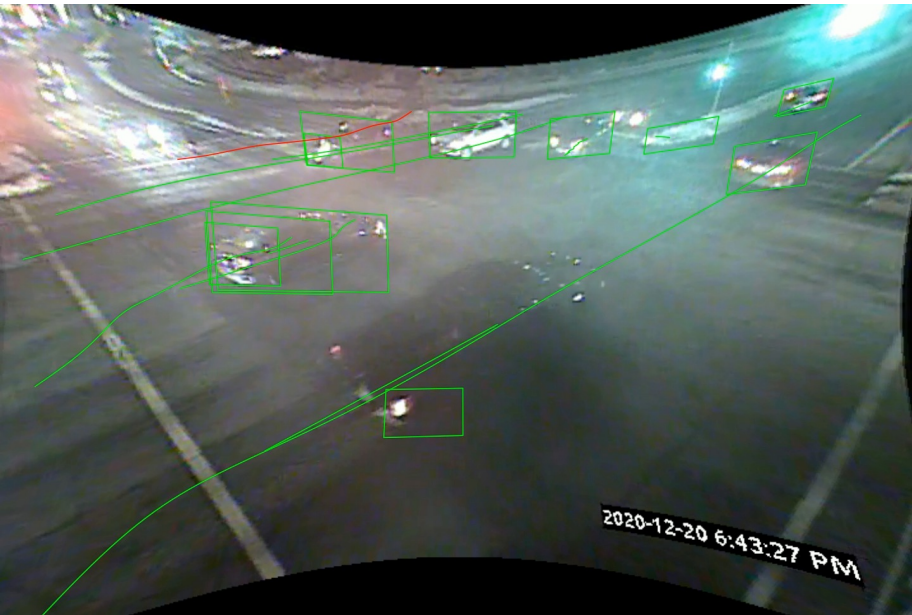
Pedestrian North Left-Hook: T2 = 2.6s, vehicle speed 14 km/h

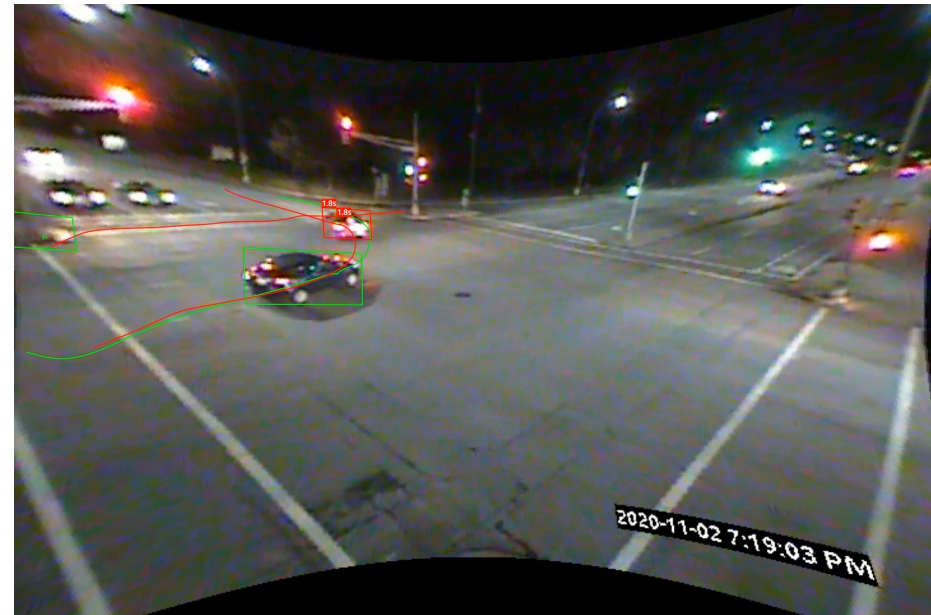
Pedestrian South Left-Hook: T2 = 1.6s, vehicle speed 20 km/h
