To:	Scott MacCallum	From:	Maureen Matthew, M.Sc., P.Geo.
	Kearney Lake Developments Limited Partnership		Stantec Consulting Ltd.
Project/File:	121624268	Date:	January 13, 2023

Reference: 209 Kearney Lake Road - Rockfall Analysis – Revision 1

Rockfall Catchment Area Analysis
209 Kearney Lake Road, Halifax, NS

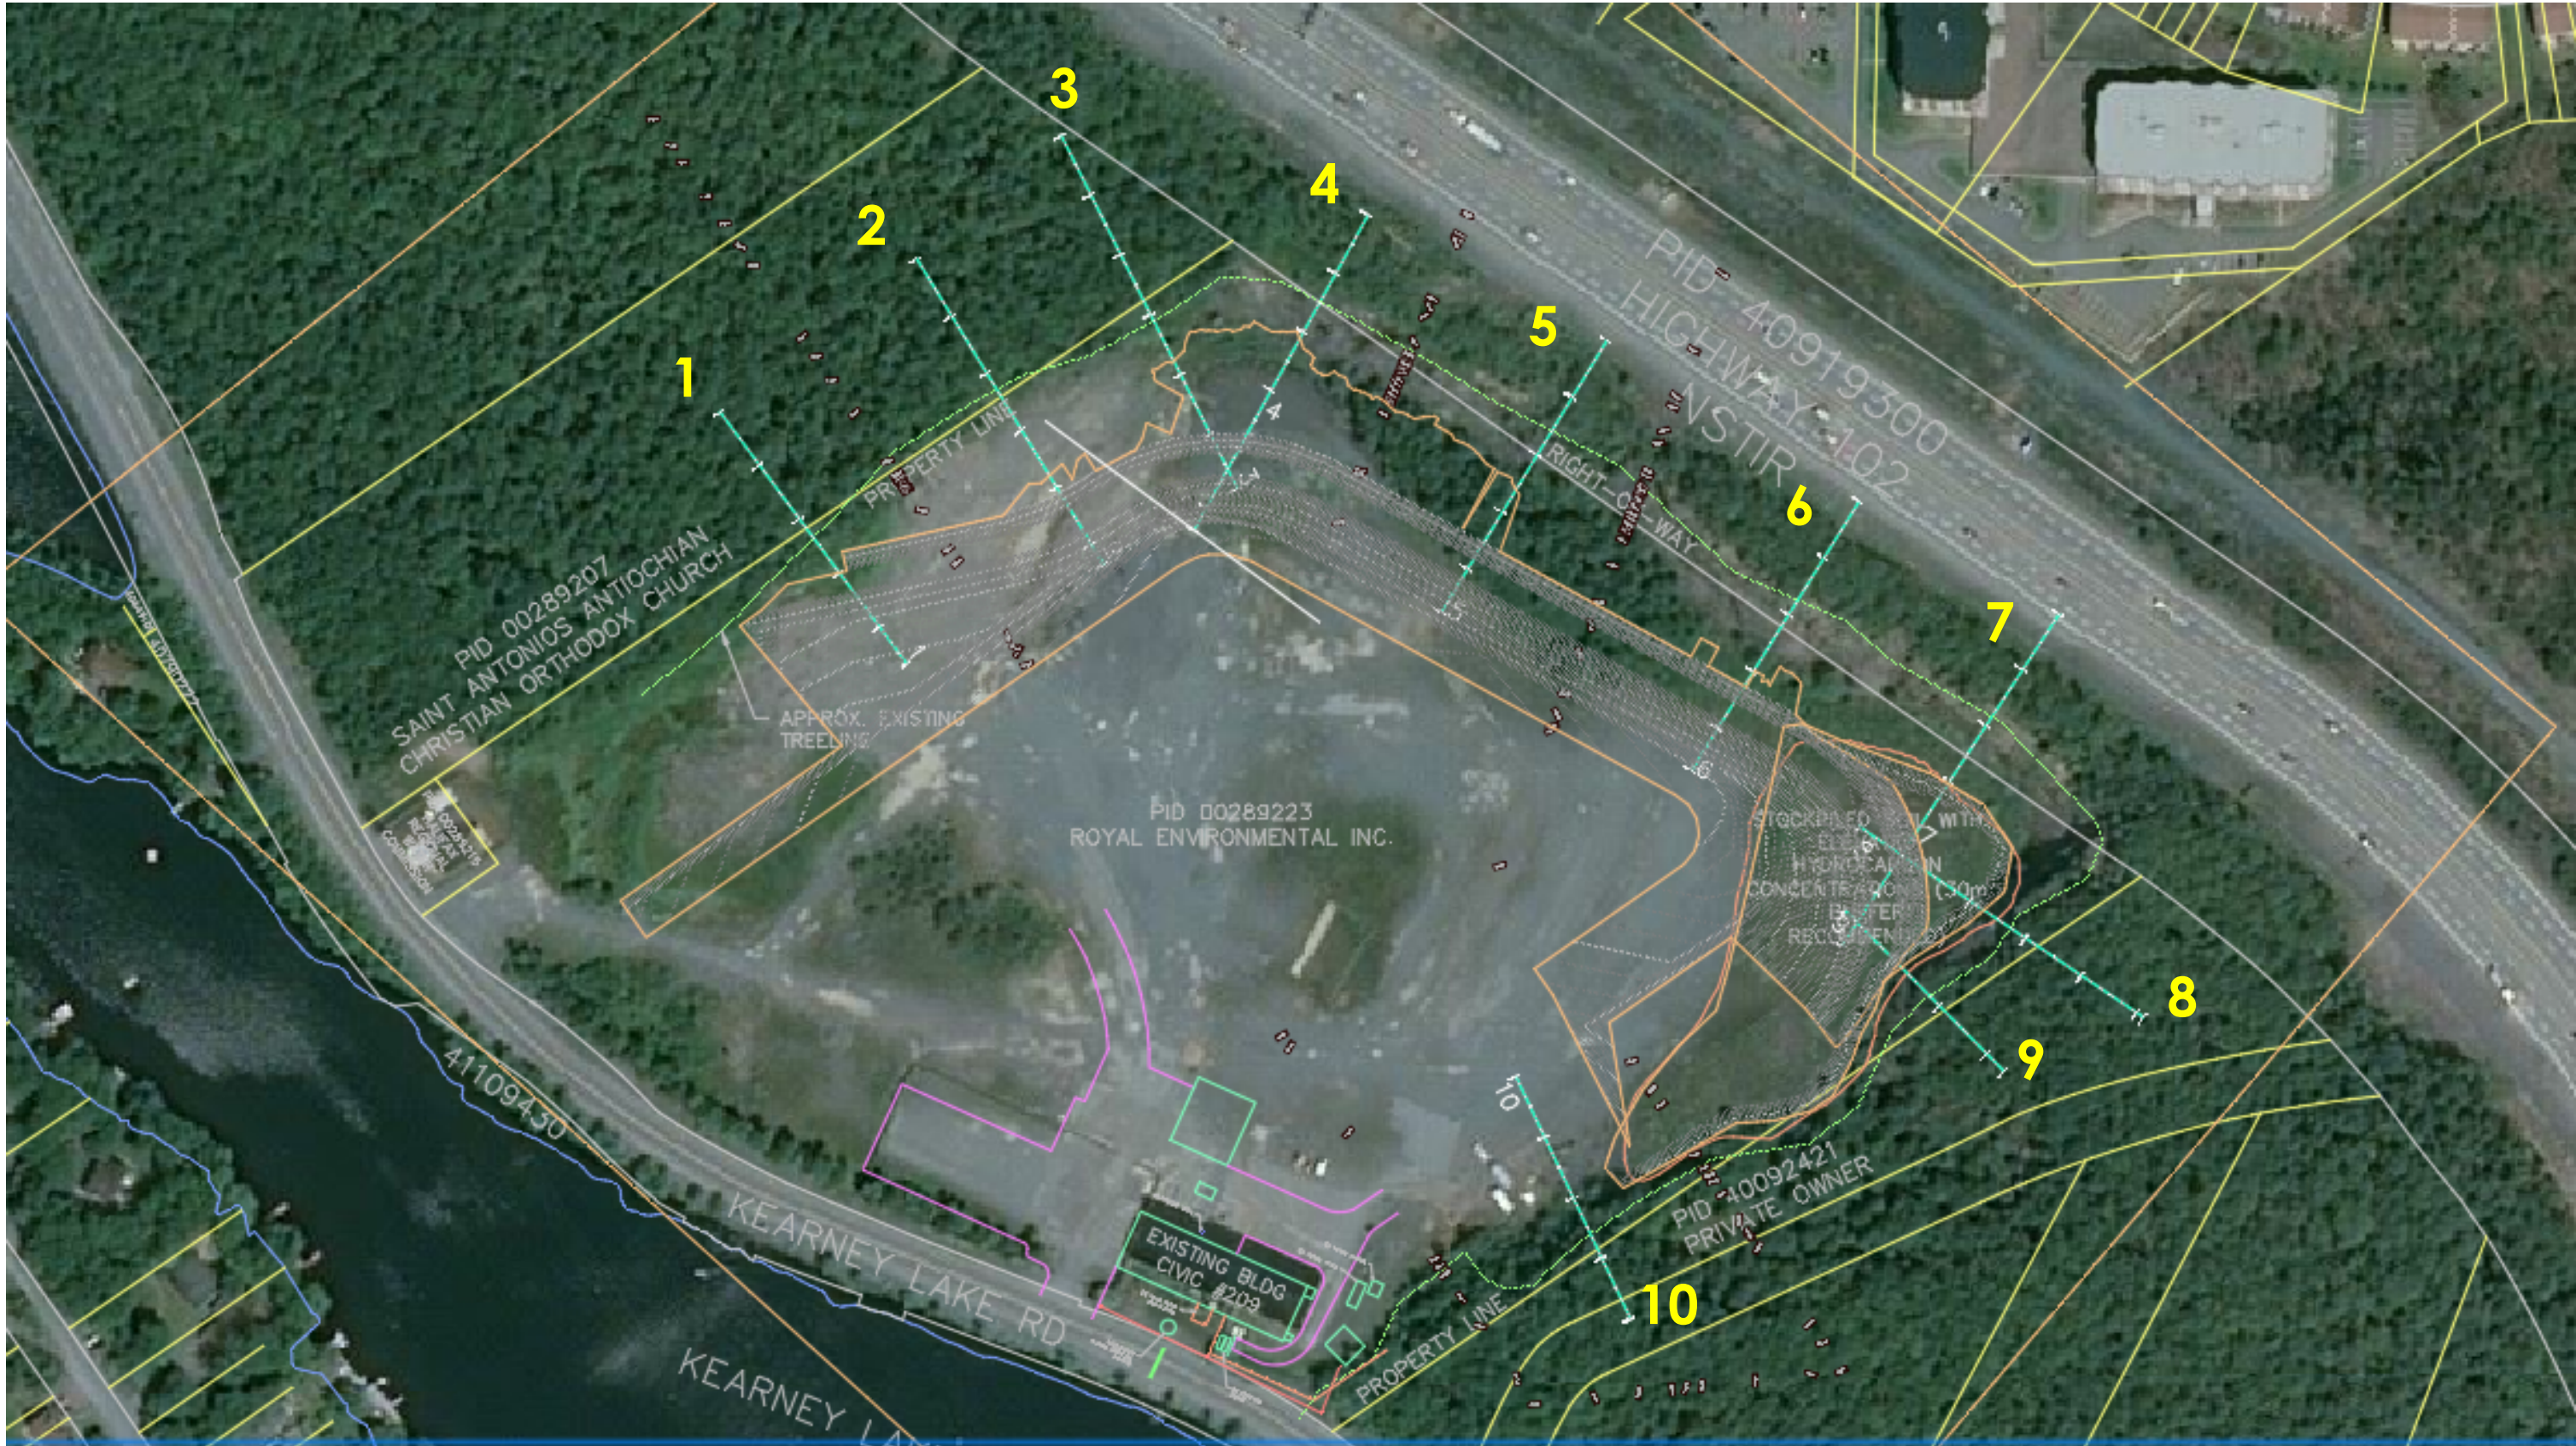
Rockfall Section Location Plan

A location plan of the cross-sections as well as the modelled results (travel paths) of each RocFall analysis are included in the attachments (Drawing 121624268-GE-01 to GE-11). The results show that in all scenarios, the modelled rockfall events are contained either within the allocated catchment zone or come to rest on the backslope (i.e., closest to the highwalls) of the proposed landscape berm that will define the “no-go” catchment area at the base of the bedrock slopes.

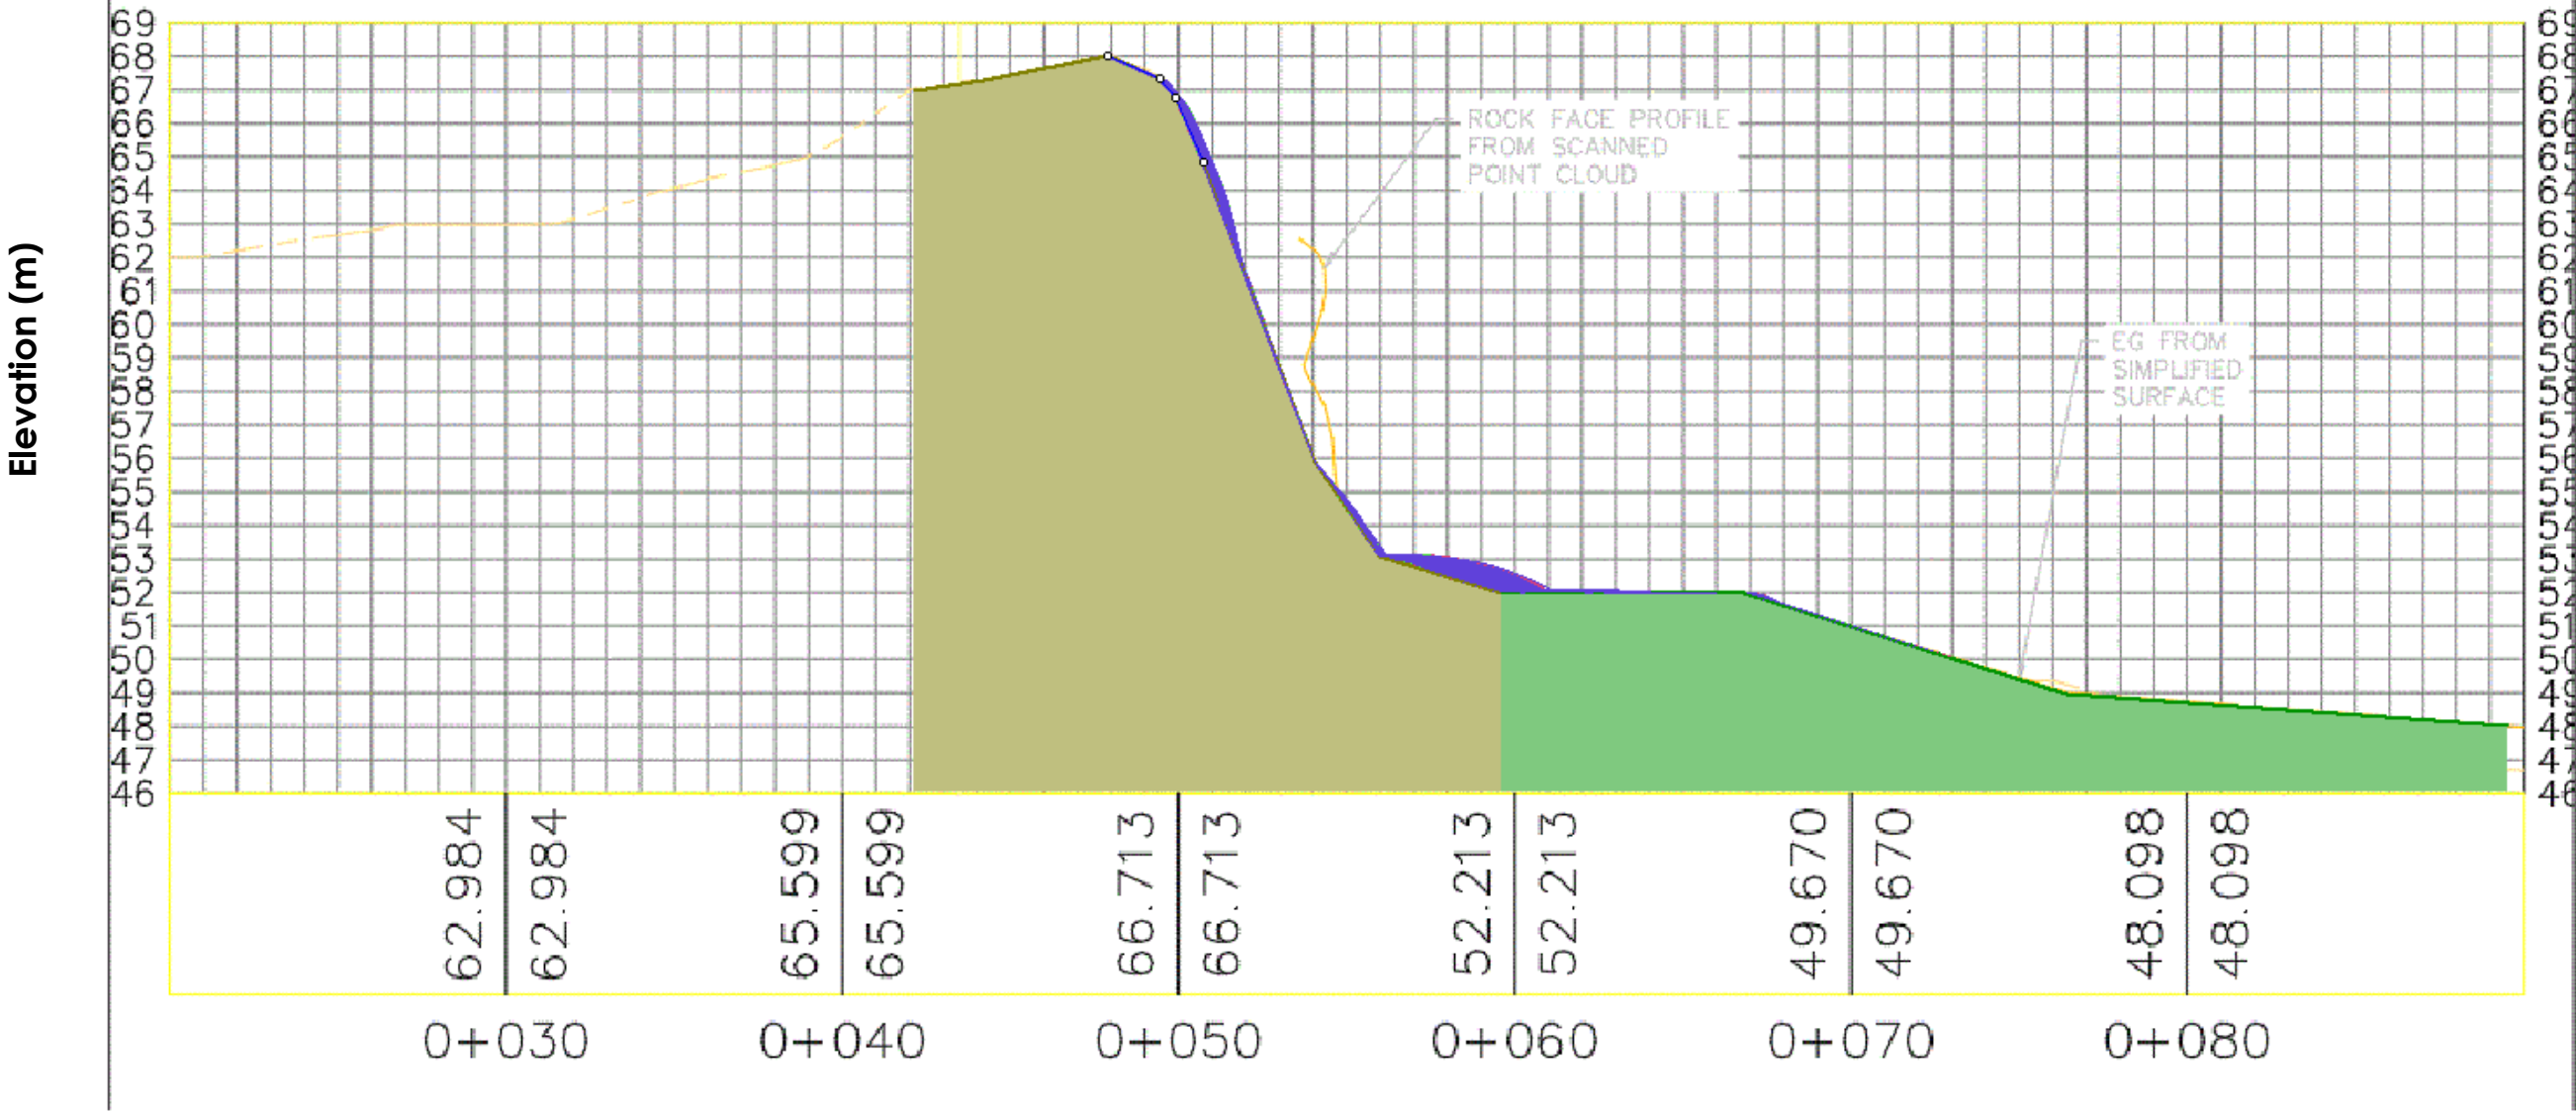
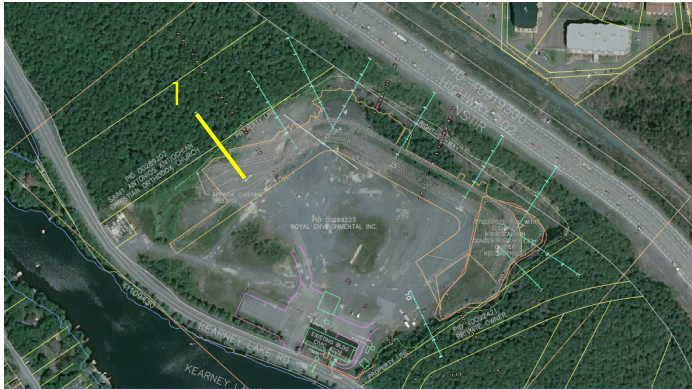
Rockfall Section 1

- Rockfall Trajectories**
- Rocks avg. 200 kg
 - Rocks avg. 500 kg
 - Rocks avg. 1,000 kg

SECTION 1 PROFILE

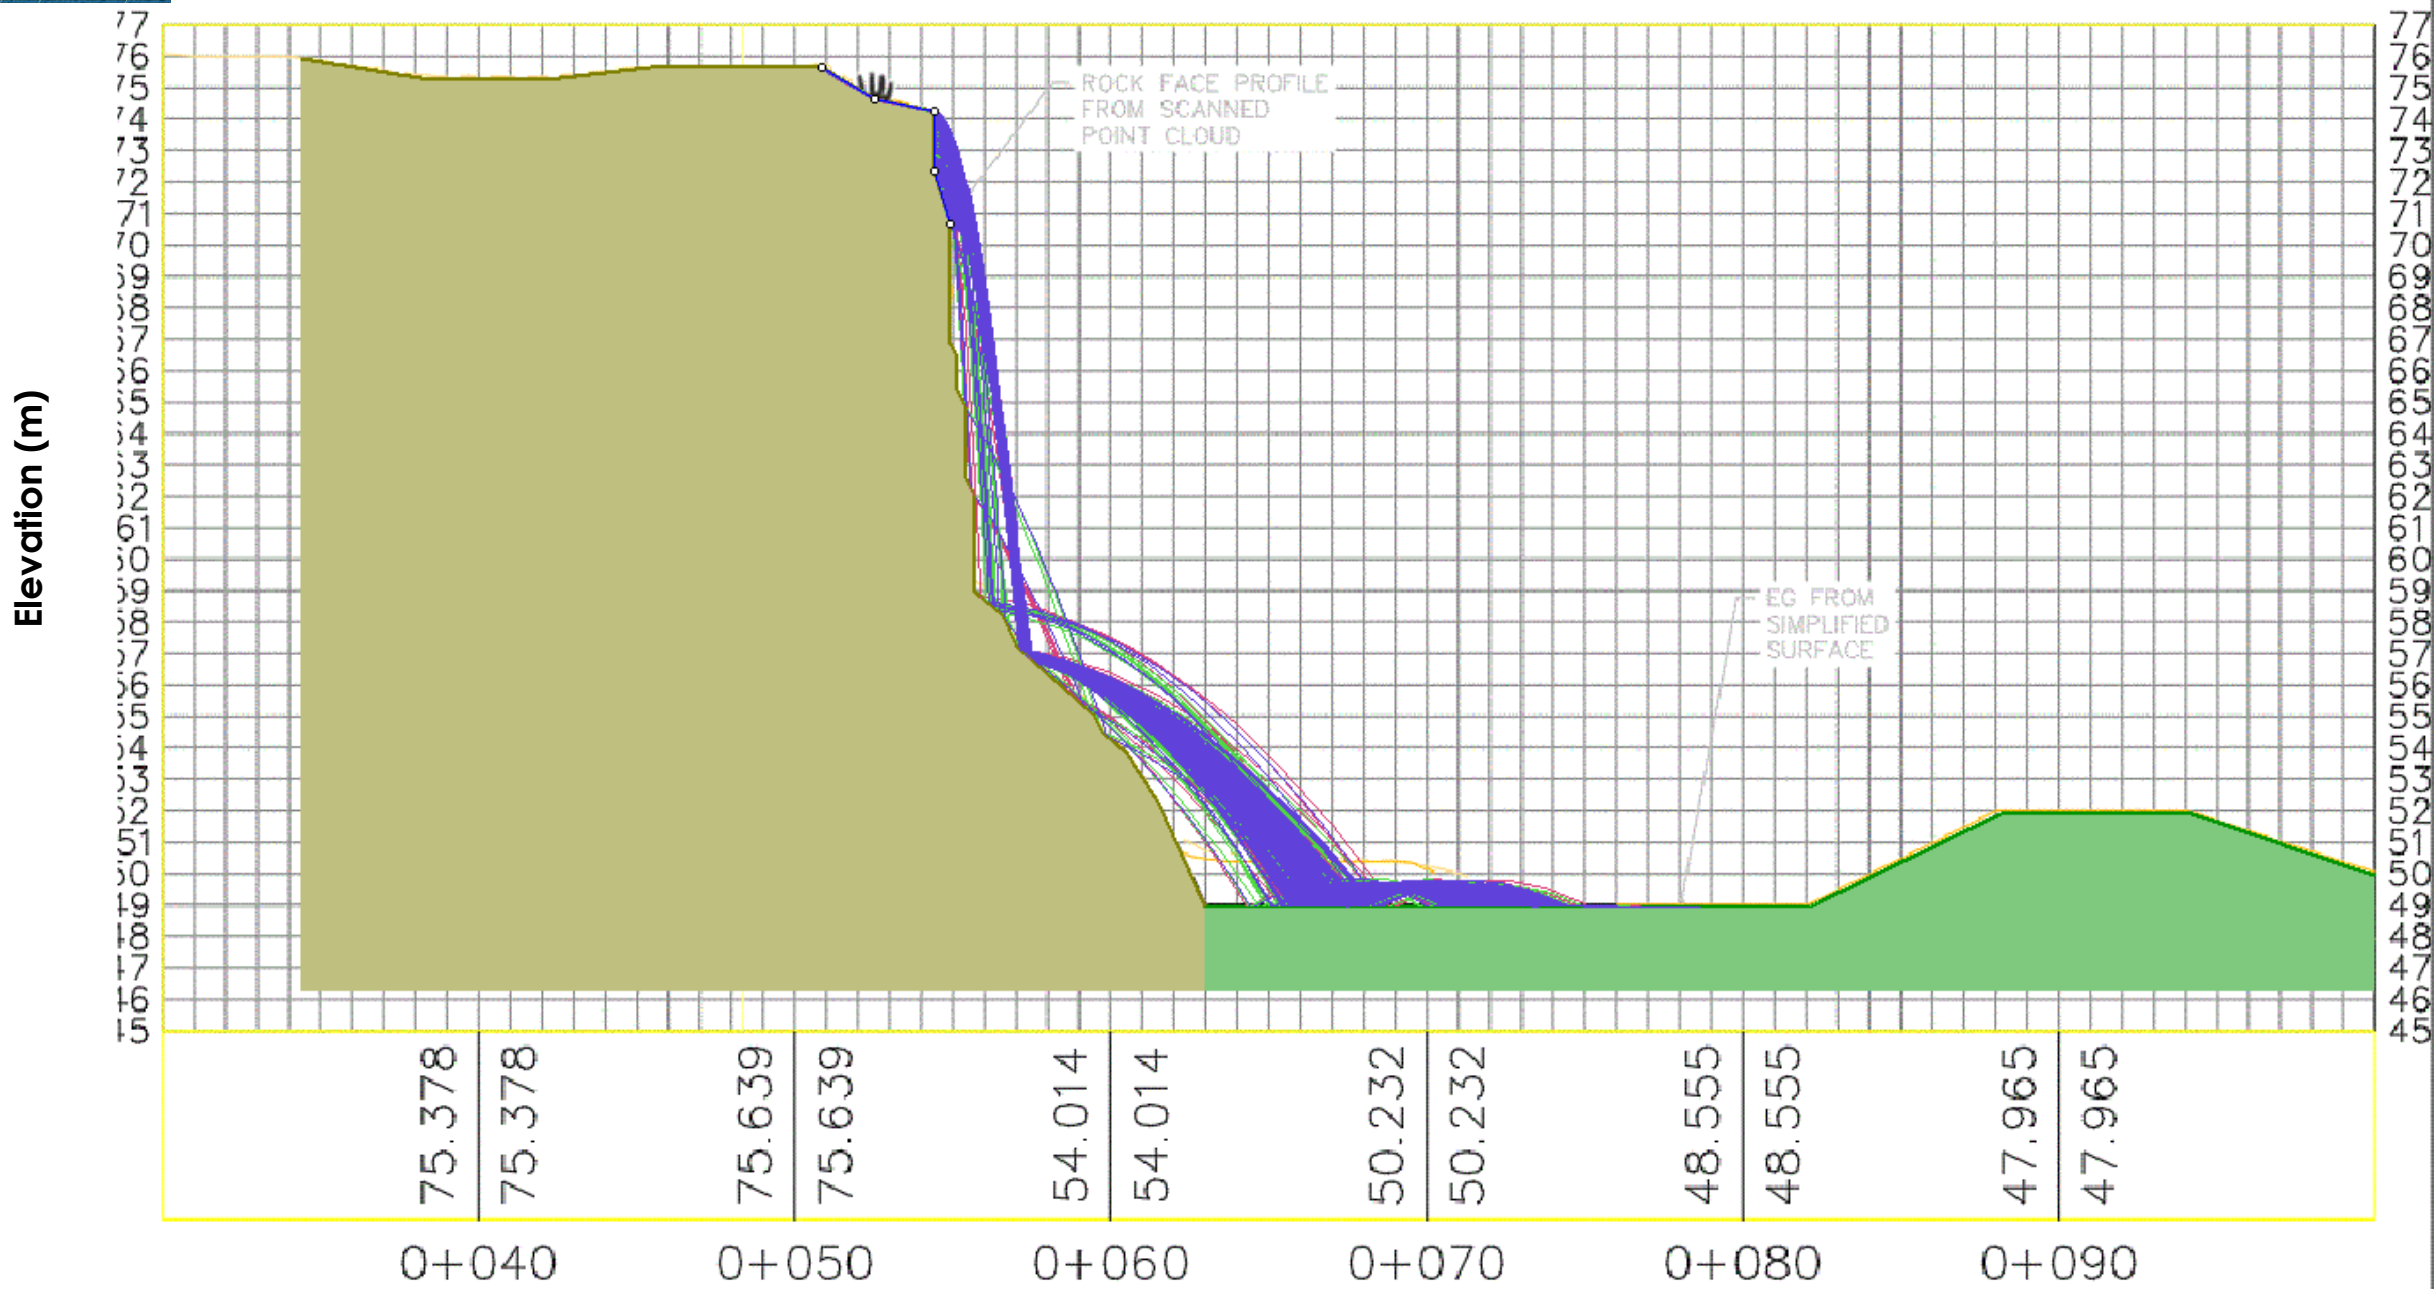
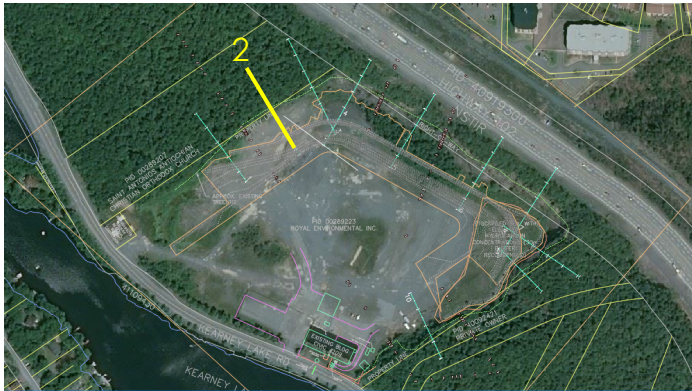
Rockfall Section 2

- Rocks avg. 200 kg
- Rocks avg. 500 kg
- Rocks avg. 1,000 kg

SECTION 2 PROFILE

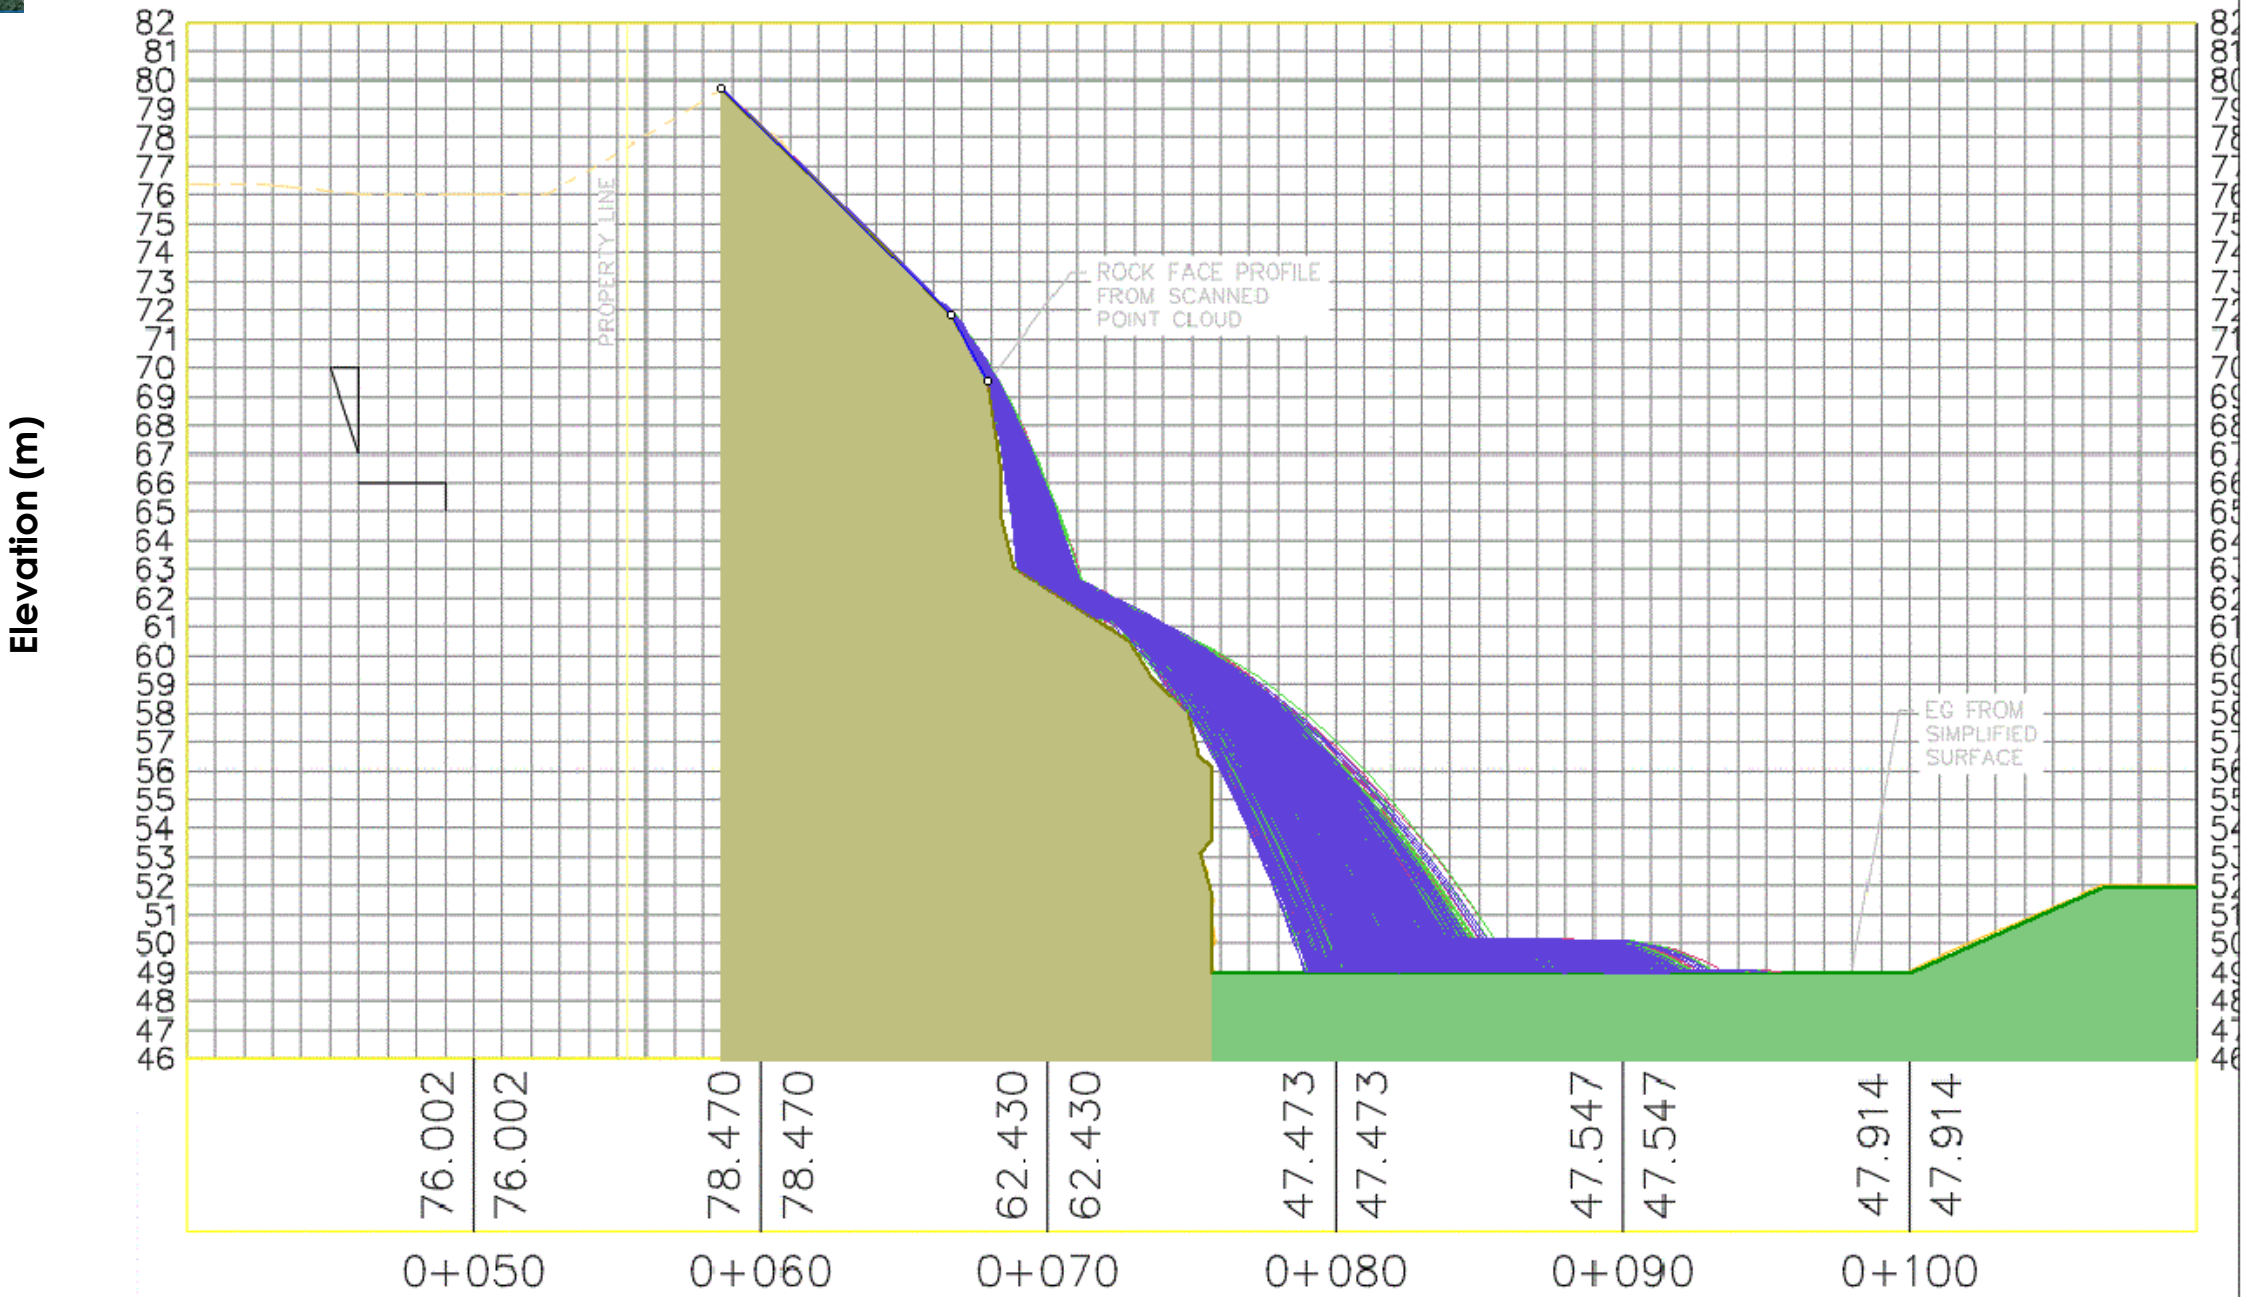
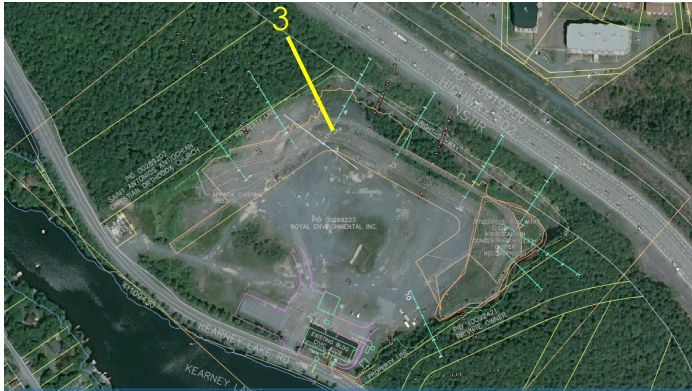
121624268-GE-04

- Rocks avg. 200 kg
- Rocks avg. 500 kg
- Rocks avg. 1,000 kg

SECTION 3 PROFILE

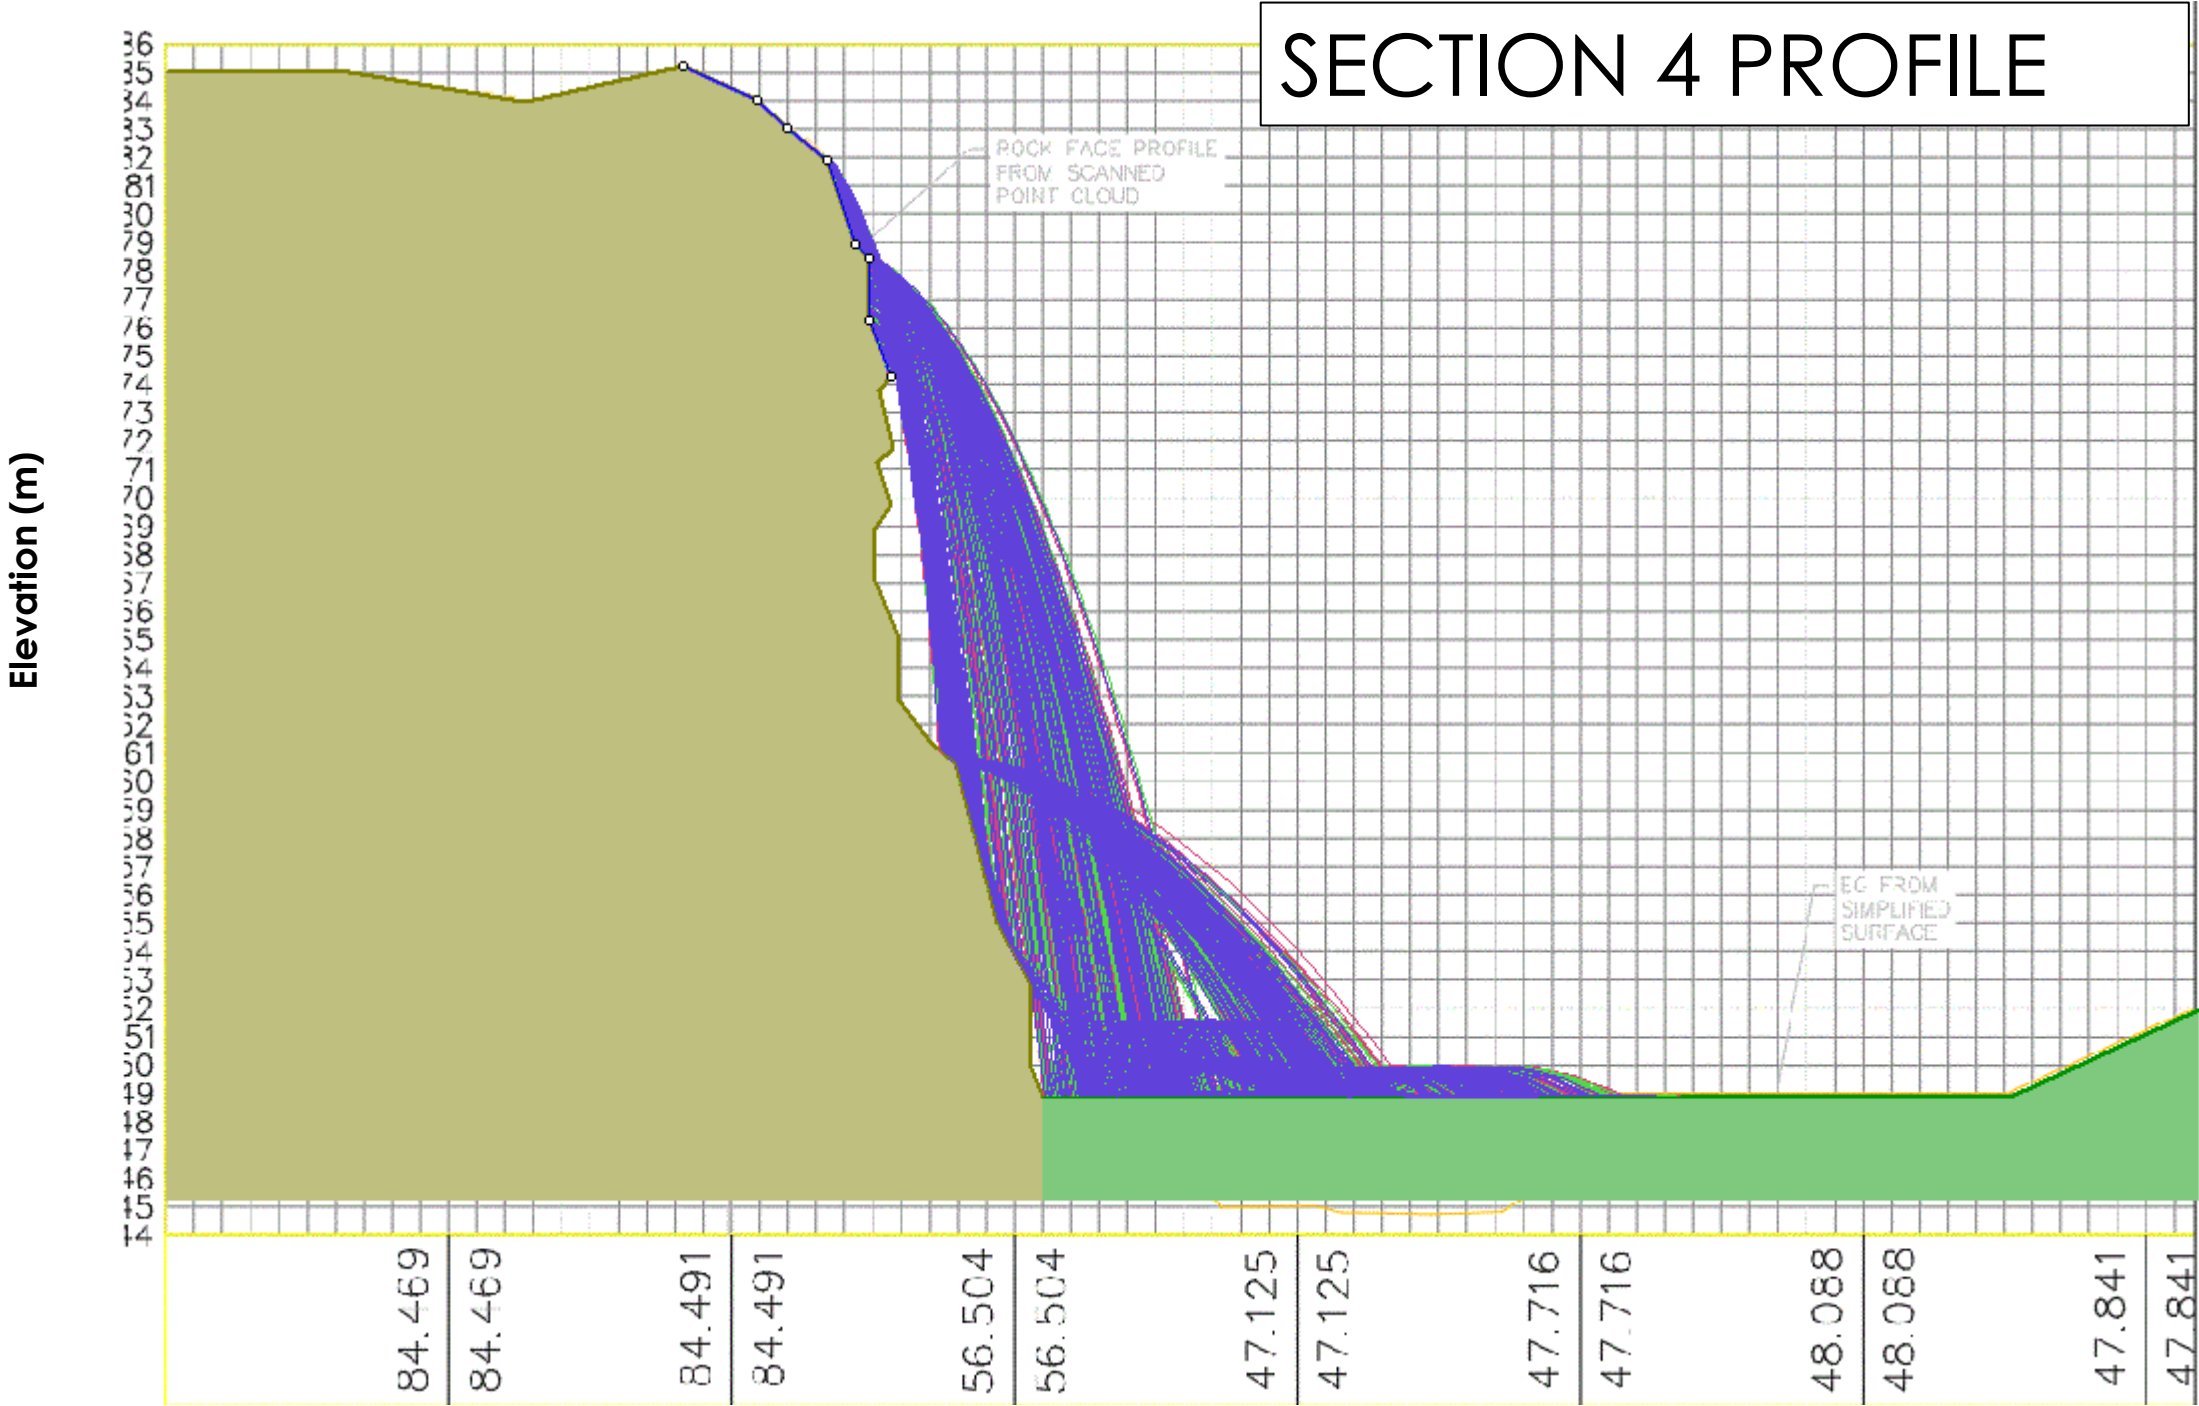
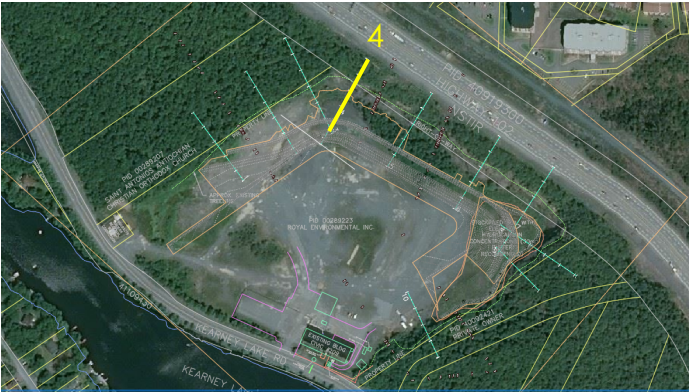
- Rockfall Trajectories**
- Rocks avg. 200 kg
 - Rocks avg. 500 kg
 - Rocks avg. 1,000 kg

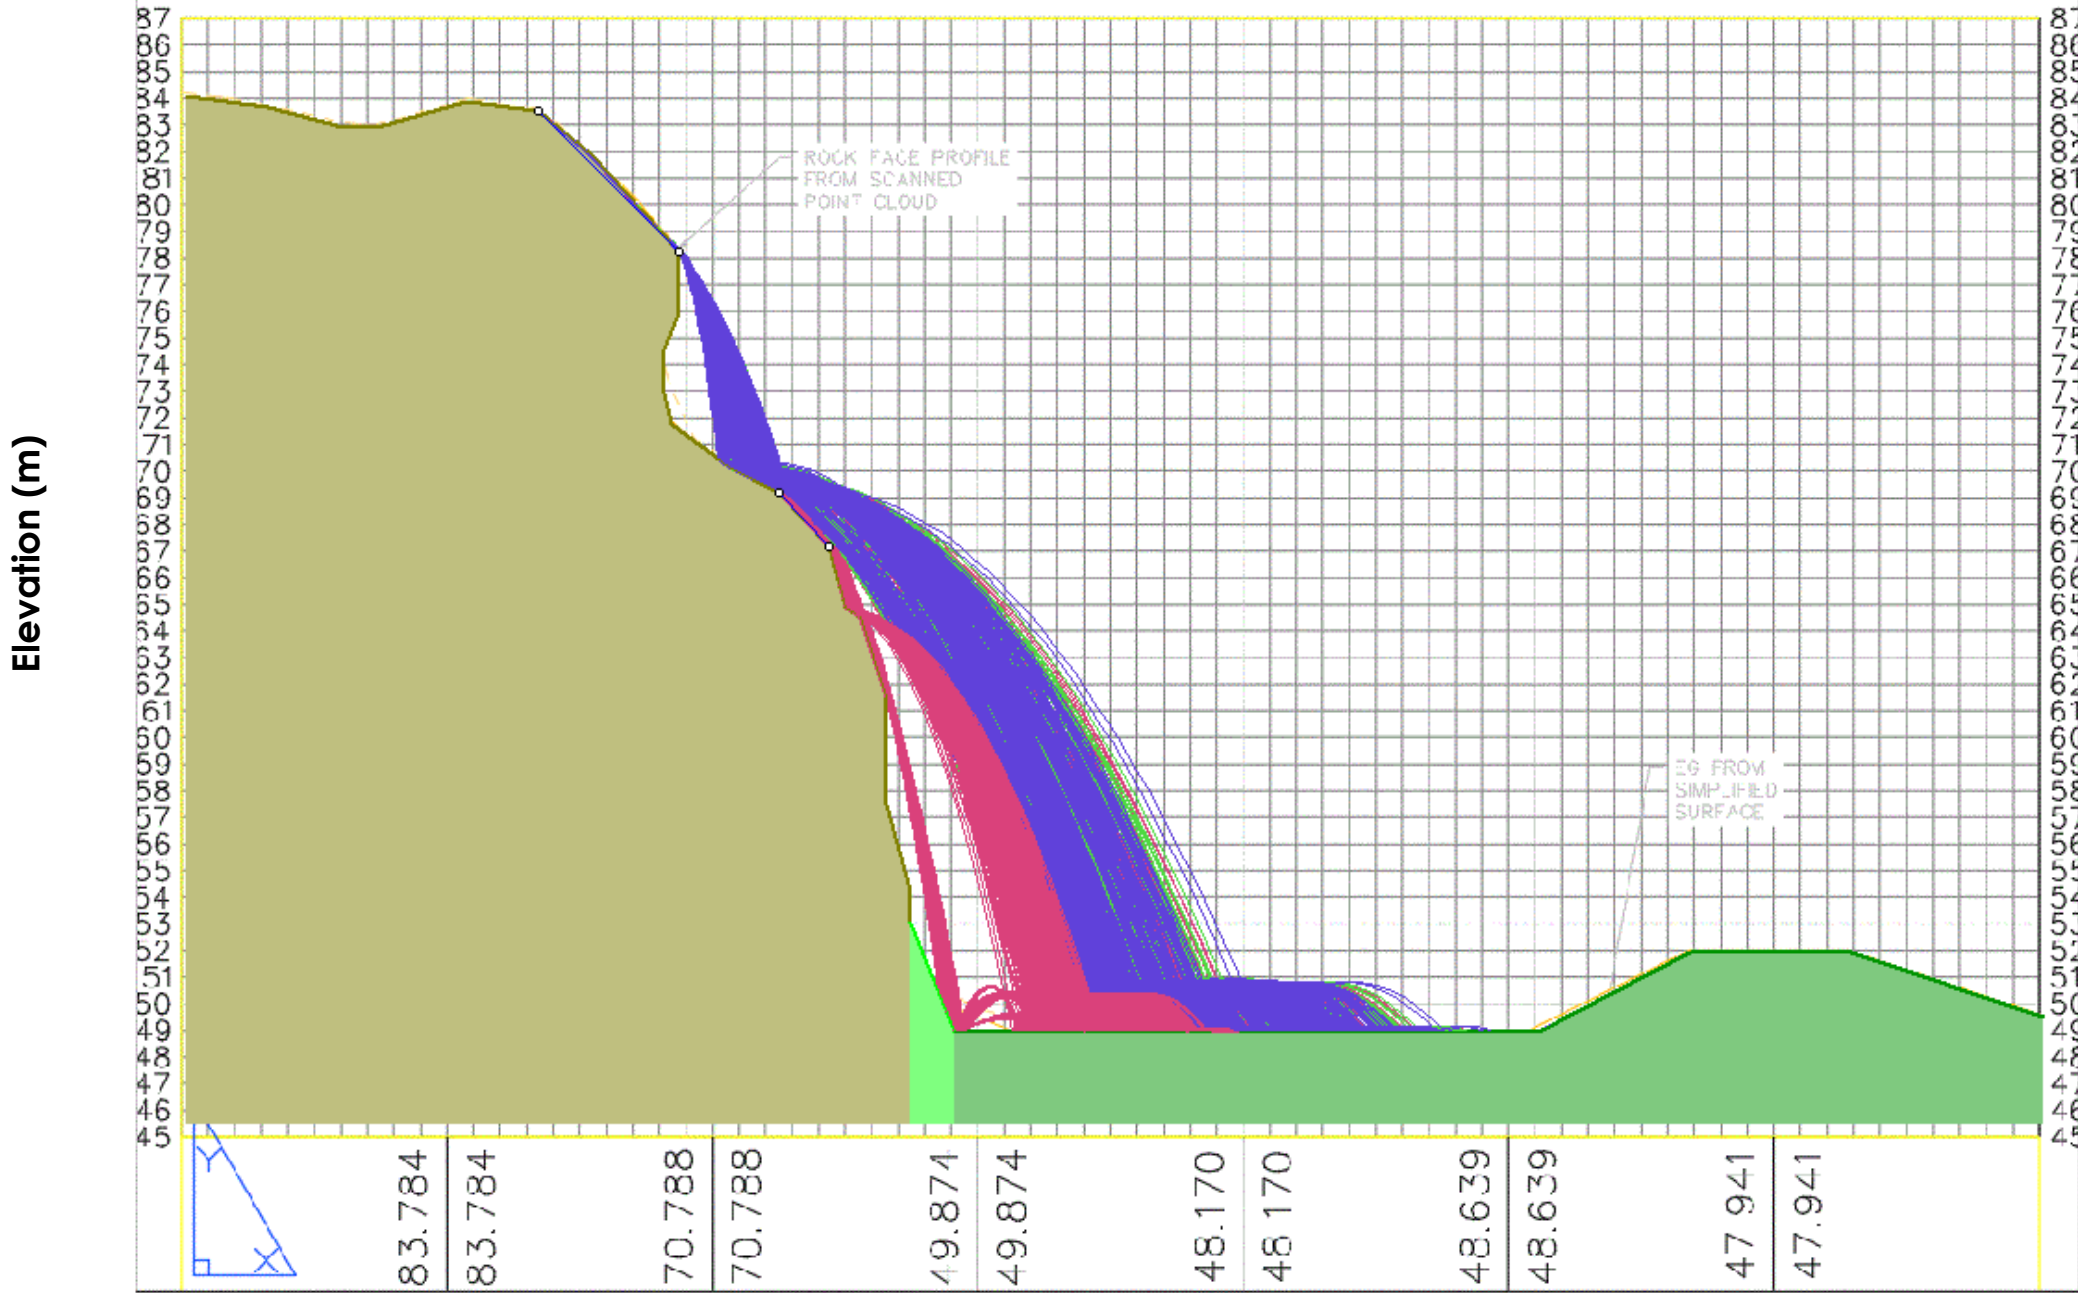
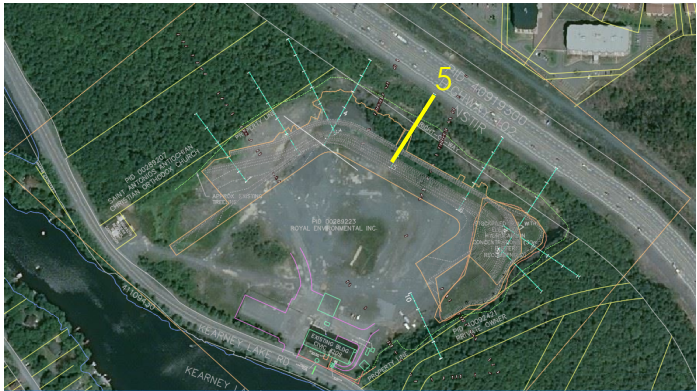
121624268-GE-06

- Rocks avg. 200 kg
- Rocks avg. 500 kg
- Rocks avg. 1,000 kg

SECTION 5 PROFILE

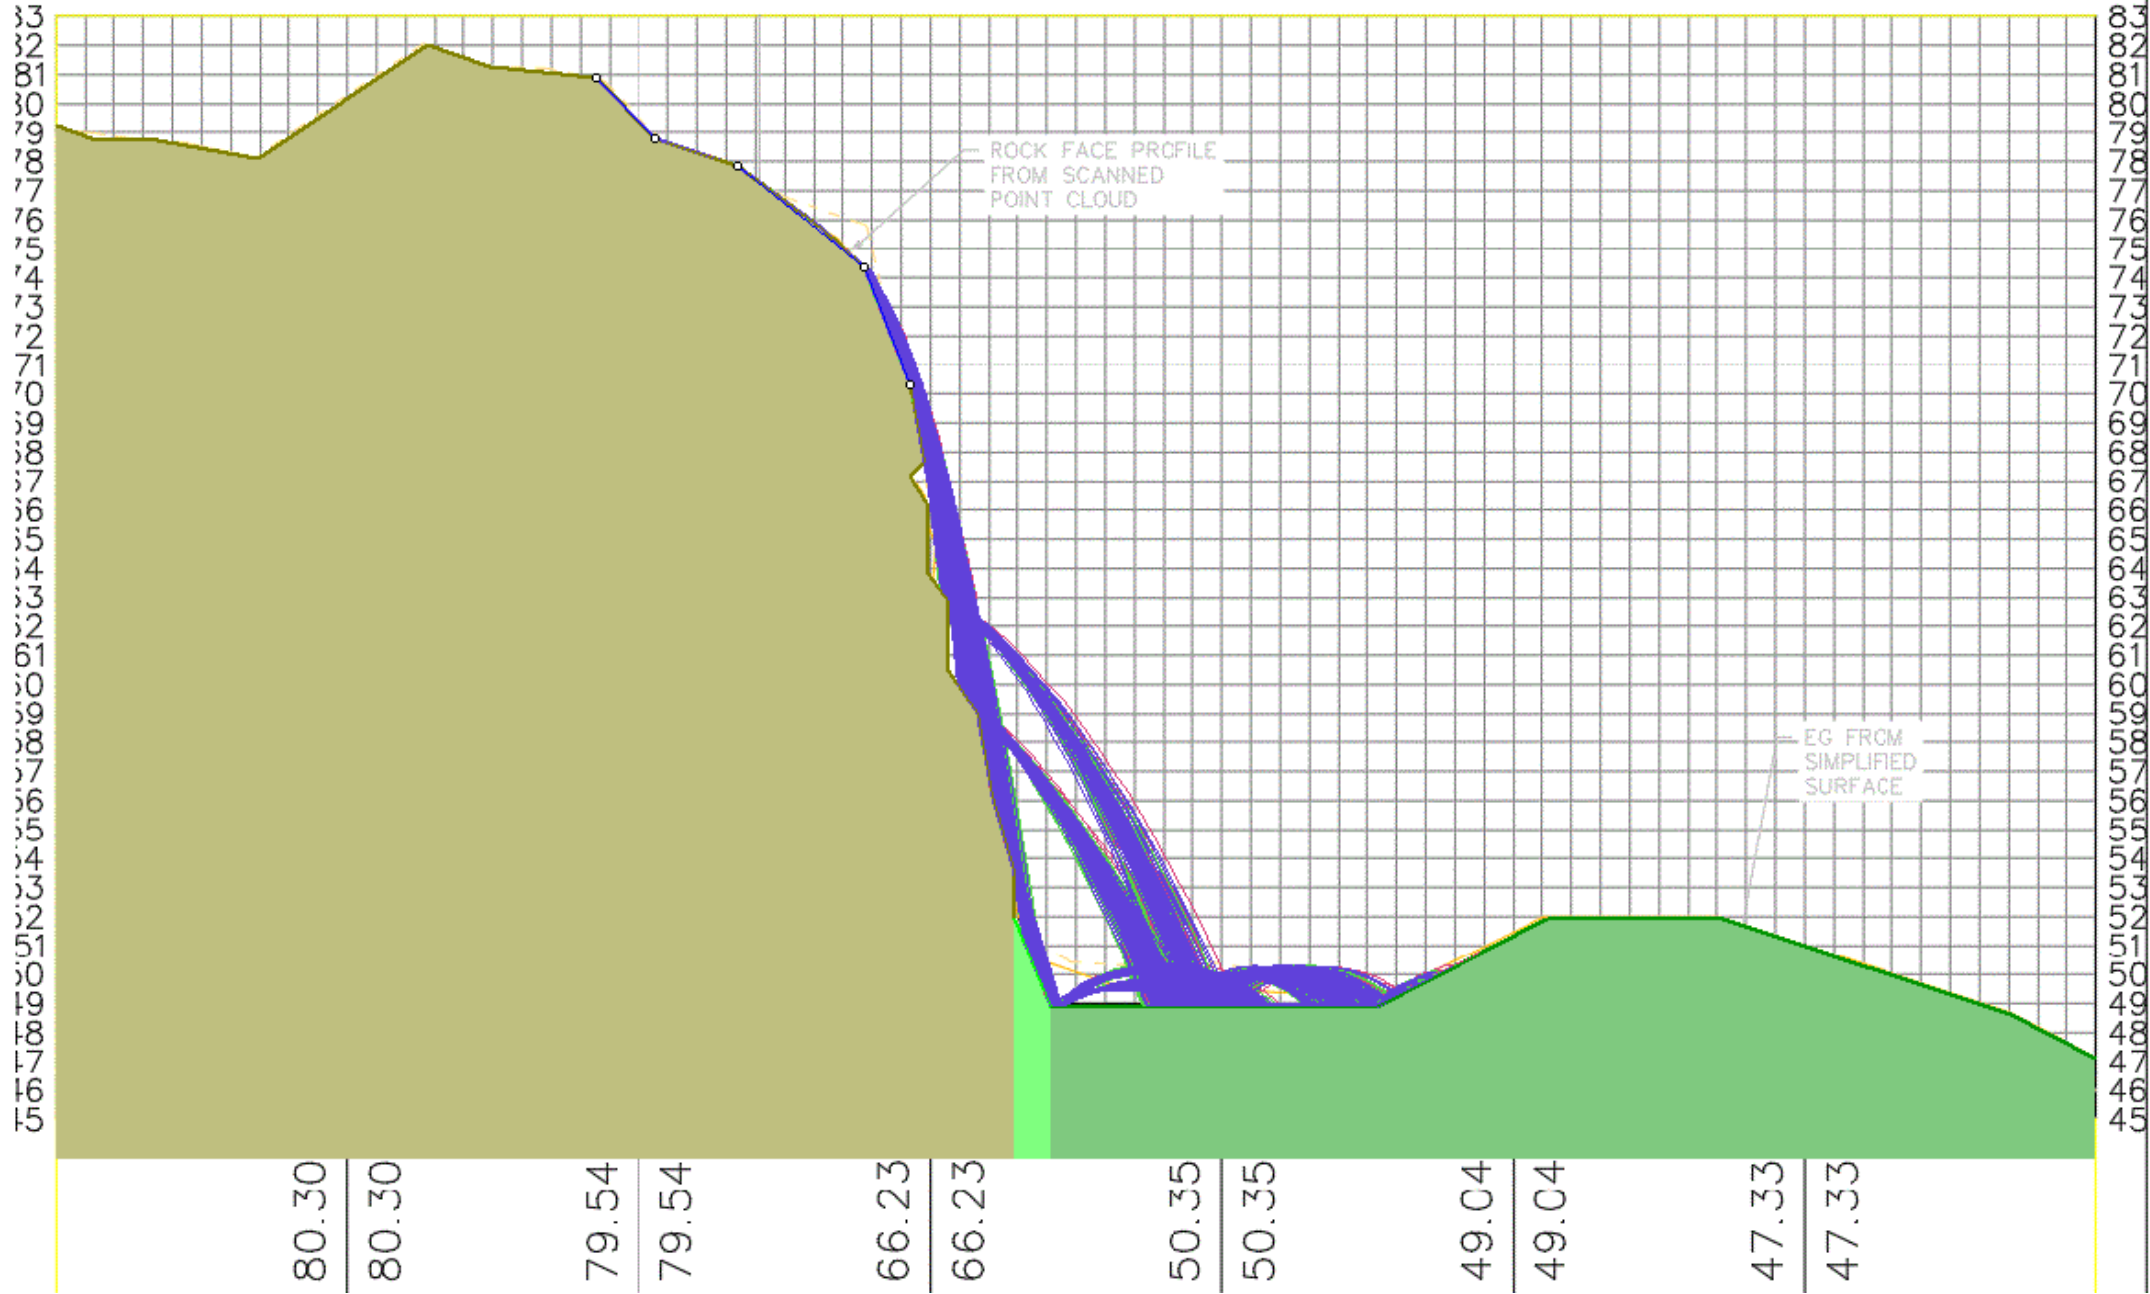
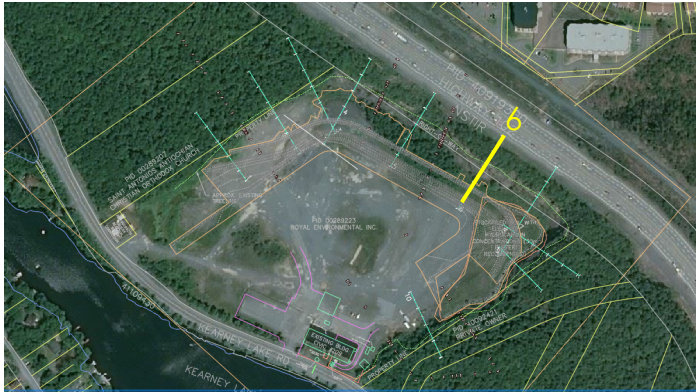
Rockfall Section 6

- Rocks avg. 200 kg
- Rocks avg. 500 kg
- Rocks avg. 1,000 kg

SECTION 6 PROFILE
