To:	Scott MacCallum	From:	Maureen Matthew, M.Sc., P.Geo.
	Kearney Lake Developments Limited Partnership		Stantec Consulting Ltd.
Project/File:	121624268	Date:	January 13, 2023

Reference: 209 Kearney Lake Road - Rockfall Analysis – Revision 1

Rockfall Catchment Area Analysis
209 Kearney Lake Road, Halifax, NS

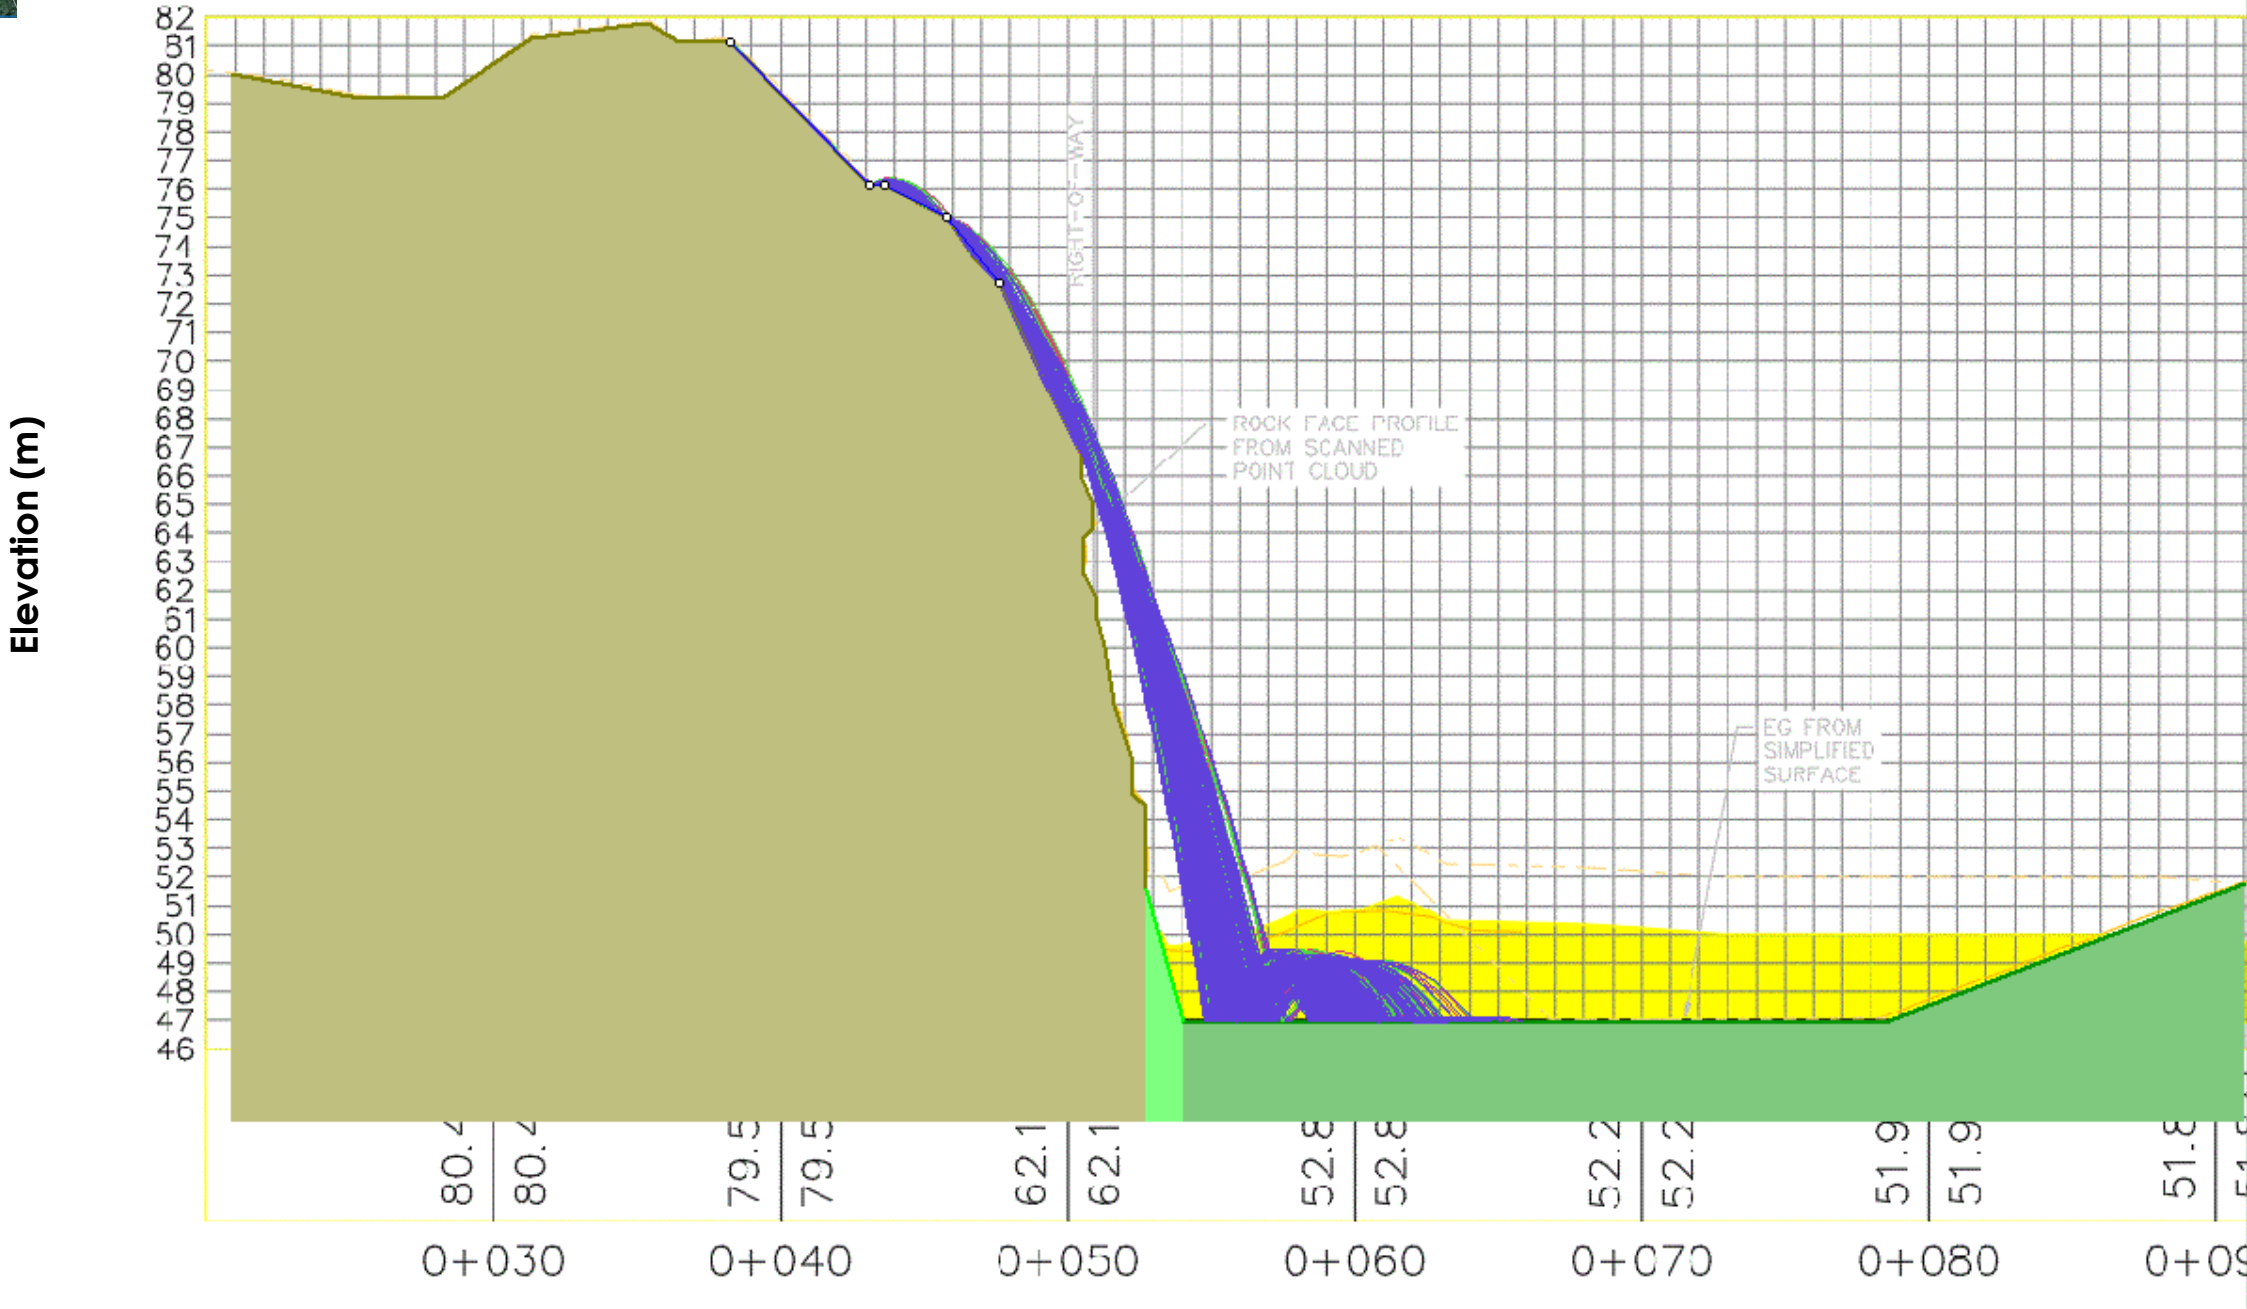
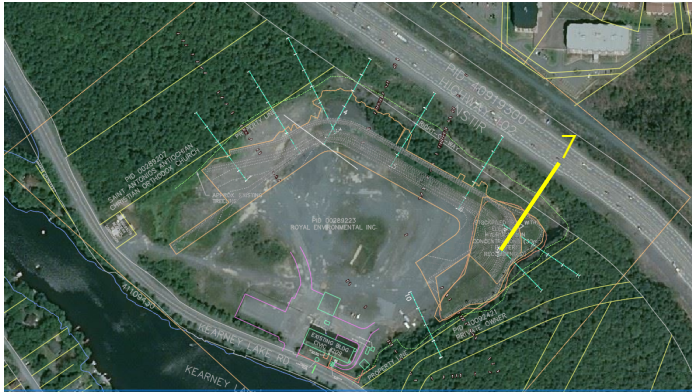
- Rockfall Trajectories**
- Rocks avg. 200 kg
 - Rocks avg. 500 kg
 - Rocks avg. 1,000 kg

SECTION 7 PROFILE

A location plan of the cross-sections as well as the modelled results (travel paths) of each RocFall analysis are included in the attachments (Drawing 121624268-GE-01 to GE-11). The results show that in all scenarios, the modelled rockfall events are contained either within the allocated catchment zone or come to rest on the backslope (i.e., closest to the highwalls) of the proposed landscape berm that will define the “no-go” catchment area at the base of the bedrock slopes.

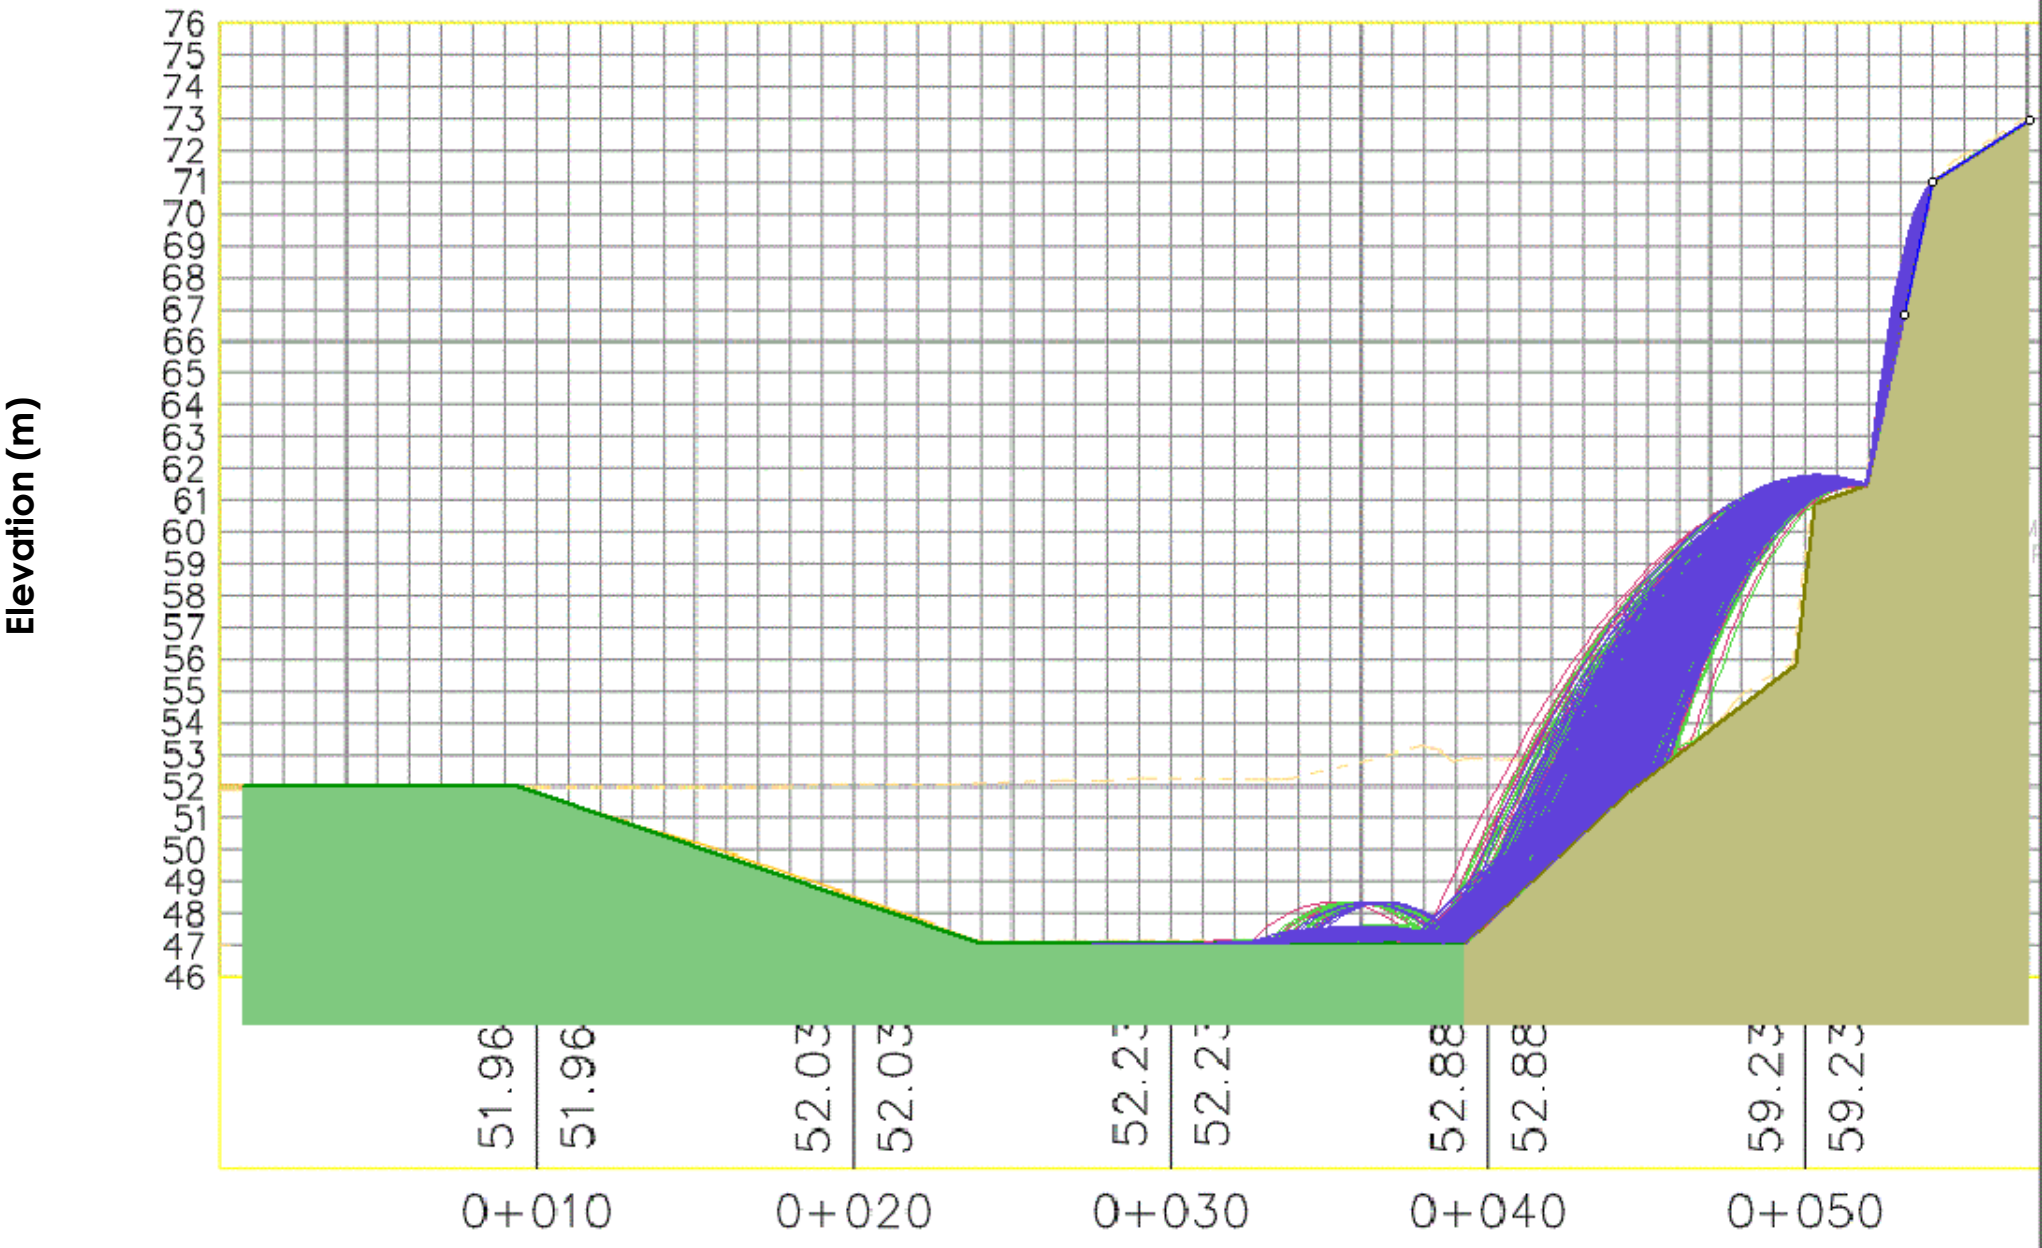
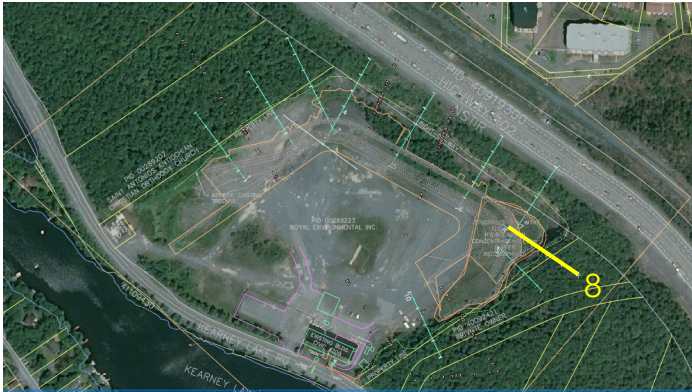
Rockfall Section 8

- Rockfall Trajectories**
- Rocks avg. 200 kg
 - Rocks avg. 500 kg
 - Rocks avg. 1,000 kg

SECTION 8 PROFILE

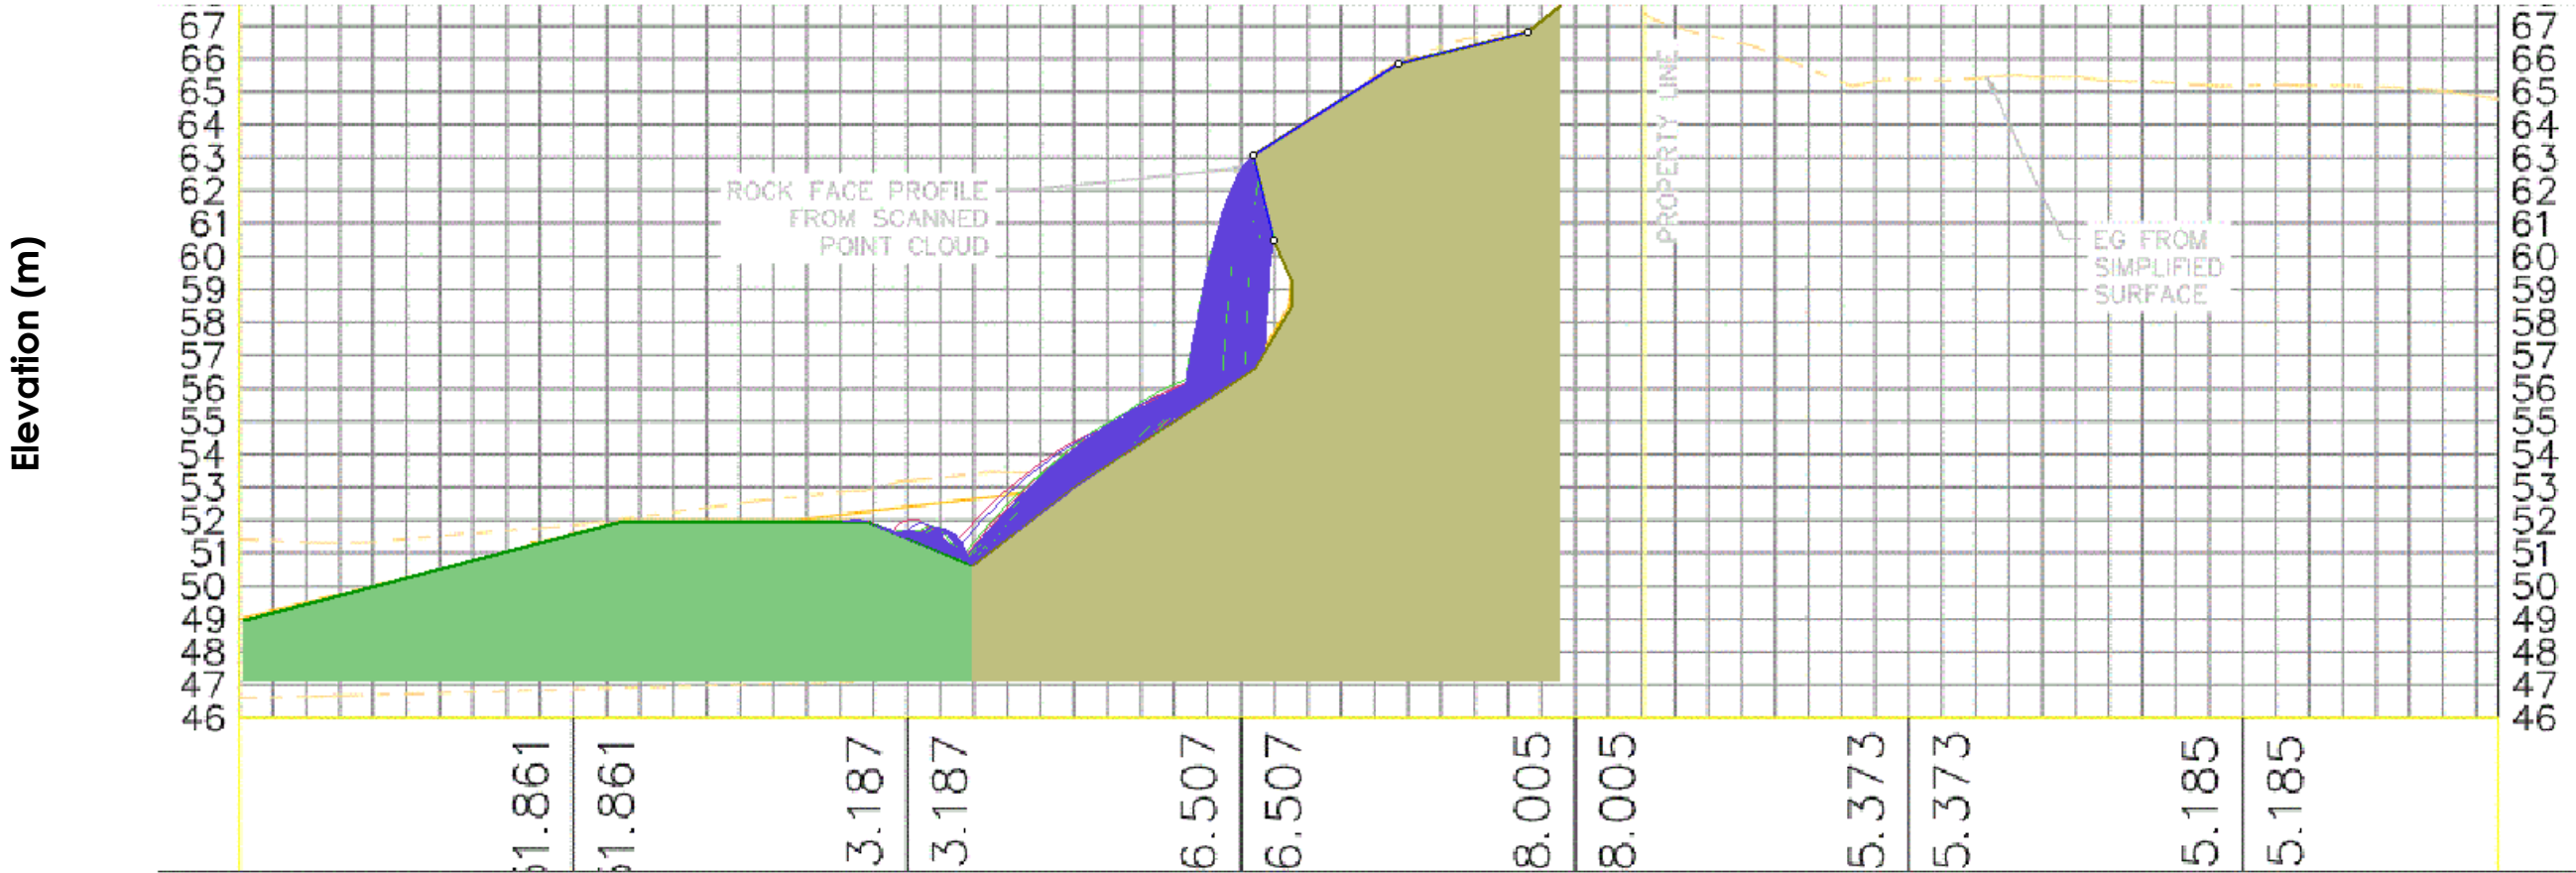
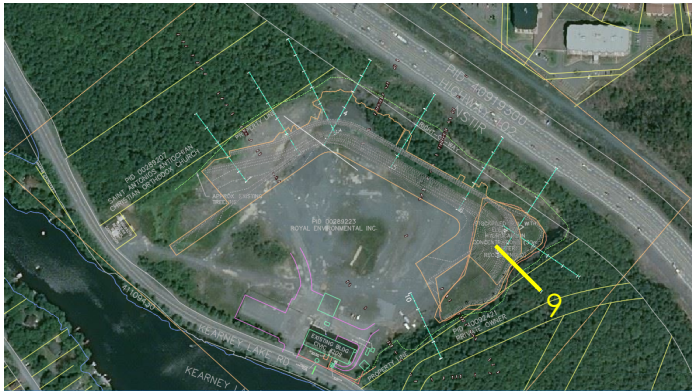
- Rocks avg. 200 kg
- Rocks avg. 500 kg
- Rocks avg. 1,000 kg

SECTION 9 PROFILE

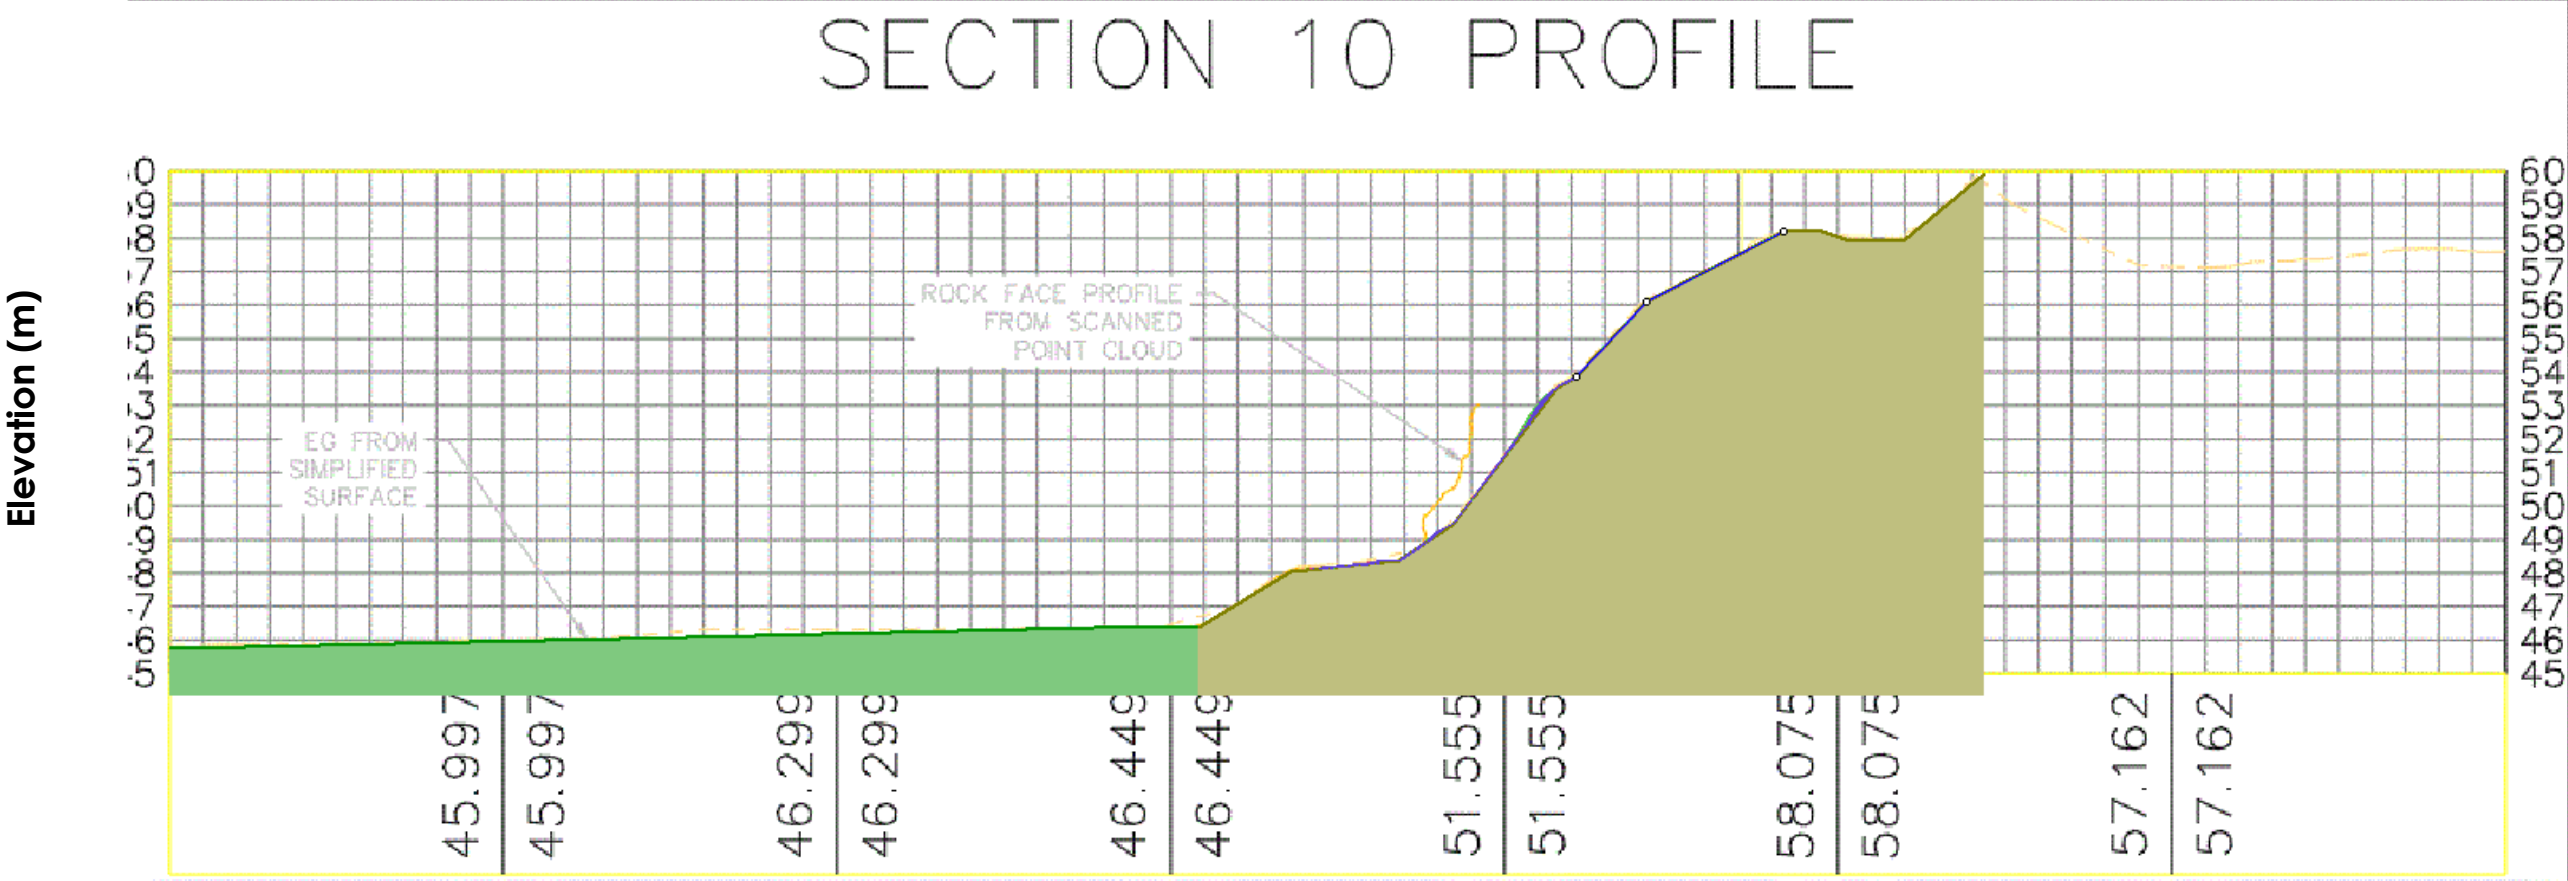
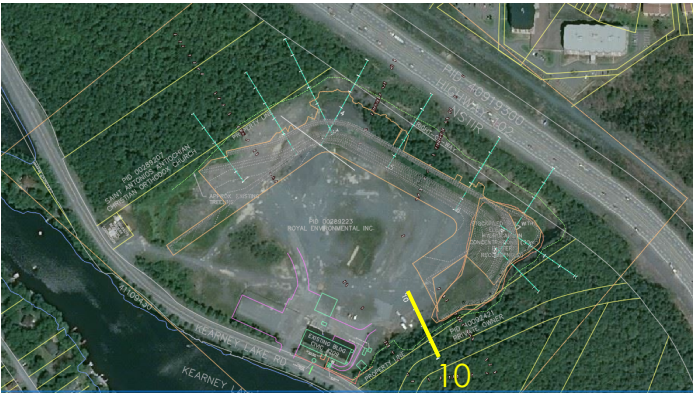
Rockfall Section 10

- Rockfall Trajectories**
- Rocks avg. 200 kg
 - Rocks avg. 500 kg
 - Rocks avg. 1,000 kg
