State of Sandy Lake (Bedford, NS)

**Presentation by David Patriquin
to Halifax North West Community Council
June 12, 2023**

Forests and surface waters of Sandy Lake & Environs (Bedford, Nova Scotia)

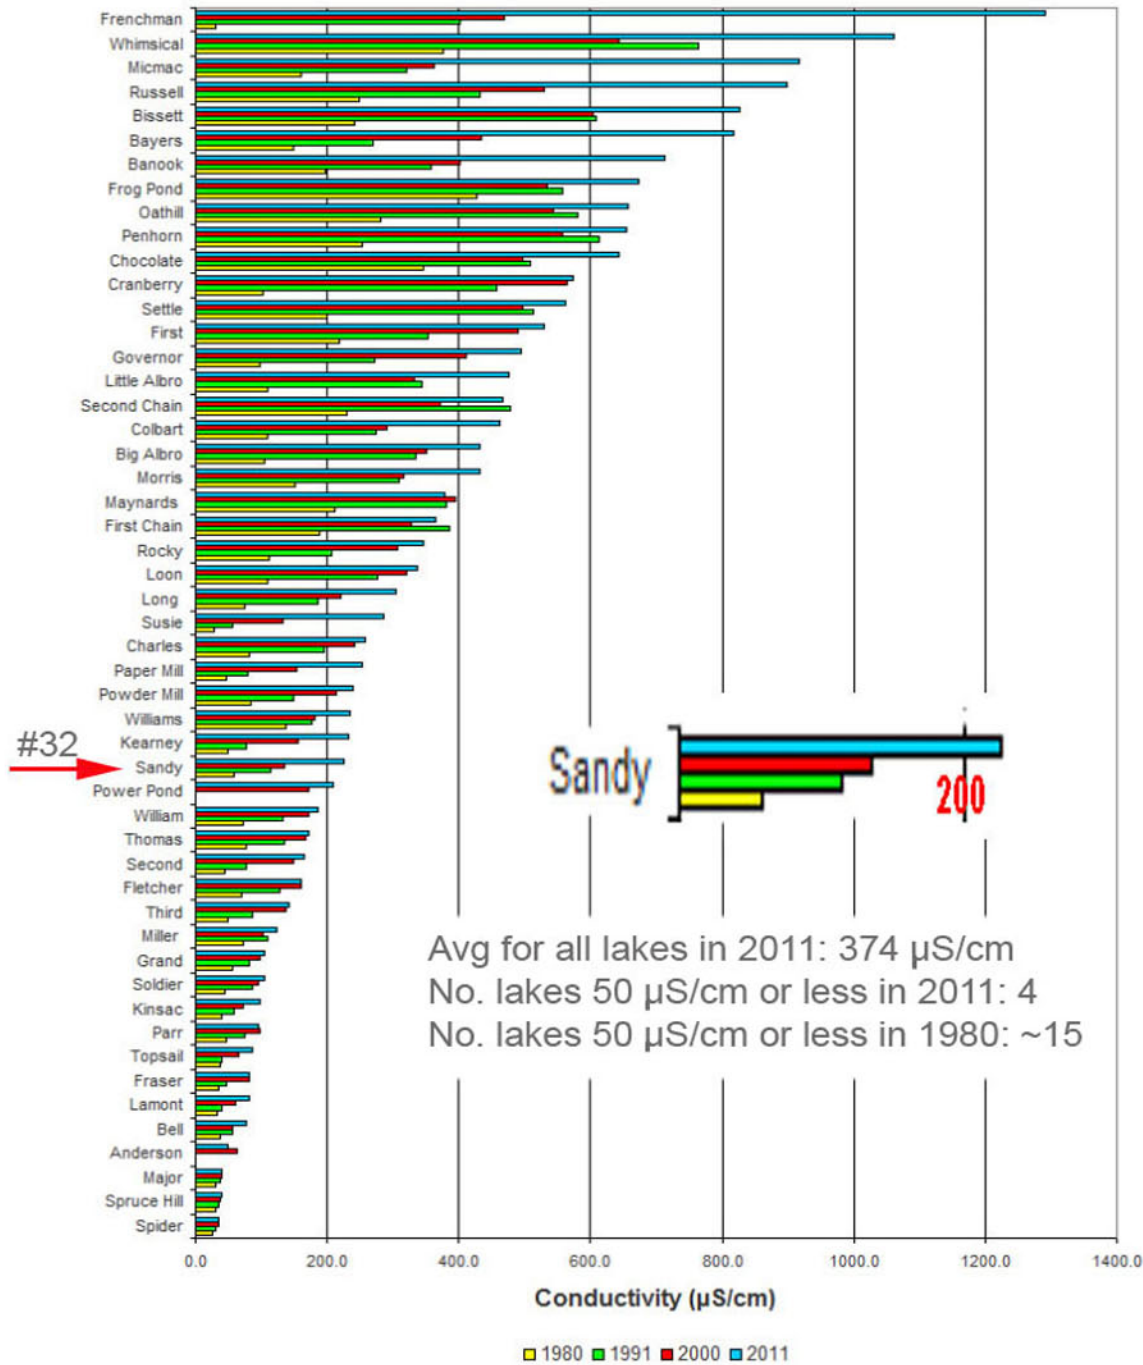
Slide 4

Historical EC values for selected Halifax-area lakes including Sandy Lake (enlarged in inset). Modified from Clement, P.M. & D.C. Gordon. 2019, Fig. 5

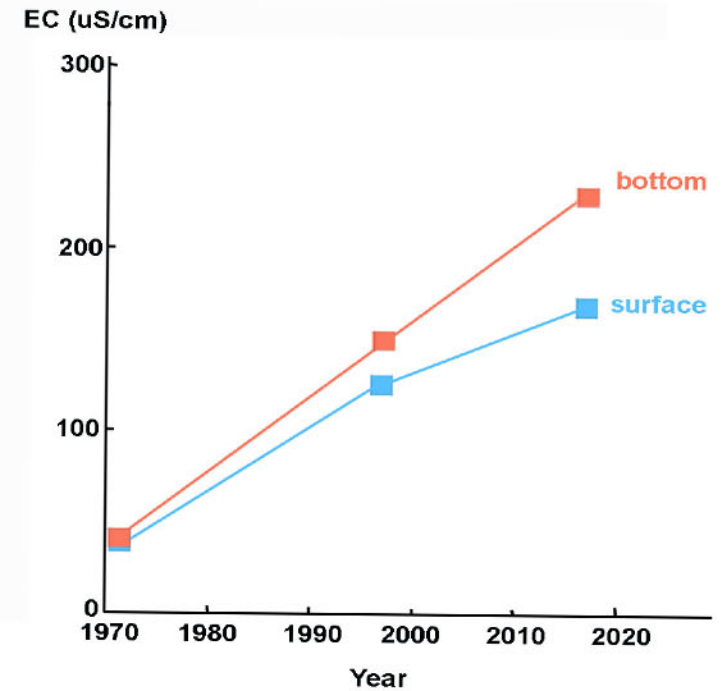
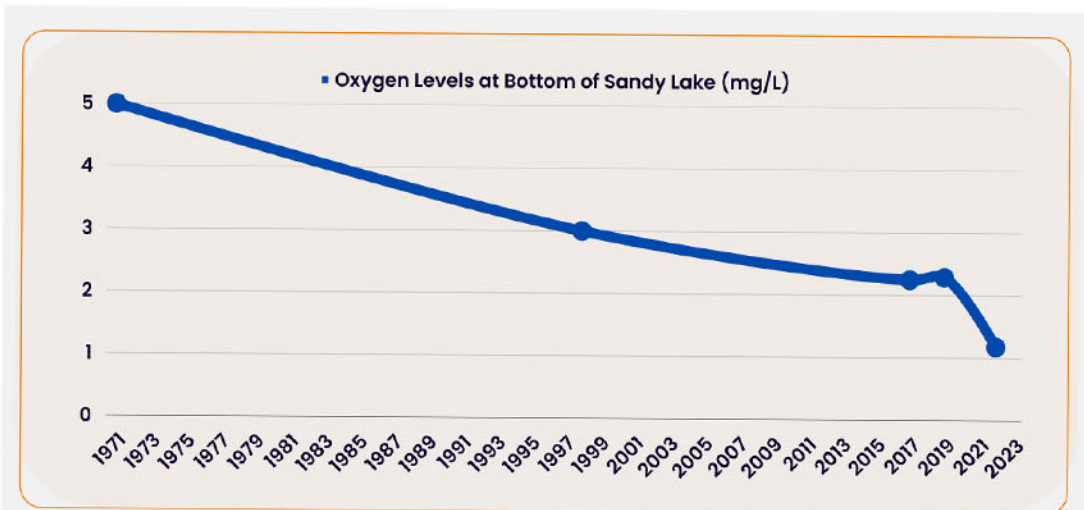
Slide 5

Variable	1971	1998	2017	2019	2022
Temp (°C):					
Surface	21	22	17.1	16.9	24.7
Bottom	-	6	5.7	7.2	7.6
Conductivity (µS/cm)					
surface	37	125	169	159	209
bottom	39	146	248	204	229
Oxygen (mg/L)					
Surface	7.25	8.6	9.42	8.85	8.06
Bottom	5.0	3	2.25	2.29	1.18

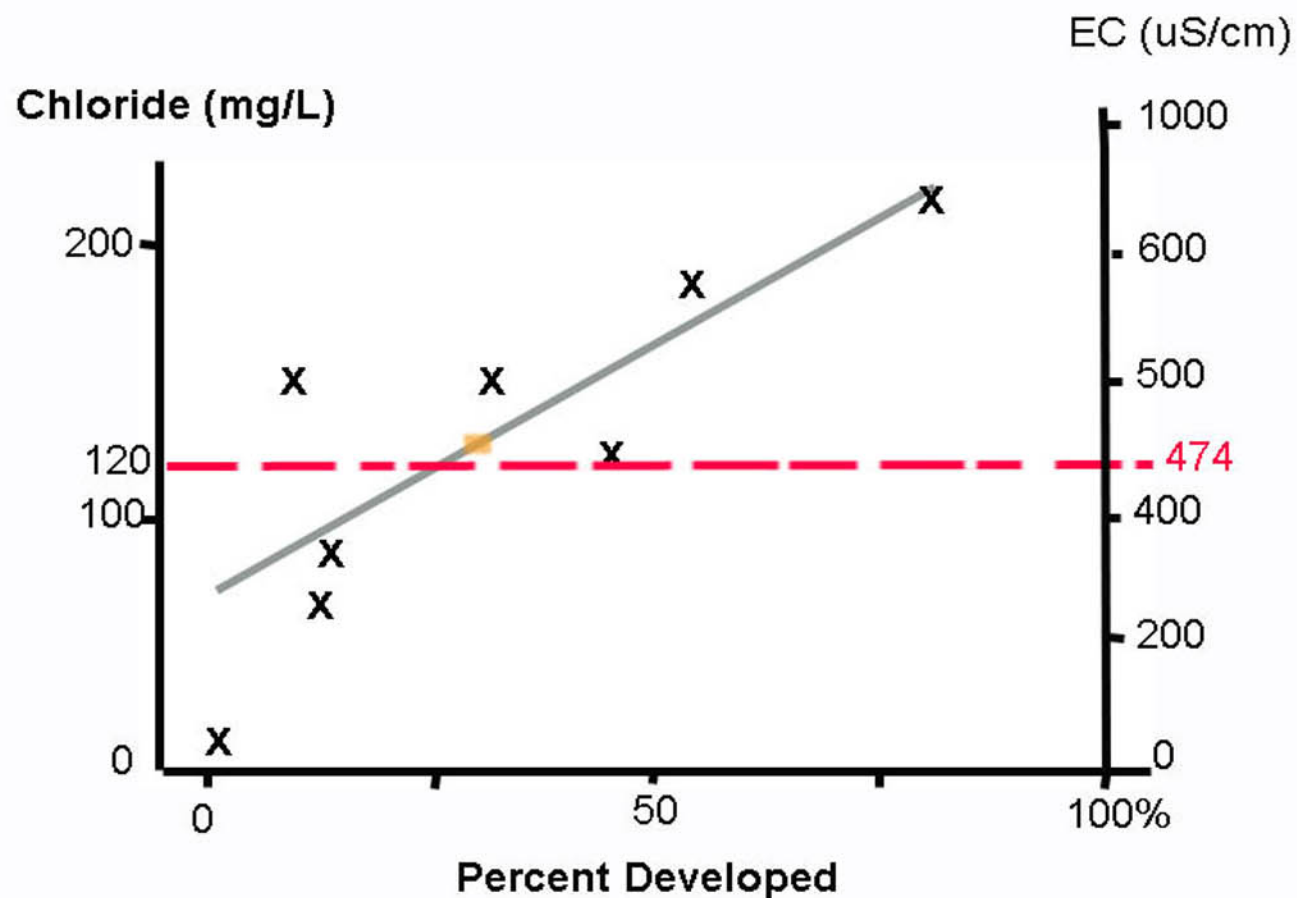
Slide 6

Graph adapted from Fig 6 in Scott et al., 2019.

The orange-filled rectangle shows where 30% Development (the approx. current level at Sandy Lake) would fit on the Scott et al., 2019 regression line relating chloride concentrations in the spring of 2013-2017 to the percent watershed developed for 9 Halifax lakes. EC values on the right correspond to the chloride values, based on the relationship given in AECOM (2020). The current spring EC value for Sandy Lake is approx 190 uS/cm. The CCME Guideline for long term exposure to chloride is 120 mg/L (the dashed red line). So if Sandy Lake behaves like the other lakes, it would achieve a steady state value just above 120 mg/L chloride – at the current level of development, higher if further developed.

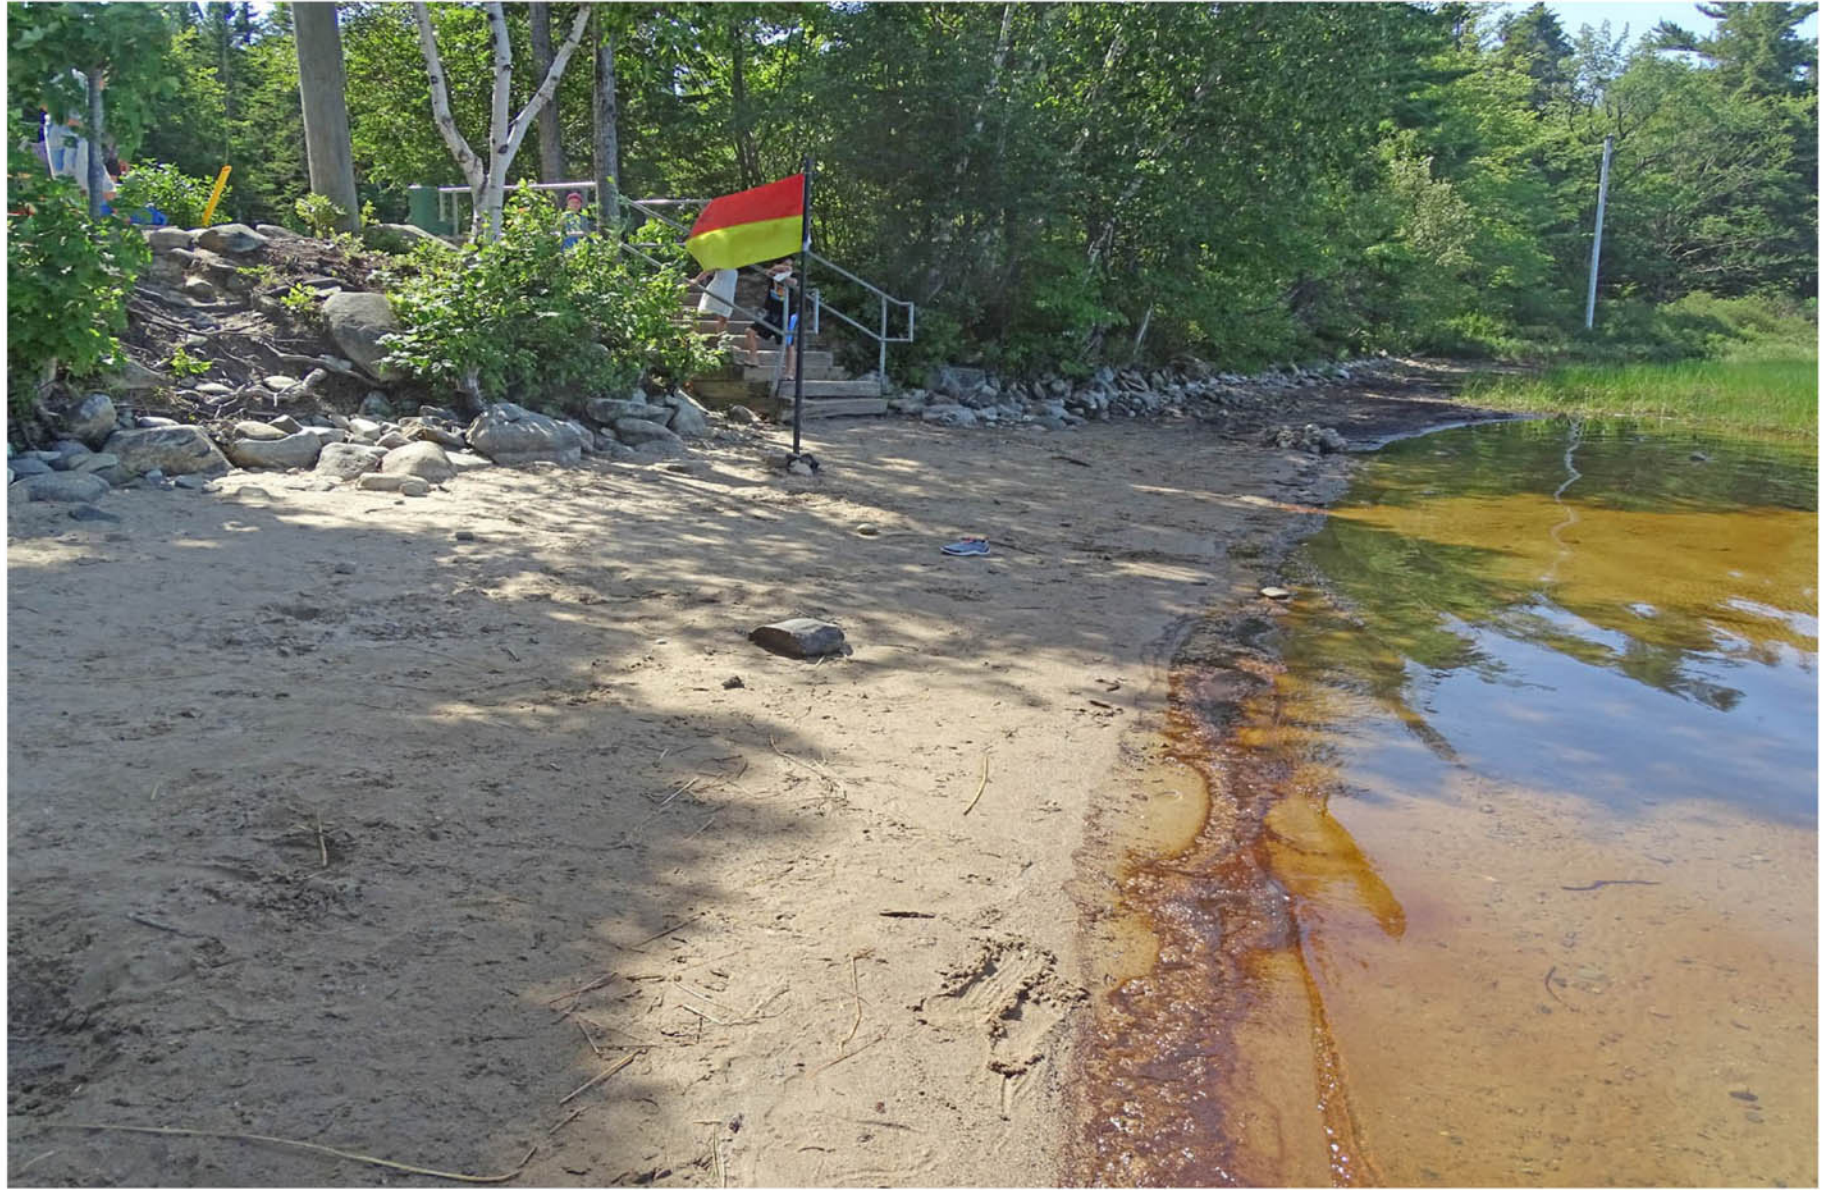
Slide 7

Algal bloom at Sandy Lake Beach, 11:13 am on Aug 6, 2019

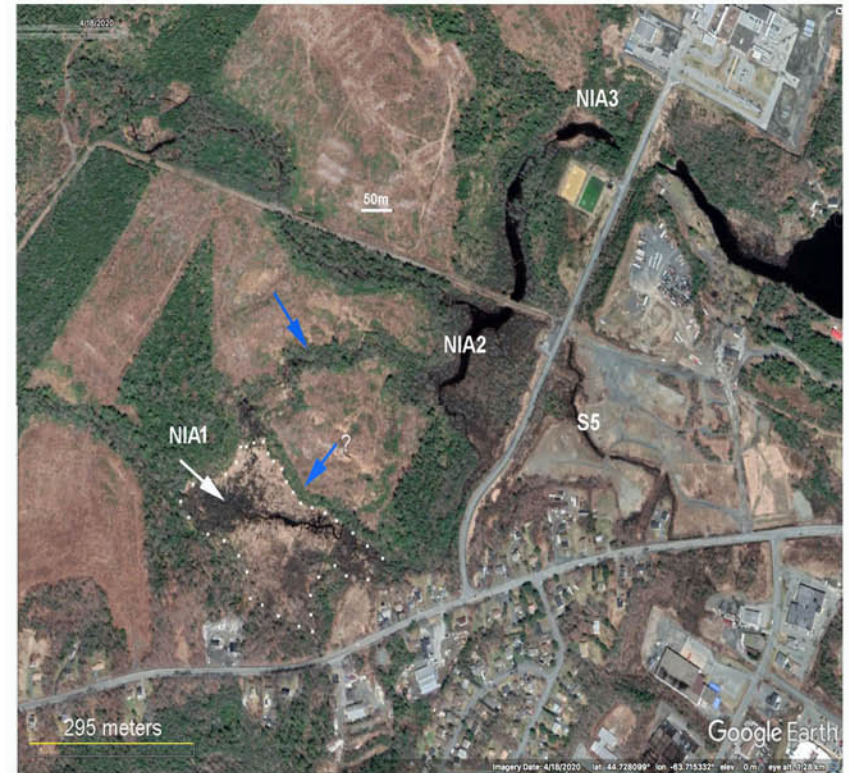
Significant wetland on headwaters that could be lost to development.

The wetland NIA1 (No Information Available - as cited on NS Provincial Landscape Viewer), more recently known as "Walters Marsh", would, according to scenarios cited in AECOM (2014), be eliminated and replaced by residential landscape.

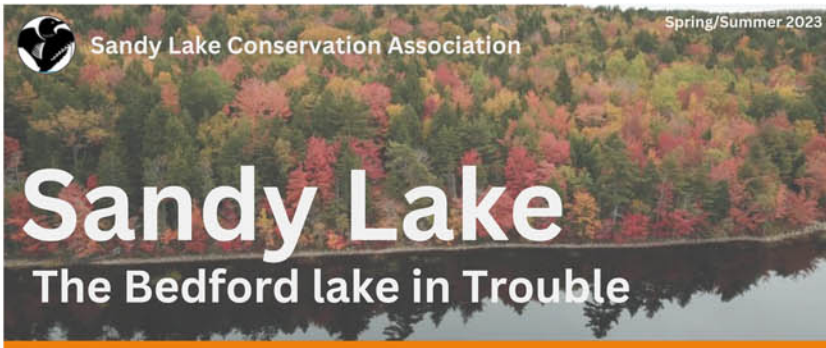
Slide 9

Sandy Lake is a deep “dimictic” lake, meaning that it “thermally stratifies” in winter and summer.

In summer, cold water is retained in the deep layer, warmer water sits at the top, and a zone of temperature change occurs between these two layers.

The deep layer provides a cool summer refuge for salmonids, including trout and the Atlantic salmon which are now coming back to the Sackville River Watershed

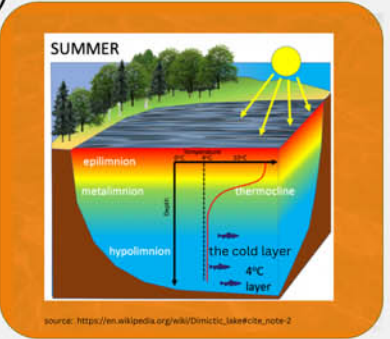
Excessive inputs of organic materials and phosphorus (P) result in “eutrophication.” Oxygen in the deep layer of the lake declines to levels inhospitable to salmonids. Also, low oxygen stimulates the release of P from sediments, further accelerating eutrophication.
