**SUBJECT:** **Restoration and Preservation of Fleming Cottage**

### **INFORMATION REPORT**

# Fleming Cottage

Assessment and Feasibility Report

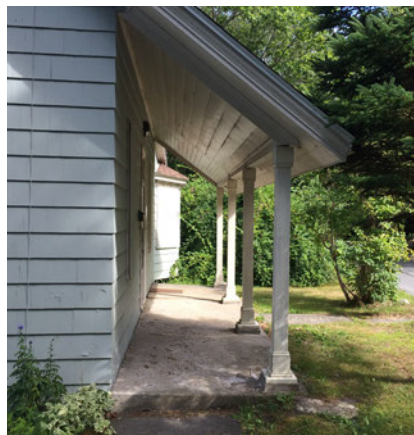
The current front entrance is not barrier free. Though it is essentially on grade with the road, there is a 6" step up from the parking space onto the concrete porch, and another 6" step up from the concrete into the house. The existing concrete pad should be removed and replaced with a barrier free wood deck. Removing the concrete pad will also remove the columns footing, so new footings for the columns should also be provided. The ground around the entrance should be regraded to aid in making the entrance barrier free.

*Step onto concrete porch*

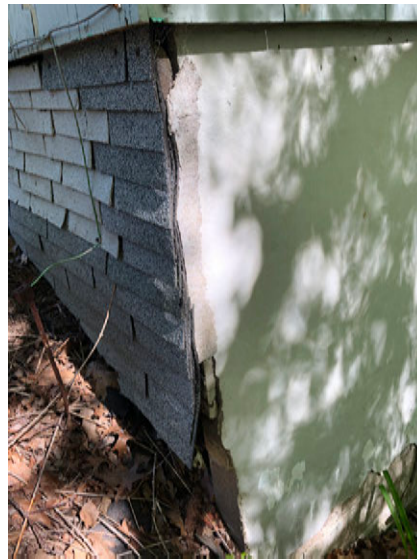
On the front of the east addition, asphalt shingles have been used as cladding over the foundation wall, which is of unknown construction. The shingles should be removed. If the wall underneath is of masonry construction, the masonry should be parged to match the other foundation walls. If it is of wood construction, the wall should be clad in wood shingles to match the rest of the wood siding.

*Concrete foundation wall and asphalt shingle clad foundation wall*

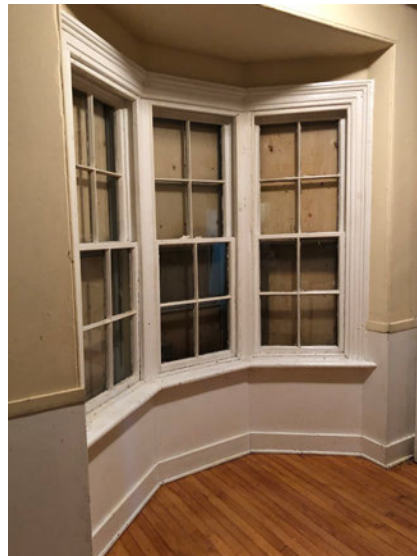
*Original windows in kitchen*

With the exception of the sashless sliding window on the north side of the addition, all windows should be rehabilitated. The broken glass in the single glazed units should be replaced. Where required, the wooden window frames and sashes should be scraped, primed, and painted. Operable, wooden storm windows should be installed over the existing windows.

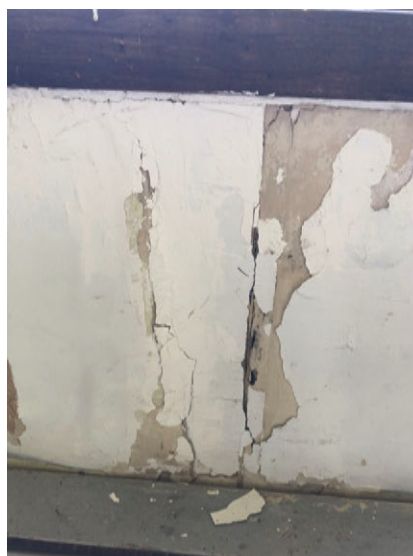
The interior walls' finishes are a mix of plaster and painted drywall, generally in fair condition. Throughout the house, minor cracks in the plaster are found, and paint is blistering and peeling. Damaged plaster should be patched and repainted to match existing. Where required, decaying paint should be scraped away and repainted to match existing. The drywall wall underneath the sliding window is significantly damaged by water, and all damaged drywall should be removed and replaced.

*Water damaged drywall underneath sliding window*

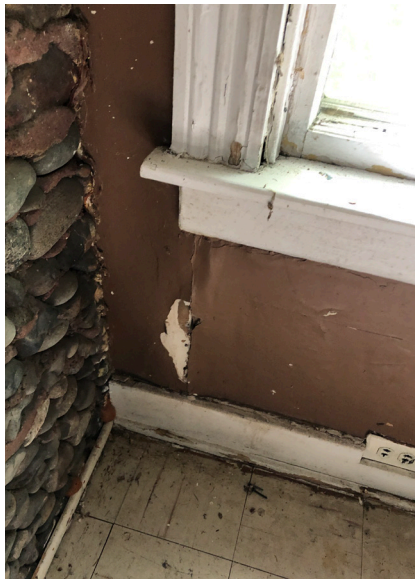
*Decaying drywall adjacent to amethyst fireplace in living room*

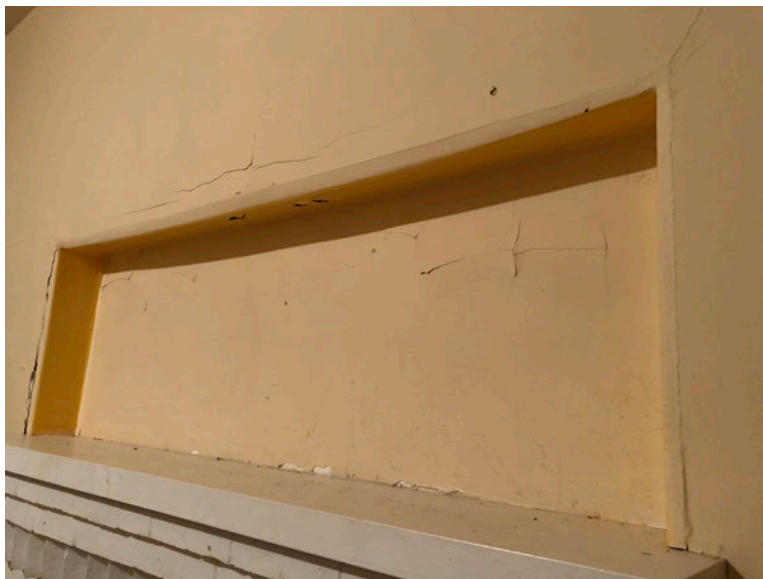
*Bowing lintel in kitchen, with cracking plaster or drywall*

The kitchen island should be removed. The existing kitchenette should also be removed and replaced with a barrier free kitchenette. The bowing lintel above the fireplace should be reinforced.

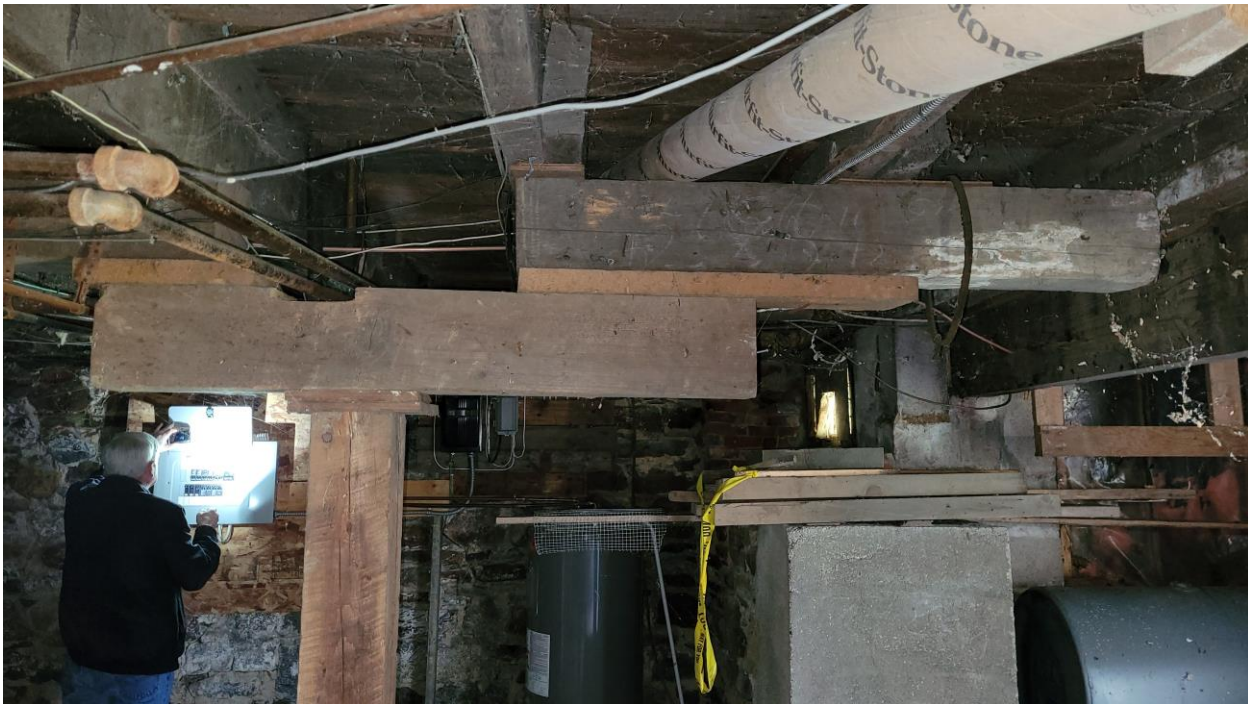
The main floor framing is framed with 3x8 joists spaced at about 27" c/c spanning 10'-0". These joists will require reinforcements for the reasons mentioned above. There is one particular section of floor framing which is completely unstable and inadequate. Refer to the photograph below.

This section of floor should be temporarily reinforced as soon as possible. A couple of jack posts will stabilize this area. The foundations walls for the original building are constructed with stone and they are generally in good condition. There is a crack in the foundation wall between the original building and the East addition and this should be repaired at some point. See the photograph on the following page.

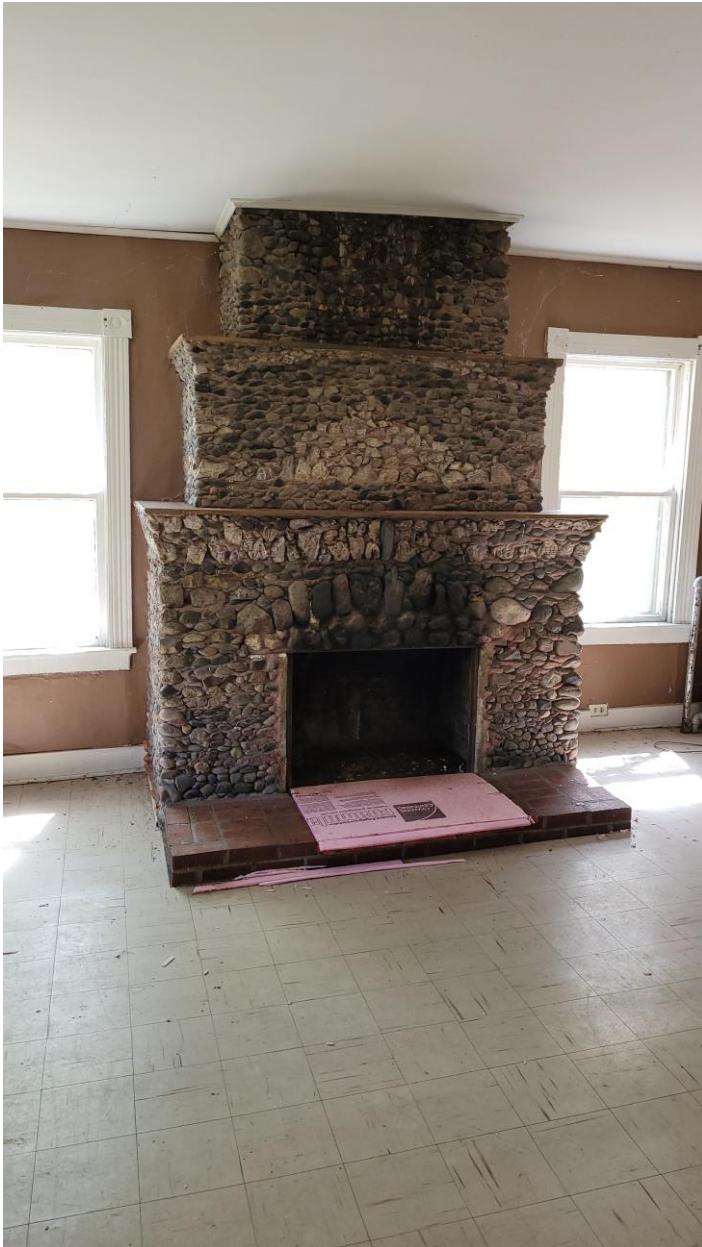
There is a large stone fireplace within the East addition, which is not completely supported from the basement below. In other words, the chimney upstairs is larger than the chimney support in the basement. It is recommended that the masonry chimney support within the basement be enlarged to match the chimney above. The fireplace is illustrated in the photograph below.

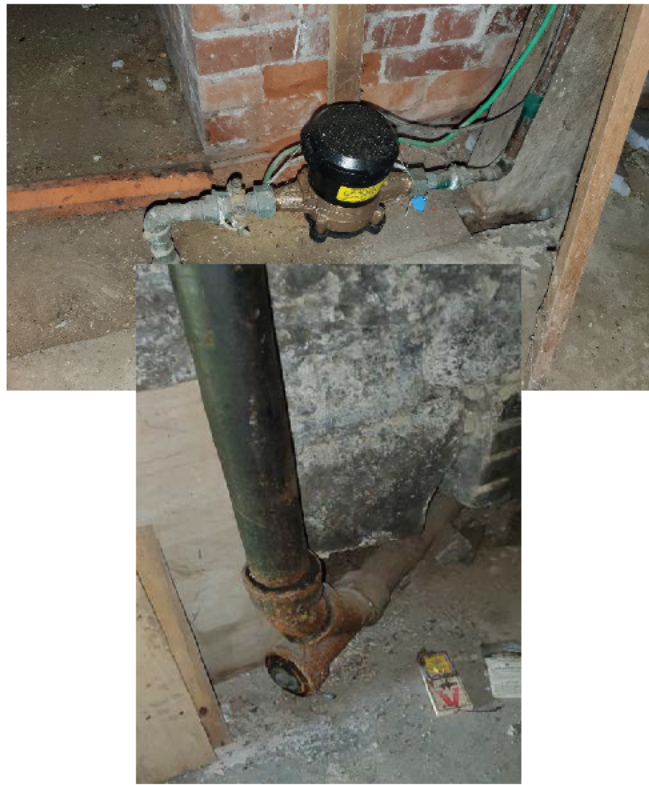
M1: Water Entrance

Plumbing fixtures appear original to when plumbing system where first installed in the building and are past their expected service life.

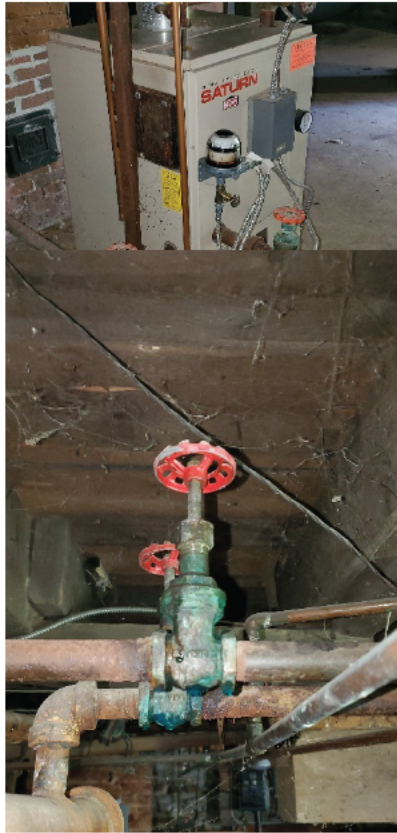
Fuel oil is stored in a 200 gallon single wall steel oil tank located in the basement below the stairs. The fill and vent pipe terminate below the porch stairs at the back of the cottage. The oil supply to the burner is flexible bare copper and has been run along the basement slab with a filter and Tiger Loop oil deaerator at the burner.

M4: Oil Fired Boiler

M5: Leaking valves

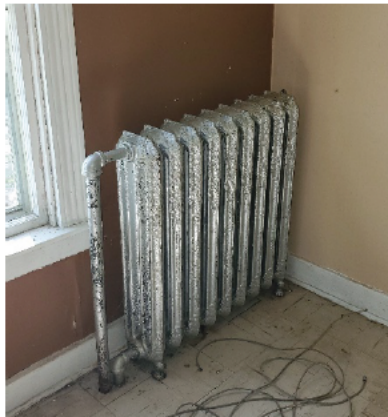
M6: Cast Iron Radiator

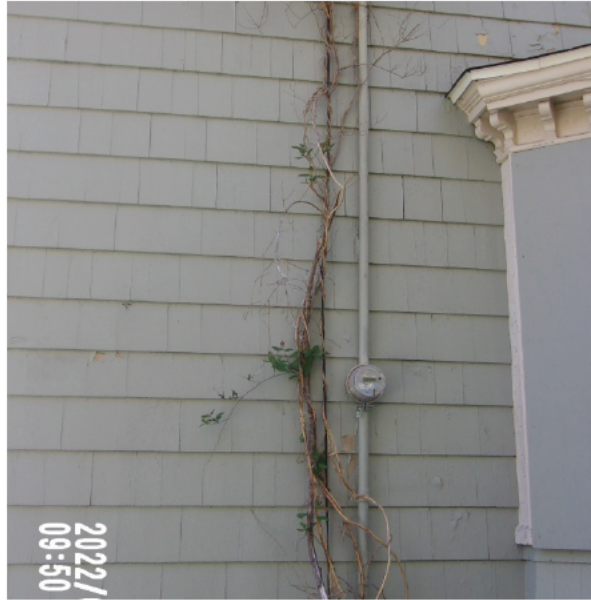
E1-Electrical Mast and Meter Base

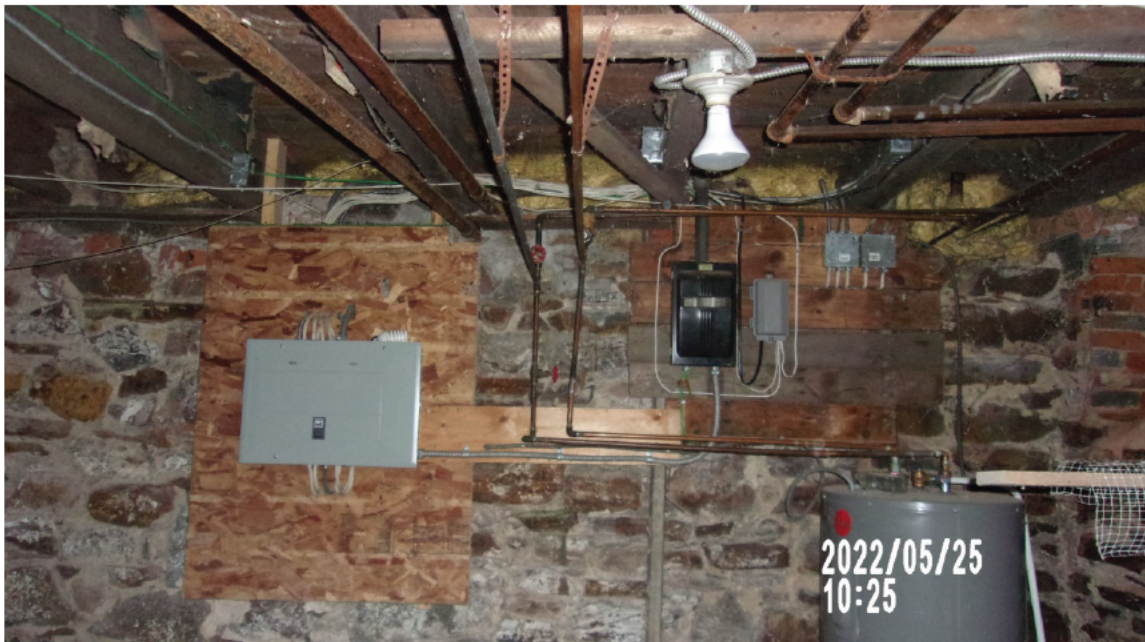
E2- Electrical Service Entrance Equipment

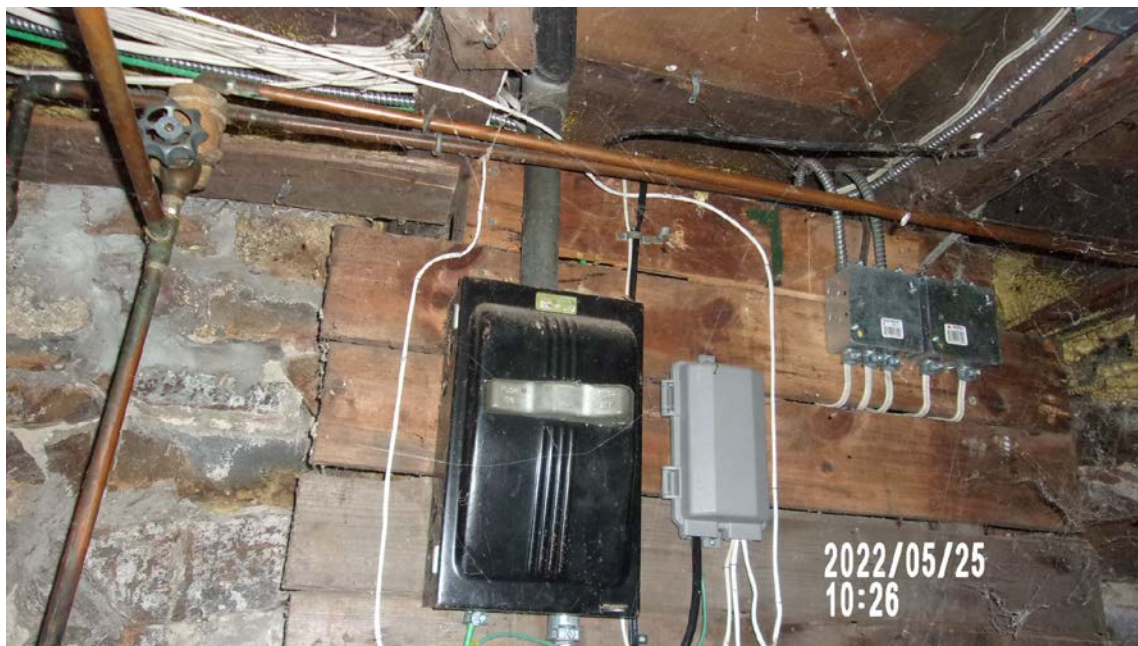
E3- Amalgamated Main Fusible Disconnect Switch Fused at 60 Amps.

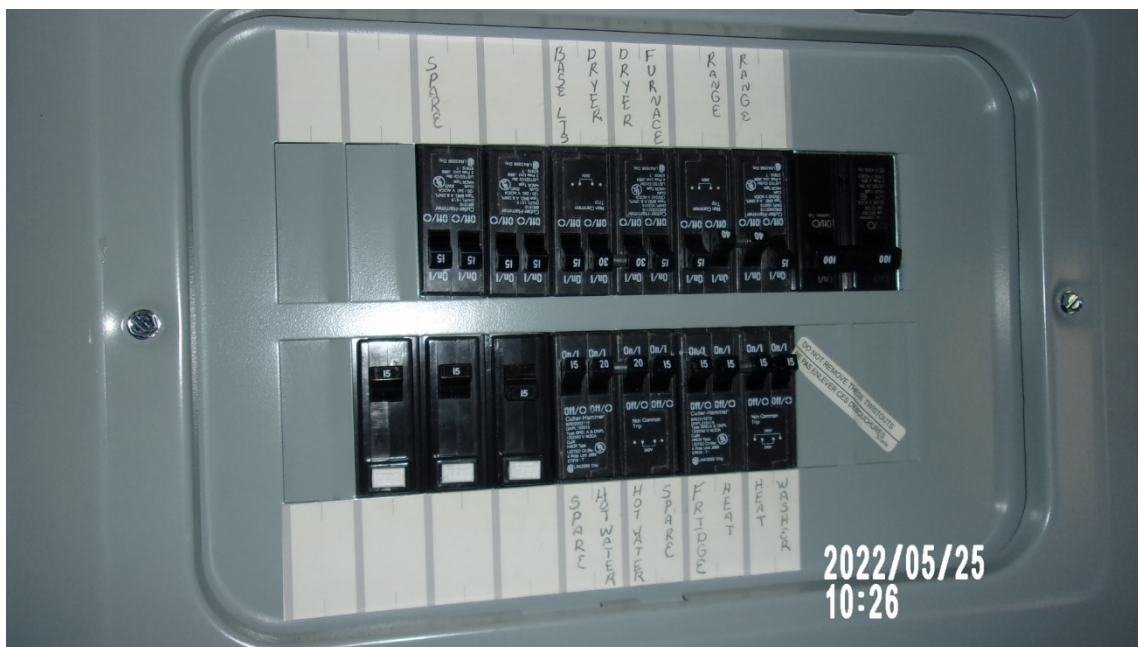
E4- Cutler-Hammer Electrical Load Centre, 16 Circuit Capacity with a 100A Main Breaker

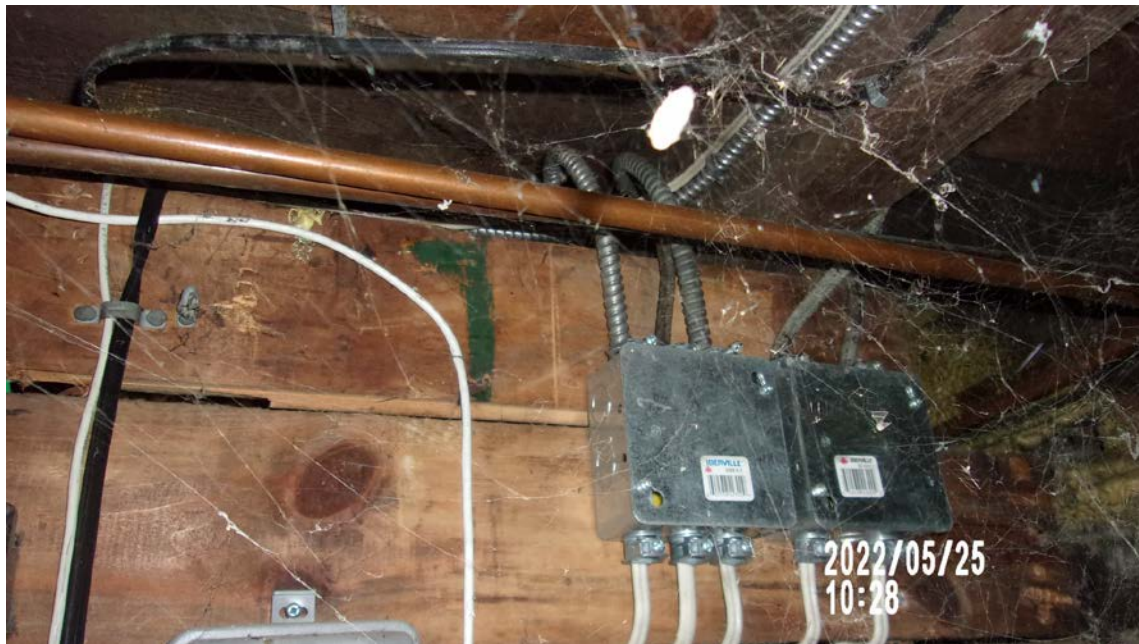
E5- Typical Wiring Methods Observed.

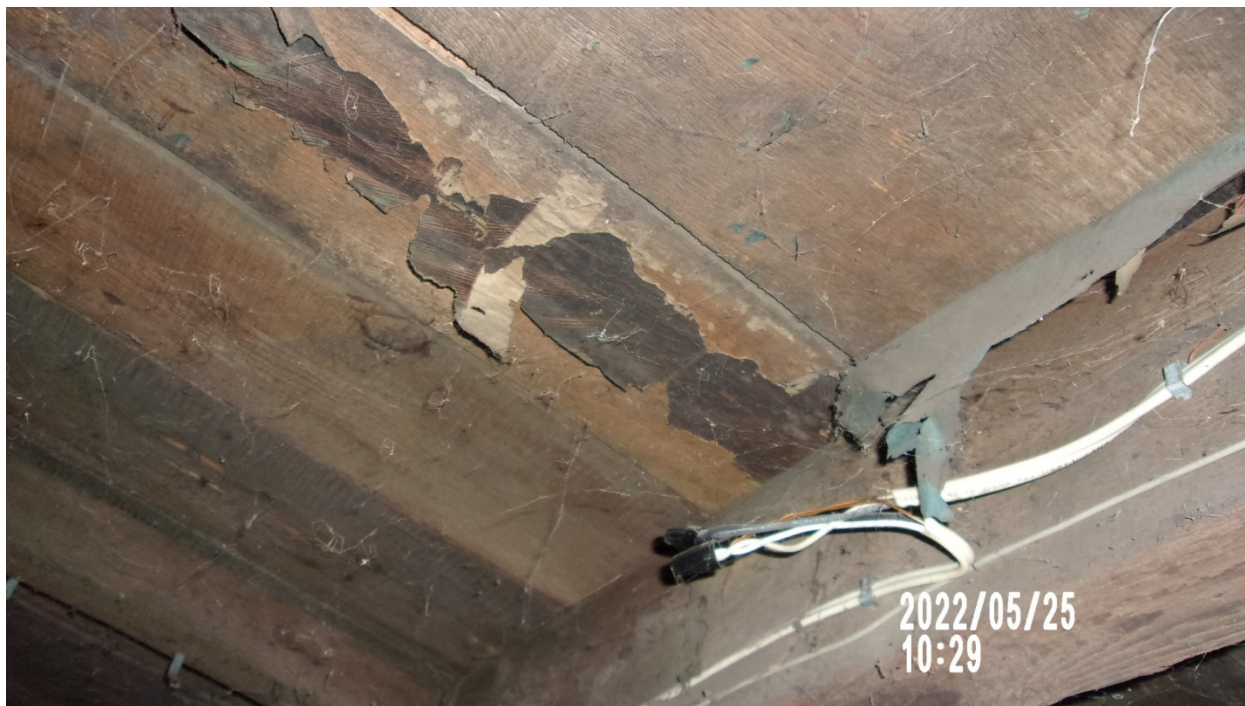
E6- Electric Joint Made Without Benefit of Junction Box.

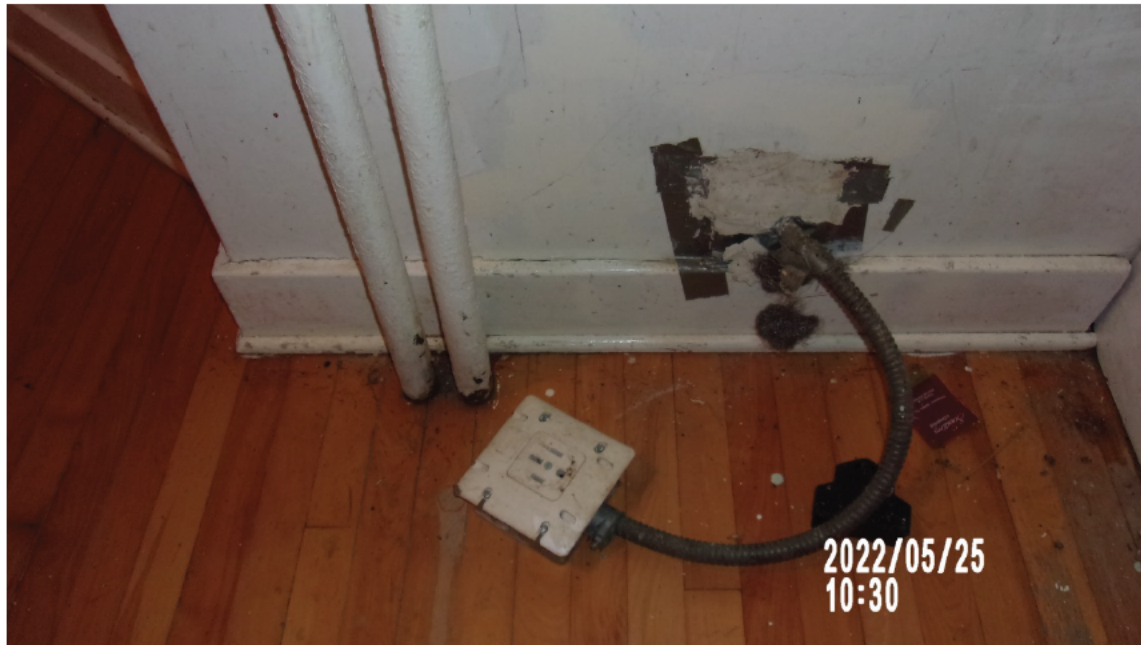
E8- Typical Appliance Receptacle

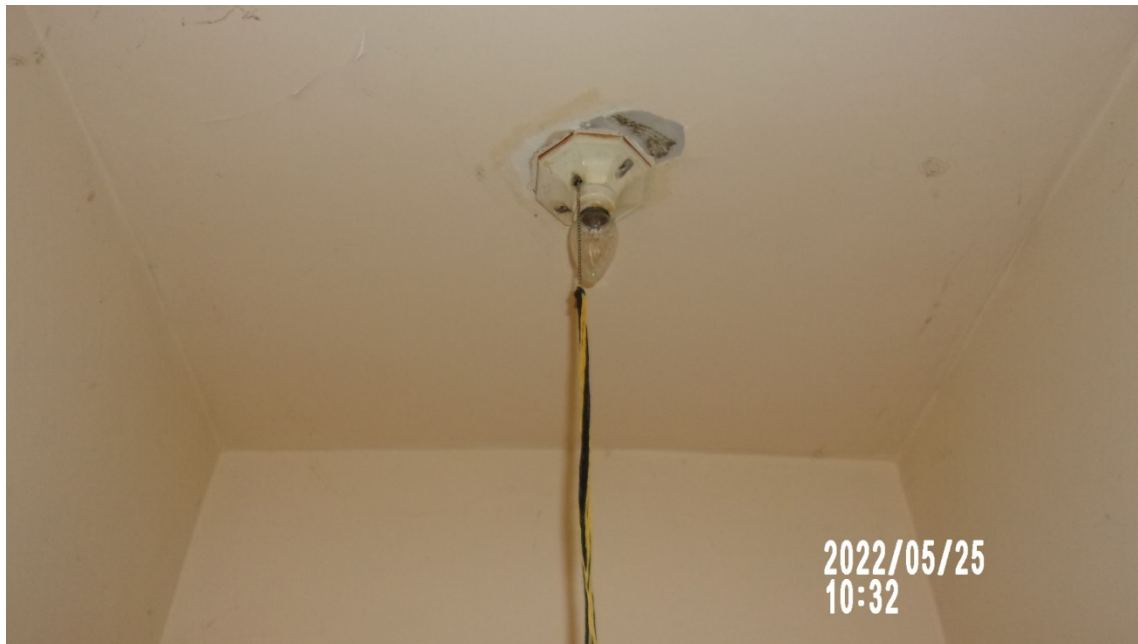
E8- Typical Light Fixture

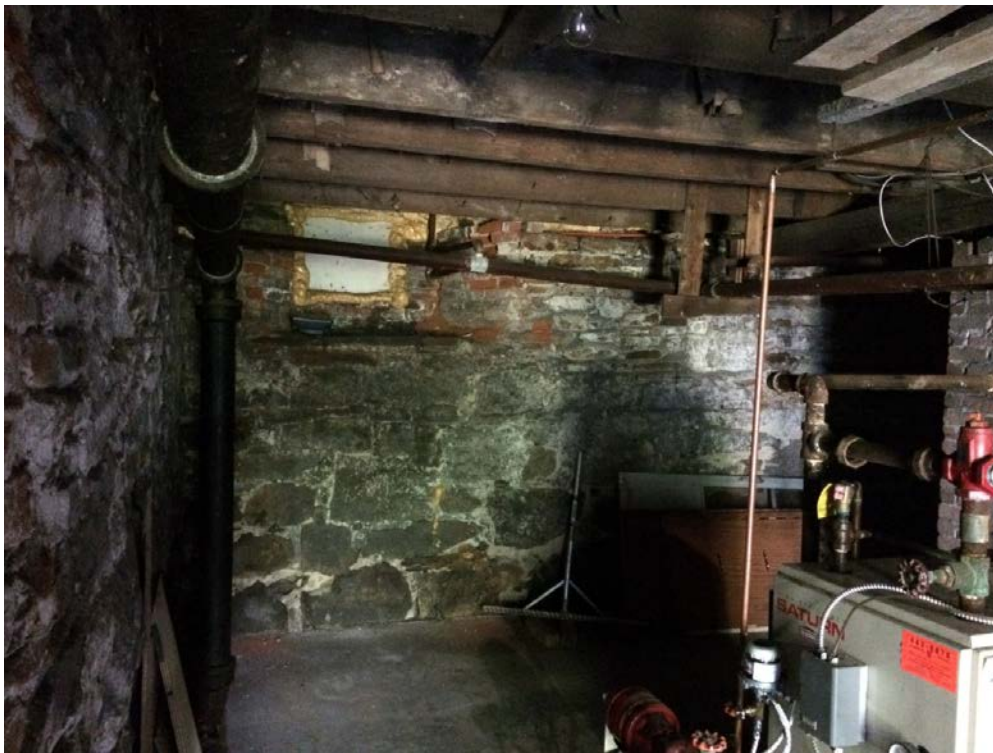
Figure 12 Ironstone foundation under original cottage

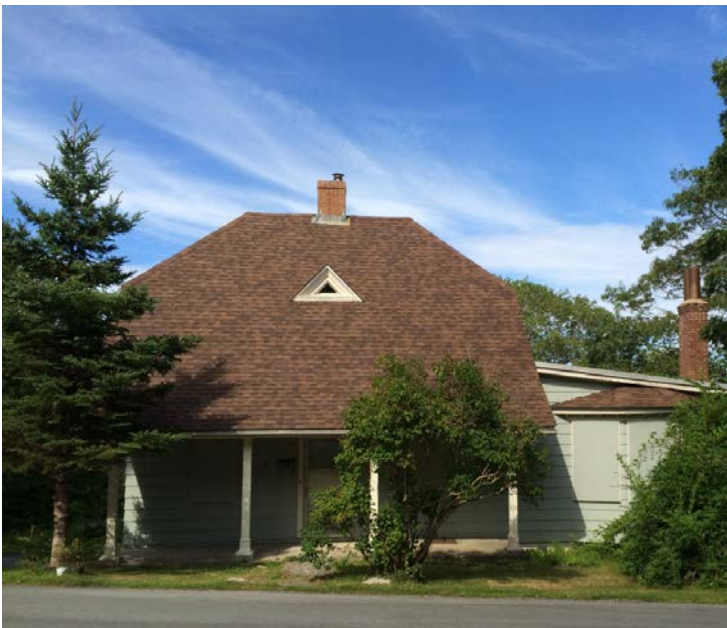
Figure 26 Cottage is very close to road

- II. Our recommendation is to access the cottage from a new parking lot near the barn. This would replicate the 1908 approach which was probably up a path up from the wharf, past the barn up to the cottage. Another parking lot could be constructed up the hill from the cottage, providing a garden loop between the parking lots, connecting the barn and the cottage and providing a safer approach to the cottage than the road. The garden loop should go through an existing gap in the stone wall which might have contained a garden gate. This path could be fully accessible, connect the barn and the cottage and could lead visitors to other pedestrian loops such as the Loop Road to the hill to the north where the summerhouse gazebo once stood and another to the shores of the Arm where the bathing/boathouse and wharf once existed.

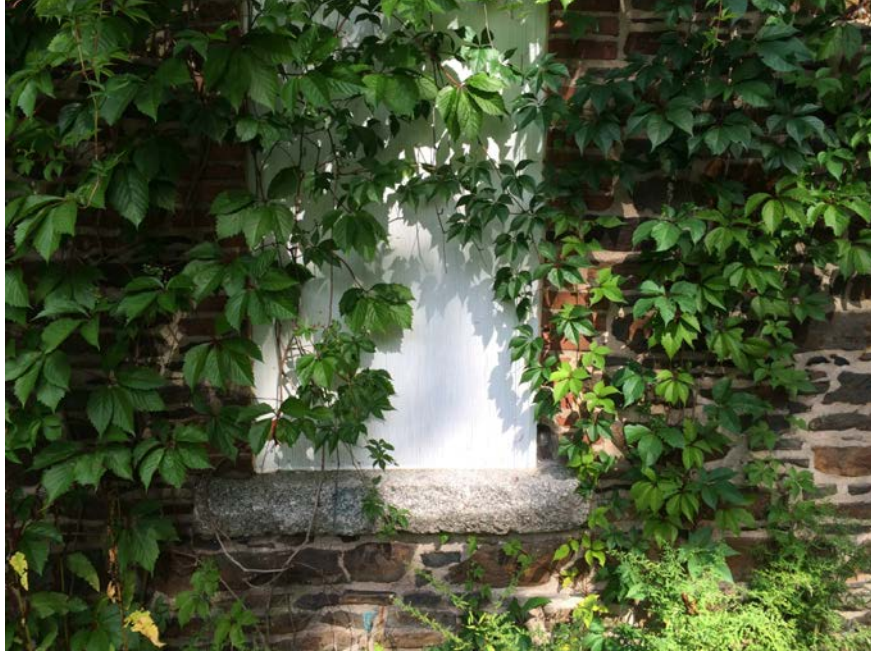
- I. The cottage is hard against the road making pedestrian access from the road a safety hazard. As the cottage still sits on its original iron stone foundation moving to a site further from the road is not recommended. Conservation principles support retaining the cottage on its original stone foundation

Figure 7 Ironstone foundation of original cottage
