Following our meeting on May 3, 2024, I am writing on behalf of our client, Adsum for Women & Children, in response to HRM's comments and questions regarding the application for non-substantive amendments to the development agreement for "Sunflower II".

**Re: Geotechnical Investigation – Proposed Additional Buildings  
Sunflower Property, Greenhead Road, Lakeside, NS**

Project Name: Addl Bldgs, Greenhead Road

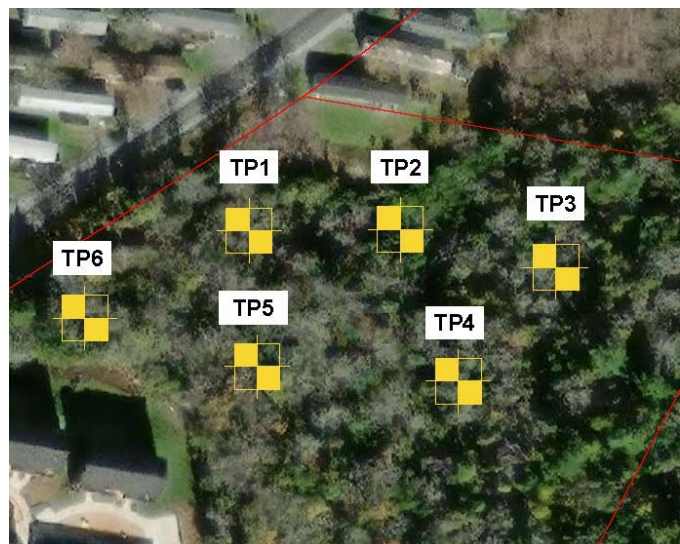
The field program consisted of six test pits (TP1 to TP6) completed on April 04, 2024. The test pit locations are shown in Figure A and on the appended Drawing 1.

The subsurface conditions encountered generally consist of rootmat/topsoil overlying glacial till overlying boulders or possible bedrock in the proposed building area. The glacial till consisted of silty sand with gravel. Boulders were encountered at the surface of the Test Pits. Slight seepage was observed in the two of the test pits. The test pits were excavated to depths up to 4.7 m.

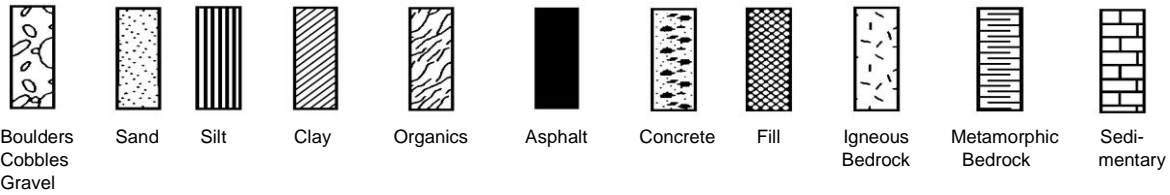
## STRATA PLOT

Strata plots symbolize the soil or bedrock description. They are combinations of the following basic symbols:

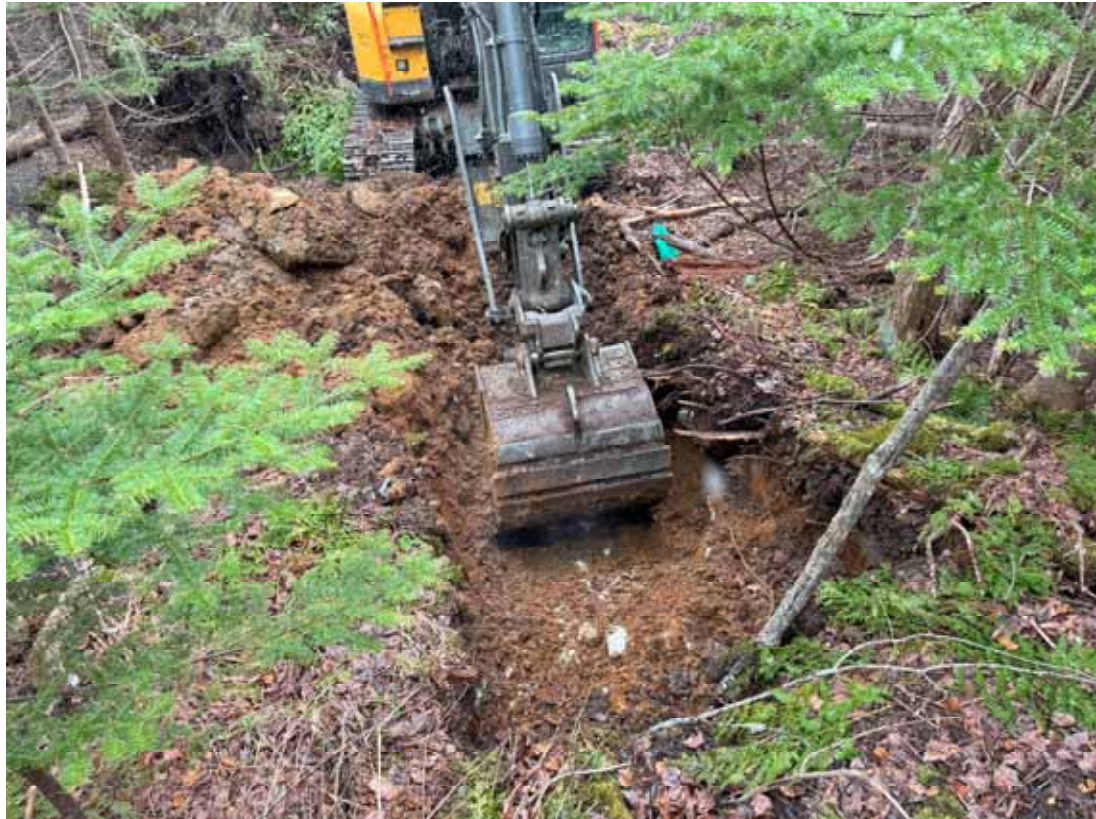
Photograph 1: Test pit 1. April 04, 2024.

TILL: Compact reddish to light brown silty sand with gravel -some large boulders			<b>BS</b>	<b>1</b>	
1							
					<b>BS</b>	<b>2</b>	
2			<b>74.3</b>				
		End of Test Pit -EXCAVATOR REFUSAL ON INFERRED BEDROCK -Groundwater seepage encountered at 0.8 m below ground surface					
3							
4							
5

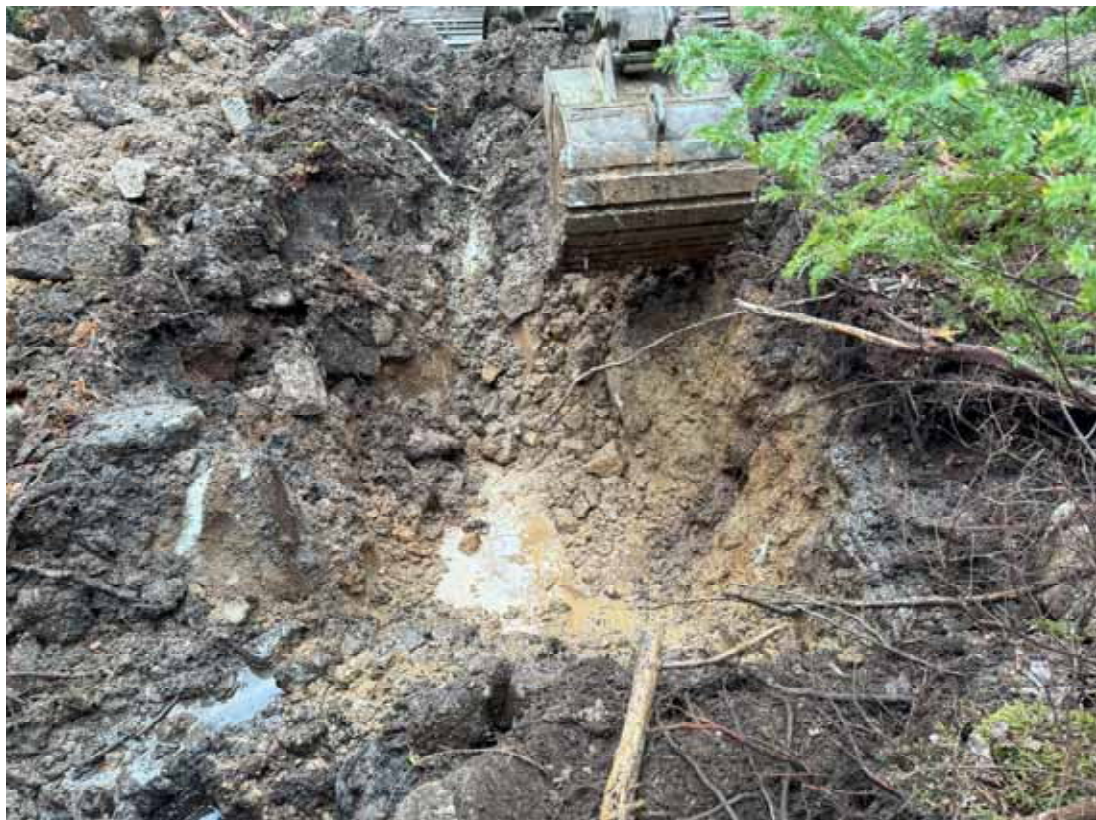
Photograph 2: Test pit 2. April 04, 2024.

-large boulders at the surface TILL: Compact brown silty sand with gravel -some boulders					
1							
2			72.4		BS	1	
		End of Test Pit - EXCAVATOR REFUSAL ON INFERRED BEDROCK *No seepage, but inflow from surface water					
3							
4							
5

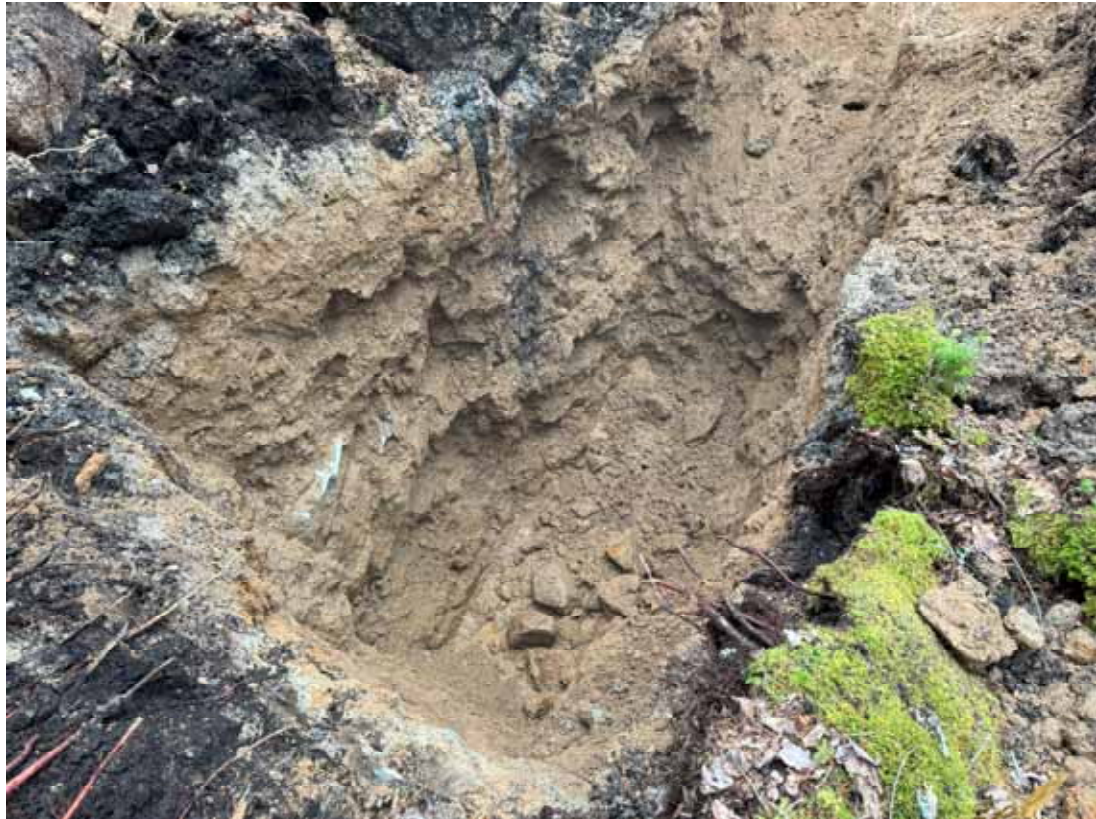
Photograph 3: Test pit 3. April 04, 2024.

TILL: Compact brown silty sand with gravel -some boulders	<b>74.2</b>				
1							
2							
3							
4							
			<b>69.9</b>				
5		End of Test Pit - EXCAVATOR REFUSAL ON INFERRED BEDROCK *No seepage, but inflow from surface water			BS	1

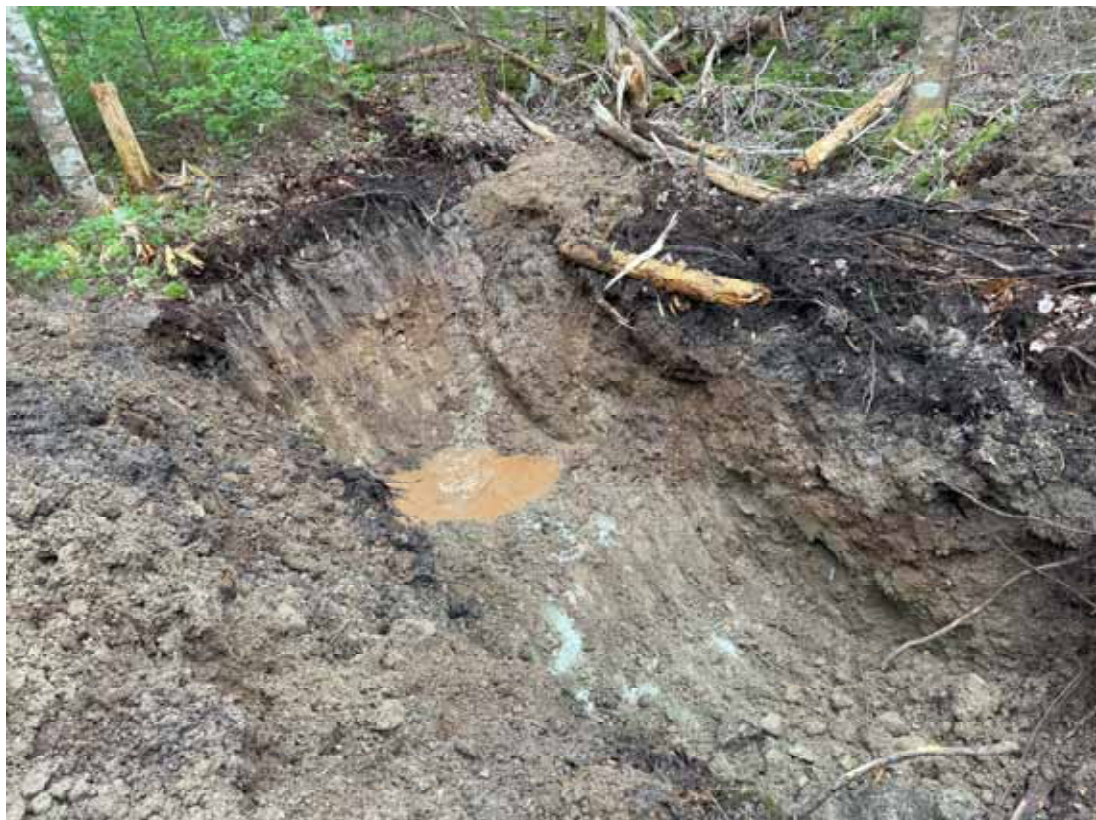
Photograph 4: Test pit 4. April 04, 2024.

TILL: Compact brown silty sand with gravel -some cobbles -some boulders					
1							
2			<b>77.0</b>				
		End of Test Pit - EXCAVATOR REFUSAL ON INFERRED BEDROCK *No seepage, but inflow from surface water					
3							
4							
5

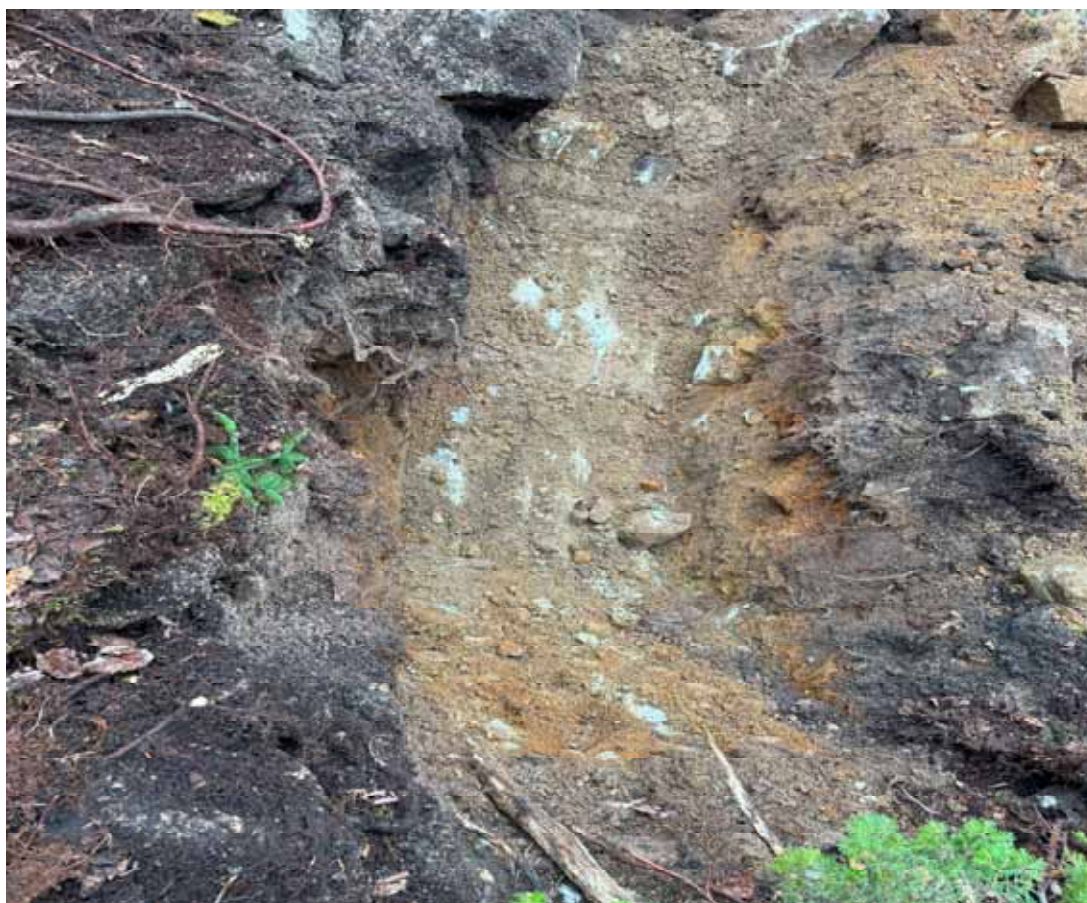
Photograph 5: Test pit 5. April 04, 2024.

TILL: Compact reddish to light brown silty sand with gravel			BS	1	
1							
					BS	2	
2			79.6				
		End of Test Pit - EXCAVATOR REFUSAL ON INFERRED GRANITE BEDROCK -Slight seepage observed at the bottom of the test pit					
3							
4							
5

In “Test Pit 5”, BME identified the presence of bedrock. However, the location of “Test Pit 5” is intended for parking spaces. BME noted that the proposed site layout was suitable for the intended development.

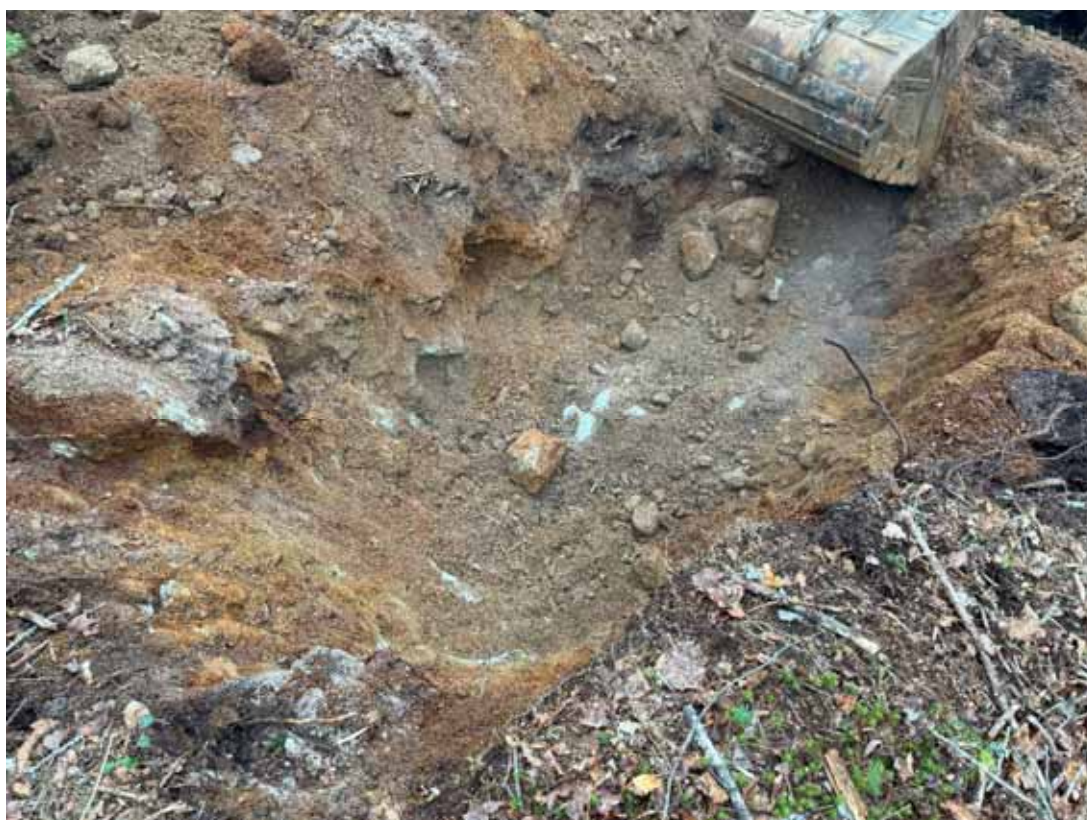
Photograph 6: Test pit 6. April 04, 2024.

SUBSURFACE PROFILE				SAMPLE			Comments
Depth (m)	Symbols	SOIL AND/OR ROCK DESCRIPTION	Elevation (m)	Water Level (m)	Type	Number	
0		<b>Ground Surface</b>	82.7				
		ROOTMAT/TOPSOIL -some large boulders	82.4				
		TILL: Compact reddish to light brown silty sand with gravel -some boulders					
1					BS	1	
2					BS	2	
			80.5				
		End of Test Pit - EXCAVATOR REFUSAL ON INFERRED BEDROCK *No seepage observed					
3							
4							
5

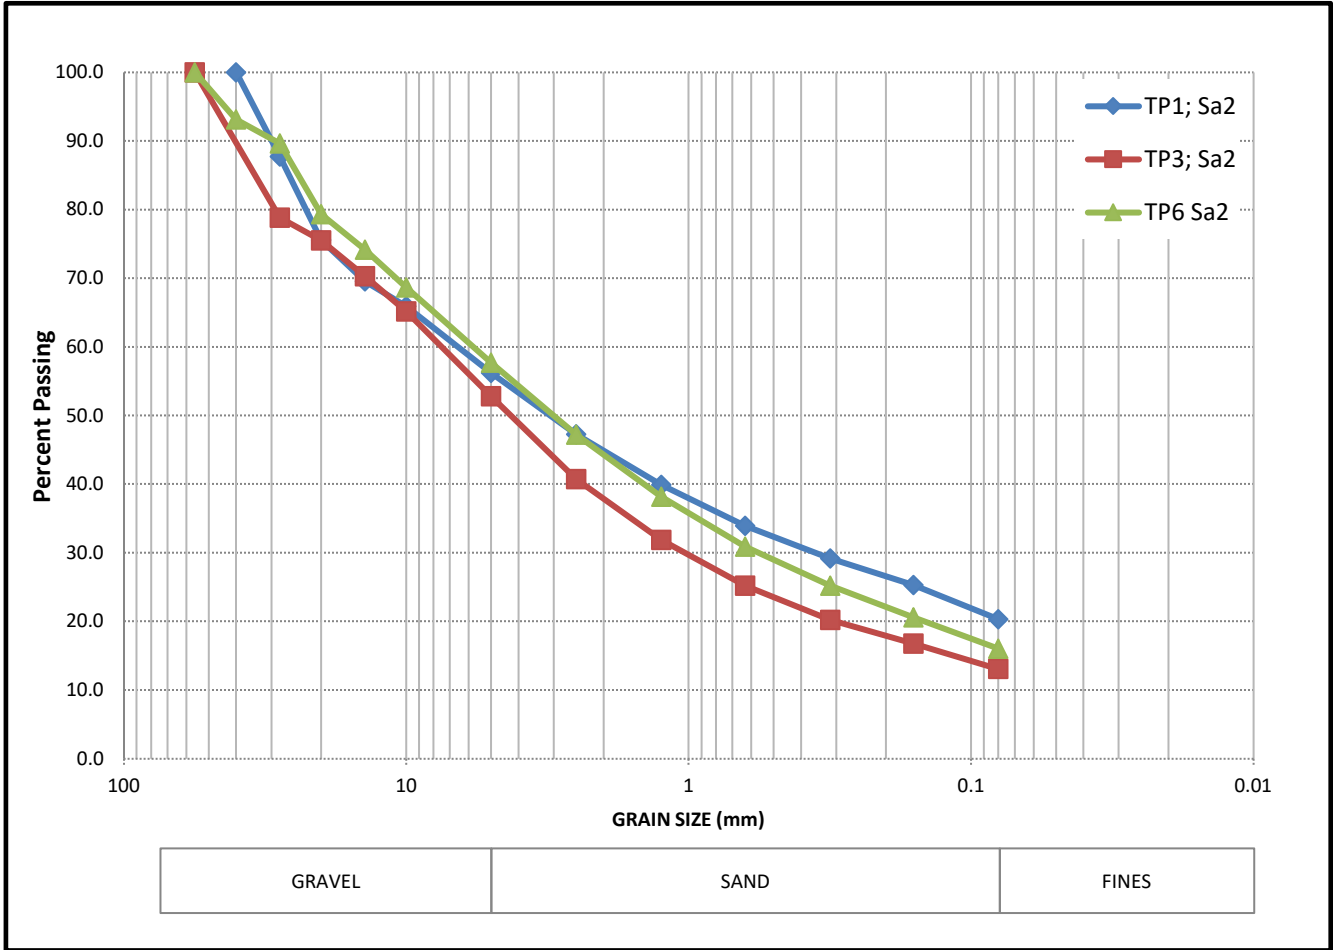
**GRAIN SIZE DISTRIBUTION PLOT**

Sample No	Depth	Classification	Moisture Content (%)	Gravel (%)	Sand (%)	Silt and Clay (%)
TP1; Sa2	1.5 m	Silty sand with gravel	18.0	44	36	20
TP3; Sa2	3.7 m	Silty sand with gravel	9.4	47	40	13
TP6 Sa2	1.6 m	Silty sand with gravel	14.9	42	42	16

Grain size testing was conducted on three samples of the silty sand glacial till from the investigation. The results from the sample show 42% to 47% gravel, 36% to 42% sand, and 13% to 20% fines. The moisture contents of the samples were 9% to 18%. The grain size distribution curve is shown in Figure 1 in the Appendix.

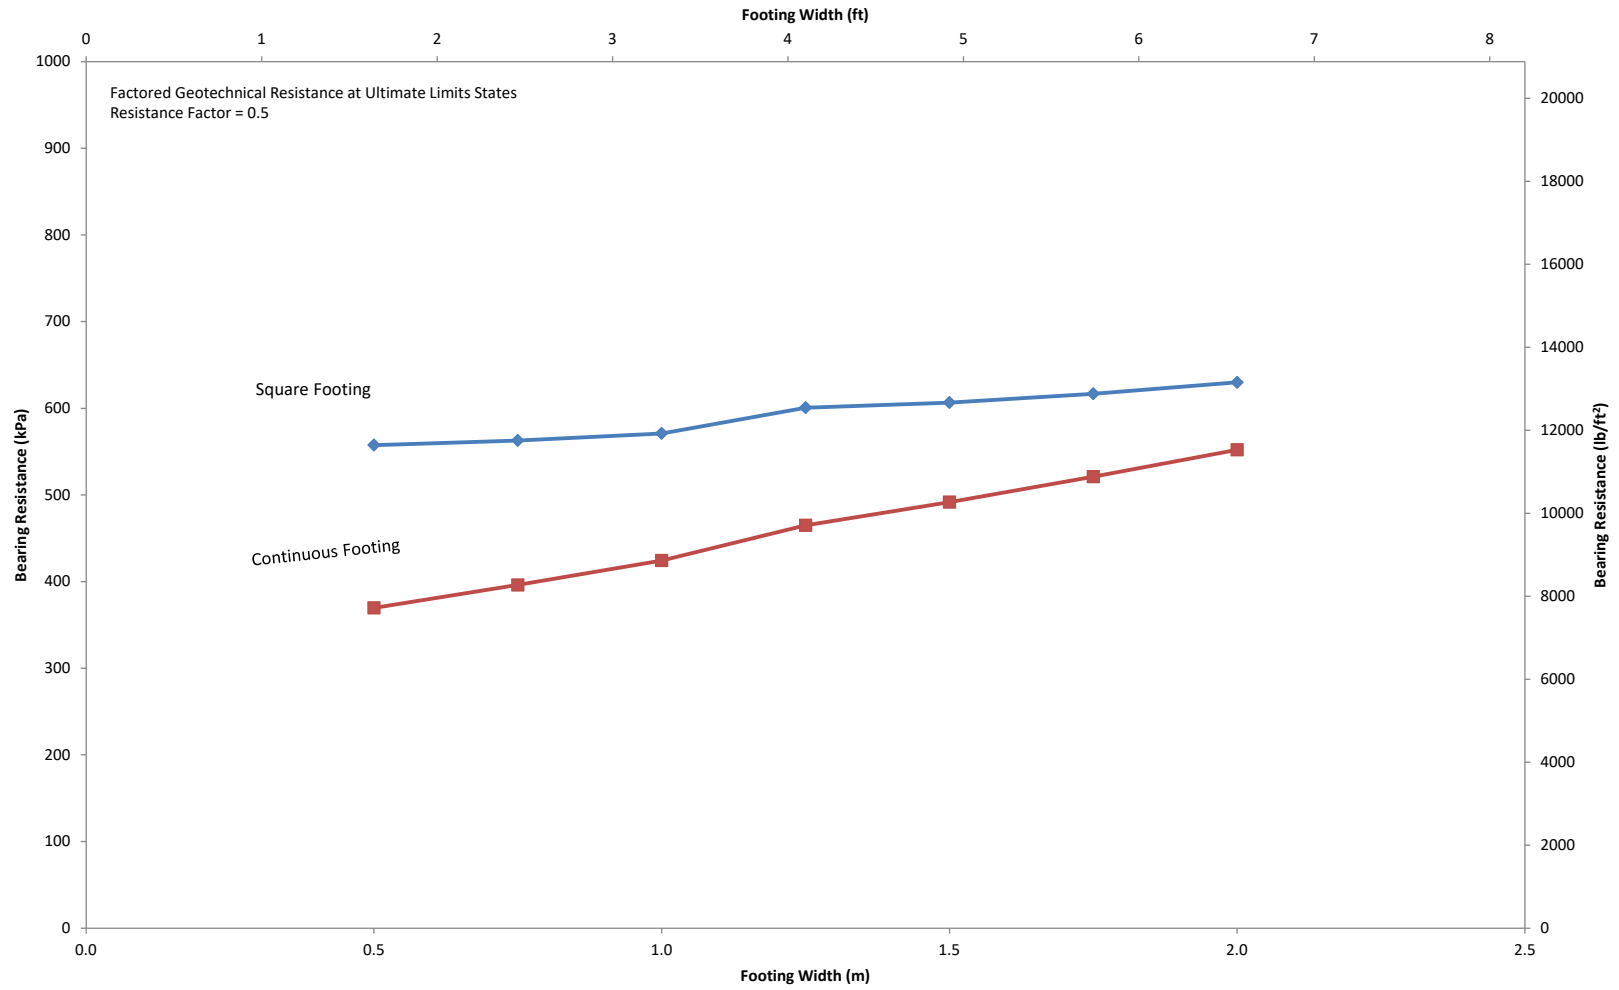
Figure 1

### FACTORED ULS BEARING RESISTANCE (Glacial Till or Approved Fill)

For analysis using Limit States Design, we calculated bearing capacities for square and strip footings up to 2.5 m for a settlement tolerance of 25 mm. Other bearing capacities for other footing sizes (or settlement tolerances) can be provided at your request. Bearing resistance values for square and strip footings found on glacial till or structural fill are plotted on Figures 2 and 3 in the Appendix. Bearing values for foundations on bedrock would be much higher and can be provided if necessary.

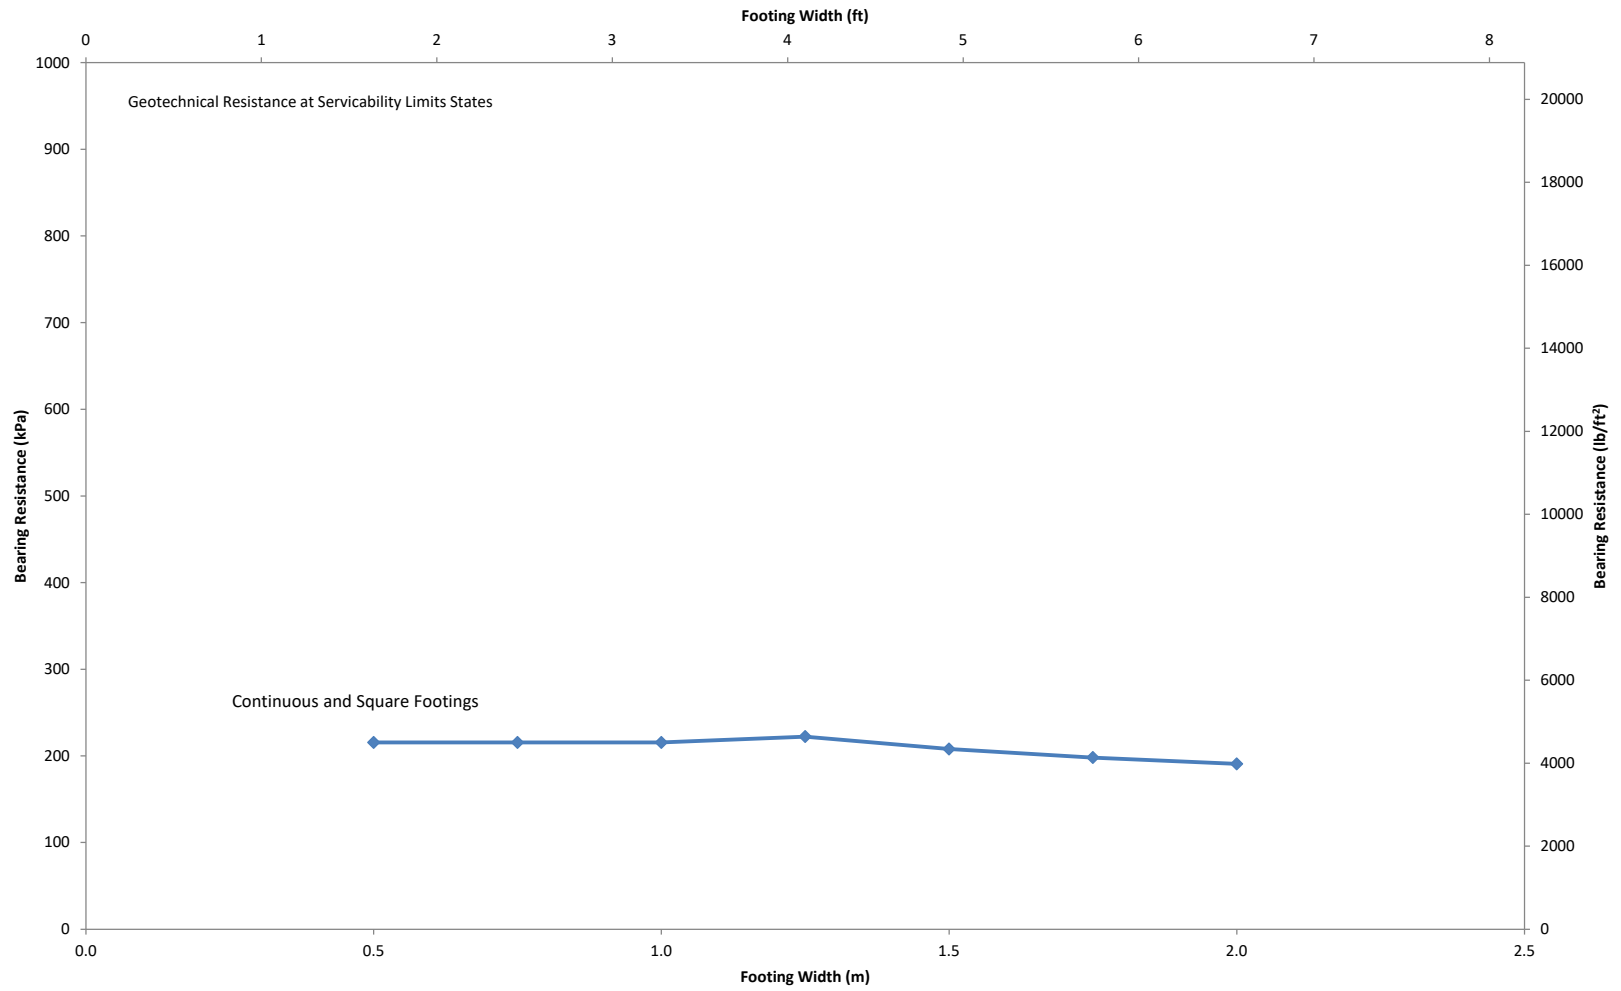
Figure 2

### SLS BEARING RESISTANCE (Glacial Till or Approved Fill)
