Subject: **Test Pit Soil Investigation Report - Civic Nos. 5249 St. Margarets Bay Road PID No. 41454133), Upper Tantallon, Nova Scotia**
Englobe reference: 2301273.001

Site Plan Showing Test Pit Location

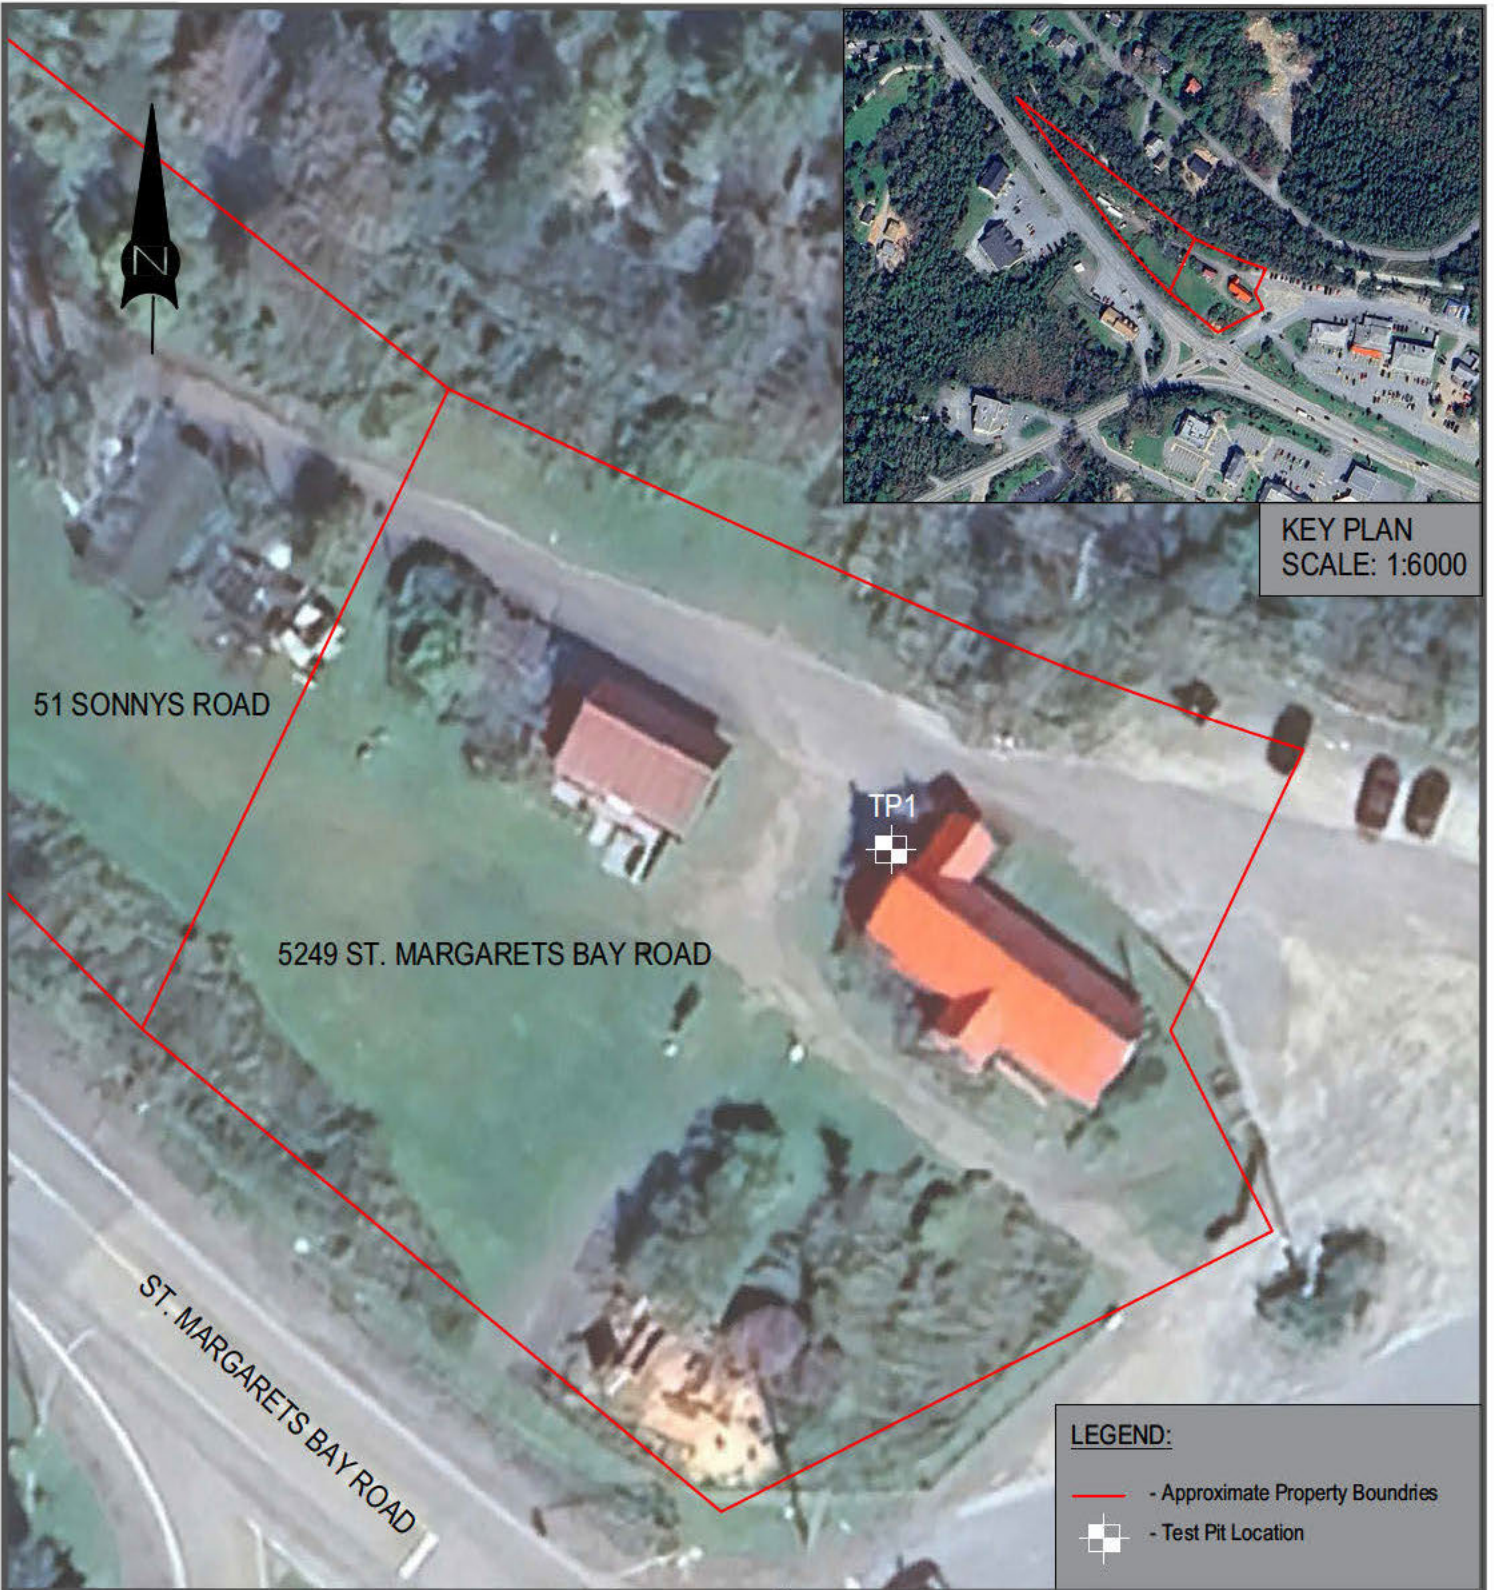
Discipline:	Environment	Prepared by:	Verified by:
Scale:	1: 500	EPC	EPC
Date:	August 2024	Drawn by:	Approved by:
Page setup:	Paper size:	JJ	RB
	8.5X11	Figure no:	1
		Register no.:

- - Approximate Property Boundaries
- Test Pit Location

On July 24, 2024, Englobe supervised the test pit investigation to assess subsurface conditions for potential PHC impacts in the area of the abandoned and current AST. The program involved excavating one test pit (TP1) at the location shown in Figure 1 of Appendix A. The excavation was carried out by the property owner using a 6-ton tracked excavator.

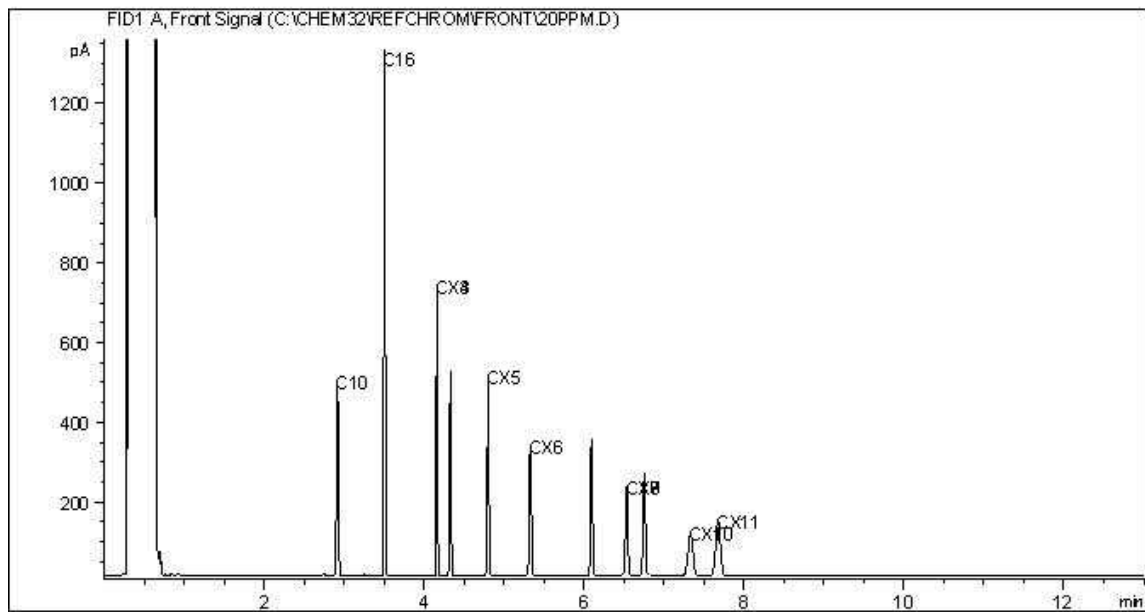
Carbon Range Distribution - Reference Chromatogram

Gasoline:	C4 - C12	Diesel:	C8 - C22
Varsol:	C8 - C12	Lubricating Oils:	C20 - C40
Kerosene:	C7 - C16	Crude Oils:	C3 - C60+

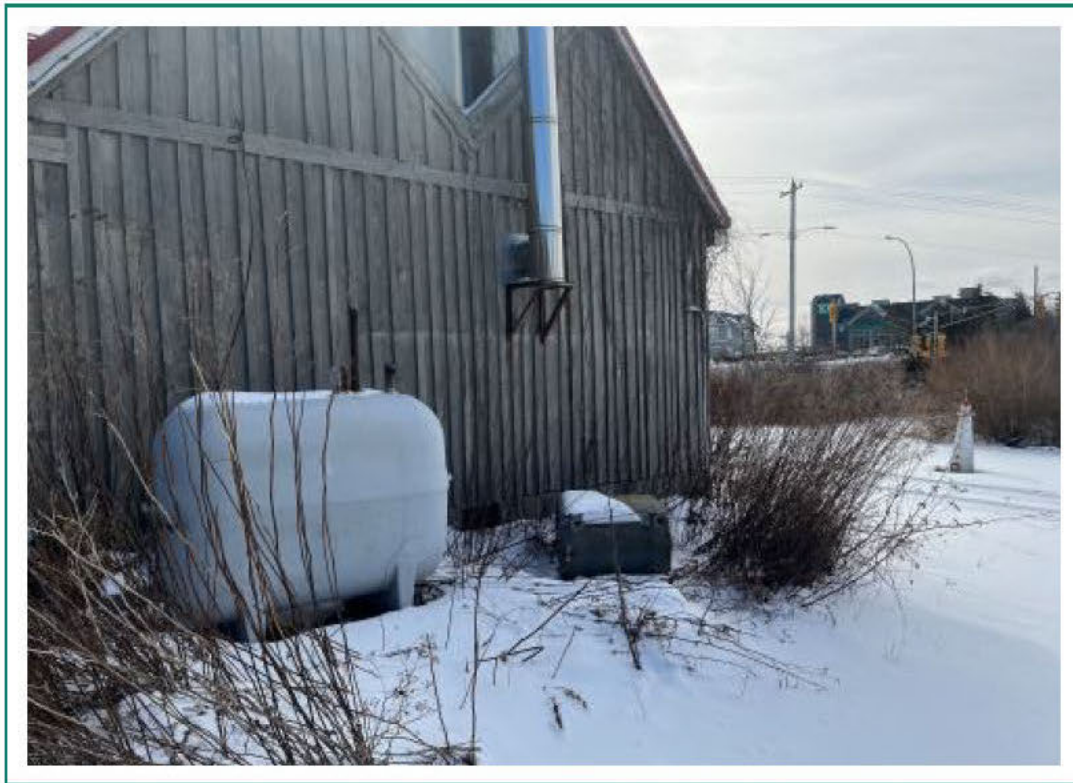
Photo 1: Photo looking south showing fibreglass fuel oil AST and the abandoned steel AST on the west side of 5249 St. Margarets Bay Road (February 28, 2023).

During the site visit for the Phase I ESA, an abandoned steel fuel oil aboveground storage tank (AST), lying on its side, was observed along the west side of the building at 5249 St. Margarets Bay Road, next to a 2006-stamped fuel oil AST that was in use at the time. The abandoned AST (450-L, date stamped 2012) appeared to be the same AST observed during a previous Phase I ESA conducted by Englobe in 2014. The abandoned AST was removed from the site before the test pit program conducted on July 24, 2024.

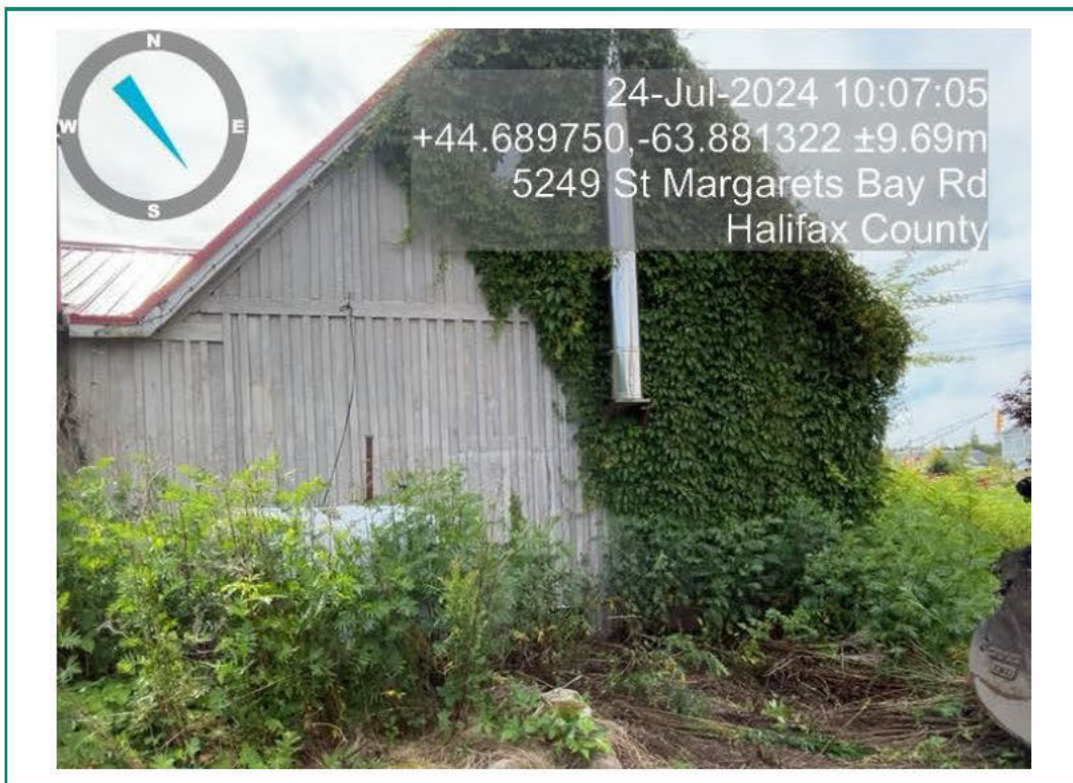
Photo 2: Photo looking southeast showing fibreglass fuel oil AST and location of old, abandoned steel AST on the west side of 5249 St. Margarets Bay Road.

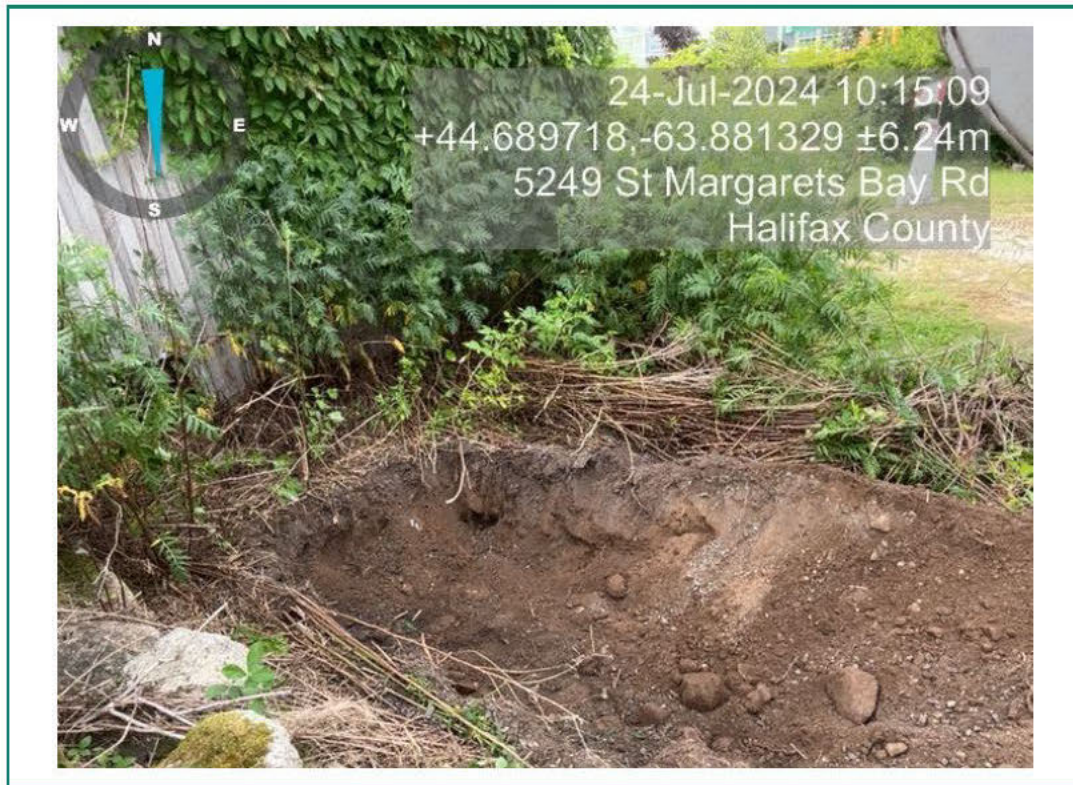
The subsurface geological conditions observed during the test pit investigation consisted of a grassed surface and topsoil layer followed by fill material. The fill was primarily loose sand with some gravel, moist, and brown in color. The test pit was terminated within this fill material at a depth of 0.61 meters below ground surface (mbgs). Groundwater was not encountered. Site photographs can be found in Appendix D.

Photo 3: TP1 in location of old, abandoned AST.

Based on the site conditions encountered during the test pit excavation program and analytical results obtained, no environmental concerns were identified at the subject site.

No further site assessment work is recommended.

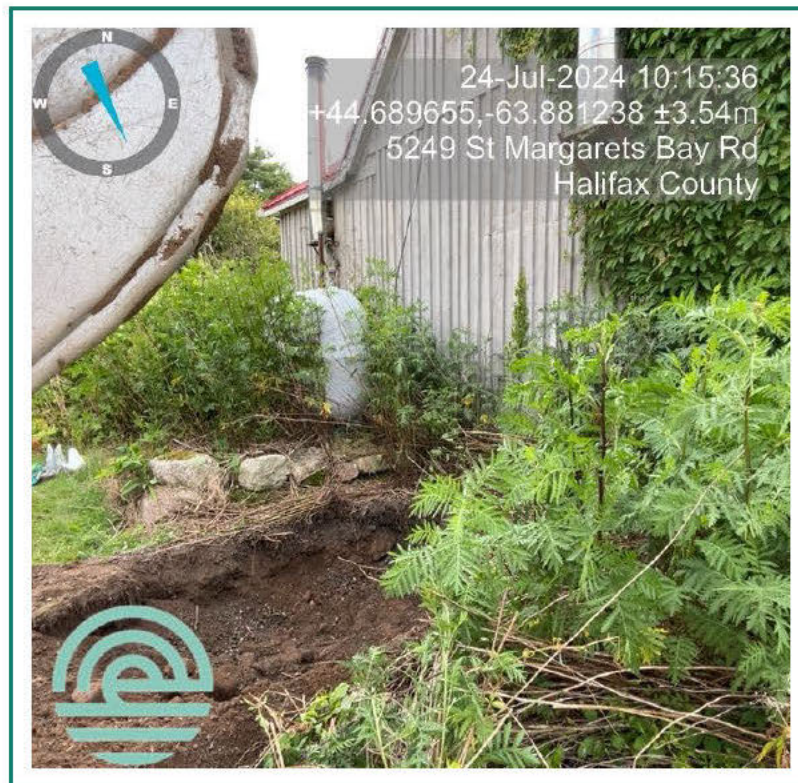
Photo 4: Photo looking northeast showing fibreglass fuel oil AST and TP1 location.
