Item No. 9.1.3
Heritage Advisory Committee
November 26, 2025

SUBJECT: **Case HRTG-2025-01649: Substantial Alteration to Multiple Municipally Registered Heritage Properties on College and Carlton Streets in Halifax**

An application by ZZap Inc. to substantially alter the municipally registered heritage properties located at 5969 College Street, 1456 Carlton Street, 1460 Carlton Street, 1466 Carlton Street, and 1468 Carlton Street, Halifax.

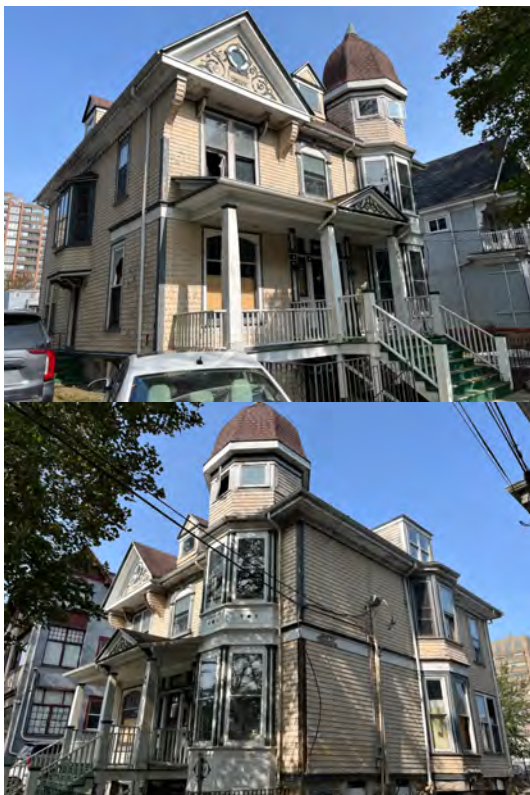
Gold Cure Institute, 5969 College Street, Halifax (1894)

- Original 2.5-storey Queen Anne style building;
- Asymmetrical façade;
- Eight-sided, three-storey tower with a bell-style roof and a pointed cap;
- Double-storey bay window in the aforementioned tower, with windows framed on the sides by small pilasters, panel mouldings below, and simple cornices above;

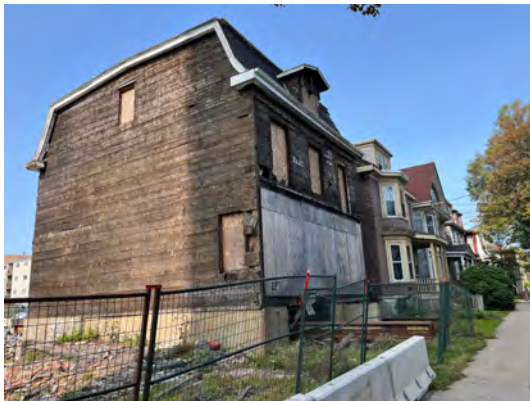
Photo of the current condition

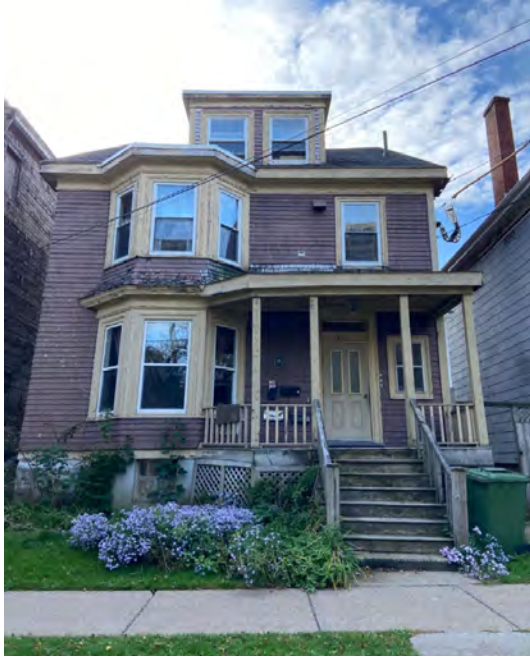
Neal Residence, 1460 Carlton Street, Halifax (1865)

- Original two-and-half-storey building;
- Asymmetrical facade;
- Gable roof;
- Stone foundation;
- Two-storey bay window with a bell cast eave divides the main and upper floor ;
- Half-width and hipped-roof front porch with turned posts, brackets and balustrades;
- Central shed dormer with two windows and corner boards;
- Entry door with single transom window;
- Windows with wood decorative trims;
- Wood shingle cladding.

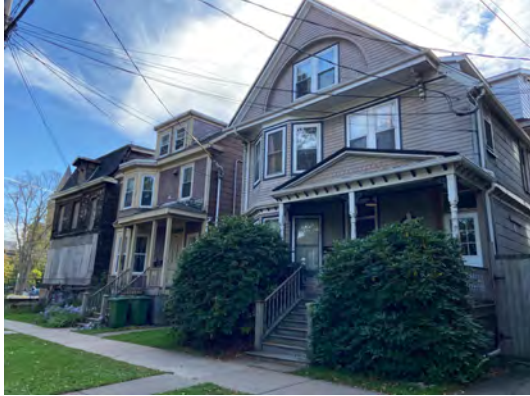
Keith Residence, 1466 Carlton Street, Halifax (1906)

- Original two-and-a-half-storey Queen Ann Style building;
- Asymmetrical façade;
- Full-width projecting front gable with a pair of windows set within a recessed arched panel, and two large brackets;
- Half-width pedimented front porch with brackets, turned posts, fish scale shingles, and turned spindles;
- Stacked bay windows under the main soffit;
- Brick chimney
- Oval windows with stained glass and “keystone” decoration;
- Double-hung windows with surrounding trims;
- Main entry door with single transom;
- Cornice with small brackets runs from the bay window to the porch;
- Shingle claddings.

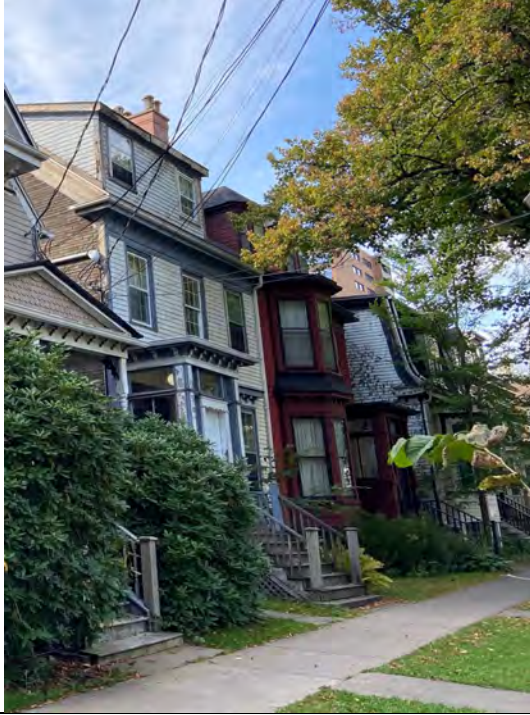
Tupper Residence, 1468 Carlton Street, Halifax (1866)

- Original 2.5-storey Halifax House style building;
- Asymmetrical façade with 3-bay arrangement and entry on one side.
- Truncated hip roof;
- Cornice with brackets on the second floor;
- Enclosed porch with brackets, entry door with side and transom lights, decorative panels and pilasters;
- Stone and brick foundation;
- Three double-hung windows with simple trims on the second floor;
- Two double-hung windows with lintel and brackets;
- Wood shingle cladding and corner boards;
- Brick chimney.

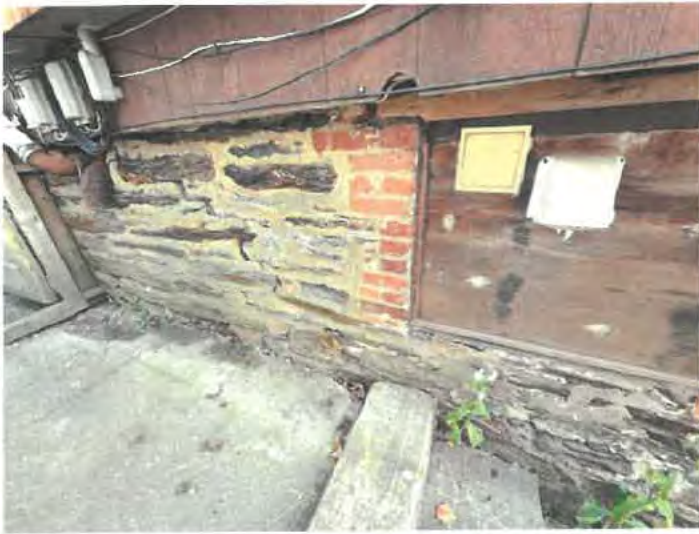
Photo No. 1 – Stepped settlement and wall deterioration in stone masonry.

Each of the building foundations display signs of weathering when viewed above grade. Civic No. 1460 displays weathered and broken parging over the masonry foundation walls. Civic No. 1466 was constructed of cast concrete. Weathering of the concrete can be observed. Civic No. 1468 displays weathered brick masonry at the front with a cast concrete overpour at the back of the front section. (Photos No. 1, 3, and 5)

For the long term and to provide for a safe modern occupied living area below grade, we recommend that the foundations of these three buildings be reconstructed. This can be done by supporting the timber frame of the existing residence temporarily while the existing foundations are removed and replaced. The new foundations would be of concrete construction. Footings and walls can be sized to meet current code requirements. Proper waterproofing and perimeter drainage can be provided.

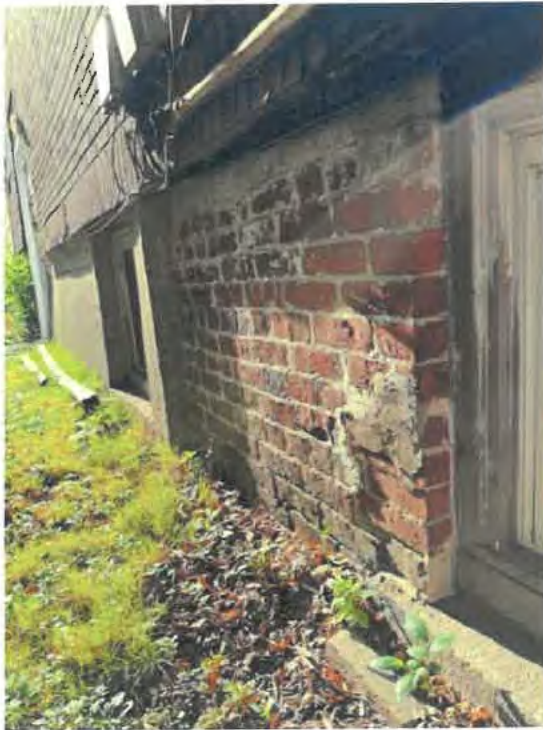
Photo No. 3 – Deteriorated brick masonry. Inward movement at grade. Concrete added to wall face in background.

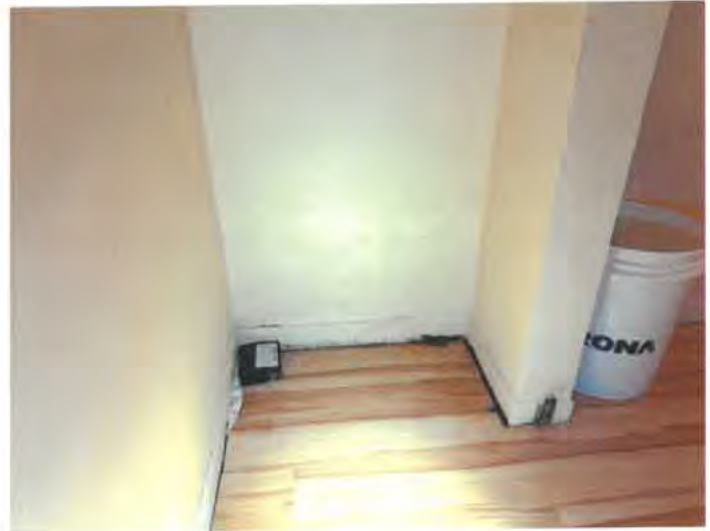
Photo No. 4 – Black staining at interior space.

The interior of the basements was observed during the site visit. The areas observed have signs of moisture penetration through the foundation walls. There are also indications of movement in the walls with the walls being pushed towards the residence interior due to ongoing seasonal freezing of the soil at the exterior face of the walls. Efflorescence (white deposits) could be observed on the interior face of the walls where openings had been cut in the interior drywall finishes. This is an indication of moisture penetration through the wall by groundwater. (Photos No. 4 and 6)

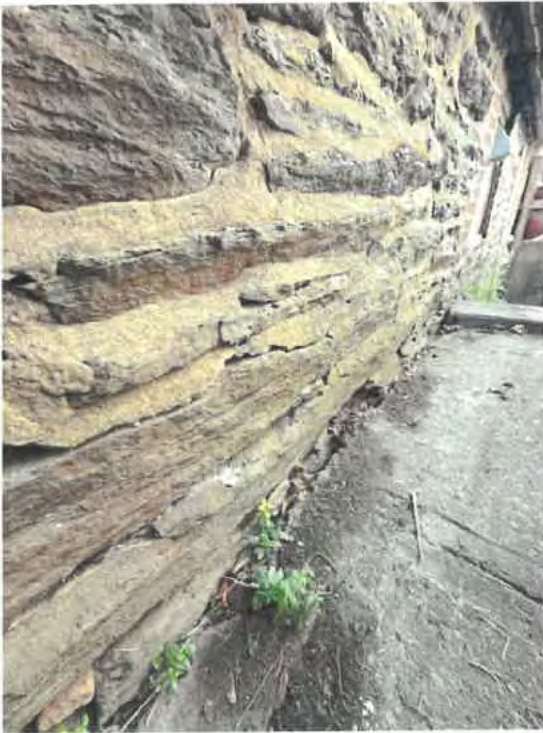
Photo No. 5 – Deteriorated stone masonry with open mortar joints and inward lean into basement.

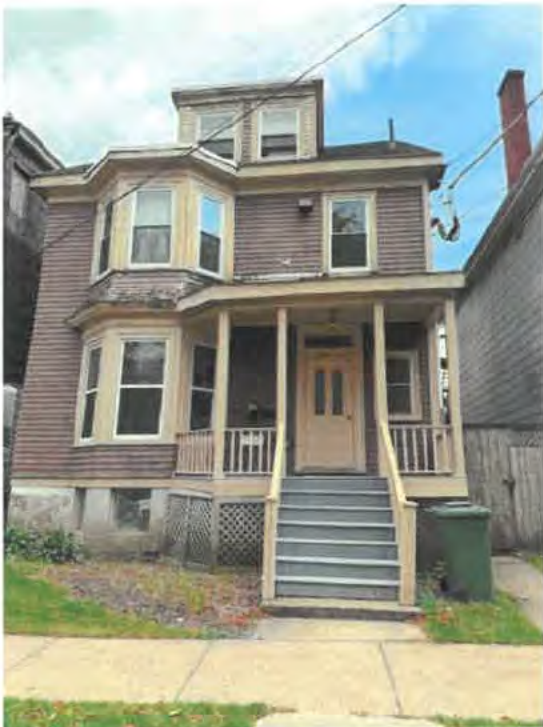
Photo No. 7 – East (front) elevation of Civic No. 1460.

These three residences are historic in nature and have been used as apartments, including basement units. The residences each have three levels above grade. Each are approximately 100 years old, and each have more recent additions at the rear. Civic No. 1460 and Civic No. 1468 each have masonry foundation walls and Civic No. 1466 has a concrete foundation wall. (Photos No. 7, 8 and 9)

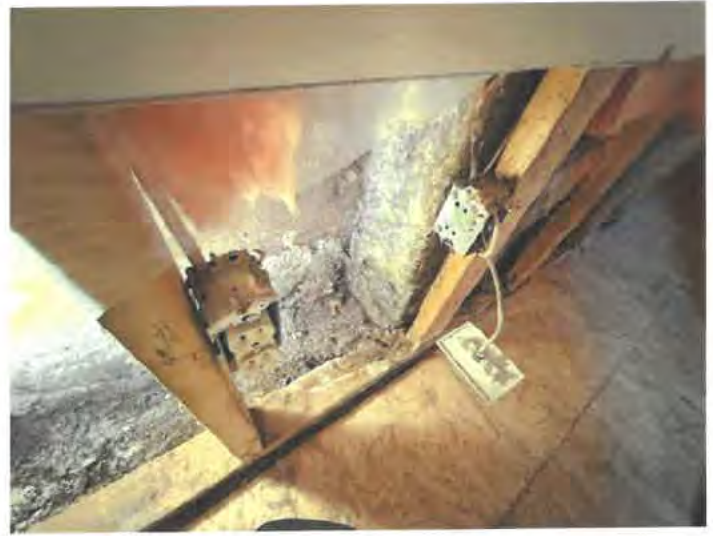
Photo No. 6 – Efflorescence and wood rot at interior wall to foundation location.

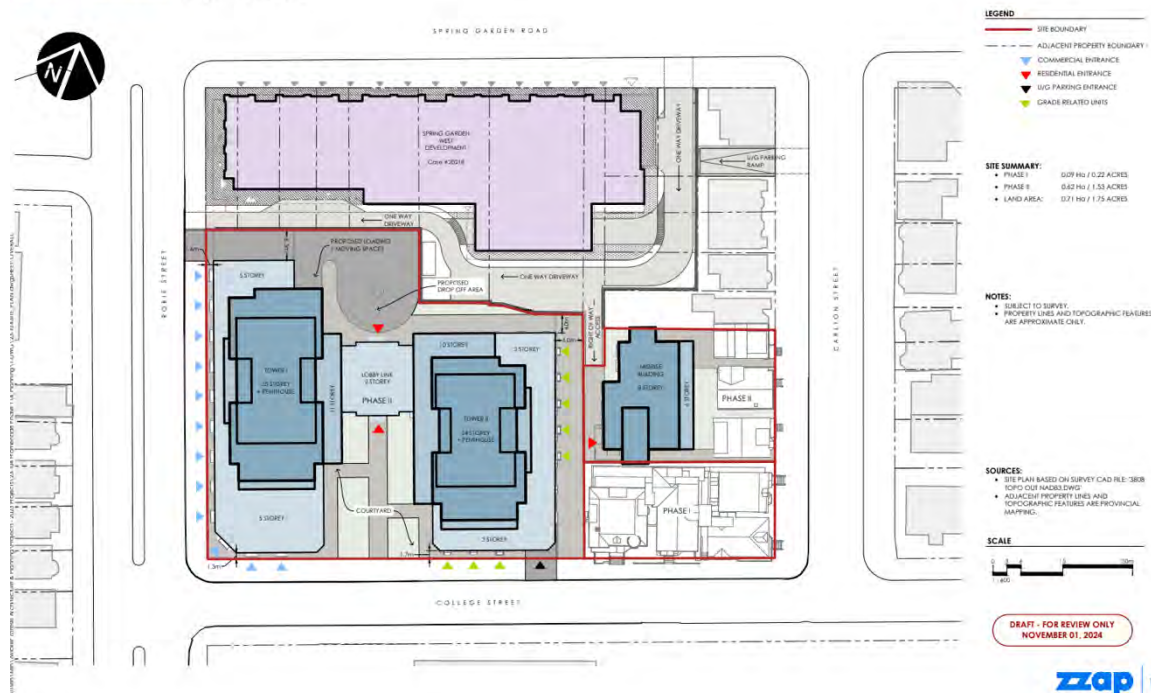
23-104 PROMENADE | OVERALL SITE PLAN

The site plan illustrates the overall development concept in its two phases. Phase 1 includes relocation of two houses on College Street and the relocation of another from Robie Street to the corner of College and Carlton Street, and the retention of a fourth building in situ on Carlton Street. Phase 2 consists of development of two towers-on-podium, mixed-use commercial and residential, along Robie Street and College Street and consolidation of the three properties on Carlton Street and development of a mid-rise residential building set immediately behind the three houses on Carlton Street (Figure 6).

Figure 6: Overall Site Plan

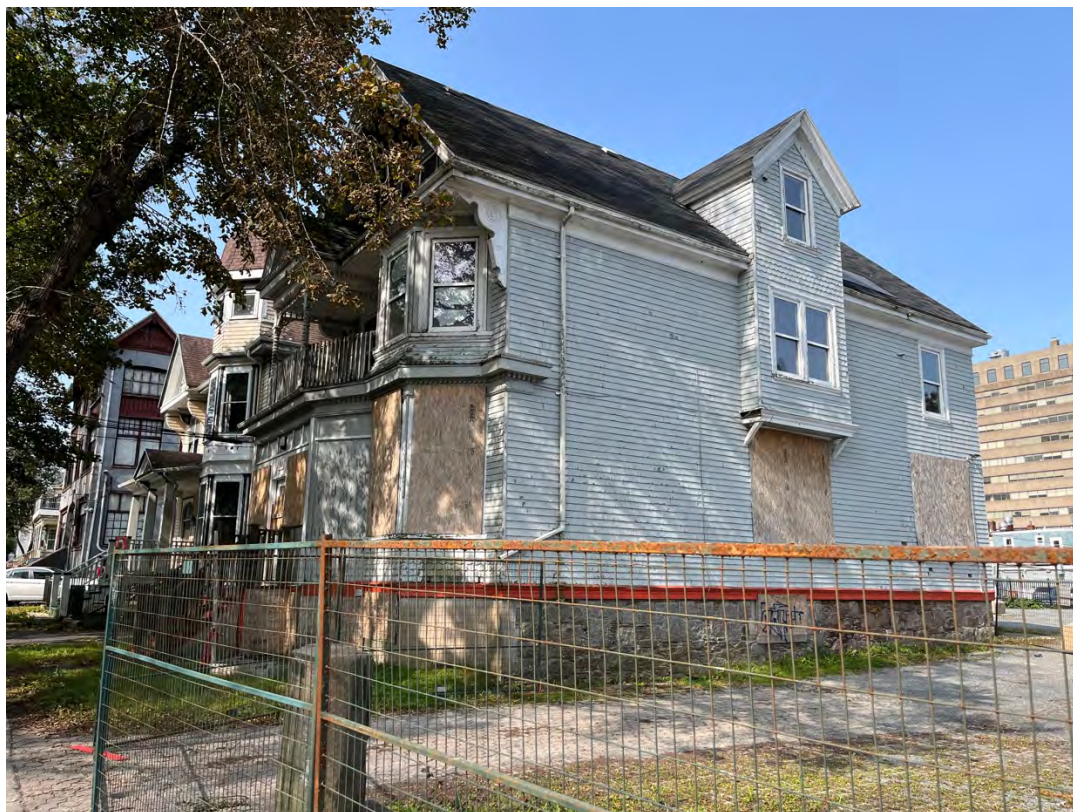
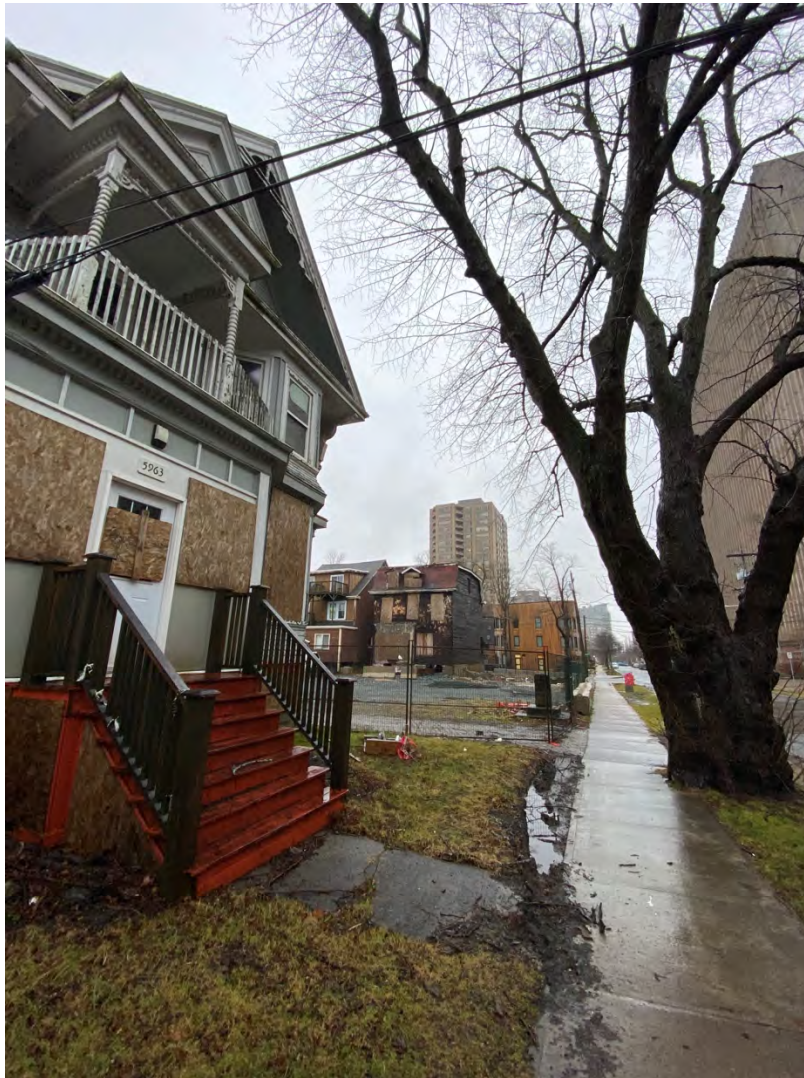
The MacCoy Residence remains a good example of housing built in the late-1800s in the neighbourhood. It is a late Victorian residence set close to the street, with a prominent front featuring a stacked bay window, a modest entry porch and a gabled floor porch directly above (Figure 21).

Figure 21a: Context of MacCoy Residence, 5963 College Street (front, looking west along College Street)

Figure 21b: Context of MacCoy Residence, 5963 College Street (front, looking east along College Street)

It has minimal setback from the street, on a deep lot that allows more room at the rear, with an ample west and east side yard.

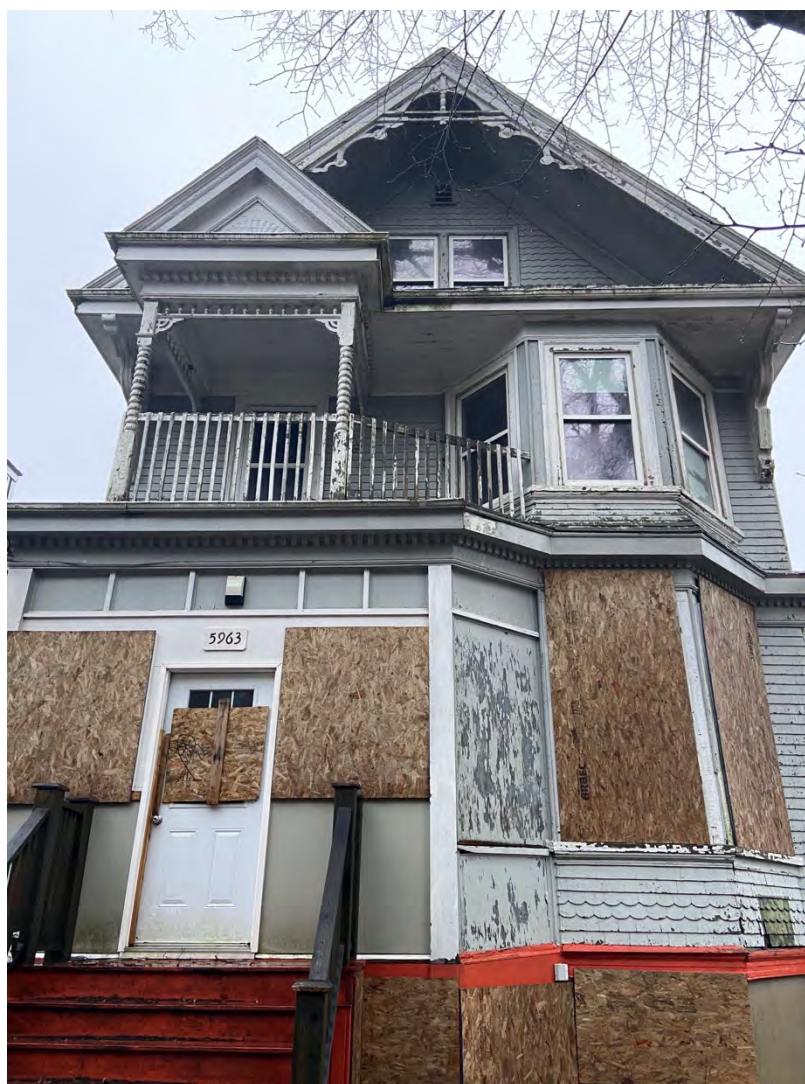
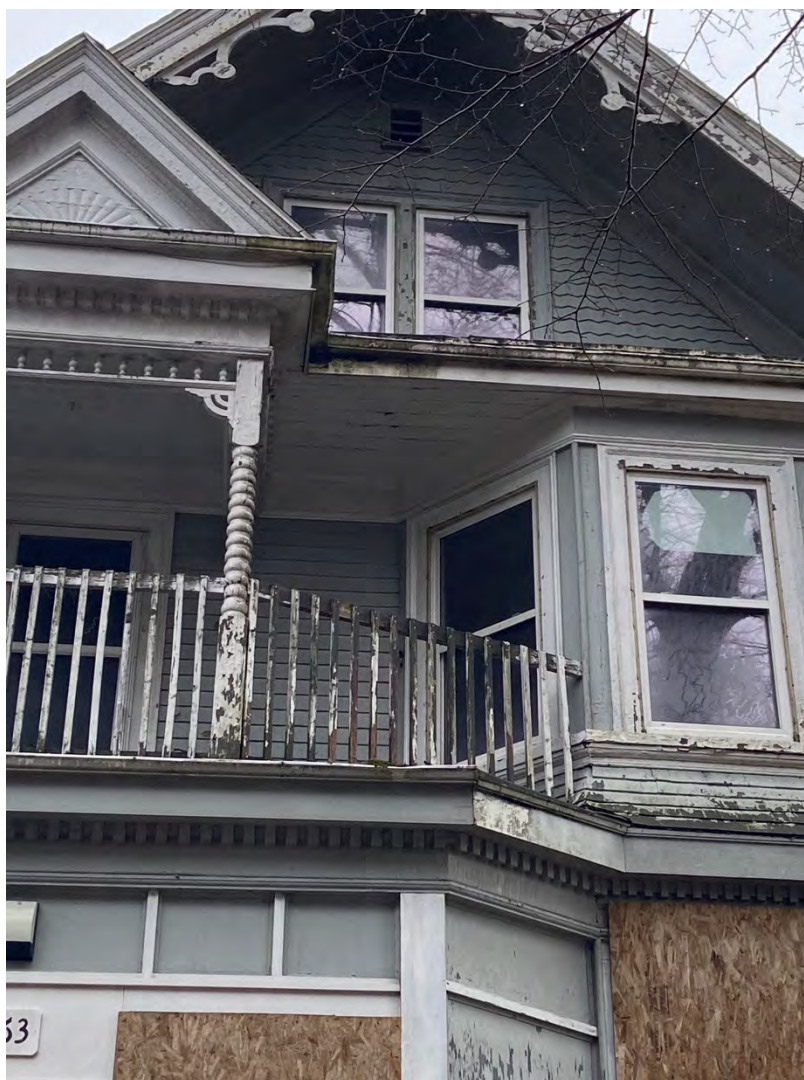
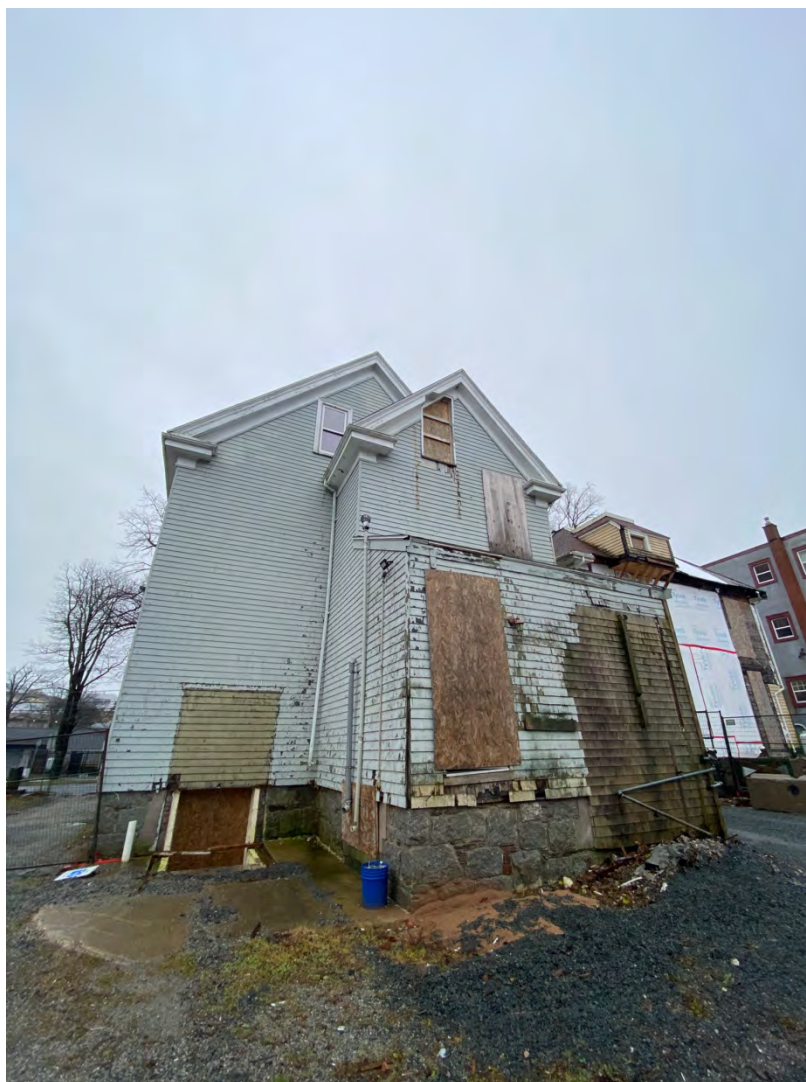
Its front-gabled form is common to the Queen Anne style, with the primary gable set dominantly above a half-width entry porch and a secondary porch situated above and a wall dormer protruding from the east side. There is a secondary gable toward the rear, along the west side (Figure 22).

Figure 22a: Front of 5963 College Street

Figure 22b: Upper floor detail of 5963 College Street

Figure 22c: Rear of 5963 College Street

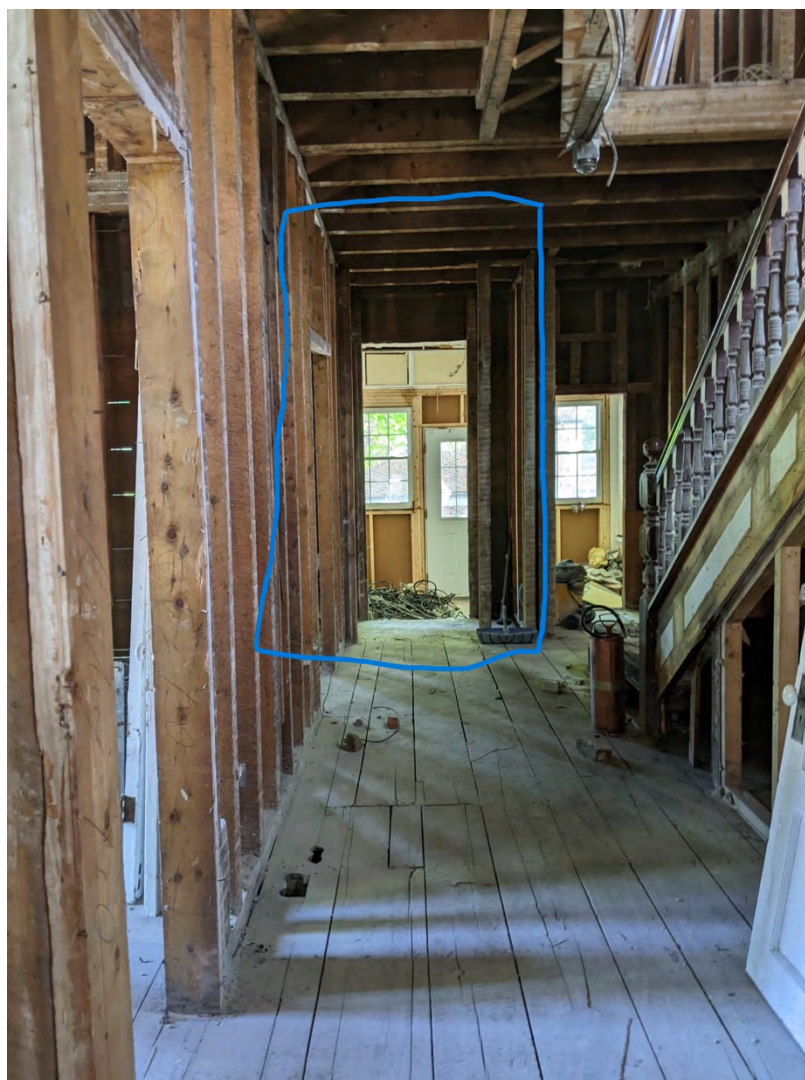
The front door is currently obscured by the enclosed porch, but the front door opening is original, as is the separate “sidelight” window, visible in a recent interior photograph (Figure 22d).

Figure 22d: Interior view of front door and window openings behind enclosed porch, 5963 College Street

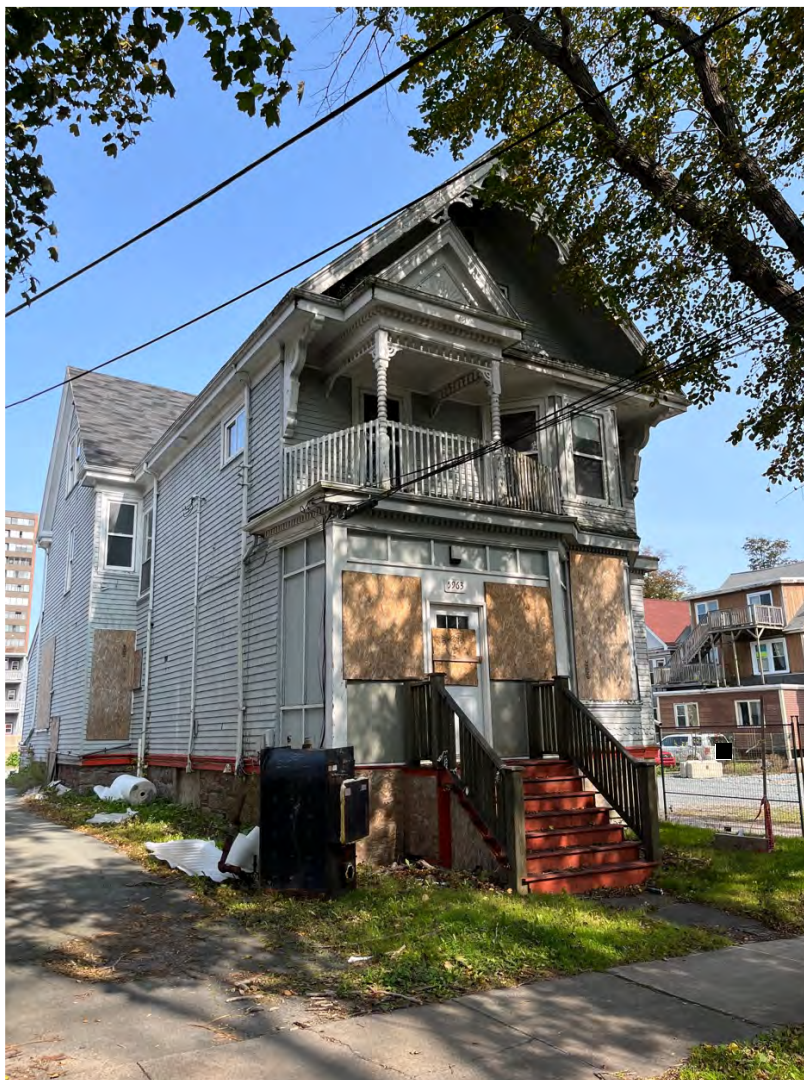
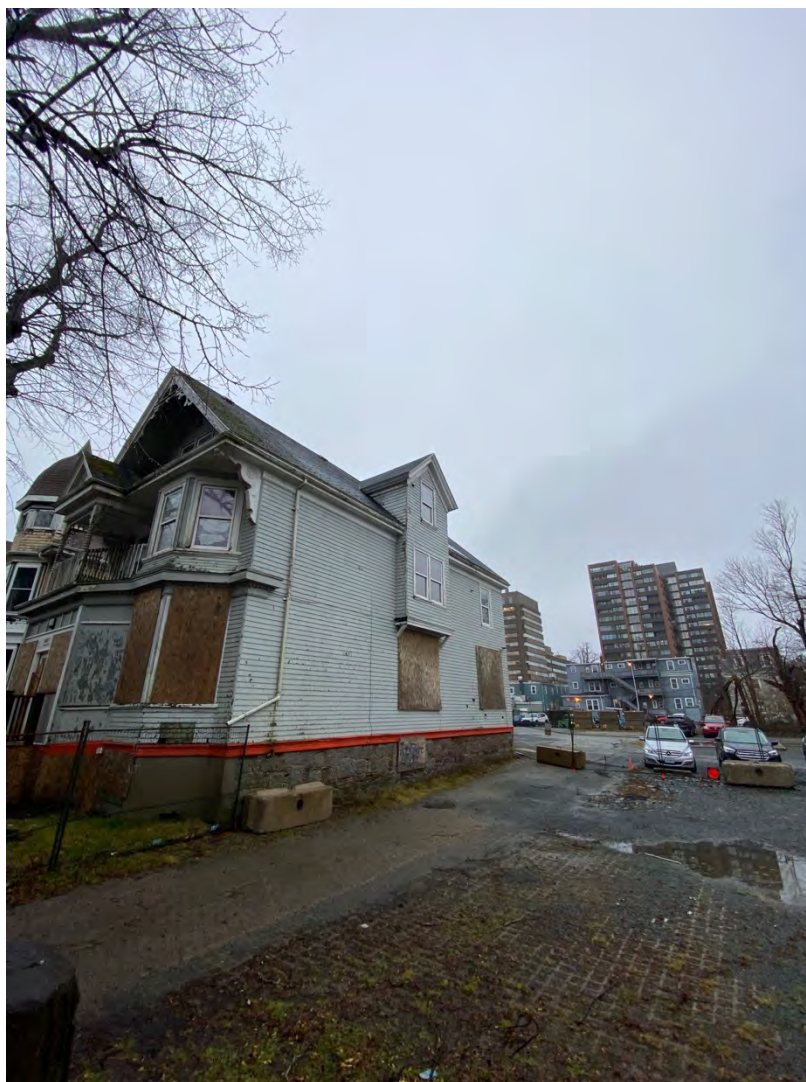
- Decorative wavy cladding in the upper front gable;
 - Gingerbread detailing in the upper gable;
- Single front entry;
- Shingle cladding.

These elements are illustrated in Figure 23.

Figure 23a: MacCoy Residence, 5963 College Street – front and west side

Figure 23b: MacCoy Residence, 5963 College Street – front and east side

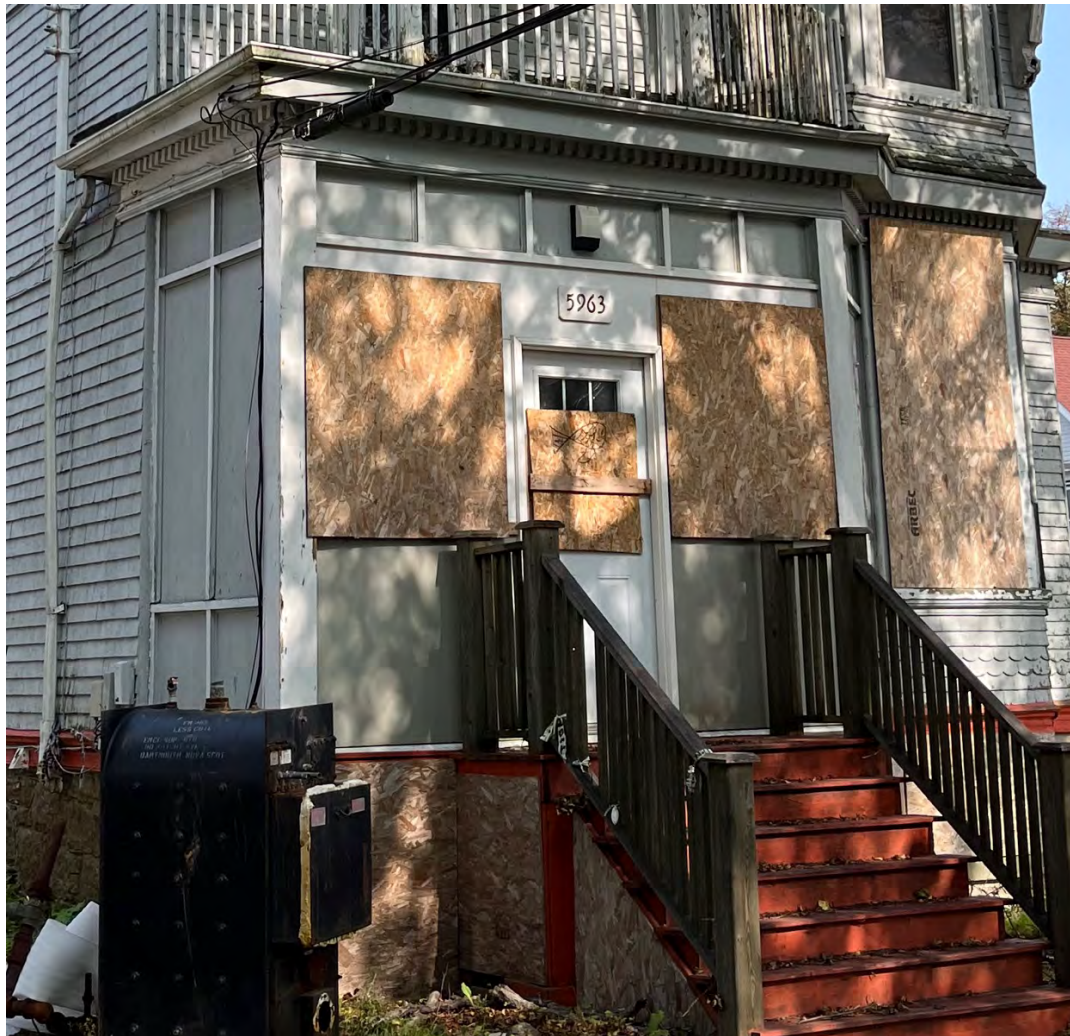
Overall, the integrity of the MacCoy Residence is excellent. The only notable alteration, on the front, is the enclosure of the small entry porch (Figure 24a).

Figure 24a: Front porch enclosure of 5963 College Street

This enclosure obscures the original entry and a single-set window to the left that would be considered a “sidelight”. The openings are intact, but the single-set door and transom (seen in the archival photos) and the sidelight window are not. The other notable alteration is at the rear which includes a shed roof extension (Figure 24b).

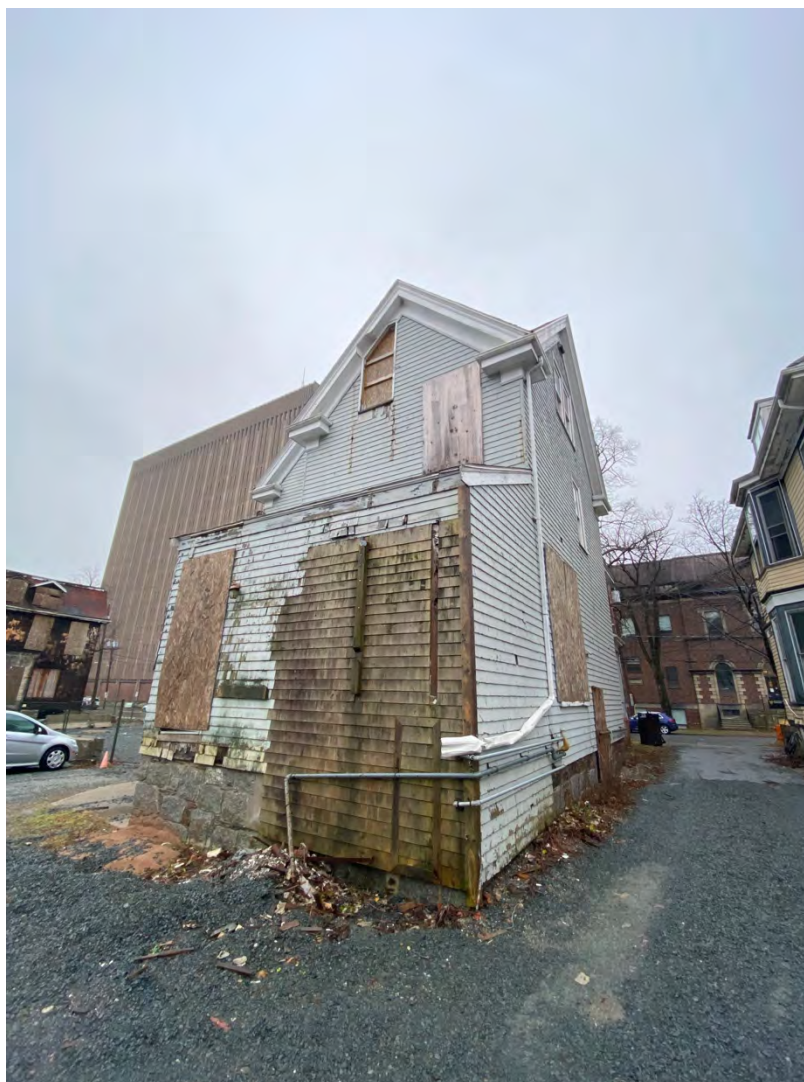
Figure 24b: Shed roof addition at the rear of 5963 College Street

Similar to the porch enclosure, these are considered easily reversible.

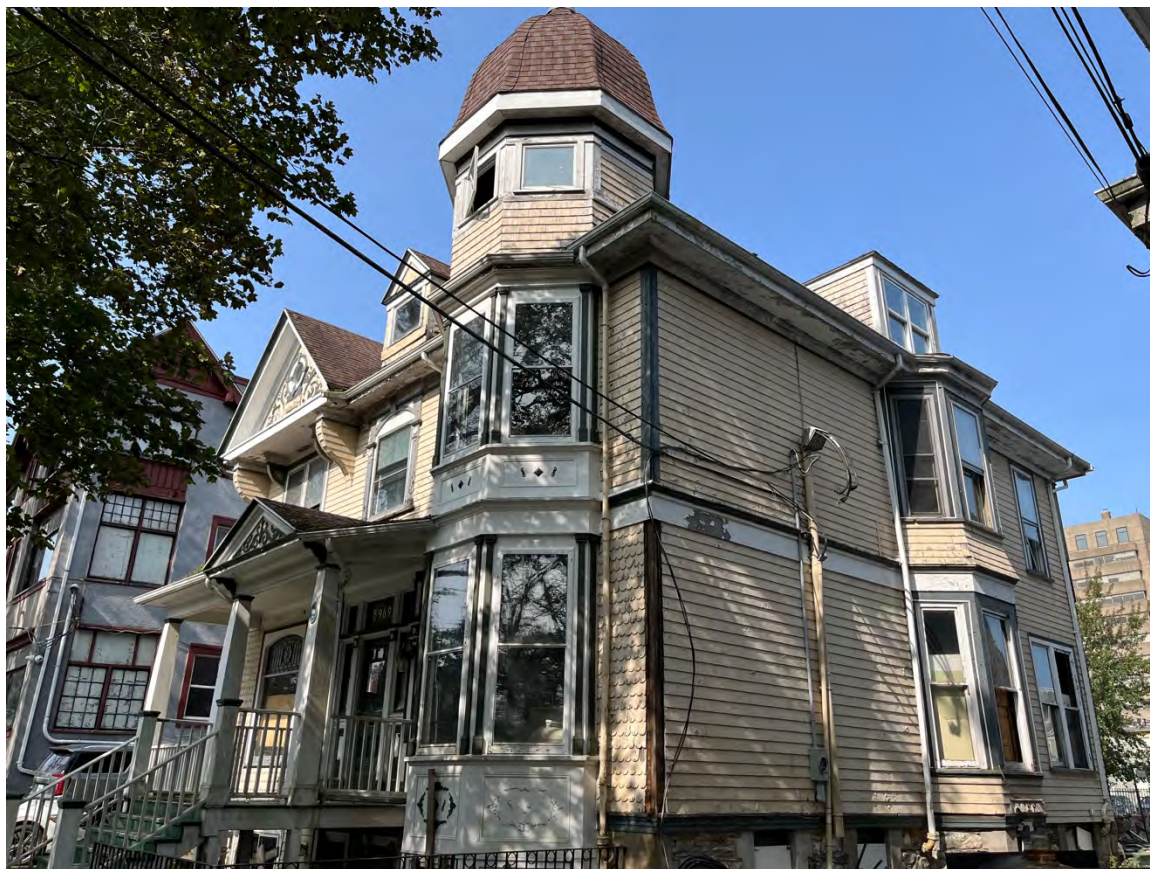
The Gold Cure Institute is a 2½ storey wood frame house that is a commanding example of the Queen Anne style. Its asymmetrical form features a three-storey turret protruding from its hipped roof form and a decorative gable on the opposite end of the front.

It has minimal setback from the street, on a deep lot that allows more room at the rear, with an ample west and east side yard. Its front is defined by a partial-width porch and a stacked bay that forms part of the octagon protruding above the attic to form the turret, with a prominent second stacked bay on the east side (Figure 27).

Figure 27: Context of the Gold Cure Institute, looking west along College Street

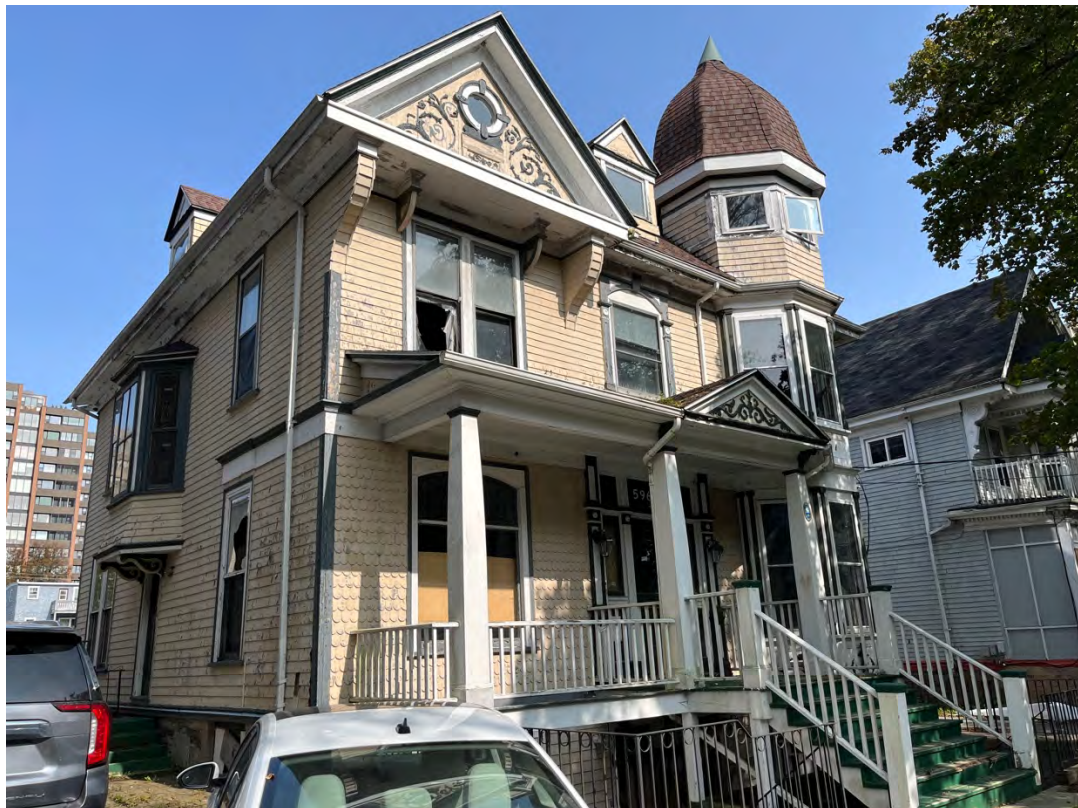
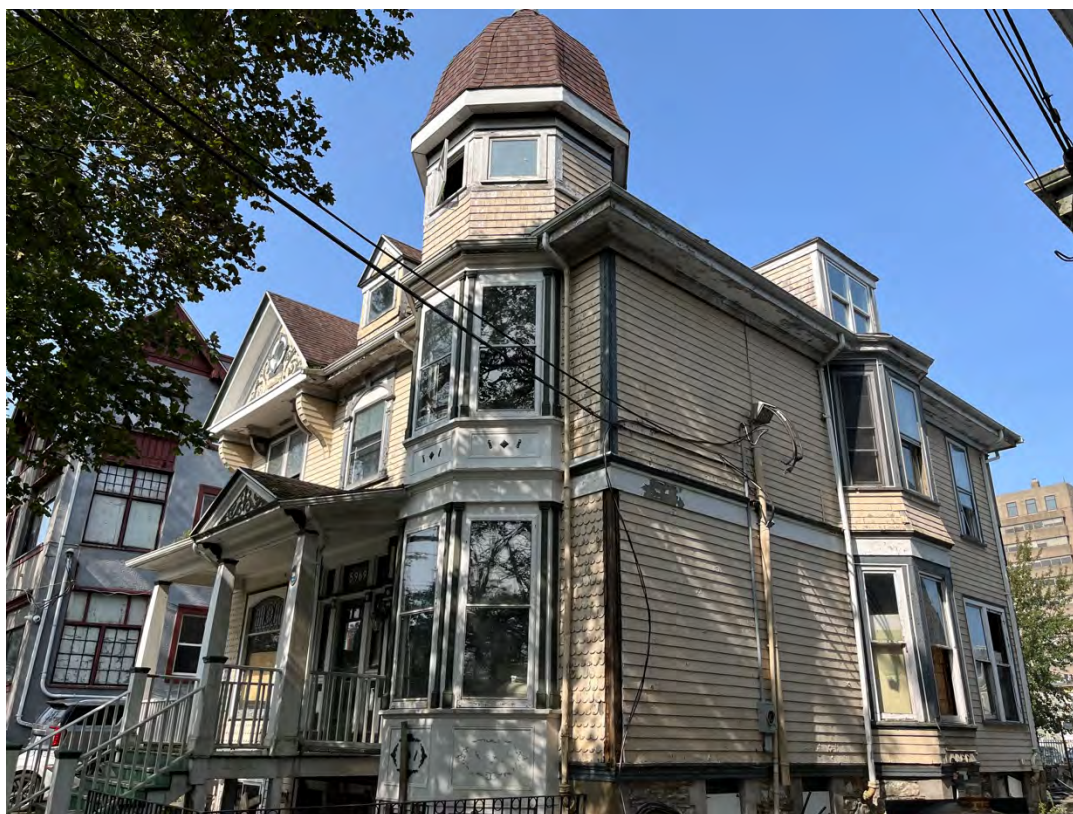
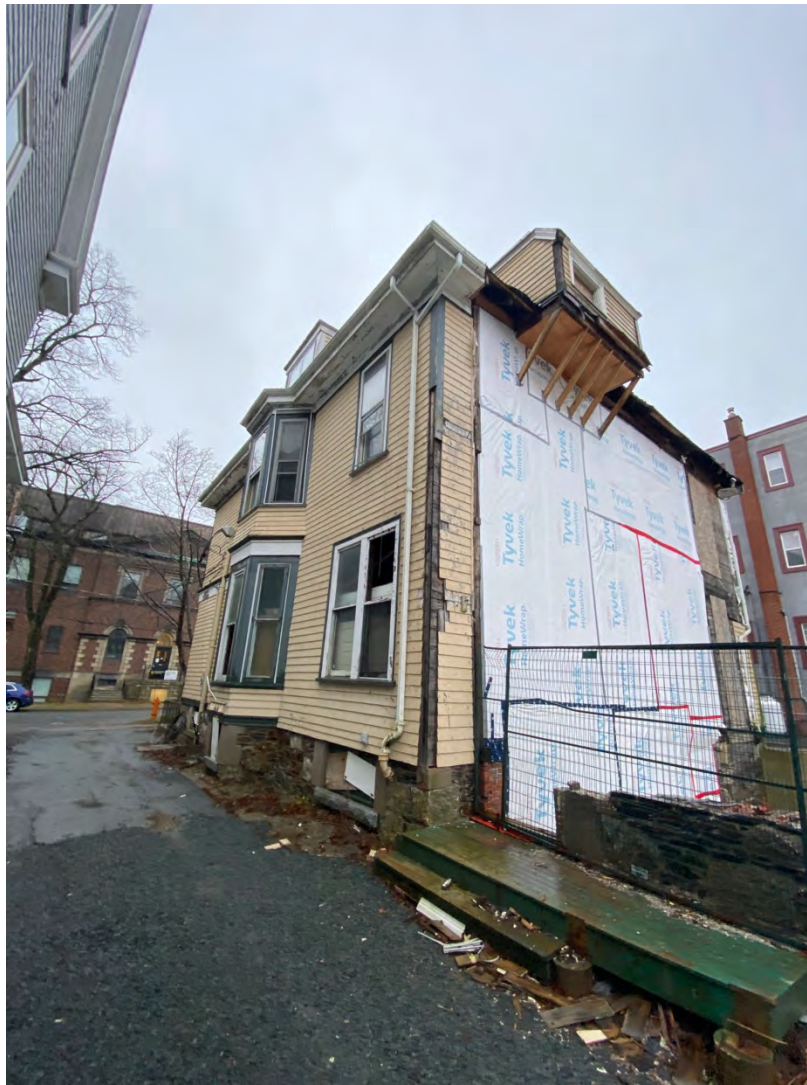
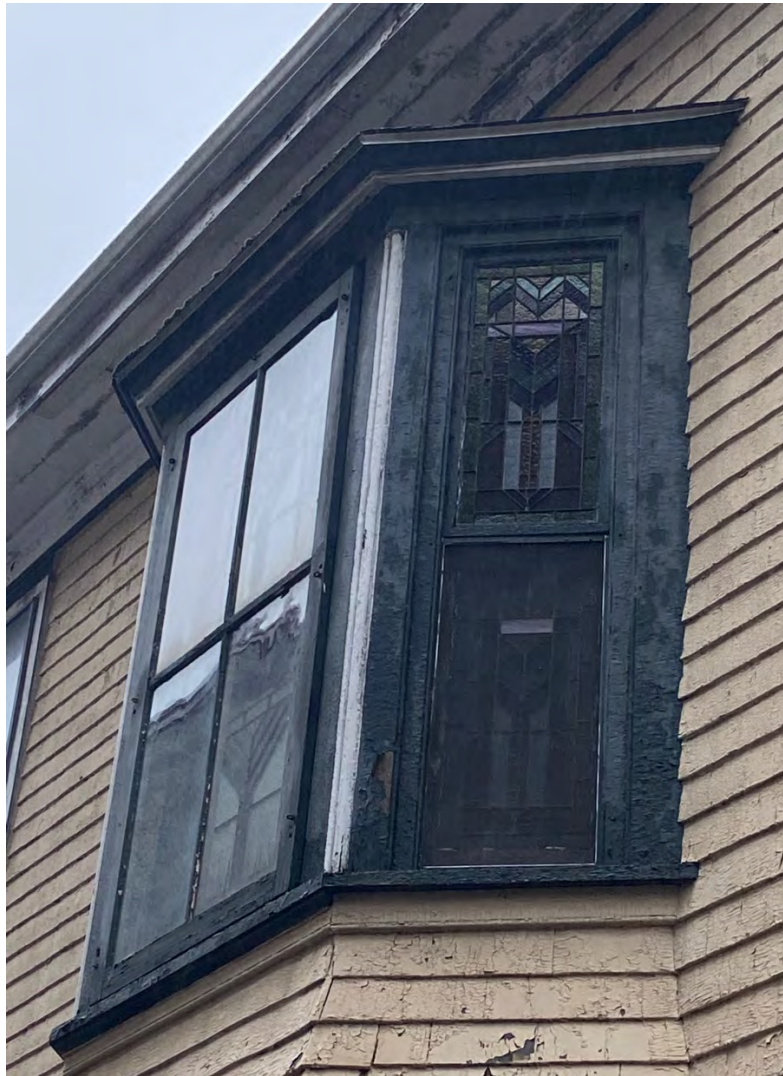
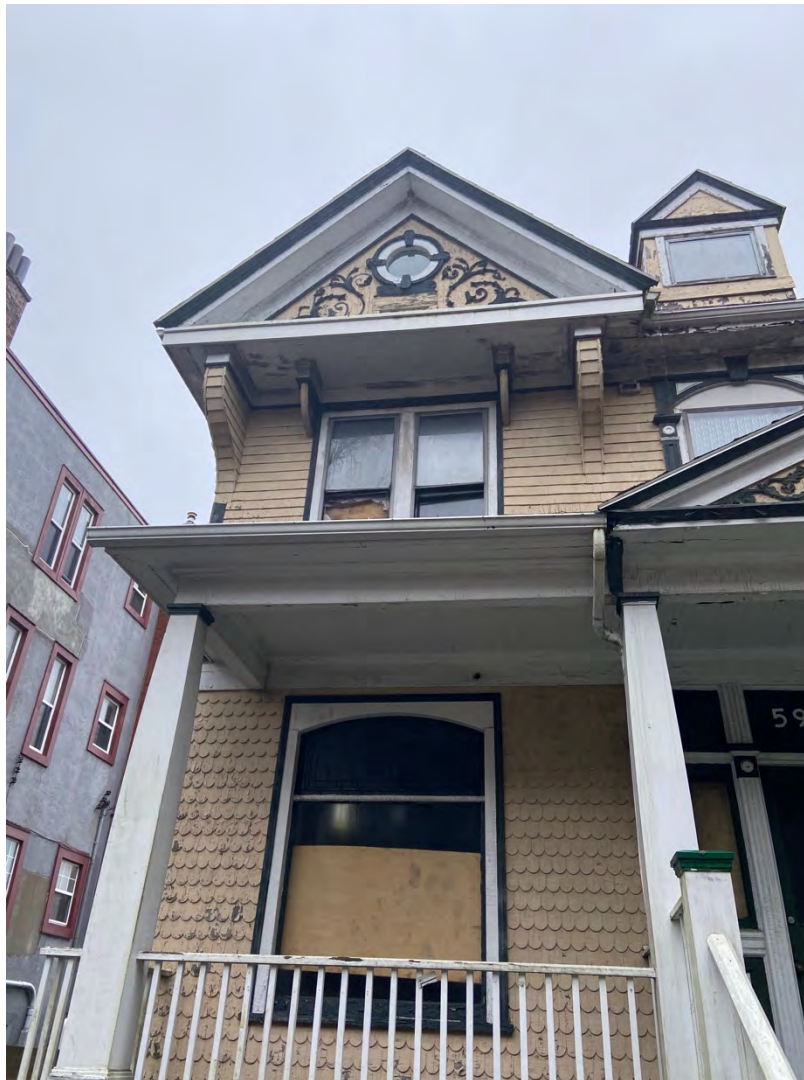
- Decorative woodwork around each of the window frames, and particularly the arched “lintel” cap and “keystone” on the second-floor centre-set window, and an oxeye window in the front gable, attic, with arabesque frieze surrounding;
- Heavy shingled brackets in the front soffit with smaller rounded inset brackets between;
- Fishscale shingle cladding on the main floor, front;
- Decorative brackets under the cant bay, north side;
- Cant bay on second floor, north side;
- Cant stacked bay on the south side;
- Small attic dormer set between the tower and attic gable with a fixed window;
- Single front door with sidelights and three-pane transom framed by decorative trim;
- Variety of wood windows including stained glass windows in the west side bay;
- Shingle cladding.

These elements are illustrated in Figures 28a to 28e.

Figure 28a: Gold Cure Institute, 5969 College Street – front and west side

Figure 28b: Gold Cure Institute, 5969 College Street – front and east side

Figure 28c: Gold Cure Institute, 5969 College Street – rear

Figure 28d: Gold Cure Institute, 5969 College Street – stained glass in side bay

Figure 28e: Gold Cure Institute, 5969 College Street – ornate detailing

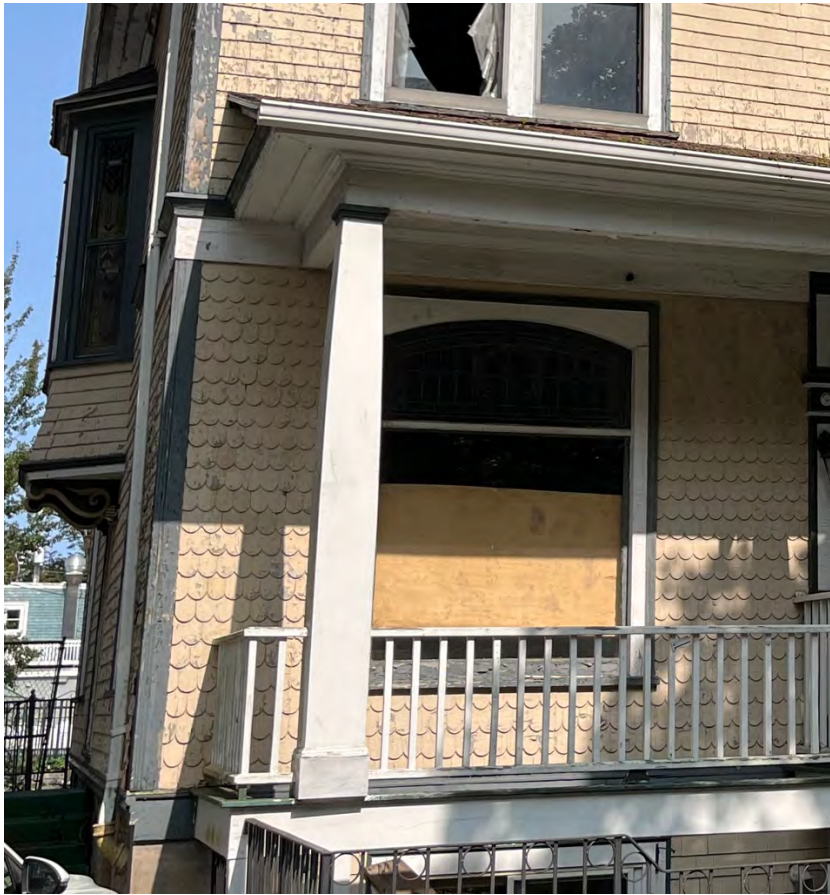
Despite modifications to the interior to accommodate additional living units, The Gold Cure Institute has had little change to the front or sides. The most notable alterations are small attic dormers on the west and east sides, and extensions to the rear. Neither of these detract from the asymmetry and overall character of the building's Queen Anne style. It is suspected that the large fixed window to the left of the front entry is not original, due to the arched upper sash which was a design characteristic more common to the 1920s and 1930s. It is quite possible that a decorative – possibly stained glass – window was here originally. However, this cannot be verified without archival evidence (Figure 29).

Figure 29: Gold Cure Institute, 5969 College Street – front porch and fixed front window with arched top sash

It is also suspected that the tapered square porch posts are also not original, as the Queen Anne style typically featured much more decorative posts.
