Item No. 9.1.3
Heritage Advisory Committee
November 26, 2025

SUBJECT: **Case HRTG-2025-01649: Substantial Alteration to Multiple Municipally Registered Heritage Properties on College and Carlton Streets in Halifax**

An application by ZZap Inc. to substantially alter the municipally registered heritage properties located at 5969 College Street, 1456 Carlton Street, 1460 Carlton Street, 1466 Carlton Street, and 1468 Carlton Street, Halifax.

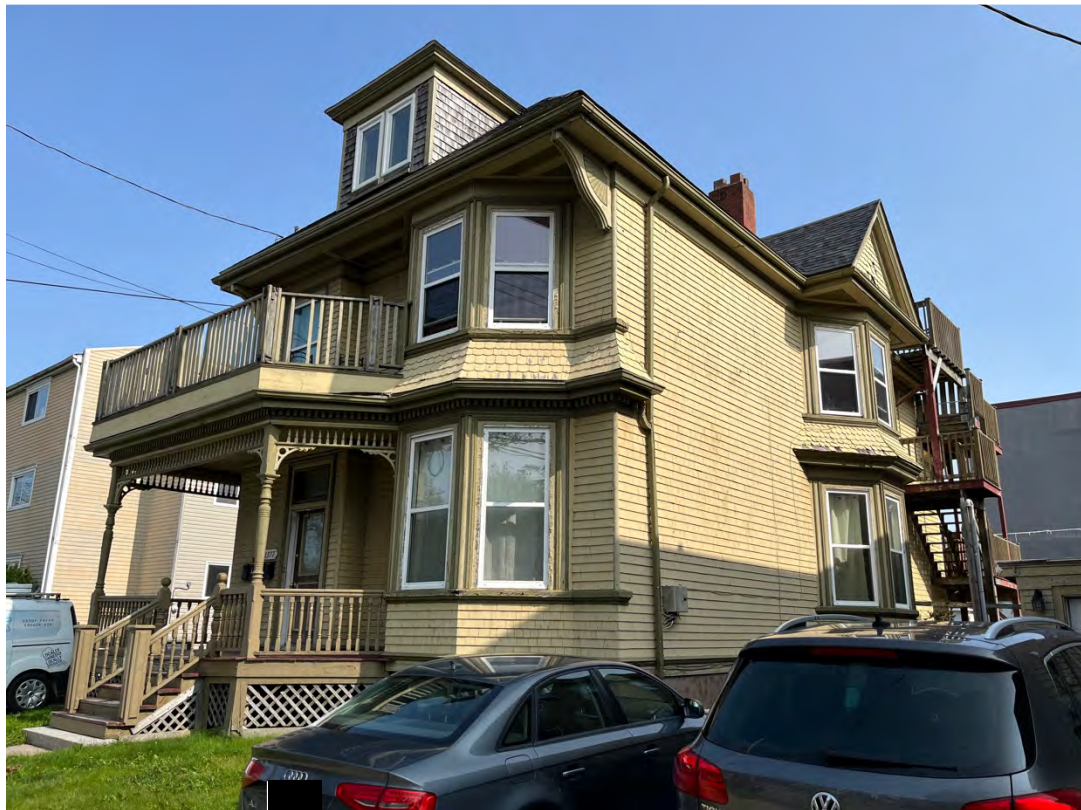
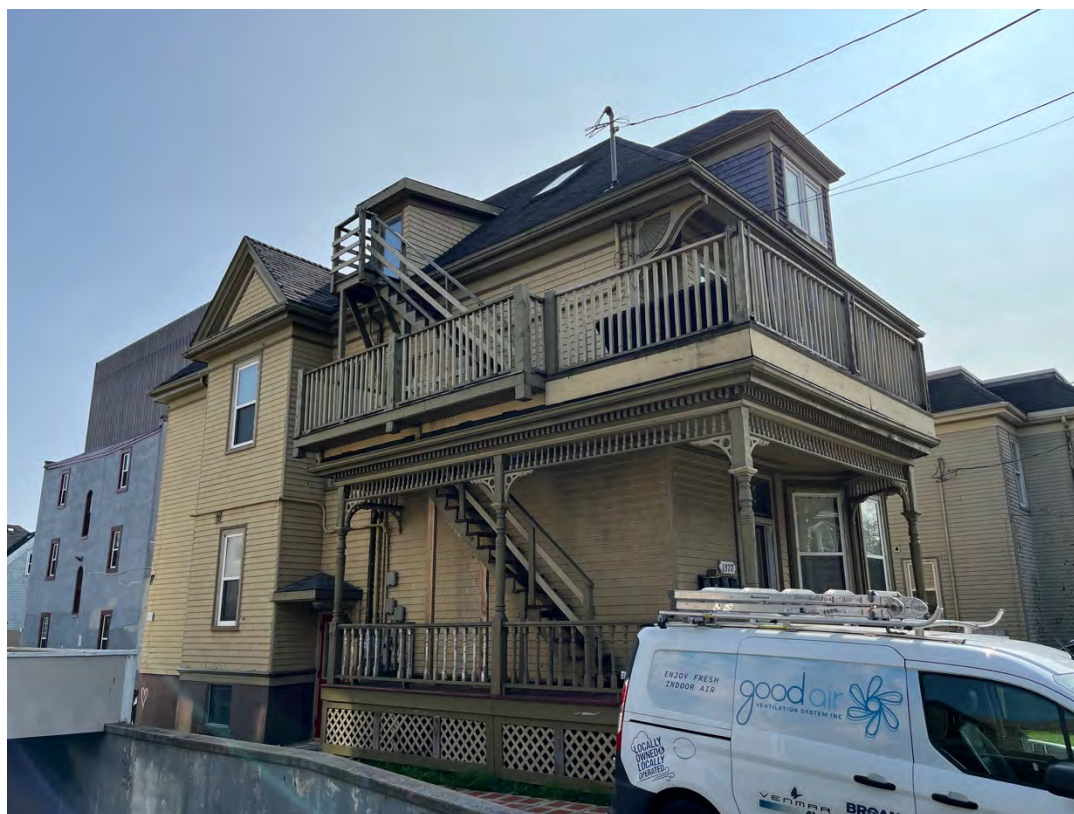
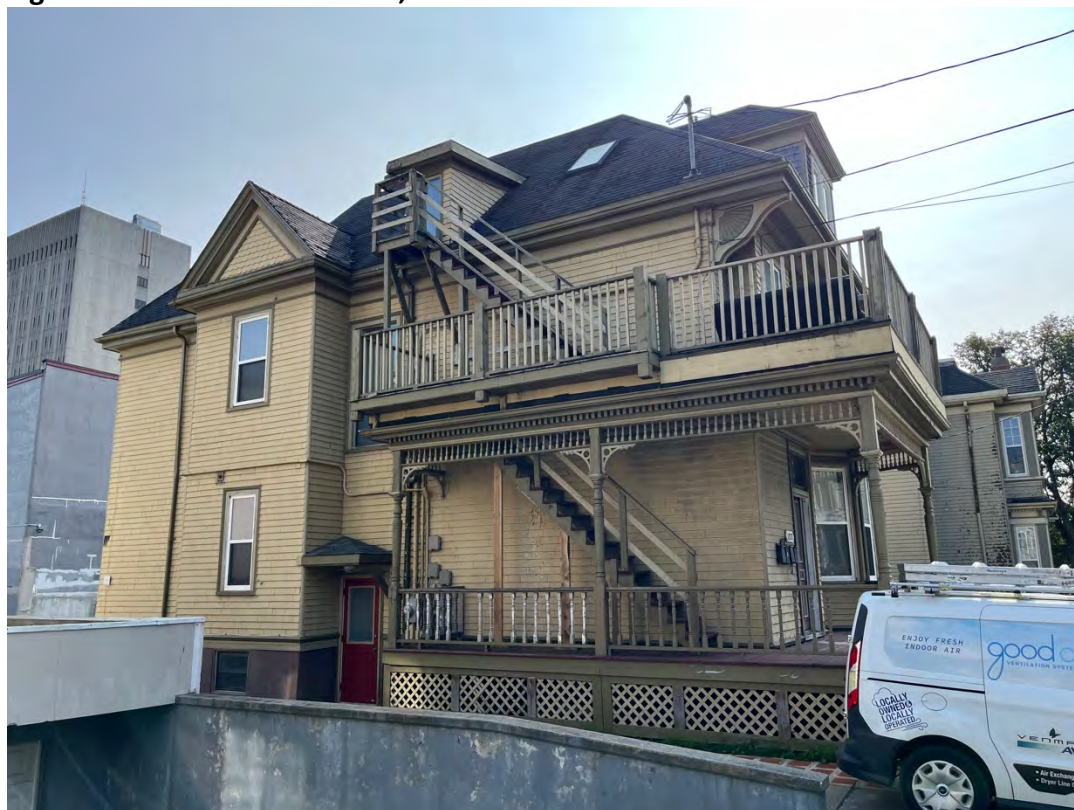
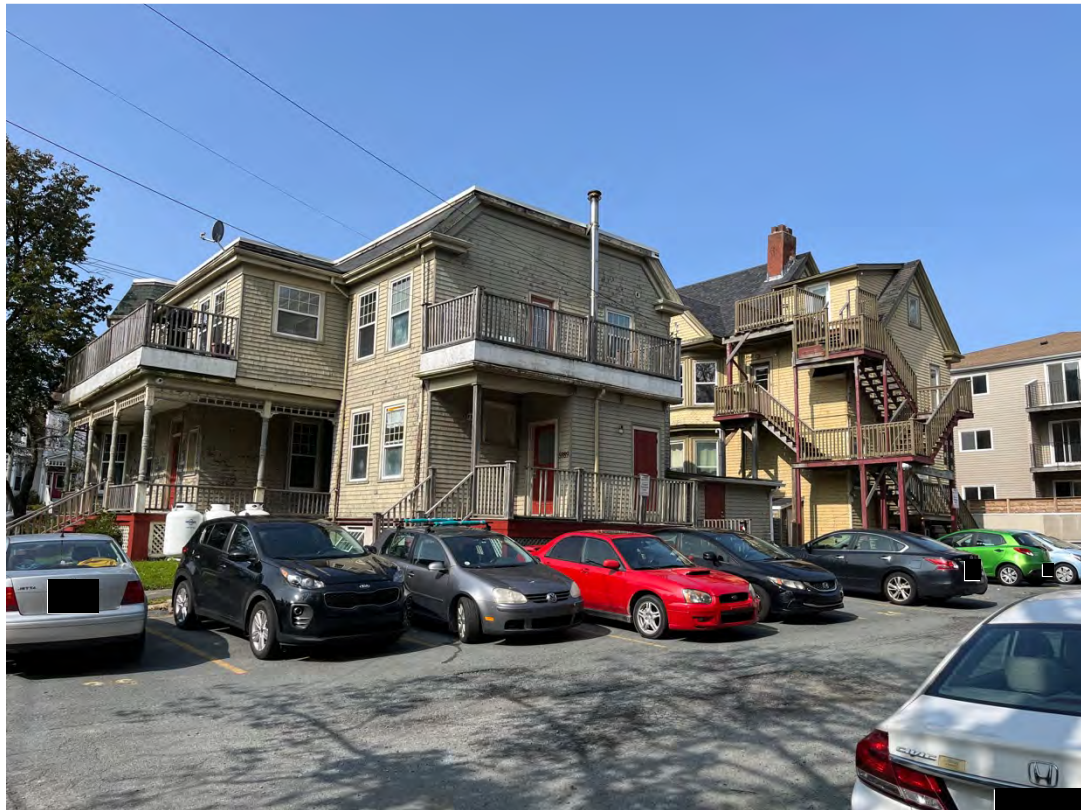
Its form, defined by its stacked bay windows and wrap-around porch, rather than elaborate fenestration (as seen on the MacCoy Residence or the Gold Cure Institute), is the most visually interesting (Figures 30a to 30d).

Figure 30a: 1377 Robie Street, front and south side

Figure 30b: 1377 Robie Street, front and north side

Figure 30c: 1377 Robie Street, north side with wrap-around porch

Figure 30d: 1377 Robie Street, rear (seen from College Street)

In particular, the double-height wrap around porch, double-height bay windows on the front and south side are its most prominent features.

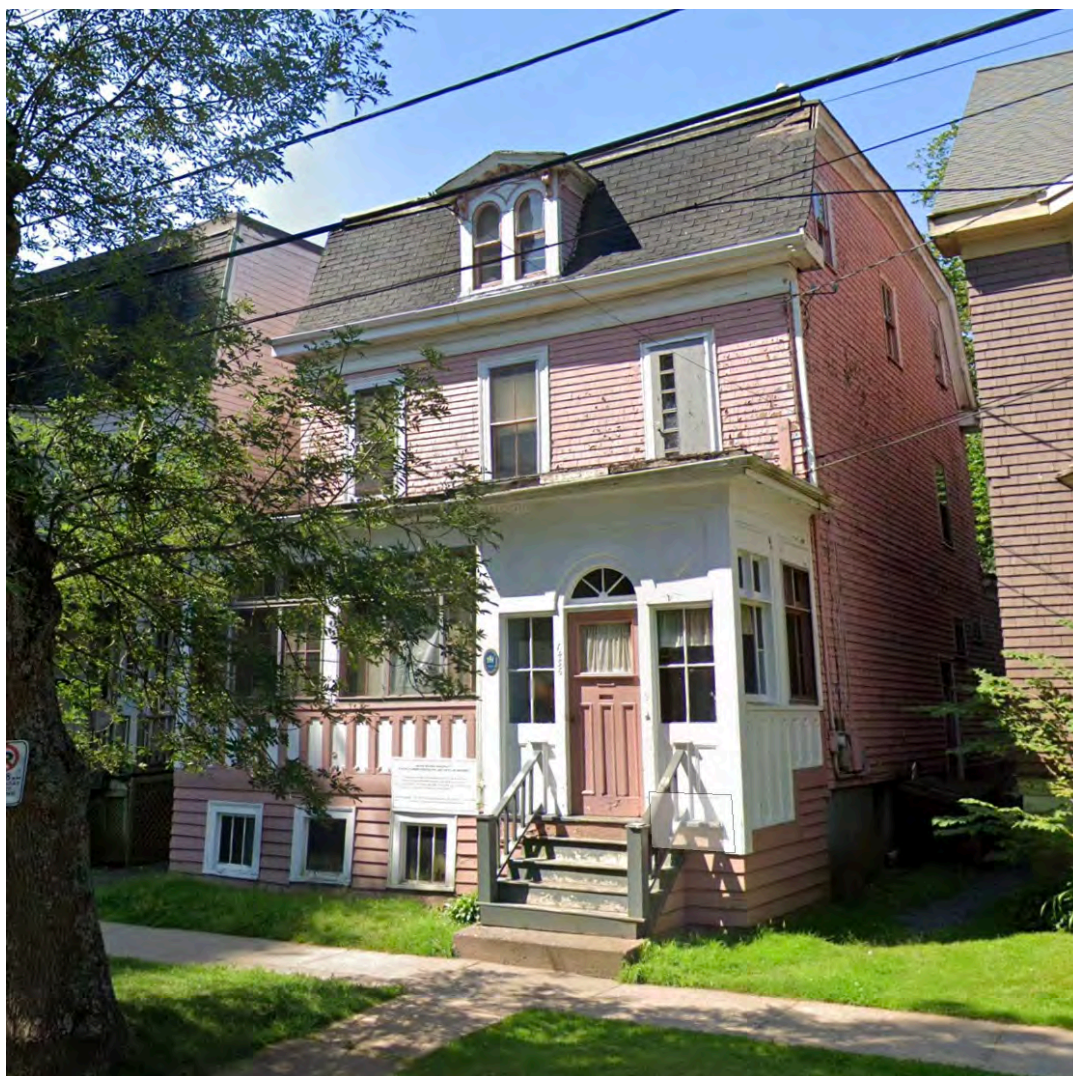
Its front was defined by an enclosed full-width porch extending out from the footprint of the house, a relatively plain second floor with three window openings, and a central-set gabled dormer in the Mansard roof of the attic (Figure 32).

Figure 32: 1456 Carlton Street, in 2019, prior to extensive exterior alterations
Source: Google Streetview

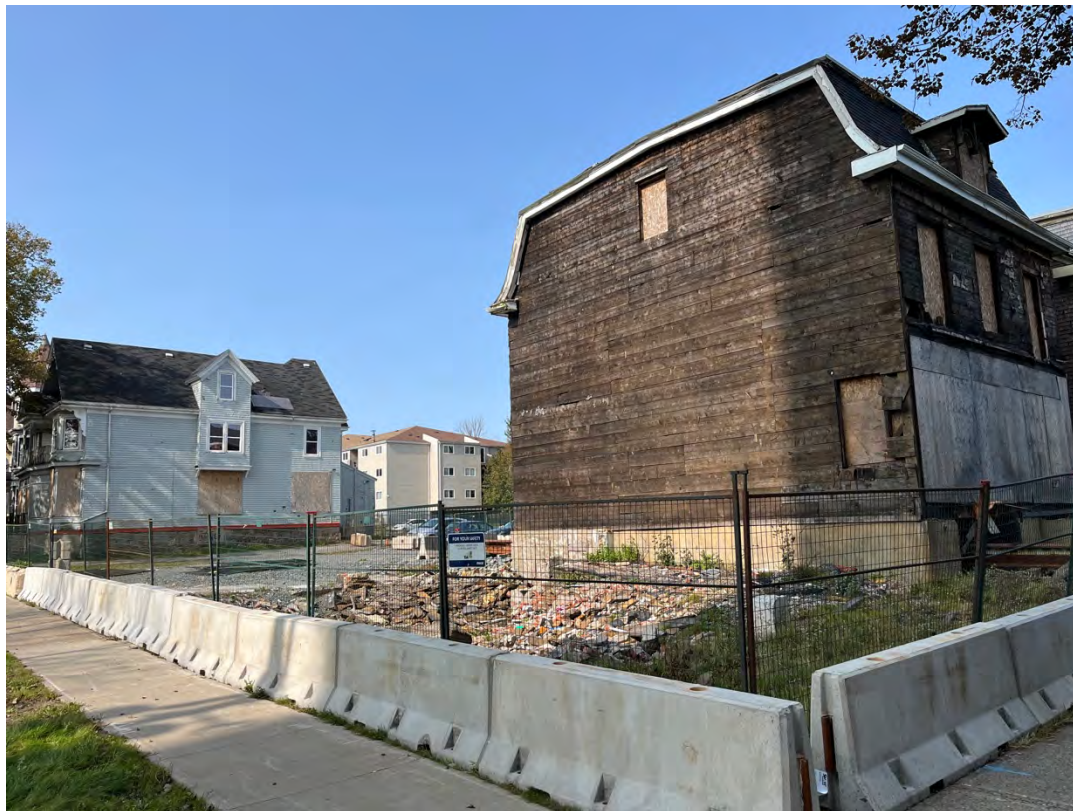
However, in early 2023, it underwent alterations that were timed with the attempted relocation and subsequent collapse of the neighbouring 1861 house at 1452 Carlton Street (also Registered as an intact Early Victorian Streetscape). This resulted in the corner site being vacant following the collapse and subsequent removal of the debris (Figure 33).

Figure 33: Corner of Carlton and College Street – vacant site following the collapse of the house previously located here

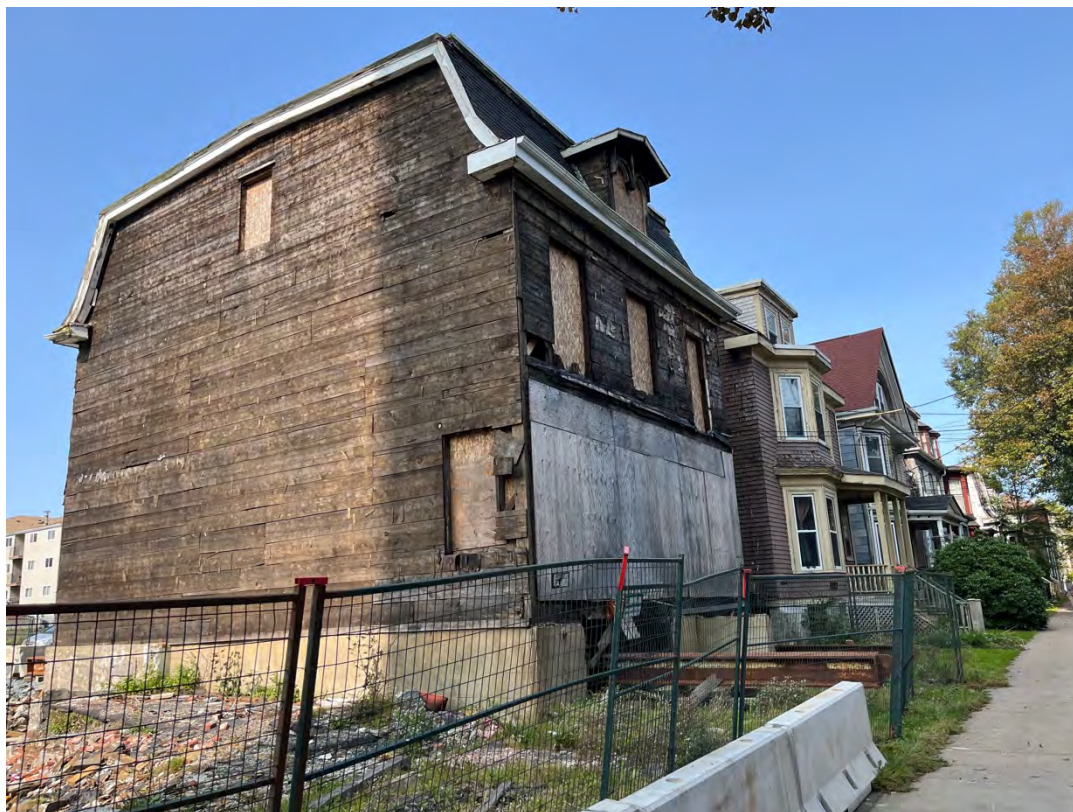
The alterations to the Crosskill Residence at 1456 Carlton Street included the removal of the entire front porch, and all fenestration including windows, doors and cladding (Figure 34).

Figure 34: 1456 Carlton Street following unauthorized alterations (front and south side)

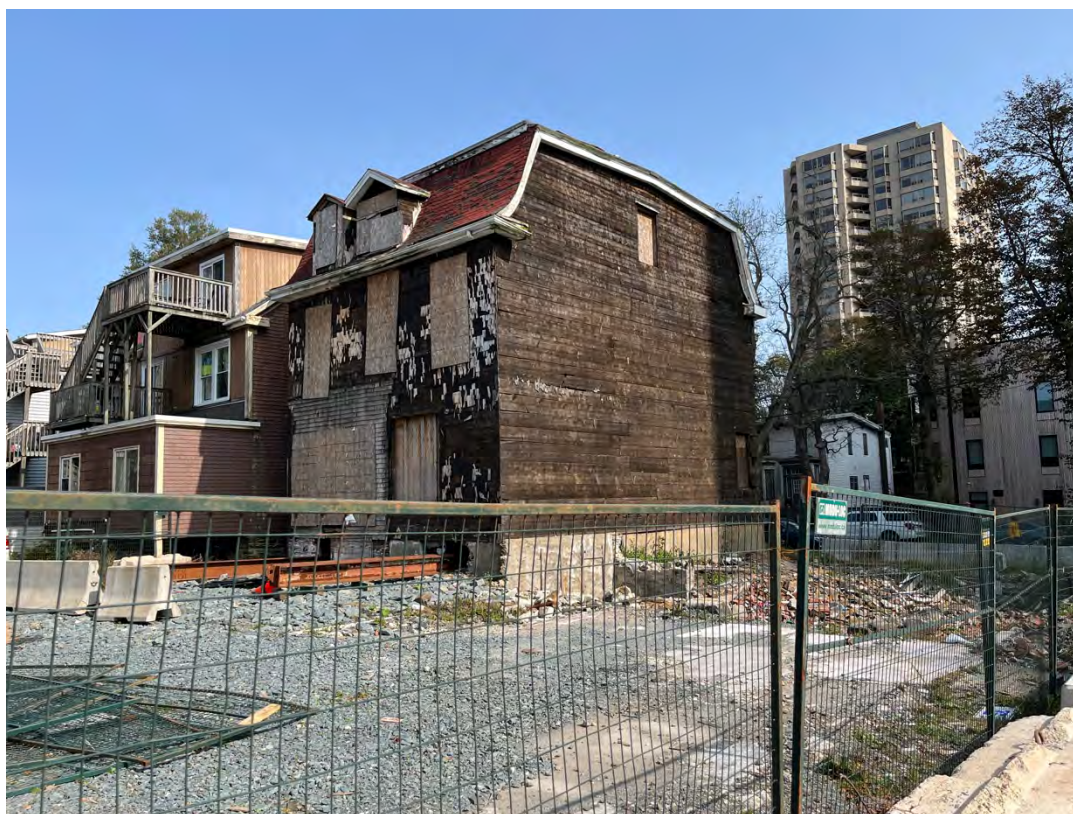
While the overall form remains intact, the elements that remain are limited, including part of the attic window frame at the front. At the rear, the alterations similarly removed all fenestration including windows, doors and cladding (Figure 35).

Figure 35: 1456 Carlton Street following unauthorized alterations (rear and south side)

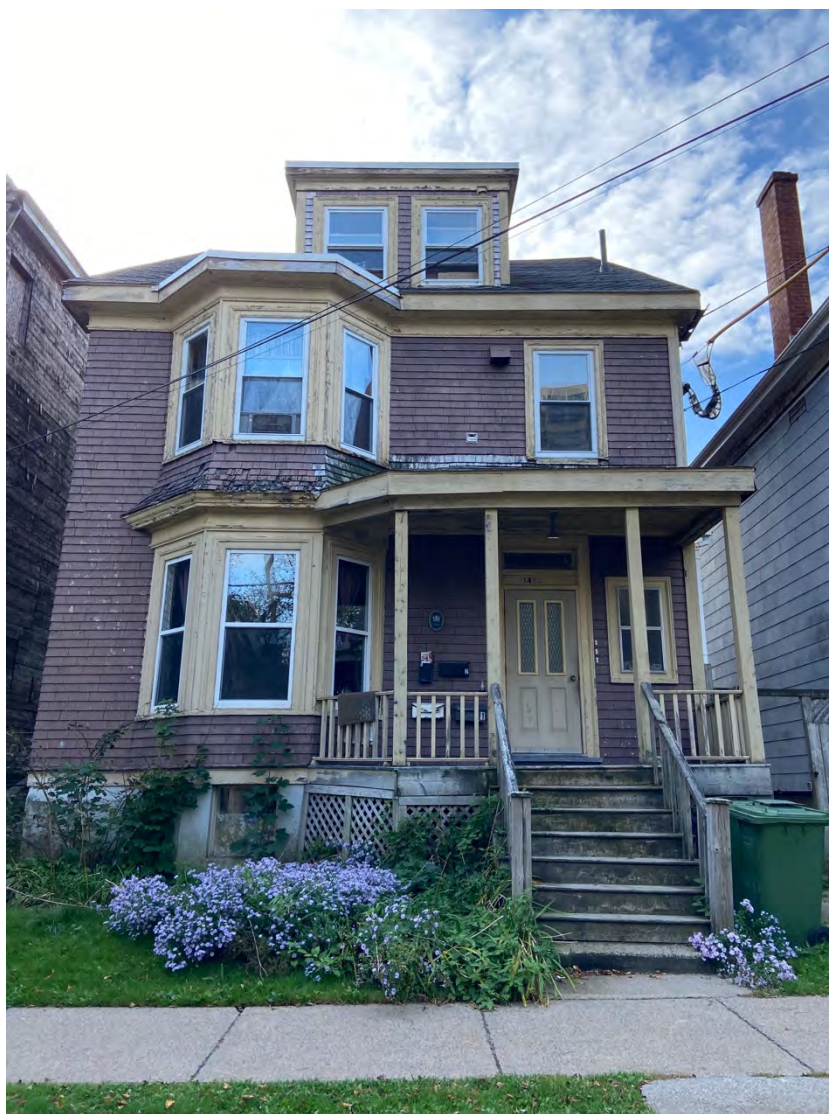
Figure 44a: Front of 1460 Carlton Street

- Location mid-block between College Street and Spring Garden Road;
- Continuous residential use;
- 2½ storey form set above a basement;
- Main floor set above grade;
- Craftsmanship as evidenced in its design and finishes;
- Side-gabled form common to the Second Empire style;
- Stone foundation;
- Half-width and hipped-roof front porch supported by squared posts and framed by a simple balustrade;
- Prominent stacked bay at the front with bellcast eave dividing the main and upper floor and capped by a flat roof;
- Fenestration including:
 - Variety of single-set window openings;
 - Single front entry with transom;
- Shingle cladding on the front and south sides;

These elements are illustrated in Figures 44a to 44d.

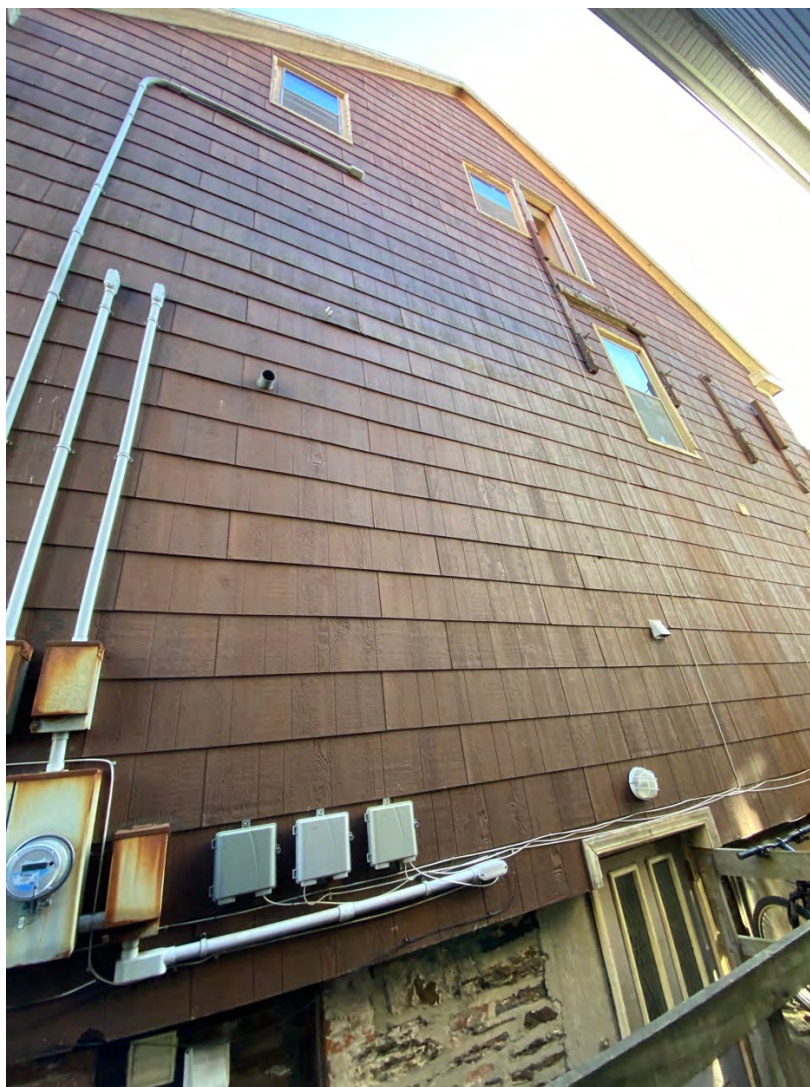
Figure 44c: North side of 1460 Carlton Street

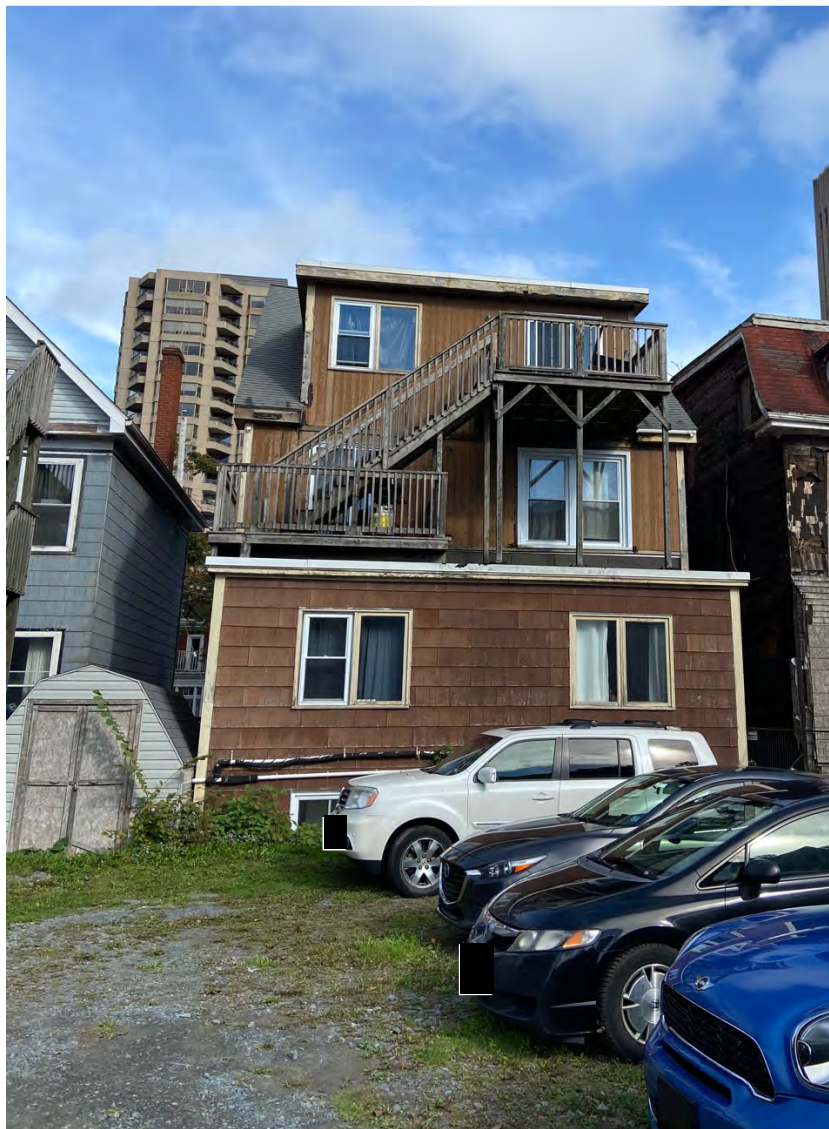
Figure 44d: Rear of 1460 Carlton Street

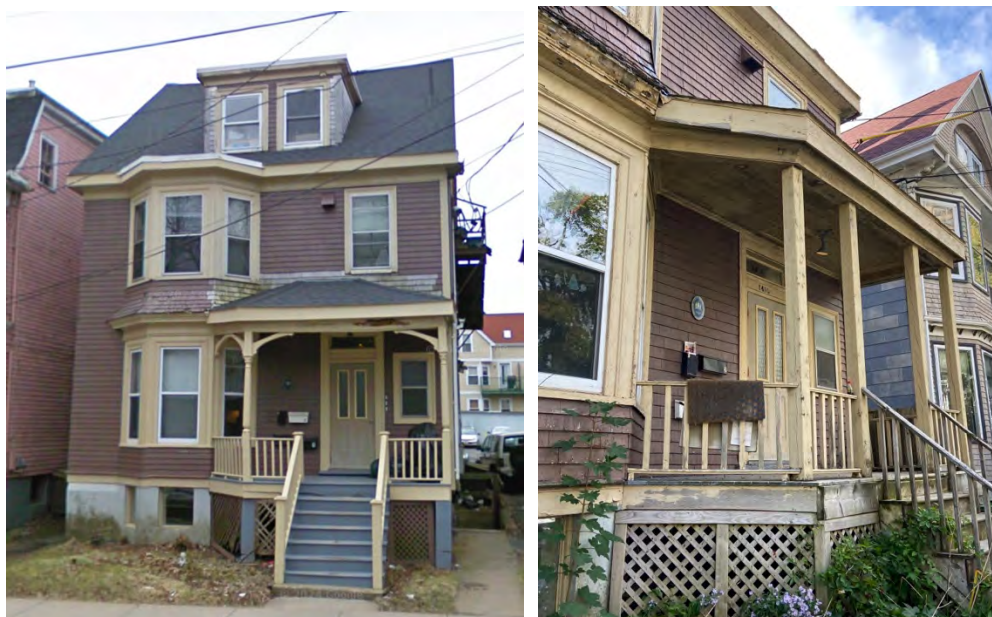
other notable alteration is the front porch detail. The turned posts and brackets were removed between April 2009 and June 2012 (Figure 45).

Figure 45: Front porch details of 1460 Carlton Street, April 2009 (left) and October 2024 (right)

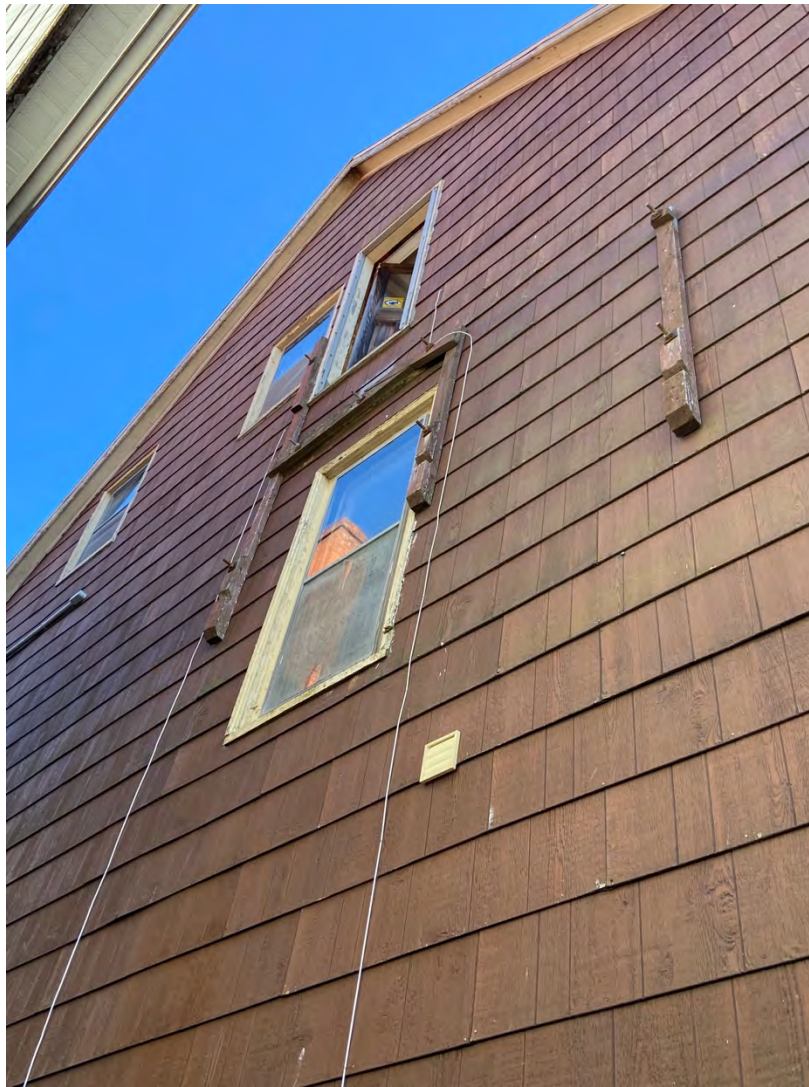
A fire escape was added to the north side, which has since been removed, along with a modification was made to that wall for an emergency exit door opening on the attic (Figure 46).

Figure 46: Shingle pattern on north side and alterations to accommodate former fire escape including a door in the attic

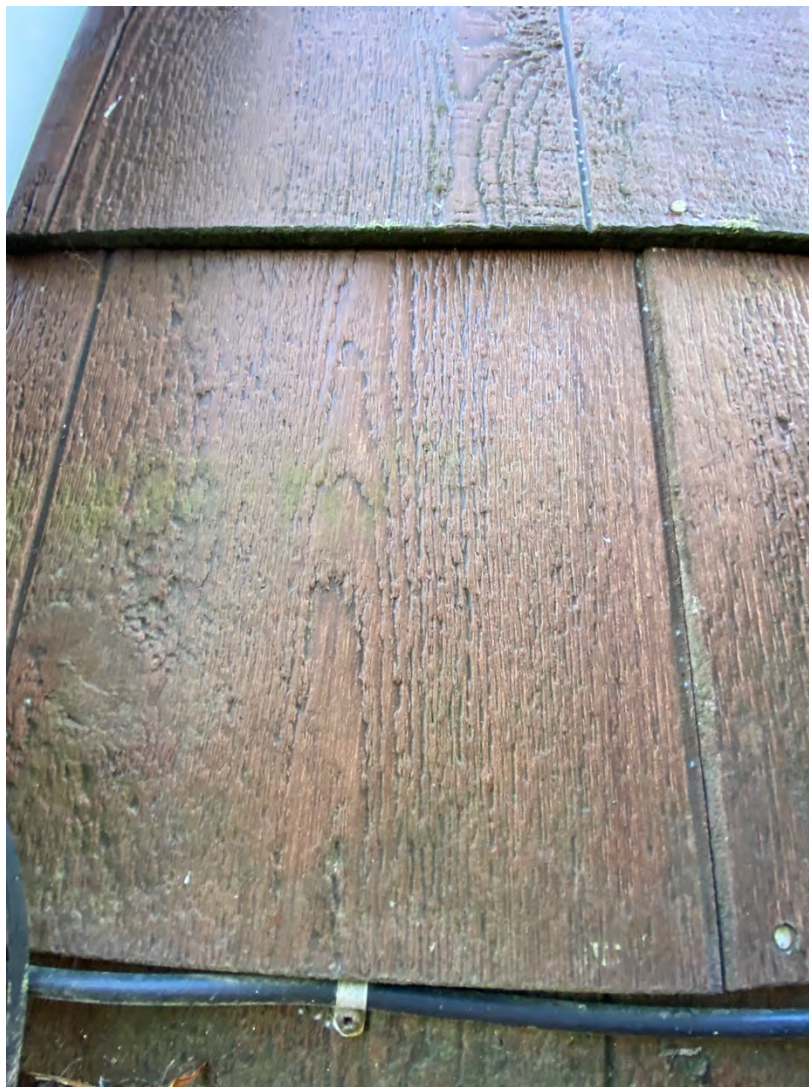
Also, that north wall has had large profile shingle siding added (Figure 47) which appears to be a composite of some sort.

Figure 47: Shingle pattern details, north side

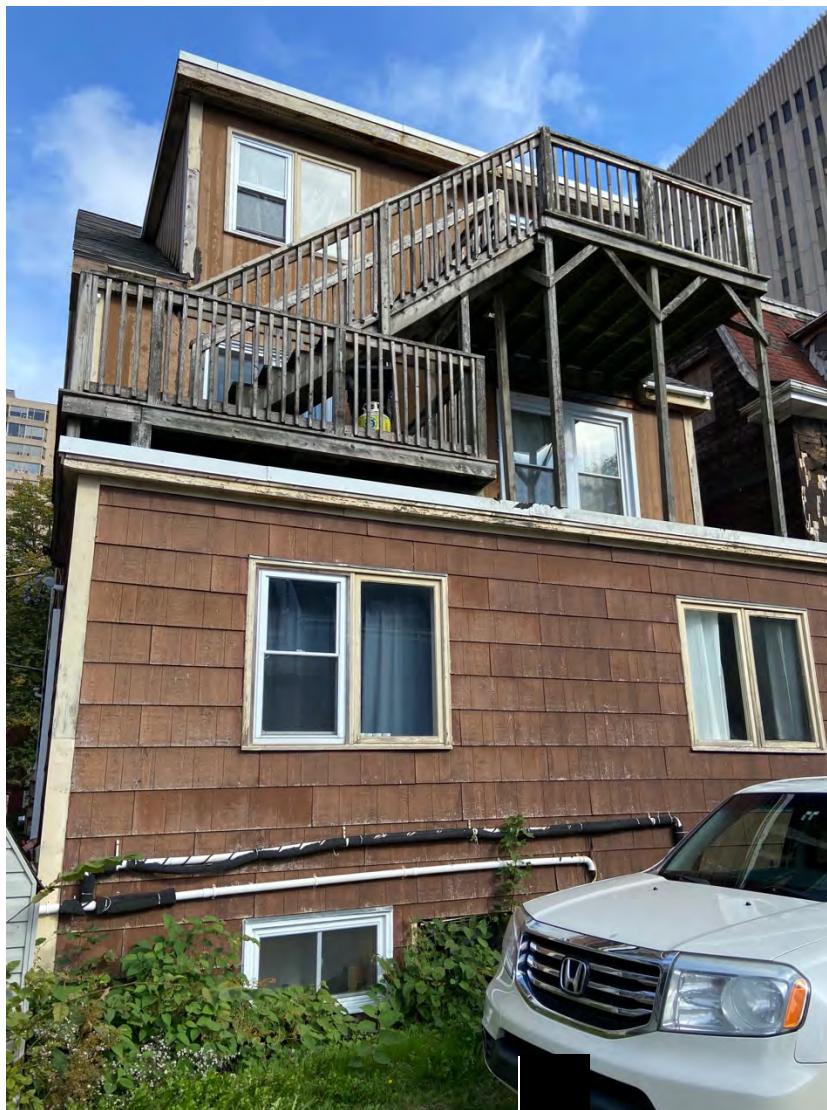
Figure 48: Extension to the main floor and basement, and attic shed dormer with fire escape at the rear of 1460 Carlton Street

The rear has undergone major alterations. Based on early Fire Insurance Plans, between 1907 and 1914 there was a single-storey addition spanning the north two-thirds of the rear with a small porch. At some later point, that addition was expanded to span the entire rear along the main floor and a full width shed dormer was added to the attic, possibly at the same time that the shed dormer was added at the front upon alteration of the roof line. (Unlike the shed dormer at the front, it is flush with the lower wall face and therefore does not have quite the same compatibility.) A fire escape was also added to the attic at the rear. The second floor and attic have a vertical board siding (Figure 48).

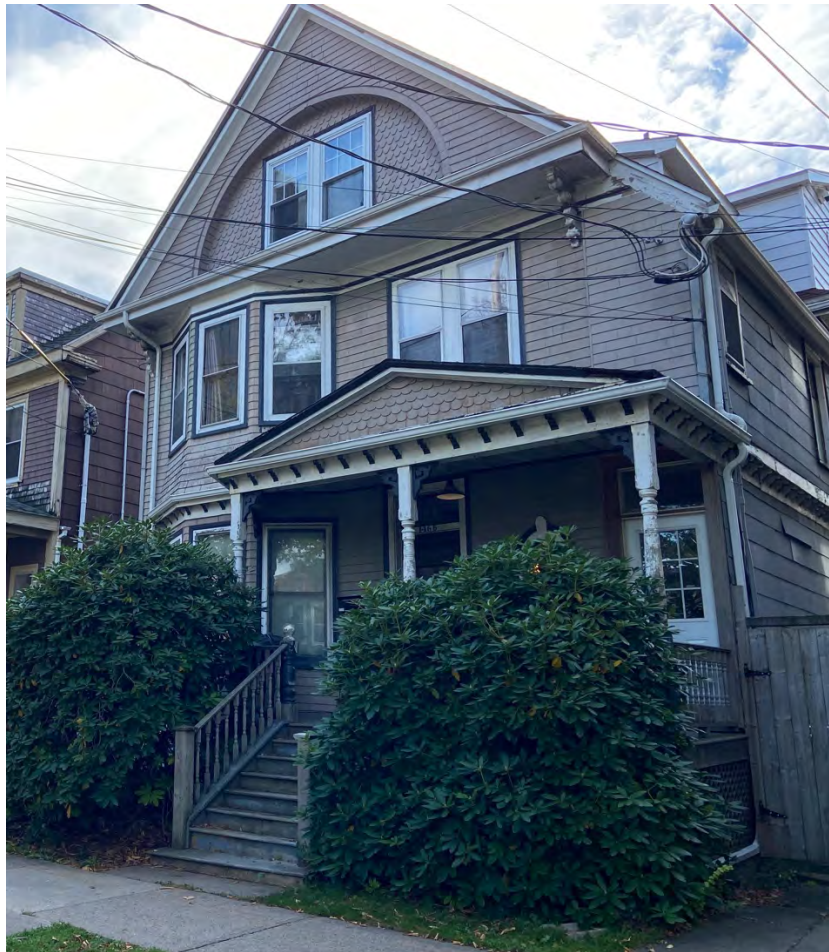
Figure 54a: Keith Residence, 1466 Carlton Street, front

- Board-formed concrete foundation;
- Half-width and gable-roof front porch supported by turned posts and framed by a decorative balustrade;
- Prominent stacked bay at the front set under the soffit;

- Recessed rounded arch set into the front gable of the attic with fishscale shingle cladding;
- Shingle cladding on the main body of the front and around the outer edge of the recessed rounded arch in the gable.

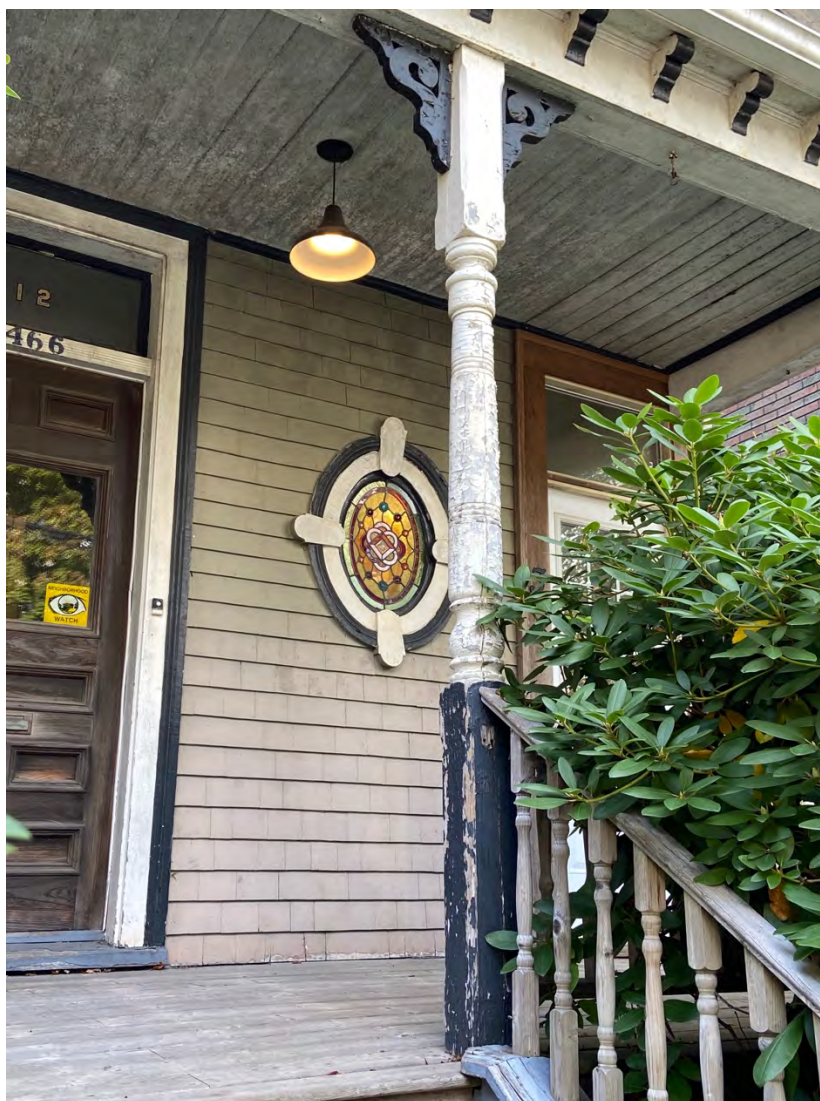
Figure 54e: Keith Residence, 1466 Carlton Street, porch design details

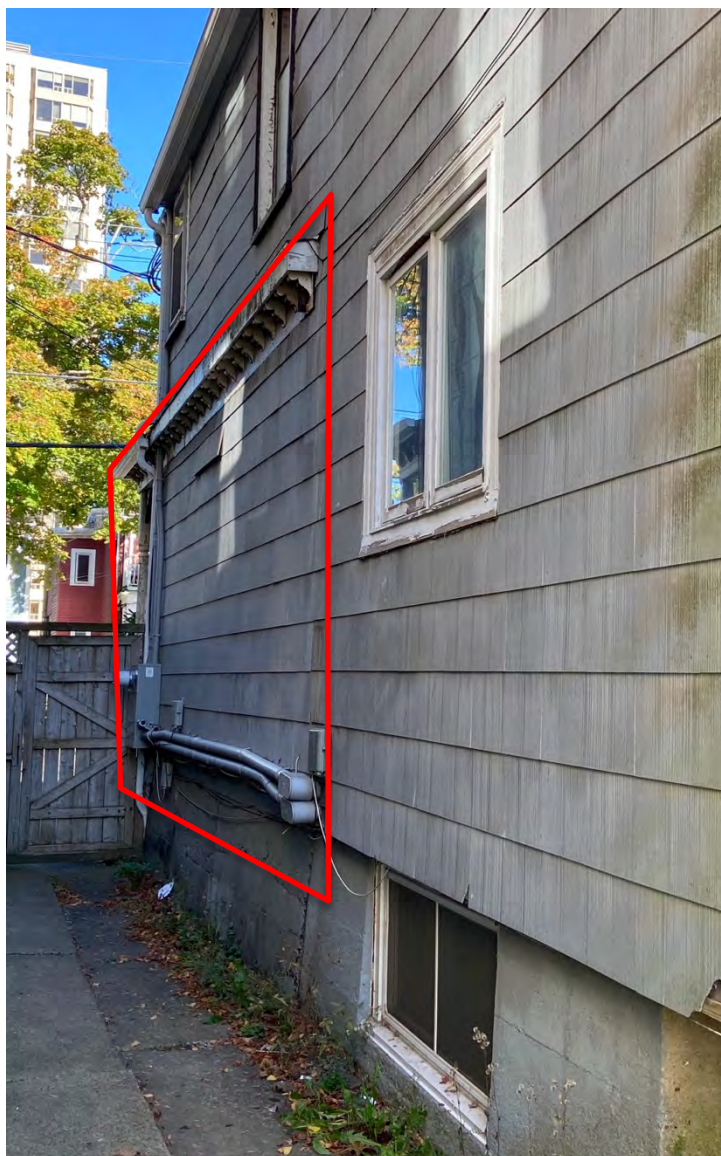
Figure 56: Remnants of wrap-around porch (roof line and brackets), and full extent of that side of porch outlined, north side

This evidently allowed for a new front entry as part of its conversion to two or more residential units, with the new units presumably on the upper floors. That addition allowed for an internal staircase to be easily added for access to the upper unit(s). Although this addition was done as discreetly as possible, with matching cladding and a period-appropriate entry opening with a transom, it has impacted both the front and north side, particularly the overall massing as seen from the front. To some degree this also detracts from the asymmetry and overall character of the building's Queen Anne style, but it also expresses the evolution of the dwelling, and its later conversion to multi-family (Figure 56).

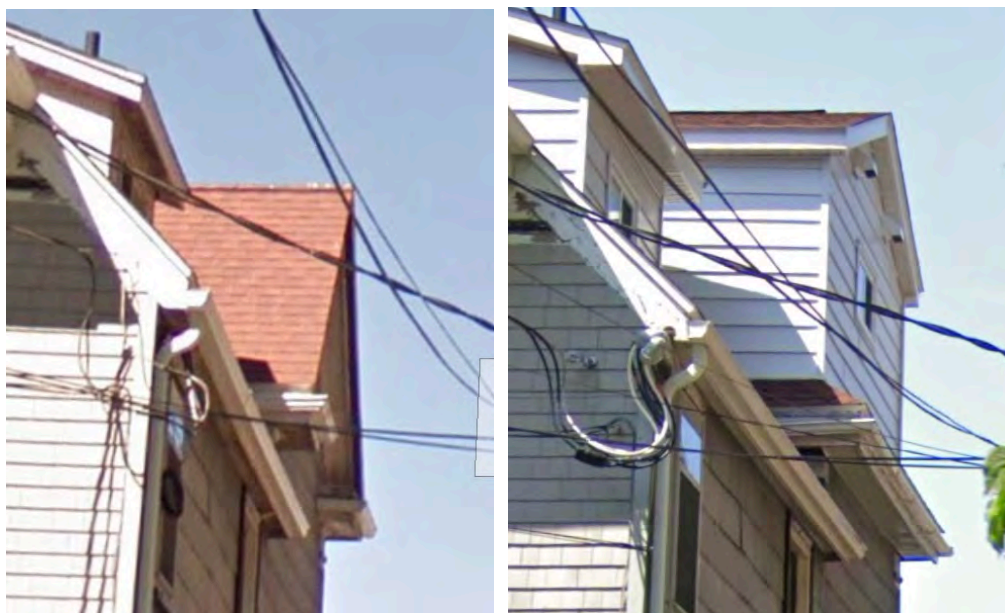
Figure 57: Keith Residence, 1466 Carlton Street – alterations to north side wall dormer, 2015 (left) and 2019 (right)

In addition, sometime between 2016 and 2018, the wall dormer on the north side was altered from a more modest gable form to a taller enclosed space which included altering the roofline significantly with extended wall faces and replacement of windows (Figure 57).

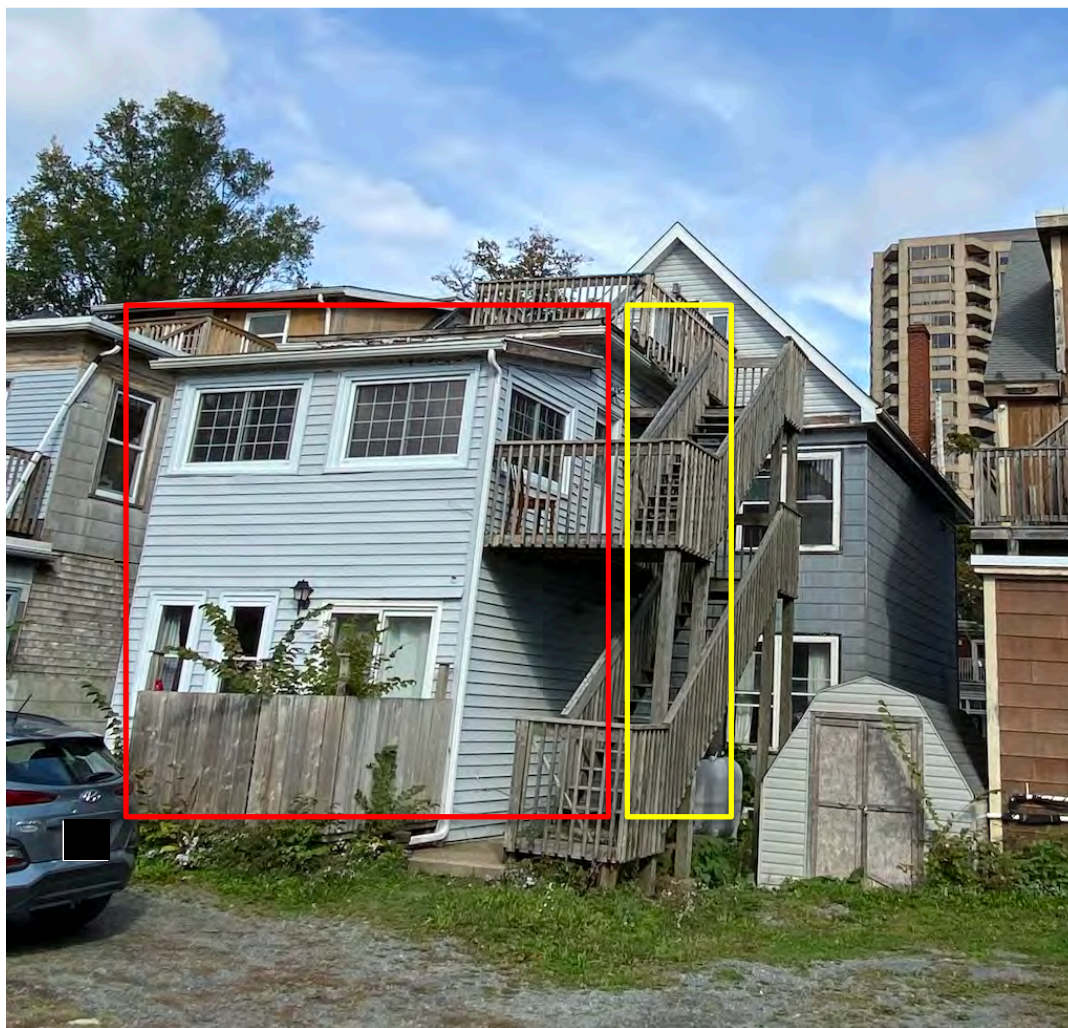
Figure 58: Keith Residence, 1466 Carlton Street – additions to the rear: 1907-1914 (yellow), later date (red)

In addition, a shed roof extension was added to the earlier extension that dates from c. 1910 (Figure 58).

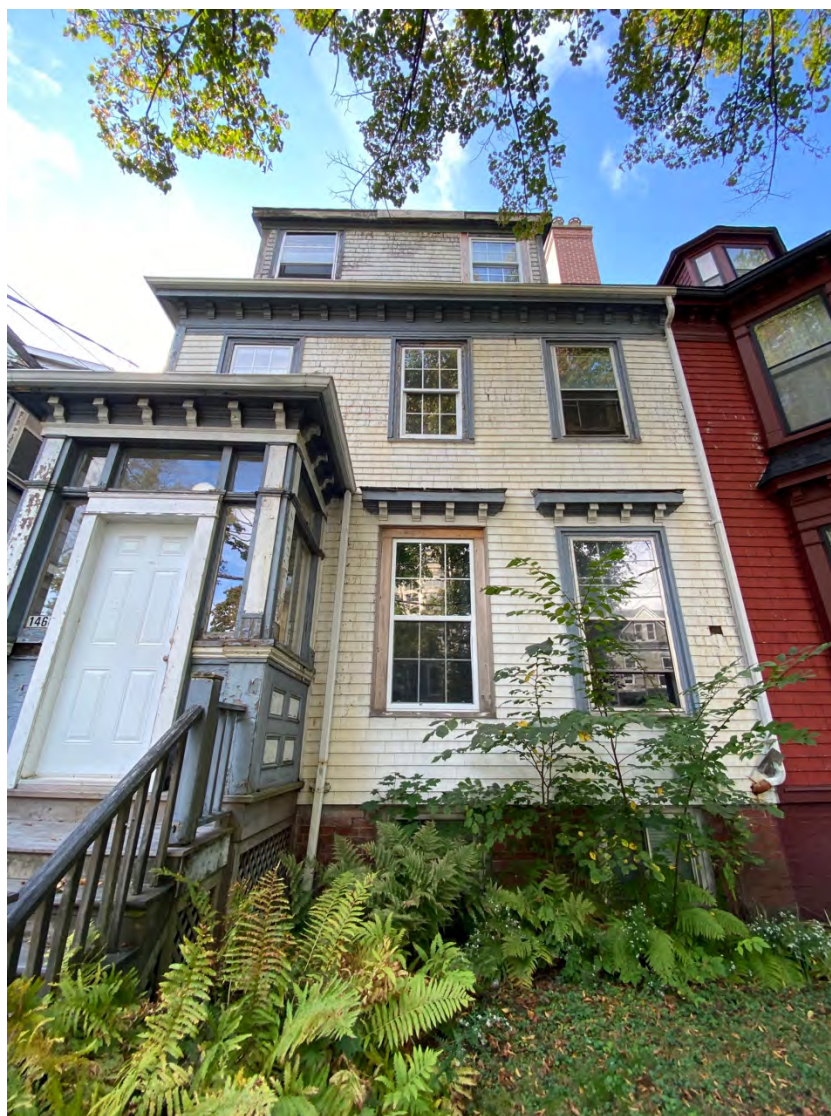
Figure 63a: Tupper Residence, 1468 Carlton Street, front

- Location mid-block between College Street and Spring Garden Road;
- Continuous residential use;
- 2½ storey form set above a basement;
- Main floor set above grade;
- Craftsmanship as evidenced in its design and finishes;
- Side-gabled form with a flat roof spanning the centre;
- Stone and brick foundation;
- Protruding flat roof front porch supported by squared posts and framed by a simple enclosed balustrade;
- Fenestration including:
 - Variety of single-set window openings;
 - Single front entry with transom;
- Design details including:
 - Curved brackets set above each of the two main floor windows, and set around the porch surround soffit, and set under the front soffit;
 - Squared porch posts;
 - Decorative panels in the enclosed balustrade;
- Shingle cladding on the front and south sides.

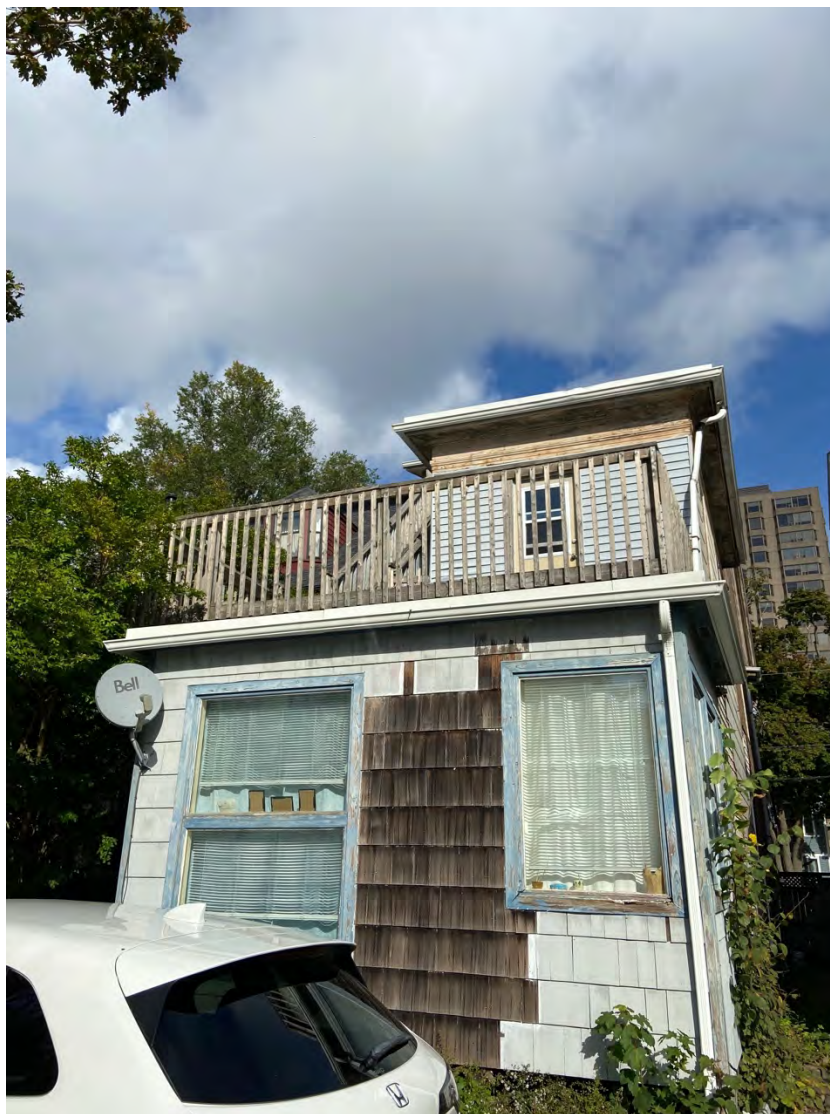
Figure 63b: Tupper Residence, 1468 Carlton Street, rear – south half with later one-storey extension

The Tupper Residence at 1468 Carlton Street appears to be in good condition and it retains much of its exterior integrity. As outlined in Section 3.1, there was an addition made between 1907 and 1914, comprising a two-storey extension spanning roughly half the rear face, followed by a single-storey addition. While the two-storey addition has historic merit as part of its evolution, the smaller single-storey addition does not. The front porch has been enclosed with an entry door added to the outer face; similarly, the specific components that enclose the porch, namely the door, sidelights and windows, do not have heritage merit although the individual design components such as balustrade, posts and decorative brackets do have merit (Figure 64).

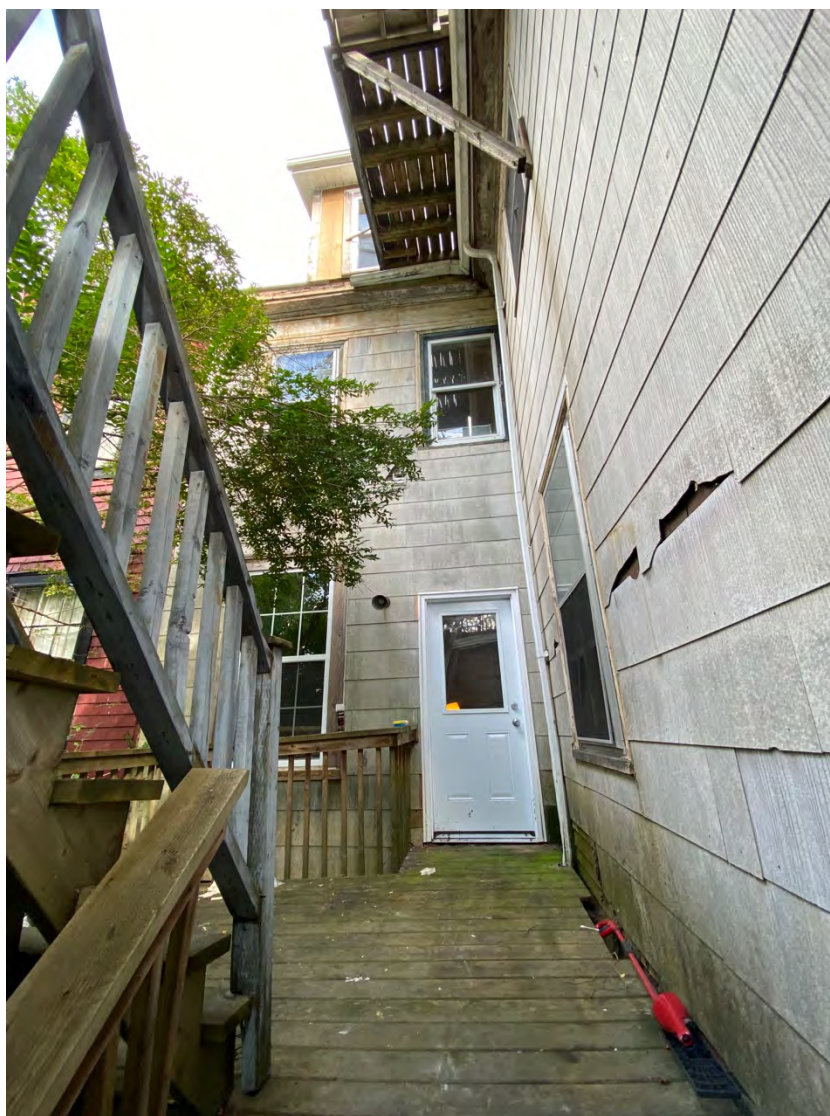
Figure 63c: Tupper Residence, 1468 Carlton Street, inset rear – north half comprising an earlier two-storey extension (c. 1910)
