Item No. 9.1.3
Heritage Advisory Committee
November 26, 2025

SUBJECT: **Case HRTG-2025-01649: Substantial Alteration to Multiple Municipally Registered Heritage Properties on College and Carlton Streets in Halifax**

An application by ZZap Inc. to substantially alter the municipally registered heritage properties located at 5969 College Street, 1456 Carlton Street, 1460 Carlton Street, 1466 Carlton Street, and 1468 Carlton Street, Halifax.

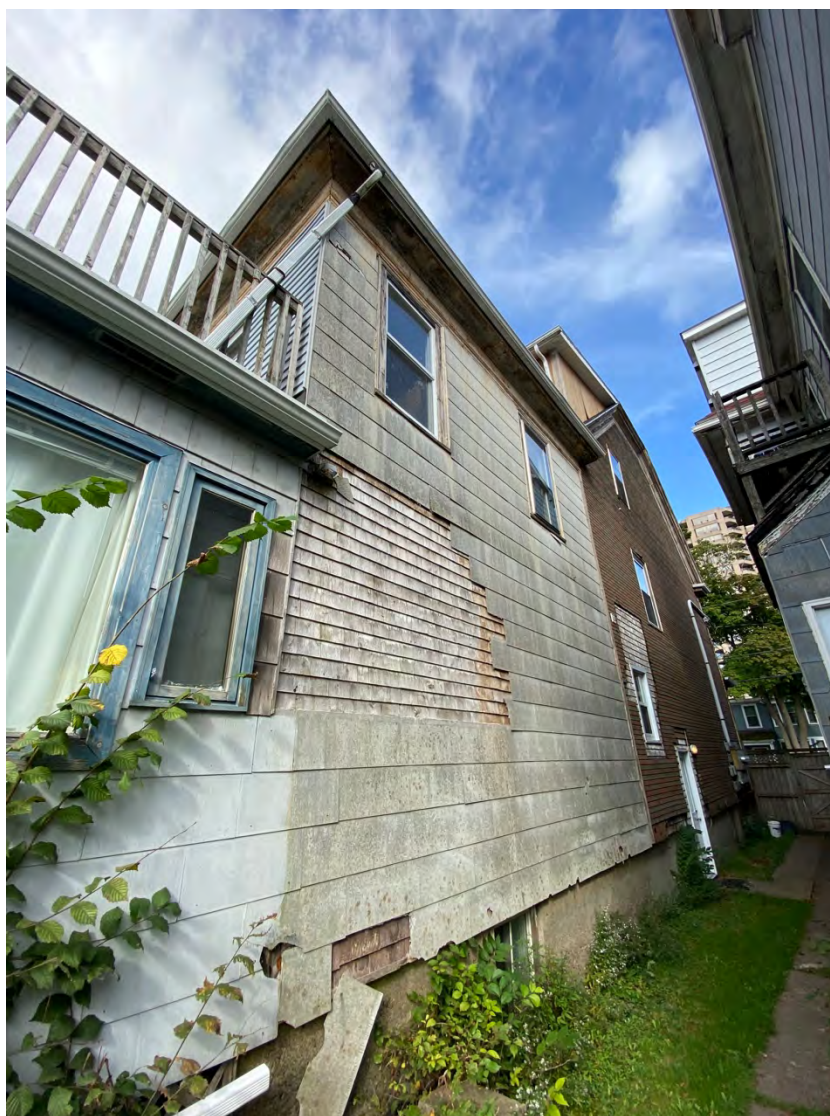
Figure 63d: Tupper Residence, 1468 Carlton Street, south side (front section): first extension, two storeys, c. 1910 and later one storey extension (far left)

The Tupper Residence at 1468 Carlton Street appears to be in good condition and it retains much of its exterior integrity. As outlined in Section 3.1, there was an addition made between 1907 and 1914, comprising a two-storey extension spanning roughly half the rear face, followed by a single-storey addition. While the two-storey addition has historic merit as part of its evolution, the smaller single-storey addition does not. The front porch has been enclosed with an entry door added to the outer face; similarly, the specific components that enclose the porch, namely the door, sidelights and windows, do not have heritage merit although the individual design components such as balustrade, posts and decorative brackets do have merit (Figure 64).

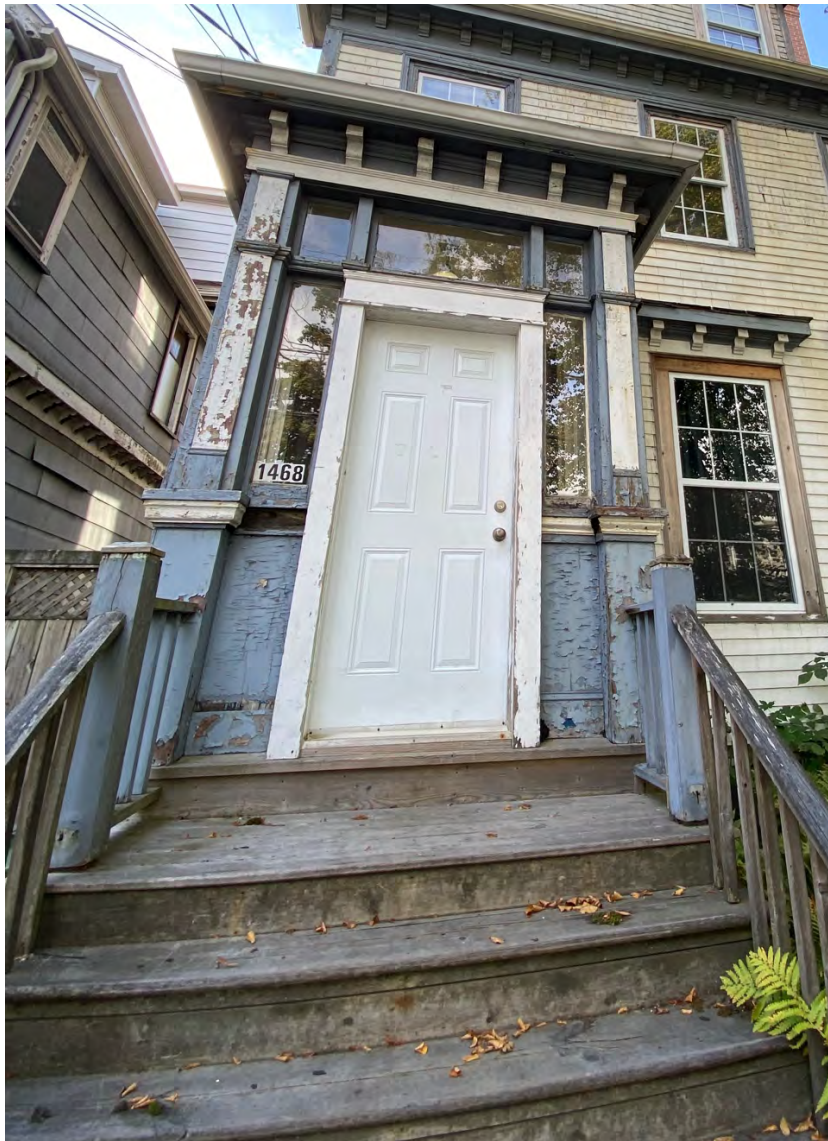
Figure 64: Original porch elements and the modern door enclosure

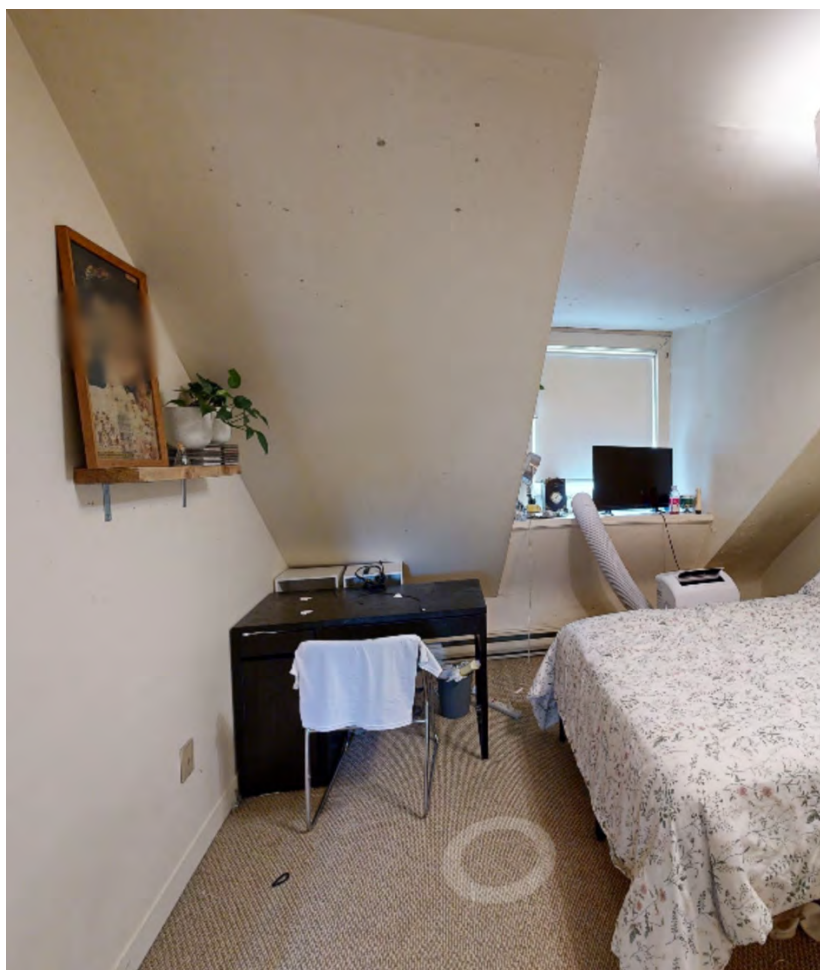
Figure 64: Interior image of the front attic of 1468 Carlton Street

The shed dormer in the front attic appears to not be original, based on evidence revealed on the inside: the attic features a space that still retains the form of the individual dormers, which are presumed to be Scottish dormers as featured in the neighbouring rowhouse to the north (Figure 64).

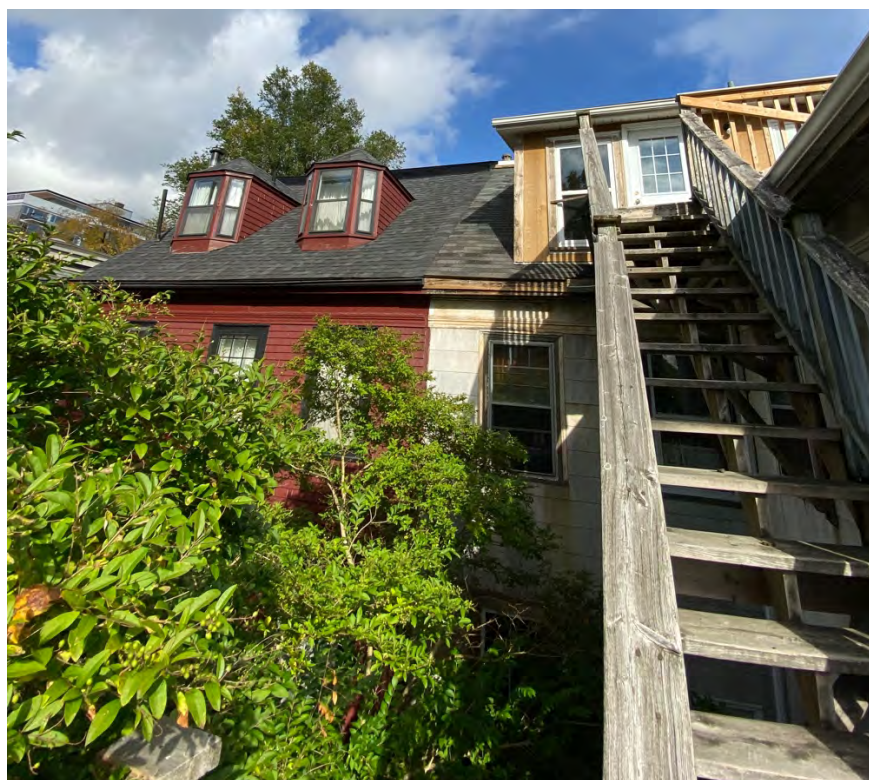
Figure 65: Contrast between the attic of 1474 Carlton Street (left), featuring original Scottish dormers, and 1468 Carlton (right) which has a full width shed dormer

This speaks to the evolution of the house. It is not known why this shed dormer was added since it did not change the living space layout in the attic, as it might be expected to do. In a similar way, the shed dormer at the rear, which spans the entire width, detracts from the overall character, even though it is at the rear. While it is evident that it is not original based on more modern windows, door and cladding, it is not known when it was added or what it may have replaced. However, the Scottish dormers on the rear of the north half of the rowhouse, suggest what it may have looked like (Figure 65).

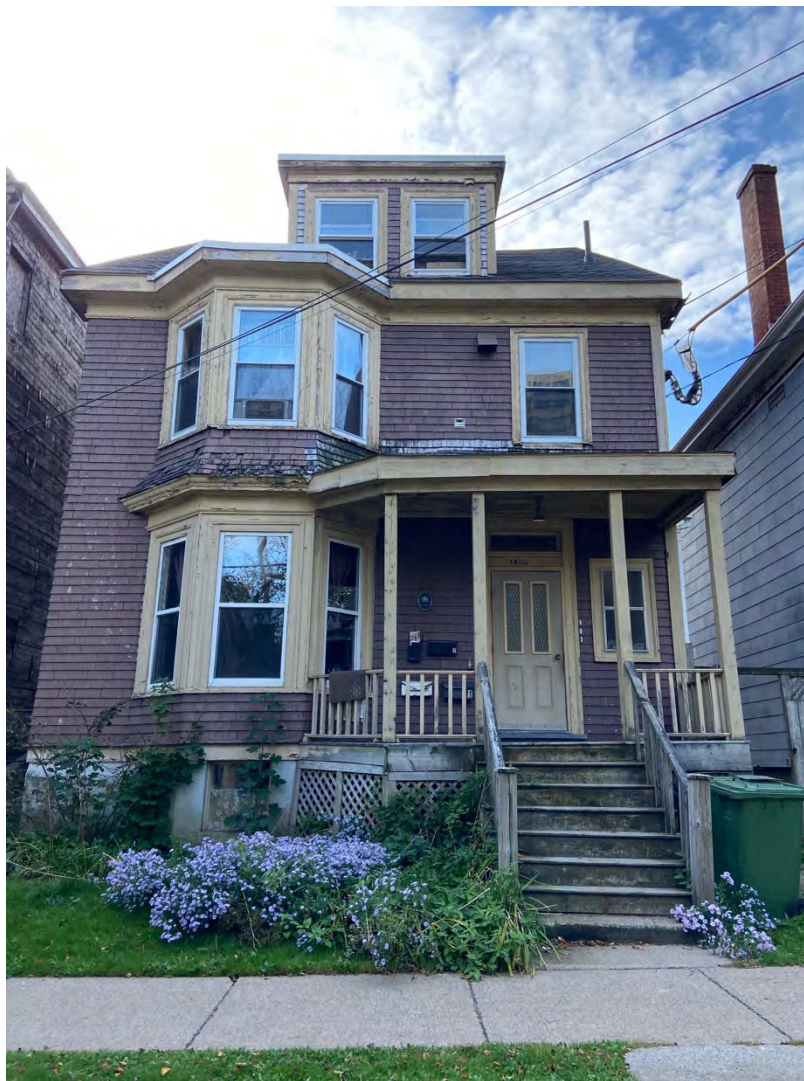
Figure 70a: Neal Residence, 1460 Carlton Street (Front)

The alterations and interventions to the Neal Residence include the restoration of original elements of the front porch including the porch posts and brackets. enclosure, and a period-appropriate wood entry door with inset glazing. The rehabilitation of the rear would include removal of both additions to bring it back to the original footprint. The full-width shed-roof wall dormer in the attic should be removed and replaced with more modest attic dormers, ideally a more contemporary interpretation of the Scottish dormers that may have been in the attic originally. The sides would require the removal of the remnants of the fire escape on the north side, and removal of the composite cladding with application of a new non-combustible cladding (assuming that this is required in the Building Code) on both the north and south sides that is period-appropriate in appearance. The alteration to the north side attic, as part of that fire escape, which still has an early wood door, should be retained (both the opening and the door itself, assuming that it is in suitable condition), with the door fixed (i.e. inoperable). Restoration of the rear wall will be necessary with period-appropriate wood windows and cladding.

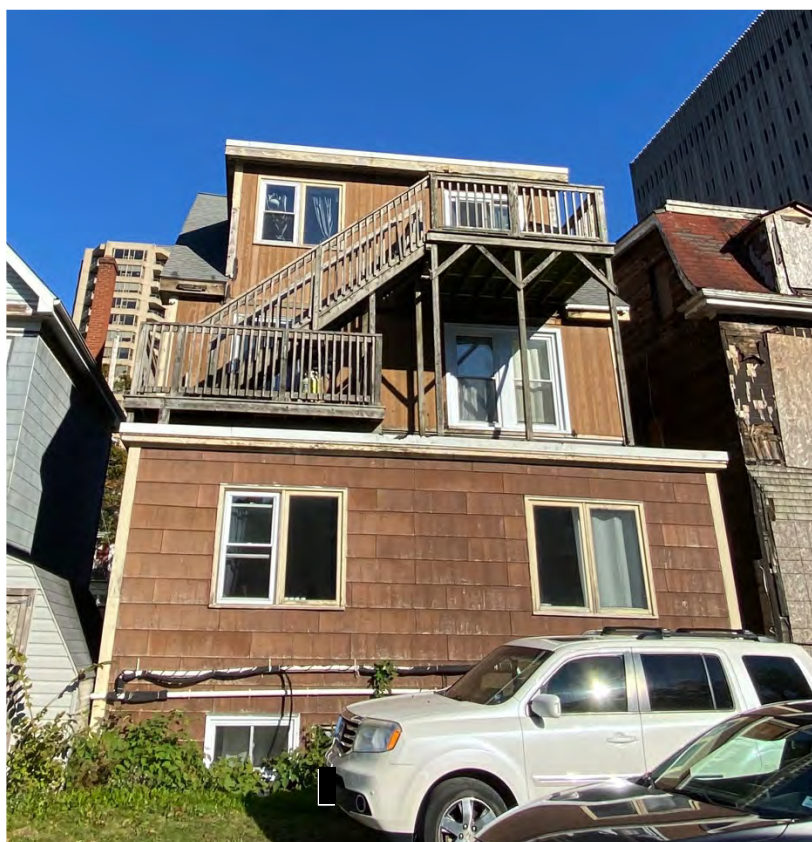
Figure 70b: Neal Residence, 1460 Carlton Street (Rear)

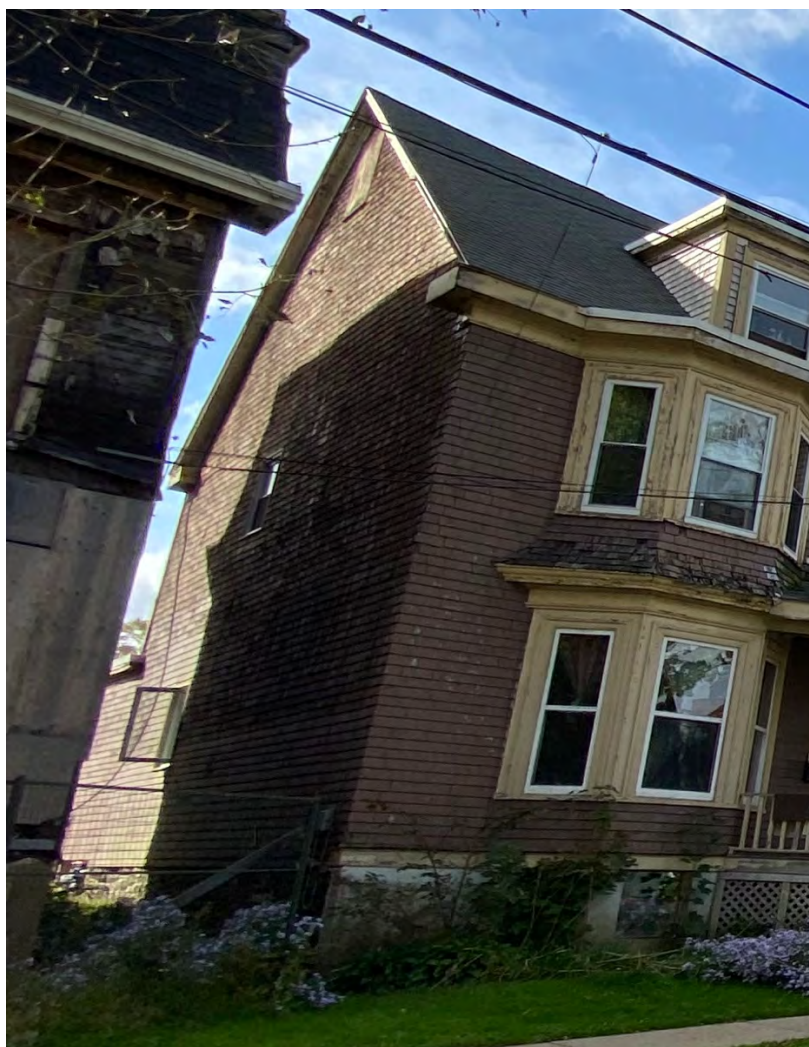
Figure 70c: Neal Residence, 1460 Carlton Street (South side)

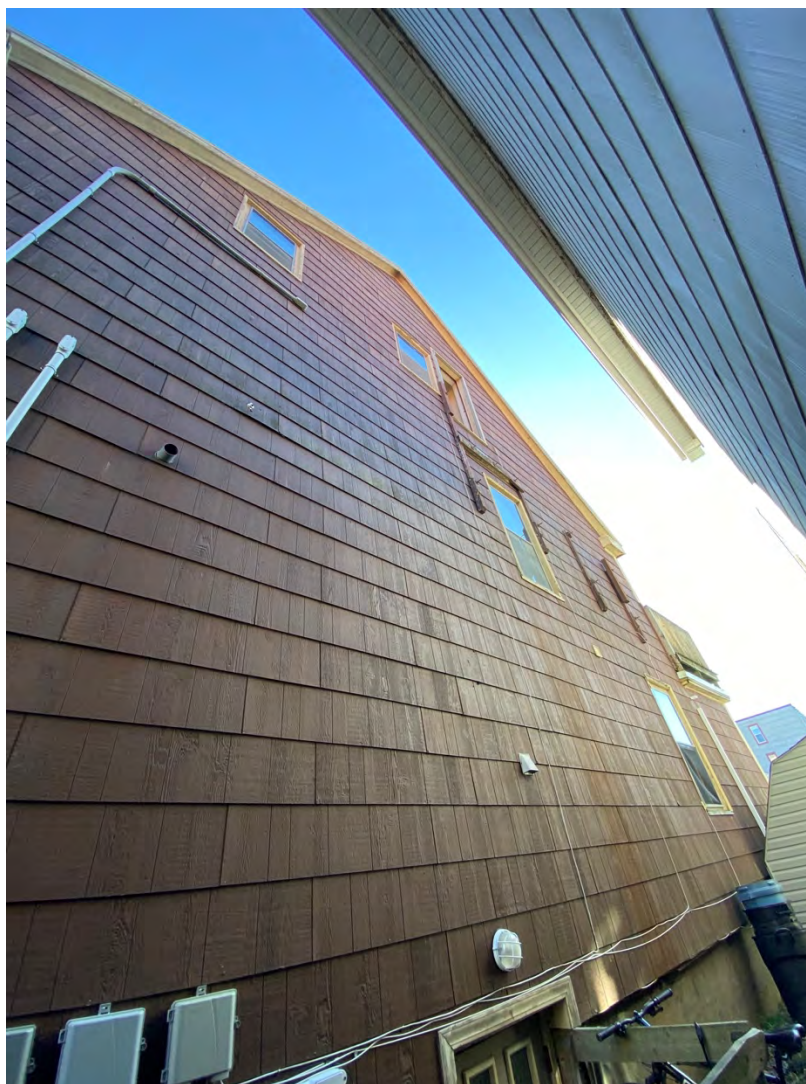
Figure 70d: Neal Residence, 1460 Carlton Street (North side)

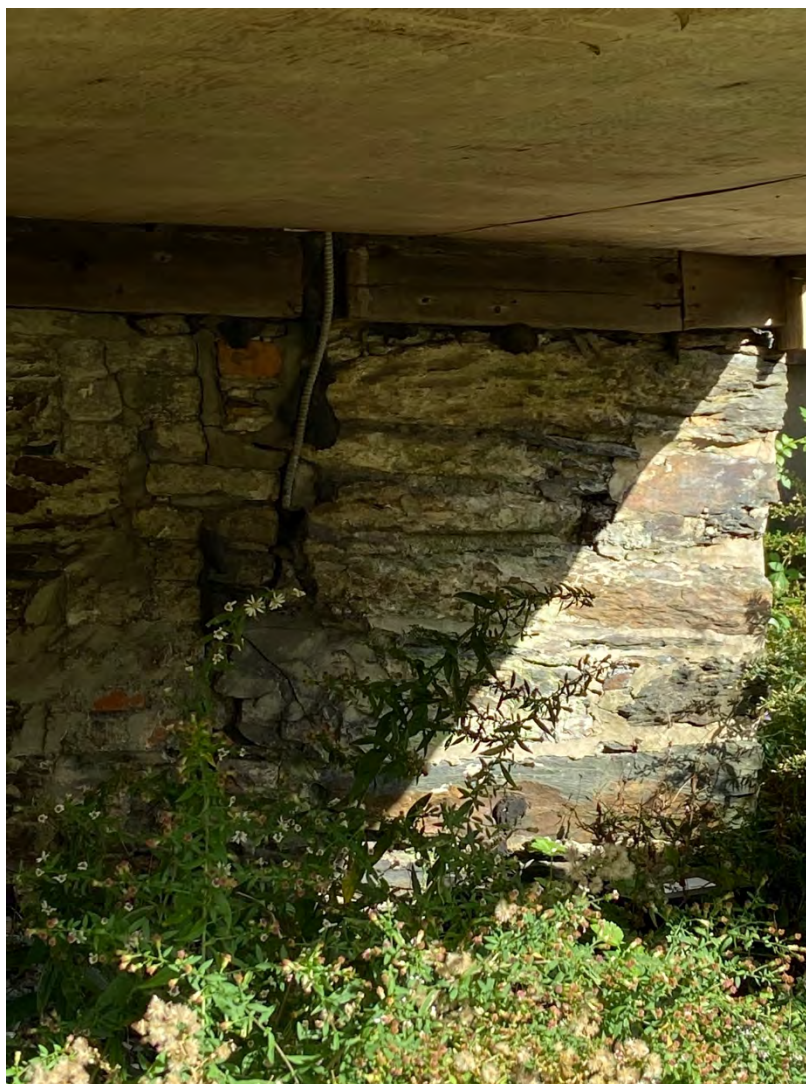
Figure 70e: Neal Residence, 1460 Carlton Street – stone foundation

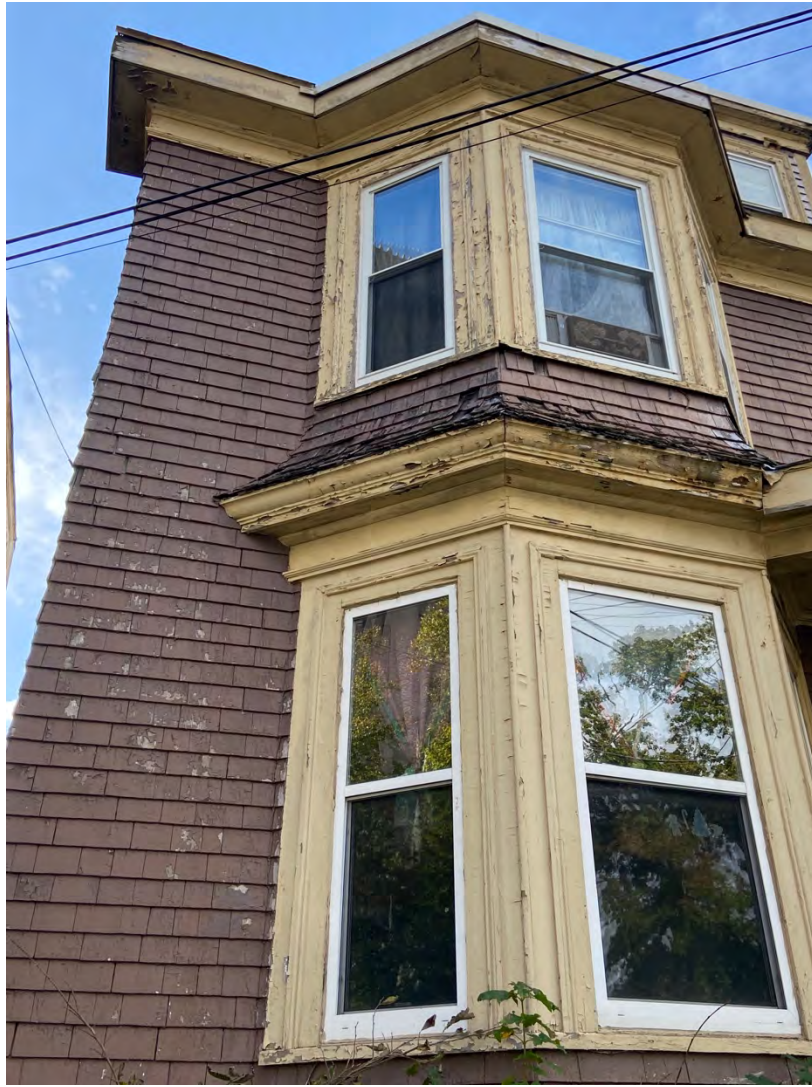
Figure 70f: Neal Residence, 1460 Carlton Street – stacked bay window

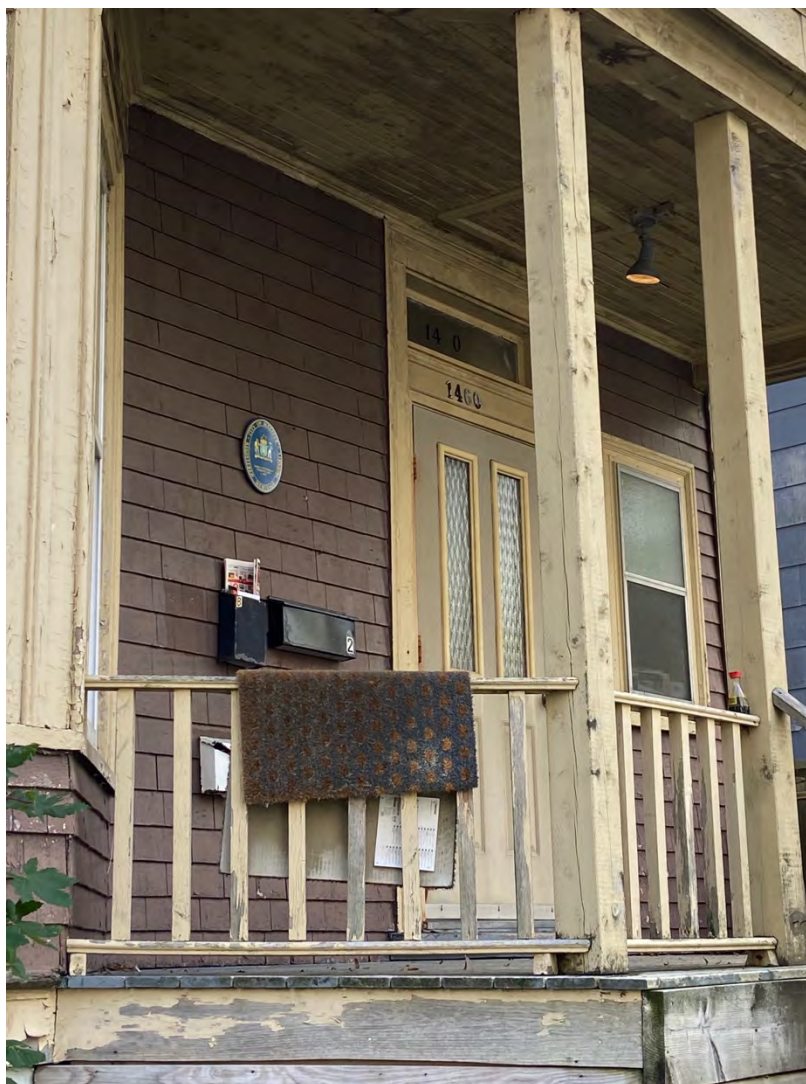
Figure 70g: Neal Residence, 1460 Carlton Street – porch details

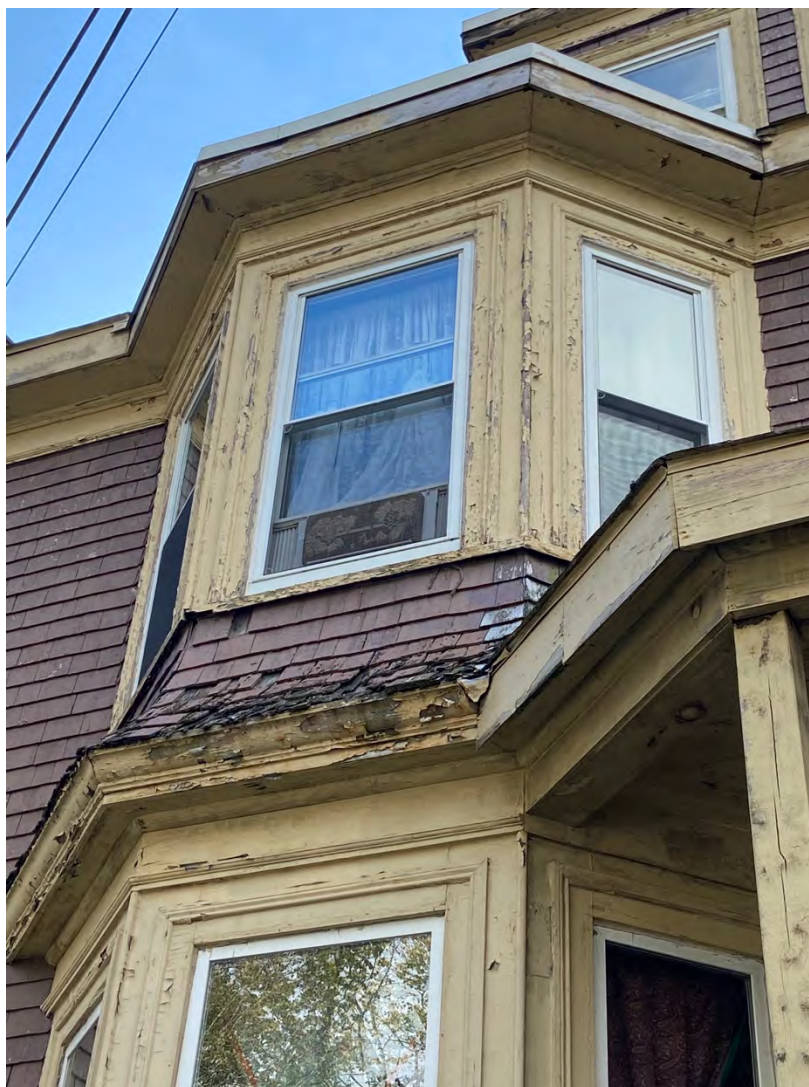
Figure 70h: Neal Residence, 1460 Carlton Street – bellcast eave

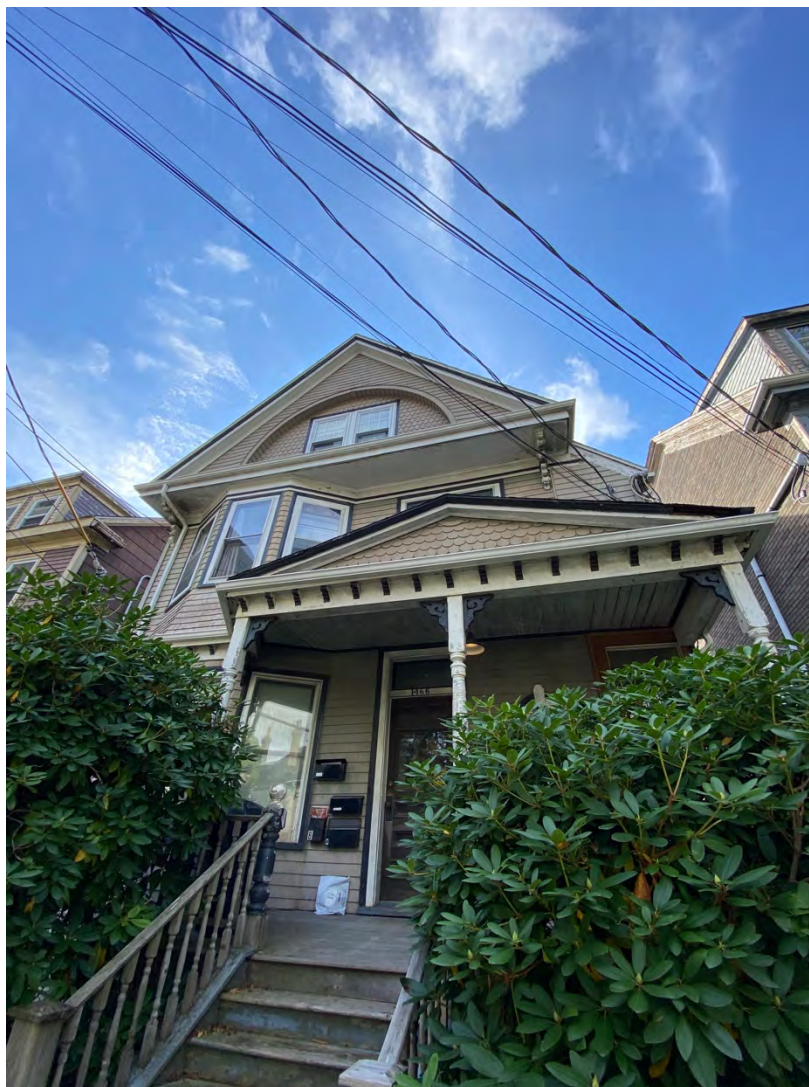
Figure 71a: Keith Residence, 1466 Carlton Street (Front)

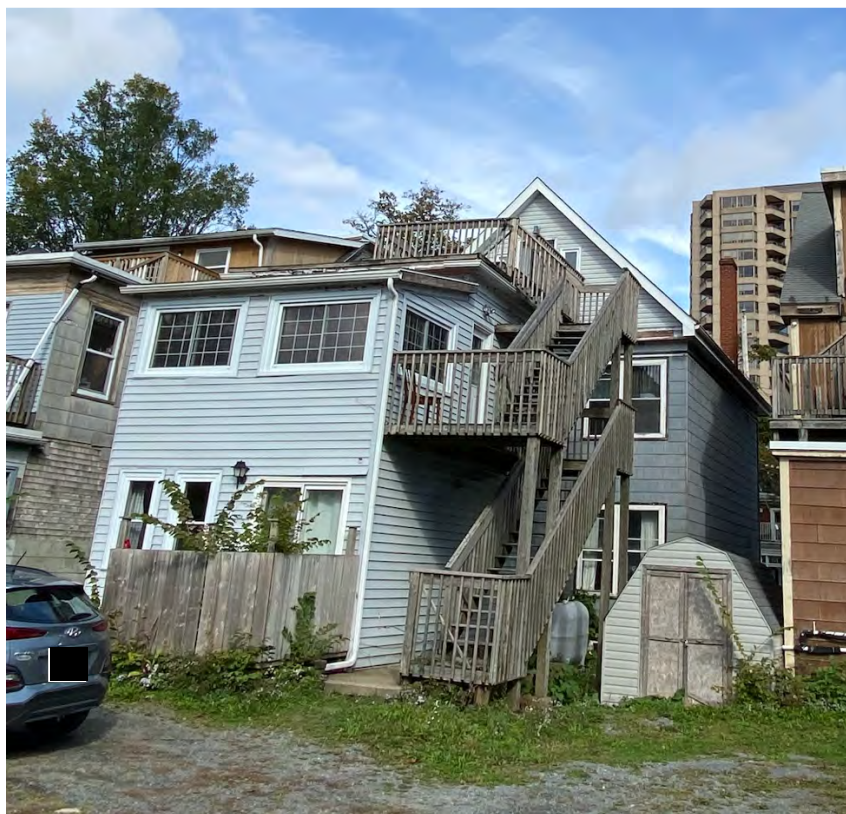
Figure 71b: Keith Residence, 1466 Carlton Street (Rear)

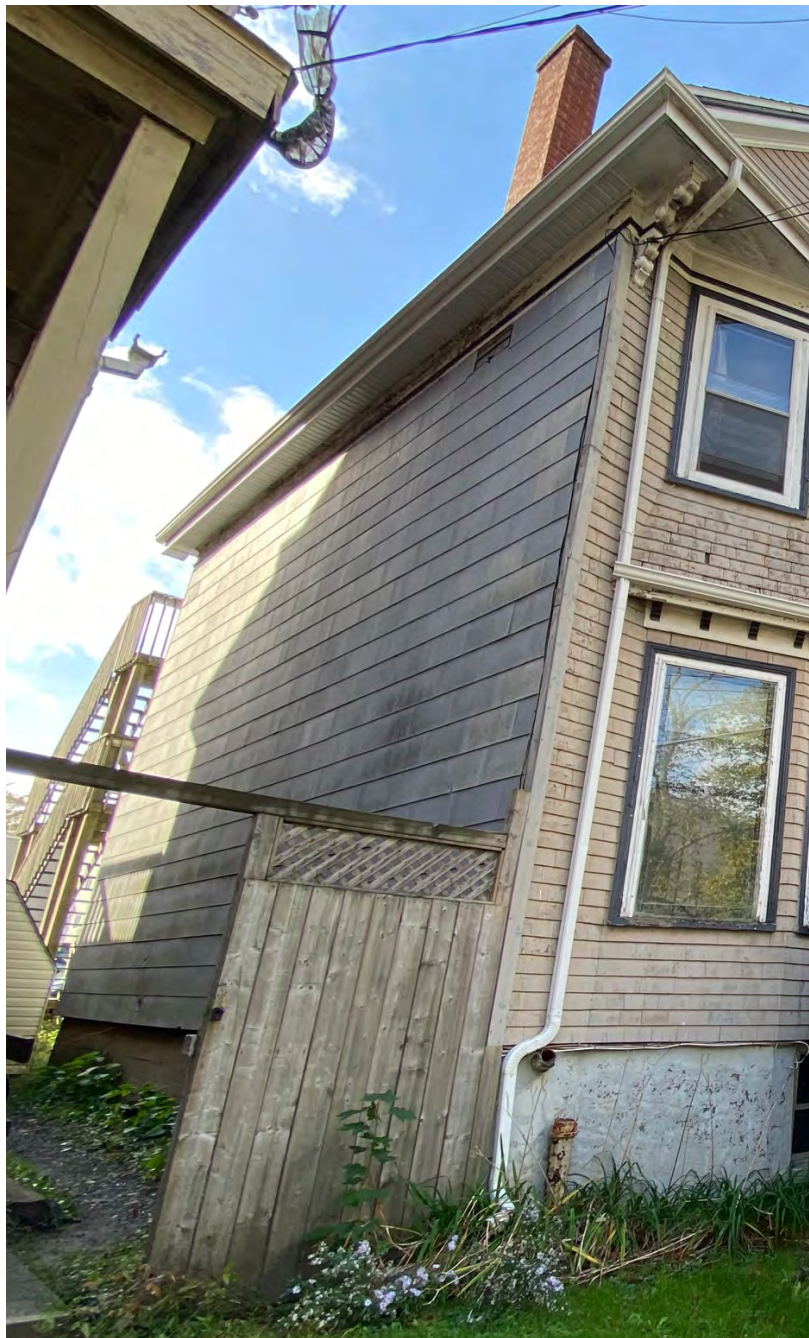
Figure 71c: Keith Residence, 1466 Carlton Street (South side)

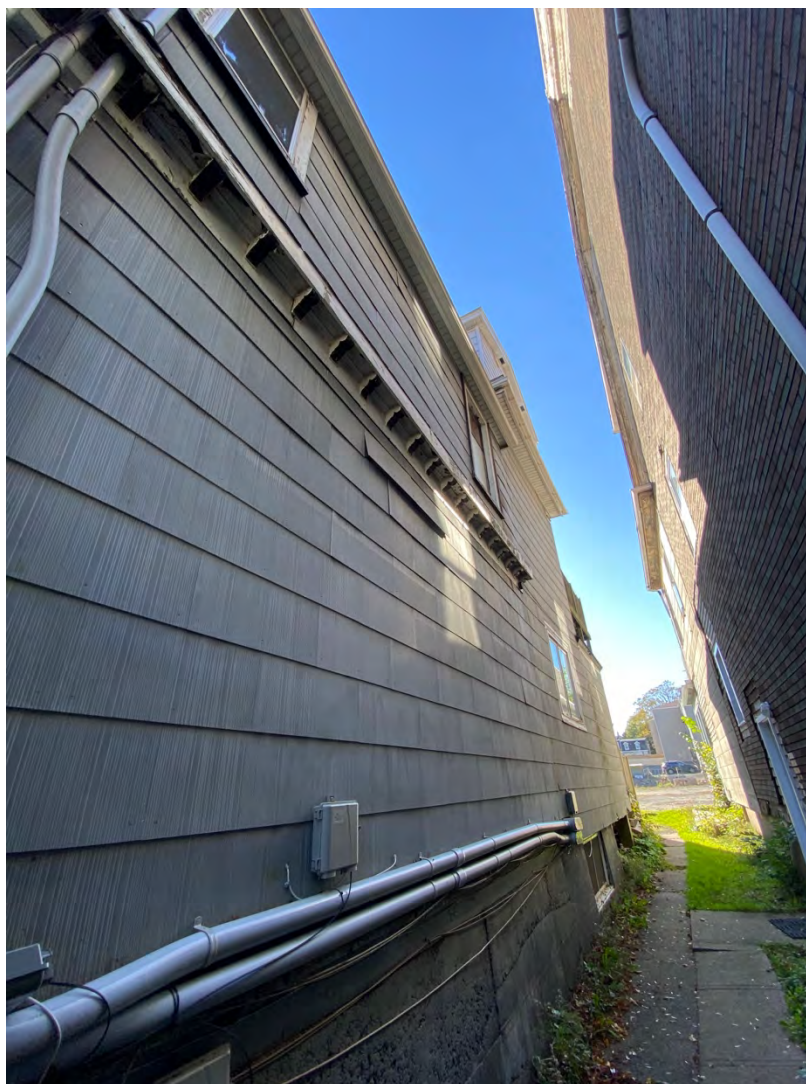
Figure 71d: Keith Residence, 1466 Carlton Street (North side)

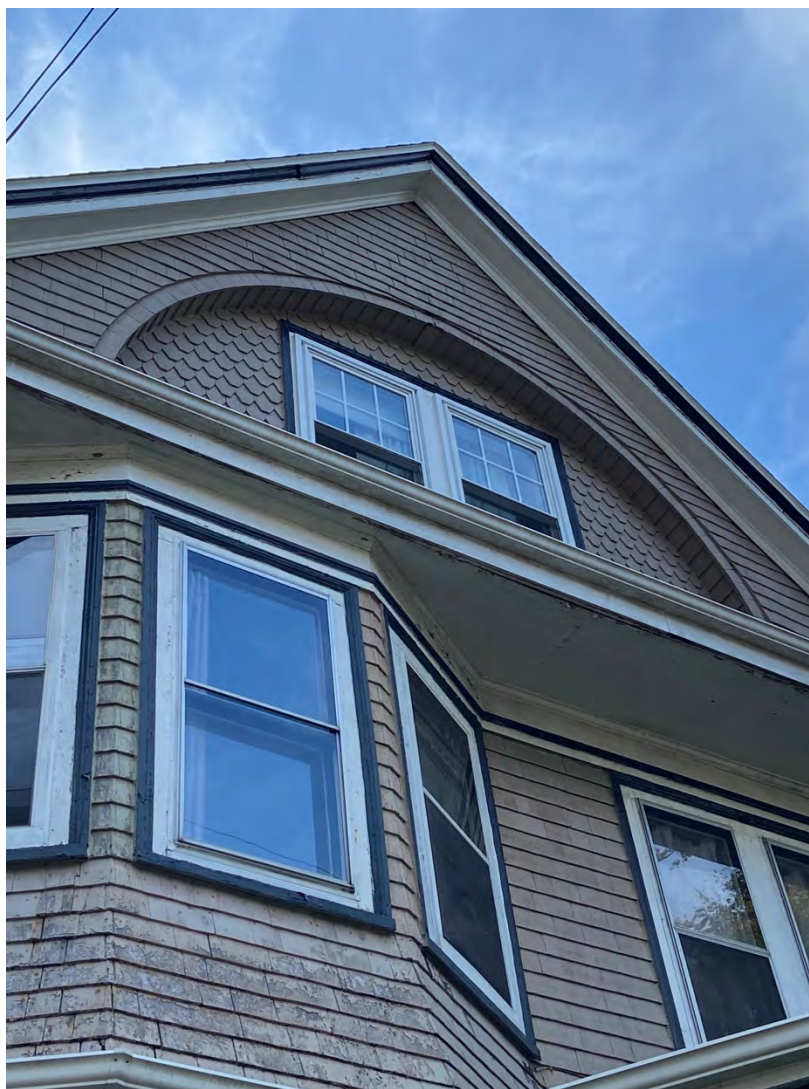
Figure 71e: Keith Residence, 1466 Carlton Street – upper portion of bay window and attic shingle details

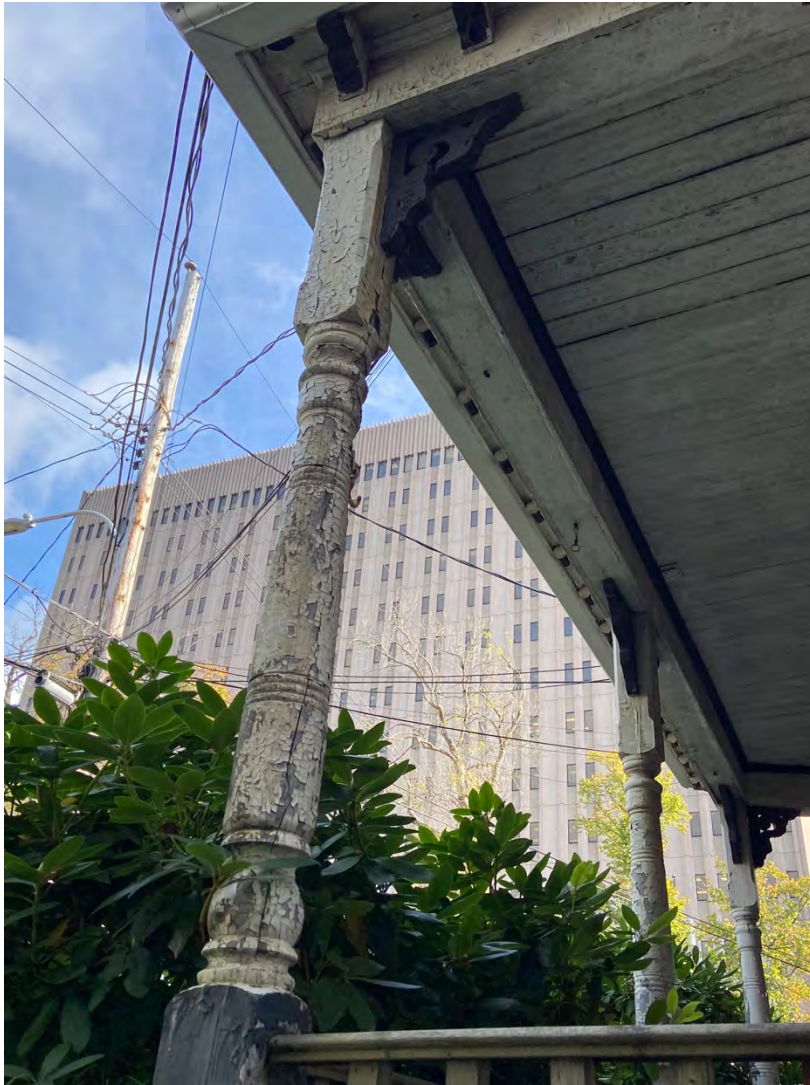
Figure 71f: Keith Residence, 1466 Carlton Street – front porch detail: turned posts, decorative brackets

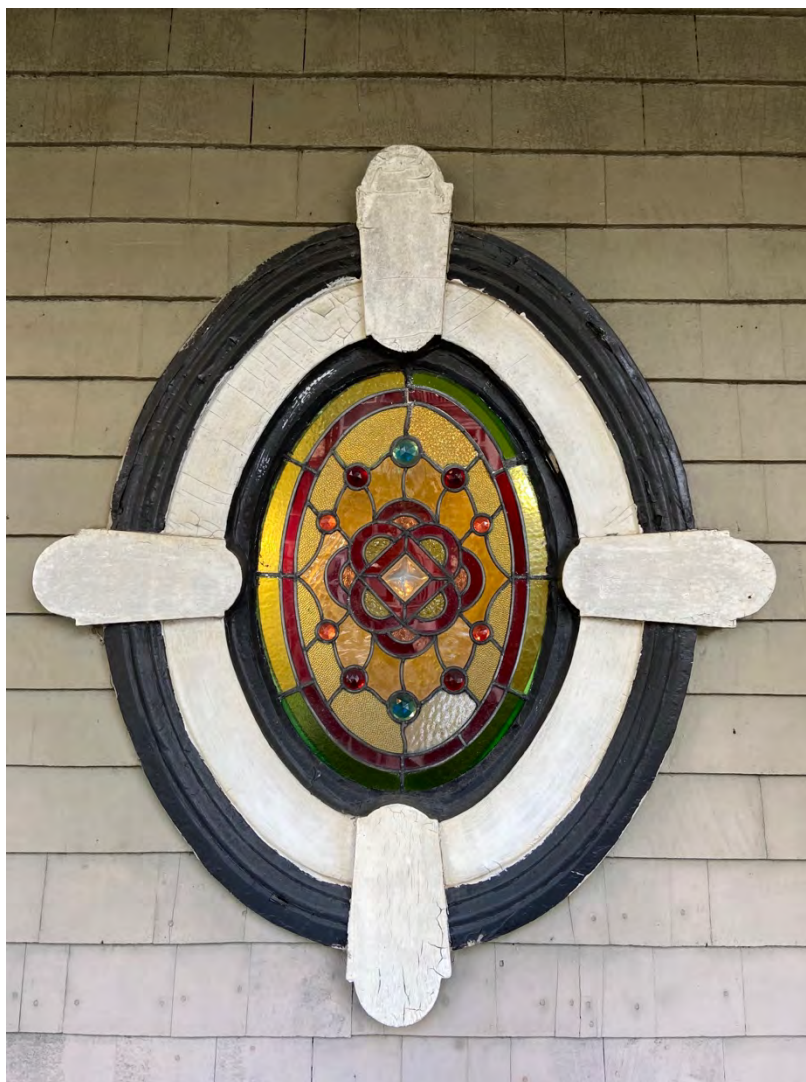
Figure 71g: Keith Residence, 1466 Carlton Street – front oriel window detail

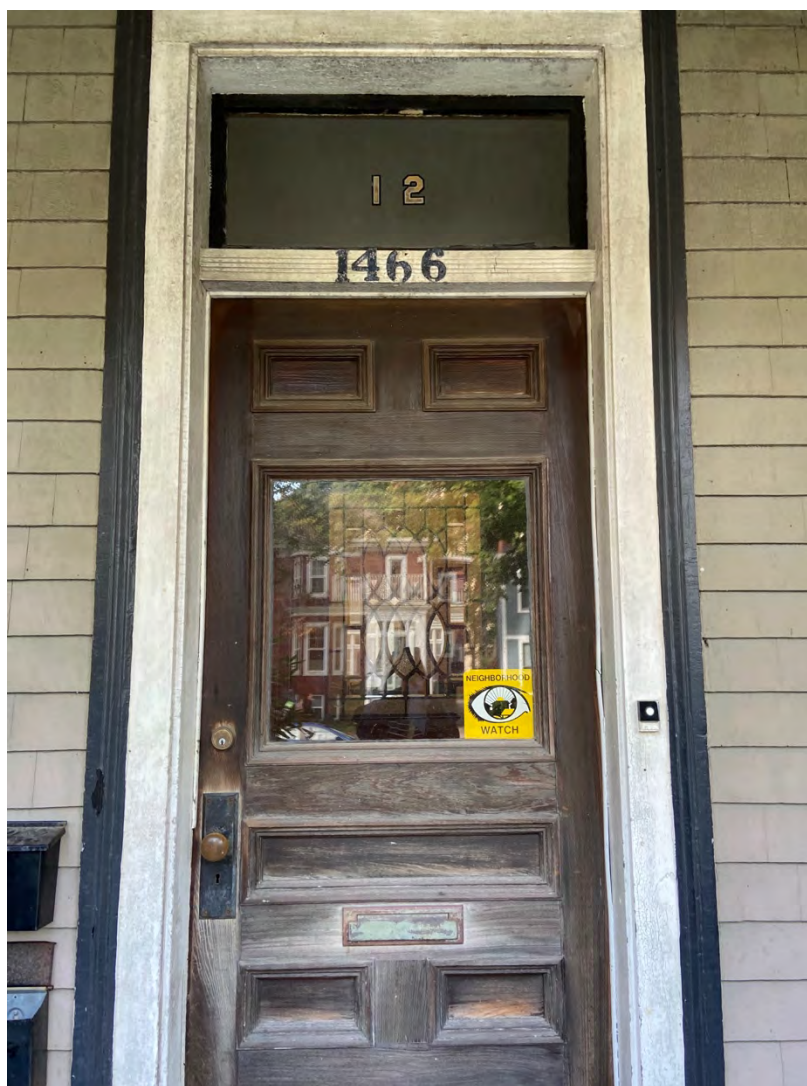
Figure 71h: Keith Residence, 1466 Carlton Street – front door and transom detail

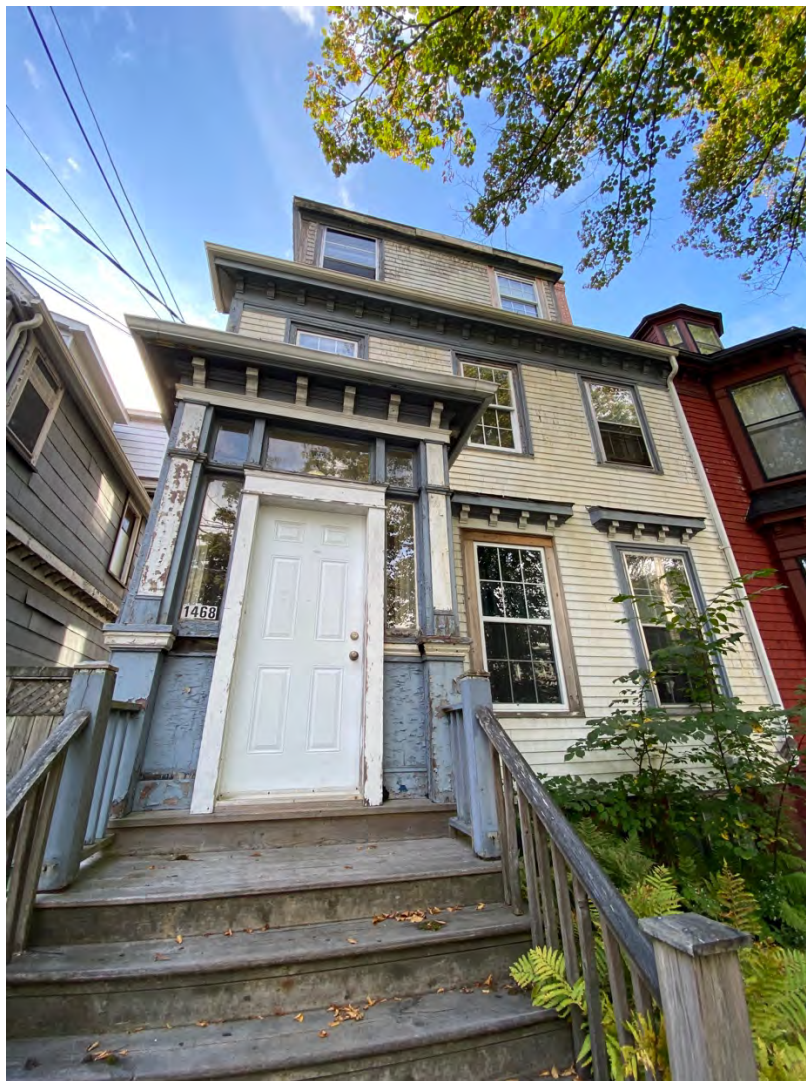
Figure 72a: Tupper Residence, 1468 Carlton Street (Front)

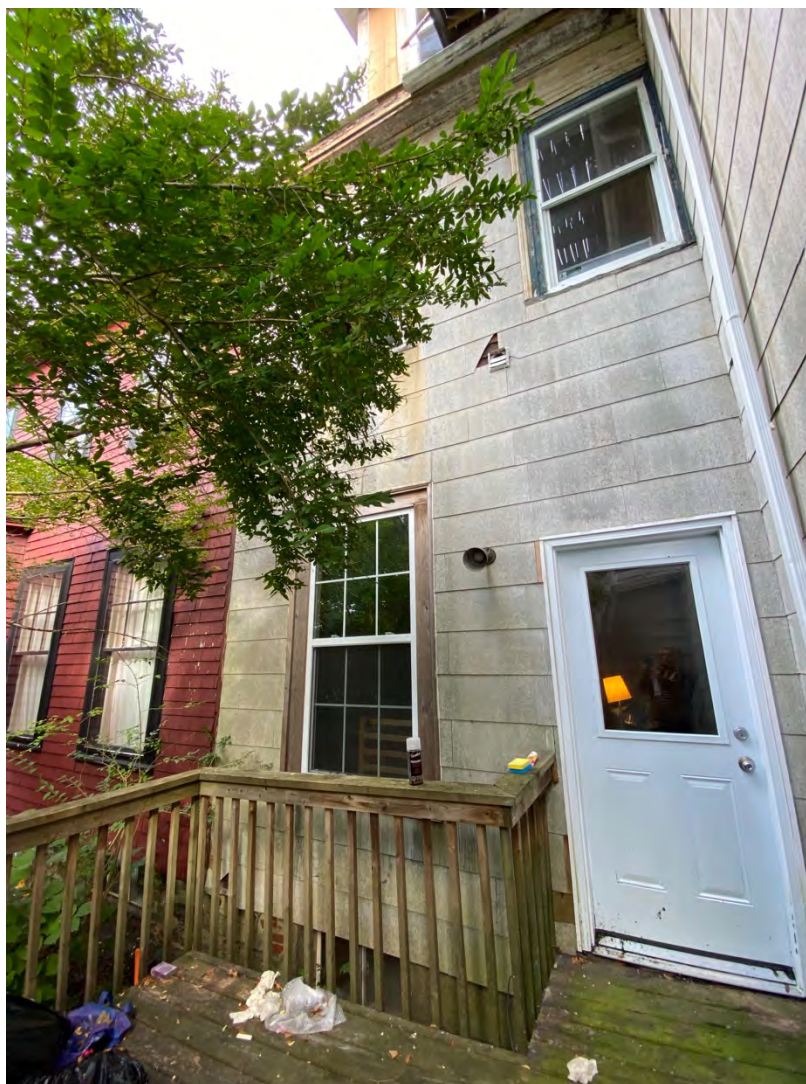
Figure 72b: Tupper Residence, 1468 Carlton Street (Rear face, north half)

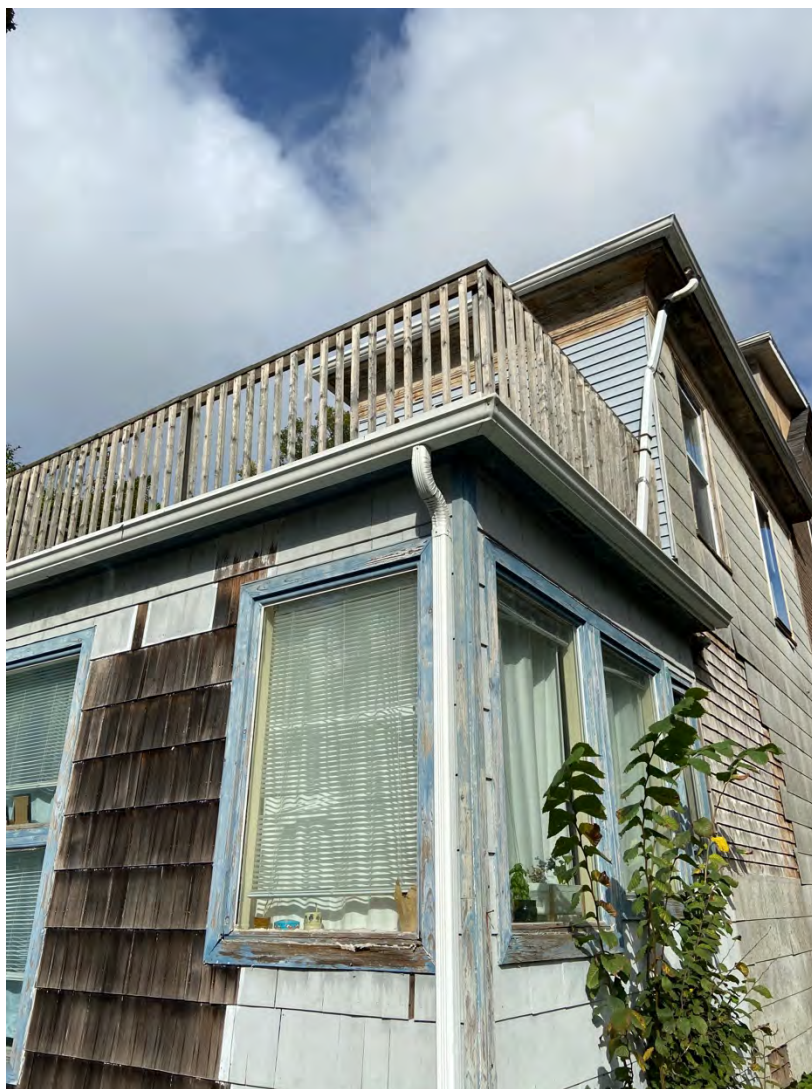
Figure 72c: Tupper Residence, 1468 Carlton Street (Rear, south half)

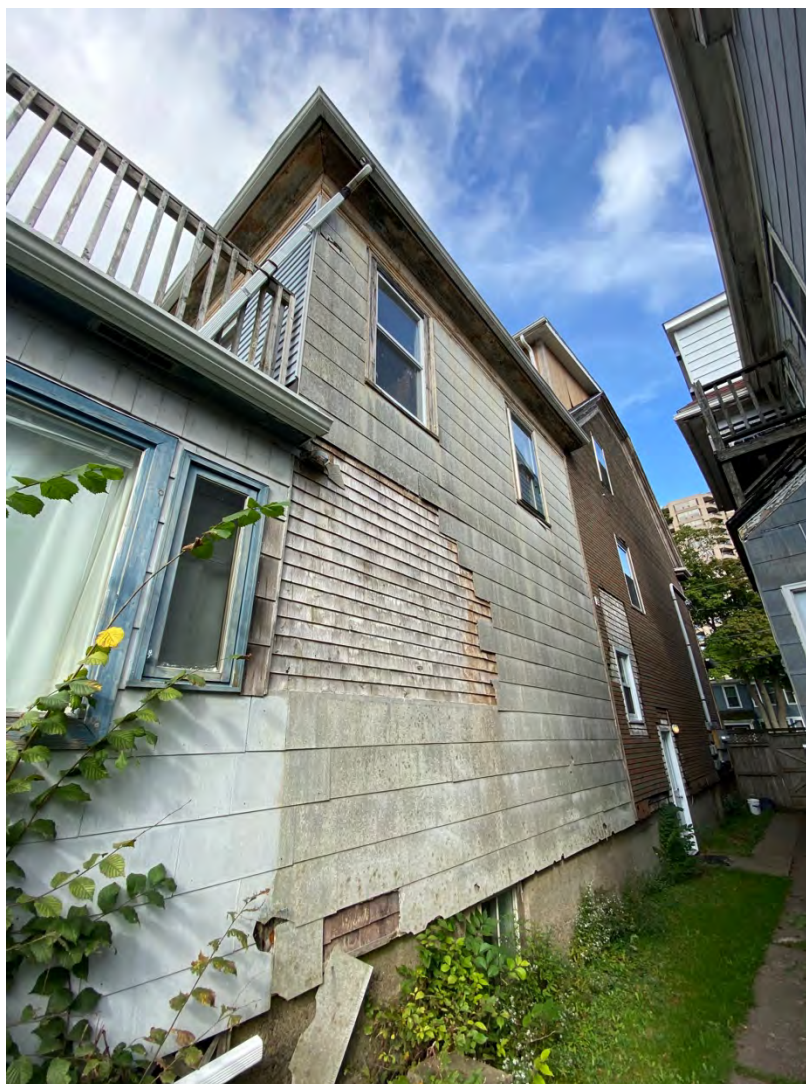
Figure 72d: Tupper Residence, 1468 Carlton Street (South side)

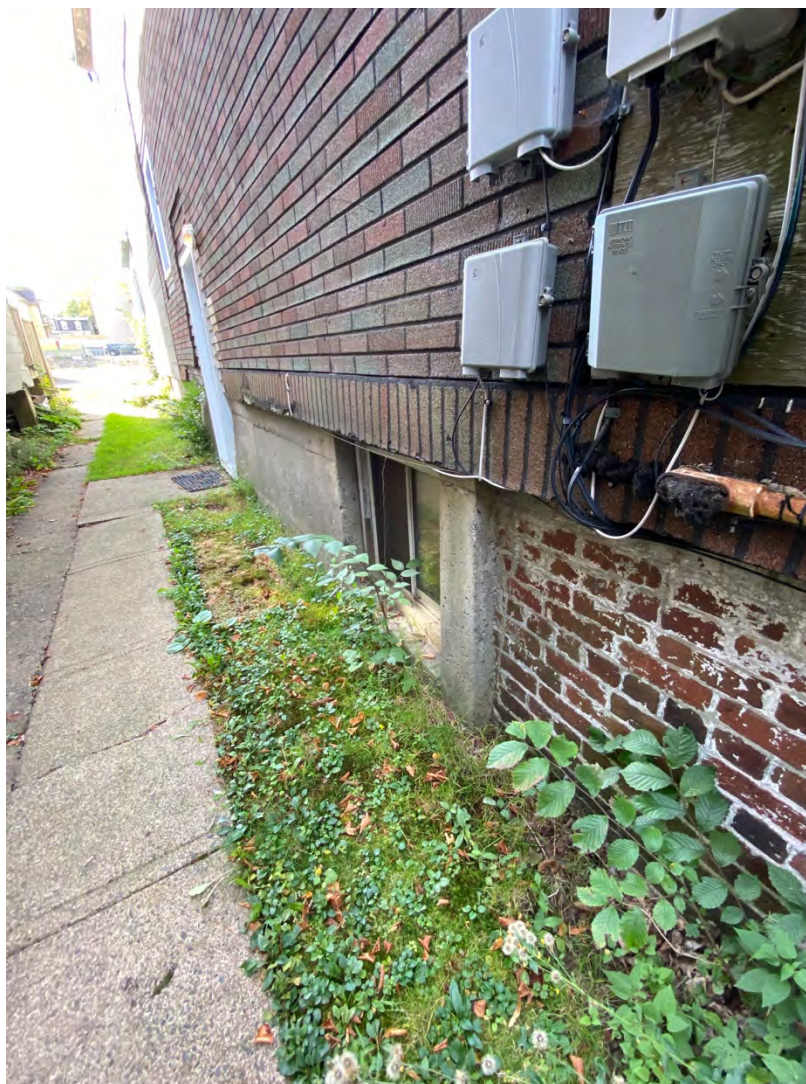
Figure 72e: Tupper Residence, 1468 Carlton Street – south side foundation comprising brick and concrete
