Item No. 9.1.3
Heritage Advisory Committee
November 26, 2025

SUBJECT: **Case HRTG-2025-01649: Substantial Alteration to Multiple Municipally Registered Heritage Properties on College and Carlton Streets in Halifax**

An application by ZZap Inc. to substantially alter the municipally registered heritage properties located at 5969 College Street, 1456 Carlton Street, 1460 Carlton Street, 1466 Carlton Street, and 1468 Carlton Street, Halifax.

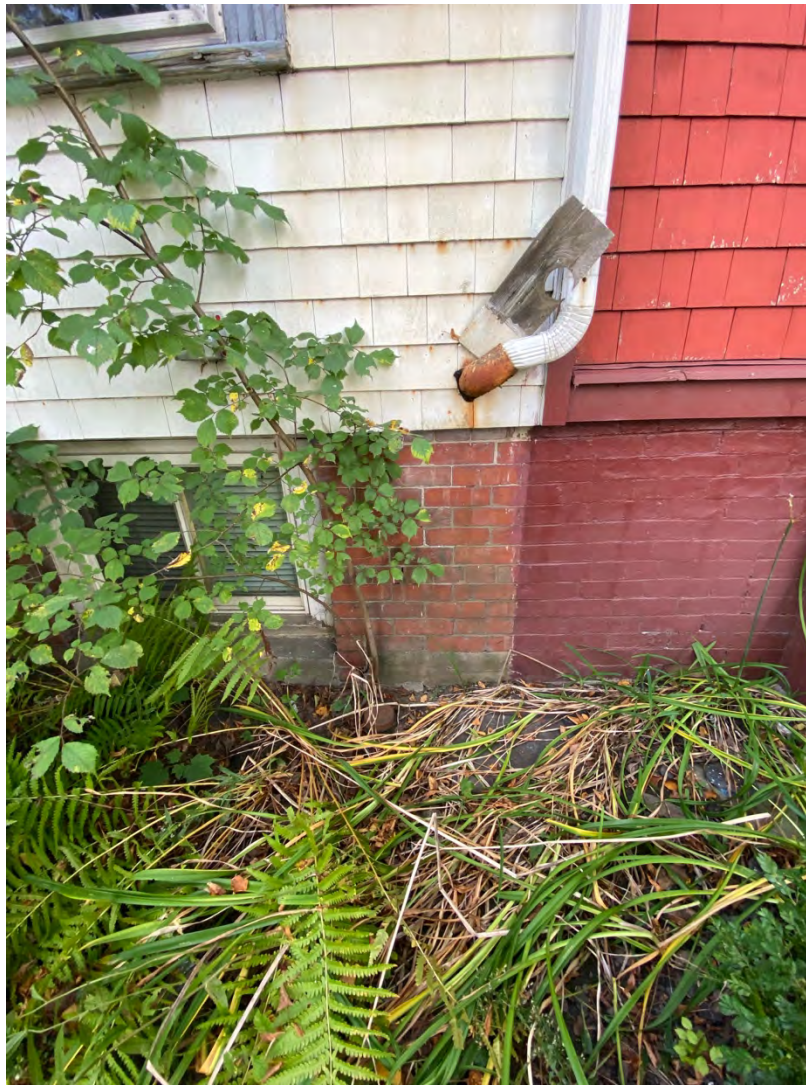
Figure 72f: Tupper Residence, 1468 Carlton Street – brick foundation, front

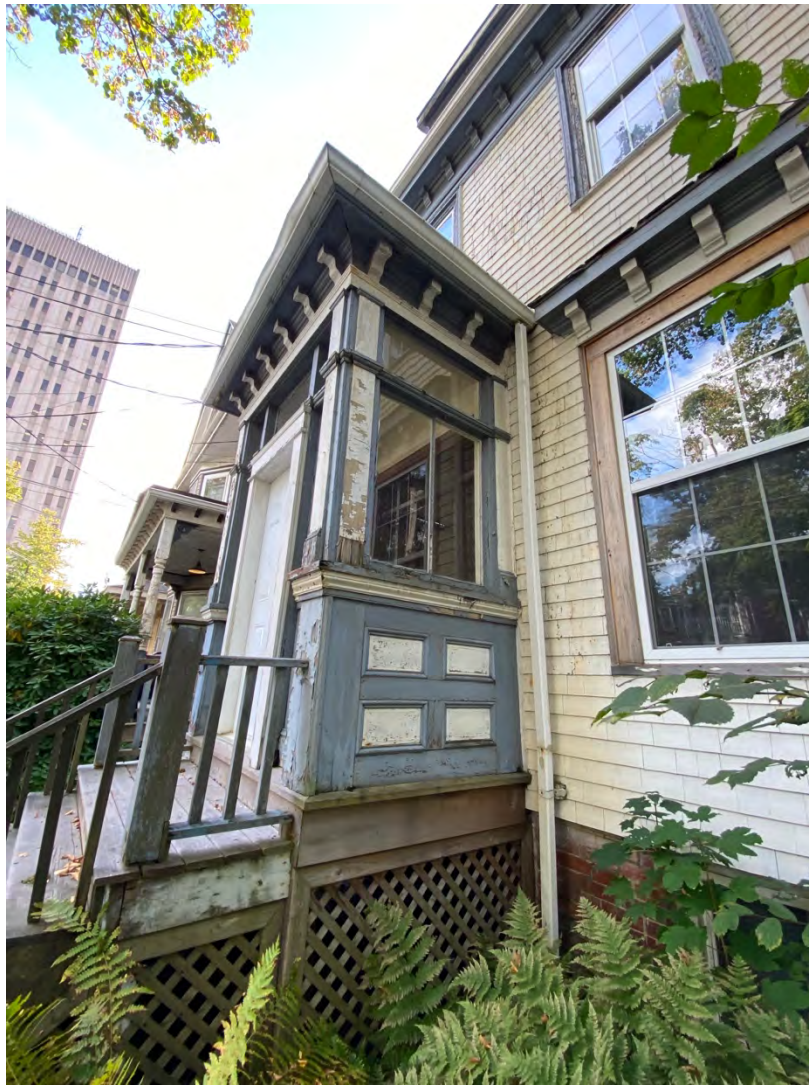
Figure 72g: Tupper Residence, 1468 Carlton Street – porch details

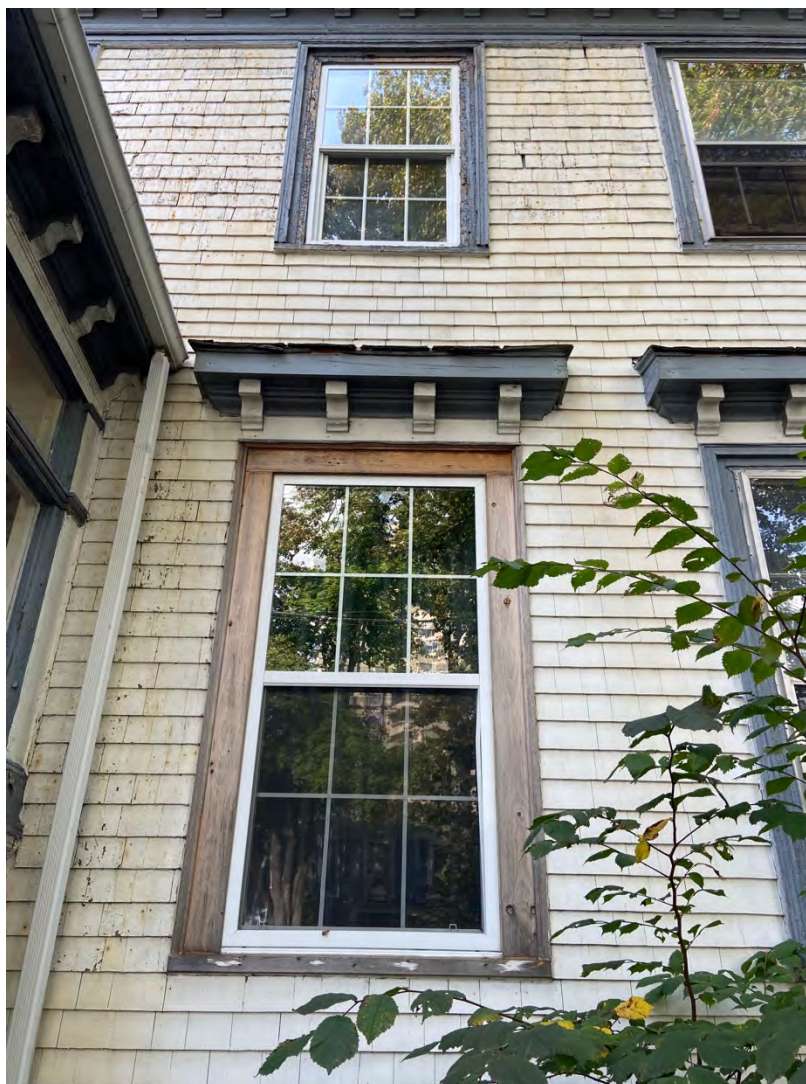
Figure 72h: Tupper Residence, 1468 Carlton Street – front window details

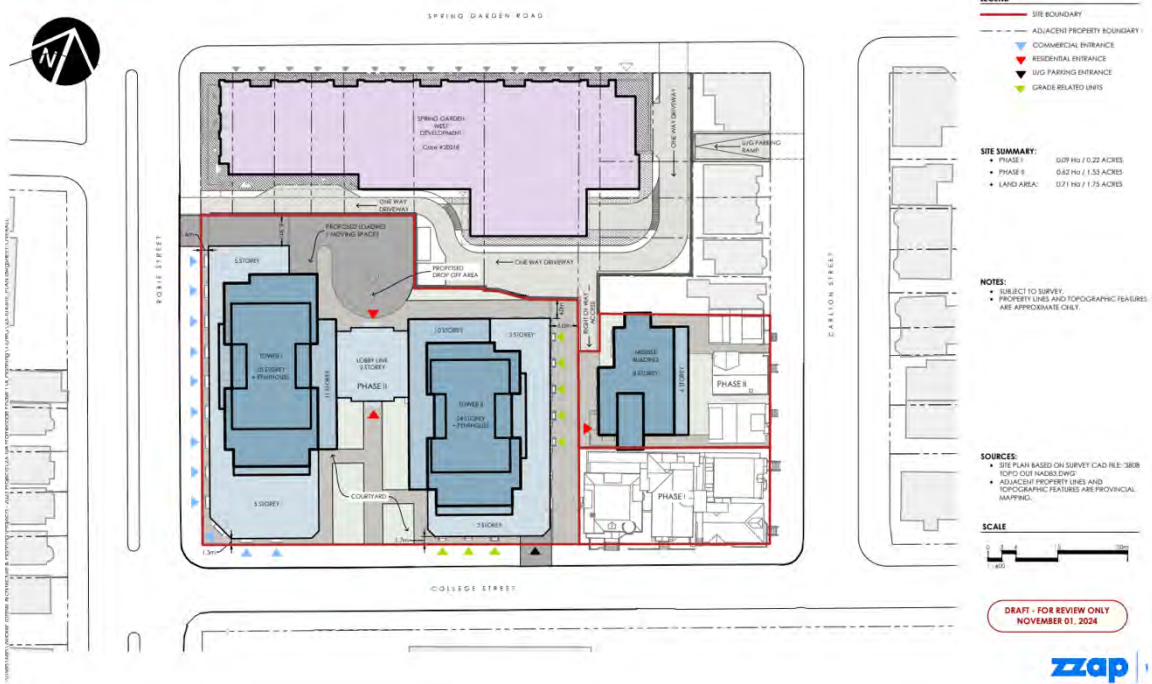
23-104 PROMENADE | OVERALL SITE PLAN

Figure 73: Site Plan

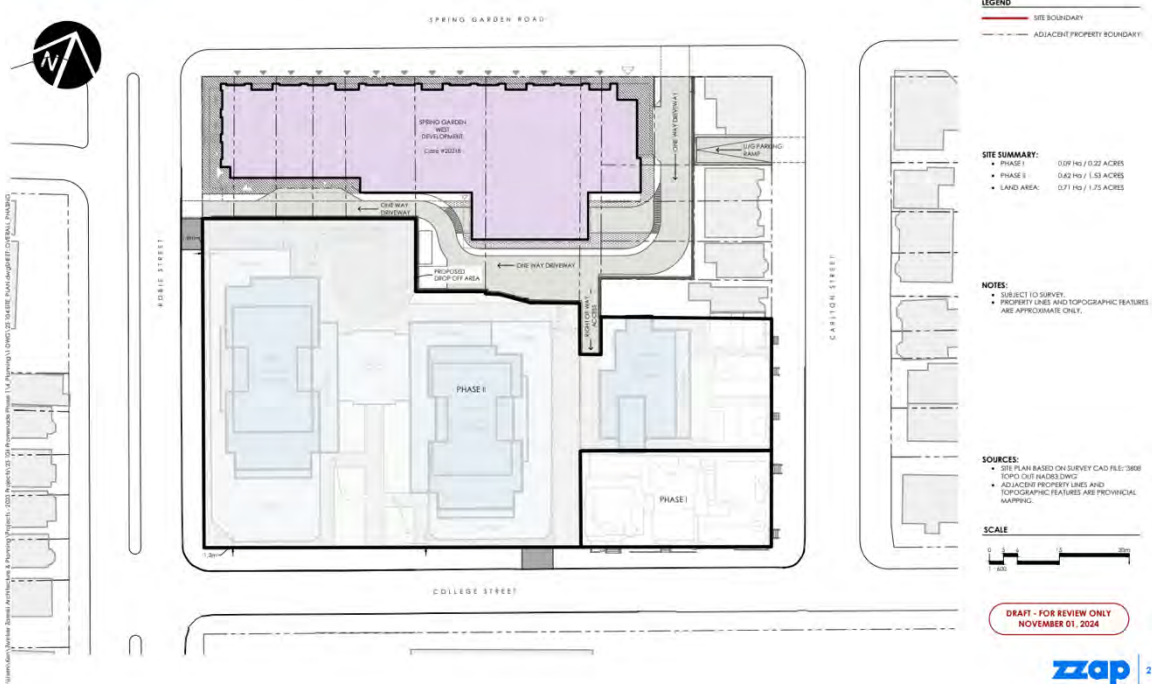
23-104 PROMENADE | OVERALL PHASING PLAN

Figure 74: Overall Phasing Plan

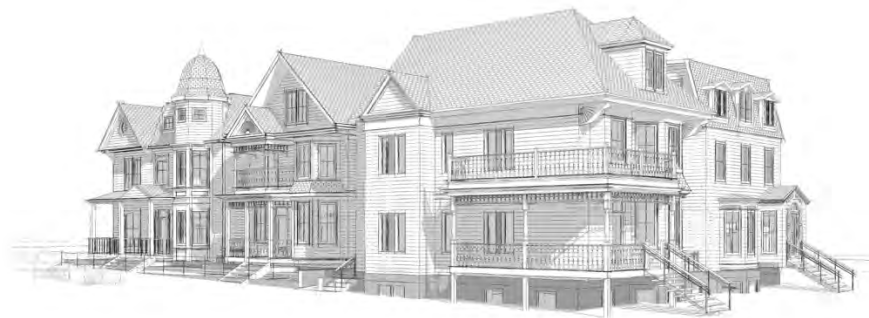
Figure 75: Perspective of Heritage Components of Development as seen from College Street

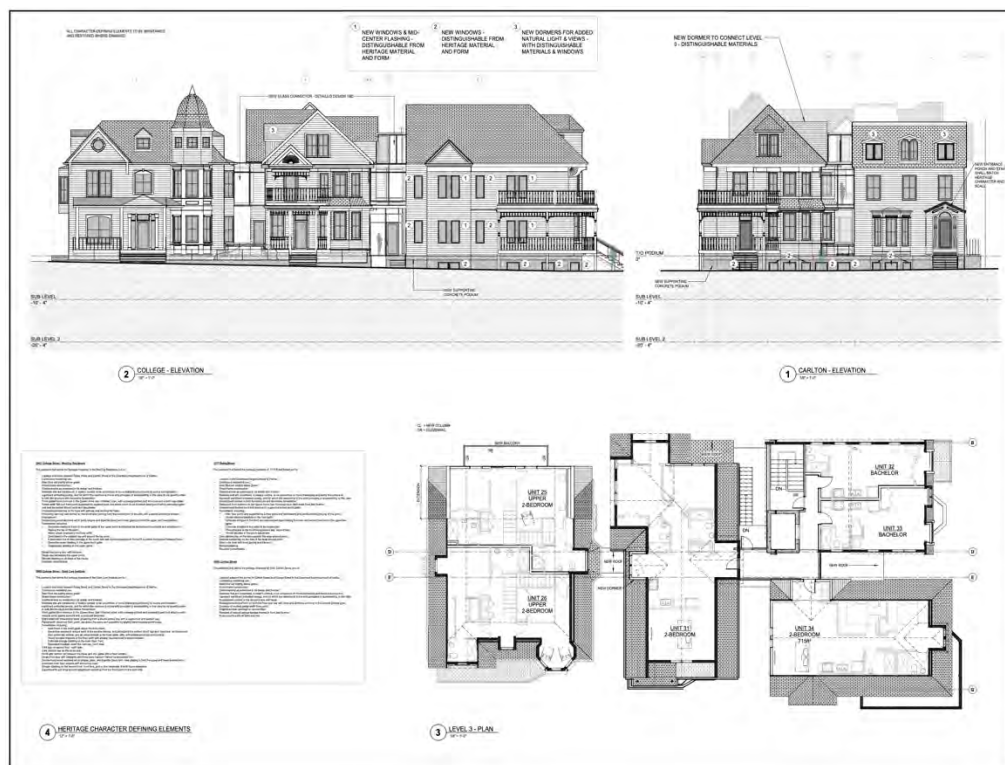
Figure 76: Elevations (Phase 1) – College Street and Carlton Street

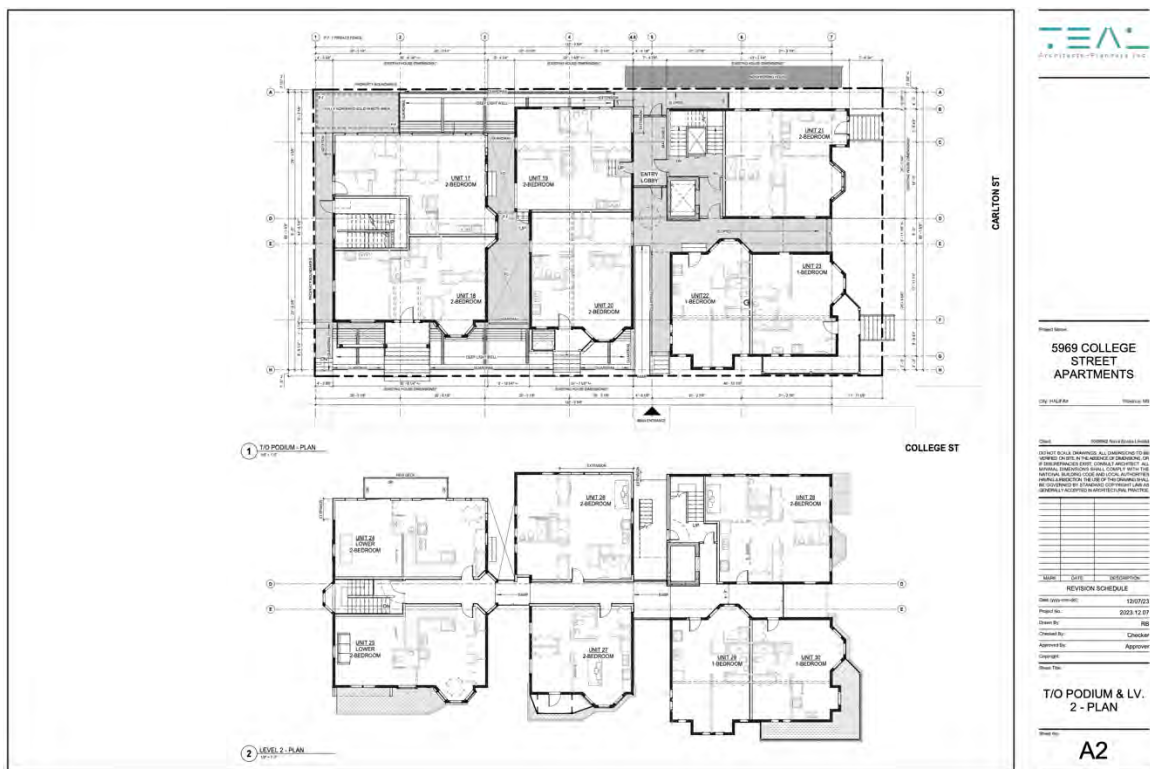
Figure 78: Floor Plans (Phase 1)

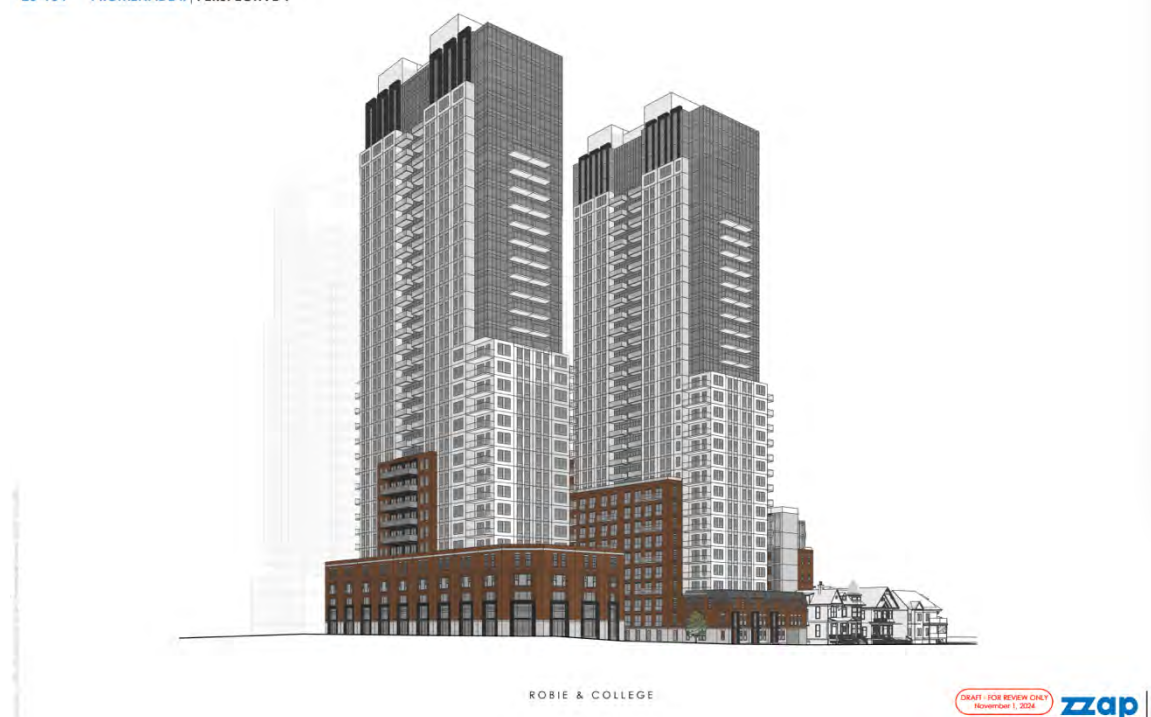
23-104 PROMENADE II | PERSPECTIVE 1

Figure 79: Larger development context – Robie and College Street Perspective
