**Lake Banook and Lake
Micmac 2018 Post-Harvest
Aquatic Vegetation Monitoring
Report**

Prepared for:
Halifax Regional Municipality
Energy & Environment
2nd Floor Alderney Gate
40 Alderney Dr.
Dartmouth Nova Scotia
B2Y 2N5

Prepared by:
Stantec Consulting Ltd.
102-40 Highfield Park Drive
Dartmouth NS B3A 0A3

February 1, 2019

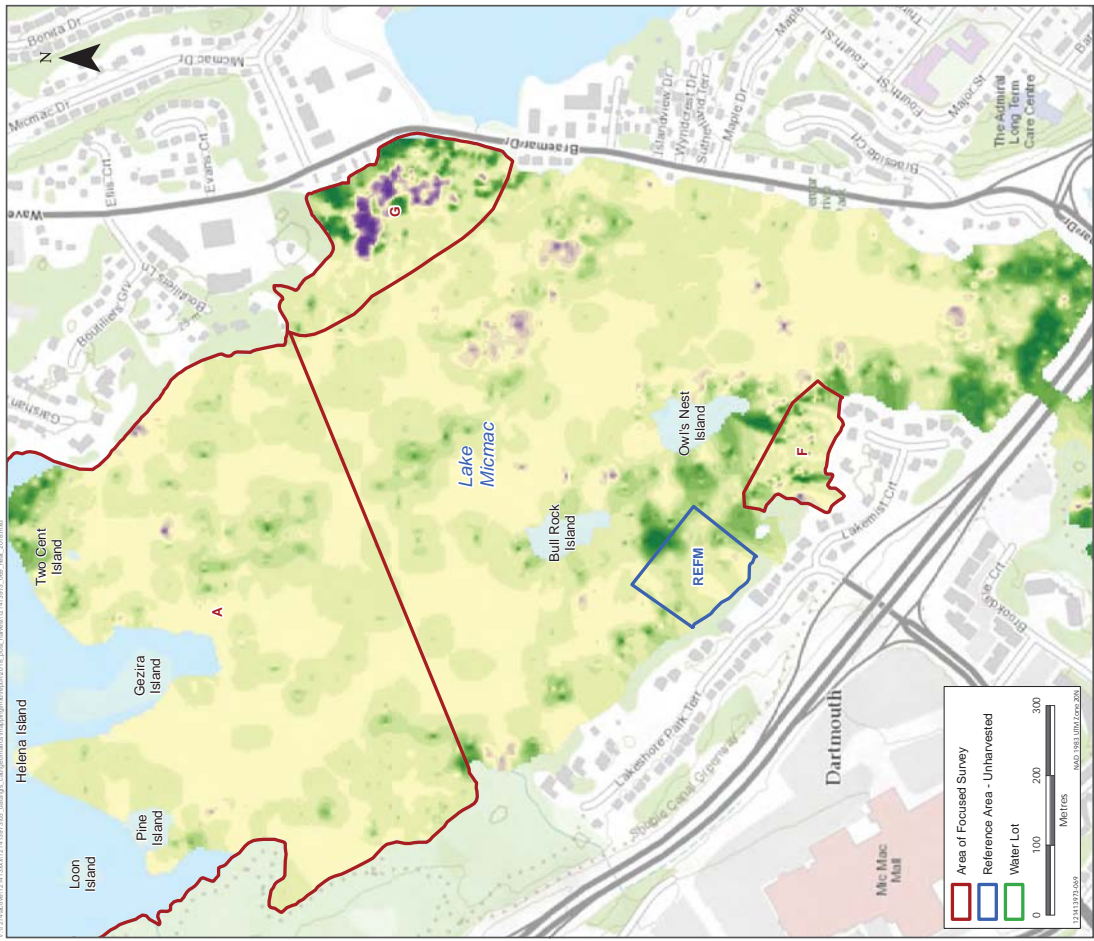
Change in Percent Cover: 2018 Post-Harvest to 2018 Pre-Harvest - Lake Micmac

Comparing Lake Micmac SAV coverage from pre-to post-harvest in 2018 depicted similar observations to previous years' surveys, with sporadic increases and decreases in vegetation coverage being observed throughout the lake (Figure 5). In Area G where the harvester was active, decreases in vegetation coverage can be seen. Conversely, zones of increase can be seen in the nearshore region of Area G, a small portion of Area F, as well as in the southern portion of the lake near the outlet to Lake Banook (Figure 5). Patterns of vegetation stasis were also evident in REFM, which was not subject to harvesting activity. Graphical examination of these trends in SAV percent cover further highlighted the generalized increase in the value as well as variation in percent cover responses for both lakes (Figures 6 and 7; Appendix B).

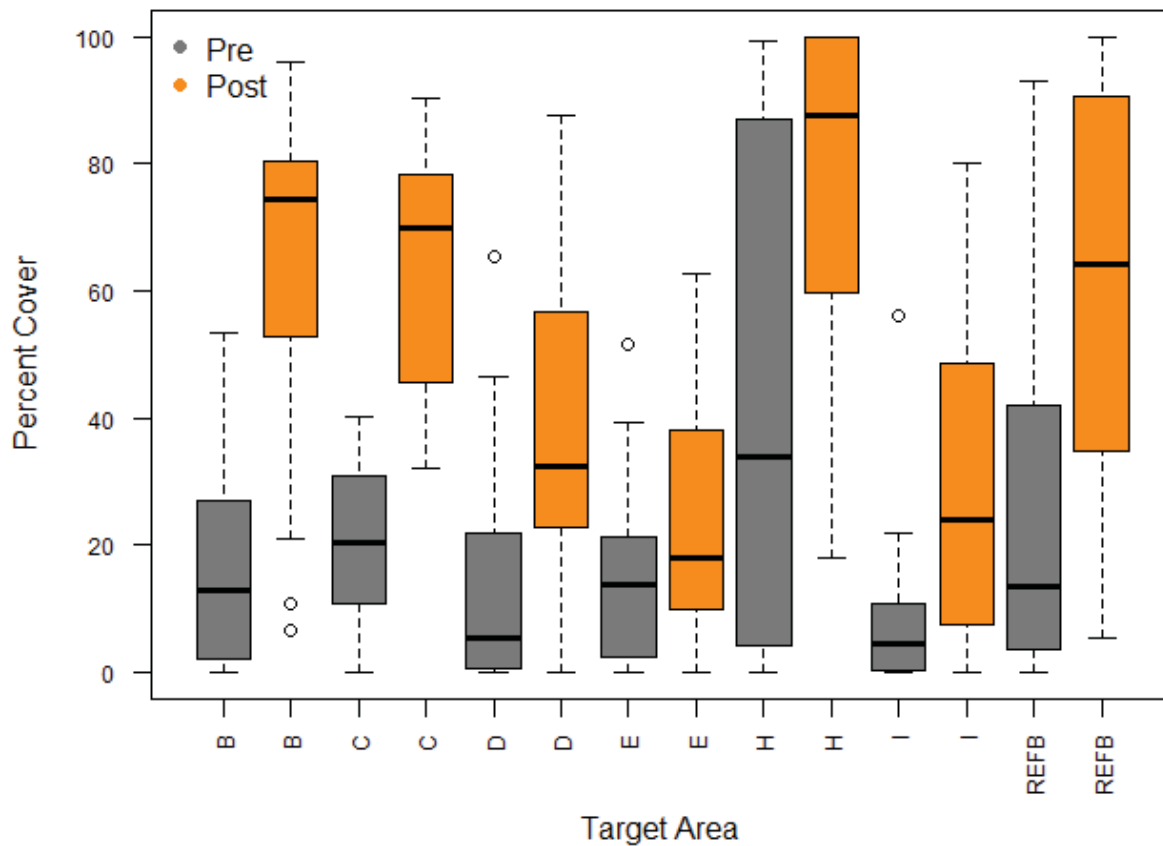
Figure 6 Boxplots of SAV Percent Cover Areas in Lake Banook for 2018 Pre- vs. Post-Harvest

Note: The centre line is the median. Ends of the box indicate the lower and upper quartiles. Ends of the whiskers indicate the quartile ± 1.5 x interquartile spread. Open circles indicate values falling outside the quartile ± 3 x interquartile spread. REF B = Reference Area B.

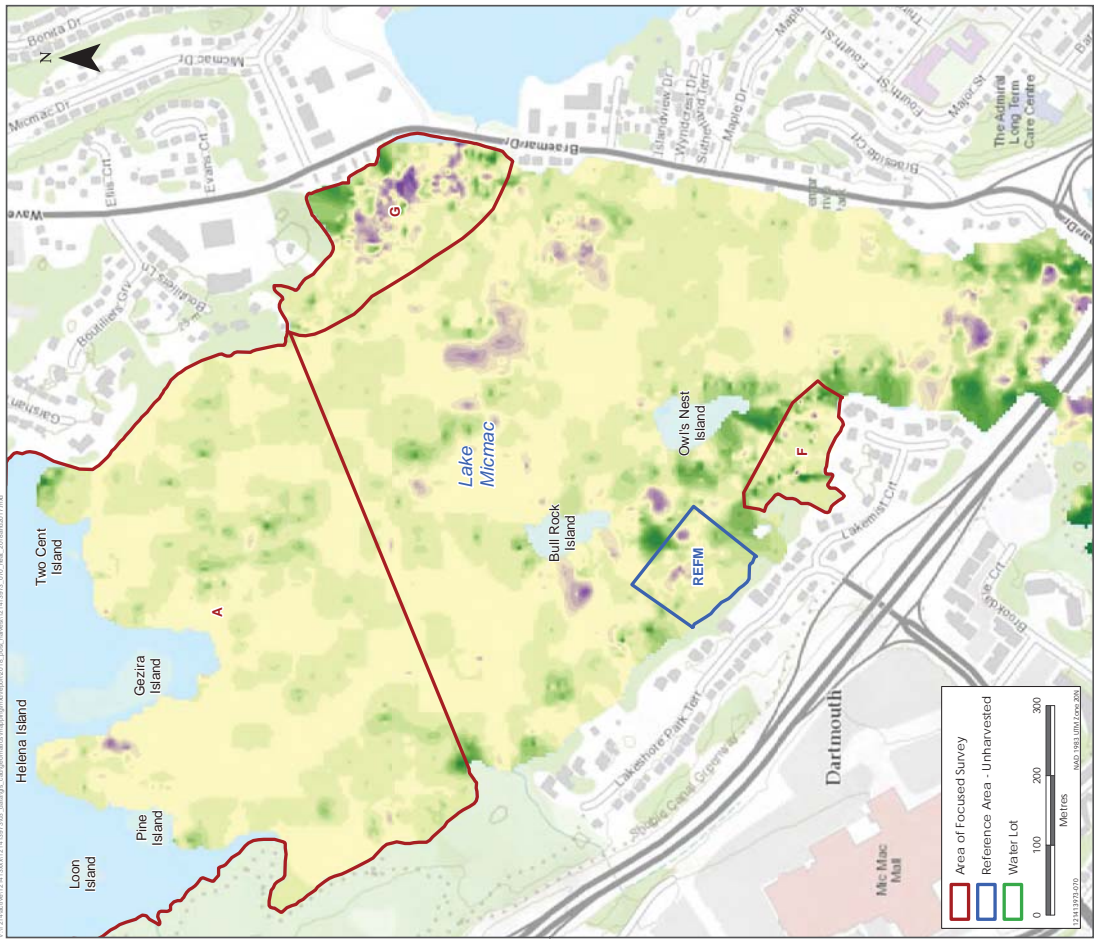
Change in Percent Cover: Post-Harvest 2018 to 2017 Post Harvest– Lake Banook and Lake Micmac
Figure 8

Representative comparisons to assess inter-annual trends potentially related to harvesting activity must be made between comparably timed surveys, such as those late-summer, post-harvest surveys which occurred from 2015-2018 in Lake Banook (as well as data from 2014 initial survey prior to harvesting) and 2015-2018 in Lake Micmac. When comparing SAV percent cover post-harvest between 2018 and 2017 in Lake Banook (Figure 8), substantial areas of increase were prevalent in all Target Areas particularly in Areas C and H, adjacent to Paddler's Cove, as well as the nearshore area between Areas D and E. This result contrasts greatly with the distinct SAV declines that had been observed from 2017-2016 (Appendix C; Stantec 2017b). Meanwhile, post-harvest data from 2018-2017 in Lake Micmac showed an overall similar trend to past surveys in which diffuse increases and decreases in SAV coverage can be seen in target harvest Areas F and G as well as in the reference area, REFM (Figure 8).

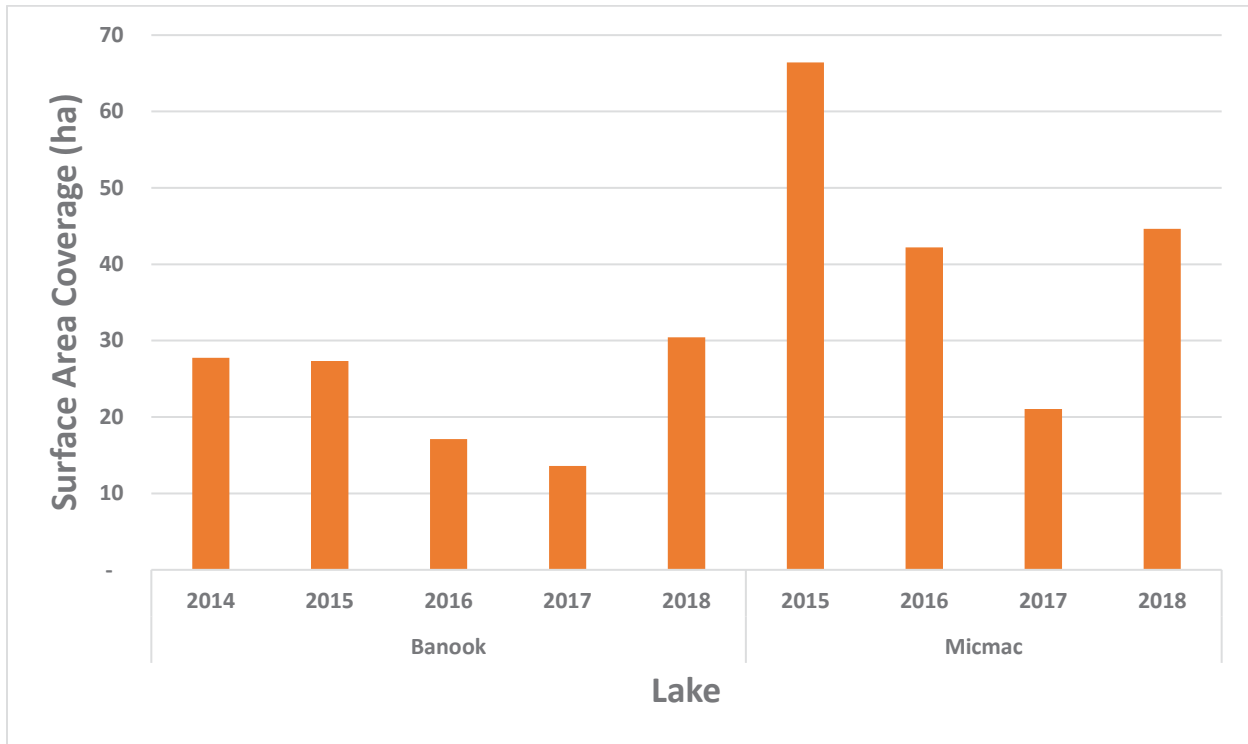
Figure 13 Temporal Trends (2015-2018) of Total Surface Area Coverage by Plants– for Lake Banook and Lake Micmac

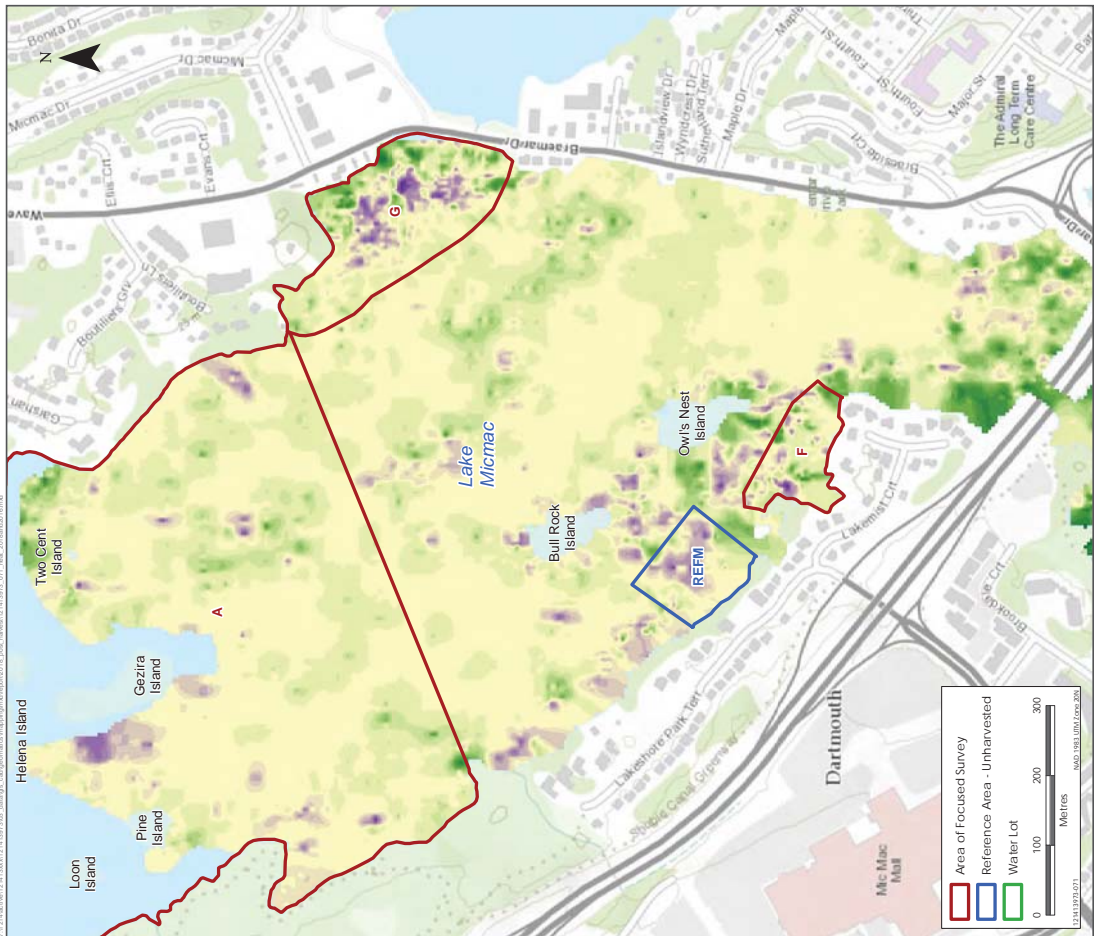
Figure C-1

Change in Percent Cover: Post-Harvest 2018 to 2016 - Lake Micmac

Change in Percent Cover: Post-Harvest 2018 to 2016 - Lake Banook

Comparing Lake Banook post-harvest SAV percent between 2018 and 2016 shows areas of large increases in extent and percent cover throughout the system. In particular, large increases were noted in target harvest Areas B, C, and D, as well as REFB and large areas offshore of Area H (Figure C-1). Other increases were also generalized throughout the nearshore area of the lake. Areas of declining SAV were noted in Area H, the south of Area C, and general areas offshore of Water Lots 3-6 (Figure C-1). Area E also indicated a narrow band of SAV increase just offshore of the public beach in that area (Figure C-1). Lake Micmac, in contrast contained few areas of large SAV increase, and these were confined to the nearshore region of Area G as well as the southernmost area of the lake near the outlet to Lake Banook (Figure C-1). Large areas of SAV decline were observed in Area G as well as REFM, the latter of which was not subjected to mechanical harvesting (Figure C-1).

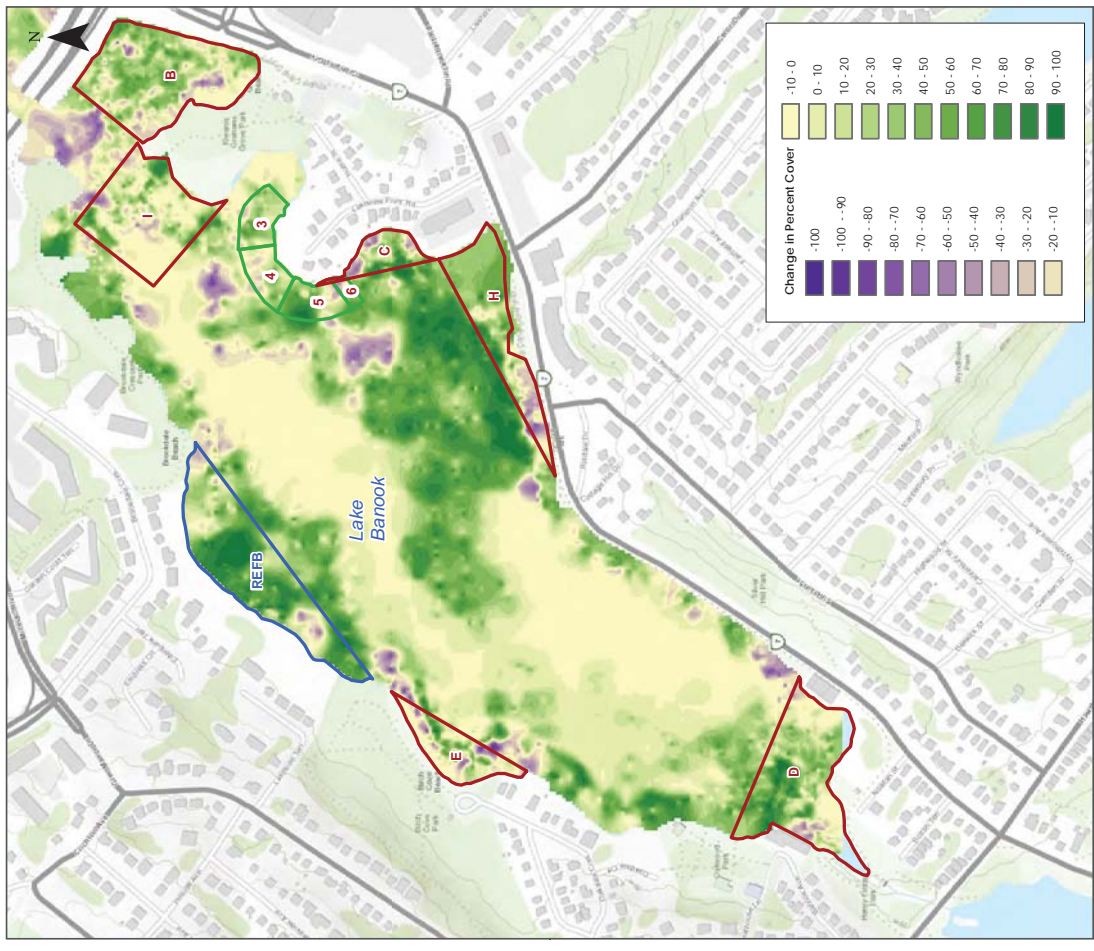
Change in Percent Cover: Post-Harvest 2018 to 2015 - Lake MicMac

Change in Percent Cover: Post-Harvest 2018 to 2015 - Lake Barnook

Lake Banook post-harvest SAV percent comparison between 2018 and 2015 (Figure C-2) followed very close to trends noted between 2018 and 2016 (Figure C-1) with increases in extent and percent cover throughout the system. Lake Micmac over the same period between 2018 and 2015 displayed large areas of SAV decline in each of Areas F and G (Figure C-2). There were also large SAV declines relative to 2015 data in the center of Lake Micmac where there had previously been a dense SAV patch that extended along a southeast to northwest axis which corresponds to a shallow plateau (Figure C-2).

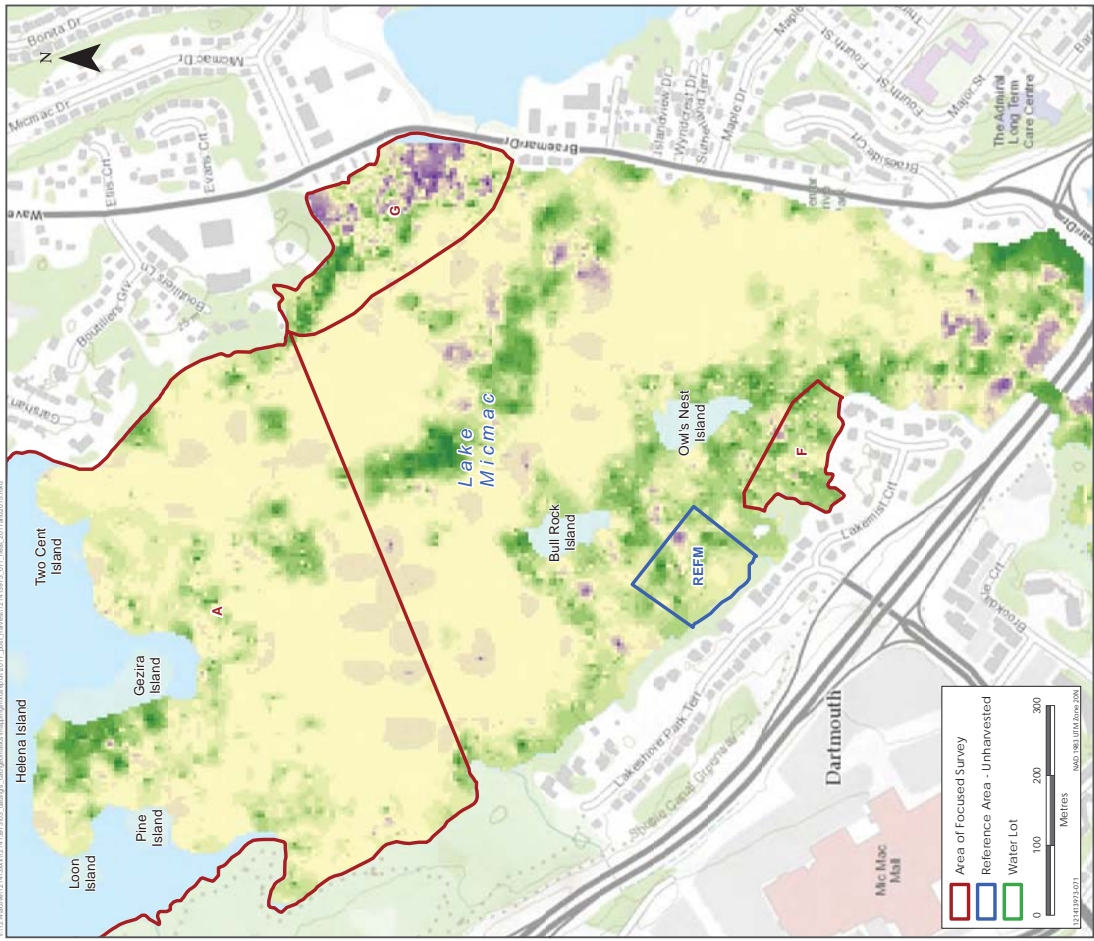
Change in Percent Cover: Post-Harvest 2017 to 2015 - Lake Banook
Figure C-4

Change in Percent Cover: Post-Harvest 2017 to 2015 - Lake Micmac

When looking at post-harvest data trends in Lake Banook between 2017 to 2015 (Figure C-4), there was a general decrease in vegetation coverage throughout most of the Target Harvest Areas as well as the majority of the lake. There were some increases in vegetation coverage noted when comparing these two years of data including parts of Area B as well as Reference Area B (REFB). Increases in vegetation were also noted in southern portions of the lake as well as the area west of Area H. When comparing post-harvest data from Lake Micmac from 2017 to 2015, there is an overall trend towards decreasing vegetation coverage throughout a majority of the lake with exceptions to Area G as well as the southern portion of the lake in the vicinity of the outlet to Banook (Figure C-4).

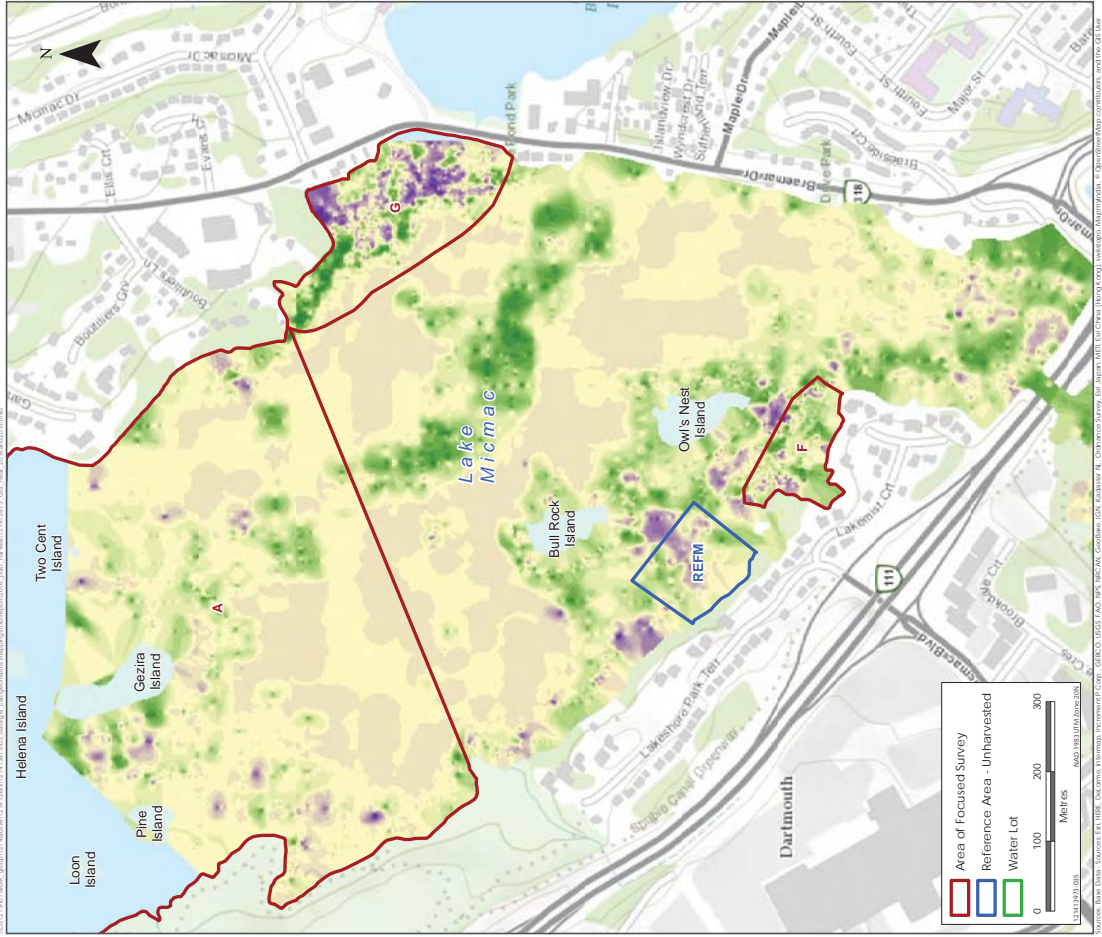
Change in Percent Cover: Post-Harvest 2016 to 2015 - Lake Micmac

Change in Percent Cover: Post-Harvest 2016 to 2015 - Lake Banook

When comparing SAV percent cover post-harvest between 2016 and 2015 in Lake Banook, there was a trend towards decreasing vegetation coverage in most nearshore areas of the lake (Figure C-6). Major decreases in SAV coverage can be seen in the northern-most areas of the lake, particularly in proximity to Graham Grove Park and in Area B (Figure C-6). Similarly, in the nearshore areas along the eastern and western shorelines in the southern end of the lake, SAV coverage decreased greatly. In contrast, vegetation coverage has increased significantly in Paddler's Cove (Area C) as well as in Area H and the waters in their immediate vicinity. Furthermore, there seems to be sporadic increases in SAV coverage from 2015 to 2016 in shallow waters of the western portion of the lake adjacent to Brookdale Crescent (REFB, Figure C-6). From 2015 to post-harvest 2016 in Lake Micmac, there were decreases in SAV coverage throughout most of the lake (Figure C-6). There are three notable increases in SAV coverage, one throughout Area G and sporadic increases south of Bulls Rock Island and Owl's Nest Island (Figure C-6). Additionally, an area of dense SAV observed in 2015 (Stantec 2015c) along a shallow ridge running southeasterly through the middle of Lake Micmac greatly declined in 2016 (Figure C-6).
