**Item No. 9.1.3**  
**Heritage Advisory Committee**  
**October 8, 2024**

**SUBJECT:** **HRTG-2023-01426: Substantial Alteration to the municipally registered heritage property at 86 Ochterloney Street, Dartmouth**

## Heritage Impact Statement

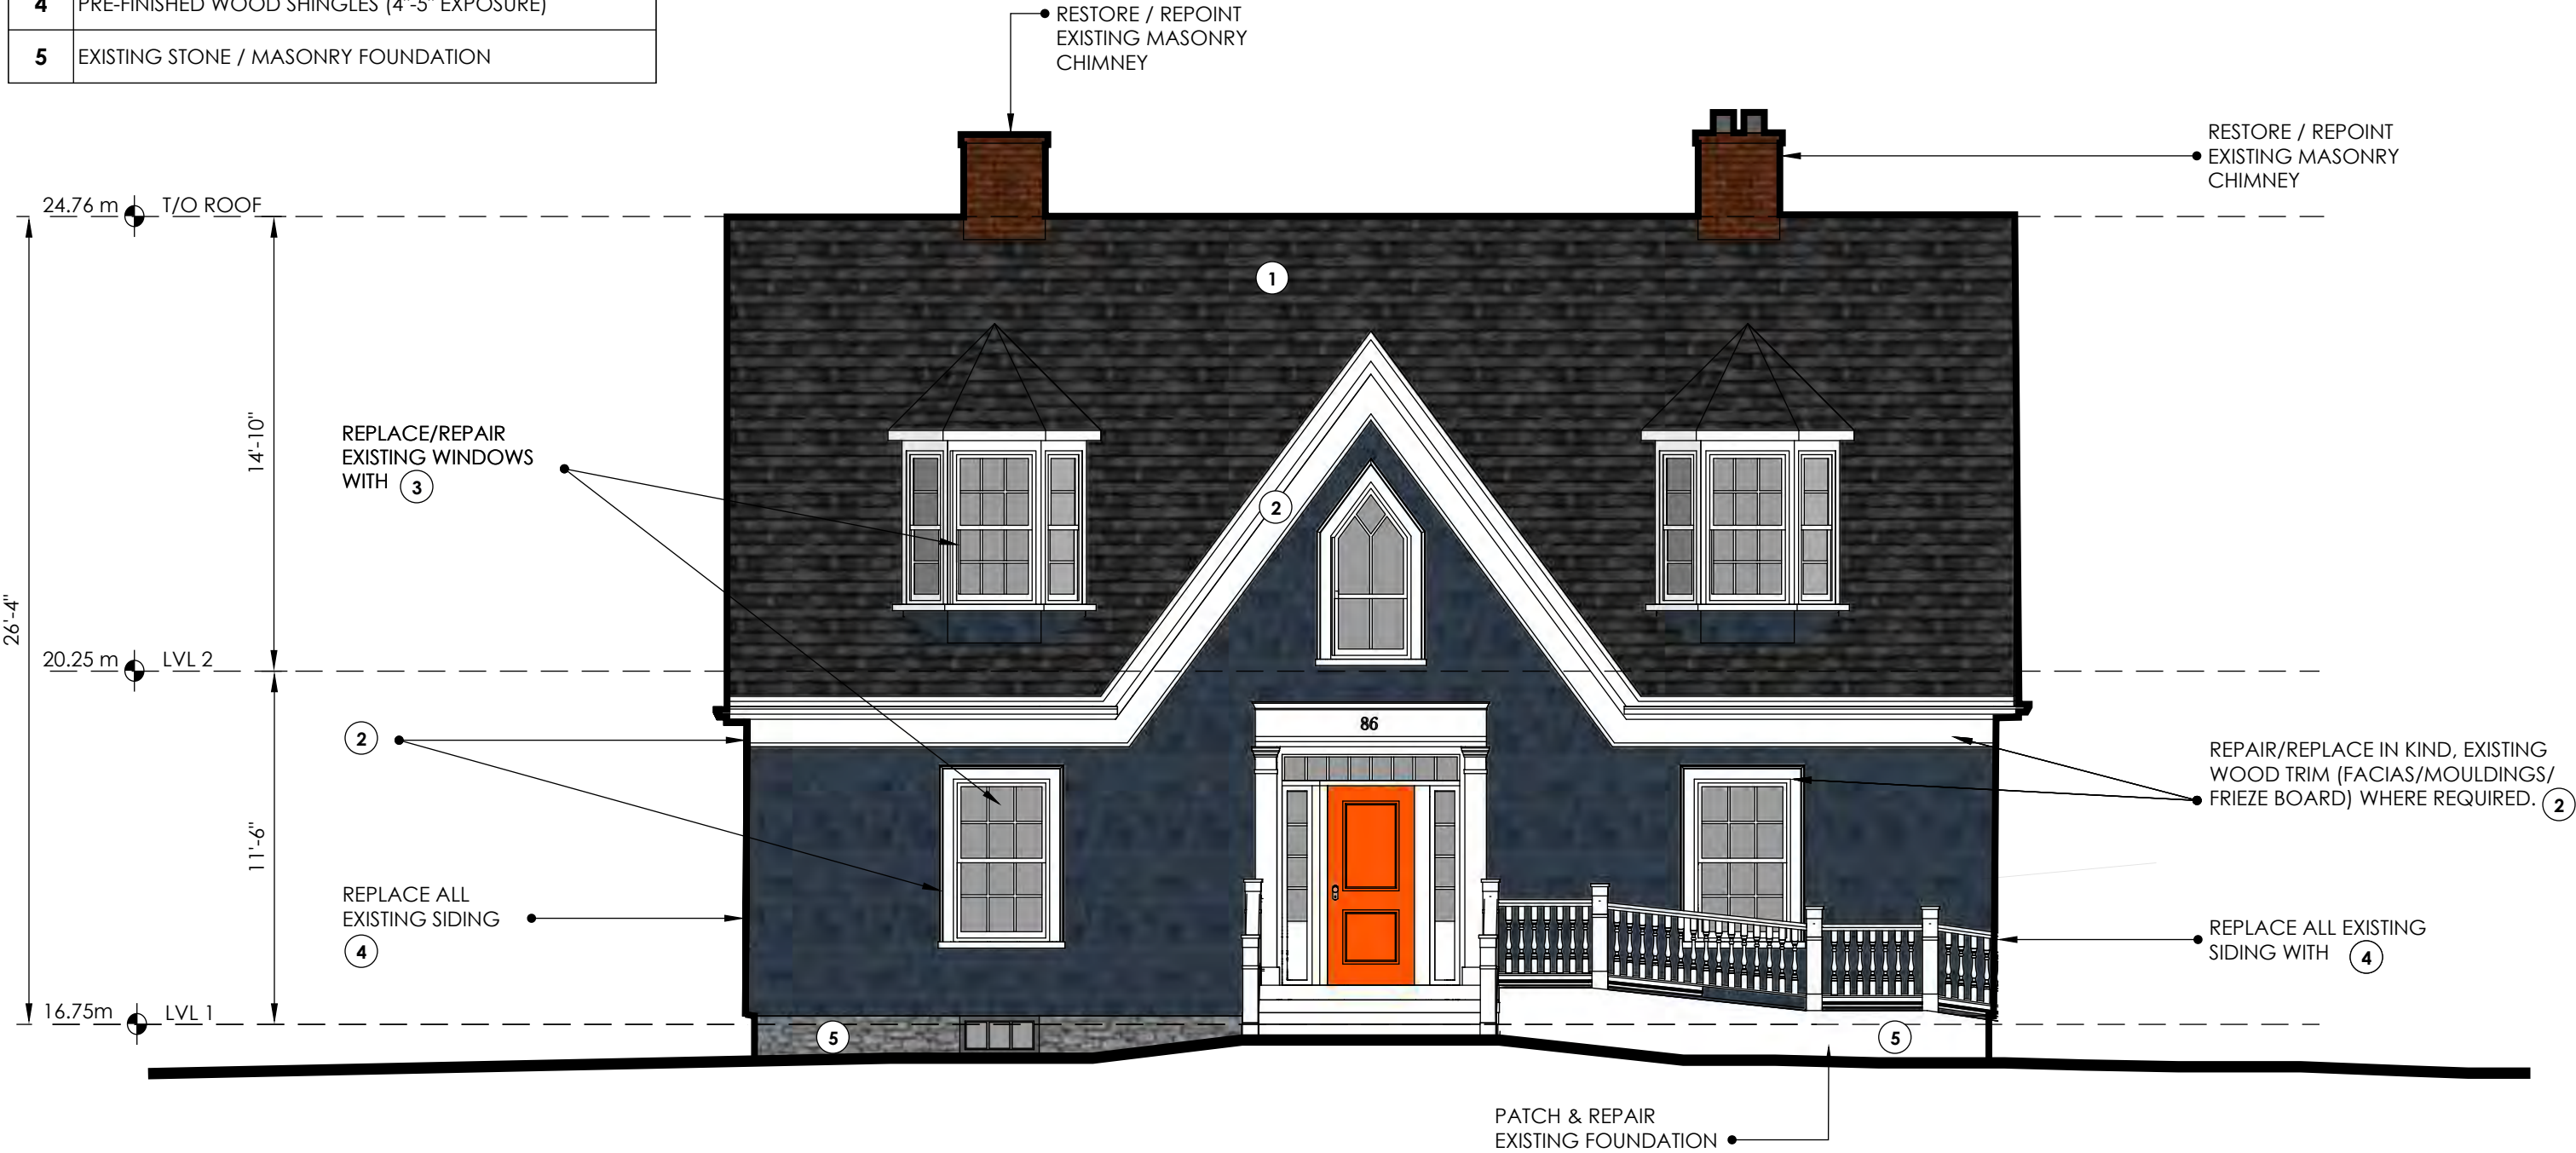
**NORTH (FRONT) ELEVATION**

EXTERIOR MATERIALS LEGEND	
1	ASPHALT SHINGLES / MODIFIED BITUMEN ROOF
2	PRE-FINISHED WOOD TRIM / MOULDINGS
3	WOOD WINDOWS / DOOR SYSTEM WITH TDL MULLIONS
4	PRE-FINISHED WOOD SHINGLES (4"-5" EXPOSURE)
5	EXISTING STONE / MASONRY FOUNDATION

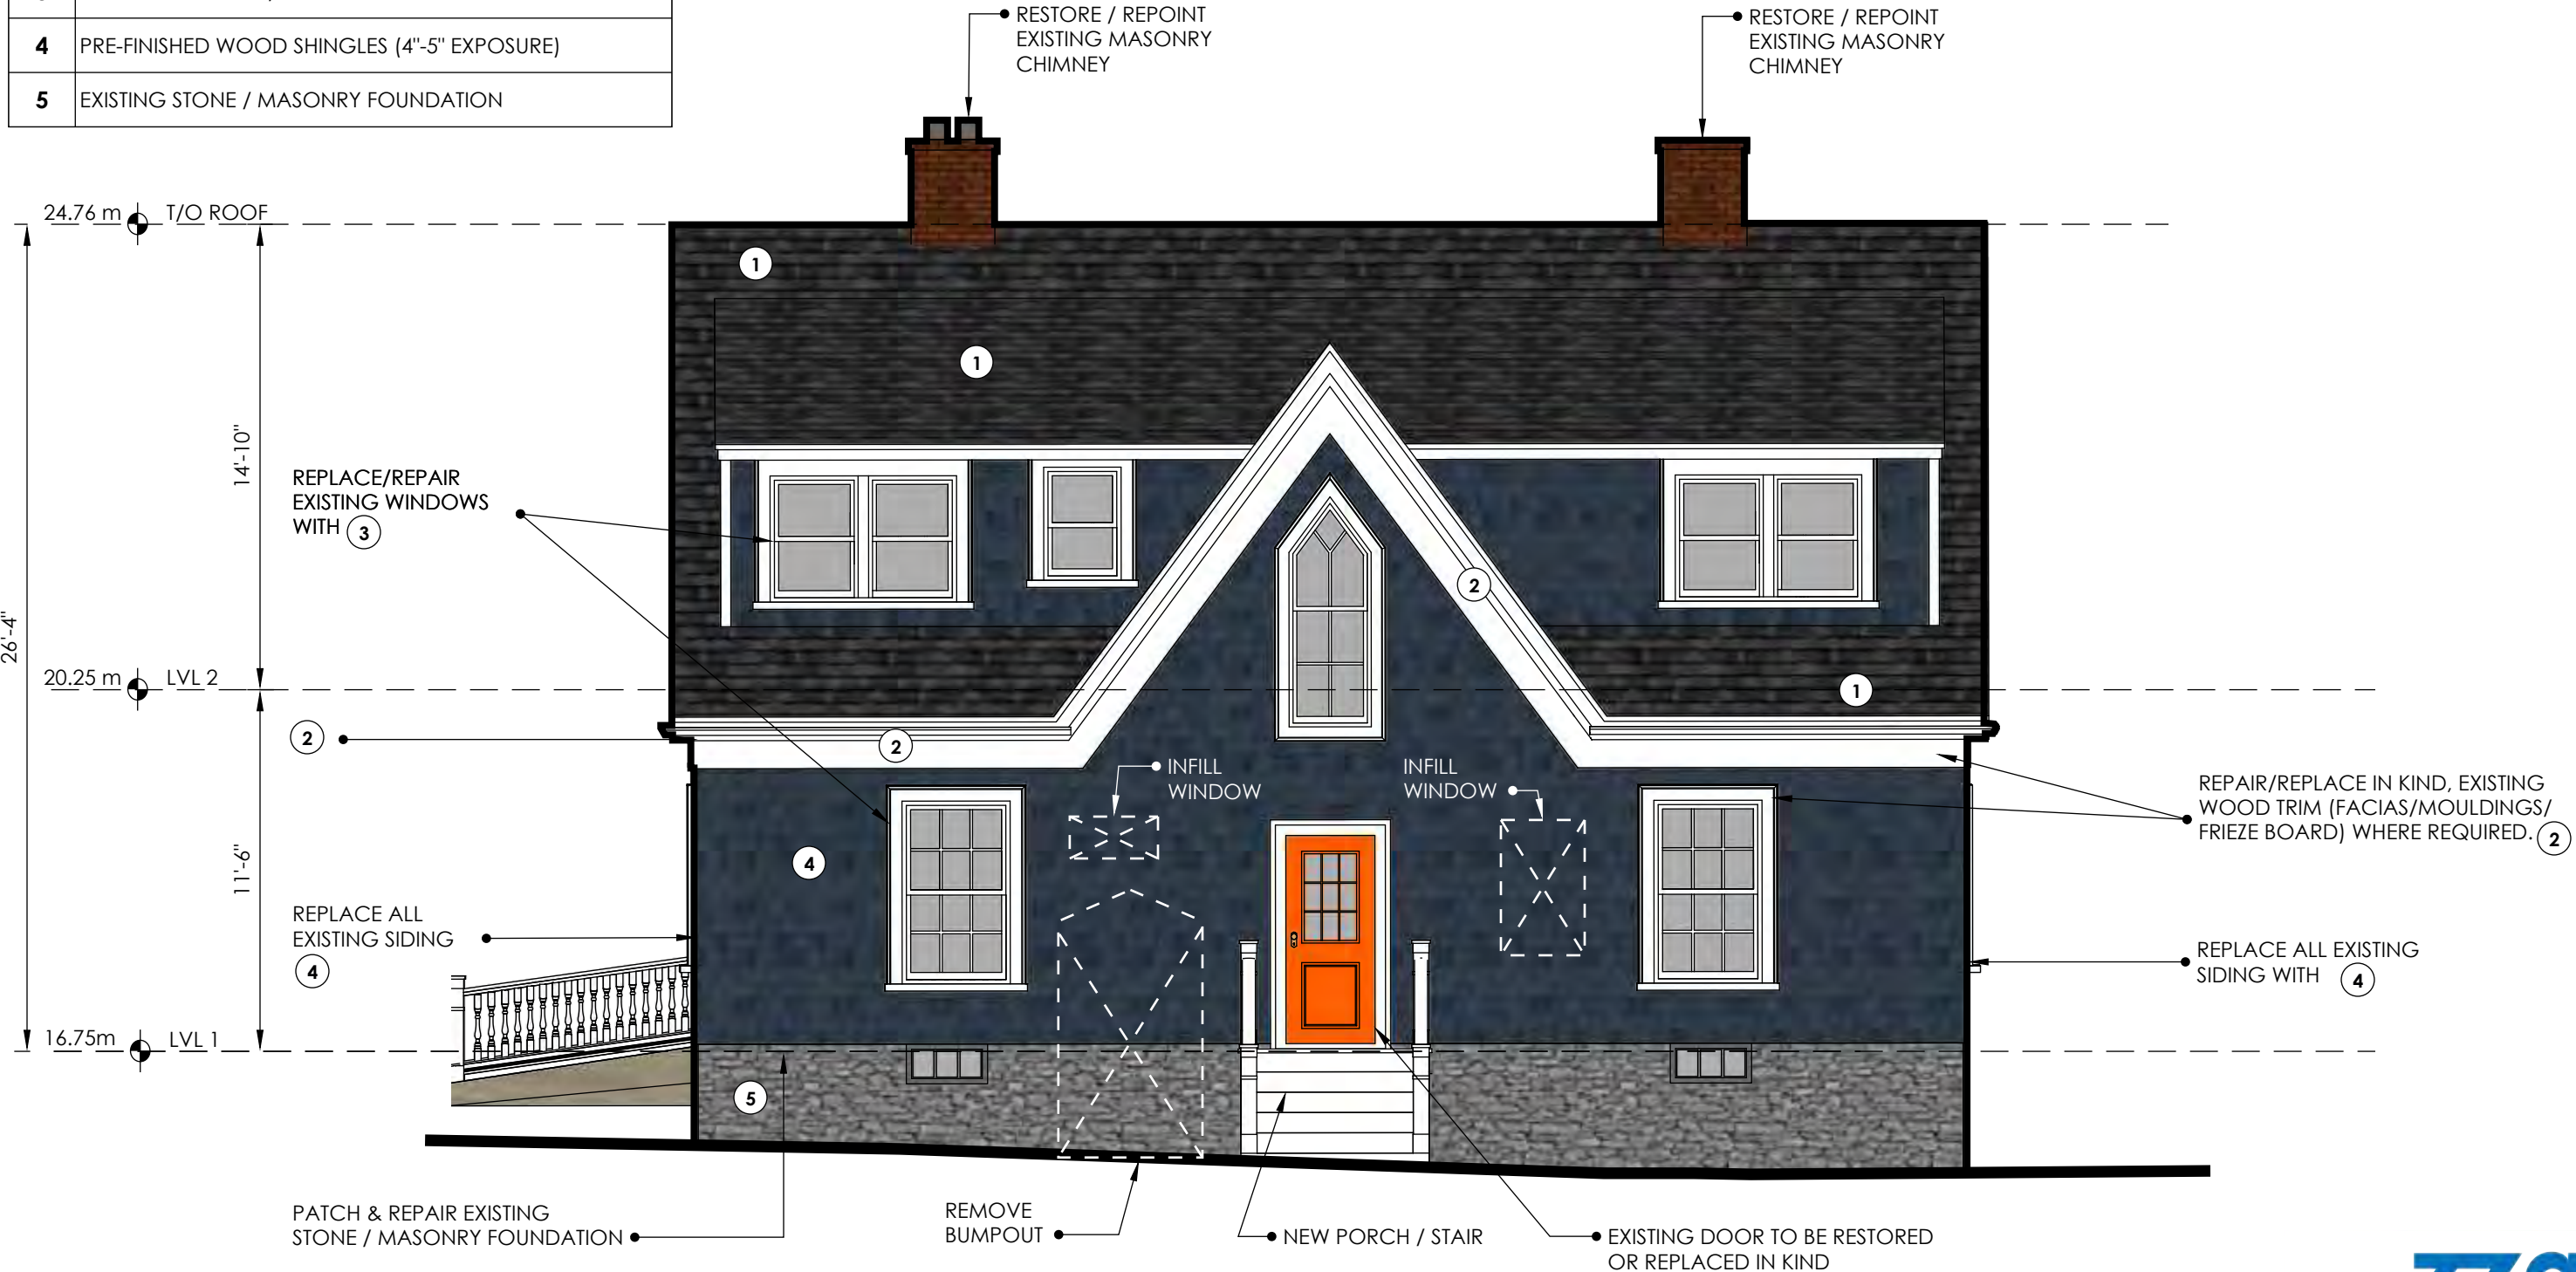
**SOUTH (REAR) ELEVATION**

EXTERIOR MATERIALS LEGEND	
1	ASPHALT SHINGLES / MODIFIED BITUMEN ROOF
2	PRE-FINISHED WOOD TRIM / MOULDINGS
3	WOOD WINDOWS / DOOR SYSTEM WITH TDL MULLIONS
4	PRE-FINISHED WOOD SHINGLES (4"-5" EXPOSURE)
5	EXISTING STONE / MASONRY FOUNDATION

- Proposed substantial alterations include infill of unoriginal windows on the south and east elevations, with one new window opening at the east elevation; removal of a small addition on the south elevation; and construct a 72.96 metre high, mixed-use development.

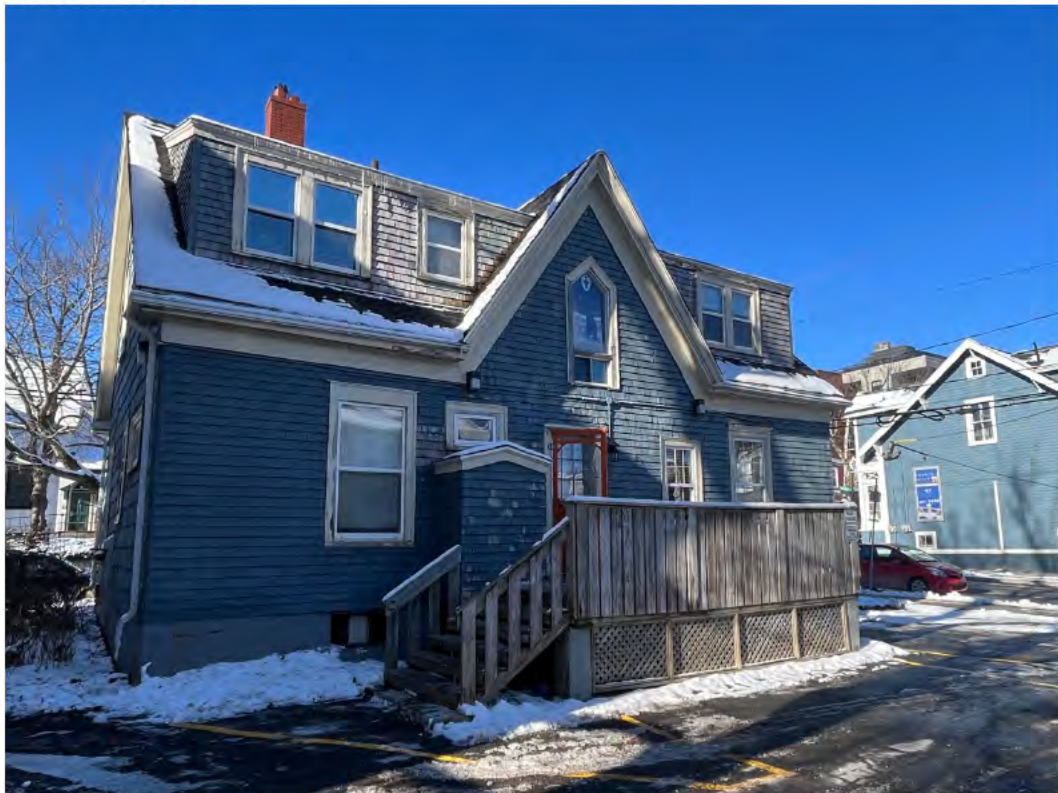
**Figure 22d: George and Mary Shields Residence, 86 Ochterloney Street – rear**

At the rear, the entry door and the two larger window openings on either side of the door appear older or may be original to the house, while the smaller windows are likely alterations. All windows on the rear are vinyl replacements.

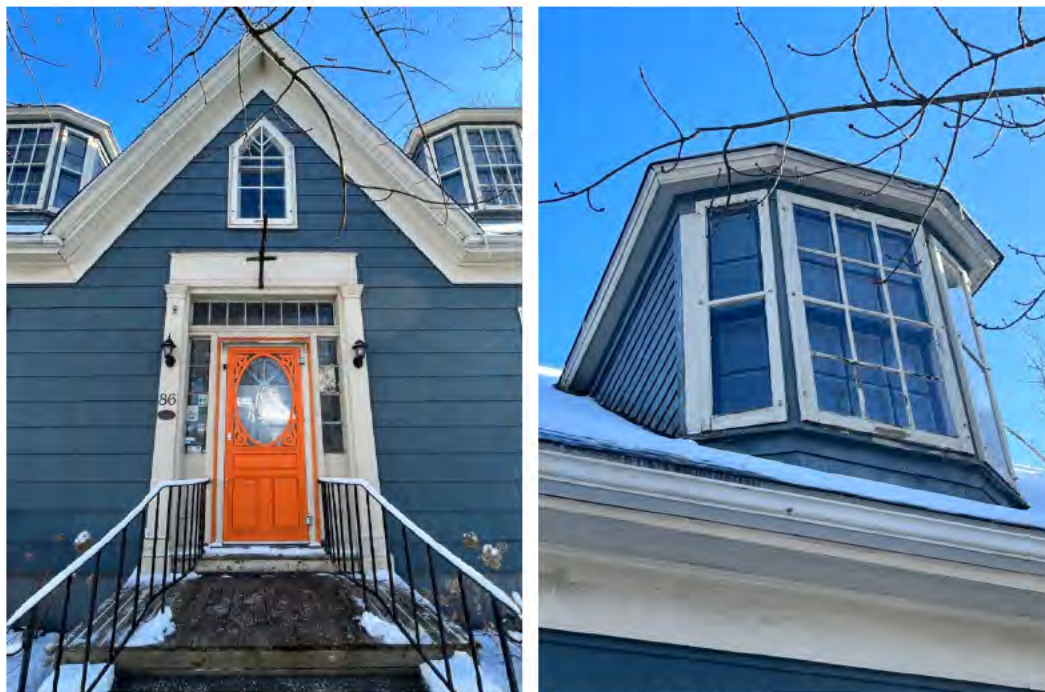
**Figure 22d: George and Mary Shiels Residence, 86 Ochterloney Street – Front detail including entry, sidelights and transom, and central-set gable; upper window detail – Scottish dormers**

The front door and sidelights are original. The double-hung front windows on the main floor, and the upper dormers, are original, with multi-panes in both the upper and lower sashes. The decorative fixed window in the central-set gable is original and features a multi-pane arrangement typical of this era. On the west and east sides, main floor, the larger openings have been replaced with vinyl windows with imitation muntins in between the panes. There are several other smaller openings with wood sash windows; these may be later additions or original. On those sides, upper floor, there are smaller-set window openings that are likely original, with vinyl replacement windows.

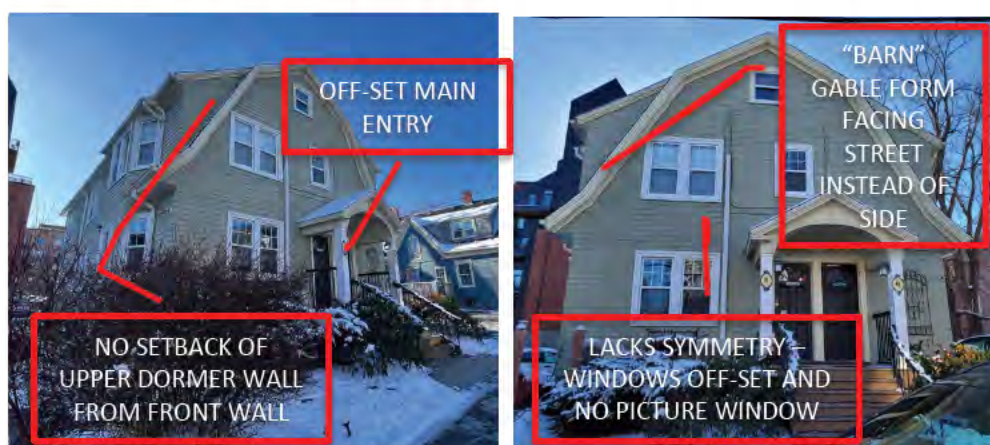
**Figure 36a: Front components of 43-45 Dundas Street that detract from the style and overall design of a Dutch Colonial Revival house.**

The house at 43-45 Dundas Street appears to be in very good condition and it retains its exterior integrity, including its dual entry – reflecting that it was purpose-built as a duplex – along with its windows, cladding and decorative covered entry porch, with an arched ceiling and squared posts. Its most significant change has been the addition of two entry doors on the north side as a result of its multi-unit conversion. However, despite the overall integrity, and as noted in Section 3.3.2, it is not a particularly good representation of the Dutch Colonial Revival Style. The basis for this conclusion is illustrated in Figure 36.

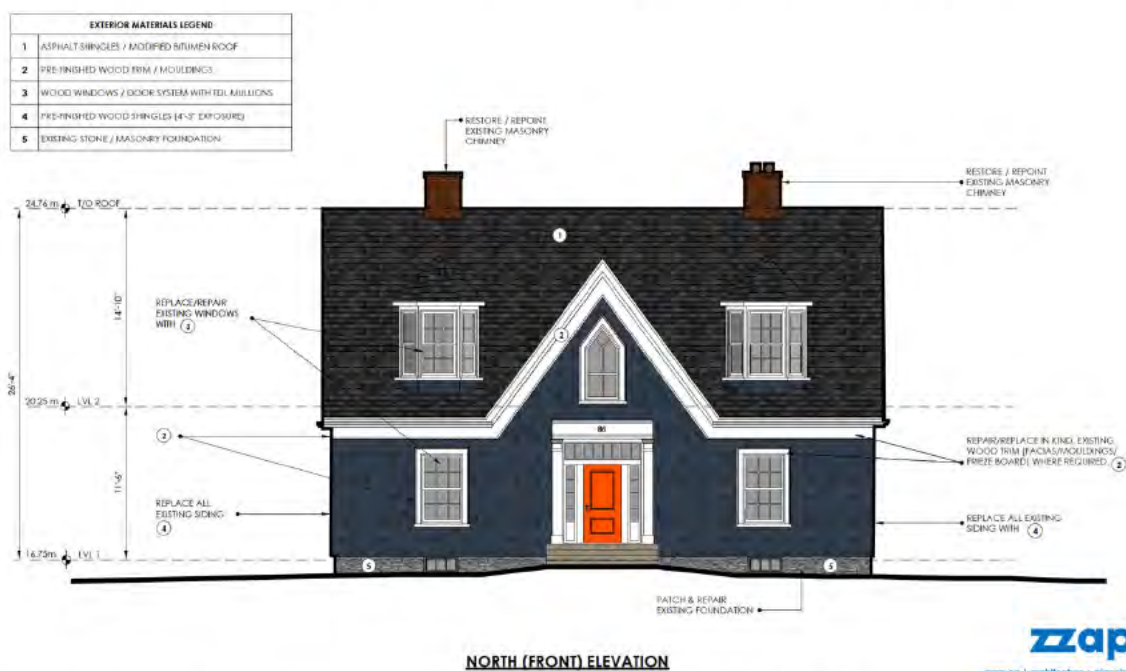
**Figure 42: North (Front) Elevation – George and Mary Shiels Residence (Restored)**

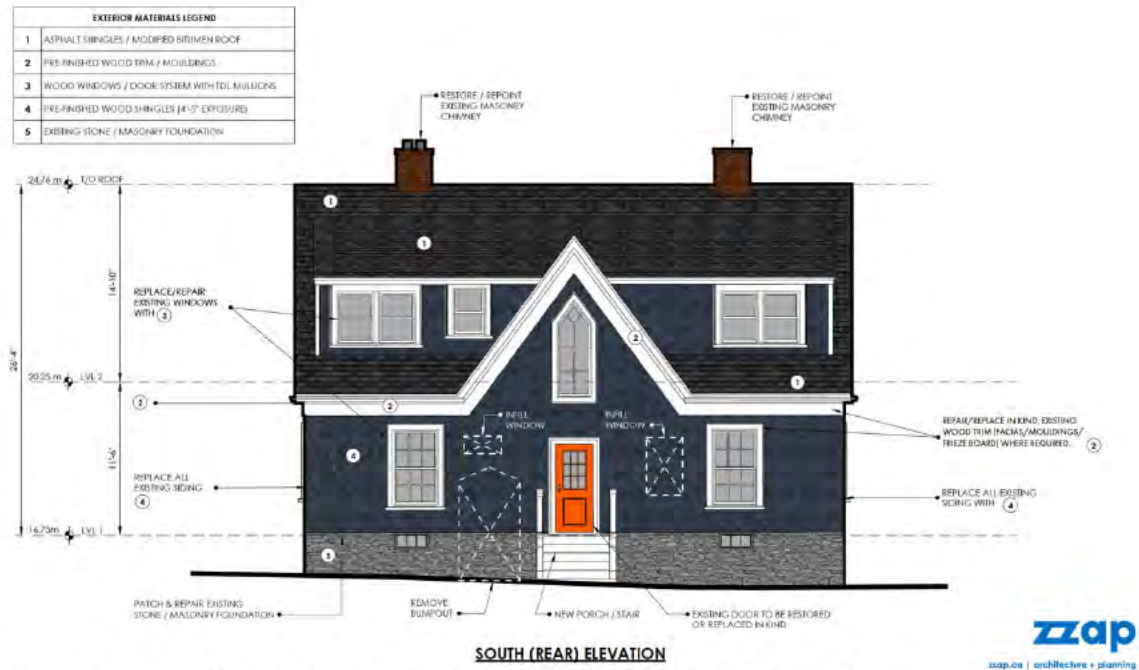
**Figure 45: South (Rear) Elevation – George and Mary Shiels Residence (Restored)**
