**SUBJECT:** **Further Ecological Testing on the Groundwater at the Ragged Lake Composting Facility**

## **Re: Ragged Lake Composting Facility: Review of Groundwater and Surface Water Quality**

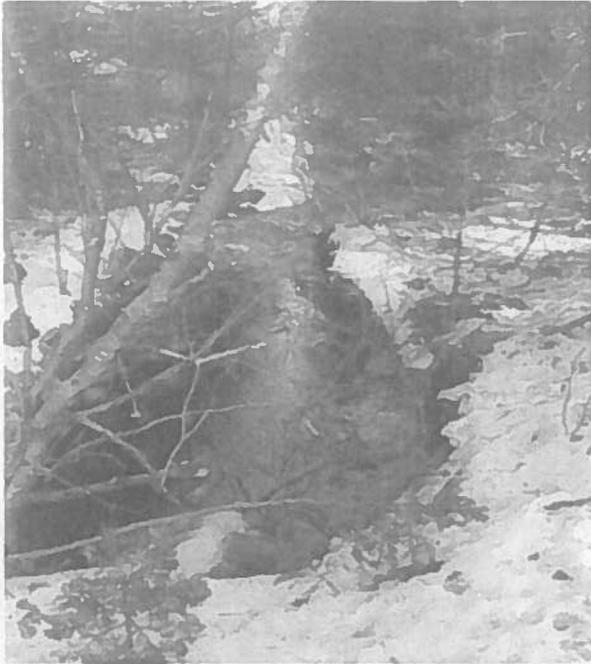
Stream crossing beneath Old Pipeline Road (suspect at SW8)

- (6) There is no physical description of the receiving stream, eg. width, depth, flow and direction it flows. As a result, I visited the stream on March 20, 2018 as it flows beneath the Old Pipeline Road and found it to be continuously flowing. Attached is a photo I took of the north flowing stream. Based on topographic maps and real time Google aerial views, this stream appears to originate from a small wetland (should be verified in the field) situated at the dead end of Evergreen Place road (as illustrated on Map 3 of the HRM staff report to Regional Council dated March 6, 2018). From there the stream flows north-northeastward as shown on the attached Figure 1 and Map 3 in the staff report, then northward beneath the Old Pipeline Road (corresponding to surface water sample location SW8 I think) and from there through a moderate sized natural bog type wetland (as shown on Map 3 of staff report). From there the stream picks up outflow from Ragged Lake, then flows northwesterly to Blueberry Lake which outlets to the south into a stream that flows to Big Indian Lake, which I understand comprises the upper reaches of the Prospect River system.

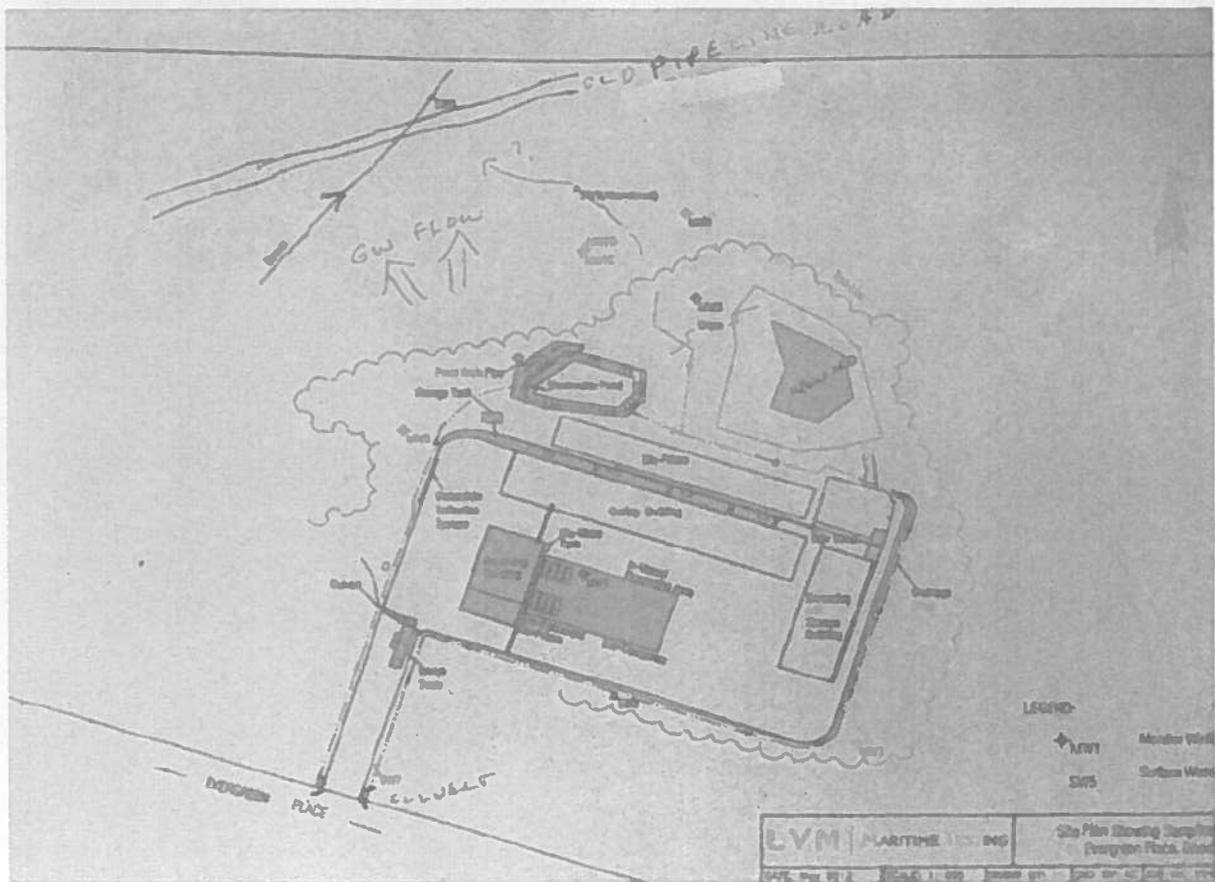
I have concluded that both groundwater and surface water exhibit evidence of impacts from the operations. That is not say that there are real adverse effects to the receiving environment, however, the potential is there. The groundwater beneath the building on-site at MW-2 (as shown on Figure 1 attached) has elevated temperature, conductivity (1,100-2,900 uS/cm), Chemical Oxygen Demand (COD with values reported in the range of 80-190mg/L), Dissolved Organic Carbon (DOC) with values reported in the range of 34-64 mg/L, Total Dissolved Solids (TDS) with values of 542-1,100mg/L reported, along with elevated chloride (280-690mg/L) and iron 69-4,300ug/L. The background monitoring well MW-1 reports much lower values for these parameters (Conductivity 290-310uS/cm, COD <5-28mg/L, TDS 160-183mg/L, chloride 5-8mg/L and iron <50ug/L). The downgradient monitoring well MW-9 also reported elevated conductivity 1,200-1,700uS/cm, COD 59-210mg/L, DOC 32-64mg/L, TDS 767-1,160mg/L and iron 340-27,000ug/L. These results indicate biological activity in groundwater beneath the floor of the facility, likely attributable to leachate leakage.

- (4) The reports do not describe depths to groundwater, nor groundwater flow direction. I determined from one set of groundwater elevation data provided in one of the reports that groundwater flows north-northwesterly toward the unnamed stream illustrated in Figure 1 (attached). This figure was the only one available in the reports I reviewed. There is no mention of calculated groundwater flow velocities, bedrock geology and overburden type and thickness. From available mapping and embankment exposures along Evergreen Place, the bedrock is granite and the overburden is granular silty sand (highly permeable) likely thinly overlying the bedrock.

- (5) It is noted that the highly used public trail that has been in existence for decades, commonly referred to as the "Old Pipeline Road", is not shown on the figures in the report, so I plotted its approximate location on the attached Figure 1 along with culverts beneath the access road to the subject facility. Of noteworthy mention is that **the "proposed trail" shown on Map 3 of the March 6, 2018 HRM staff report corresponds to this existing well used "Old Pipeline Road"**.

- (7) Of note is that the real-time Google aerial view shows the stormwater pond at the north perimeter of the subject composting facility containing visible iron-laden silty water. Based on topographic mapping, the subject facility is situated in the headwaters of the aforementioned stream. As a result, shallow groundwater discharge to the stream from beneath the subject facility would be most impacted after a rainfall in late summer months. As mentioned earlier in this letter, no surface water samples were collected for analyses in late summer. Also of note is that there is no monitoring well positioned between the subject facility and the stream where I have GW flow arrows shown on the attached figure.
