**Item No. 15.3.1**  
**Halifax Regional Council**  
**August 23, 2022**

**SUBJECT:** **Yellow Floating Heart Control – Little Albro Lake 2022**

In 2021, a research team from the Centre for Water Resource Studies at Dalhousie University (CWRS) undertook a pilot program testing the use of benthic mats to eradicate YFH in Little Albro Lake. The full report from this study can be found in Attachment A. Two types of barriers, permeable (to water flow) and impermeable, were installed in test plots between May 3-5, 2021, and monitored against adjacent control sites in both shallow (roughly 1 metre (m) in depth) and deep (roughly 3m in depth) areas of the lake. Plots were installed by Dominion Diving, with oversight by McCallum Environmental Ltd.

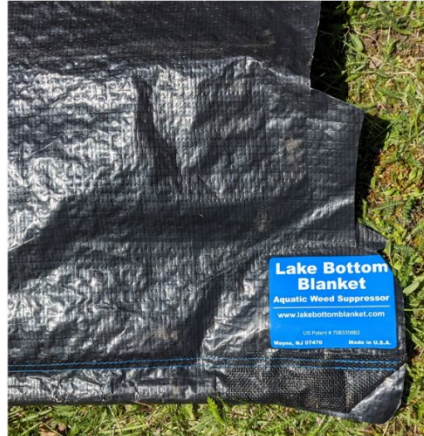
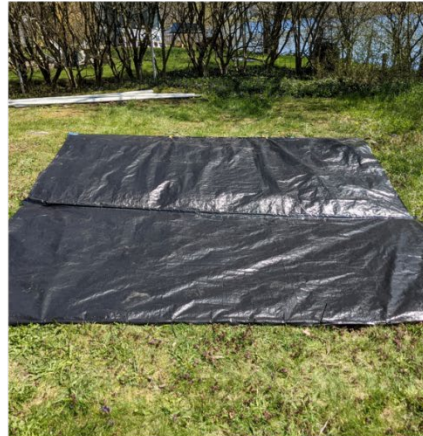
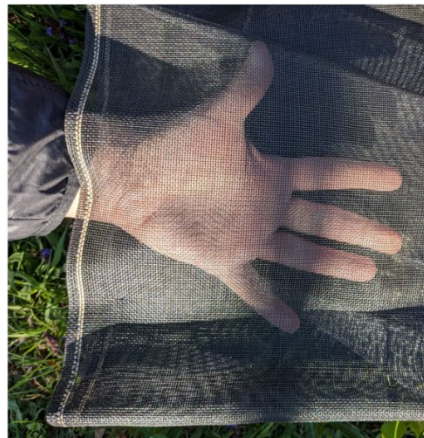
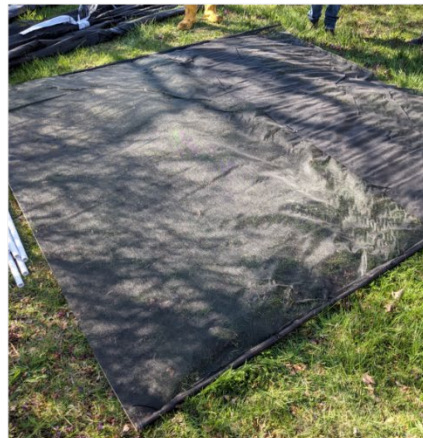
Figure 2. Barrier types used in Little Albro Lake Pilot Study. Top: Lake Bottom Blanket impermeable barrier, bottom: Aquascreen permeable barrier.

*Aquascreen* is a mesh fabric that is designed to allow liquids and gasses to pass freely across the barrier while prohibiting plants from growing up to the water surface (Figure 2). Plots barriered with this material were considered permeable plots. This barrier material does not prevent light from reaching the plants underneath them but retains the plants near the bottom of the lake.

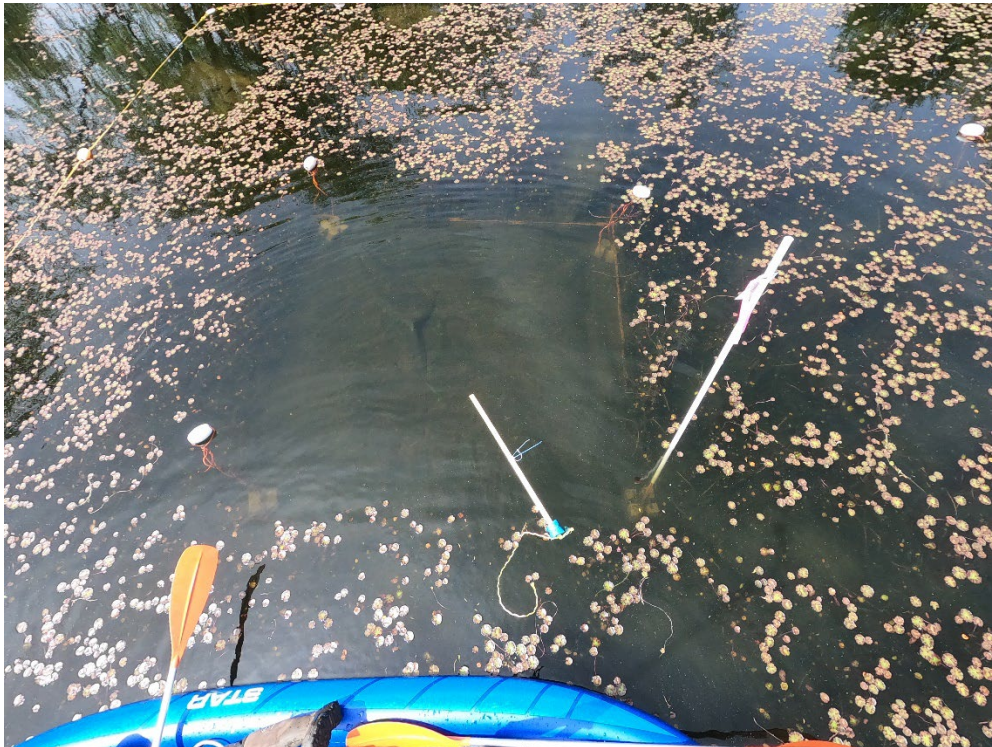
Figure 4. Overhead photo of a shallow permeable plot on May 28, 2021. Concrete blocks, horizontal rebar, and vertical marker visible under water.

Divers installed the control plots using a 3 m length of PVC as a guide to mark the plot corners with concrete blocks and buoys. The two types of barriers were installed differently. This was done to best approximate how each barrier type would perform at a larger scale. For barriered plots, the horizontal rebar was attached or fitted to barrier materials onshore and brought to the study areas on a boat. For permeable plots, all four edges of the material were anchored with a length of rebar to ensure the edges sat as flat against the lakebed as possible (Figure 4). Impermeable barriers were installed as specified by the manufacturer, with rebar fitted into sleeves in the material at two parallel edges, and through the middle in the same direction, to create two channels in each plot. Plots in the shallow zone could be installed with only one diver intermittently underwater to check the placement of the plot and condition of the barrier. The plots in the deep zone required more divers in under the water and took significantly longer to install.

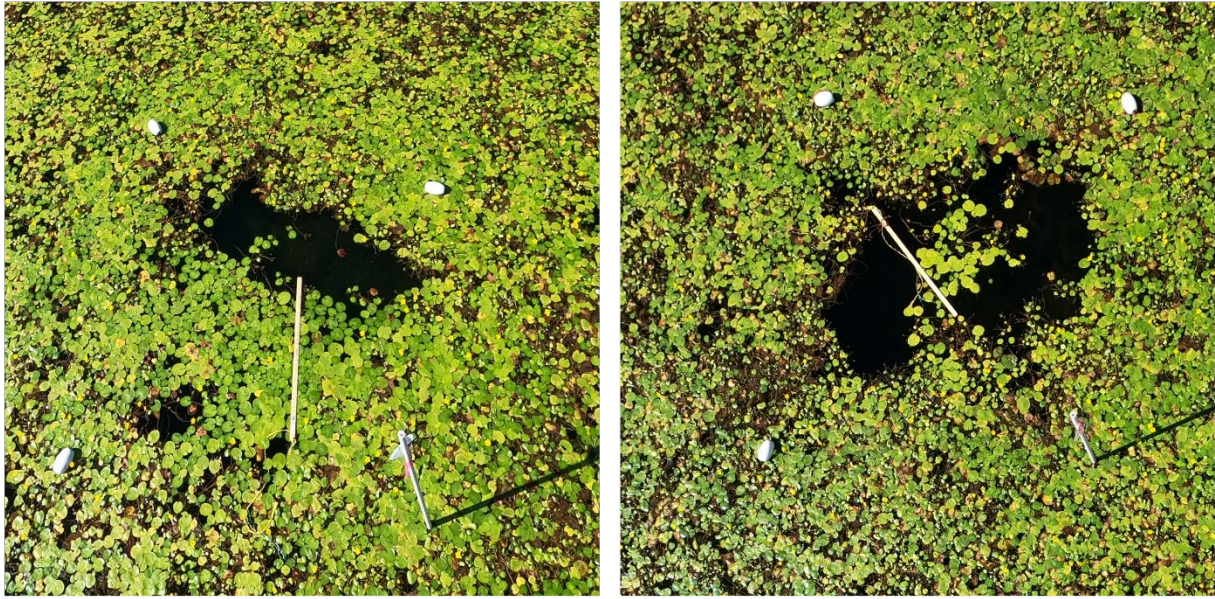
Figure 7. Failed barriers in shallow study zone, photographs taken on September 20th, left: plot 14P (permeable barrier), right: plot 17I (impermeable barrier).

Two barriered plots in the shallow zone had YFH growth occur in the centre of the plot. This growth was not rooted past the plot's edge, but on/through the barrier itself. The two plots in which this happened had different barrier types installed. Figure 7 shows the failed barriers in the shallow study zone. The permeable plot where this occurred, 14P, had a large amount of YFH growth, and by the end of the study period, the growth in this plot was so intense that the barrier was determined to have failed. In the impermeable plot where this occurred, 17I, the growth was minimal in comparison and contained to the centerline of the plot. Both plots were included in the statistical analysis.

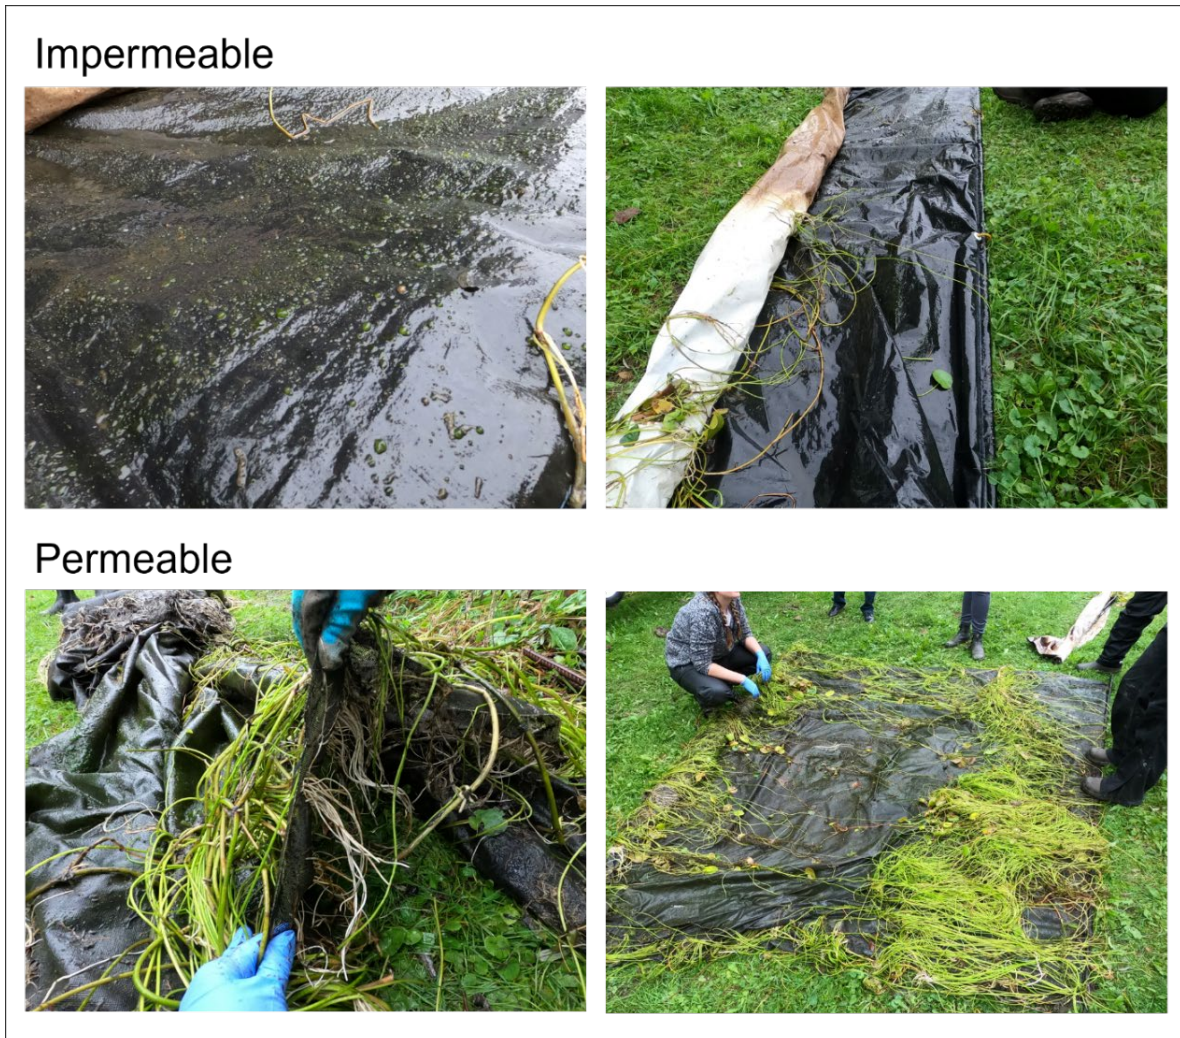
Figure 8. Barriers after removal from Little Albro Lake on September 29th, top: impermeable barrier, bottom: permeable barrier showing YFH growth through material.

Both types of barriers were effective in reducing YFH growth, with barriered plots possessing significantly less YFH coverage than control plots. Inspection of the permeable barriers after their removal from the lake, however, revealed that YFH had been able to grow through this barrier material. This indicates that the impermeable barrier (Lake Bottom Blanket) would be a more durable, and effective, product for YFH control. Several maintenance issues were noted during regular inspections conducted by diving technicians. Most notable was (i) gas build-up under the barriers, which caused billowing, and (ii) an accumulation of sediment on top of the barriers, and growth of YFH through these sediment layers. Both issues would need to be managed during a full-scale benthic barrier application program.

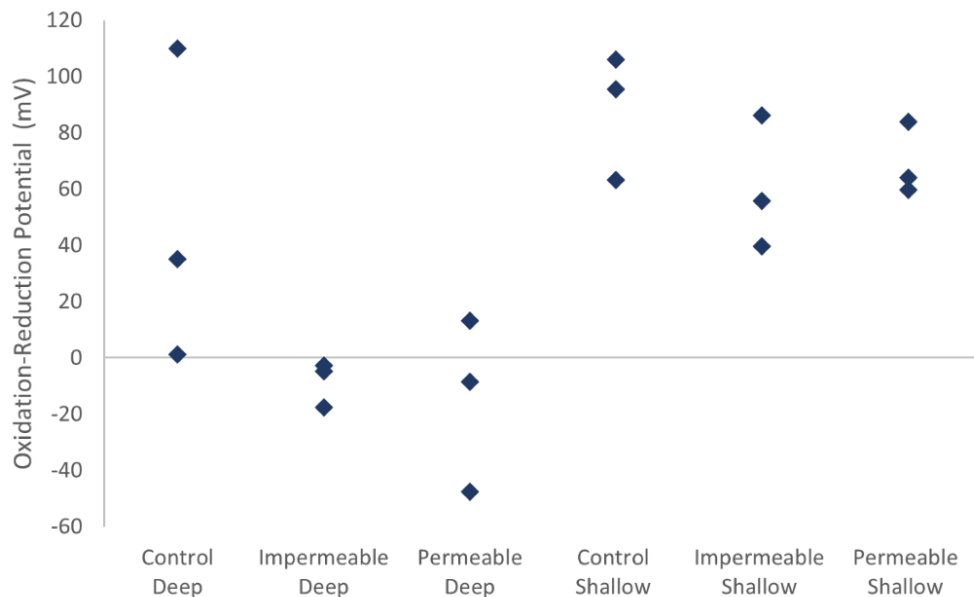
Figure 9. Oxidation-reduction potential measurements taken from sampled sediments of study plots after barrier removal, control plots: September 28th, barriered plots: September 29th.

When all three deep zone plot treatments were compared in a one-way ANOVA, no significant statistical difference was found between any treatments (control, permeable, impermeable) ( $p = 0.149$ ). However, when data from barriered plots (impermeable and permeable) is combined to create a 'barrier treated' category, barrier treated plots are found to be significantly different from control plots ( $p = 0.043$ ) (APPENDIX D).

Barriers in the shallow zone did not appear to affect the ORP of the sediments below them. The ORP values measured in these plots were close to those of control plots, with ORP values in all shallow zone plots being positive. ORP measurements taken at control plots ranged from 63 – 106 mV, while measurements at most of the barriered plots measured between 55 – 86 mV, with one plot (15I) having a lower ORP measurement of 40 mV (Figure 9). No plot type was found to be significantly different from another ( $p = 0.302$ ). Barriers in the areas deeper than 2 m altered the ORP of the lake sediments to be more strongly reducing environments than the sediments in control plots at the same depth. This difference was not dependent on barrier type. Sediment ORP in the shallow zone (~1 m) were not greatly altered by the barriers.

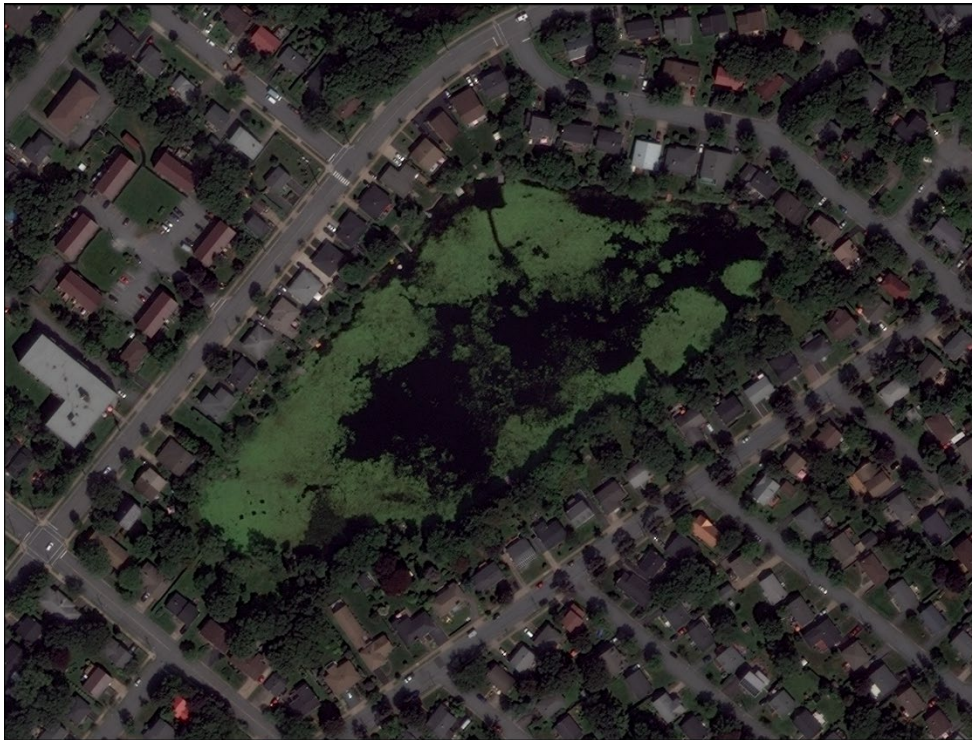
Figure 12. GE1 satellite image of YFH coverage of Little Albro Lake (40 cm resolution) acquired September 1, 2021

An image classification was performed on a 40 cm resolution GeoEye-1 satellite image taken September 1<sup>st</sup>, 2021, to determine the areal coverage of YFH during the peak of the growing season. The satellite image was acquired from Apollo Mapping and analyzed in ArcGIS Pro 2.7.0 using the Spatial Analyst extension. YFH was estimated to cover 55% of the lake surface on September 1<sup>st</sup>, 2021, at a maximum depth of 3.1 m. This YFH coverage is illustrated in Figure 12. To cover this area with benthic barriers, adding an extra 10% (65% lake surface area) to account for wastage and overlapping sections, would require approximately 19,500 m<sup>2</sup> of material. The impermeable barrier product (Lake Bottom Blanket) costs approximately \$14/m<sup>2</sup>, therefore the costs of the barriers for a full-scale application would be in the range of \$270,000. Other potential costs would include (i) additional materials (e.g., rebar), (ii) labour for installation, maintenance, and removal of the barriers, (iii) consulting fees for planning, permitting, and monitoring of the restoration program, (iv) laboratory fees for sediment and water quality monitoring, and (v) disposal of the barriers in an appropriate landfill facility at the end of the project. It should be noted that the barriers may need to be installed and removed annually for several years to eradicate and/or control YFH.
