**SUBJECT:** **HRTG-2023-00871: Substantial Alteration to the municipally registered heritage property at 17 Banook Avenue, Dartmouth**

# BANOOK CANOE CLUB RENOVATIONS HERITAGE IMPACT STATEMENT

**BANOOK CANOE CLUB RENOVATIONS PHASE 2**  
17 BANOOK AVE.  
DARTMOUTH, NOVA SCOTIA  
**BUILDING ELEVATIONS**  
Drawing number  
**A-4**

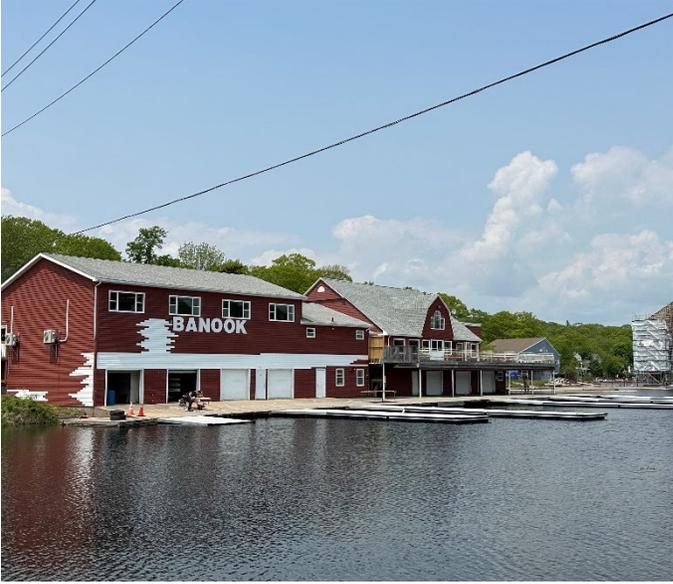
**17 Banook Avenue (c.1906)**

- Early recreational club building designed by Dartmouth architect H.E. Gates circa 1906;
- Wood framing;
- Wood shake cladding;
- Gambrel dormer with Palladian window;
- Gable roof with protruding triangular inset;
- Moulded trim around fenestration; and,
- View of Lake Banook.

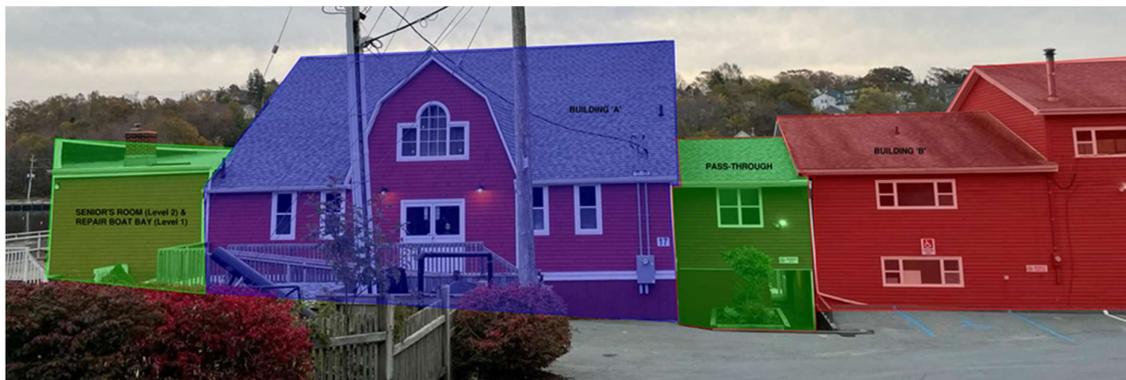
**Figure 1.0 – Building Sections**

Throughout this report, we will make numerous references to Building A and Building B – building A being the heritage classified section of the complex. Please see the inserted figures below.

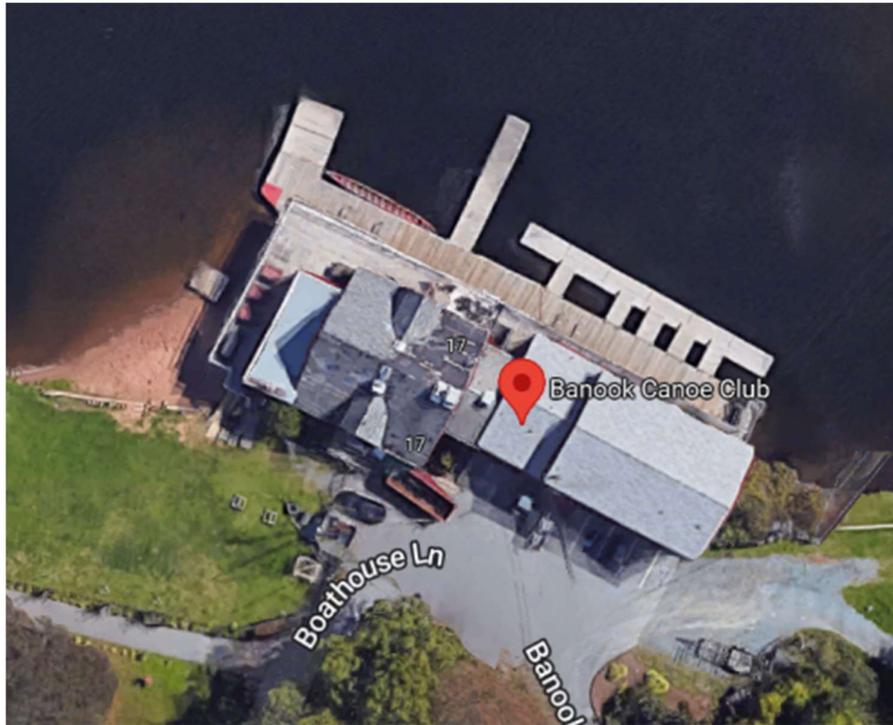
Figure 3.0 - Aerial View of Banook Canoe Club

Throughout years of upgrades, the building has remained in the same spot with similar wharf access throughout the last 120 years.

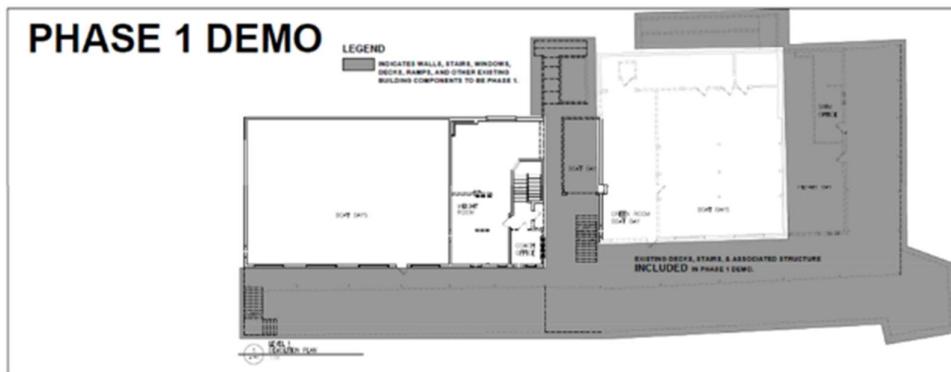
Level 1 Proposed Demo

To accomplish the structural upgrades, the “Senior Room” and Boat Bay directly underneath, as well as the “pass through” structure on the opposite side of Building A, will need to be demolished to enable the isolation of Buildings A and B to enable the replacement of the deteriorated and heavily cracked foundation. Sketches indicating the areas to be demolished have been provided at the end of this section.

**Figure 4.0 – Demolition Markups**

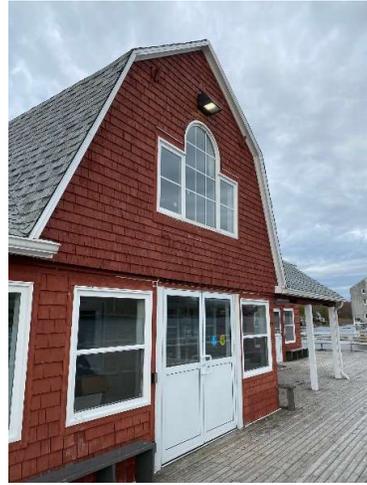
Gambrel Roof Line at the front and back of the building

These are the most prominent features of the canoe club, which has existed and been retained since the original construction in early 1900s.

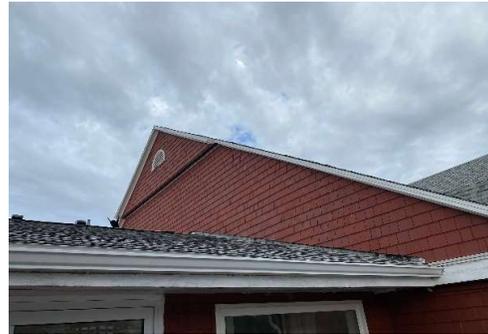
Gable roof jut outs along with a semi-circle vent

A lot of the Dartmouth residential properties that are historic have similar roof styles, on a smaller scale. While the residential soffits tend to be wider, the use of it here warrants heritage value.

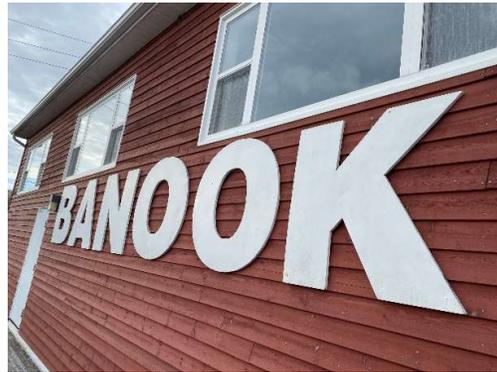
Building 'A' currently has vinyl windows that will be replaced with wood windows. They will be designed to enhance the heritage features of the building and reflect the original look of the building.

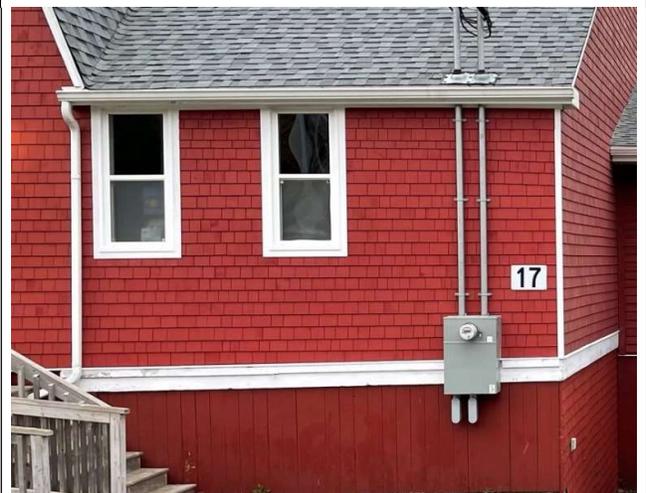
Cedar siding (shake styled) and white trim work around windows, roof lines.

This is a large feature of the majority of historic properties in Dartmouth.

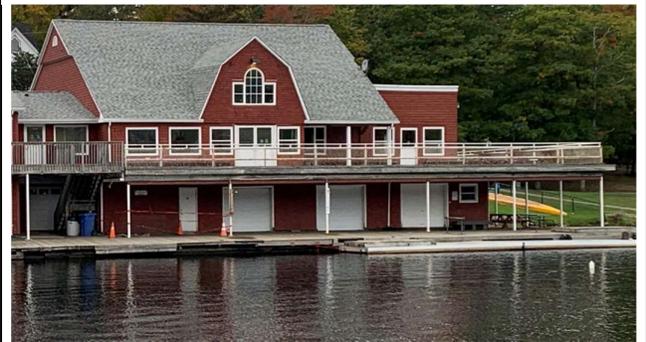
Exterior Veranda/Patio (Lakeside Facing)

The second floor façade was originally symmetrical on either side of the door; a feature that was changed in a later revision to what you see in the photograph.

This proposal will reinstate the symmetry.

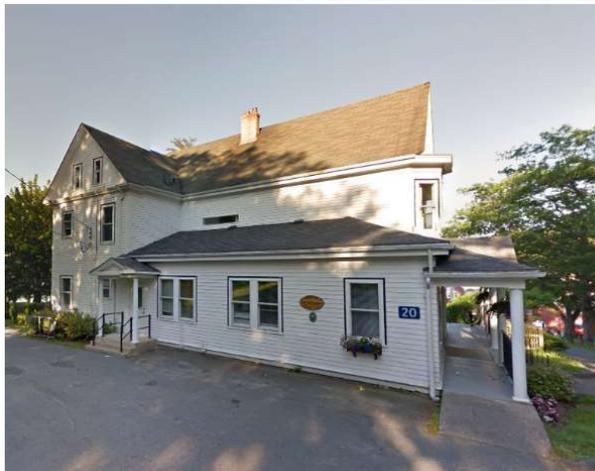
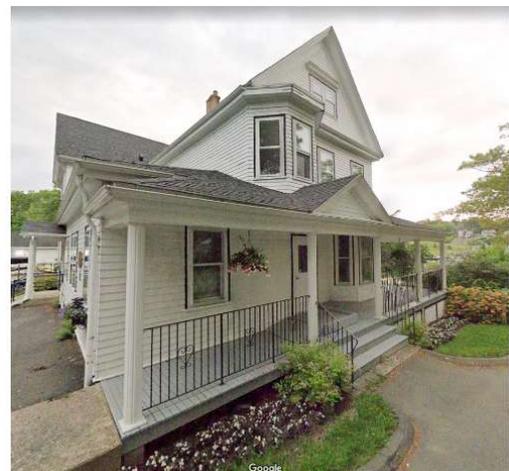
**Figure 5.1 - Oakwood House**

The Oakwood House is a fellow rowing house owned and operated by the North Star Rowing Club. There are some similarities to the two properties. The ages of the buildings are within years of original construction, have similar gable style roof features and window placement. The Oakwood House heritage features are more in line with other residential historical properties in Dartmouth but both of these properties compliment the neighbourhood well.

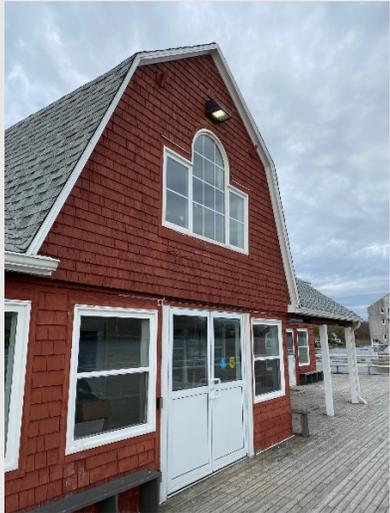
<p>Element: Gambrel roof line at the front and back of the building</p> <p>This is the most prominent feature of the canoe club, which has existed and has been retained since the original construction in the early 1900s.</p> <p>No change to be made here – fully retained.</p>

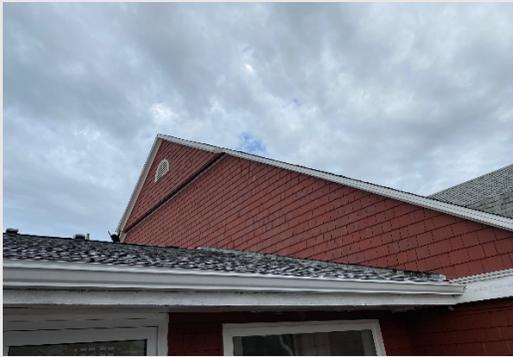
<p>Element: Gable roof jut outs along &amp; half-moon vent</p> <p>A lot of the Dartmouth residential properties that are historic have similar roof styles, on a smaller scale. While the residential soffits tend to be wider, the use of it here warrants heritage value.</p> <p>No change to be made here – fully retained.</p>

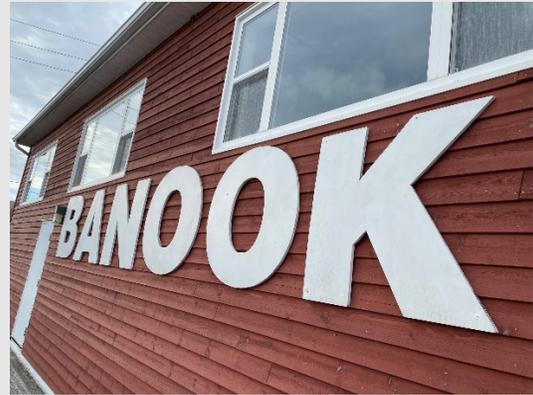
Element: Windows placement, wide frames and white frames

Building A currently has vinyl windows that will all be replaced with wood windows, that will be designed to reflect the heritage era of the building.

Installation of wood windows will restore a more original look.

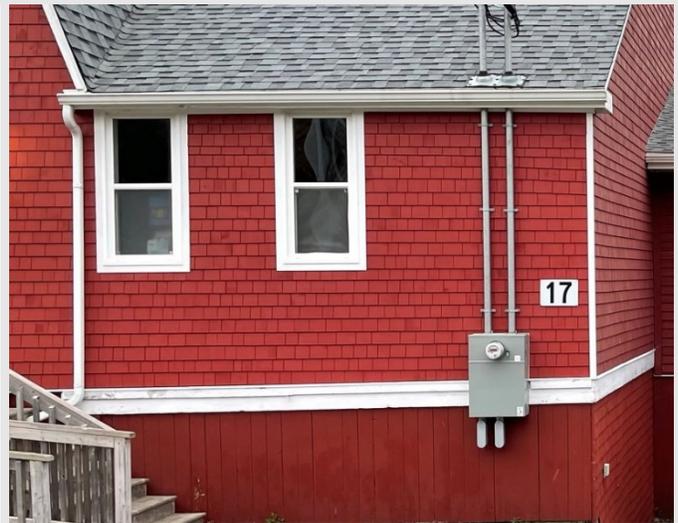
Element: Cedar siding (shake styled) and white trim work around windows, roof lines.

This is a large feature of the majority of historic properties in Dartmouth.

No change here – reuse of wood siding will retain original look.

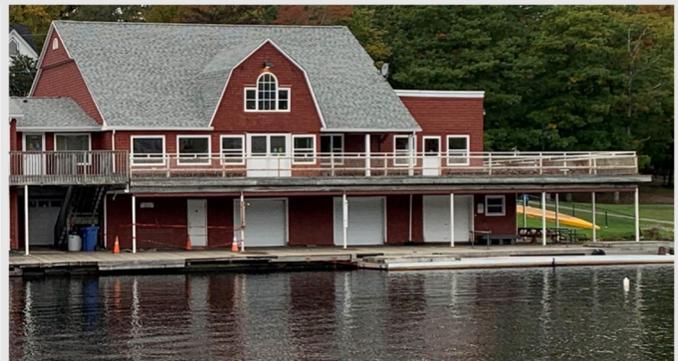
Exterior Veranda/Patio (Lakeside Facing)

This feature has evolved but has been maintained since day 1 of the club.

The original second floor façade was originally symmetrical on either side of the door; a feature that was changed in a later revision. These upgrades will reinstate the symmetry.

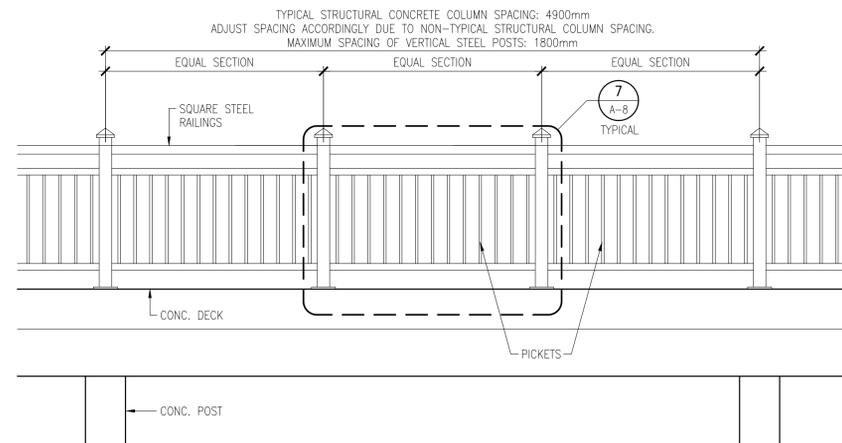
**6** ELEVATION - TYPICAL GUARDRAIL  
A-8 1:25

**NOTES:**  
- ALL RAILS, POSTS AND PICKETS TO BE CUSTOM SQUARE STEEL TUBES  
- HOT-DIPPED GALVANIZED, BRUSH-BLASTED  
- SINGLE COAT OF EPOXY, SINGLE COAT OF POLYURETHANE TOPCOAT  
- SHOP DRAWINGS TO BE SUBMITTED PRIOR TO FABRICATION

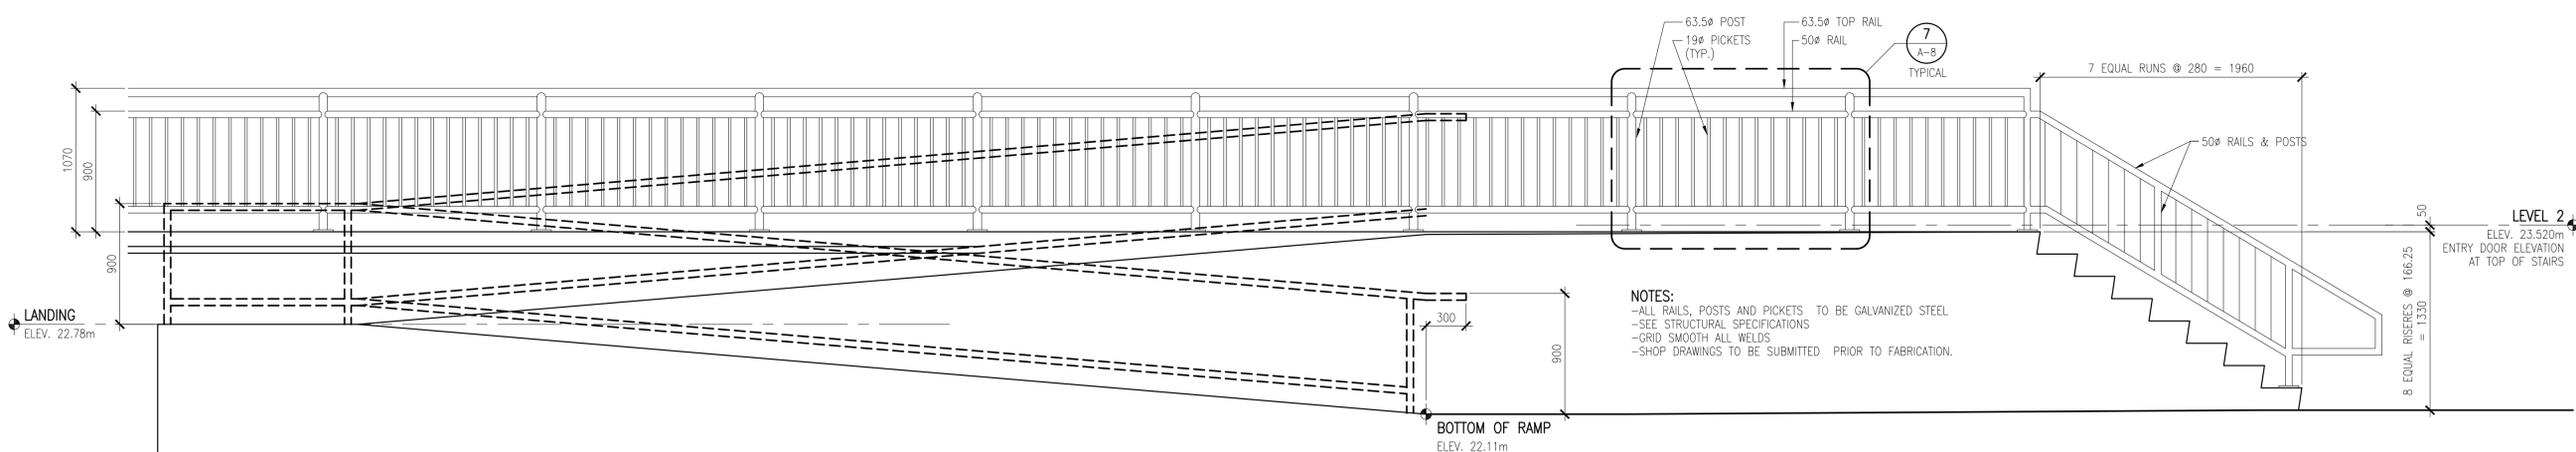
**NOTES:**  
- ALL RAILS, POSTS AND PICKETS TO BE GALVANIZED STEEL  
- SEE STRUCTURAL SPECIFICATIONS  
- GRID SMOOTH ALL WELDS  
- SHOP DRAWINGS TO BE SUBMITTED PRIOR TO FABRICATION.

RAILINGS POSTS & PICKETS OF RAMPS NOT SHOWN FOR CLARITY - SEE **7** A-8 SIMILAR - NO TOP RAIL
